**Investigation of Paint Failure at
Brunswick Estate
Hove
Brighton**

August 2013

**BRUNSWICK ESTATE
HOVE**

The following document investigates the failure of the external paint-system at Brunswick Estate, Hove based on research carried out by Elizabeth Hirst and Rachel Morley of Hirst Conservation between August and November 2013. The work was commissioned by Brighton & Hove City Council.

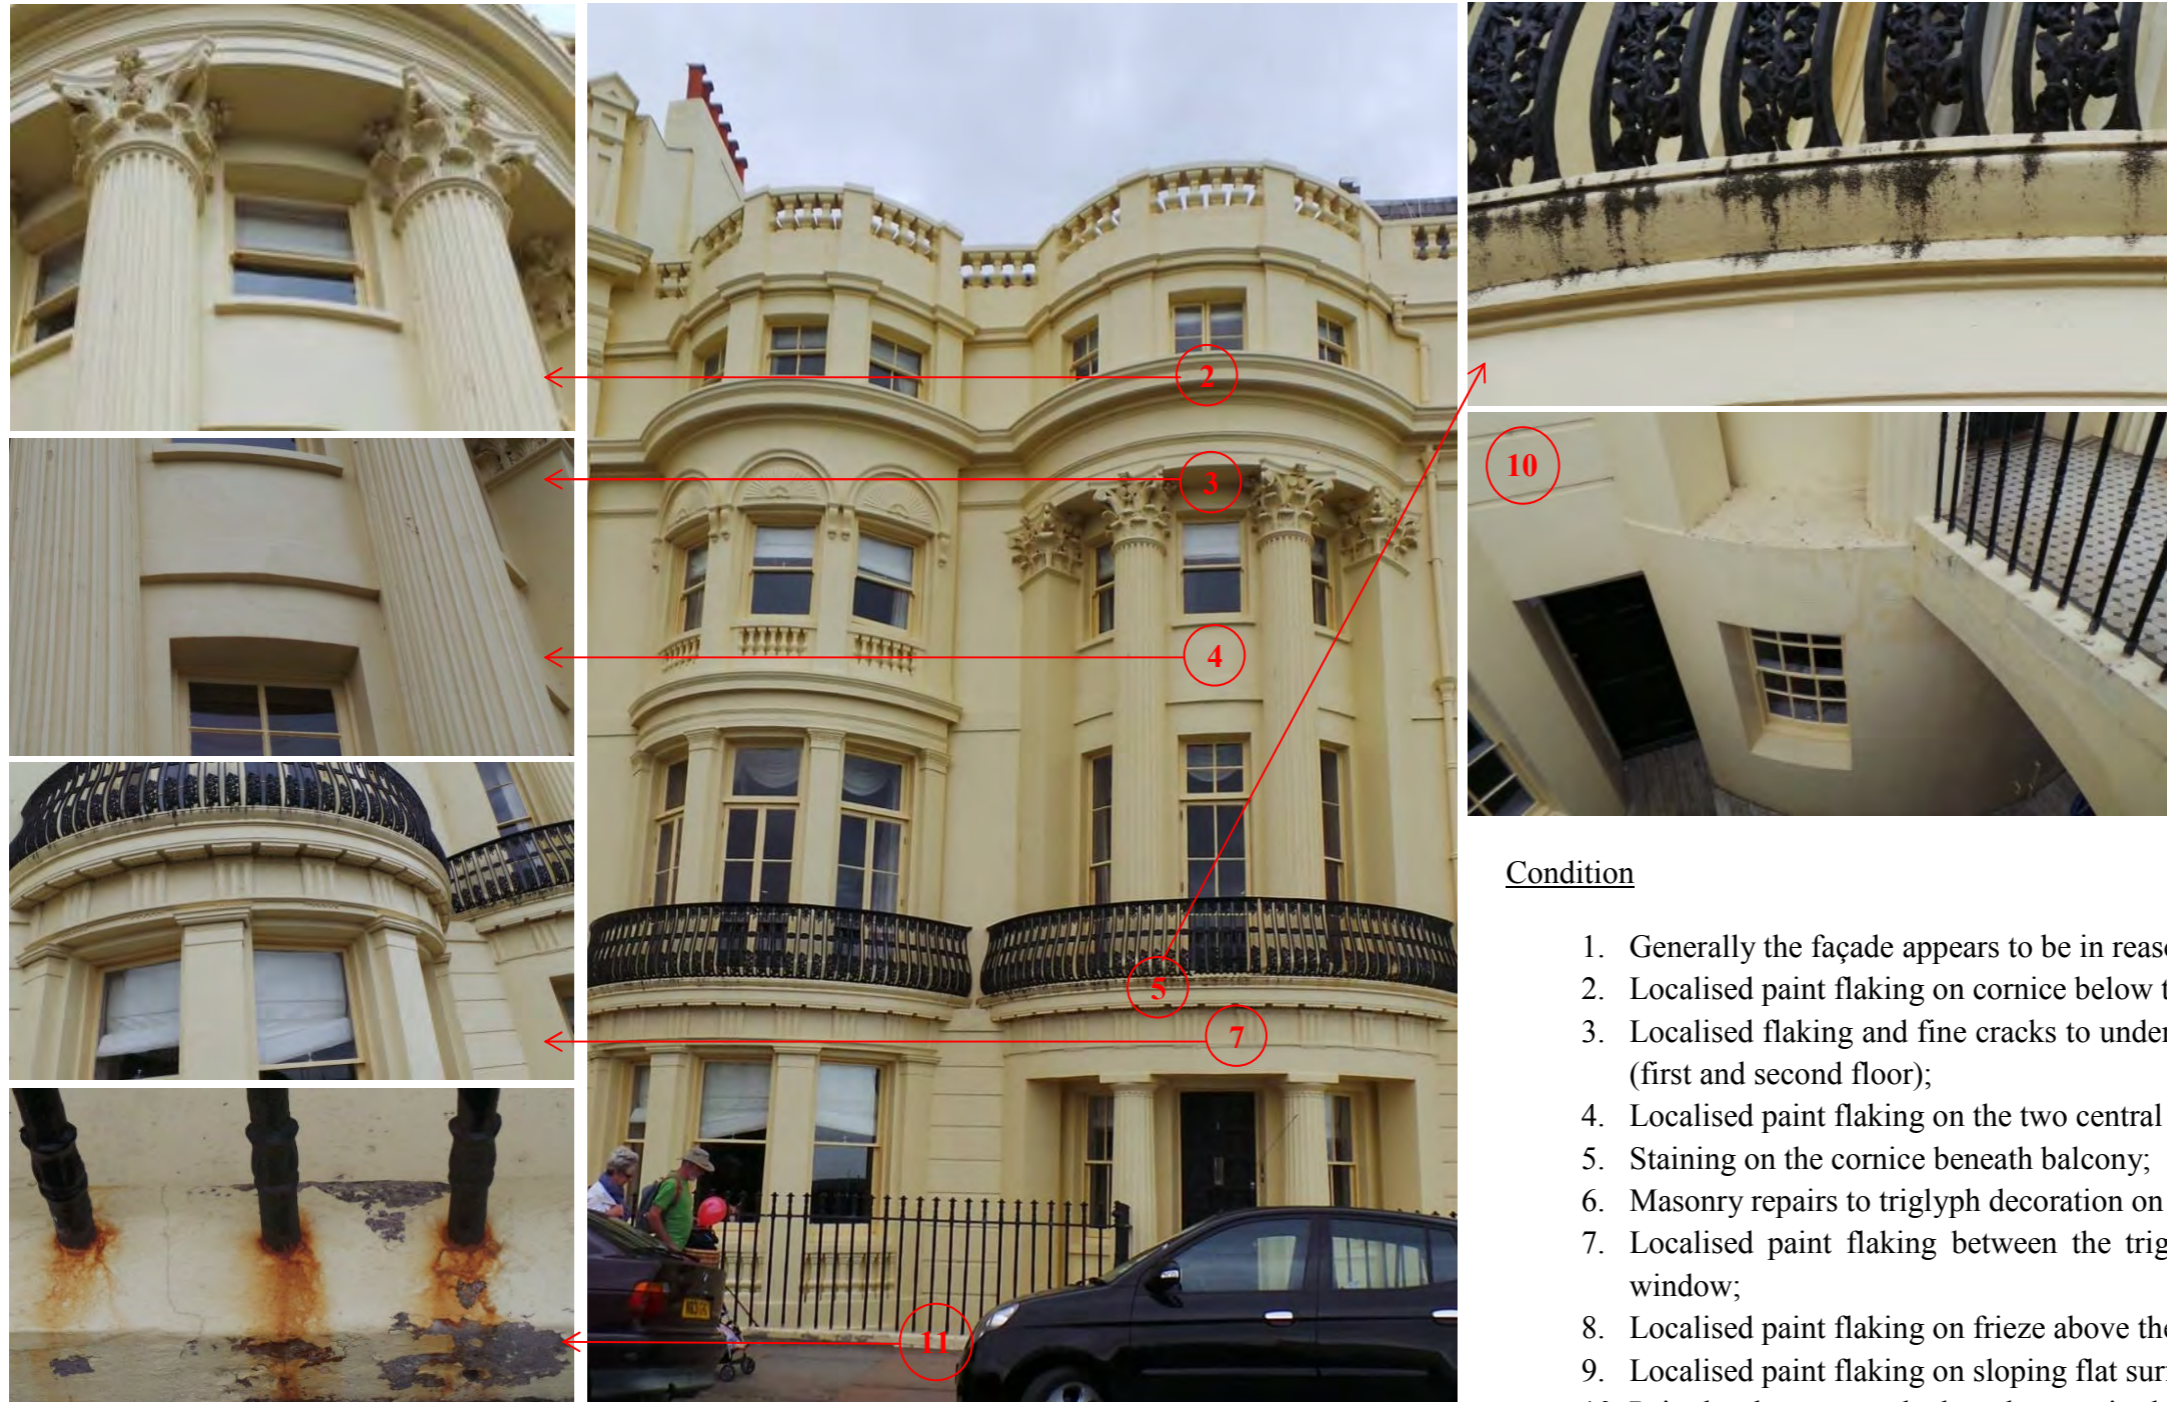
4.1 1 Brunswick Square

1. Generally the façade appears to be in reasonably good condition;
2. Localised paint flaking on cornice below the third floor;
3. Localised flaking and fine cracks to underside of the entablature between the central columns (first and second floor);

4. Localised paint flaking on the two central columns (first and second floor);
5. Staining on the cornice beneath balcony;
6. Masonry repairs to triglyph decoration on the frieze above the doorway;

7. Localised paint flaking between the triglyph decoration on the frieze above ground floor window;
8. Localised paint flaking on frieze above the doorway possibly as a result of salts and moisture;

11. Failing paint on the masonry below the railings adjacent to pavement and entrance path;
12. Generally the painted timber work appears to be in reasonably good condition.

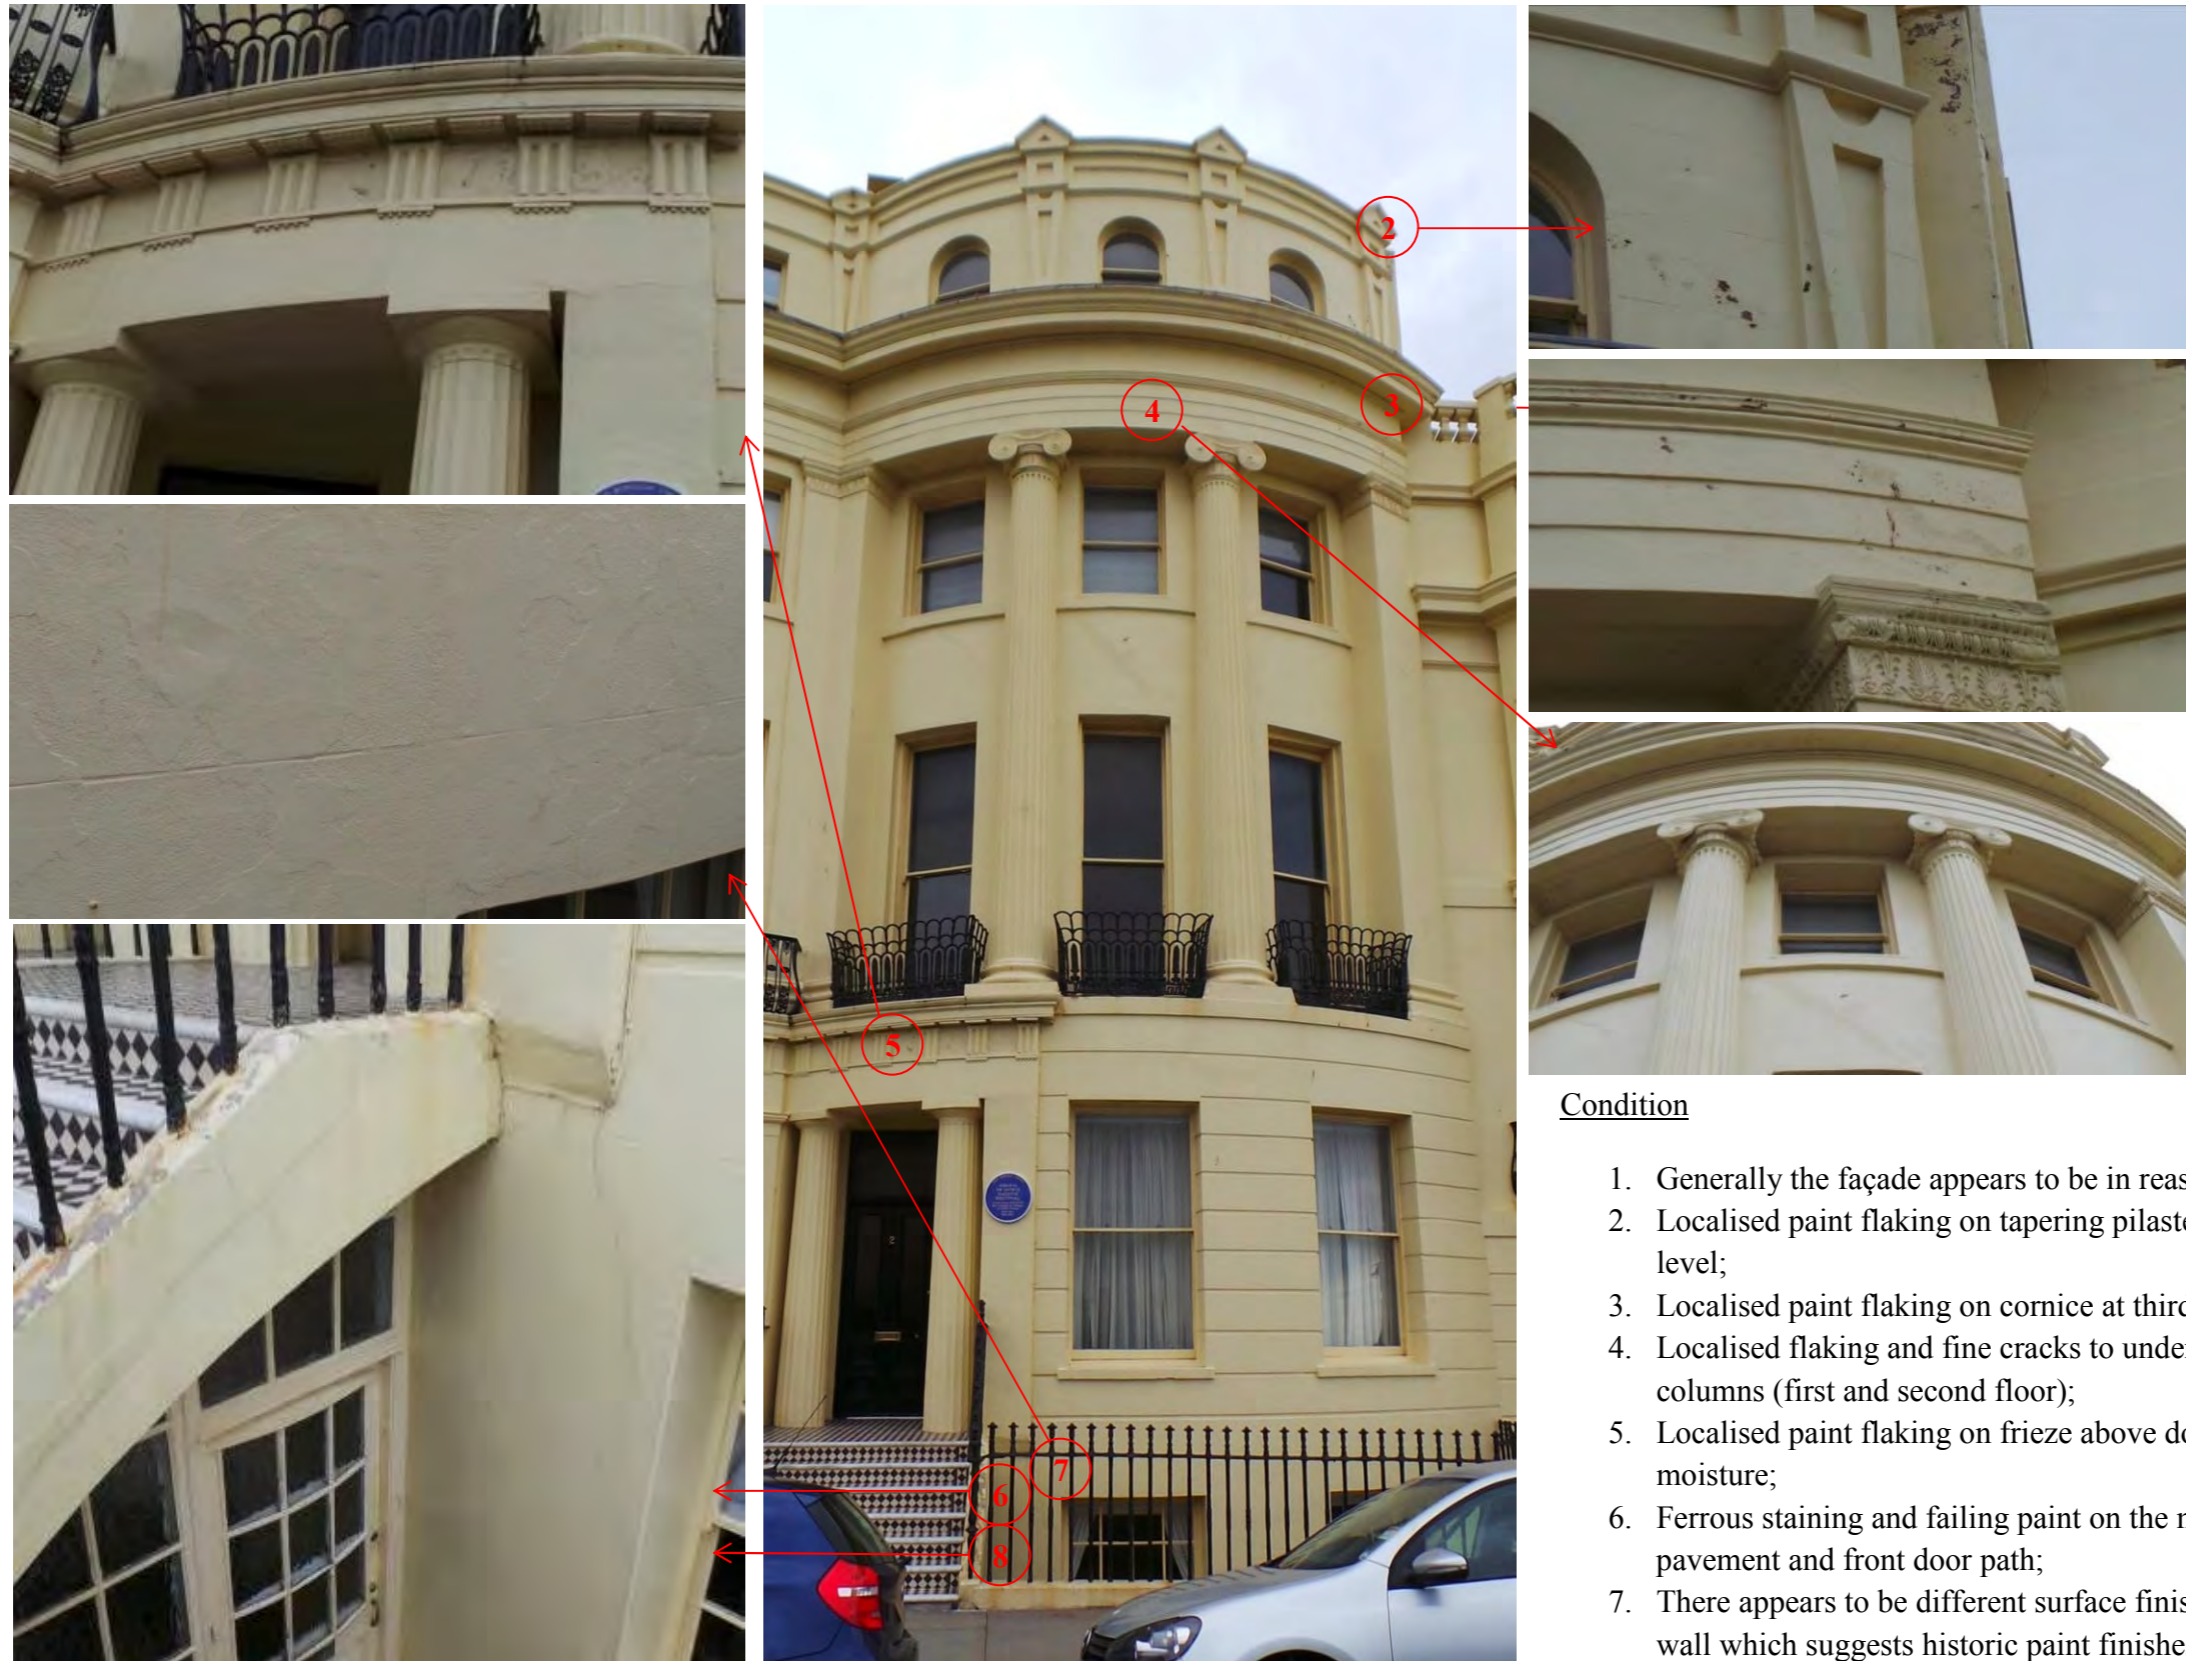
2 Brunswick Square

1. Generally the façade appears to be in reasonably good condition;
2. Localised paint flaking on tapering pilasters and adjacent wall at third floor level;
3. Localised paint flaking on cornice at third floor level;
4. Localised flaking and fine cracks to underside of entablature between central columns (first and second floor);
5. Localised paint flaking on frieze above doorway possibly as a result of salts and moisture;
6. Ferrous staining and failing paint on the masonry below the railings adjacent the pavement and front door path;
7. There appears to be different surface finishes (paint/render) on the basement wall which suggests historic paint finishes remain in localised areas;
8. The painted timber generally appears to be in a reasonable condition although the timber at basement level is in poor condition.

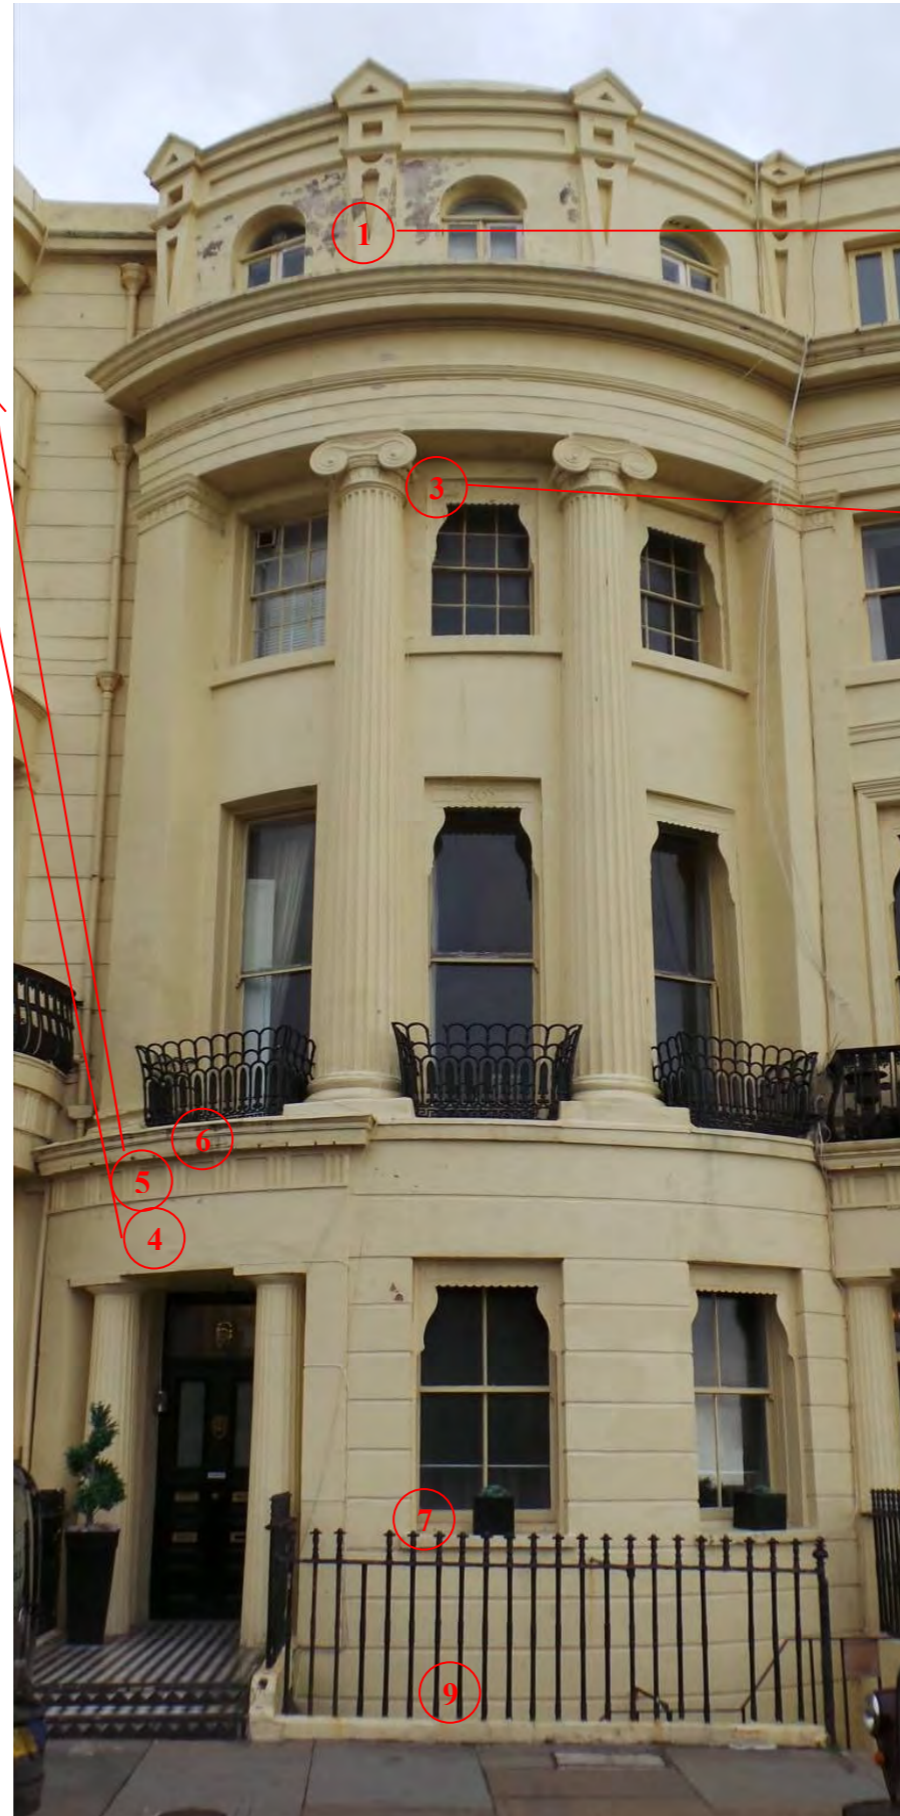
6 Brunswick Square

1. Extensive paint flaking to parapet;
2. Localised paint flaking to cornice. This may be due to the lead capping above the cornice has been removed causing moisture damage;
3. Localised flaking and fine cracks above the windows at second floor level;
4. Localised paint flaking on frieze above the doorway possibly as a result of salts and moisture;
5. Masonry repairs to the triglyph decoration on frieze above the doorway;
6. Staining on the cornice beneath balcony;
7. Localised paint flaking on window ledge (ground floor level);
8. The render substrate has been 'patched-in' with an inappropriate repair material and the paint has been retouched around the ground floor windows;
9. Vegetation growth (mould and algae) at basement level indicates excessive moisture and insufficient drying-out of substrate. Extensive paint flaking at basement level.

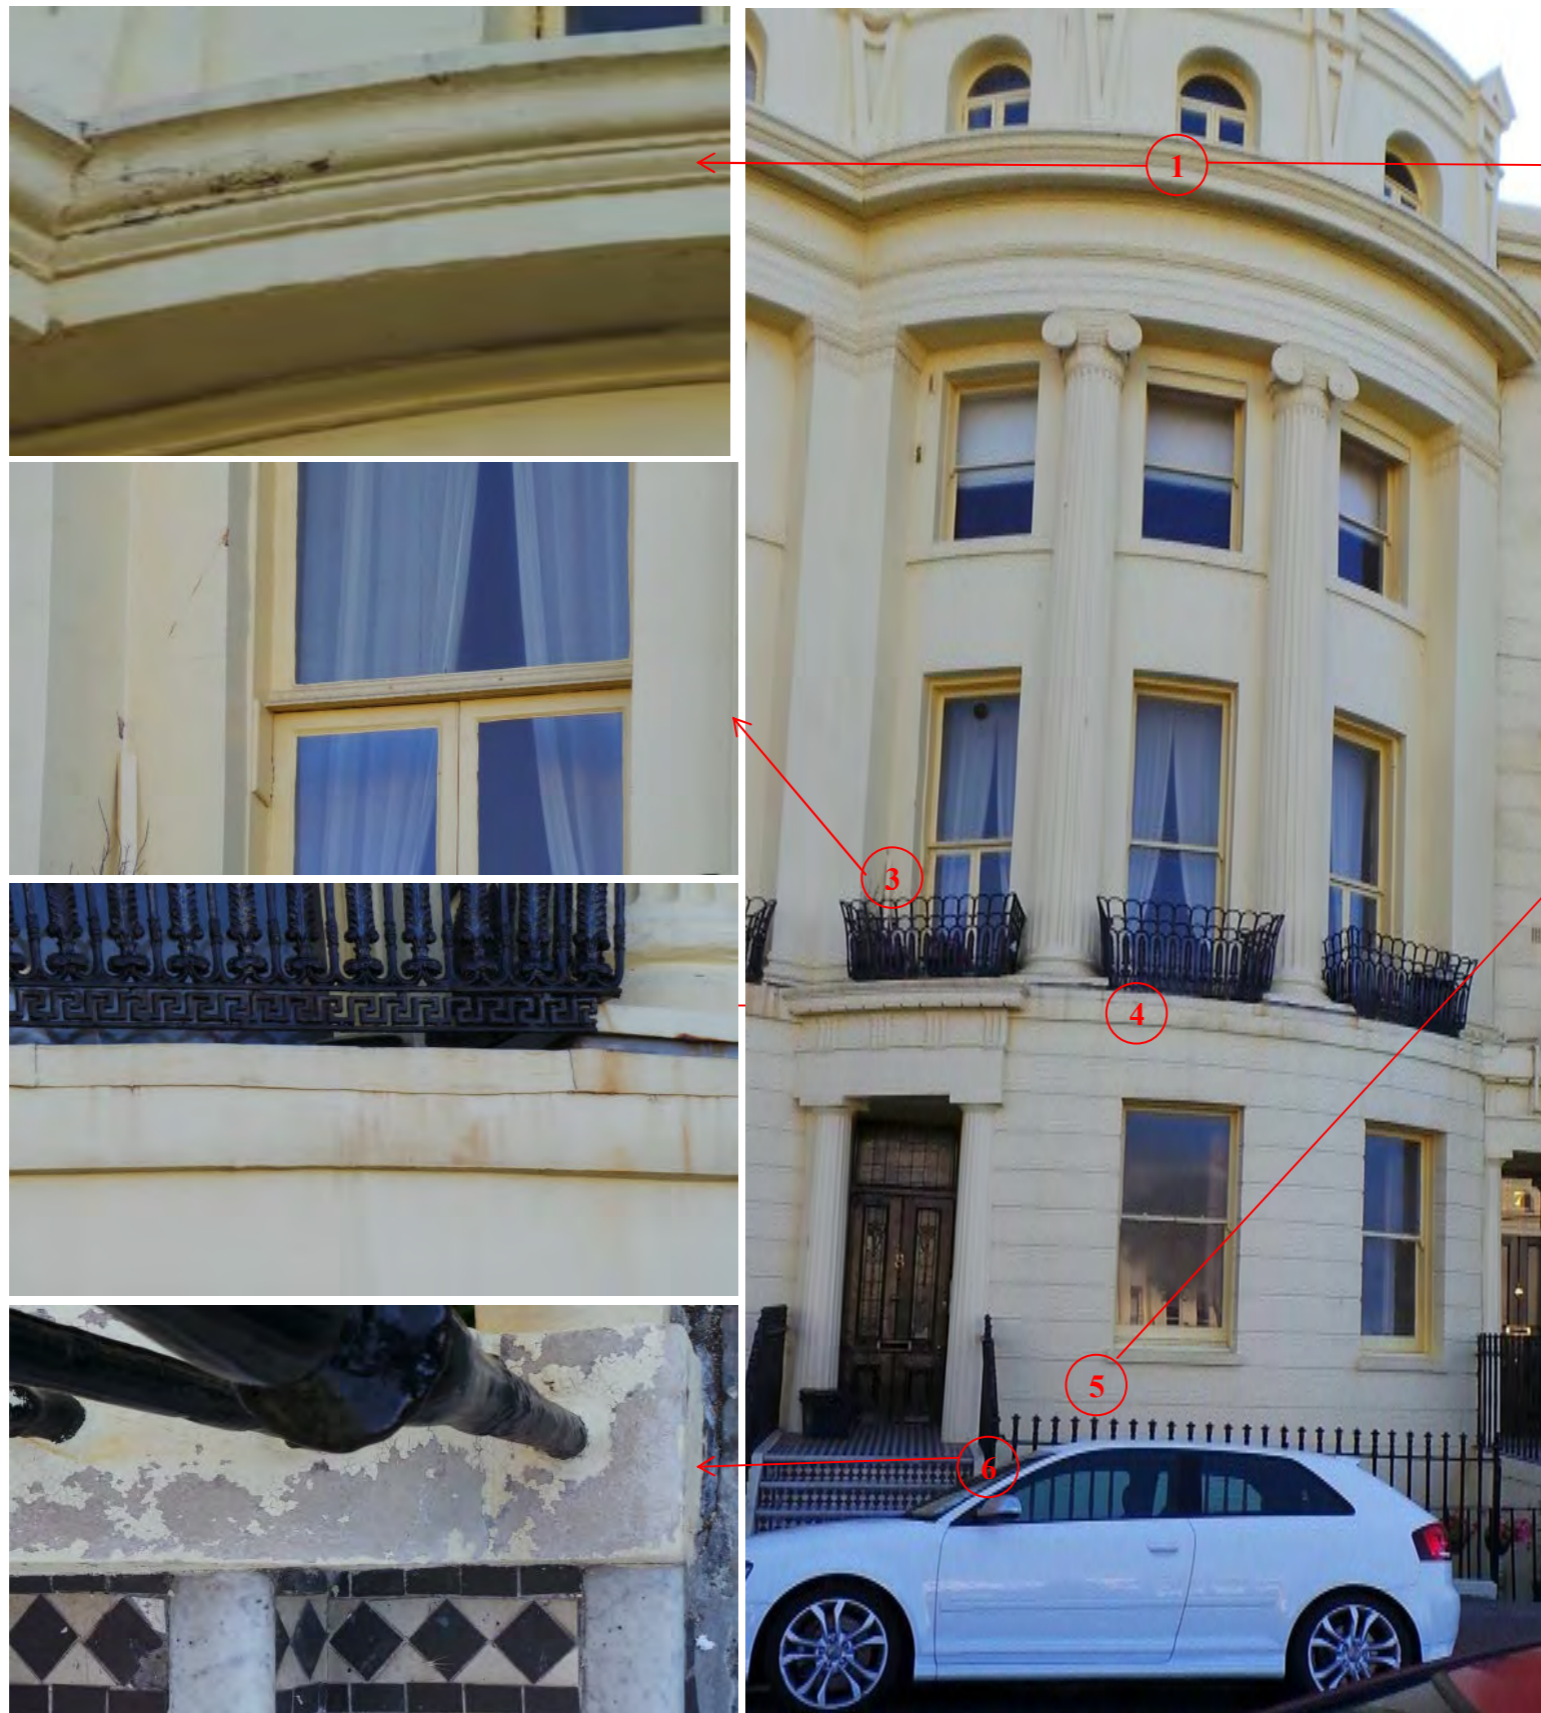
8 Brunswick Square

1. Extensive paint flaking to cornice
2. Localised flaking and fine cracks between the two central columns (between first and second floor levels);
3. Fracture running vertically on the left hand side of the left window (first floor level);
4. Staining on the cornice beneath the three wrought iron balconies (first floor level);
5. Fracture running vertically from the left hand corner of the right hand window sill (ground floor level) to the top of the right hand basement window beneath;
6. Failing paint on the masonry below the railings adjacent the pavement and front door path;
7. Generally the painted timber work appears to be in reasonably good condition.

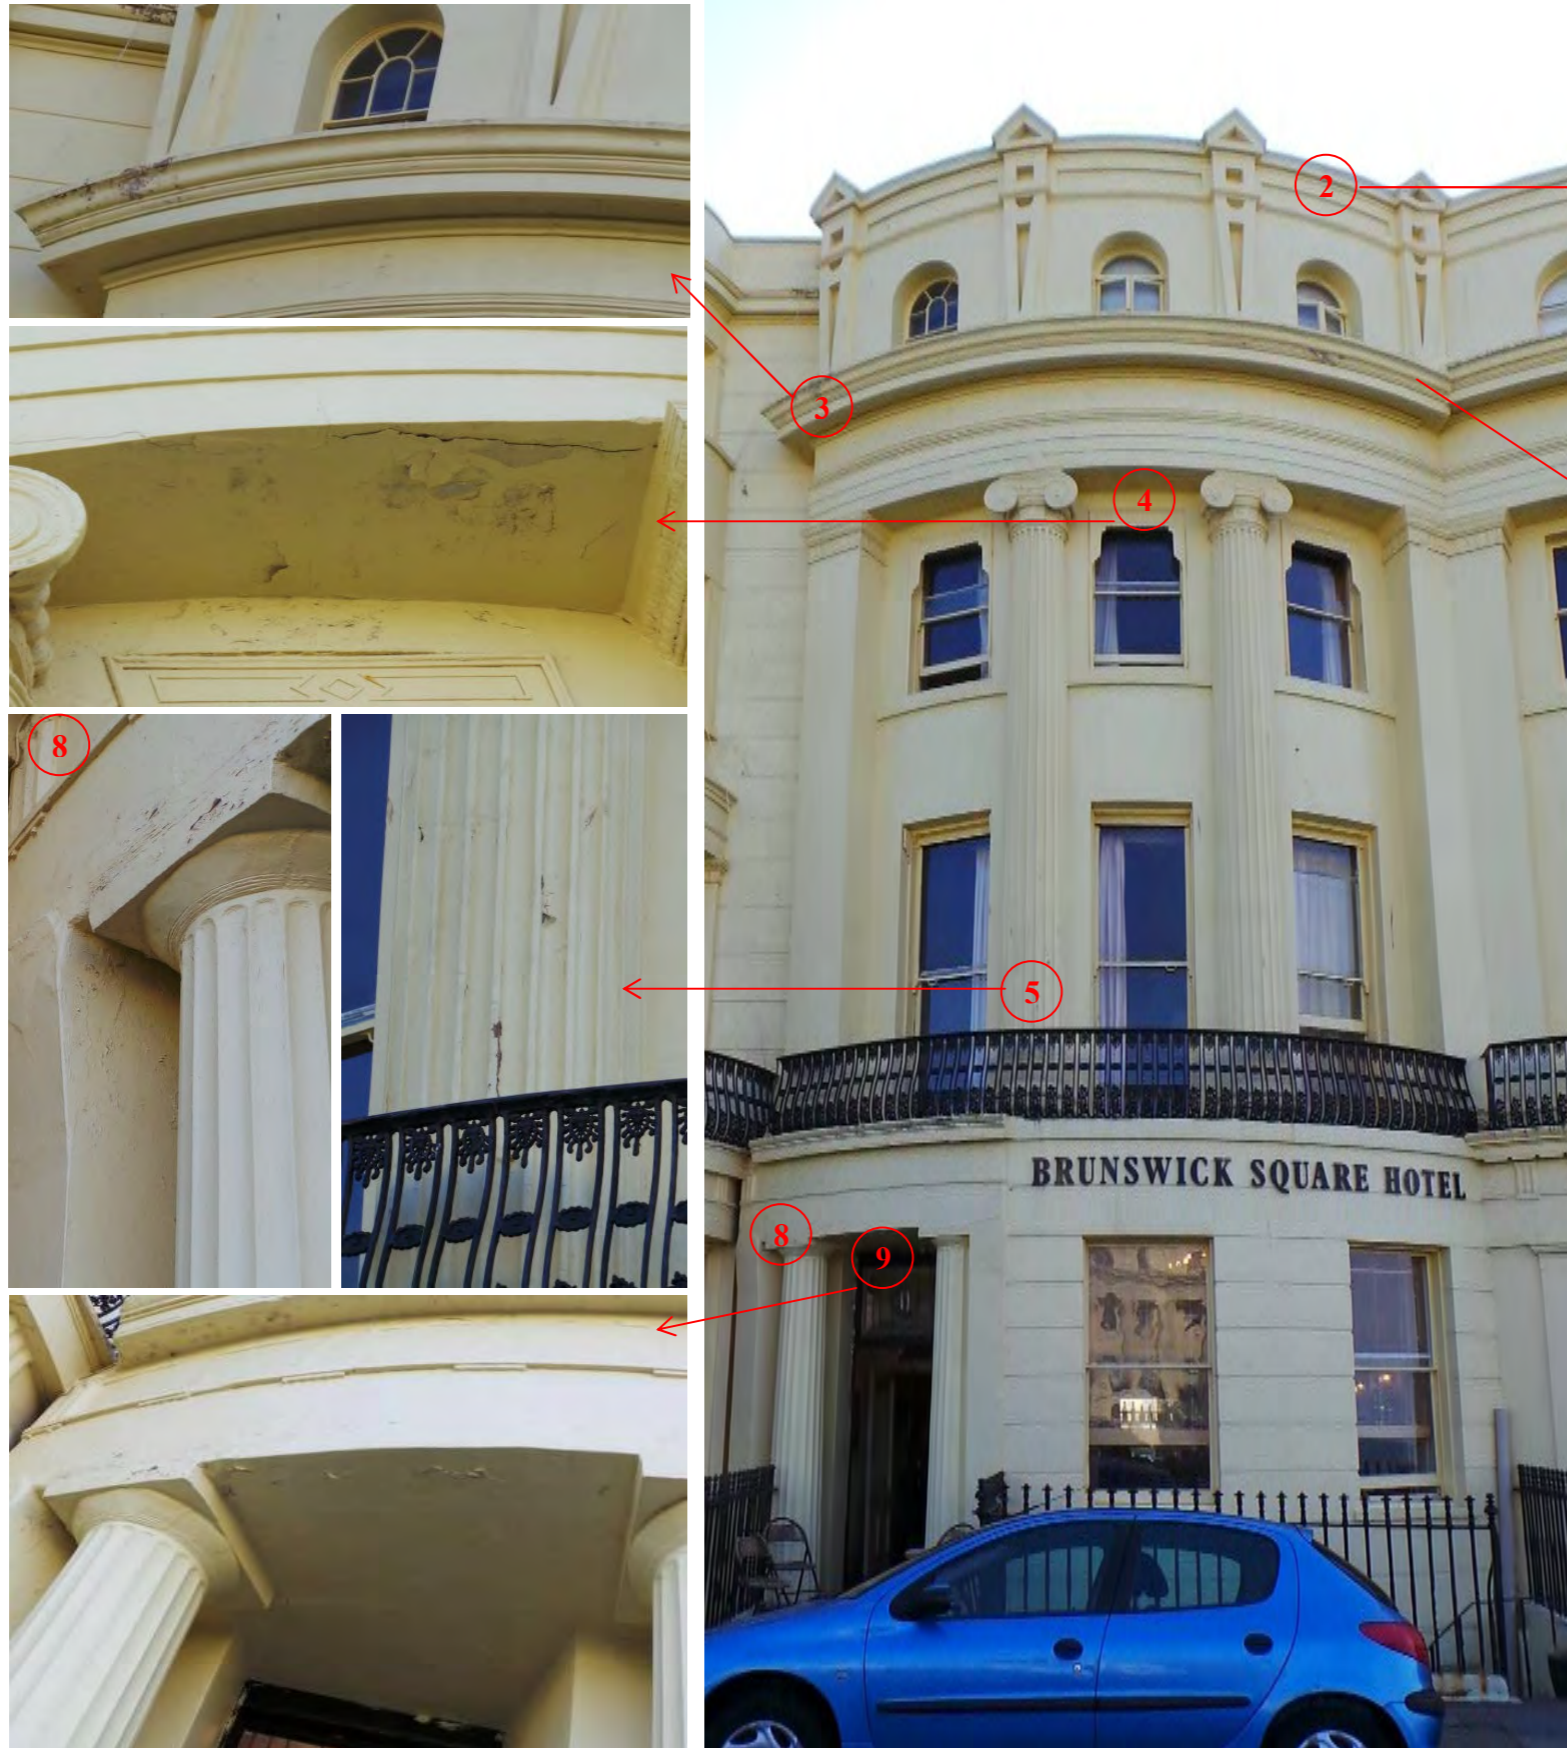
11 Brunswick Square

1. Localised paint flaking on the panelling on the left hand side above left window at parapet level;
2. Localised paint flaking on the right hand pediment at parapet level;
3. Extensive paint flaking and fine cracks to cornice;
4. Localised flaking and blistering above each of the windows on the underside of the cornice;
5. Fracture and localised paint flaking on the left hand column at first floor level;
6. Staining on the cornice beneath balcony;
7. Triglyph decoration to frieze above the doorway has been lost;
8. Localised paint flaking on the column on the left hand side of the front door;
9. Localised paint flaking on the underside of the porch;
10. Failing paint on the masonry below the railings adjacent the pavement and front door path;
11. Biological growth (mould and algae) and localised paint flaking on the basement walls indicating excessive moisture within the substrate

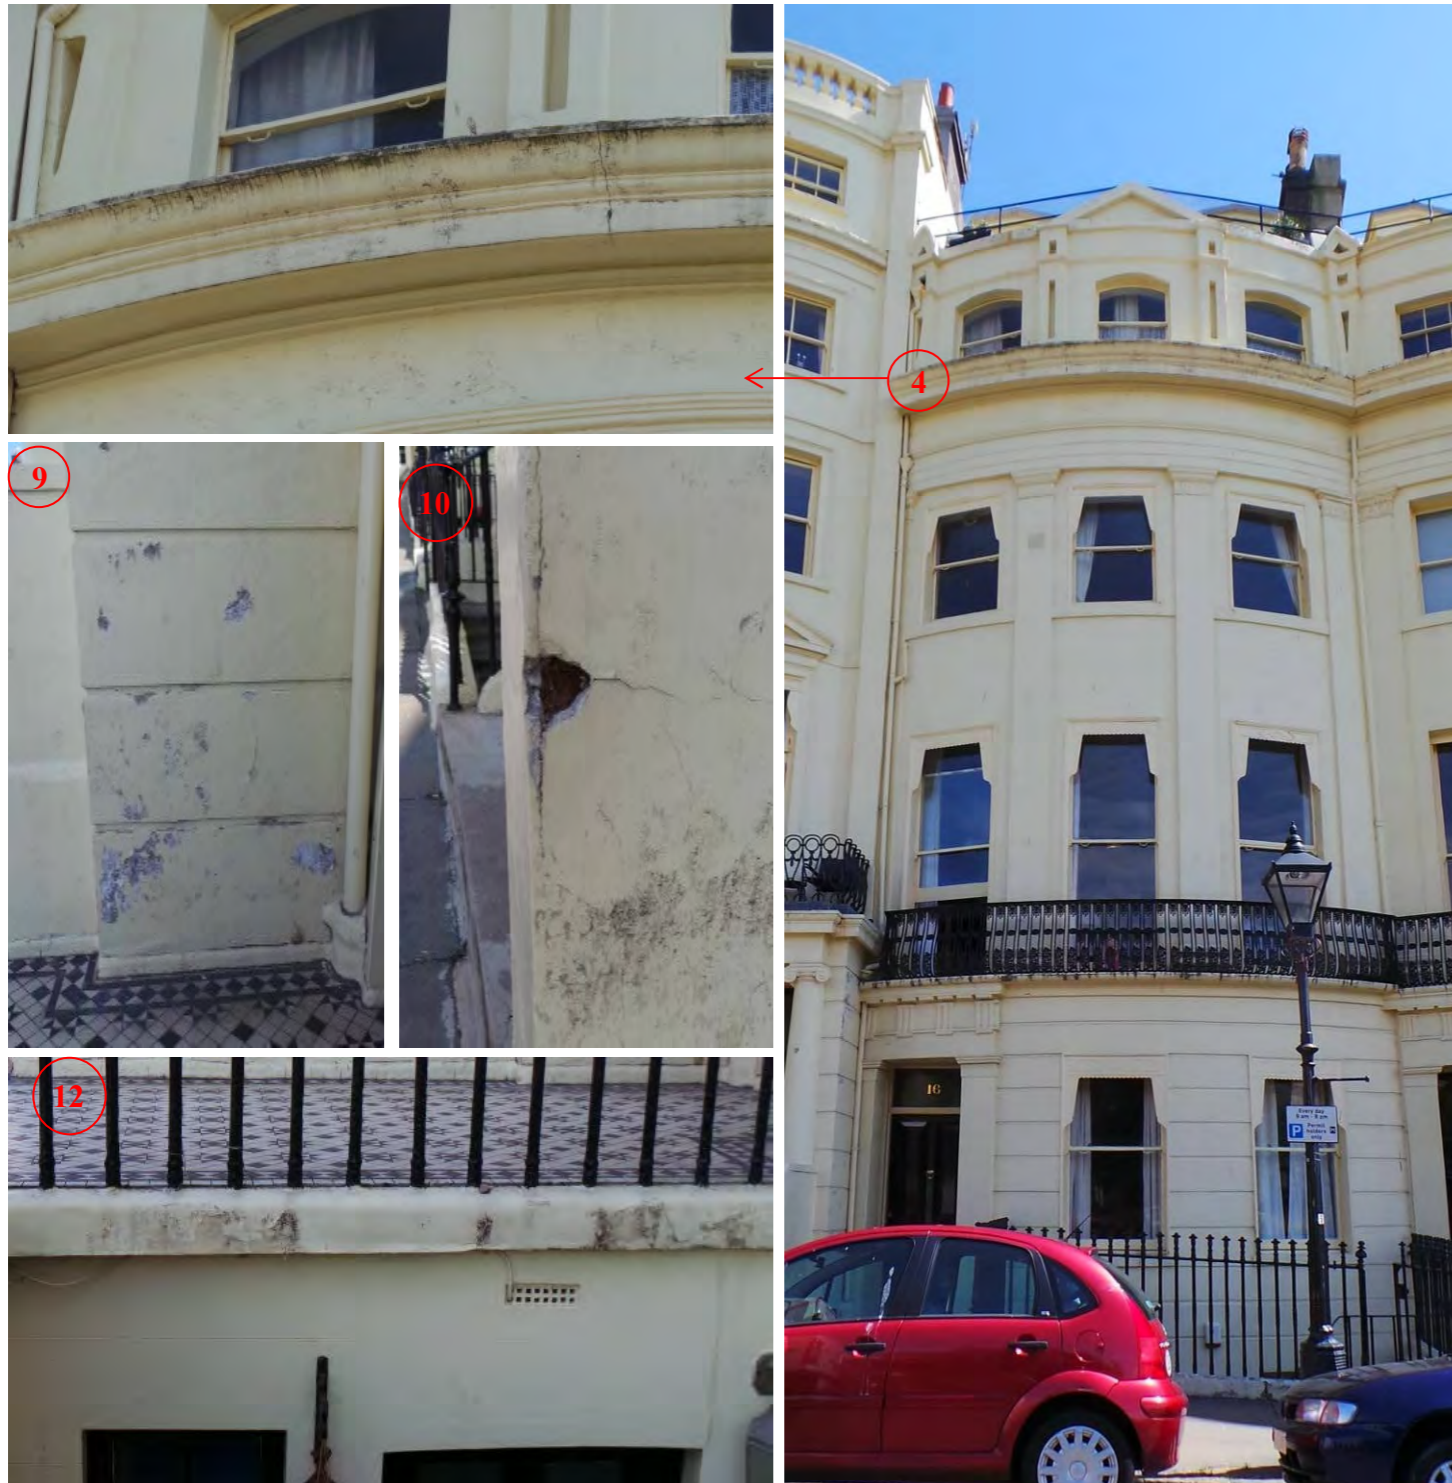
16 Brunswick Square

1. Localised paint flaking on the central pediment at parapet level;
2. Ferrrous staining on the pediment and flaking panelling at parapet level;
3. Localised paint flaking on the underside of the arched recess of the central window (third floor);

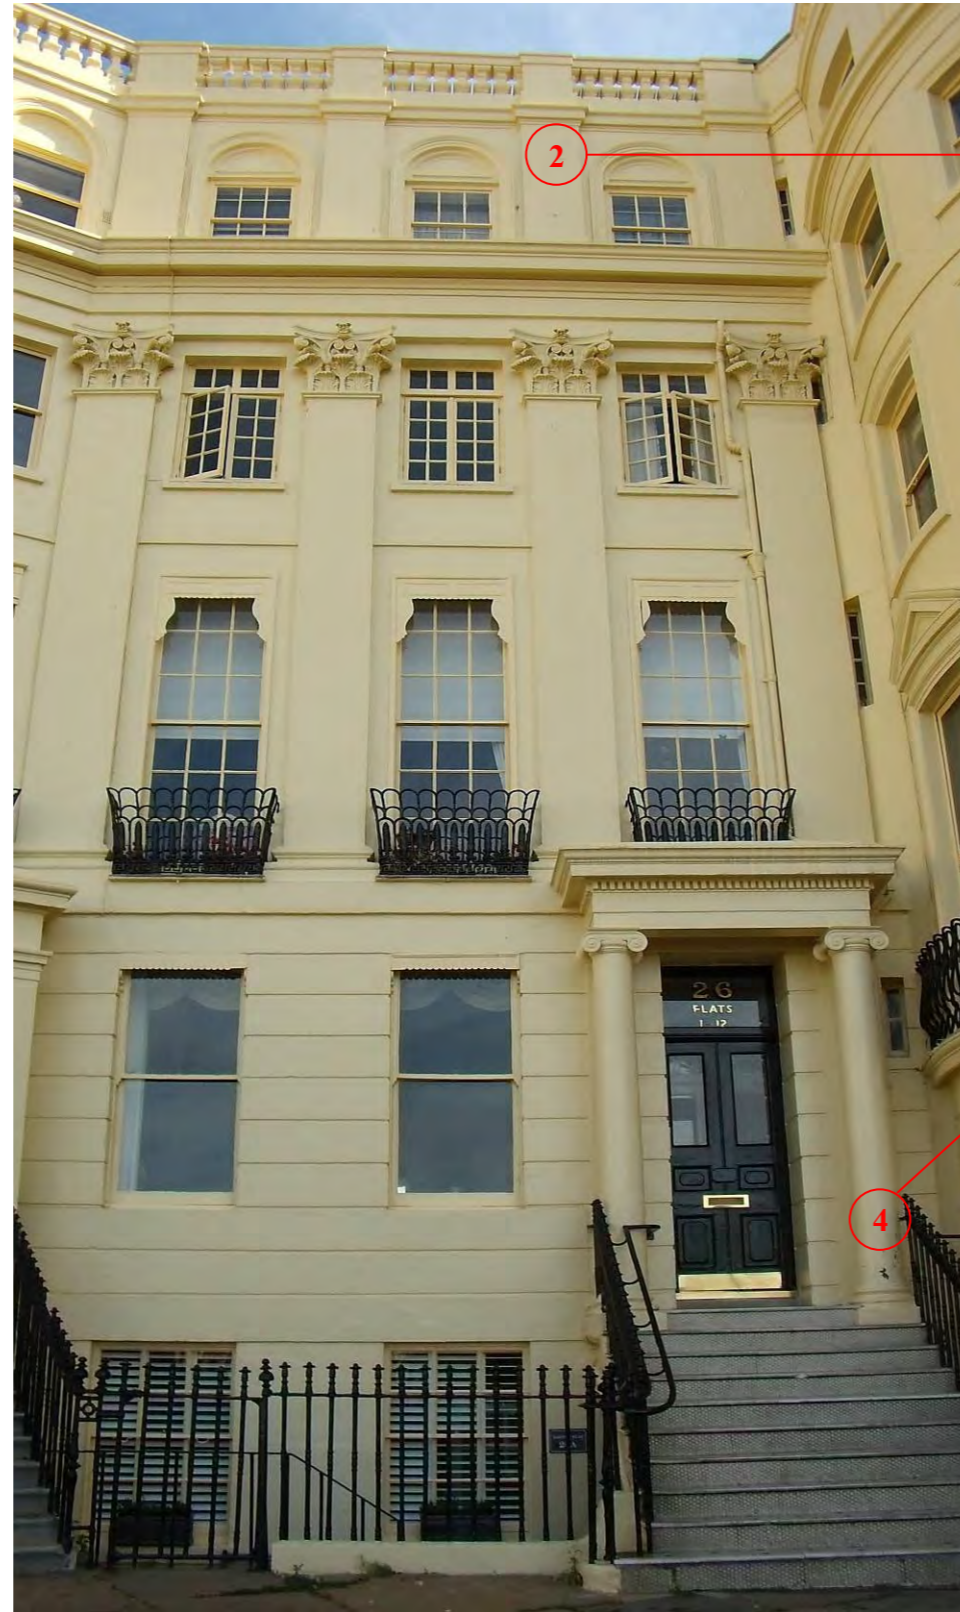
26 Brunswick Square

1. Generally the façade appears to be in reasonably good condition;
2. Localised paint flaking to right hand square pilaster at parapet level;
3. Localised paint flaking to underside of the porch. The paint has blistered and there is evidence of salt effervesce beneath the blistering paint;
4. Localised paint flaking on the column bases either side of doorway;
5. Failing paint to plinth wall;
6. Salt deliquescence and flaking paint to basement.

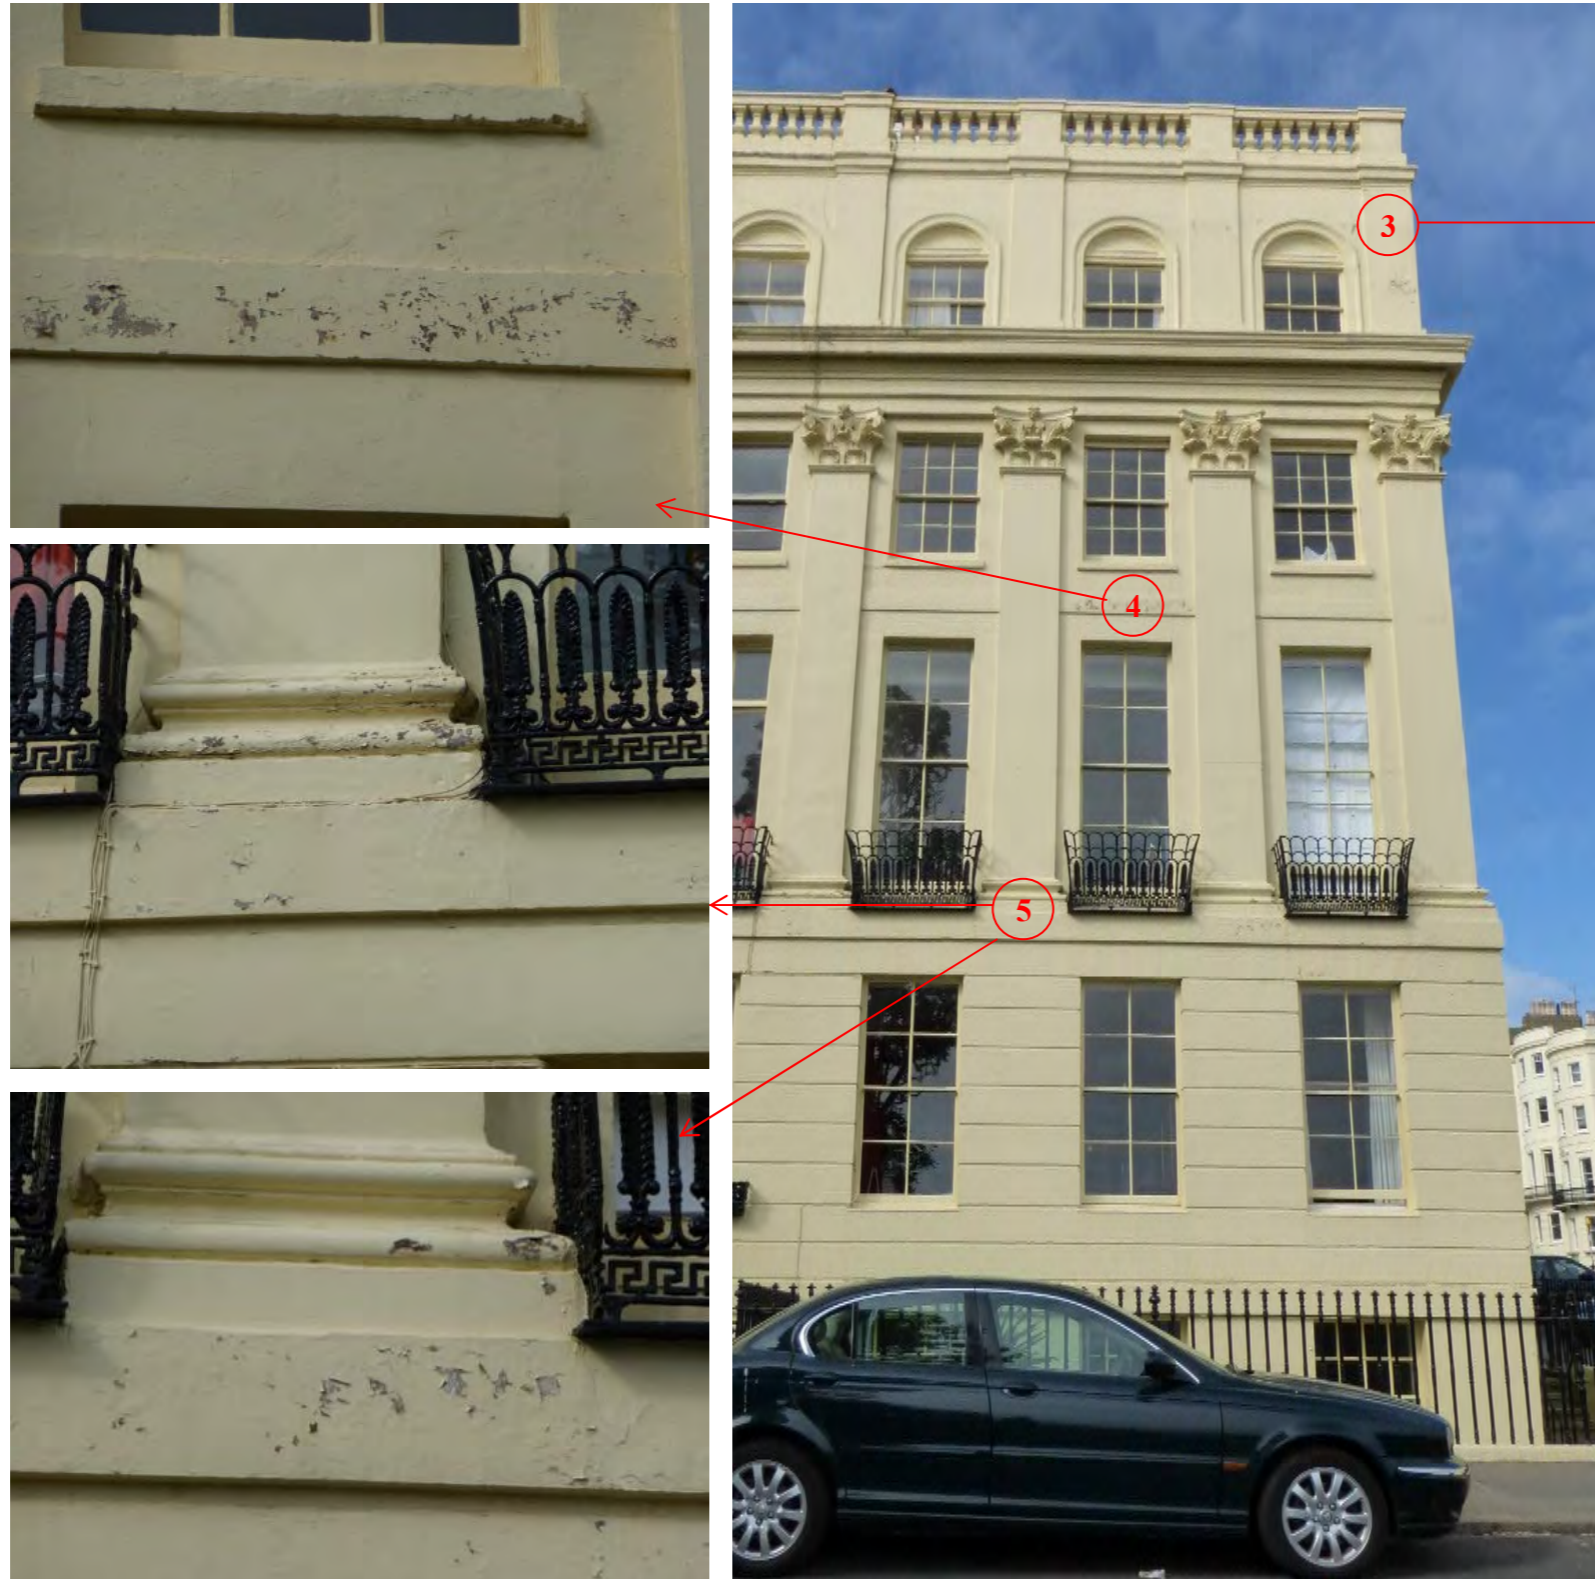
30 Brunswick Square

1. Localised paint flaking to cornice beneath parapet;
2. Localised paint flaking to cornice below the fourth floor;
3. Localised paint flaking to pilasters either side of the fourth floor windows;
4. Localised paint flaking to flat band beneath the third floor windows;
5. Localised paint flaking to bases of the square pilasters (second floor level);
6. Localised salt deliquescence and paint flaking to rusticated wall between the first floor and basement level;
7. Failing paint to plinth wall.

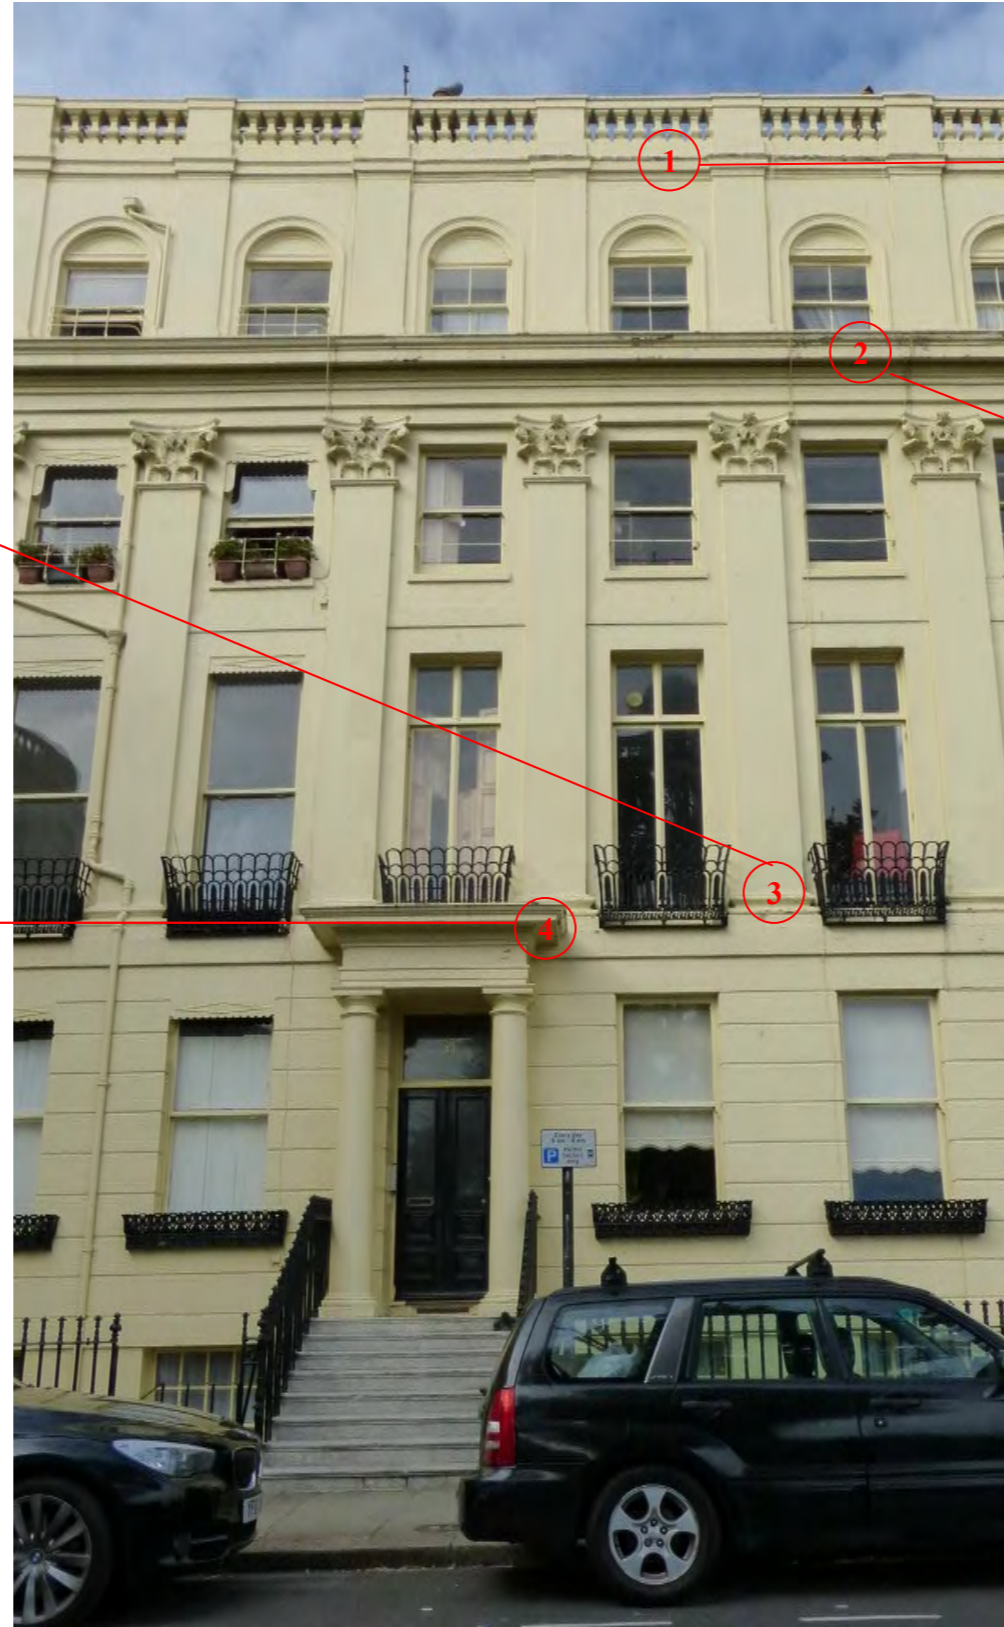
31 Brunswick Square

1. Extensive paint flaking to cornice below parapet;
2. Extensive paint flaking to cornice below the fourth floor;
3. Localised paint flaking to bases of the square pilasters (second floor level) flanking the balconies;
4. Localised paint flaking to cornice of porch;
5. Localised staining on the frieze above the doorway (right hand side);
6. Localised paint flaking to bases of entrance columns.
