**Investigation of Paint Failure at
Brunswick Estate
Hove
Brighton**

August 2013

**BRUNSWICK ESTATE
HOVE**

The following document investigates the failure of the external paint-system at Brunswick Estate, Hove based on research carried out by Elizabeth Hirst and Rachel Morley of Hirst Conservation between August and November 2013. The work was commissioned by Brighton & Hove City Council.

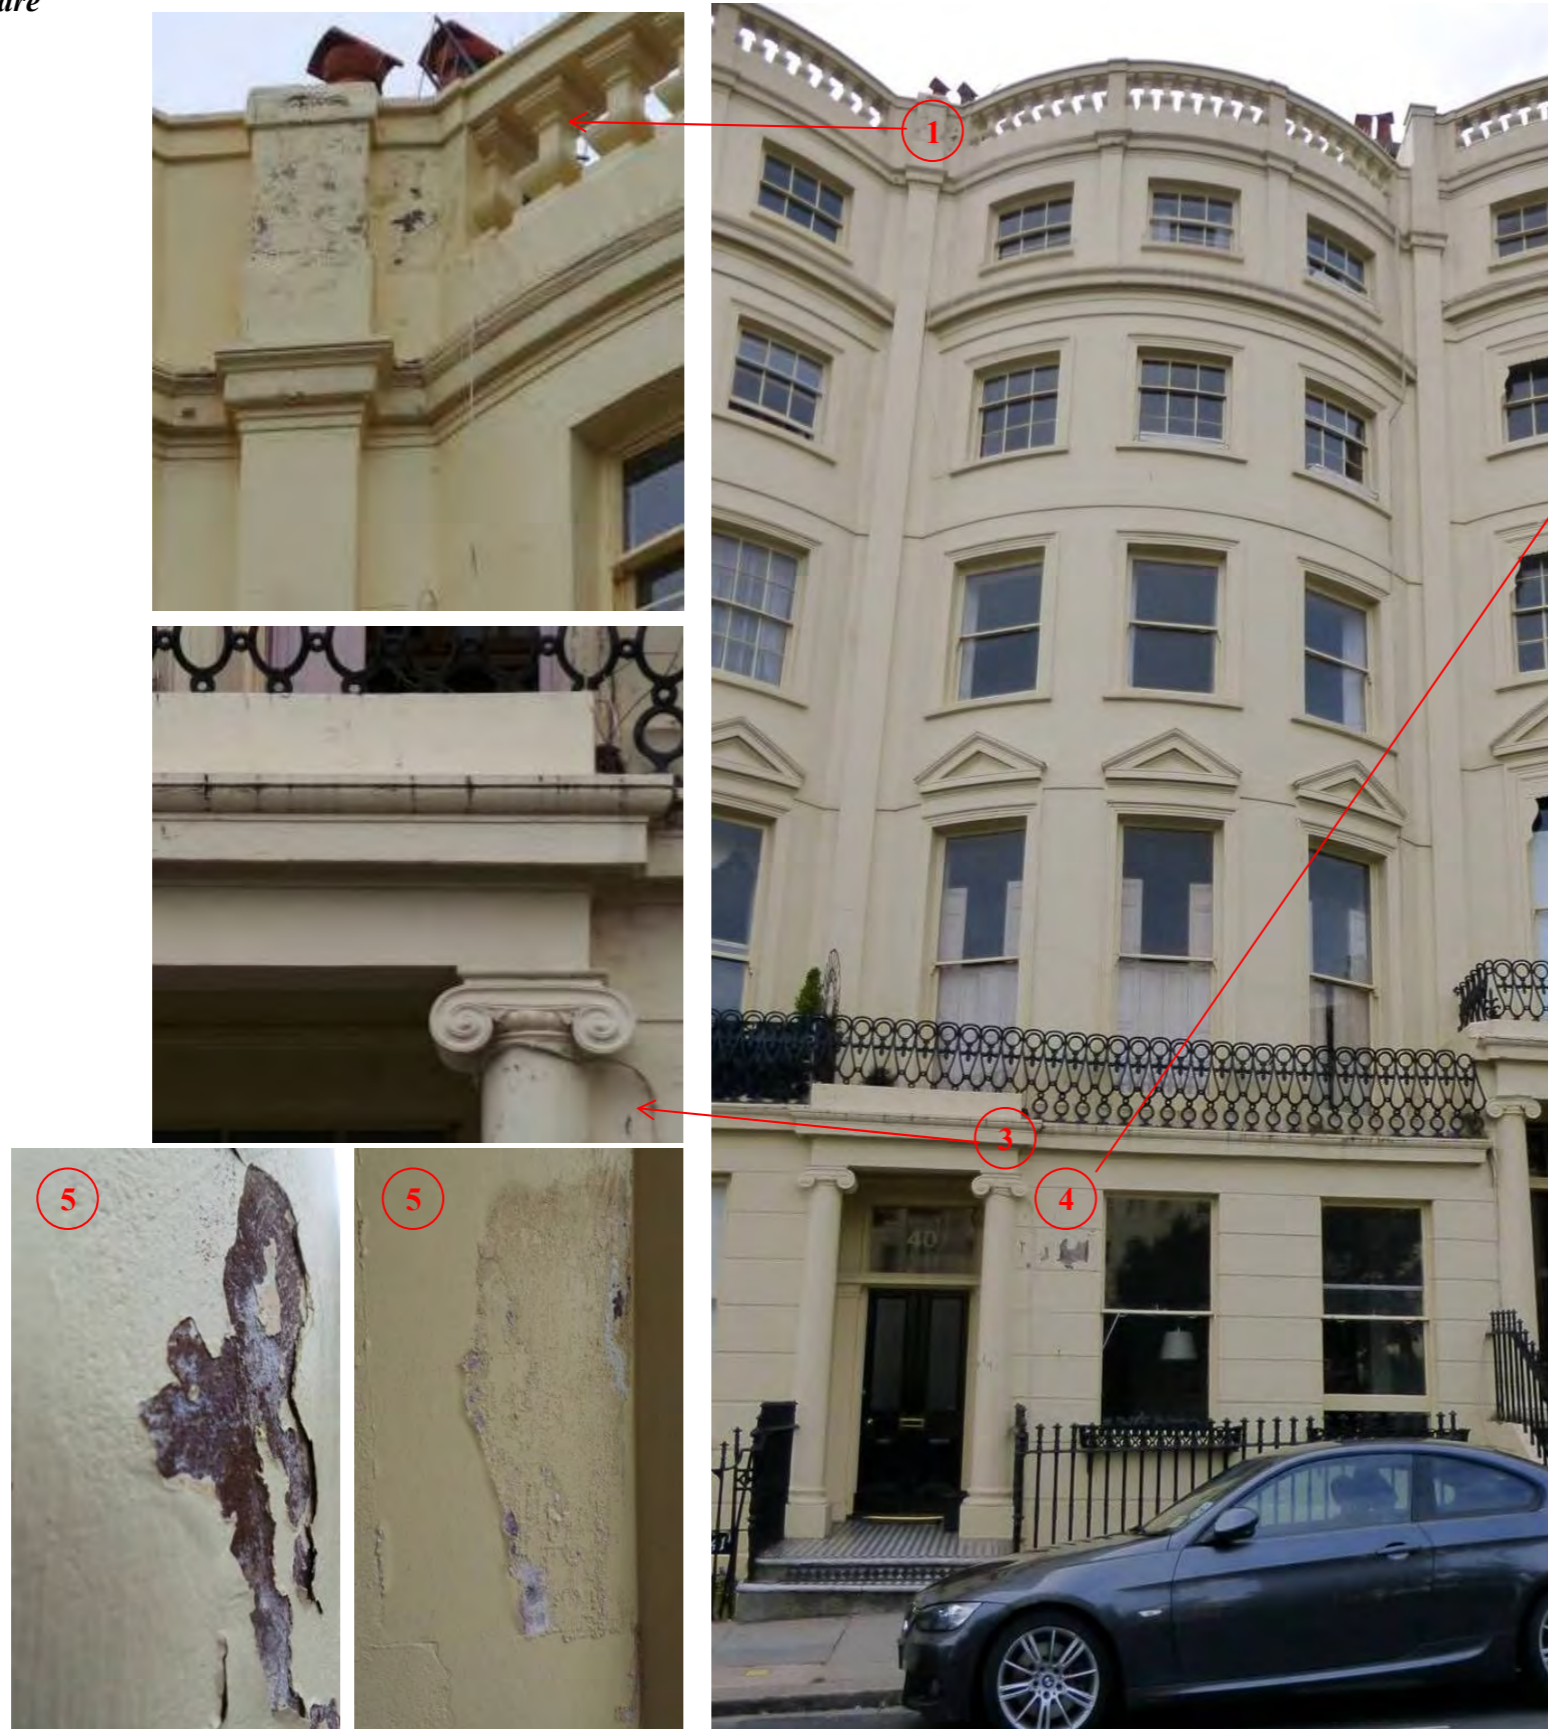
40 Brunswick Square

1. Paint flaking on the left hand side of parapet;
2. Paint flaking to right hand side of the cornice at parapet level;
3. Localised staining and paint flaking to cornice beneath balcony;
4. Extensive paint flaking to right hand side of the right column;
5. Extensive salt deliquescence and paint flaking to entrance columns;
6. Localised paint flaking to base of entrance columns.

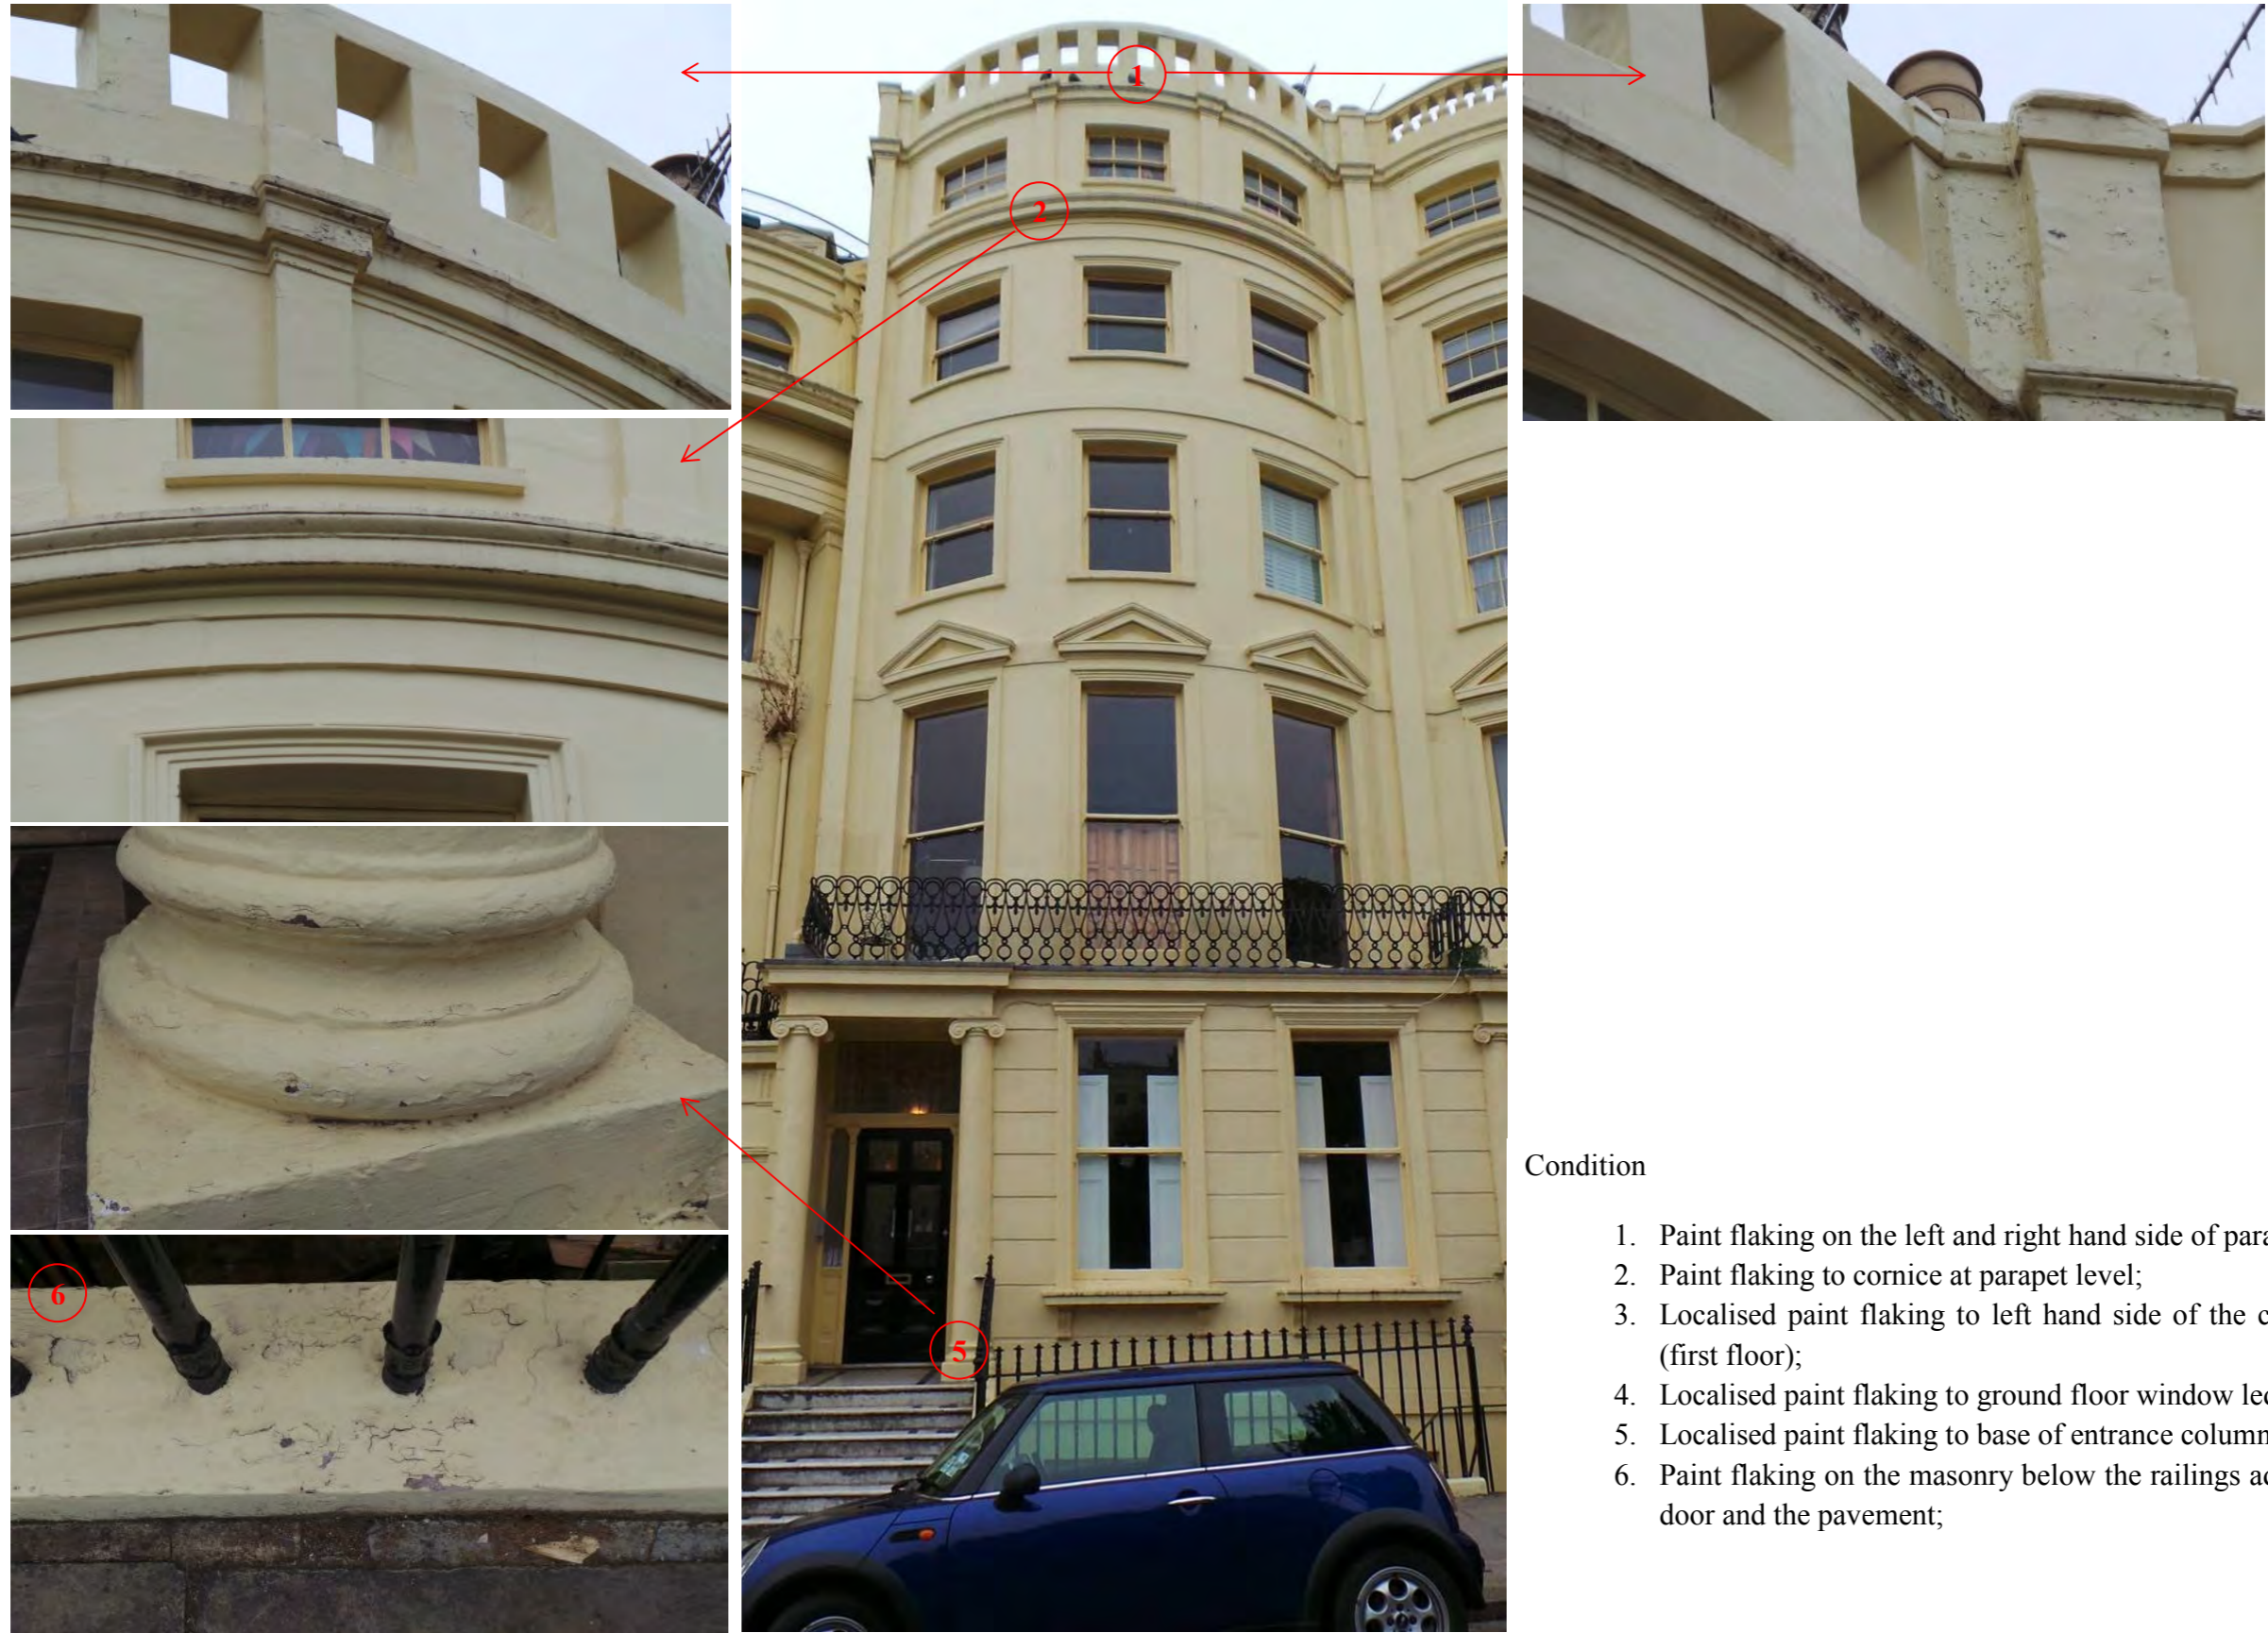
42 Brunswick Square

1. Paint flaking on the left and right hand side of parapet;
2. Paint flaking to cornice at parapet level;
3. Localised paint flaking to left hand side of the central pediment (first floor);
4. Localised paint flaking to ground floor window ledges;
5. Localised paint flaking to base of entrance columns;
6. Paint flaking on the masonry below the railings adjacent the front door and the pavement;

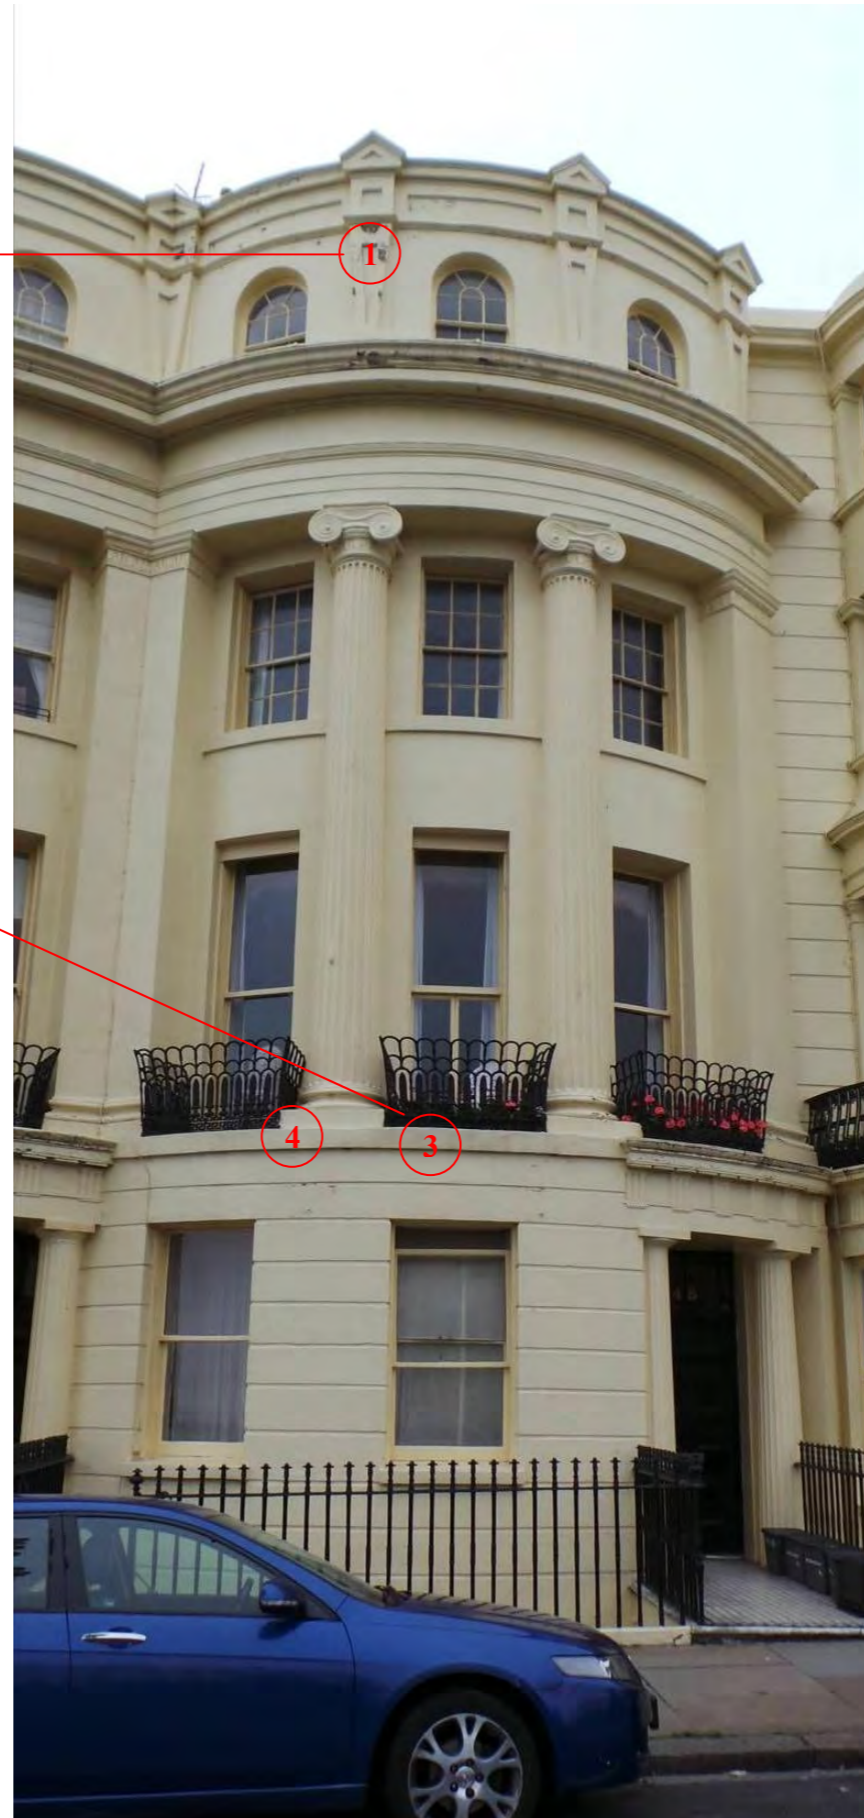
48 Brunswick Square

1. Extensive paint flaking to panelling at parapet level;
2. Extensive paint flaking to cornice at parapet level;
3. Staining and paint flaking to cornice beneath balconies;
4. Localised salt deliquescence and paint flaking to base of the right hand column (first floor level);
5. Paint flaking underneath the entablature above the second floor central window;
6. Paint flaking to entrance columns and adjacent wall;
7. Paint flaking and salt deliquescence above the ground floor windows;
8. Paint flaking and salt deliquescence to walls at basement and ground floor level.

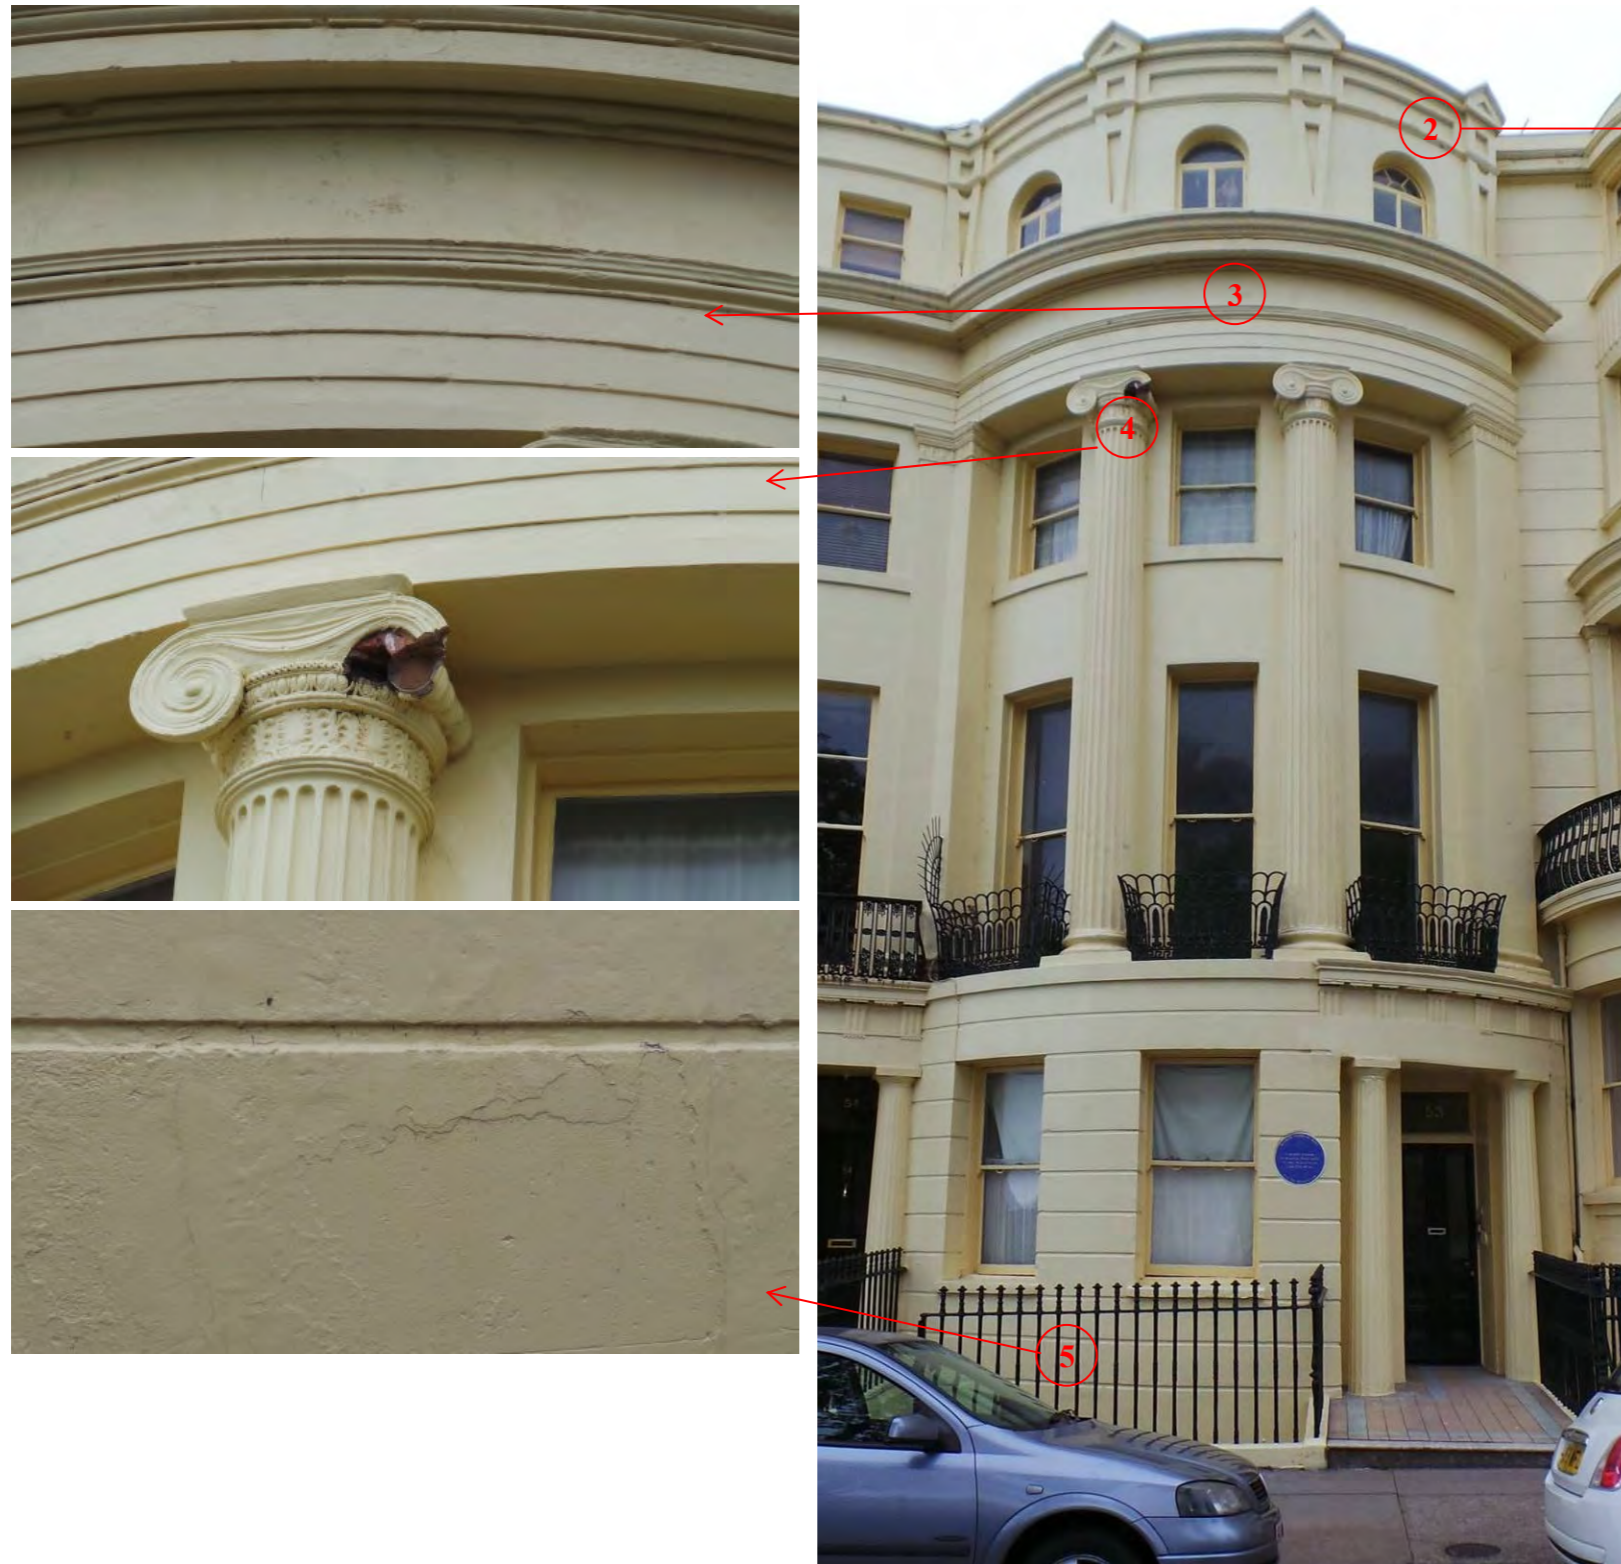
53 Brunswick Square

1. Generally the façade appears to be in reasonably good condition;
2. Paint flaking to right hand side panelling at parapet level (third floor level);
3. Salt deliquescence to centre of the cornice;
4. Damaged and partly missing scroll detail on the right hand side of the left ionic capital (second floor level);
5. Localised salt deliquescence on the wall beneath the ground floor windows (first floor level);

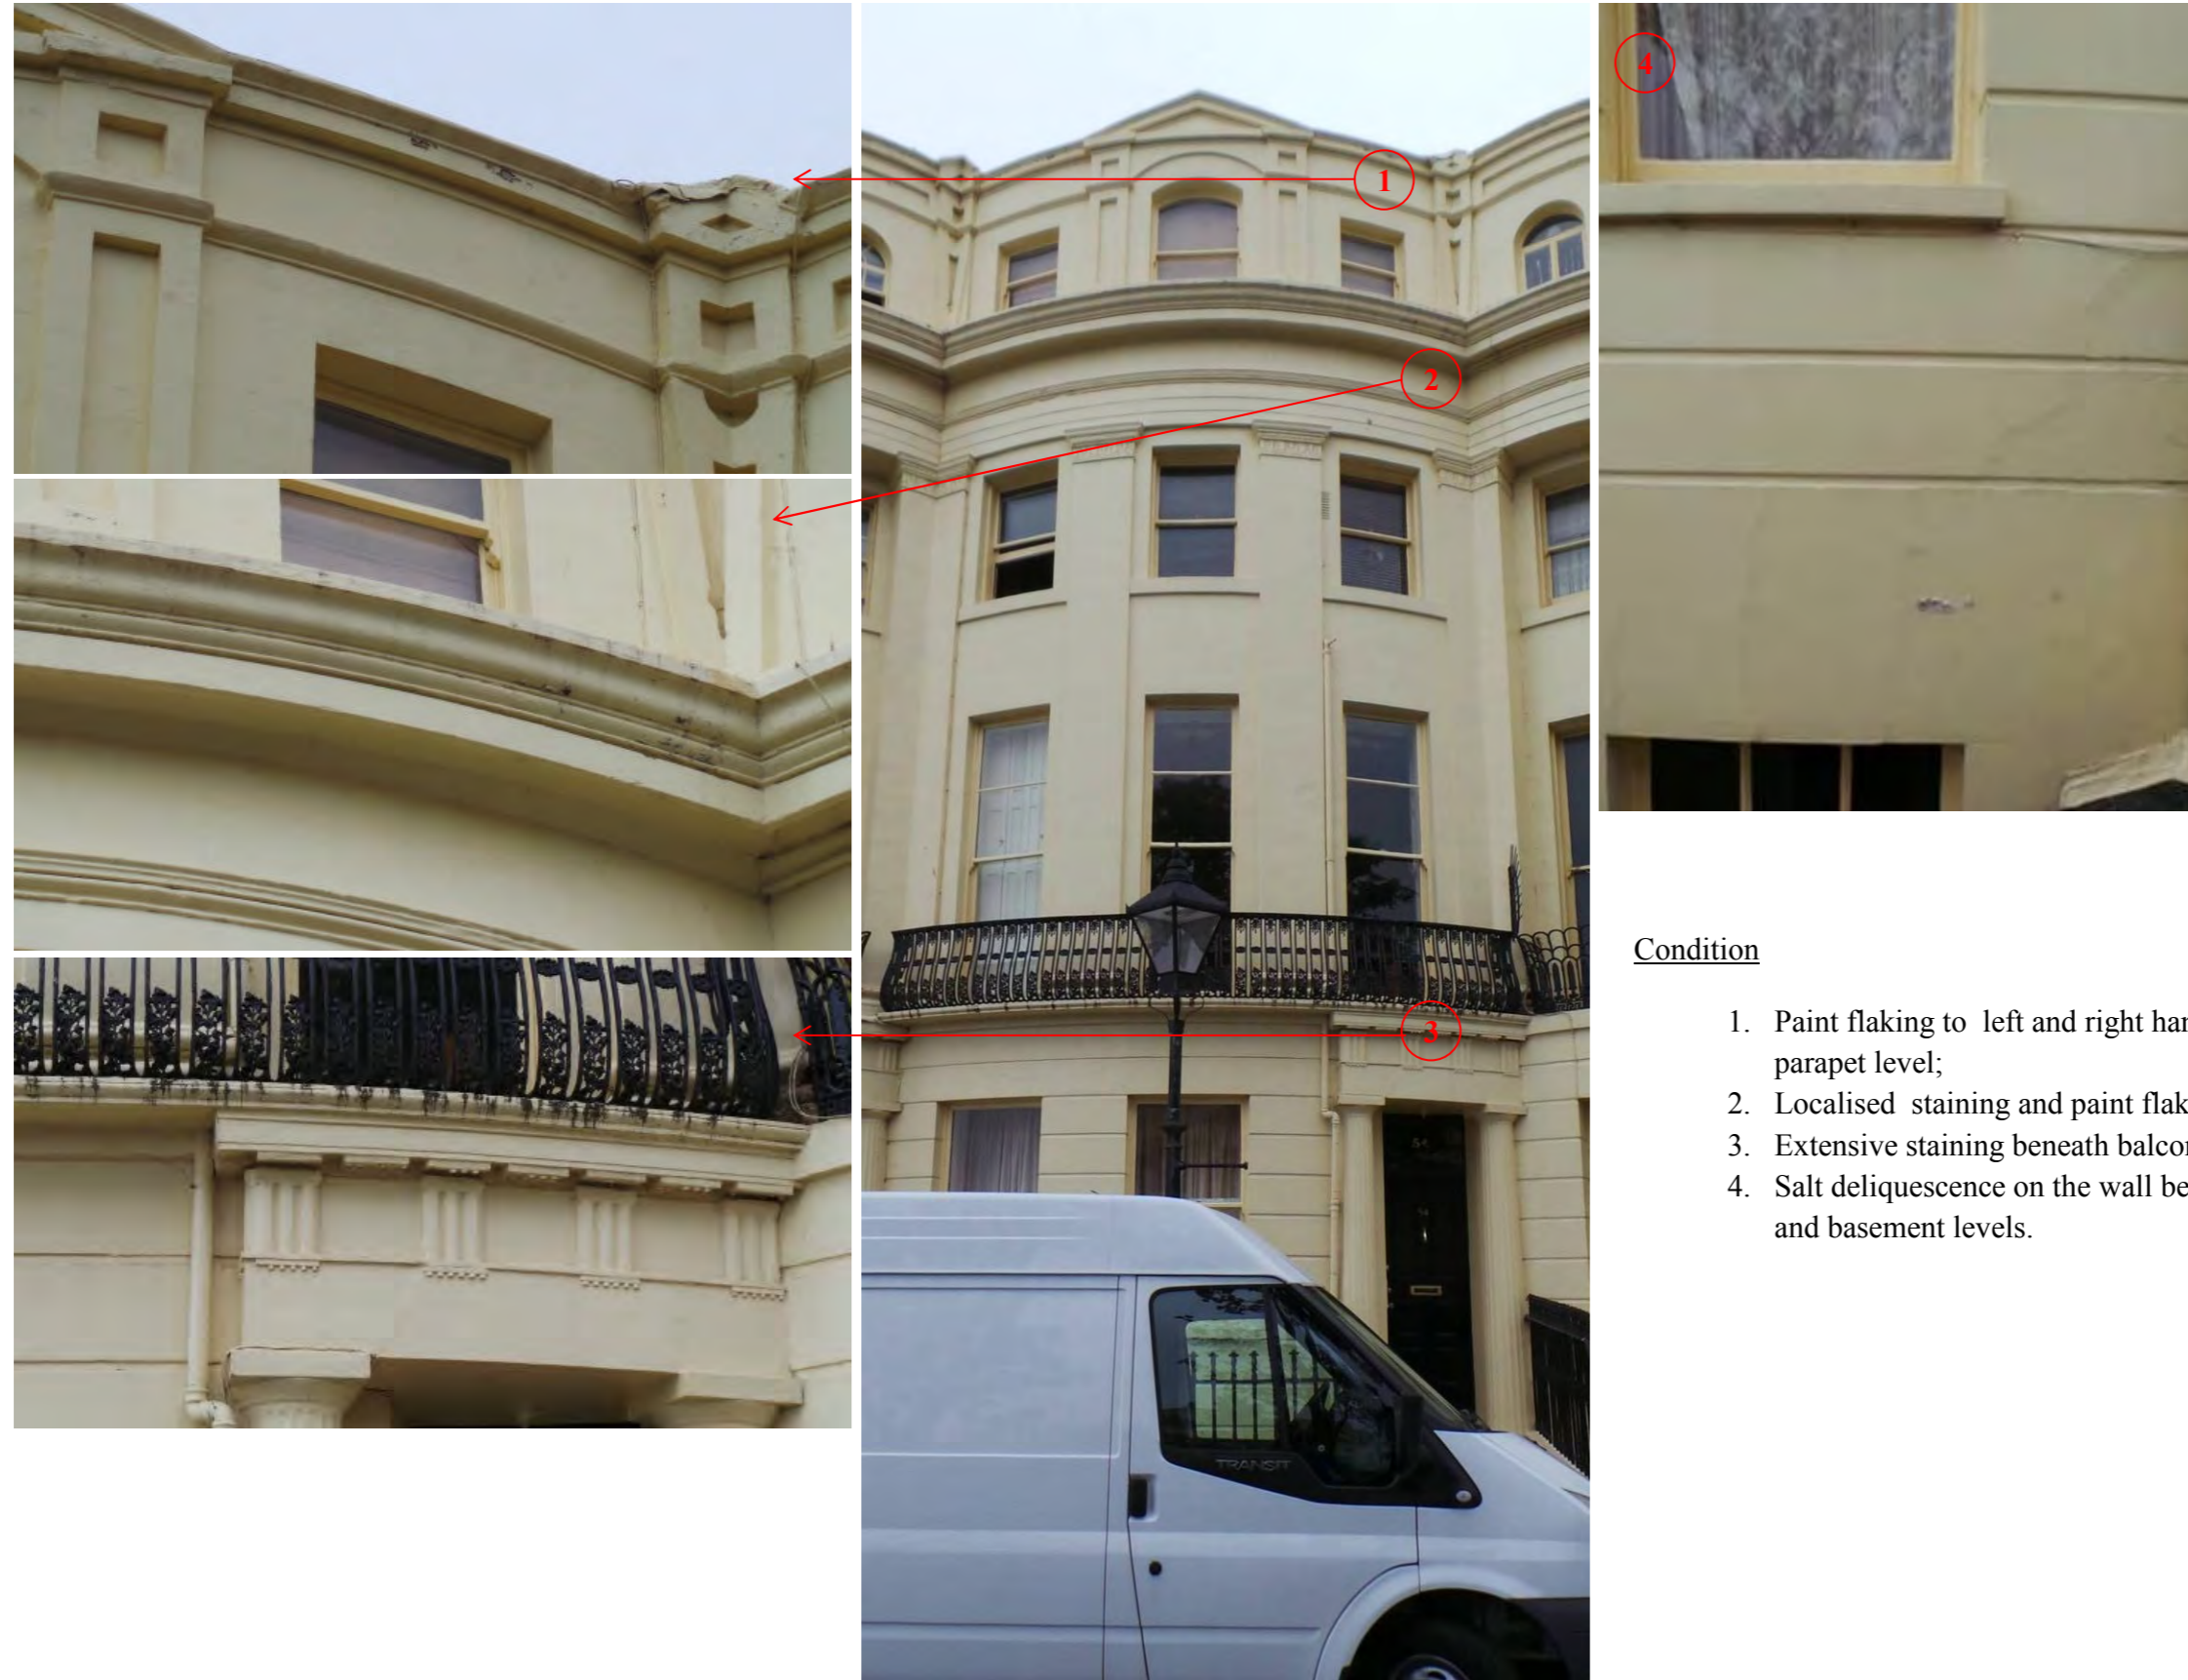
54 Brunswick Square

1. Paint flaking to left and right hand side of the panelling at parapet level;
2. Localised staining and paint flaking to cornice;
3. Extensive staining beneath balcony;
4. Salt deliquescence on the wall between the ground floor and basement levels.

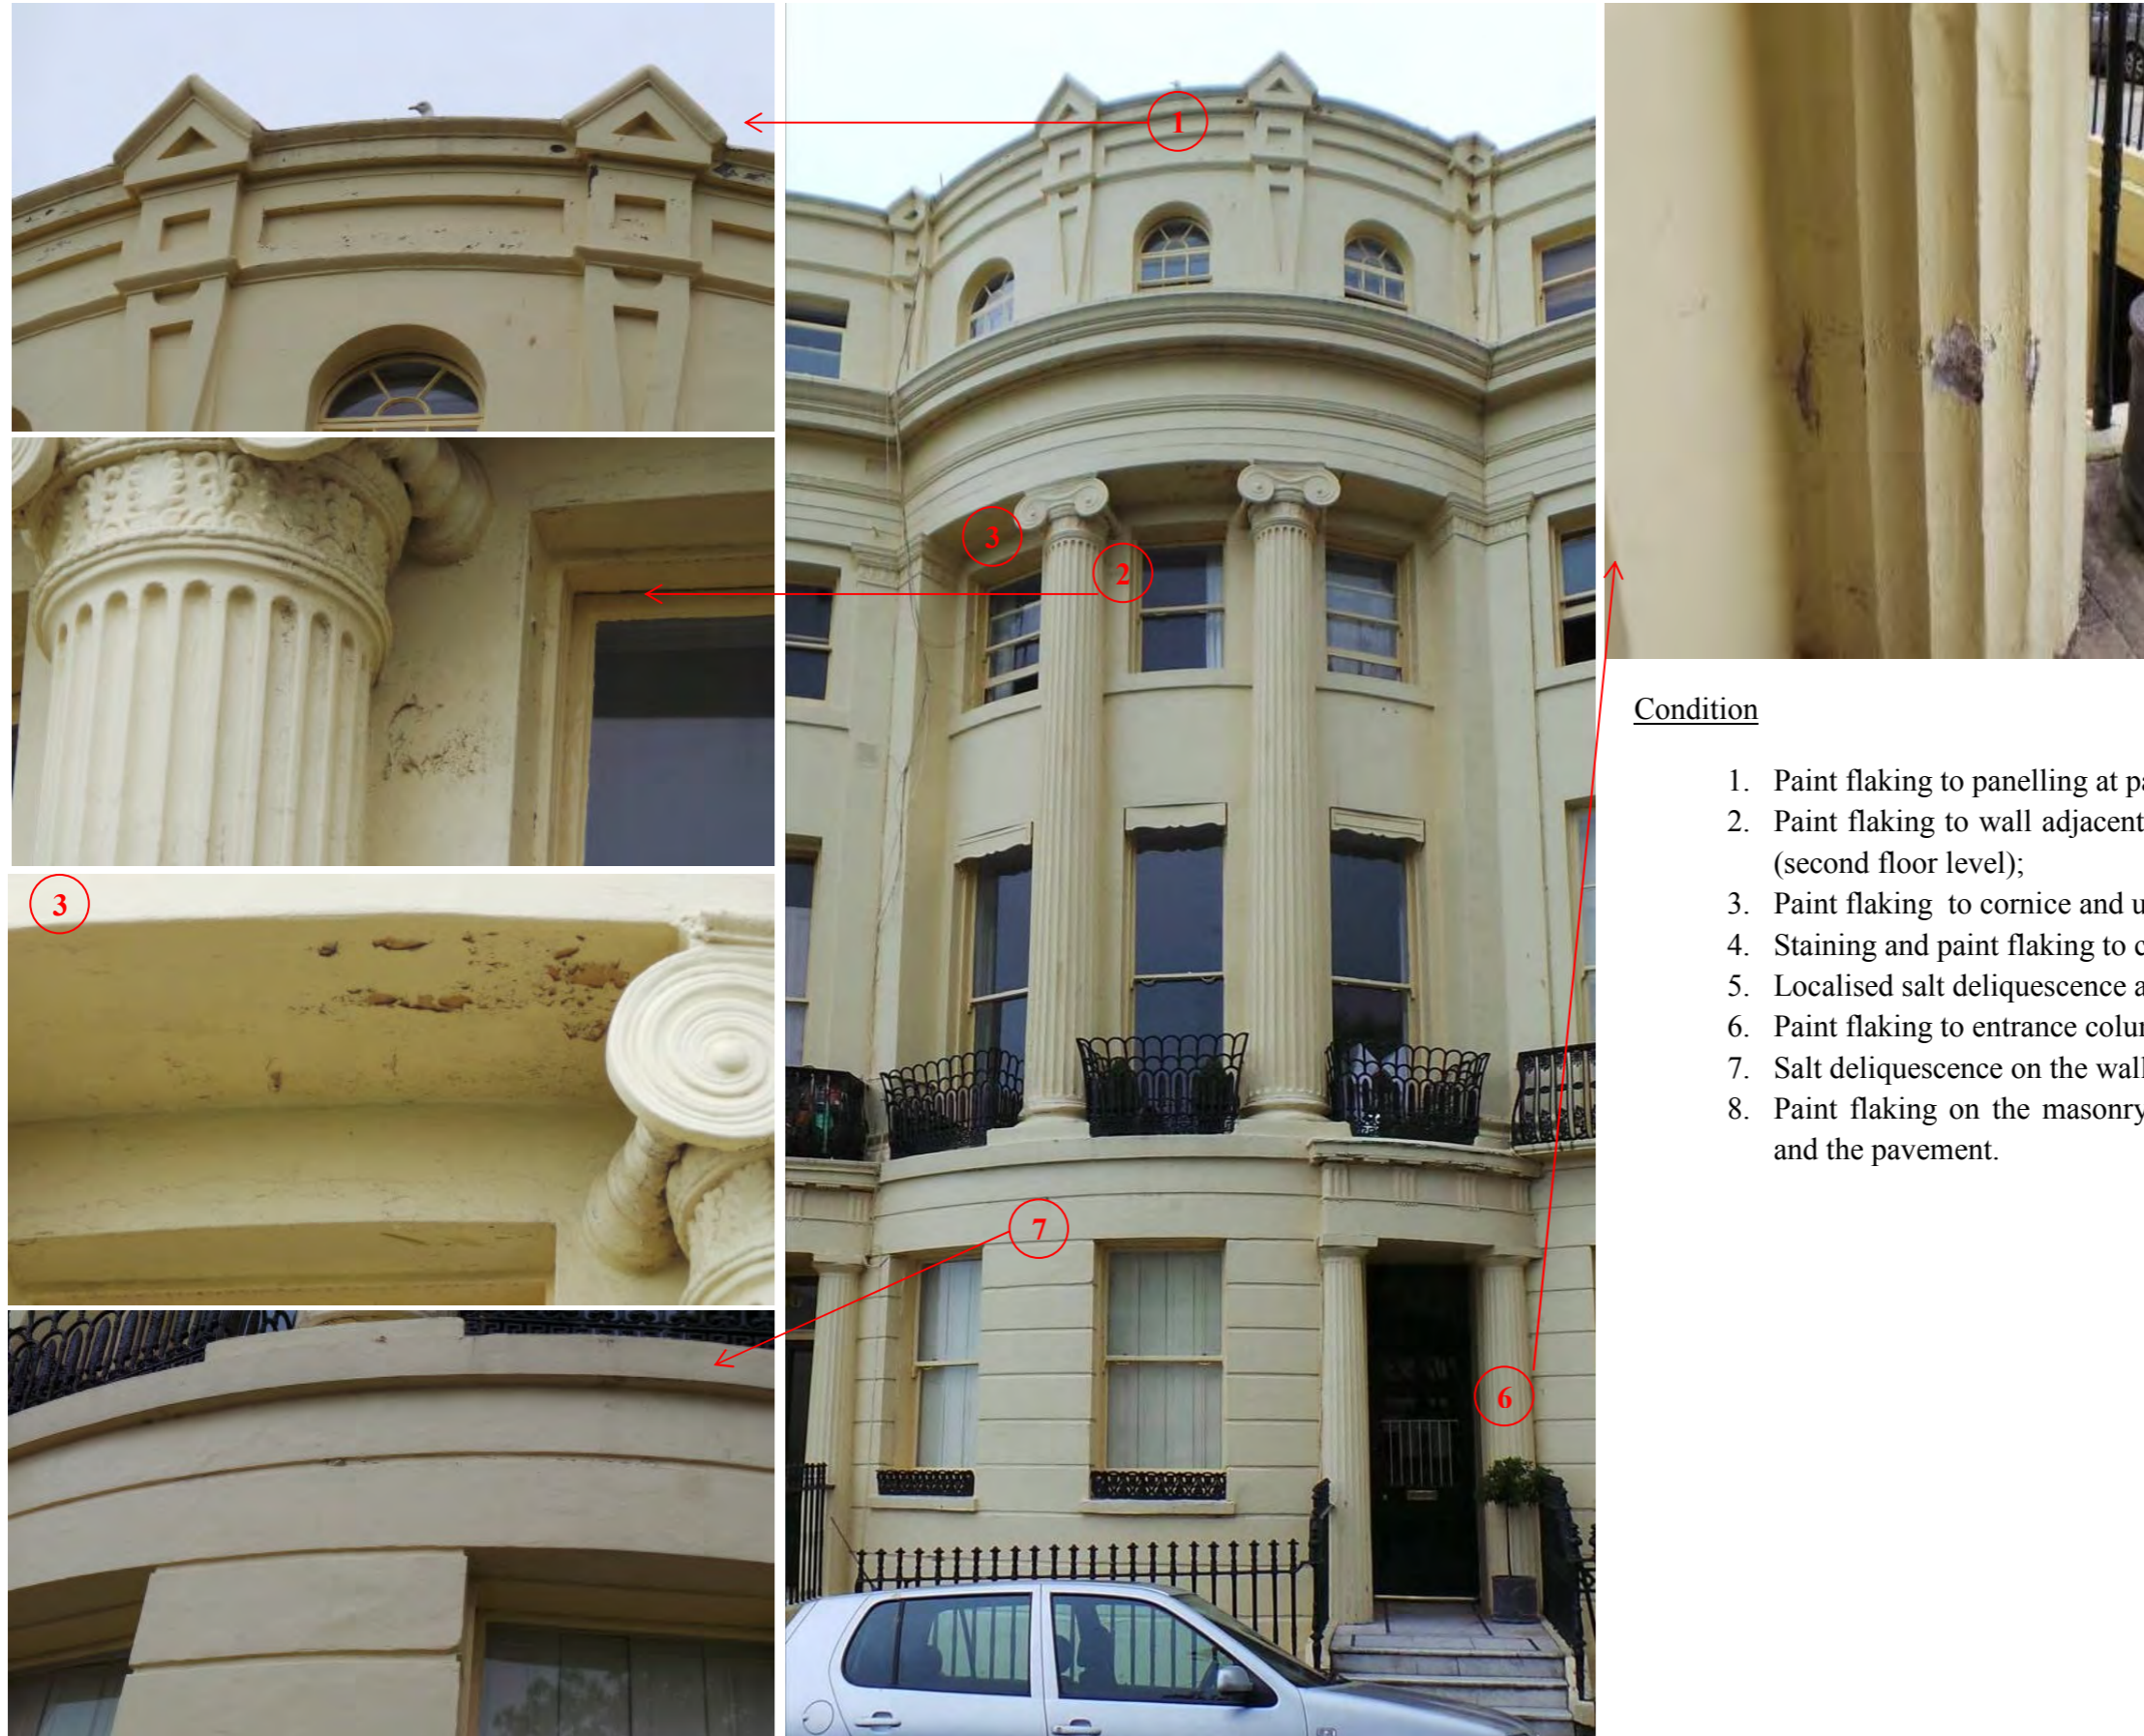
55 Brunswick Square

1. Paint flaking to panelling at parapet level;
2. Paint flaking to wall adjacent the right hand side of the left hand column (second floor level);
3. Paint flaking to cornice and under the entablature (second floor level);
4. Staining and paint flaking to cornice beneath balconies;
5. Localised salt deliquescence and paint flaking to underside of the porch;
6. Paint flaking to entrance columns;
7. Salt deliquescence on the wall above the ground floor windows ;
8. Paint flaking on the masonry below the railings adjacent the front door and the pavement.

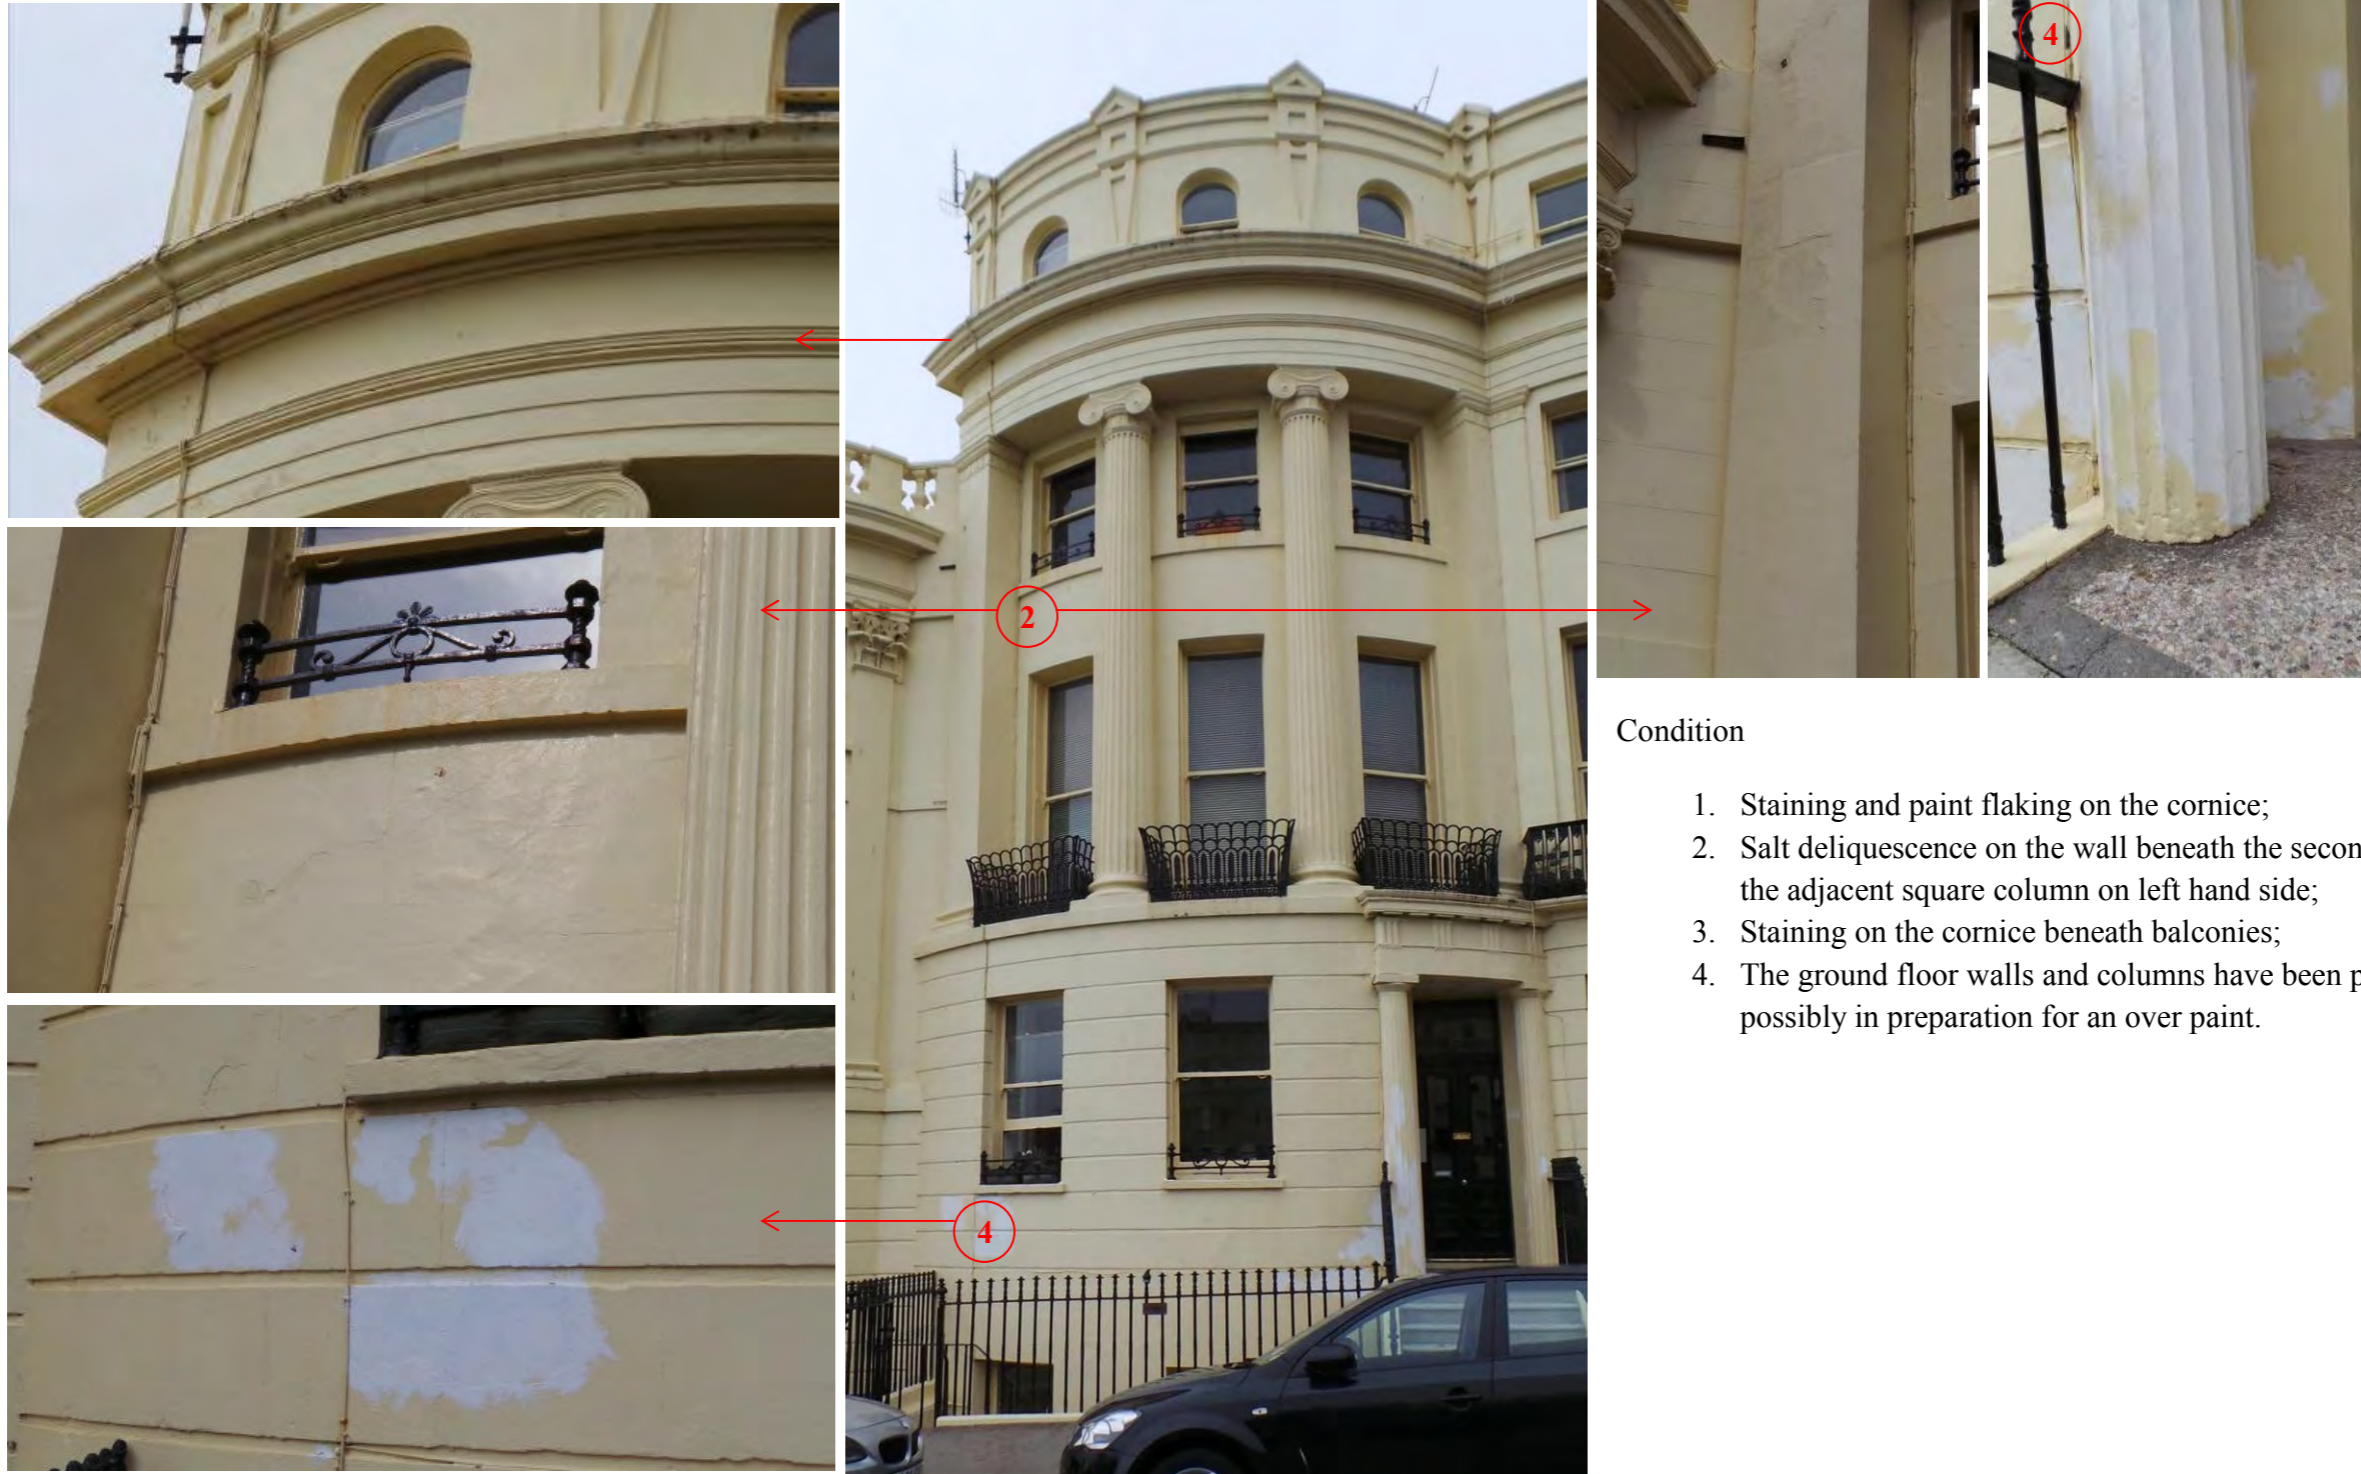
57 Brunswick Square

1. Staining and paint flaking on the cornice;
2. Salt deliquescence on the wall beneath the second floor window and on the adjacent square column on left hand side;
3. Staining on the cornice beneath balconies;
4. The ground floor walls and columns have been primed in areas possibly in preparation for an over paint.
