**Investigation of Paint Failure at
Brunswick Estate
Hove
Brighton**

August 2013

**BRUNSWICK ESTATE
HOVE**

The following document investigates the failure of the external paint-system at Brunswick Estate, Hove based on research carried out by Elizabeth Hirst and Rachel Morley of Hirst Conservation between August and November 2013. The work was commissioned by Brighton & Hove City Council.

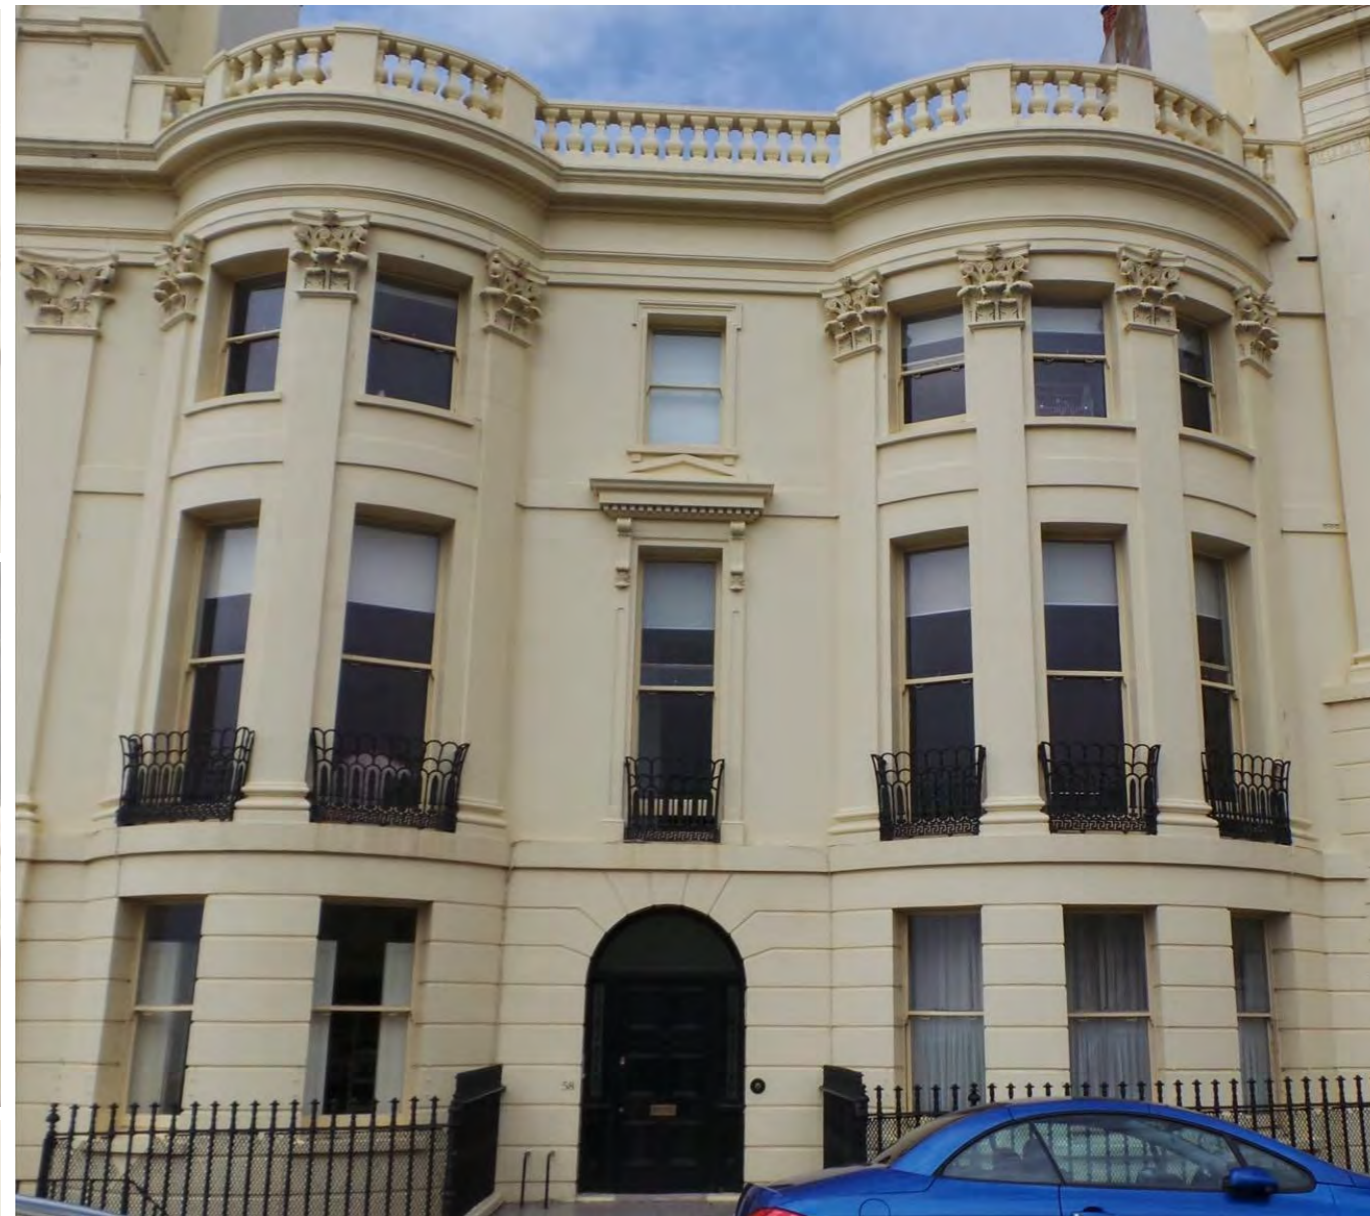
58 Brunswick Square

1. Generally the façade appears to be in reasonably good condition.
2. Ferrous staining under the central and flanking left hand side window beneath balconies;
3. Paint flaking on the masonry below the railings adjacent the front door and the pavement;
4. Paint flaking on the basement window ledges.

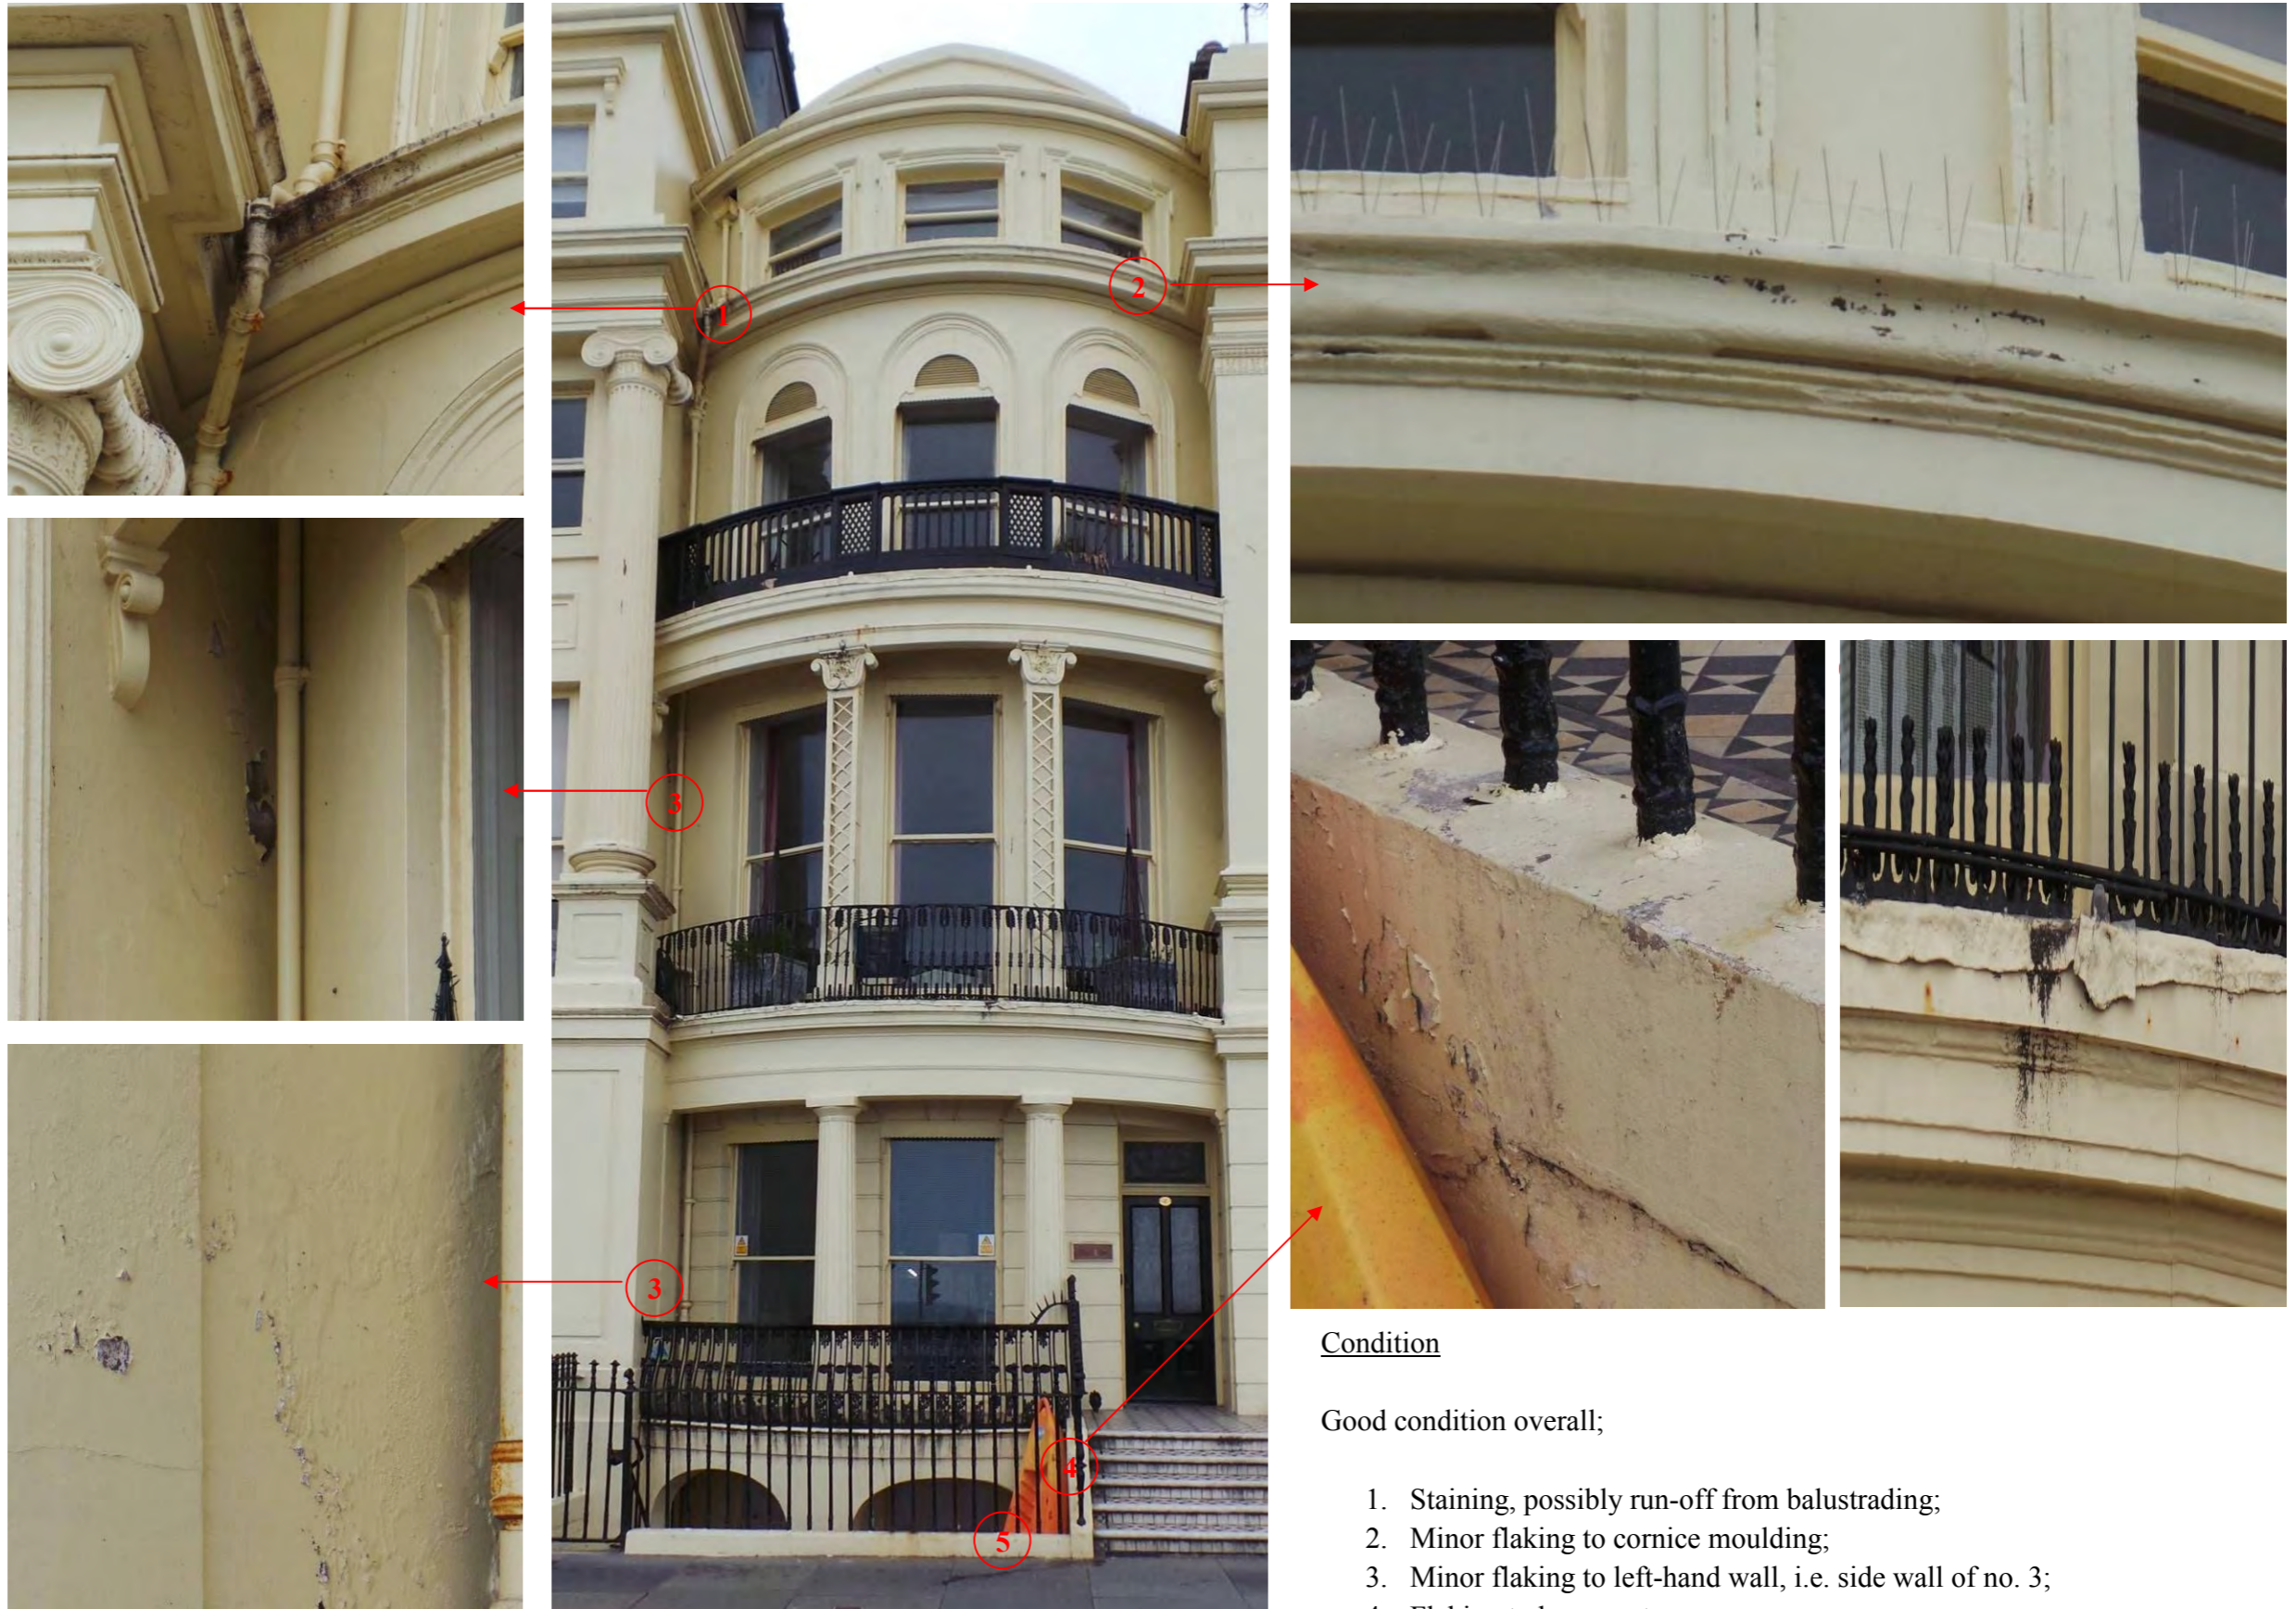
2 Brunswick Terrace

Good condition overall;

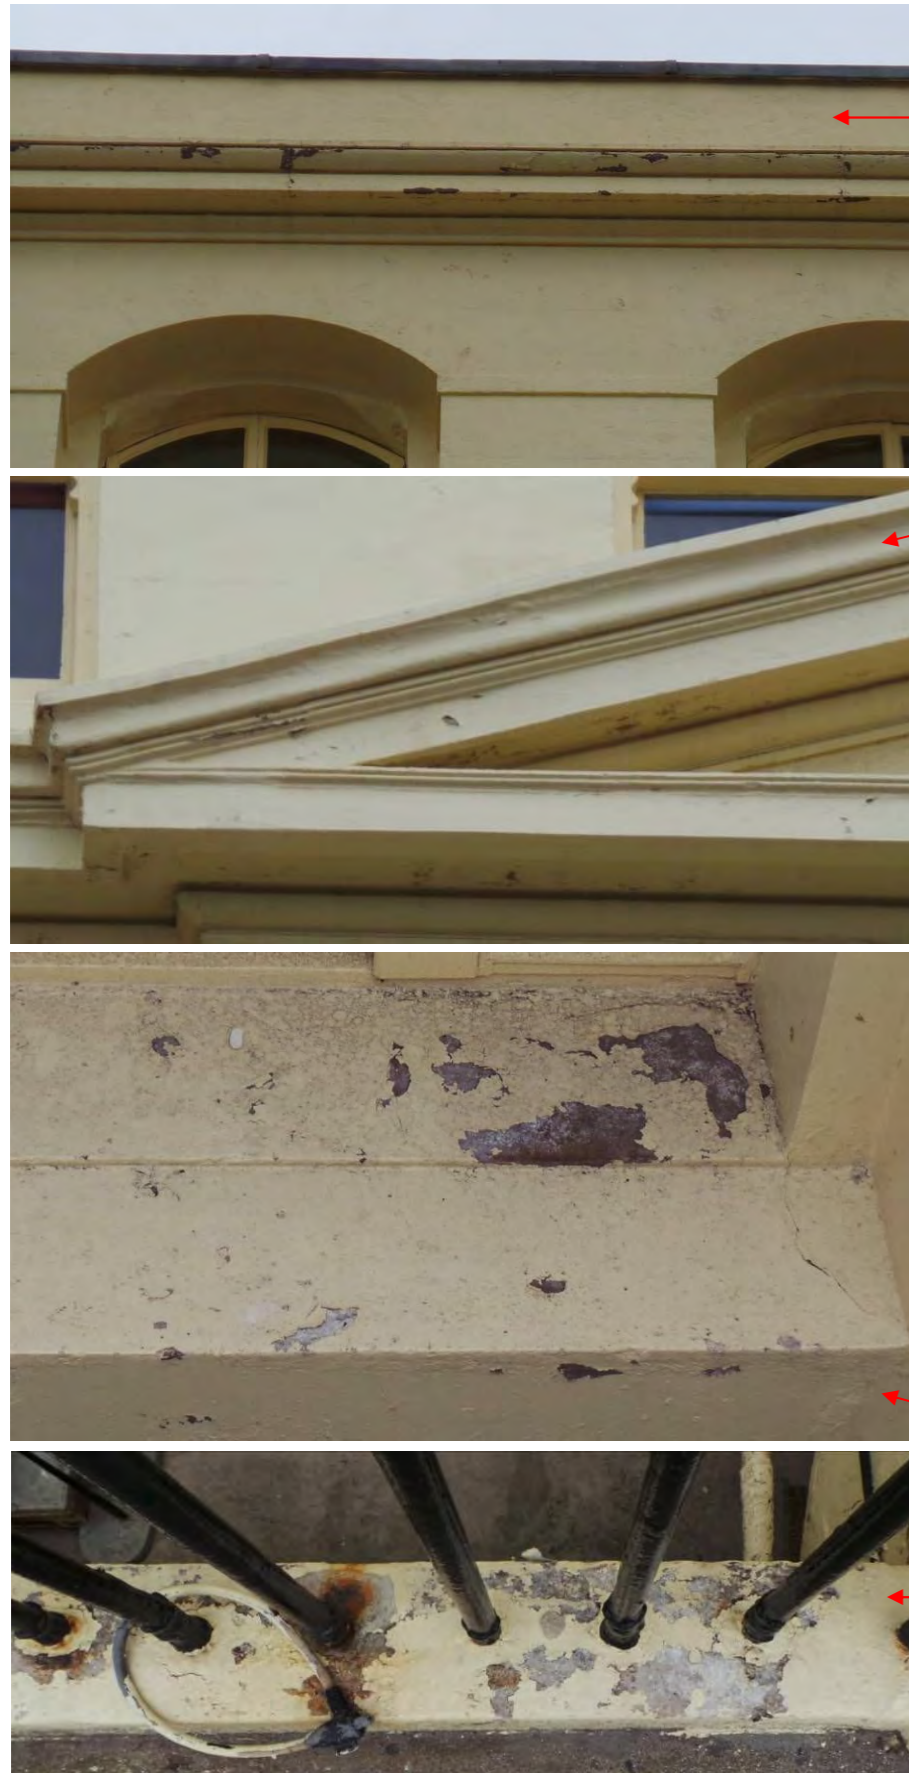
4 Brunswick Terrace

1. Minor losses along top edge of parapet moulding;
2. Minor, localised losses and flaking in recesses of pediment and cornice over second floor;
3. Flaking to column bases;
4. Replacement concrete lintel/render installed over entrance;
5. Significant losses to entrance and basement with some evidence of salting;
6. Moderate losses, ferrous staining and flaking to plinth wall.

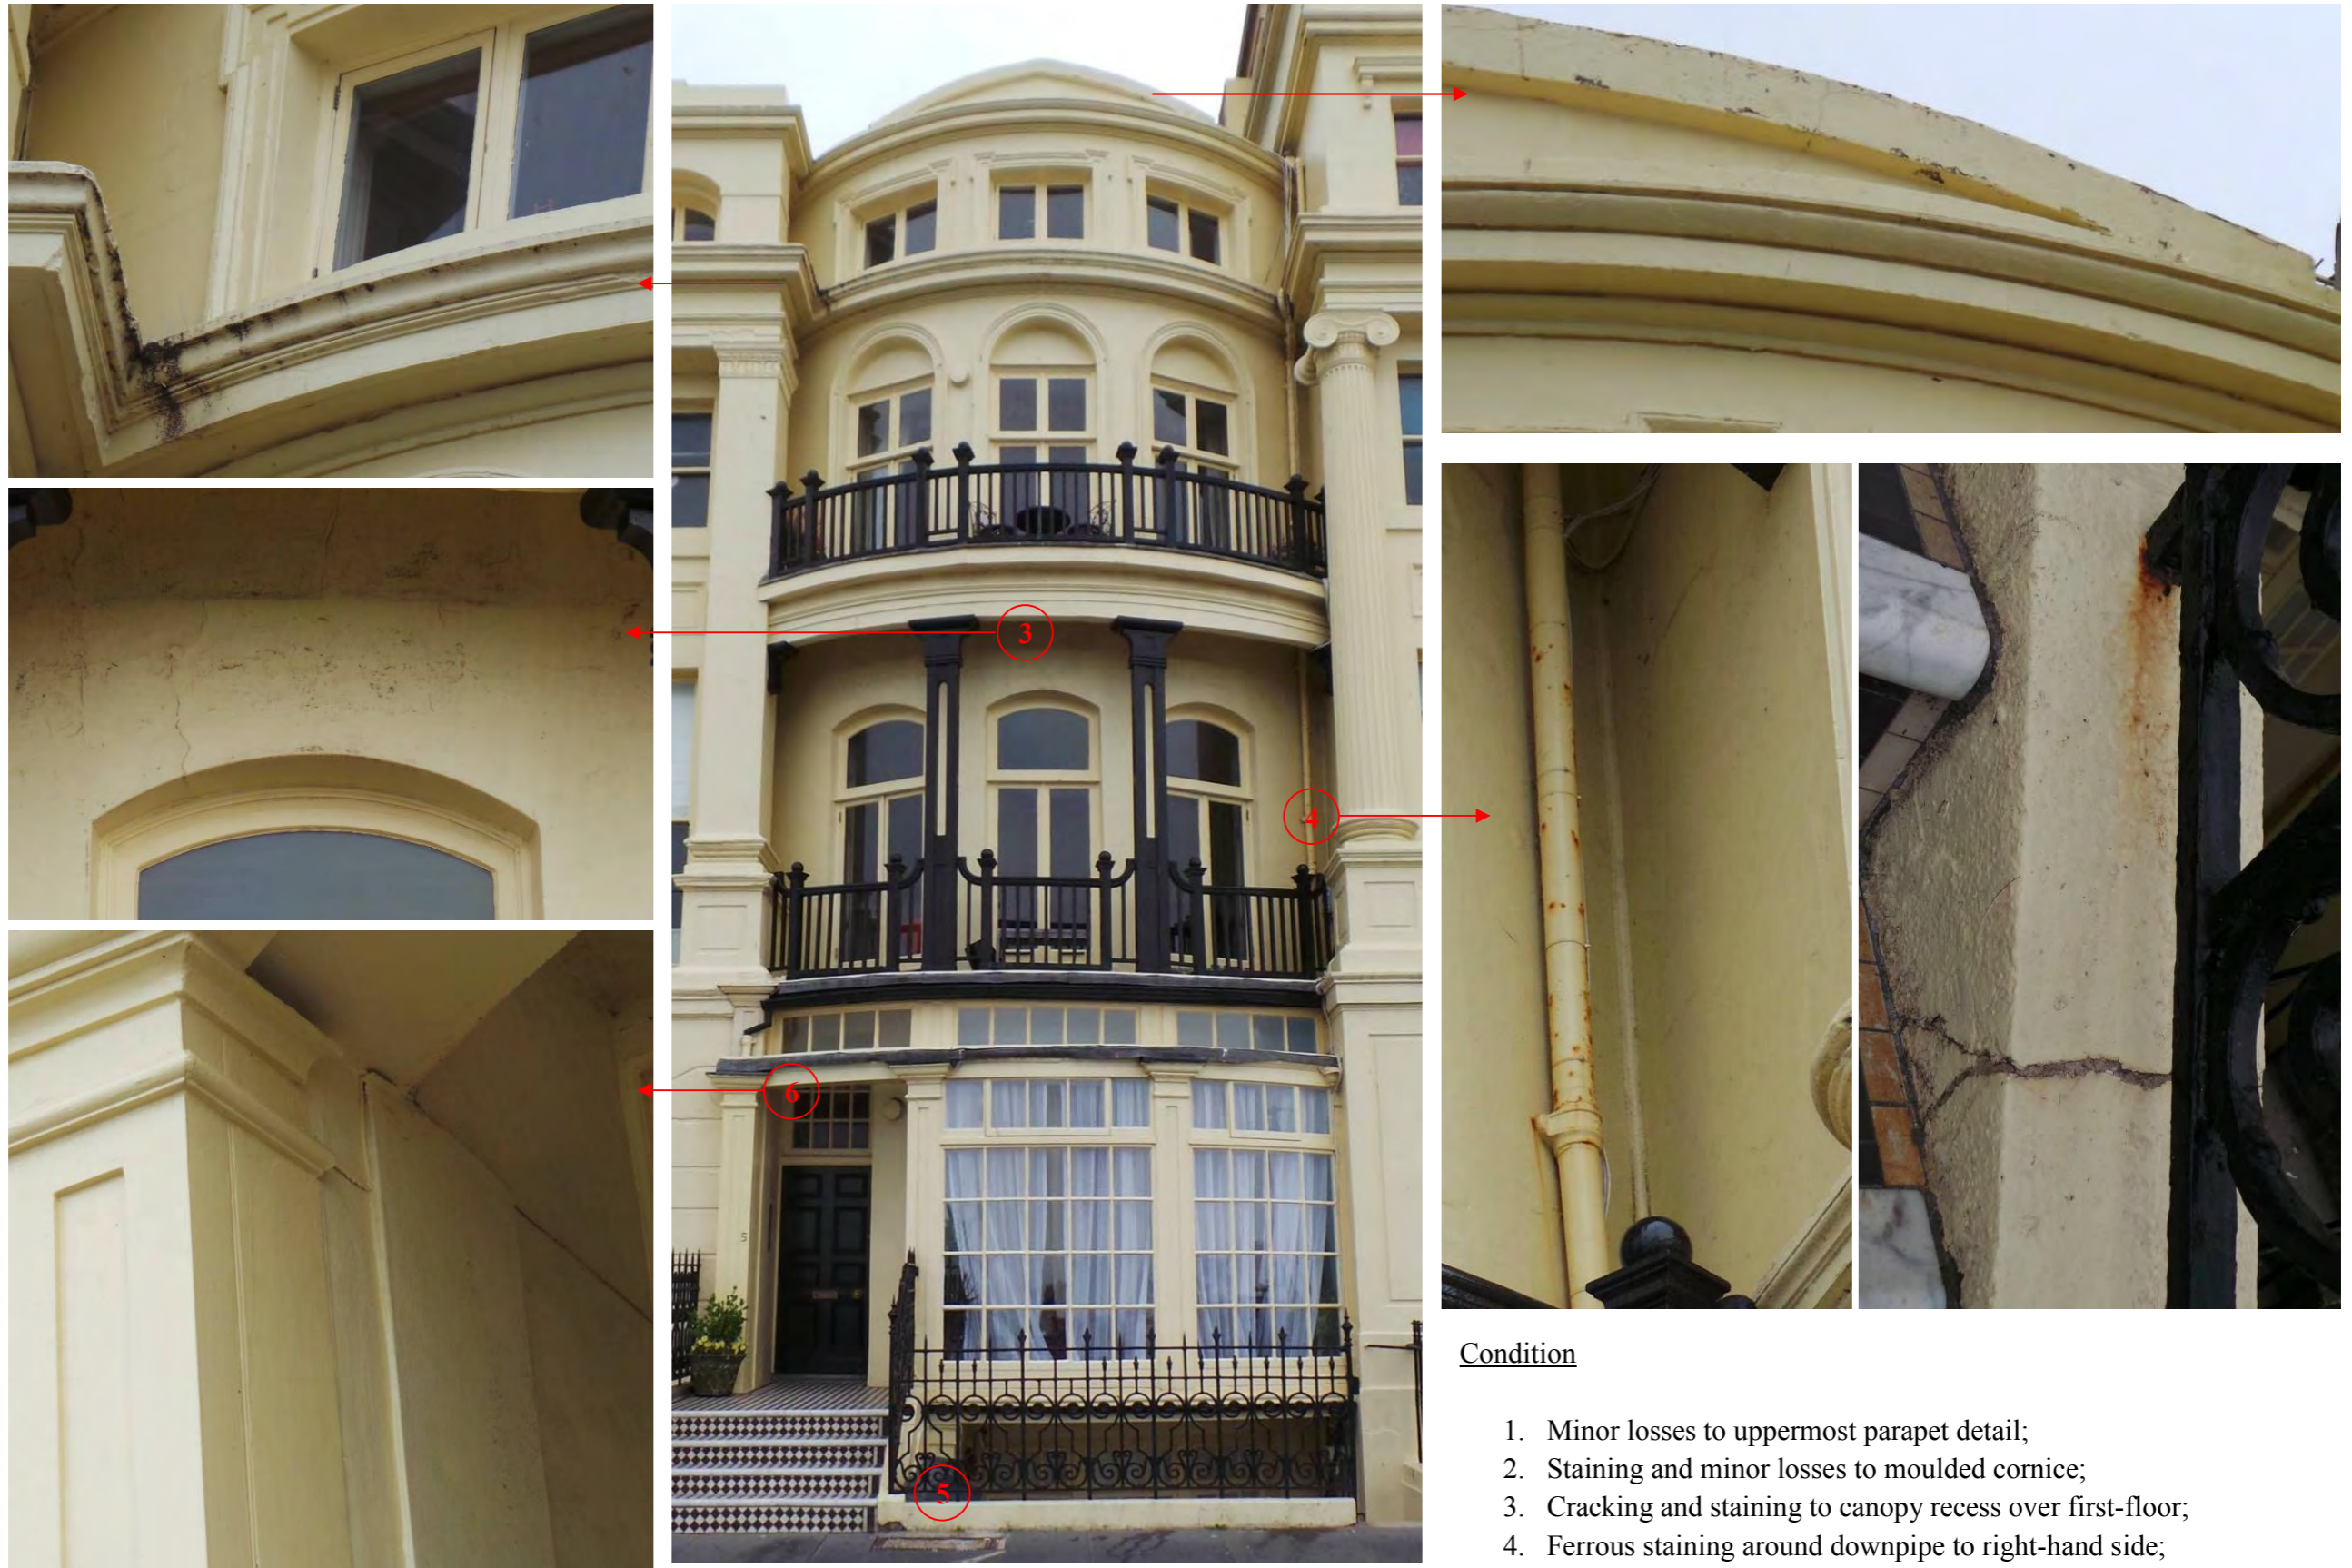
5 Brunswick Terrace

1. Minor losses to uppermost parapet detail;
2. Staining and minor losses to moulded cornice;
3. Cracking and staining to canopy recess over first-floor;
4. Ferrous staining around downpipe to right-hand side;
5. Substrate cracking and ferrous staining to plinth wall;
6. Porch appears to be painted/retouched in a different shade.

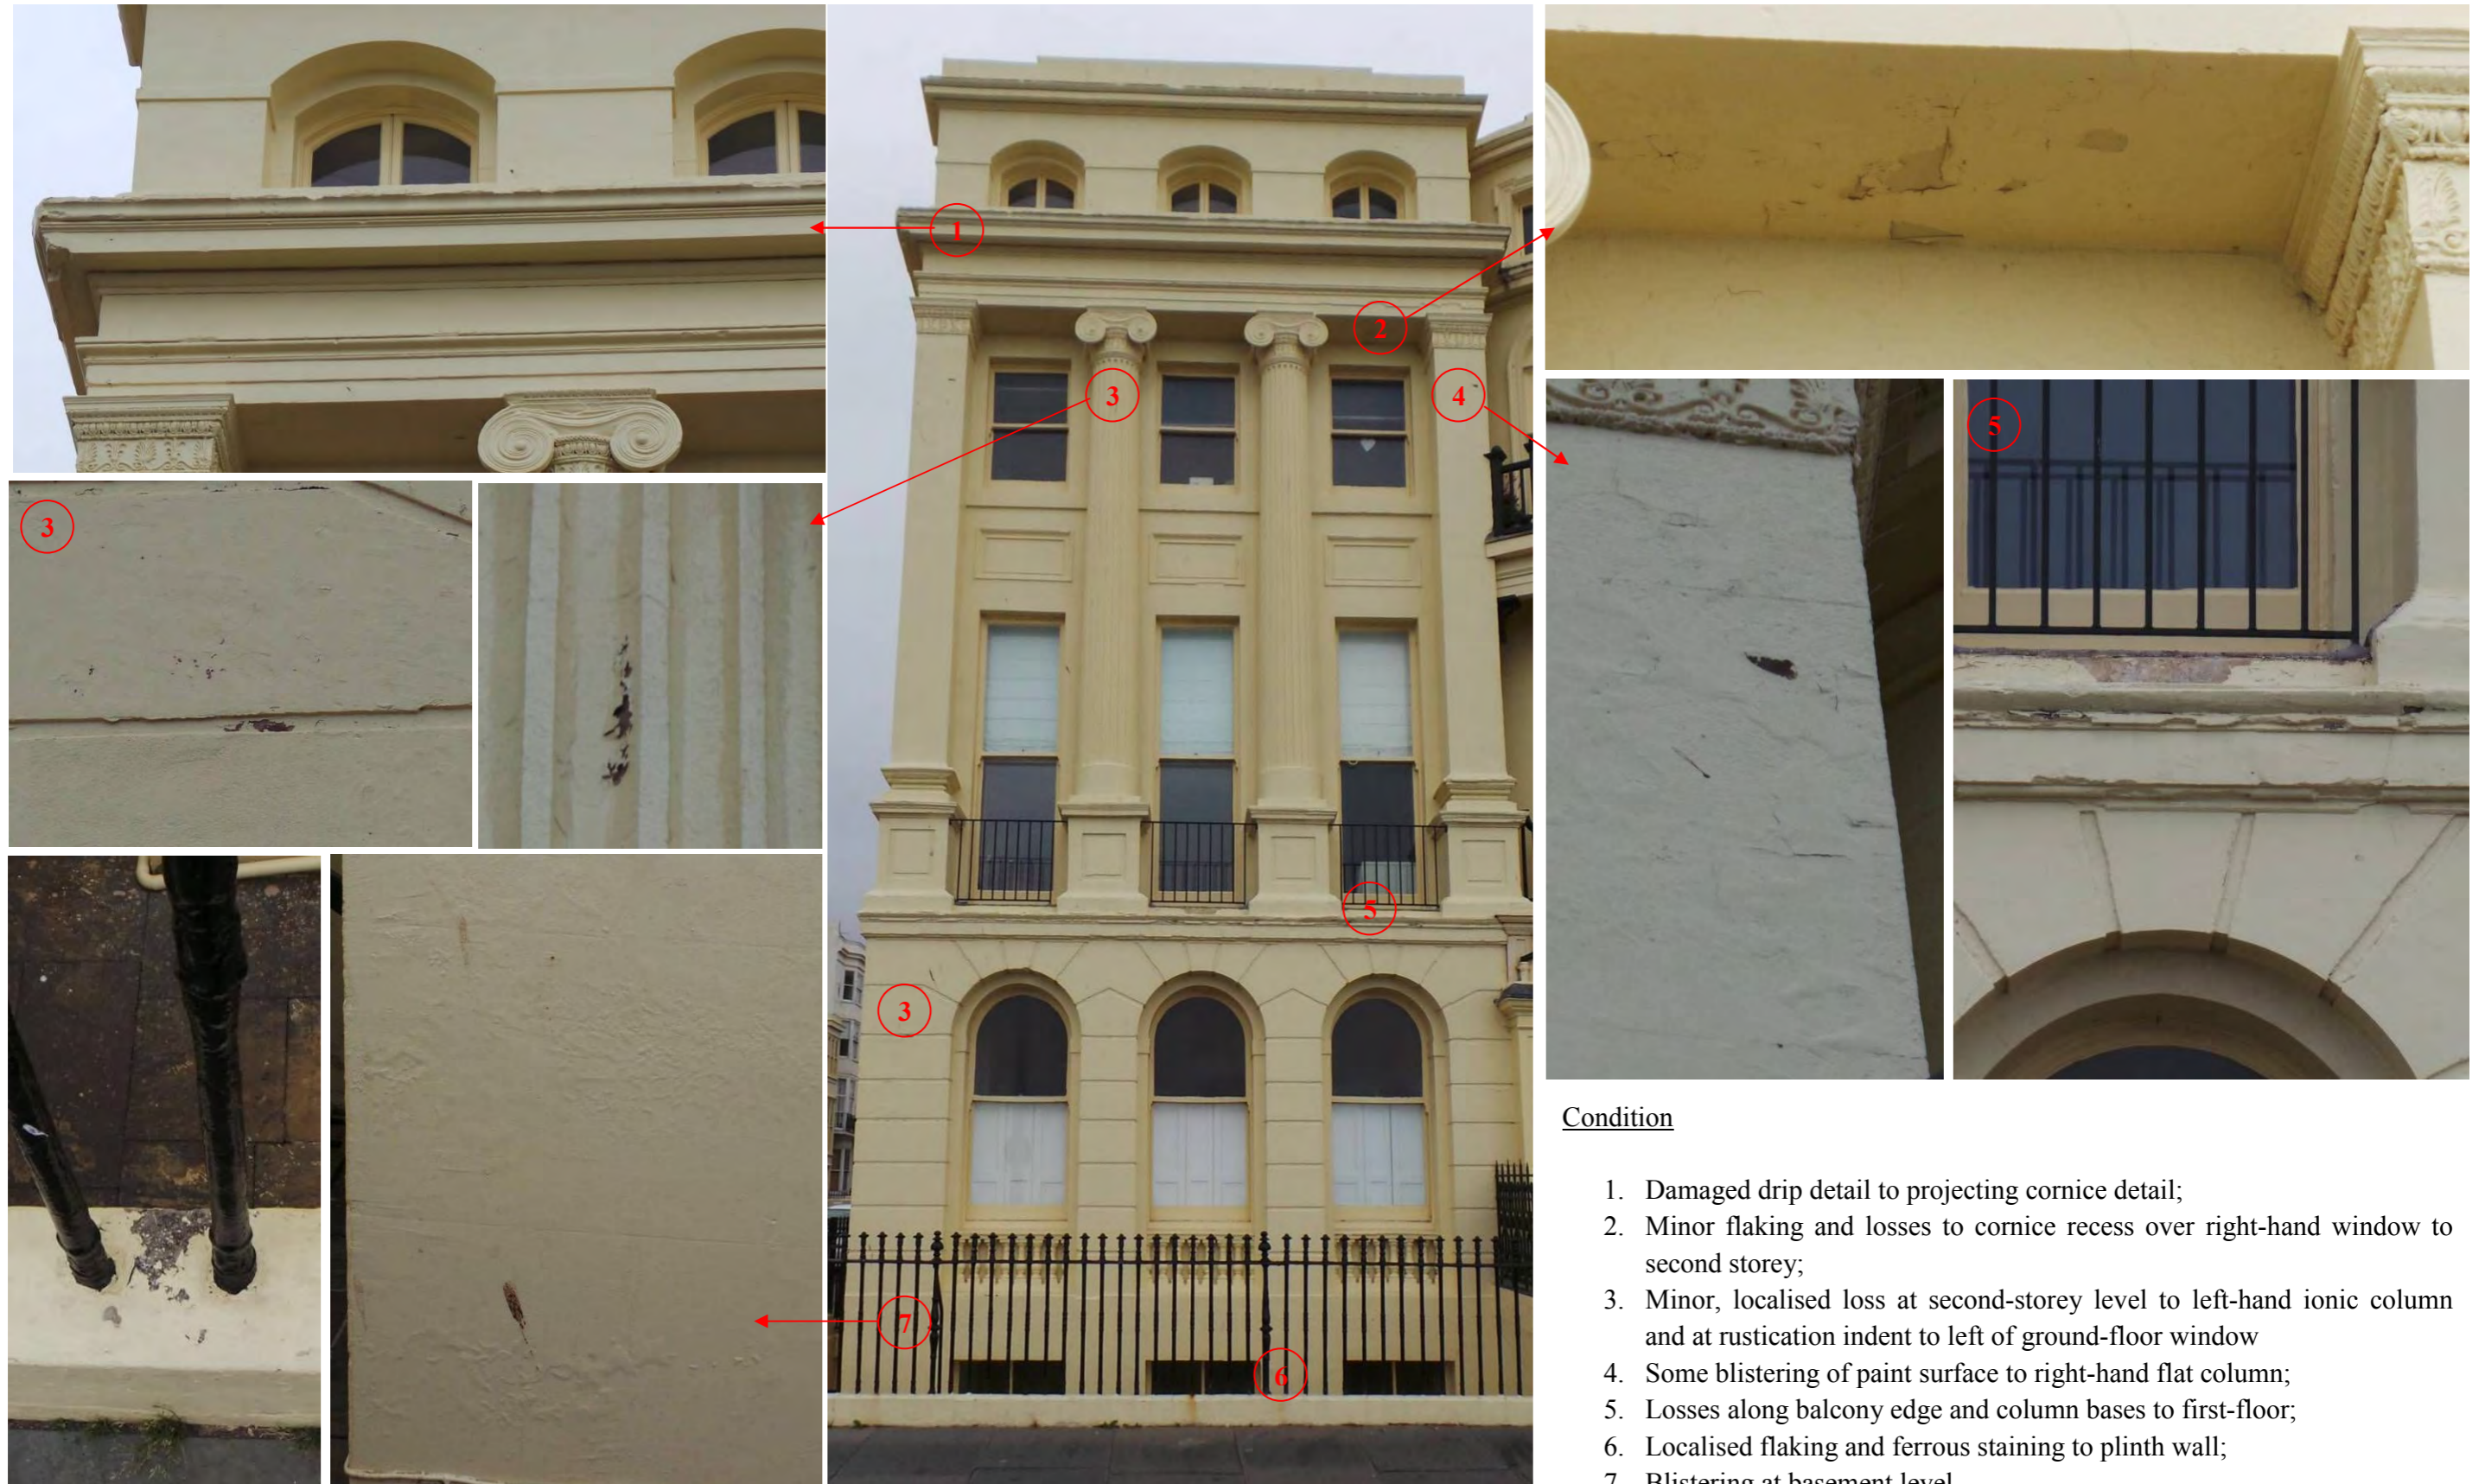
6 Brunswick Terrace

1. Damaged drip detail to projecting cornice detail;
2. Minor flaking and losses to cornice recess over right-hand window to second storey;
3. Minor, localised loss at second-storey level to left-hand ionic column and at rustication indent to left of ground-floor window
4. Some blistering of paint surface to right-hand flat column;
5. Losses along balcony edge and column bases to first-floor;
6. Localised flaking and ferrous staining to plinth wall;
7. Blistering at basement level.

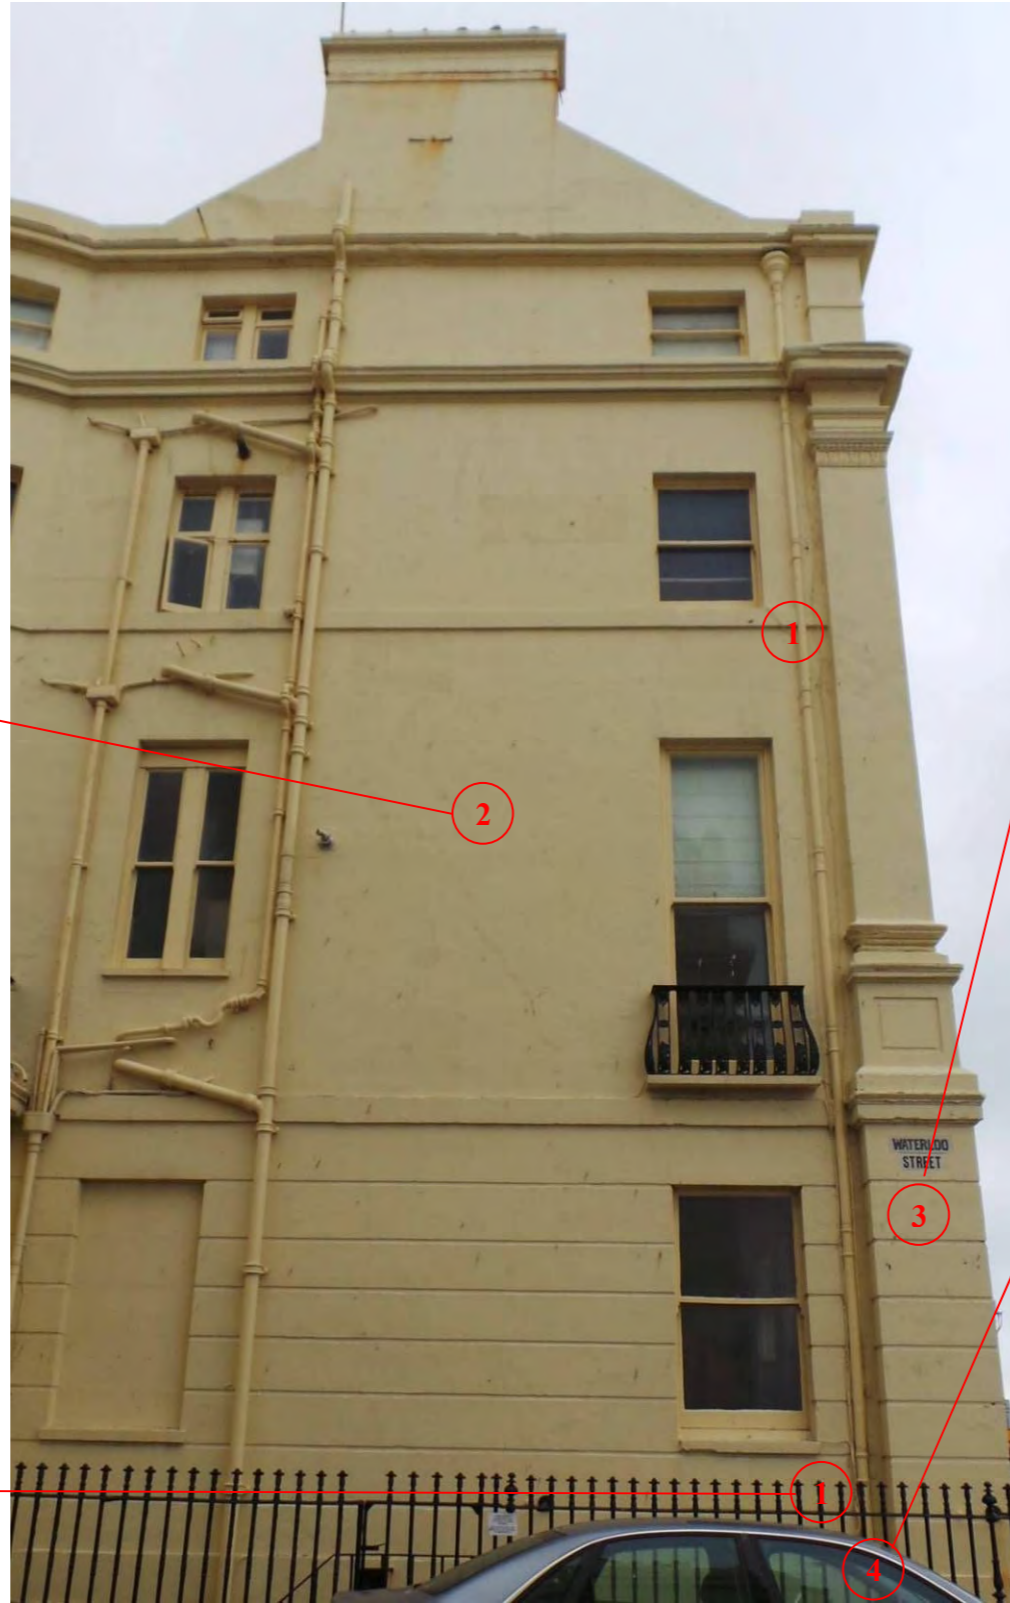
6 Brunswick Terrace (Waterloo Street Elevation)

1. Drain-pipe and wiring systems exhibiting failure to surrounding areas;
2. Evidence of previous repairs to flat surface of first-floor;
3. Blistering and minor losses to projecting rusticated column base;
4. Slight ferrous staining to plinth wall.

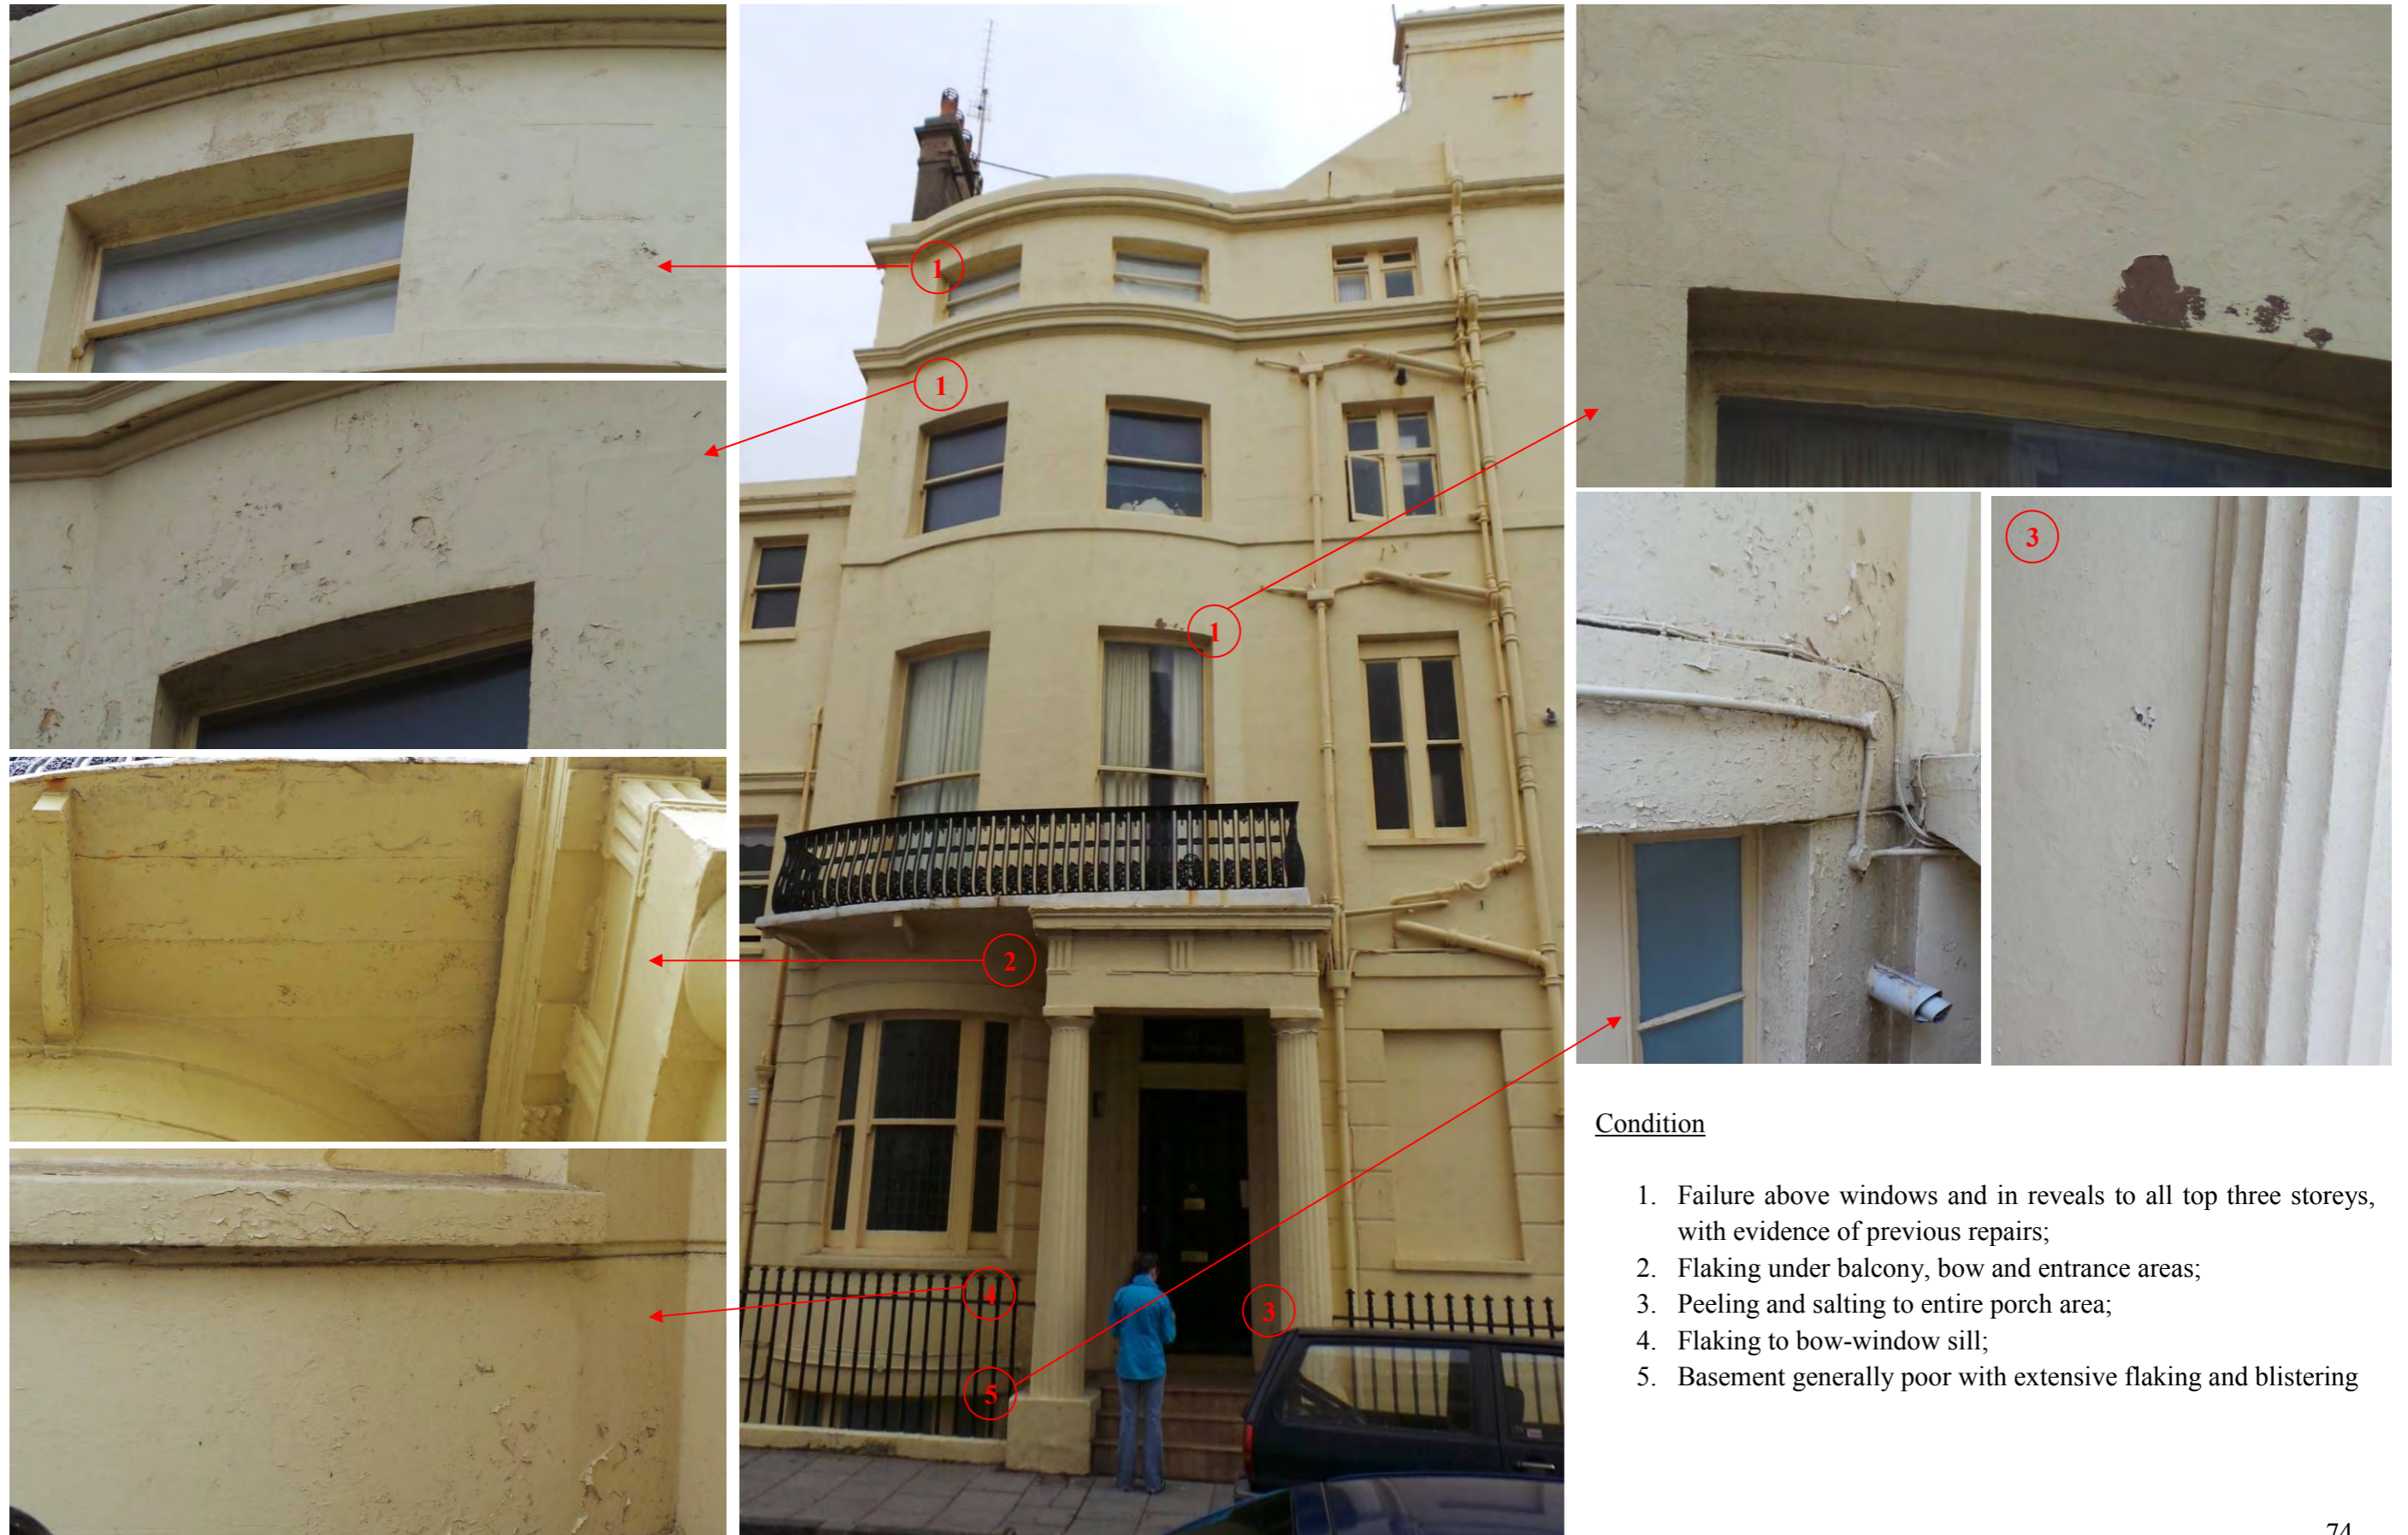
6 Brunswick Terrace – (Waterloo Street Elevation contd.)

1. Failure above windows and in reveals to all top three storeys, with evidence of previous repairs;
2. Flaking under balcony, bow and entrance areas;
3. Peeling and salting to entire porch area;
4. Flaking to bow-window sill;
5. Basement generally poor with extensive flaking and blistering
