**Investigation of Paint Failure at
Brunswick Estate
Hove
Brighton**

August 2013

**BRUNSWICK ESTATE
HOVE**

The following document investigates the failure of the external paint-system at Brunswick Estate, Hove based on research carried out by Elizabeth Hirst and Rachel Morley of Hirst Conservation between August and November 2013. The work was commissioned by Brighton & Hove City Council.

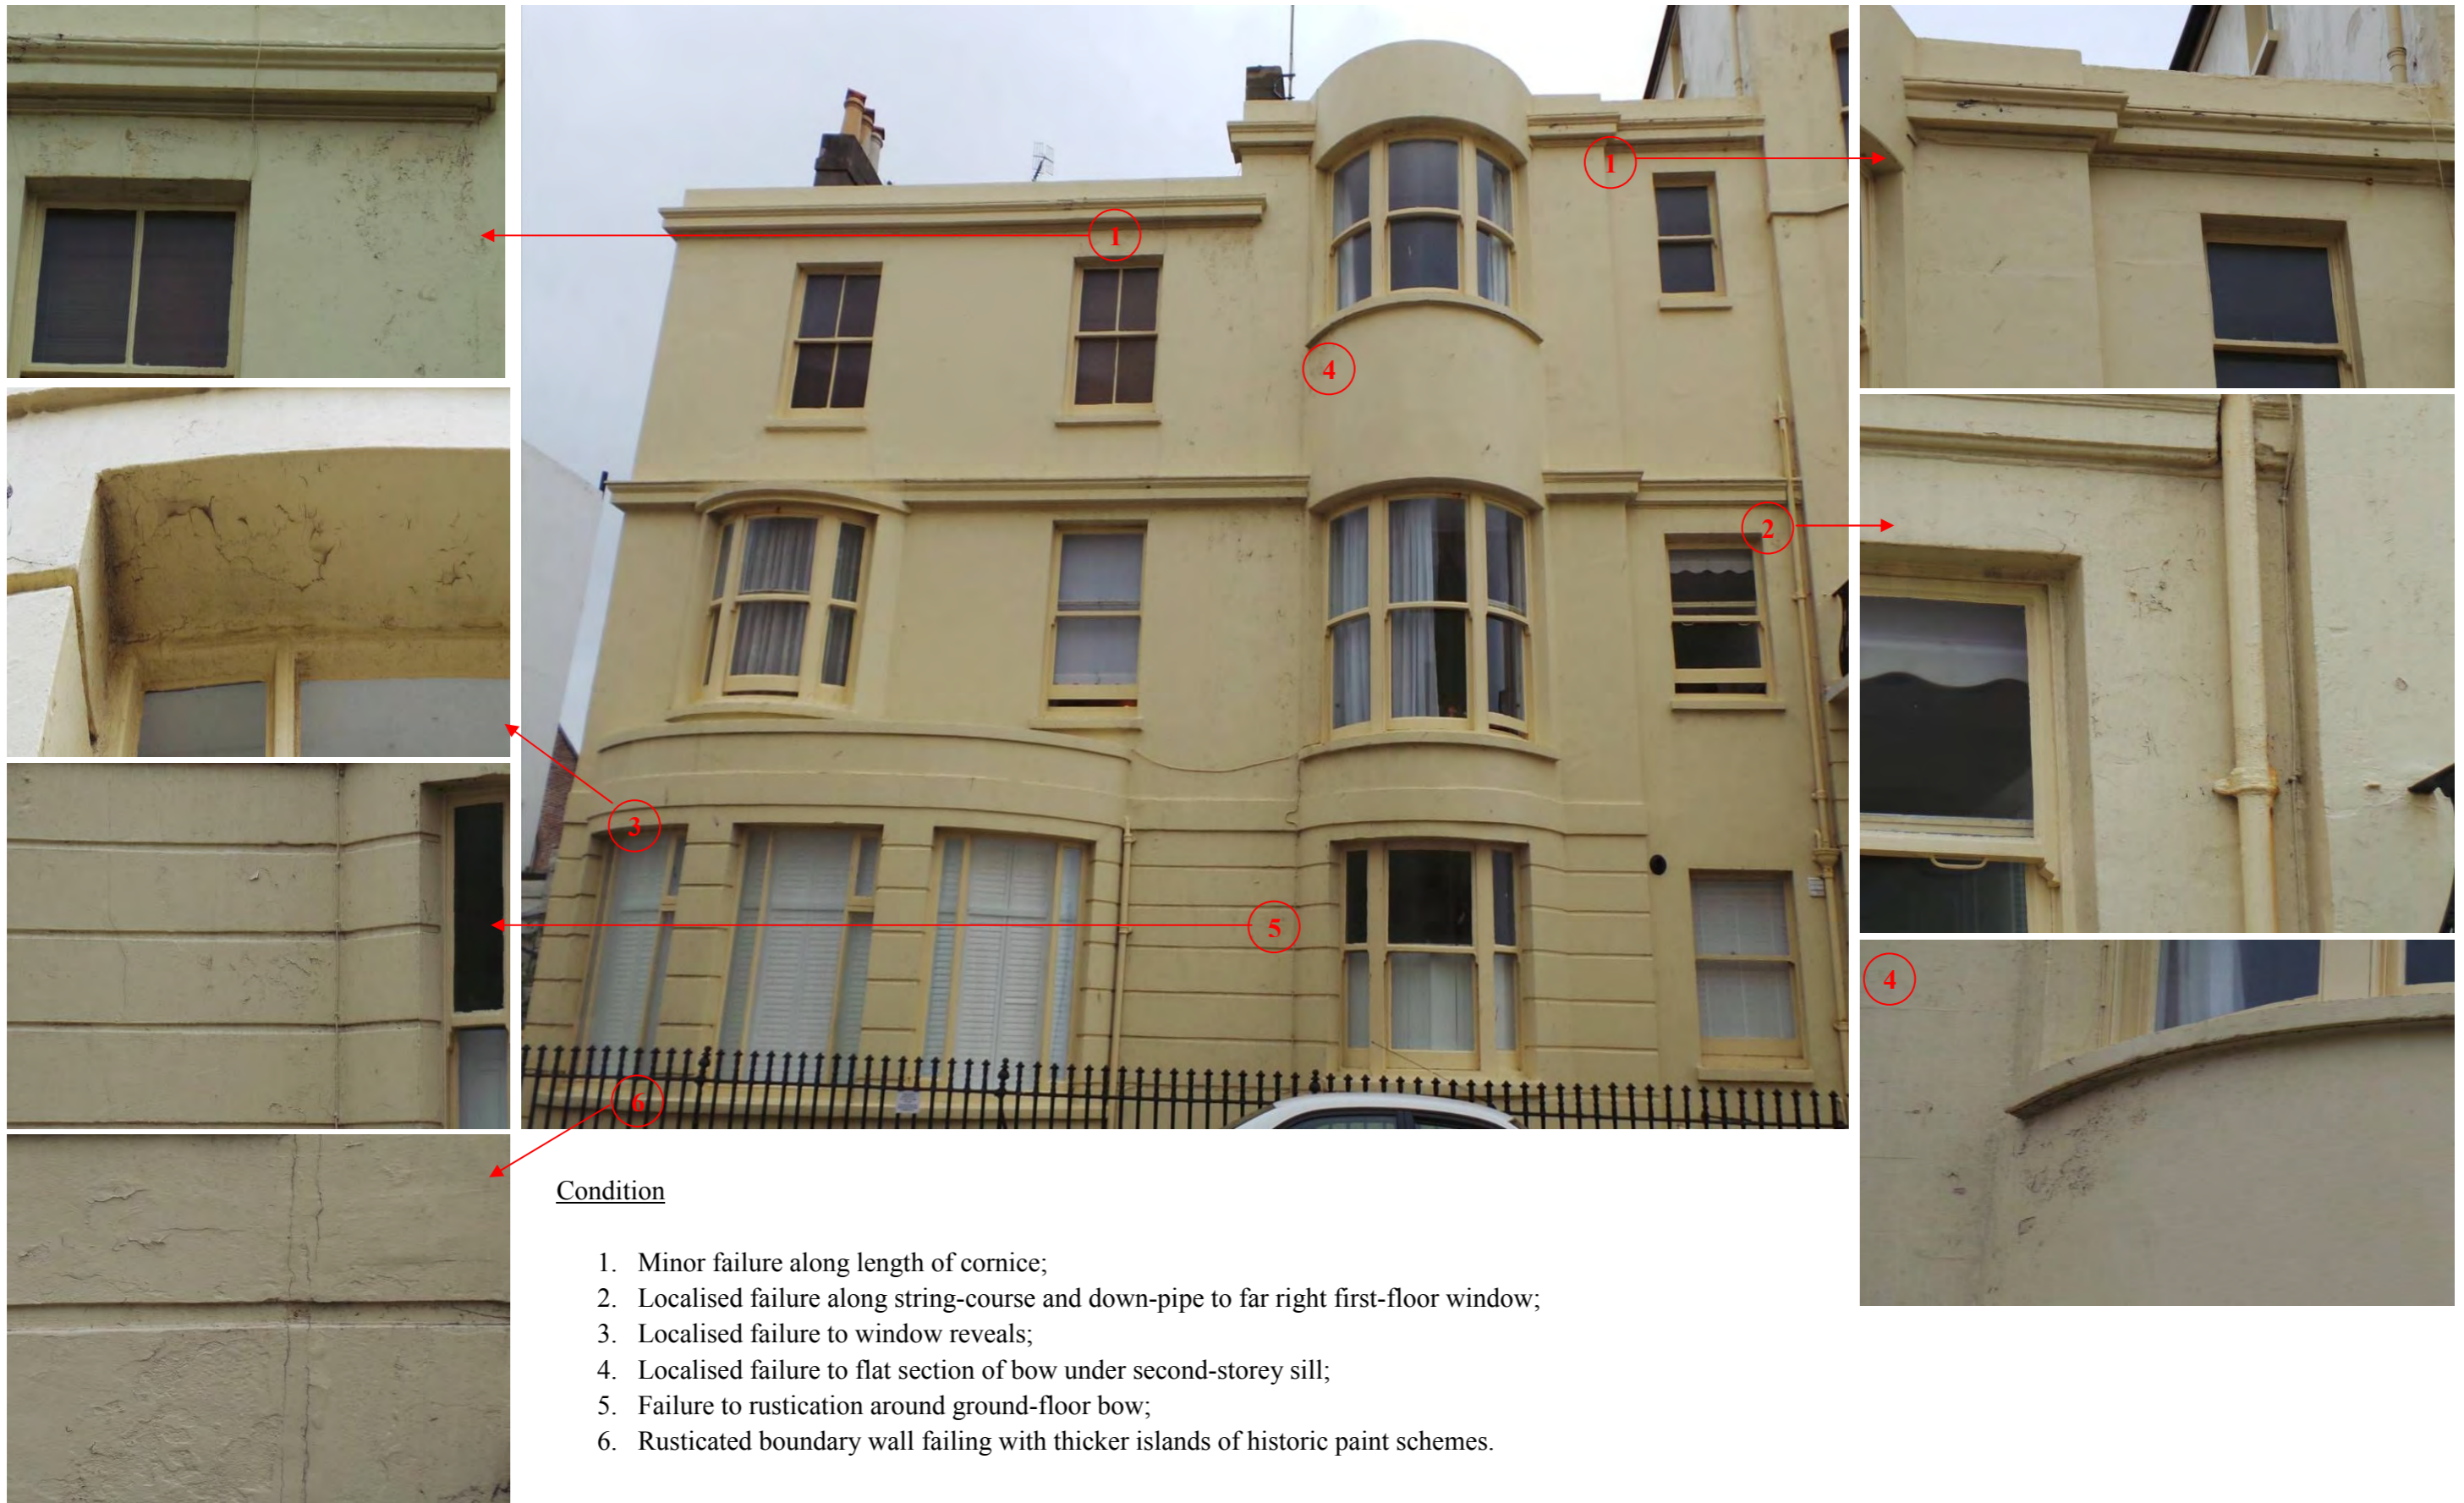
6 Brunswick Terrace (Waterloo Street Elevation contd.)

1. Minor failure along length of cornice;
2. Localised failure along string-course and down-pipe to far right first-floor window;
3. Localised failure to window reveals;
4. Localised failure to flat section of bow under second-storey sill;
5. Failure to rustication around ground-floor bow;
6. Rusticated boundary wall failing with thicker islands of historic paint schemes.

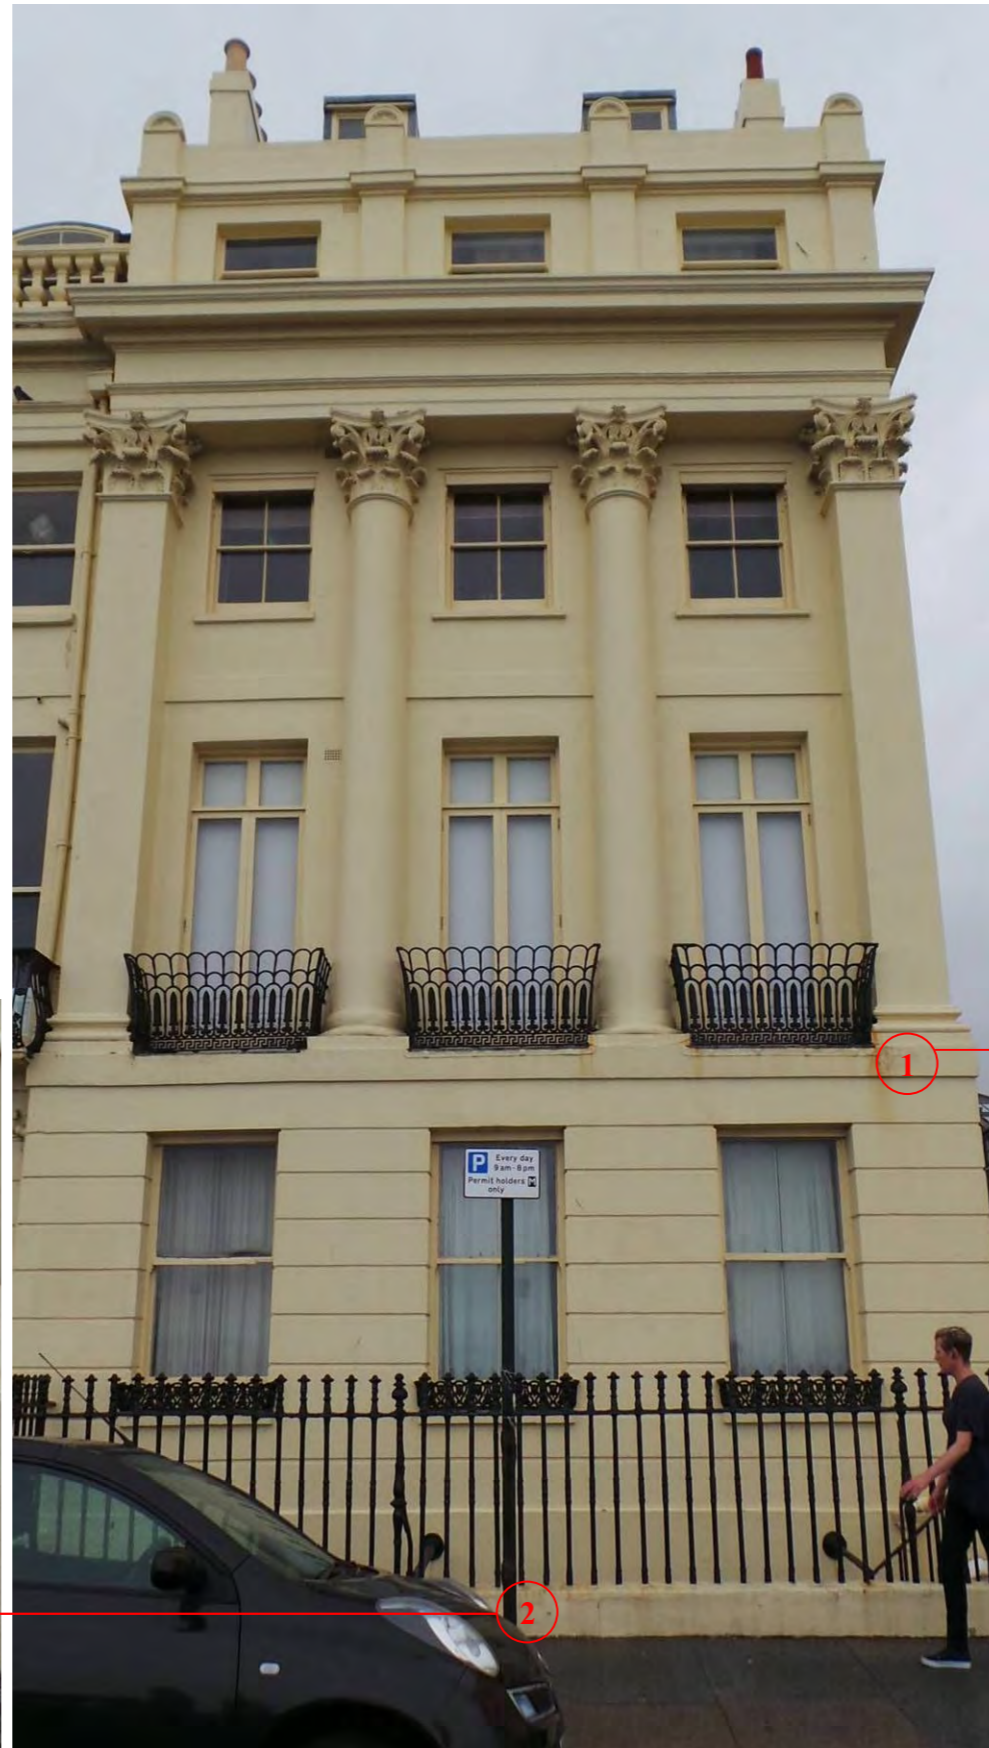
7 Brunswick Terrace (Brunswick Terrace Elevation)

1. Slight ferrous staining from balustrade and cracking to first floor balcony areas;
2. Minor ferrous staining and losses to low plinth wall;
3. Basement generally good.

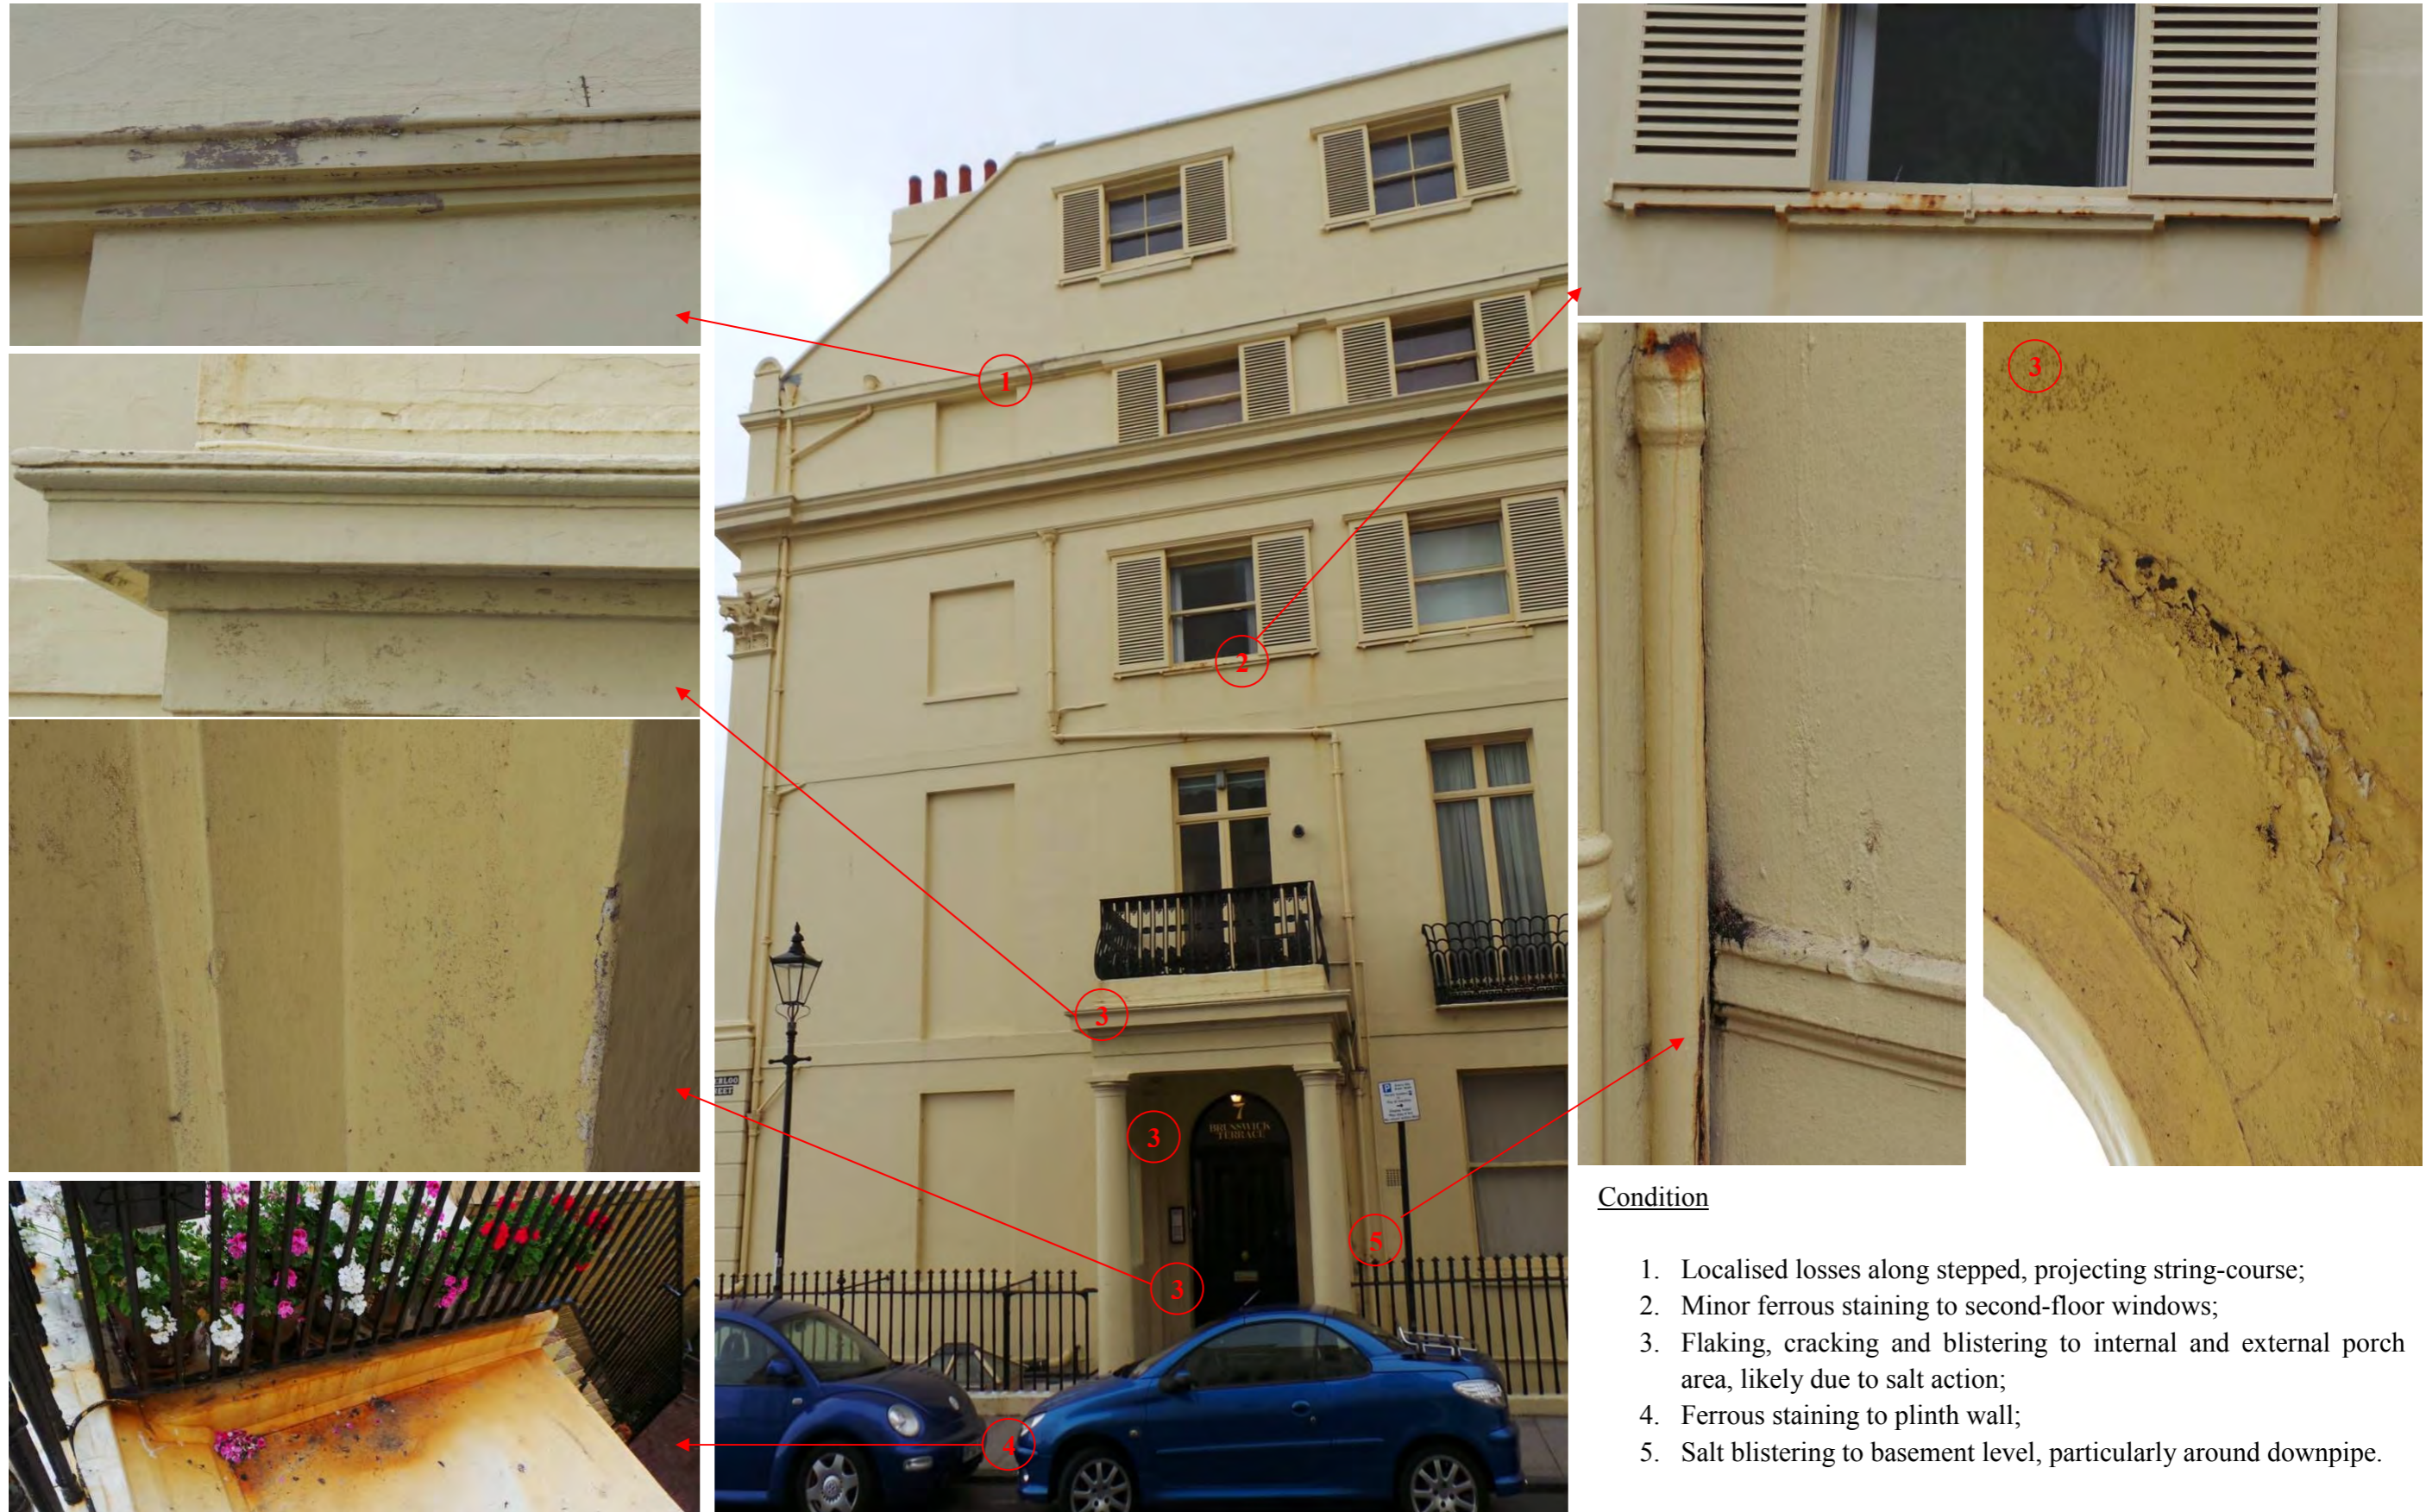
7 Brunswick Terrace (Waterloo Road Elevation)

1. Localised losses along stepped, projecting string-course;
2. Minor ferrous staining to second-floor windows;
3. Flaking, cracking and blistering to internal and external porch area, likely due to salt action;
4. Ferrous staining to plinth wall;
5. Salt blistering to basement level, particularly around downpipe.

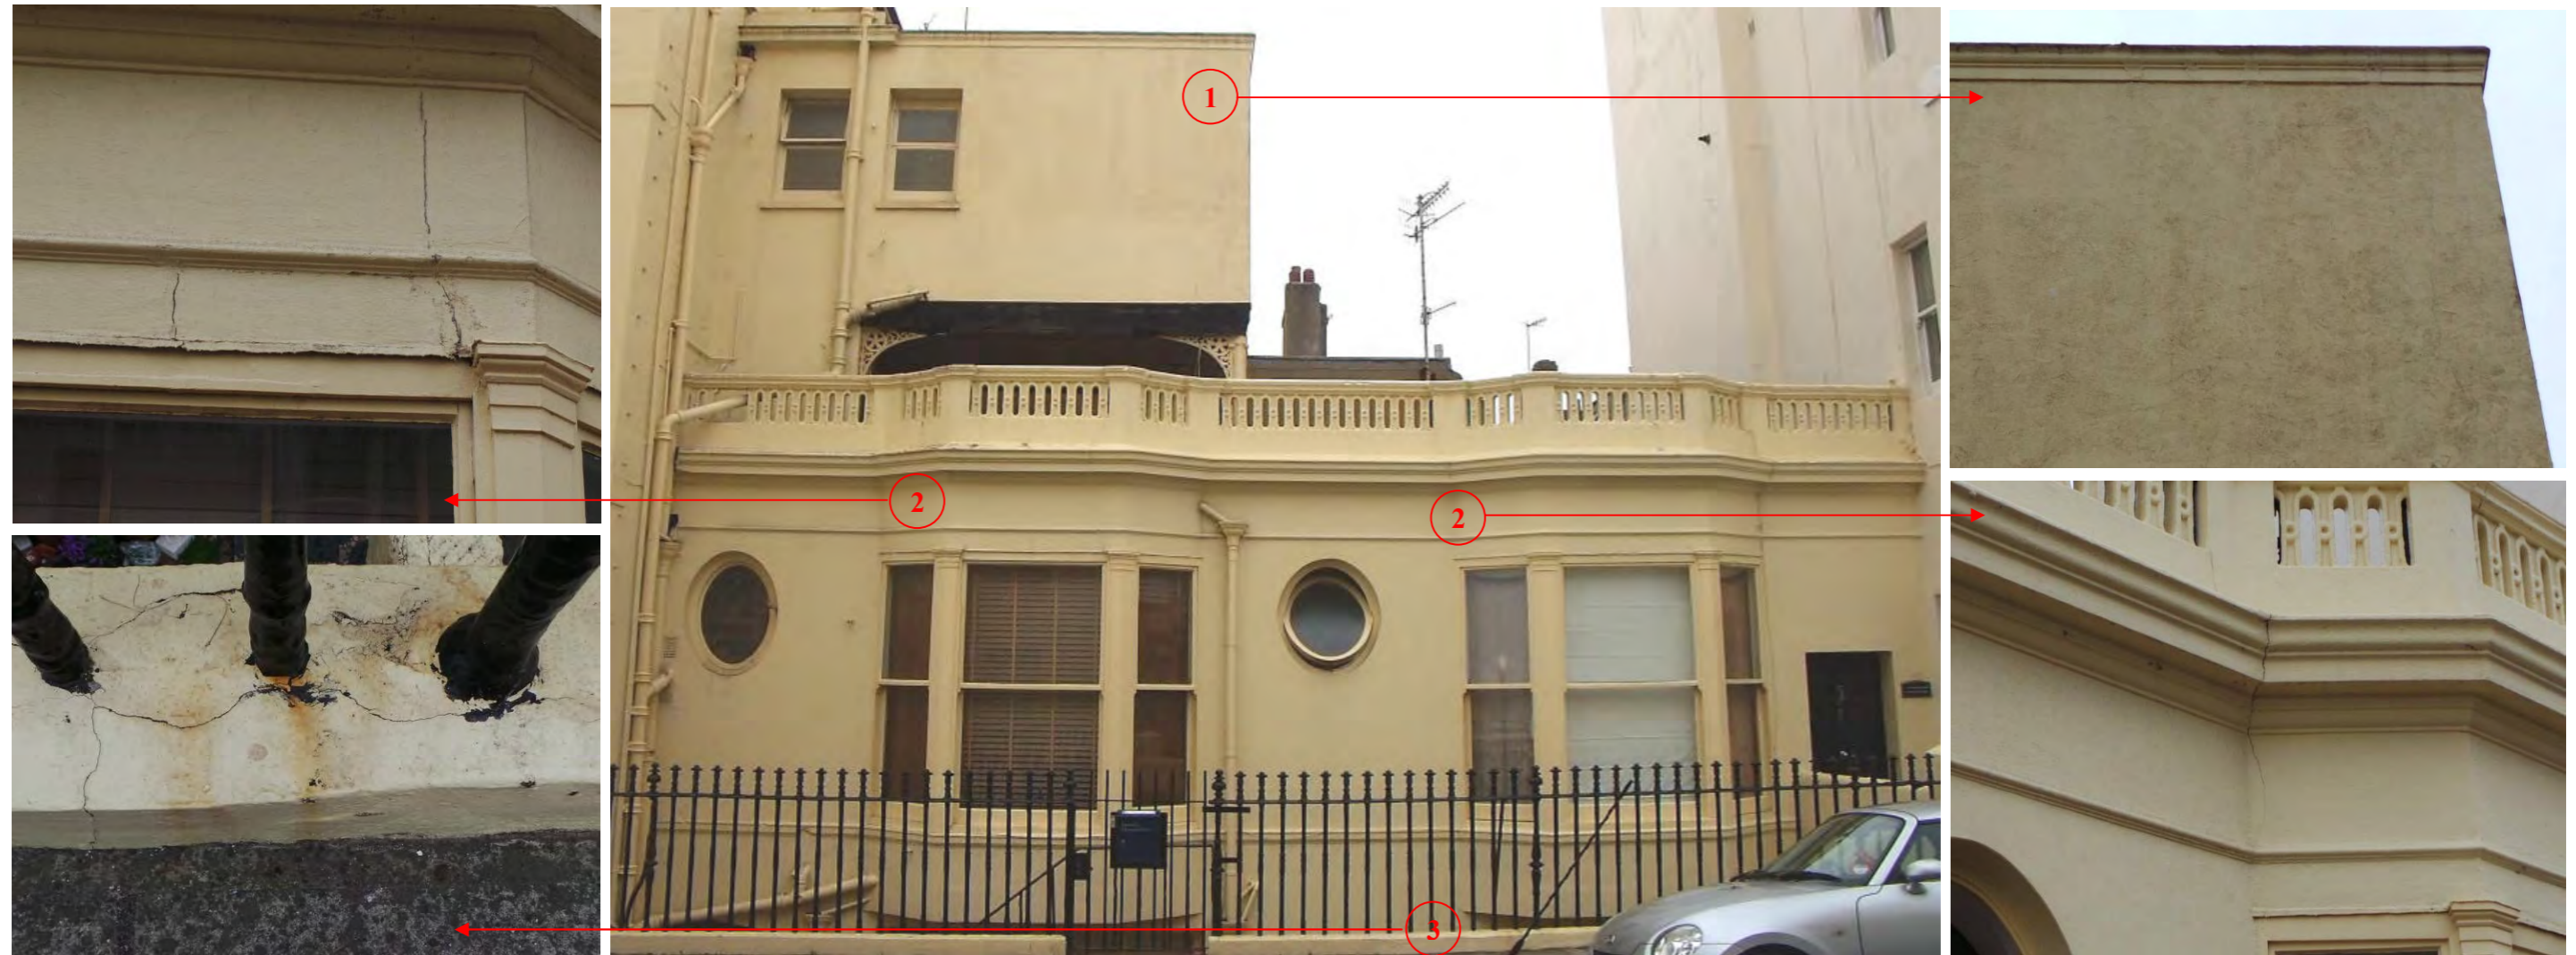
7 Brunswick Terrace (Waterloo Road Elevation contd).

1. Large patch of rough finish flat roof extension;
2. Occasional fractures, but paint adhering well overall;
3. Plinth and railings significantly better to right of door – less exposed to sea environment;
4. Basement generally good.

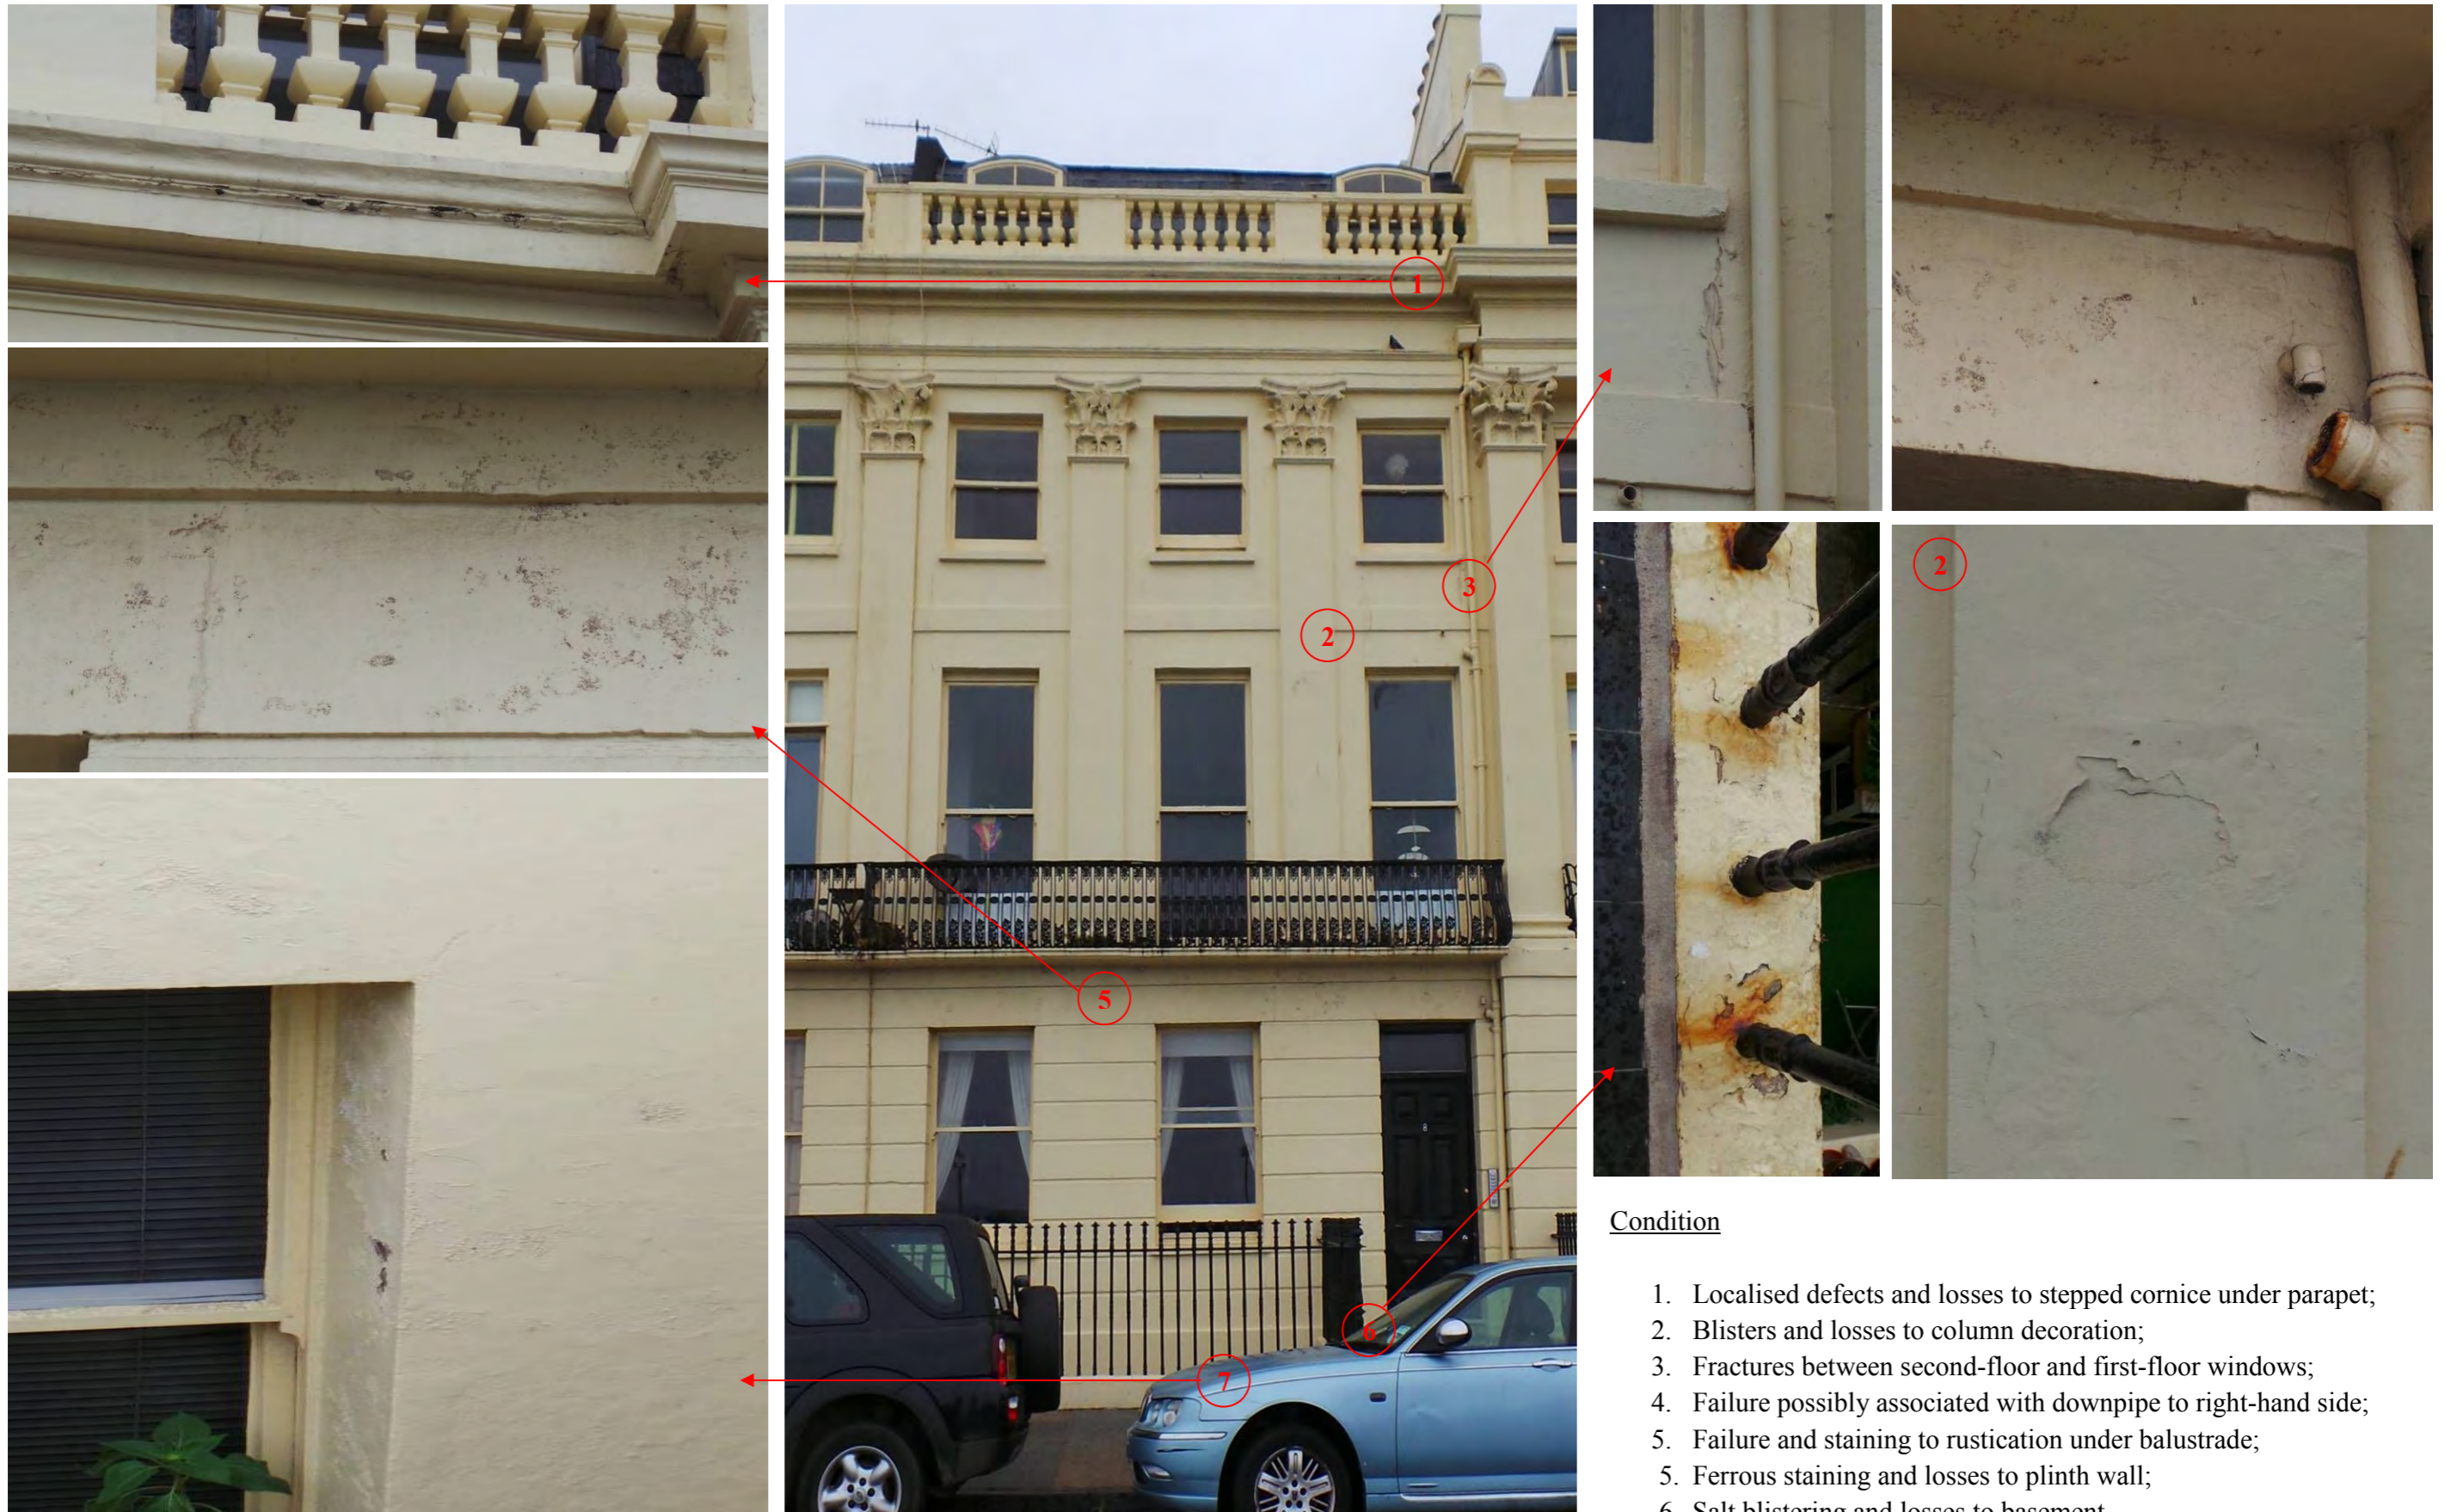
8 Brunswick Terrace

1. Localised defects and losses to stepped cornice under parapet;
2. Blisters and losses to column decoration;
3. Fractures between second-floor and first-floor windows;
4. Failure possibly associated with downpipe to right-hand side;
5. Failure and staining to rustication under balustrade;
5. Ferrous staining and losses to plinth wall;
6. Salt blistering and losses to basement.

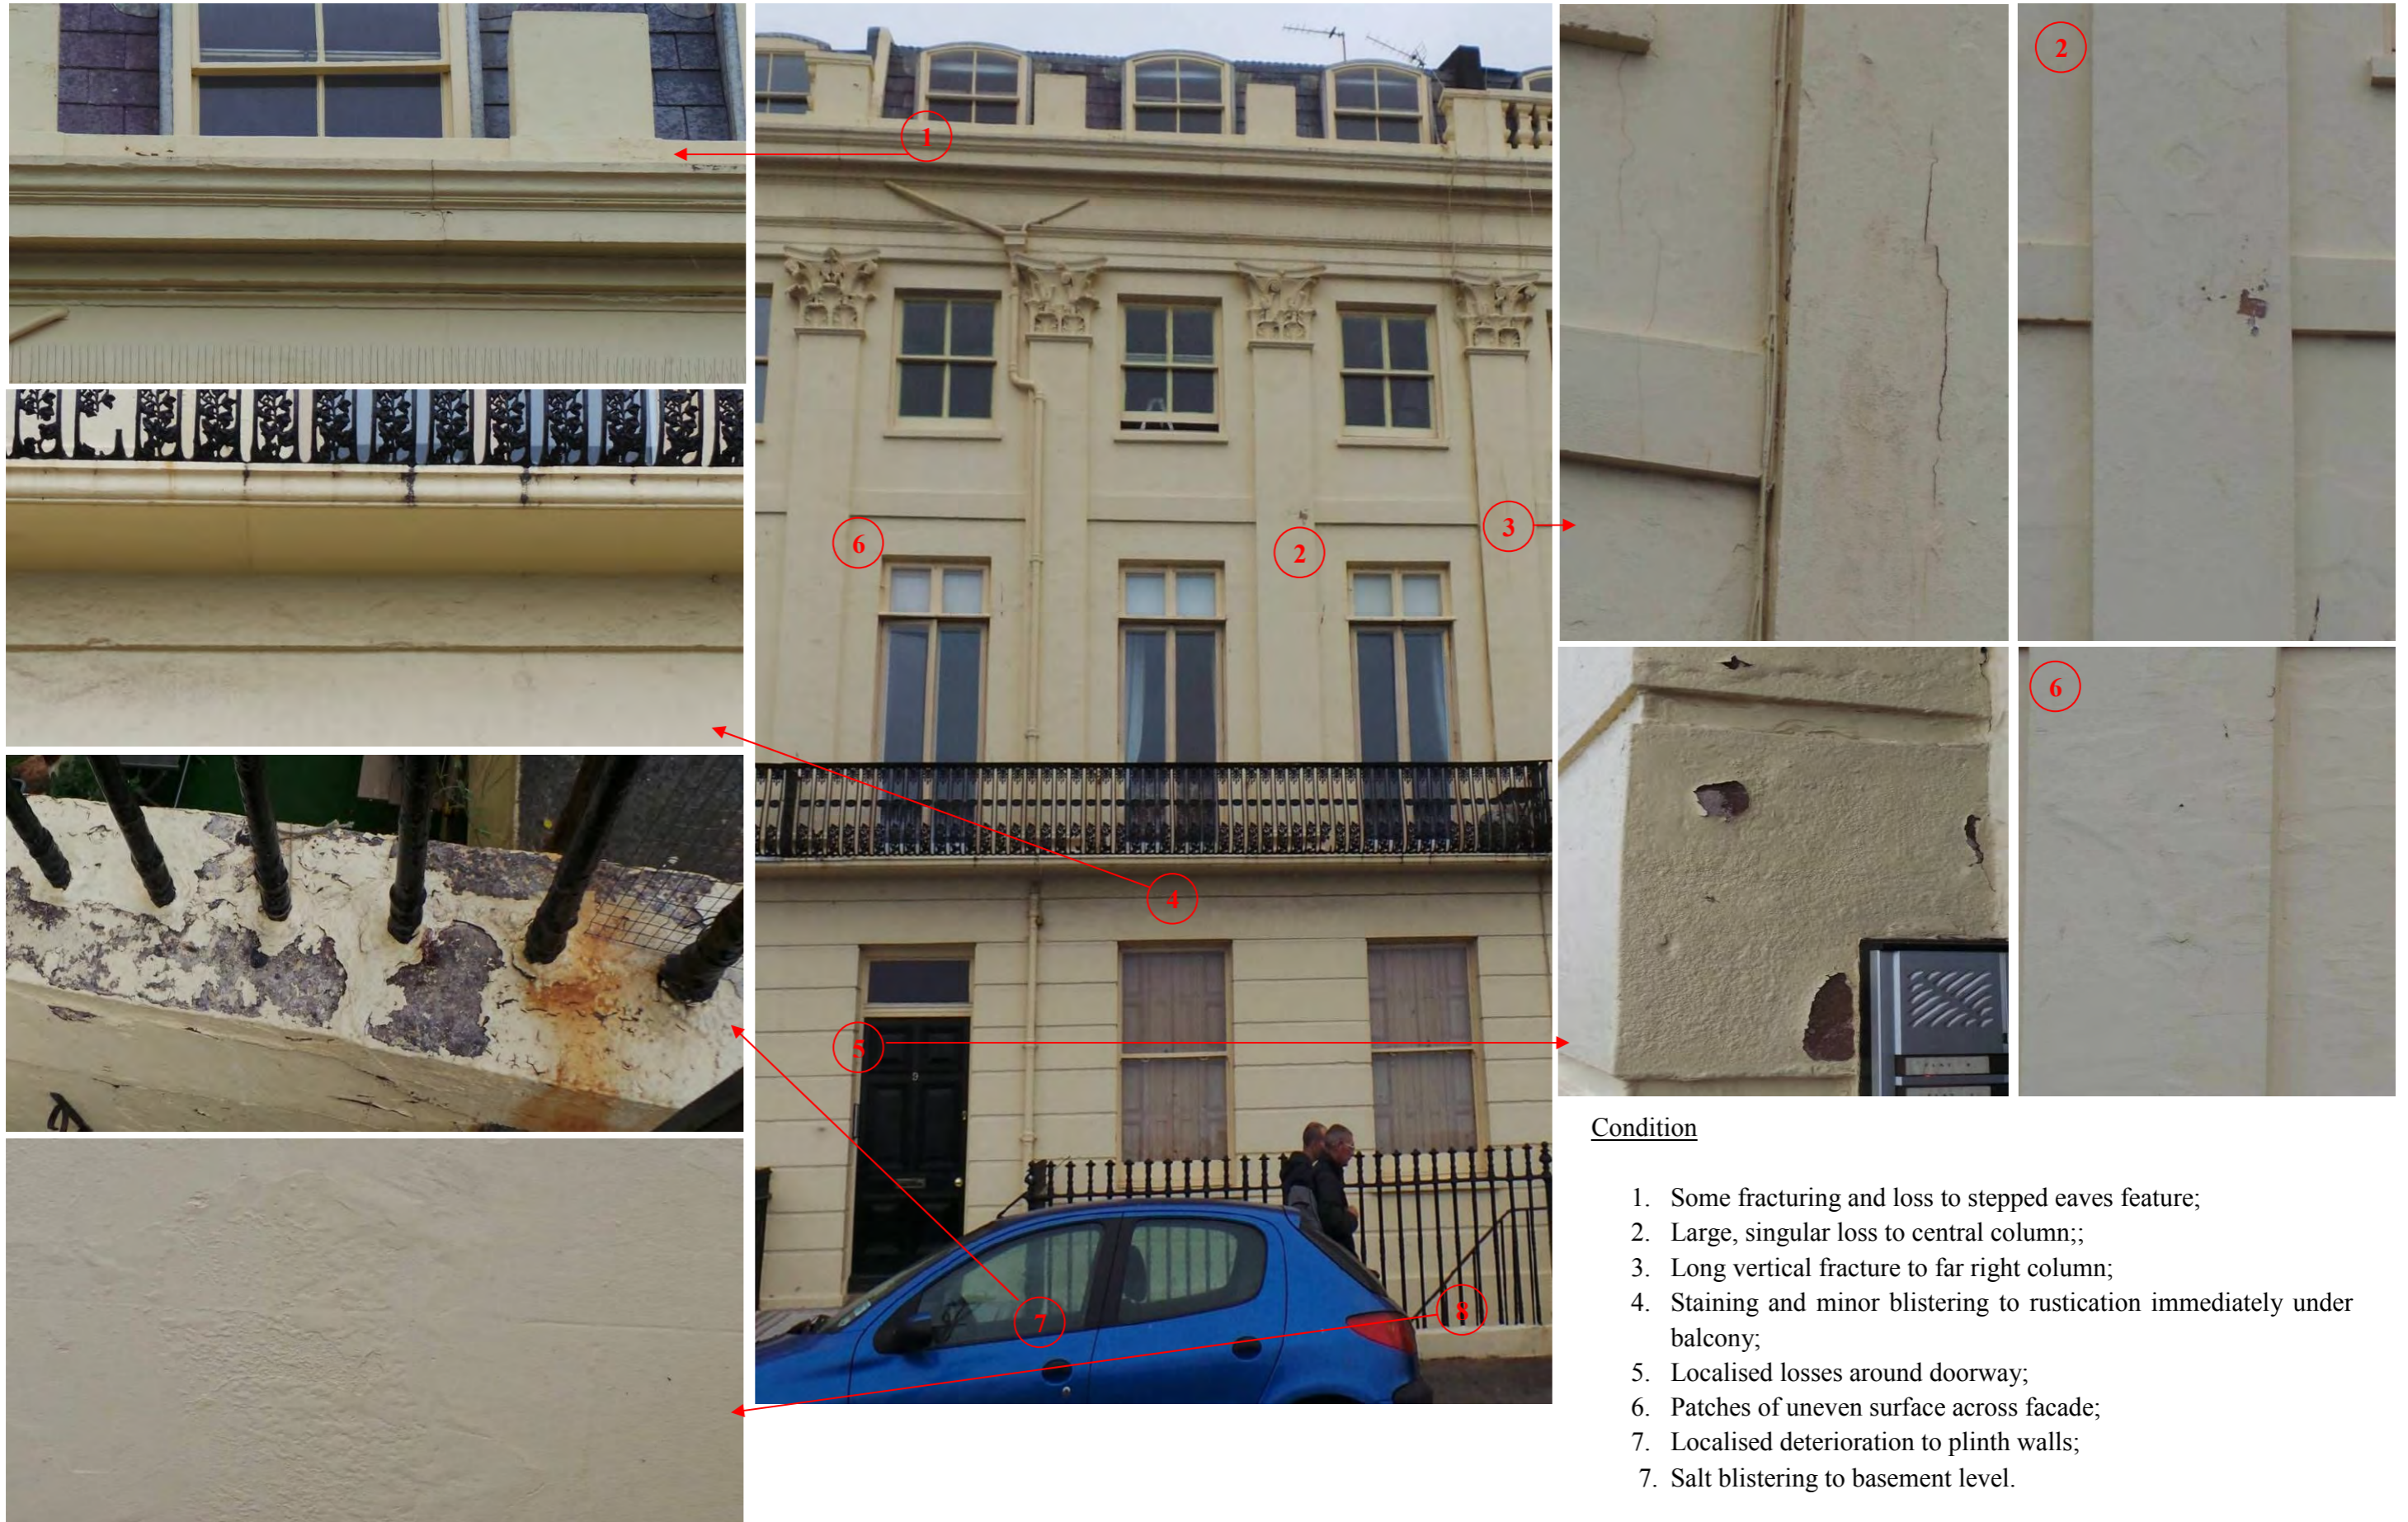
9 Brunswick Terrace

1. Some fracturing and loss to stepped eaves feature;
2. Large, singular loss to central column;;
3. Long vertical fracture to far right column;
4. Staining and minor blistering to rustication immediately under balcony;
5. Localised losses around doorway;
6. Patches of uneven surface across facade;
7. Localised deterioration to plinth walls;
7. Salt blistering to basement level.

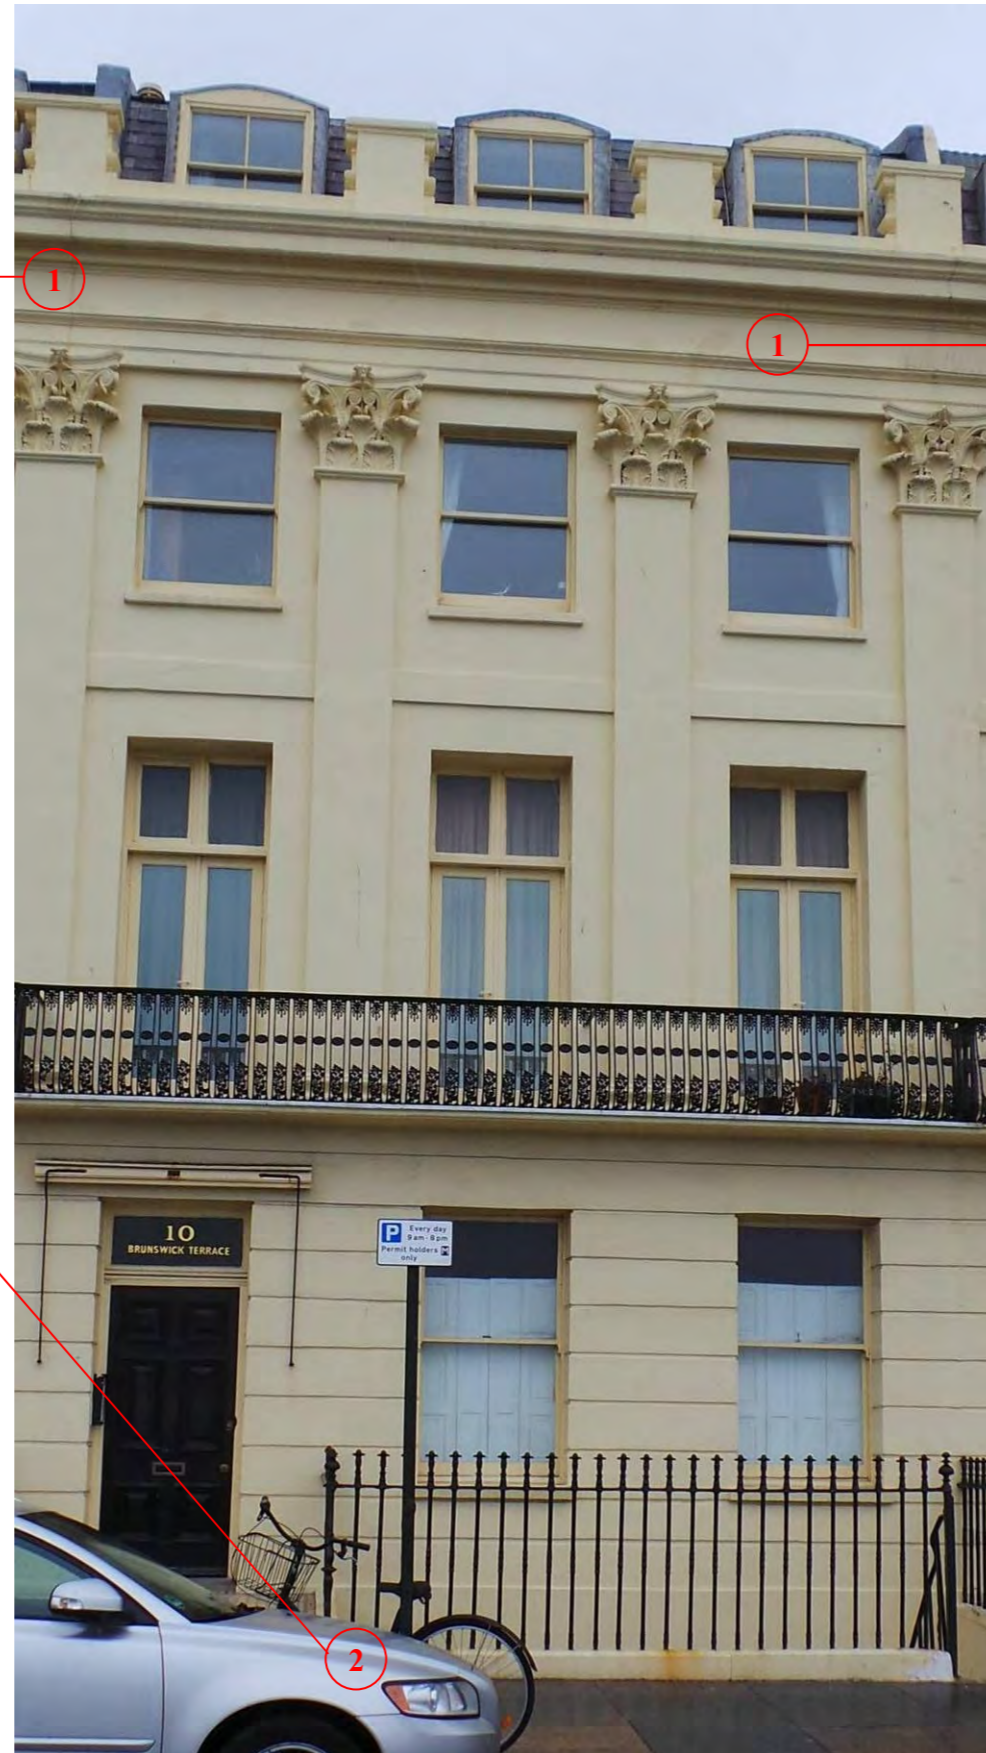
10 Brunswick Terrace

1. Patchy colouring to flat section immediately above columns and along centre right column;
1. Ferrous staining and losses to plinth wall;
