**Investigation of Paint Failure at
Brunswick Estate
Hove
Brighton**

August 2013

**BRUNSWICK ESTATE
HOVE**

The following document investigates the failure of the external paint-system at Brunswick Estate, Hove based on research carried out by Elizabeth Hirst and Rachel Morley of Hirst Conservation between August and November 2013. The work was commissioned by Brighton & Hove City Council.

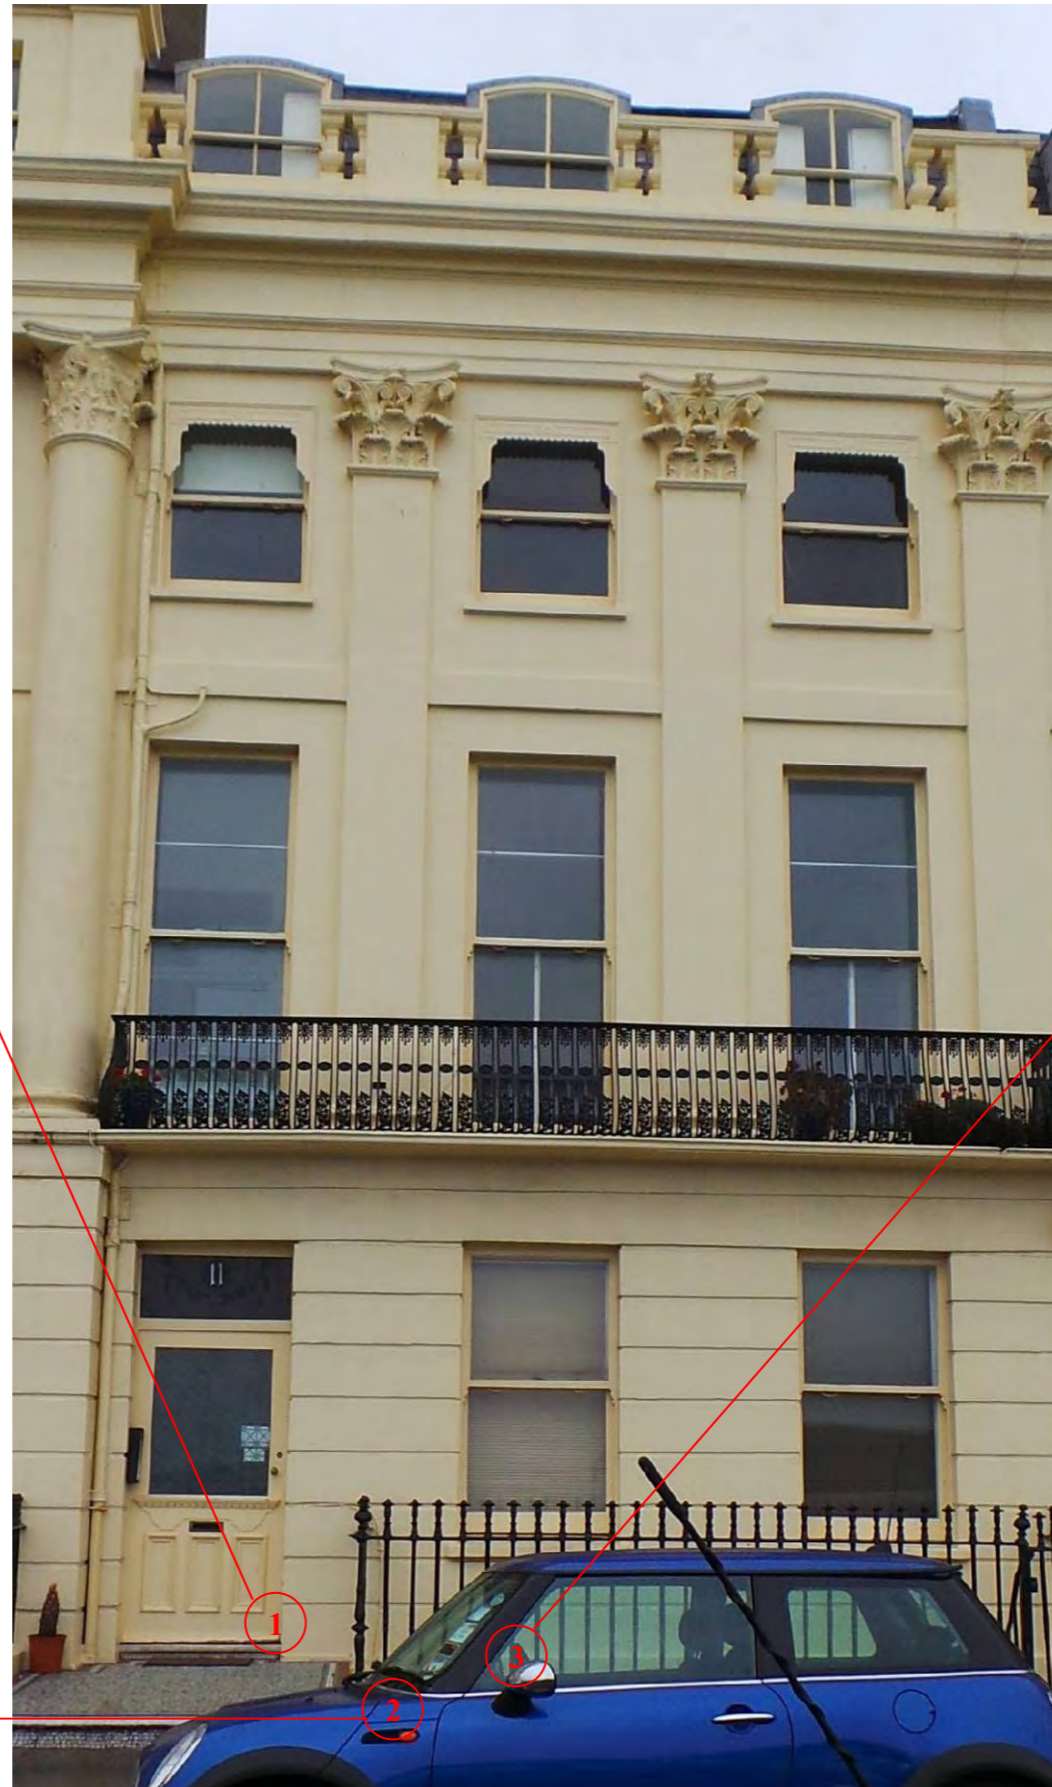
11 Brunswick Terrace

2. Losses due to wear to base of door – to be expected;
3. Ferrous staining and losses to plinth wall;
4. Salts blistering through at basement level.

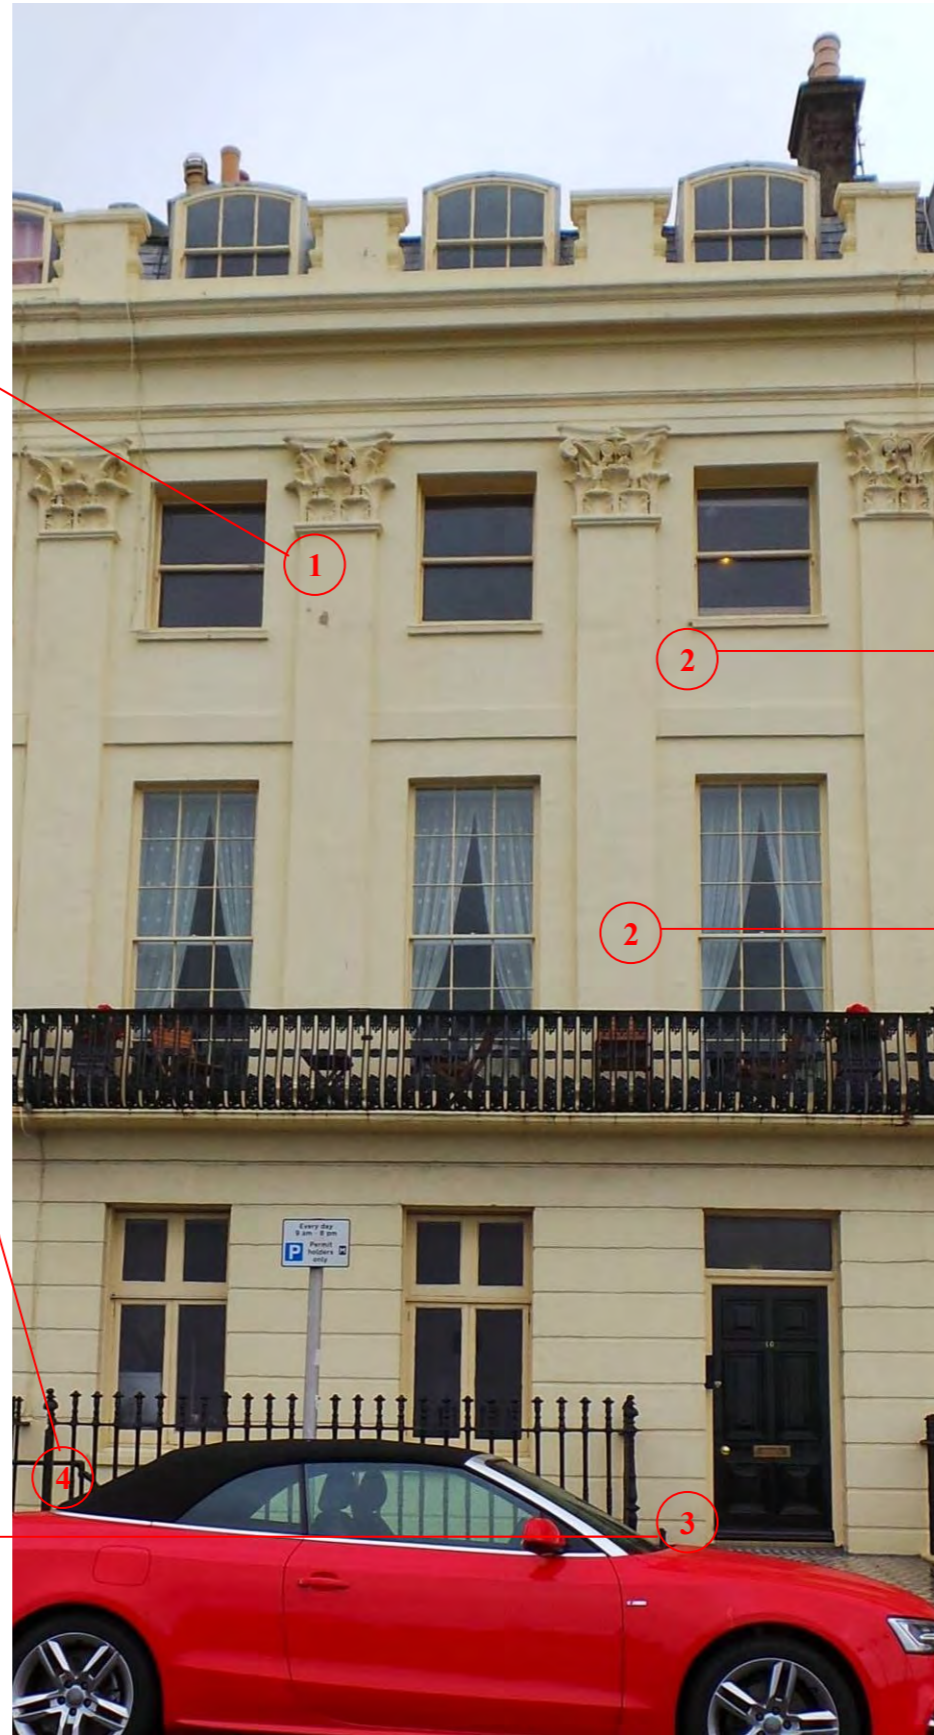
16 Brunswick Terrace

Generally good at high level;

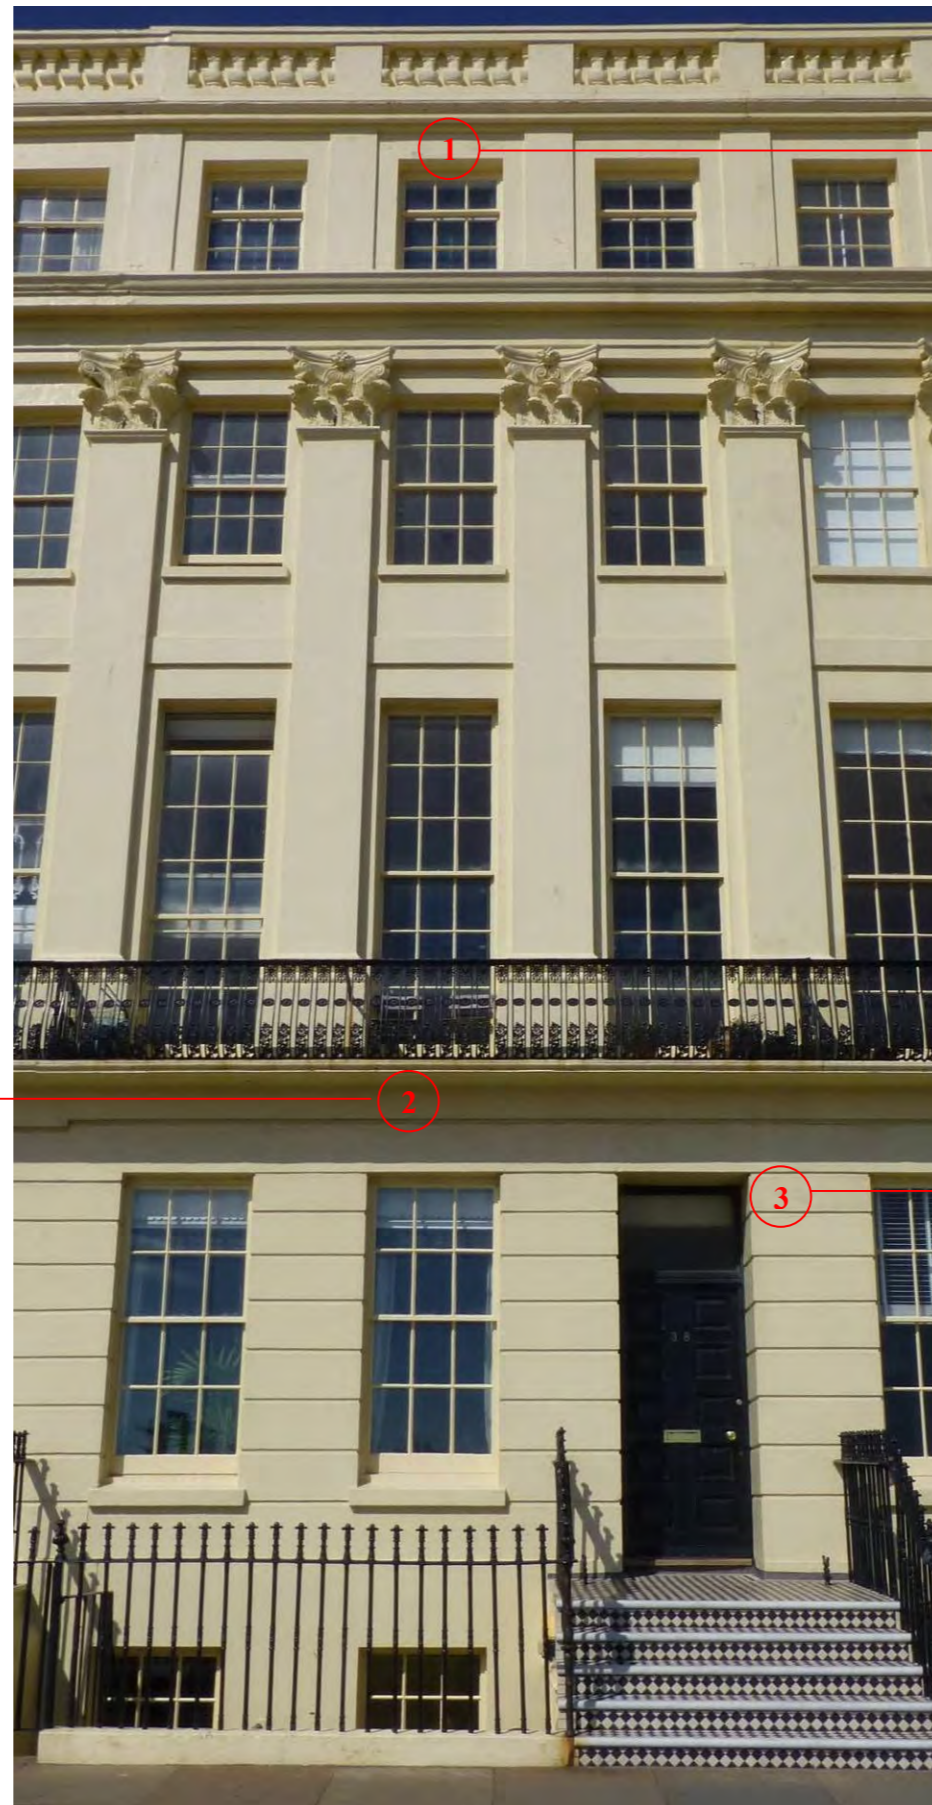
38 Brunswick Terrace

1. Failure at high-level cornice below balustrade and extending to wall below;
2. Very minor staining and substrate cracking to underside of balcony;
3. Isolated salt-eruption to top right-hand corner of entrance.

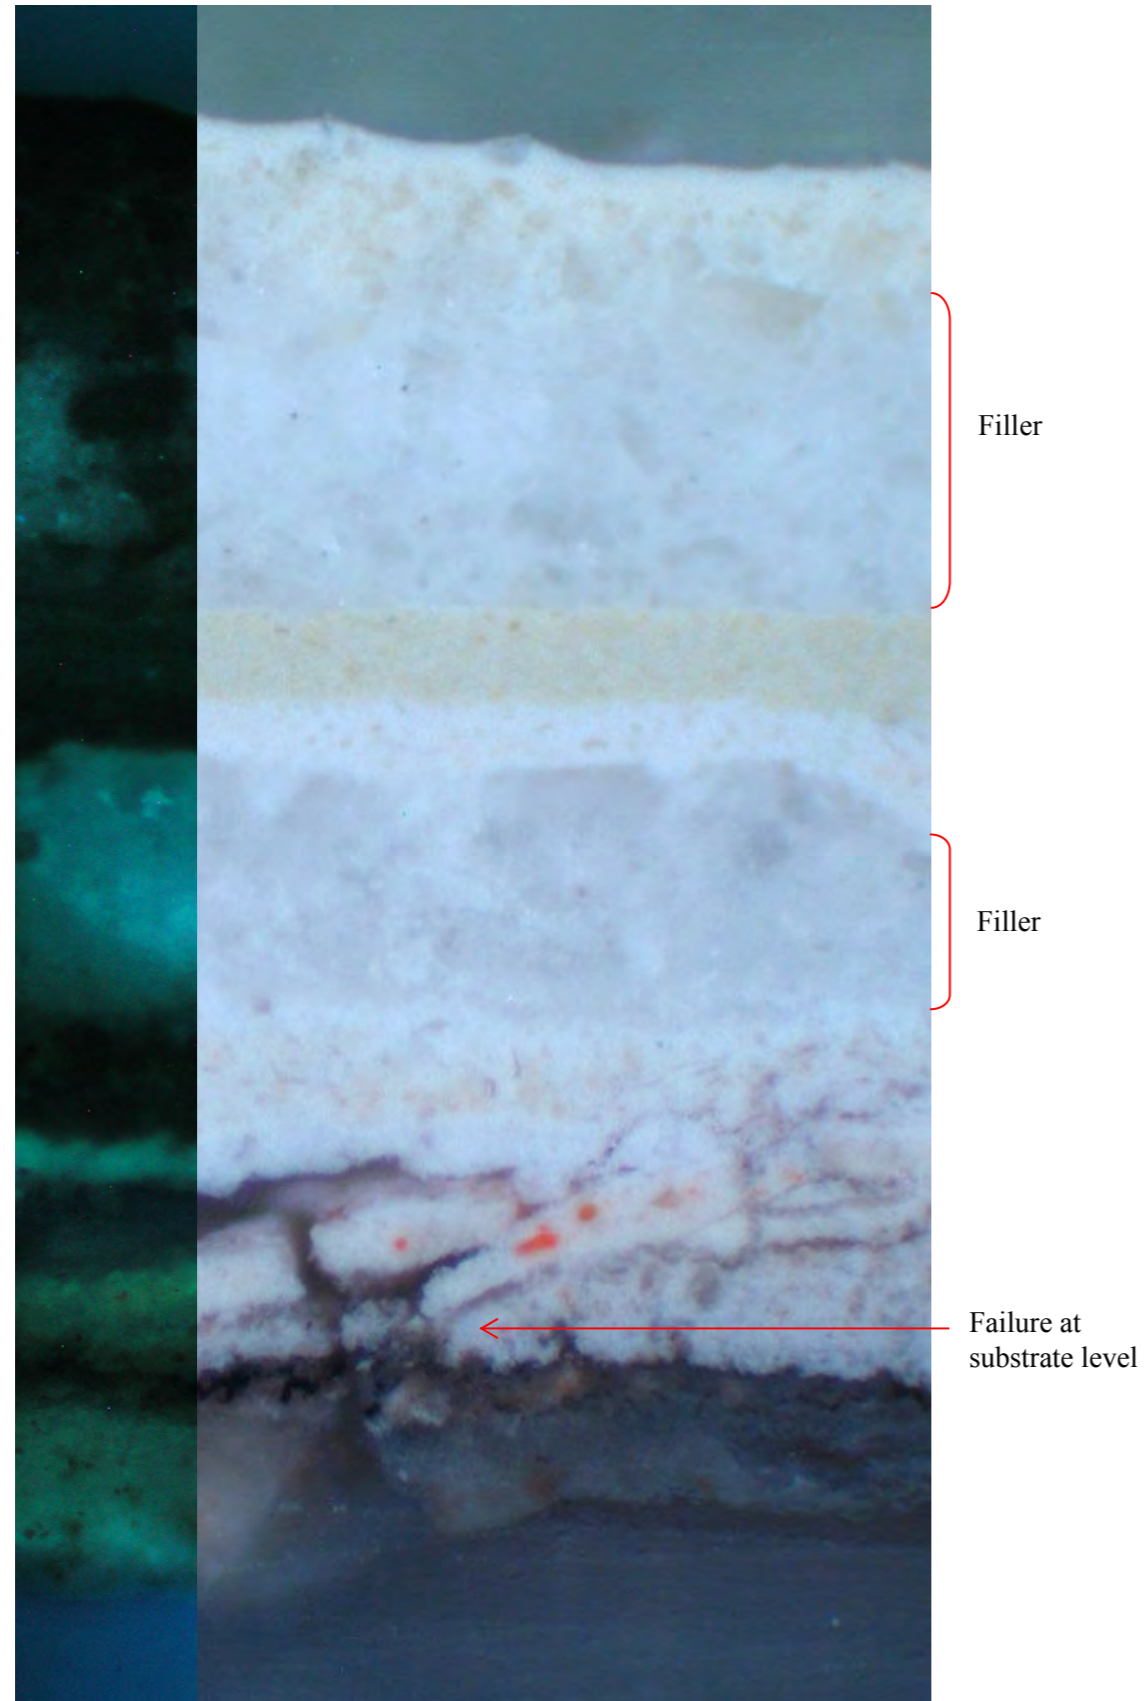
Sample 16
(Failed surface to entrance wall)
