**Investigation of Paint Failure at
Brunswick Estate
Hove
Brighton**

August 2013

**BRUNSWICK ESTATE
HOVE**

The following document investigates the failure of the external paint-system at Brunswick Estate, Hove based on research carried out by Elizabeth Hirst and Rachel Morley of Hirst Conservation between August and November 2013. The work was commissioned by Brighton & Hove City Council.

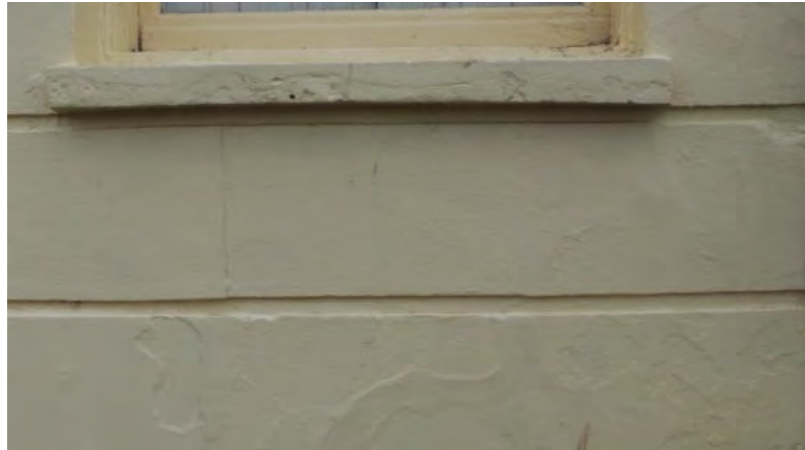
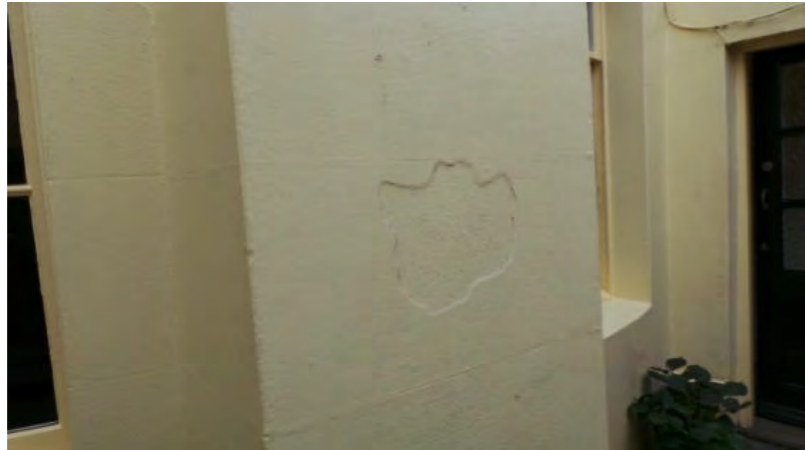
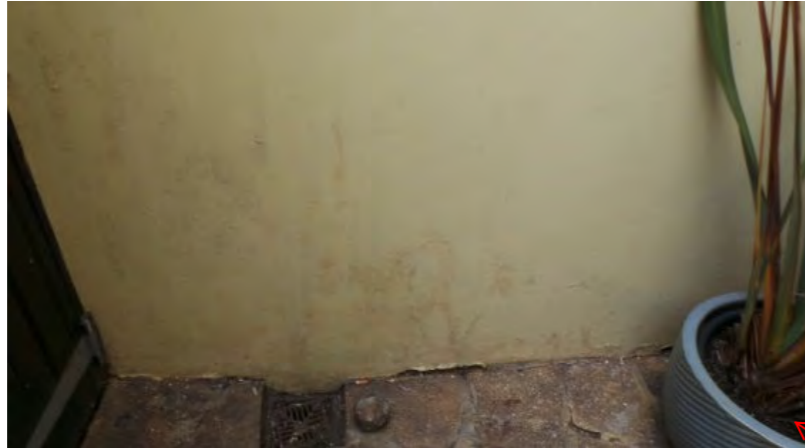
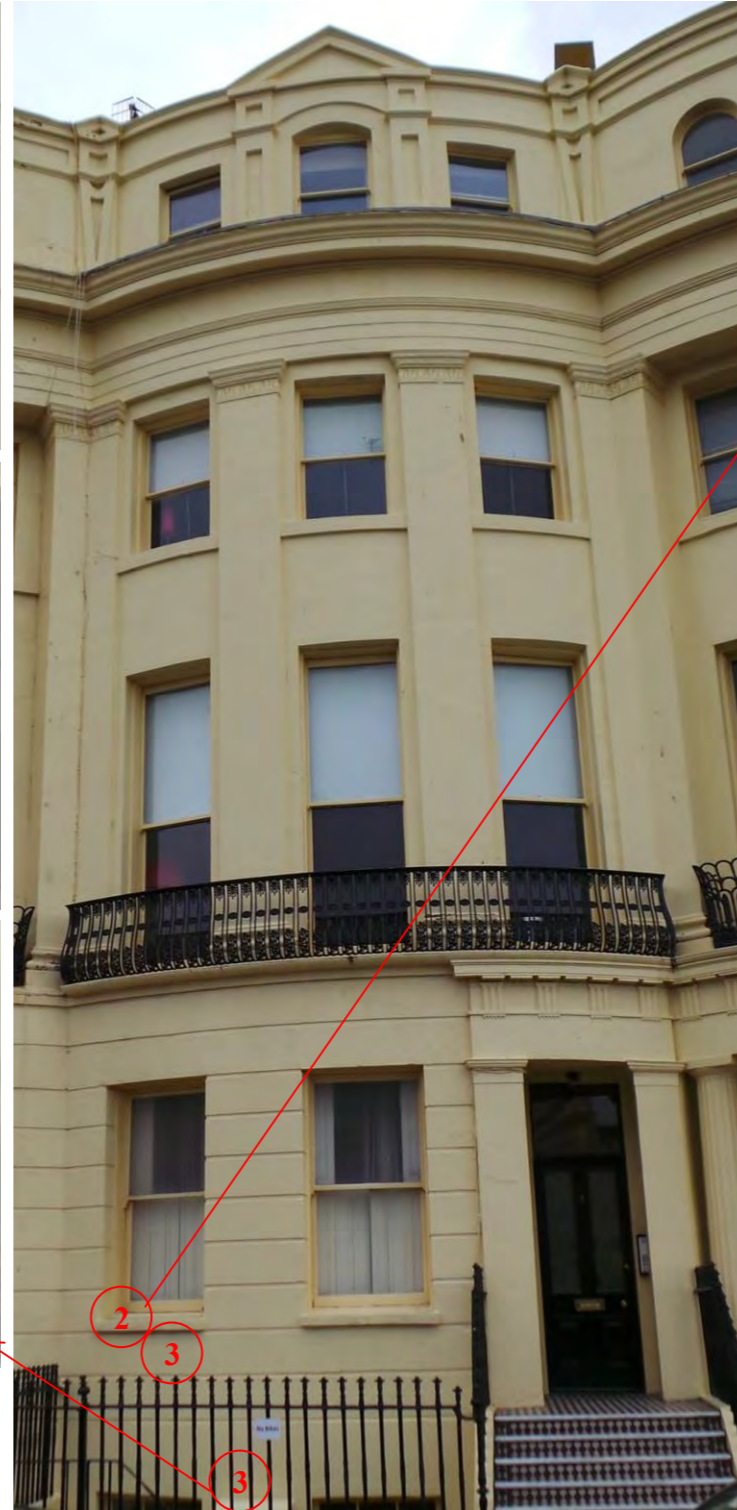
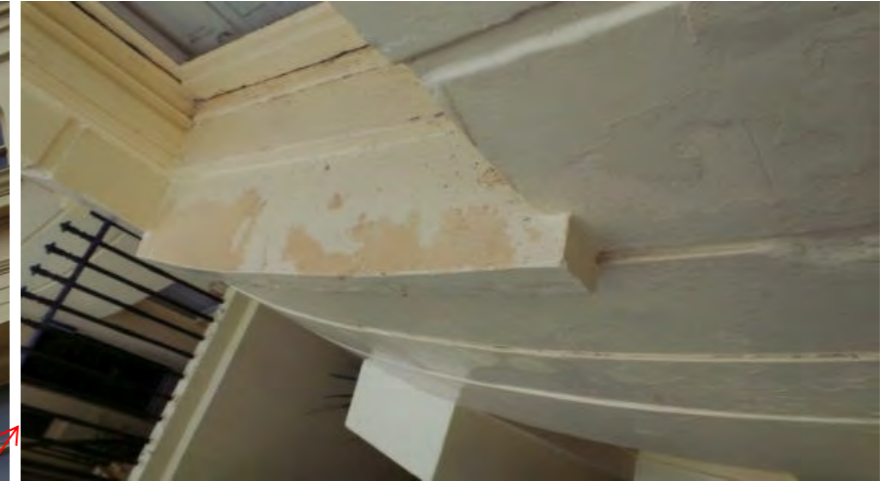
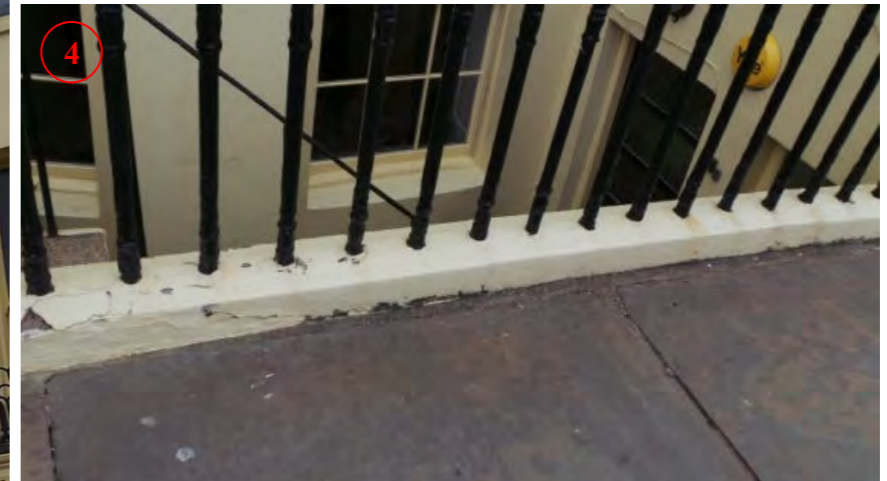
3 Brunswick Square

1. Generally the façade appears to be in reasonably good condition;
2. Localised paint flaking on window ledge at ground floor level;
3. Localised paint flaking where paint has been applied over historic paint finishes at basement level. This is prevalent around windows, the doorway and ground floor level;
4. Failing paint on the masonry below the railings adjacent the pavement and front door path;
5. Generally the painted timber work appears to be in reasonably good condition.

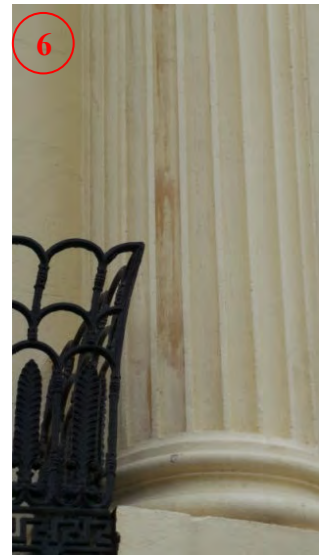
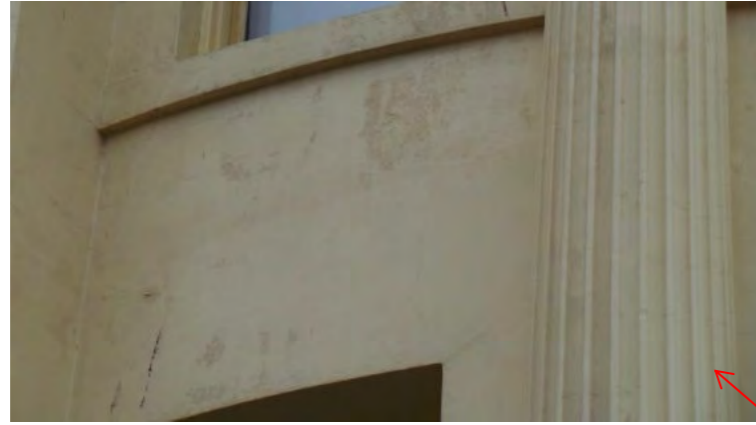
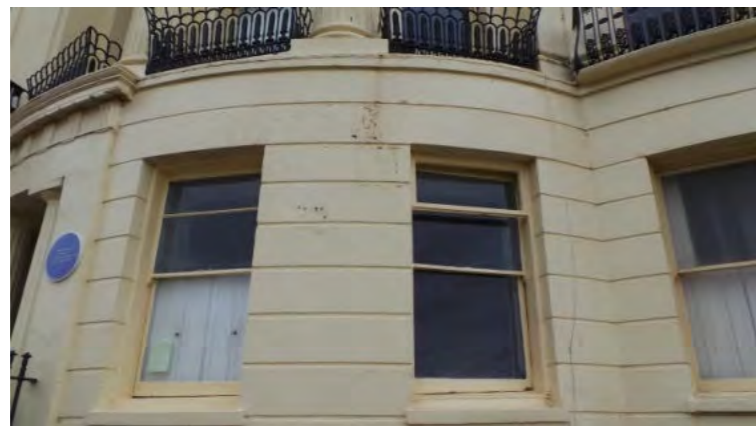
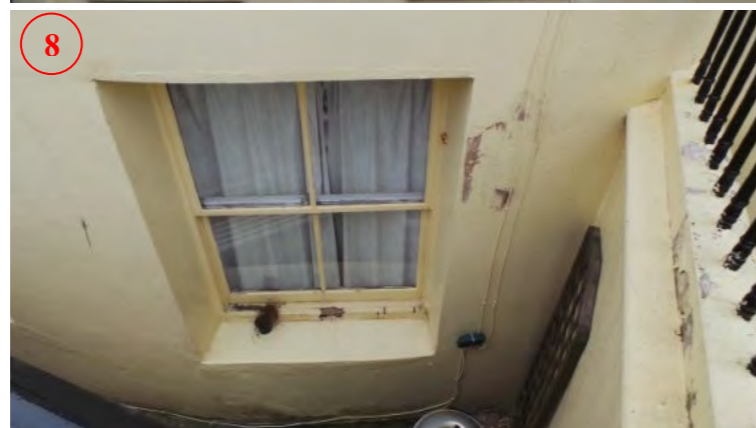
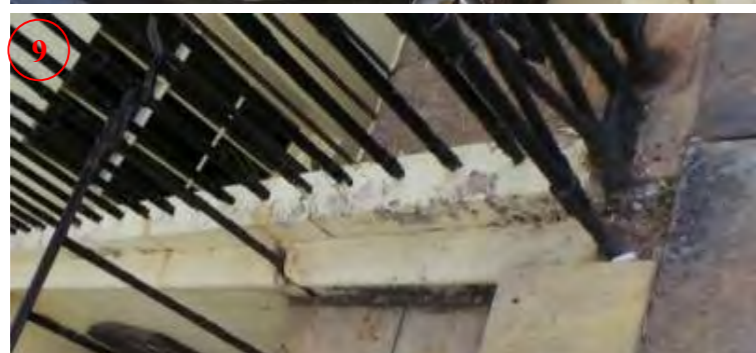
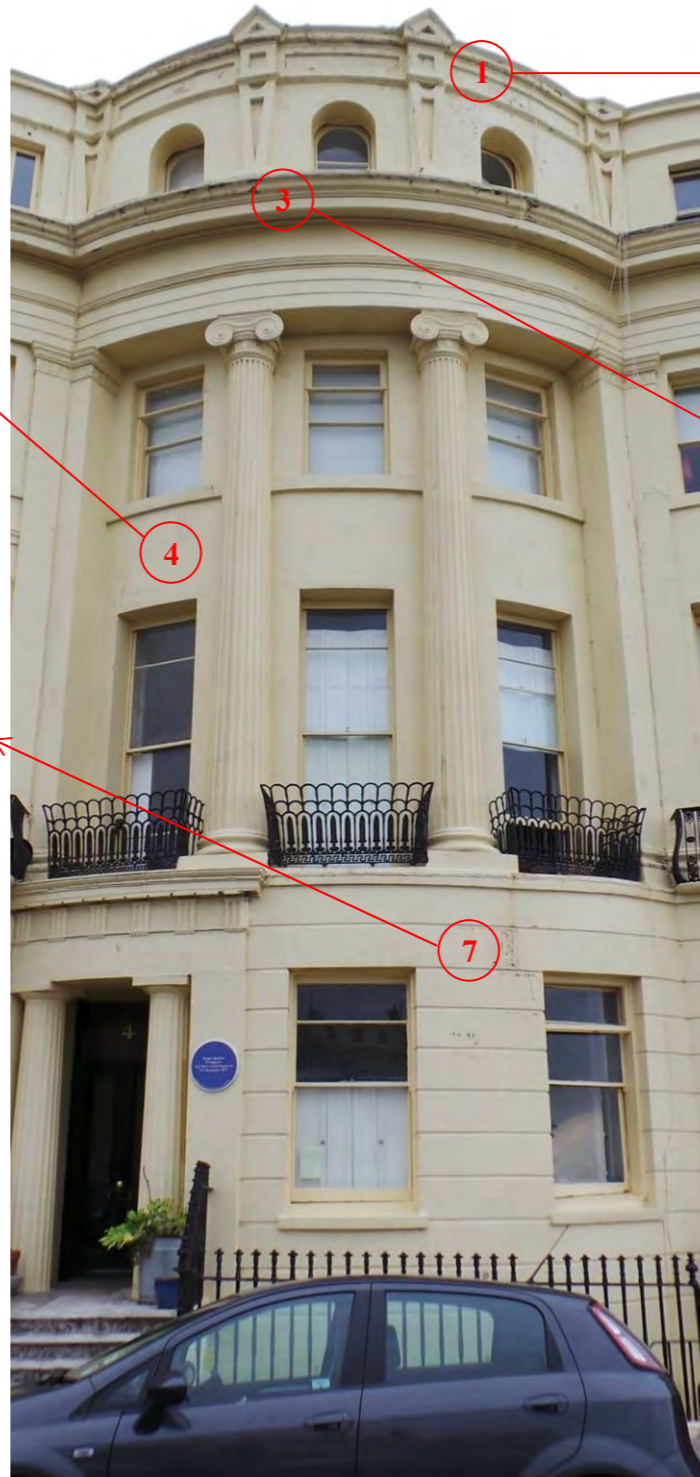
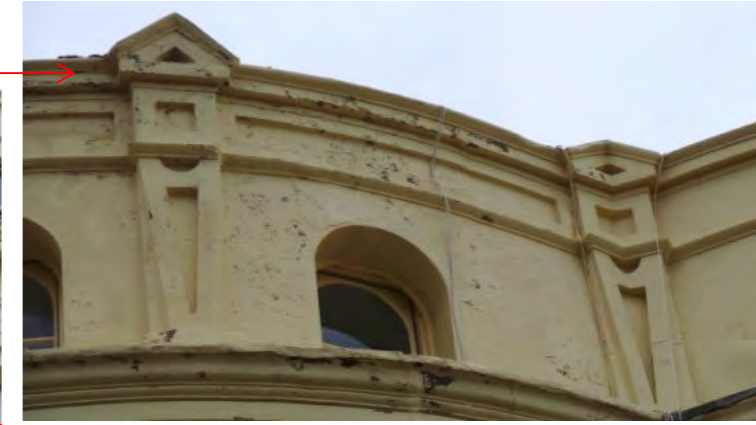
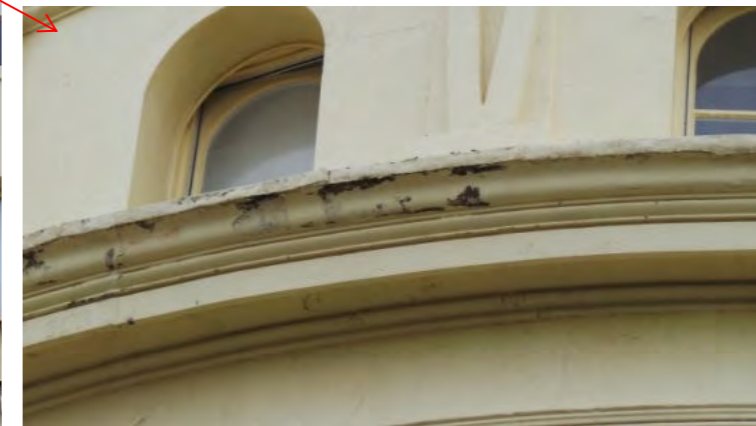
4 Brunswick Square

1. Extensive paint flaking to parapet;
2. Vegetation growth (moss) on top of the parapet indicating excessive moisture within the substrate;
3. Extensive paint flaking on the cornice below the third floor level;
4. Localised salt deliquescence and paint flaking beneath the left hand side window (second floor) ;
5. Localised paint flaking above left-hand side window (first floor);
6. Localised staining and flaking on the right-hand column (first floor level);
7. Localised staining and paint flaking as a result of fracture in the masonry between the ground floor windows;
8. Generally painted timber work appears to be in reasonably good condition although there is localised paint flaking on the timber window frame at basement level;
9. Failing paint on the masonry below the railings adjacent the pavement.

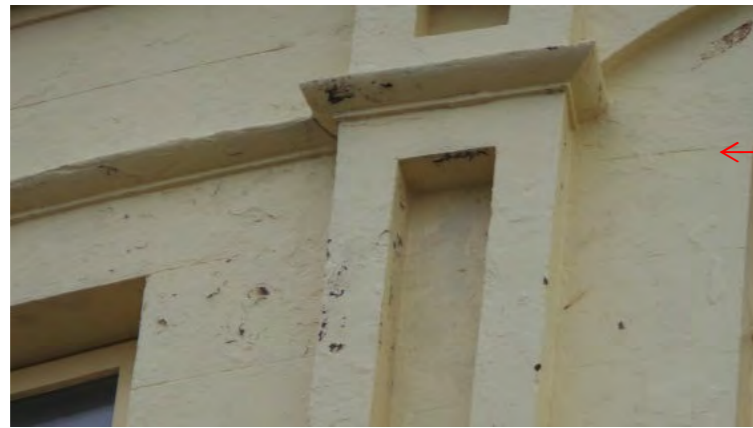
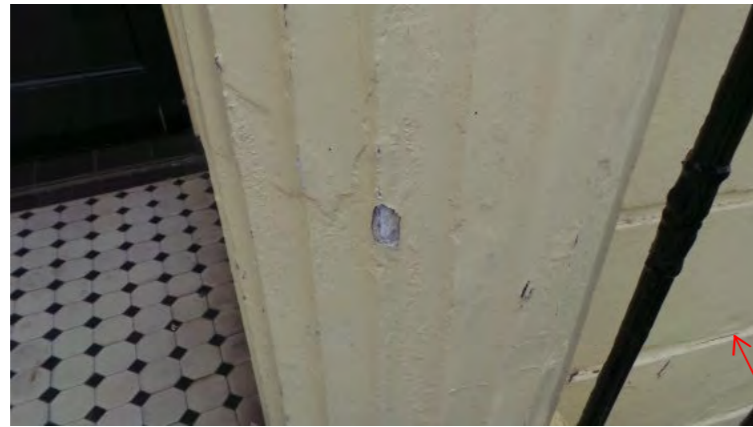
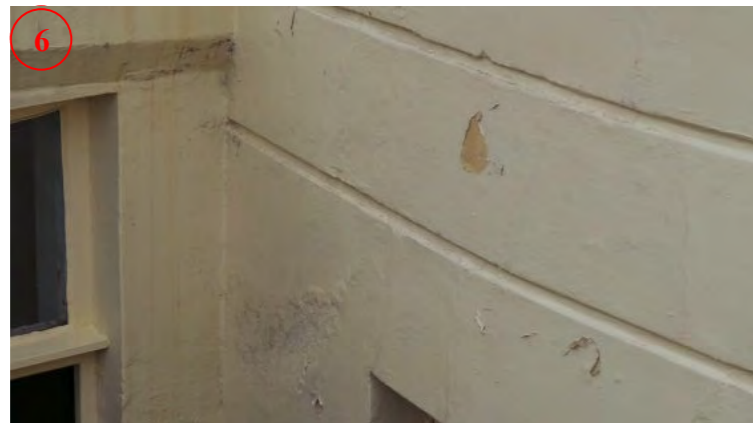
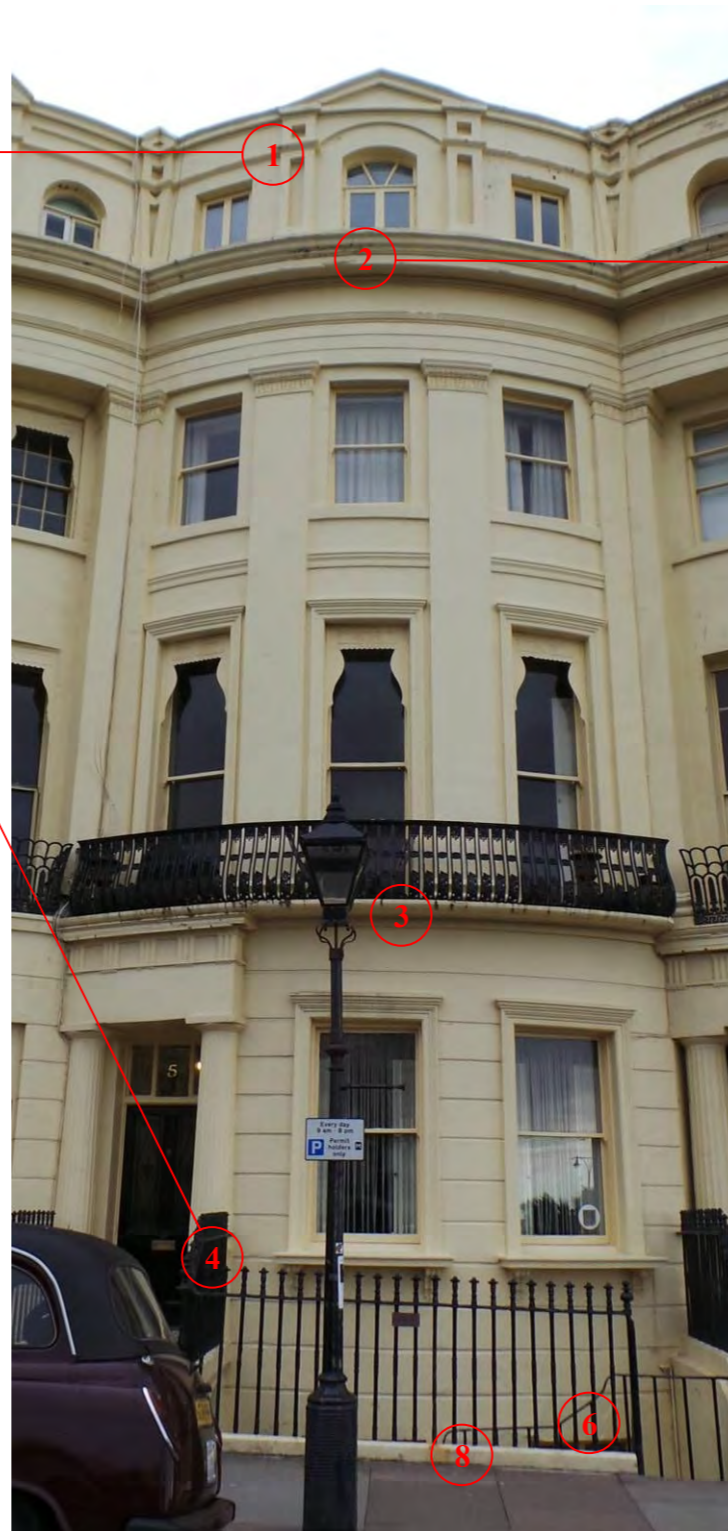
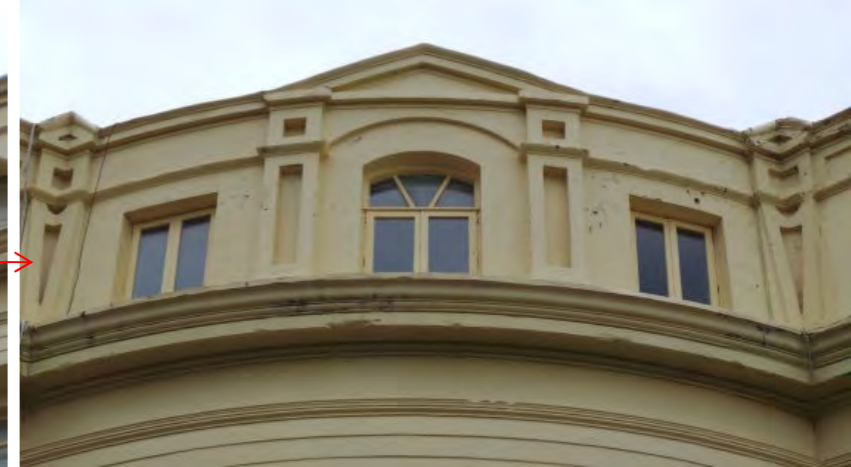
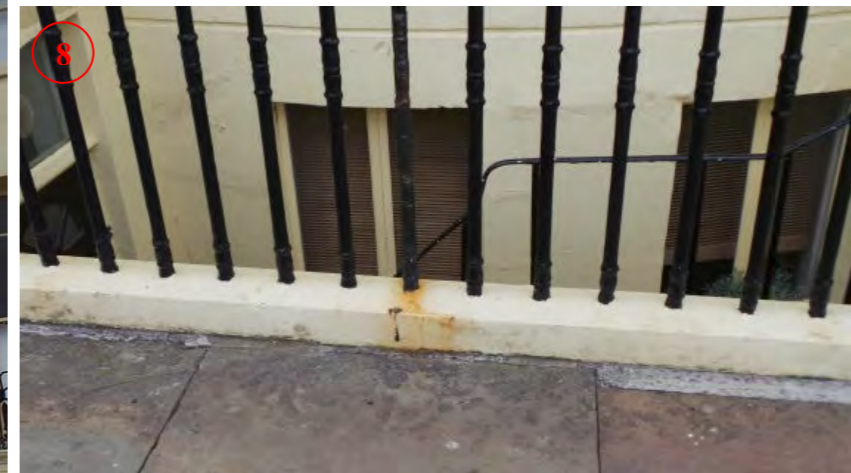
5 Brunswick Square

1. Localised paint flaking to parapet;
2. Localised paint flaking to cornice;
3. Staining and paint failure on cornice beneath balcony;
4. Localised paint flaking on right-hand column and adjacent wall where paint has been applied over historic paint finishes (ground floor level);

5. In areas of historic and recent paint loss there is evidence of salts and moisture damage. Salt deliquescence may occur in these areas because there are fewer paint systems resulting in greater permeability;

6. Localised paint flaking where paint has been applied over historic paint finishes at basement level possibly as a result of salts and moisture. The historic paint system (dark beige) may be seen beneath the modern paint layers;

7. Localised paint flaking on the sloping flat surface beneath the ground floor hall window;
8. Ferrous staining and failing paint on the masonry below the railings adjacent the pavement;

9. Generally painted timber work appears to be in good condition.

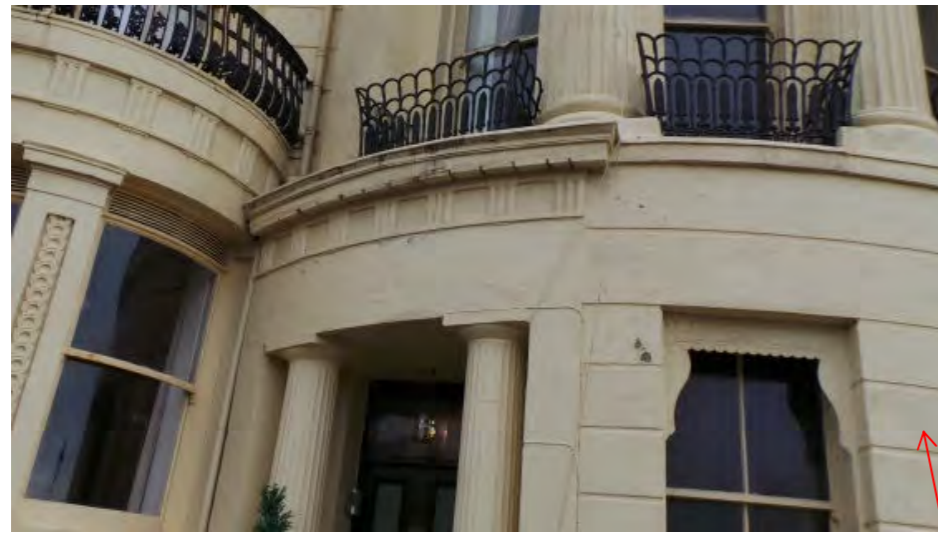
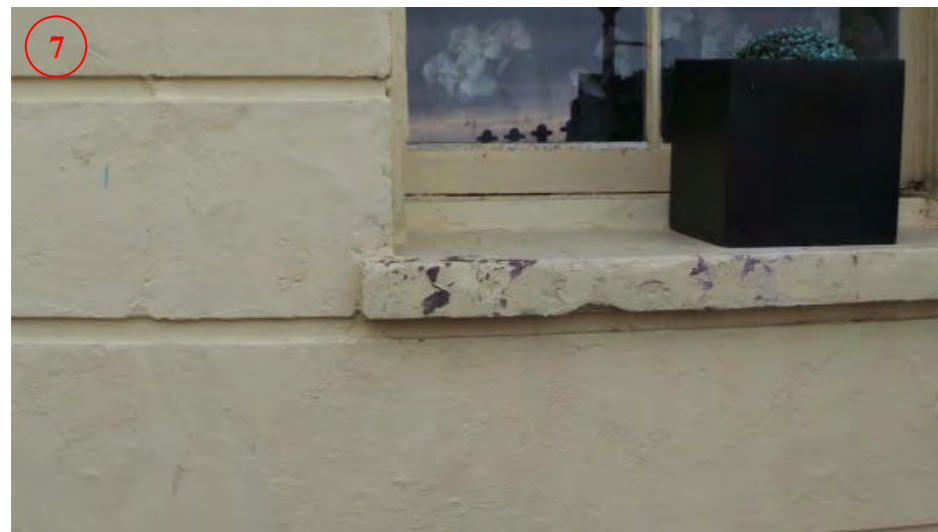
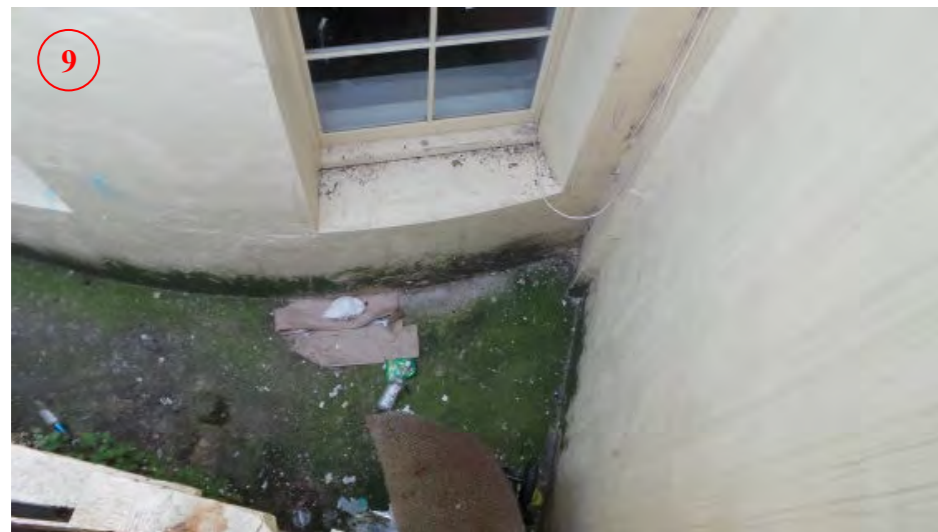
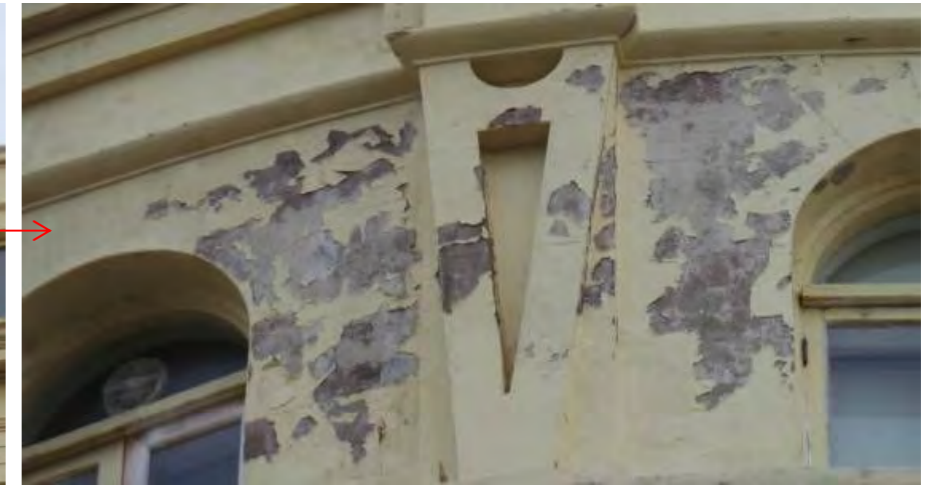
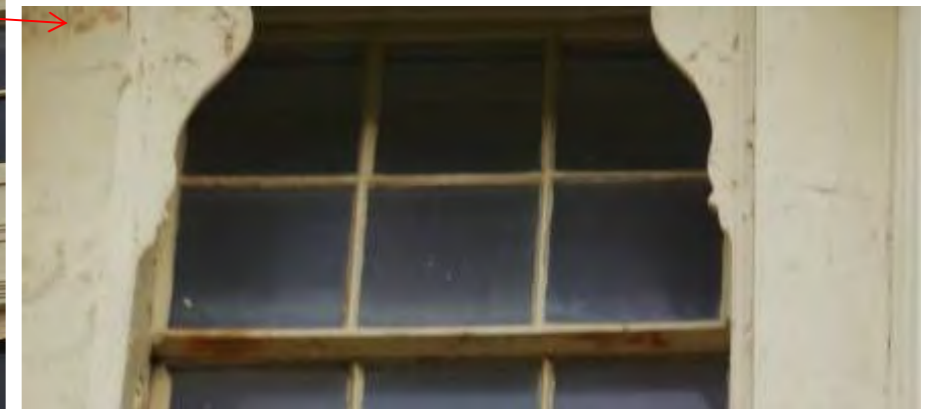
6 Brunswick Square

1. Extensive paint flaking to parapet;
2. Localised paint flaking to cornice. This may be due to the lead capping above the cornice has been removed causing moisture damage;
3. Localised flaking and fine cracks above the windows at second floor level;
4. Localised paint flaking on frieze above the doorway possibly as a result of salts and moisture;
5. Masonry repairs to the triglyph decoration on frieze above the doorway;
6. Staining on the cornice beneath balcony;
7. Localised paint flaking on window ledge (ground floor level);
8. The render substrate has been 'patched-in' with an inappropriate repair material and the paint has been retouched around the ground floor windows;
9. Vegetation growth (mould and algae) at basement level indicates excessive moisture and insufficient drying-out of substrate. Extensive paint flaking at basement level.

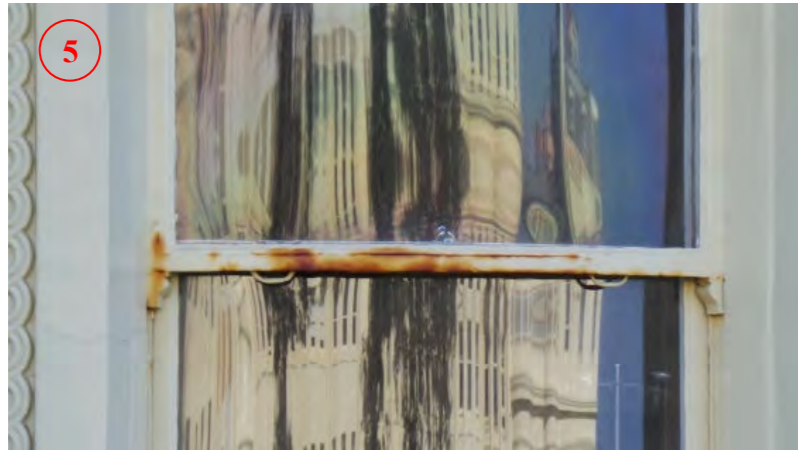
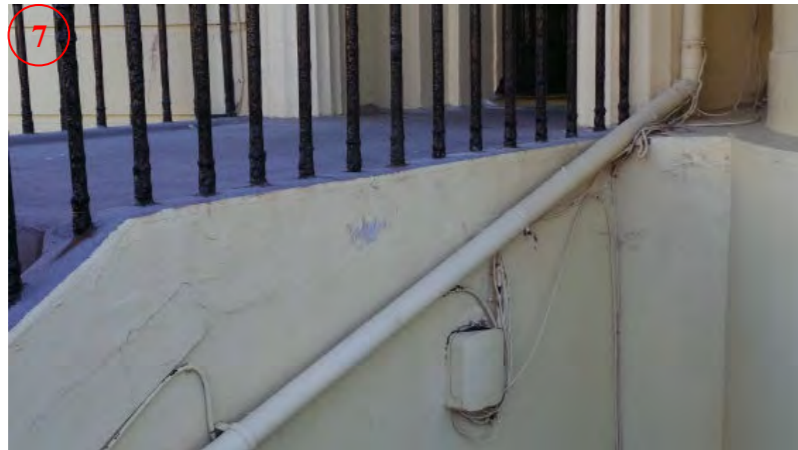
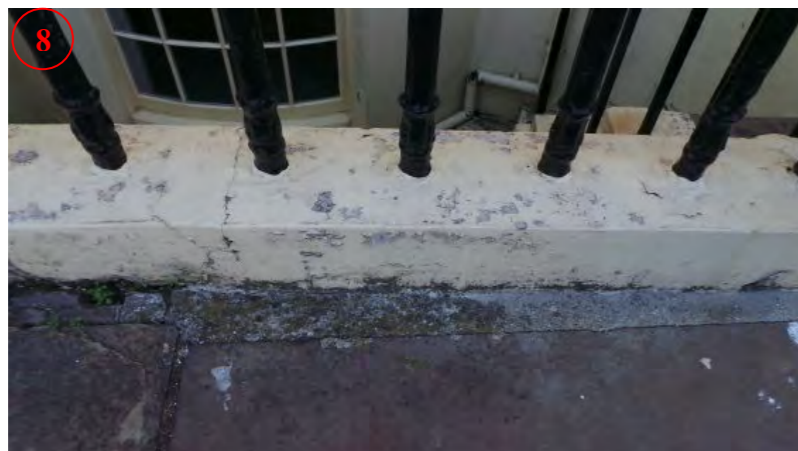
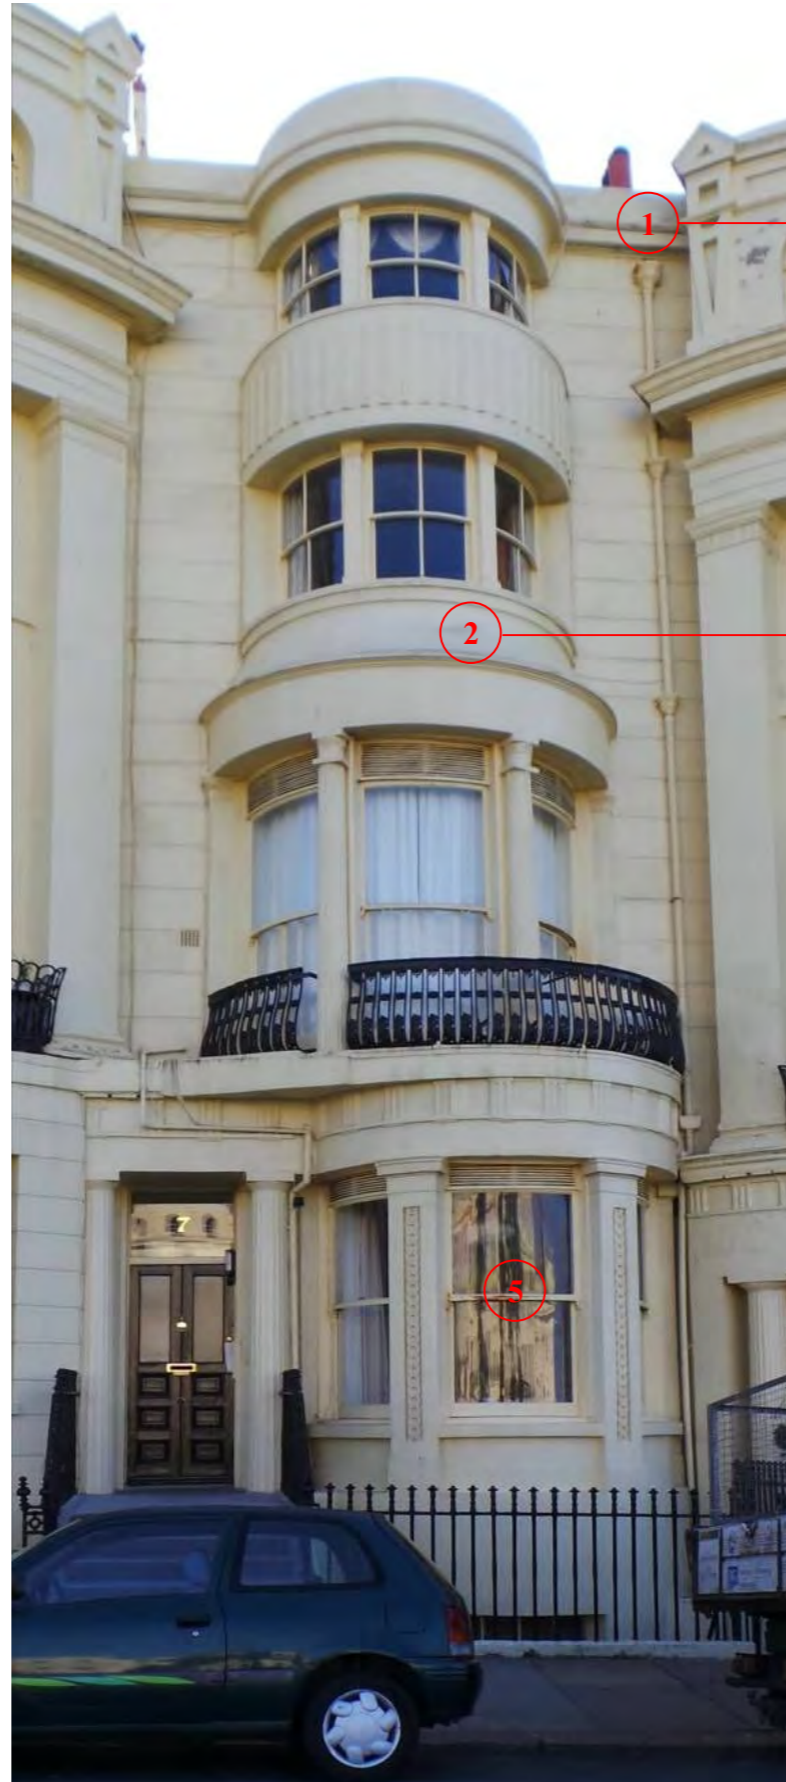
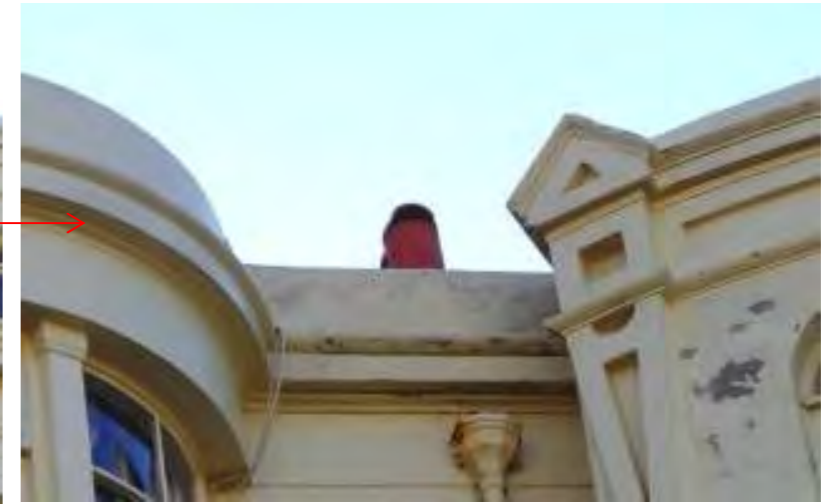
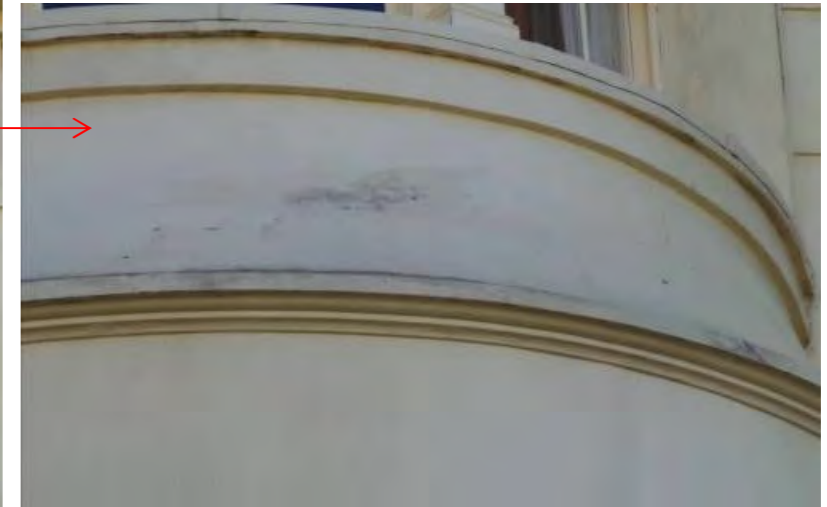
7 Brunswick Square

1. Paint flaking to right of parapet above the water hopper;
2. Localised paint flaking and staining beneath the second-floor and above first-floor bow windows;
3. Staining on cornice beneath balcony;
4. Localised paint flaking on frieze between front door and bow window;
5. Ferrous staining on central sash of the ground floor bow window;
6. Fracture running vertically beneath the ground floor bow window to the basement window;
7. Localised paint flaking above basement door;
8. Failing paint on the masonry below the railings adjacent the pavement and front door path;
9. Generally the painted timber work appears to be in reasonably good condition.

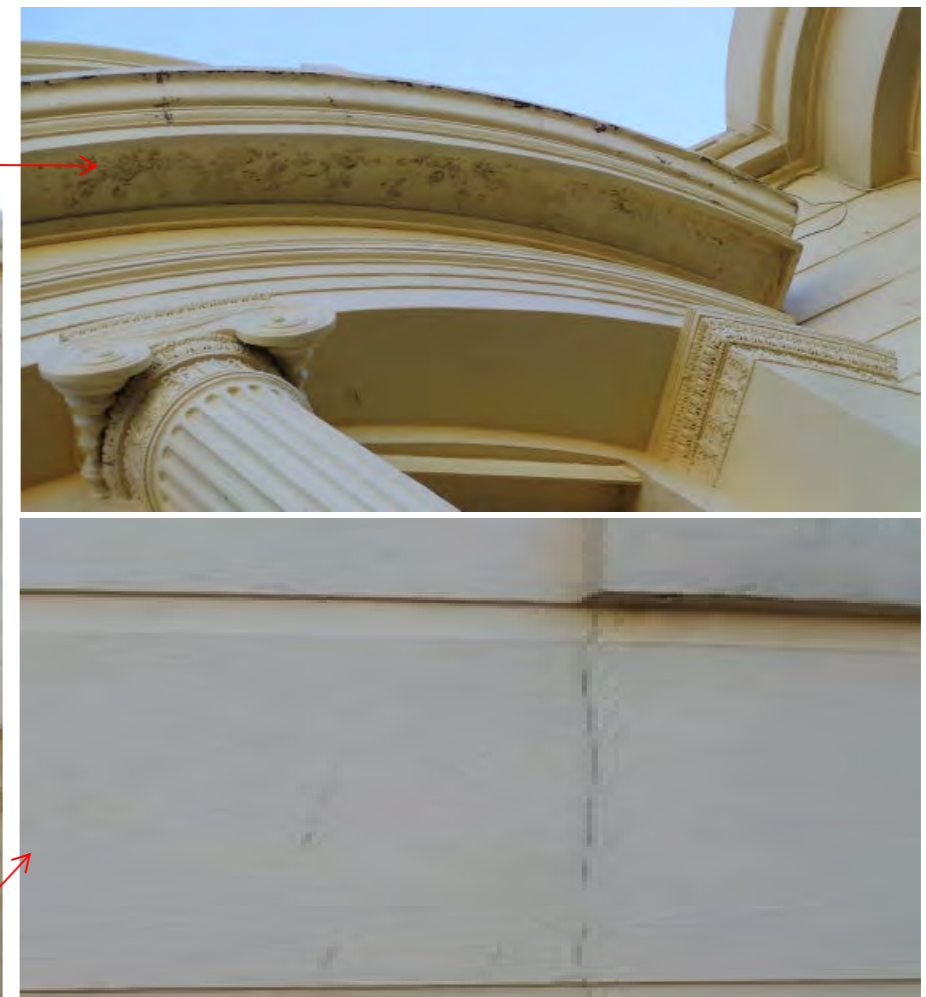
8 Brunswick Square

1. Extensive paint flaking to cornice
2. Localised flaking and fine cracks between the two central columns (between first and second floor levels);
3. Fracture running vertically on the left hand side of the left window (first floor level);
4. Staining on the cornice beneath the three wrought iron balconies (first floor level);
5. Fracture running vertically from the left hand corner of the right hand window sill (ground floor level) to the top of the right hand basement window beneath;
6. Failing paint on the masonry below the railings adjacent the pavement and front door path;
7. Generally the painted timber work appears to be in reasonably good condition.

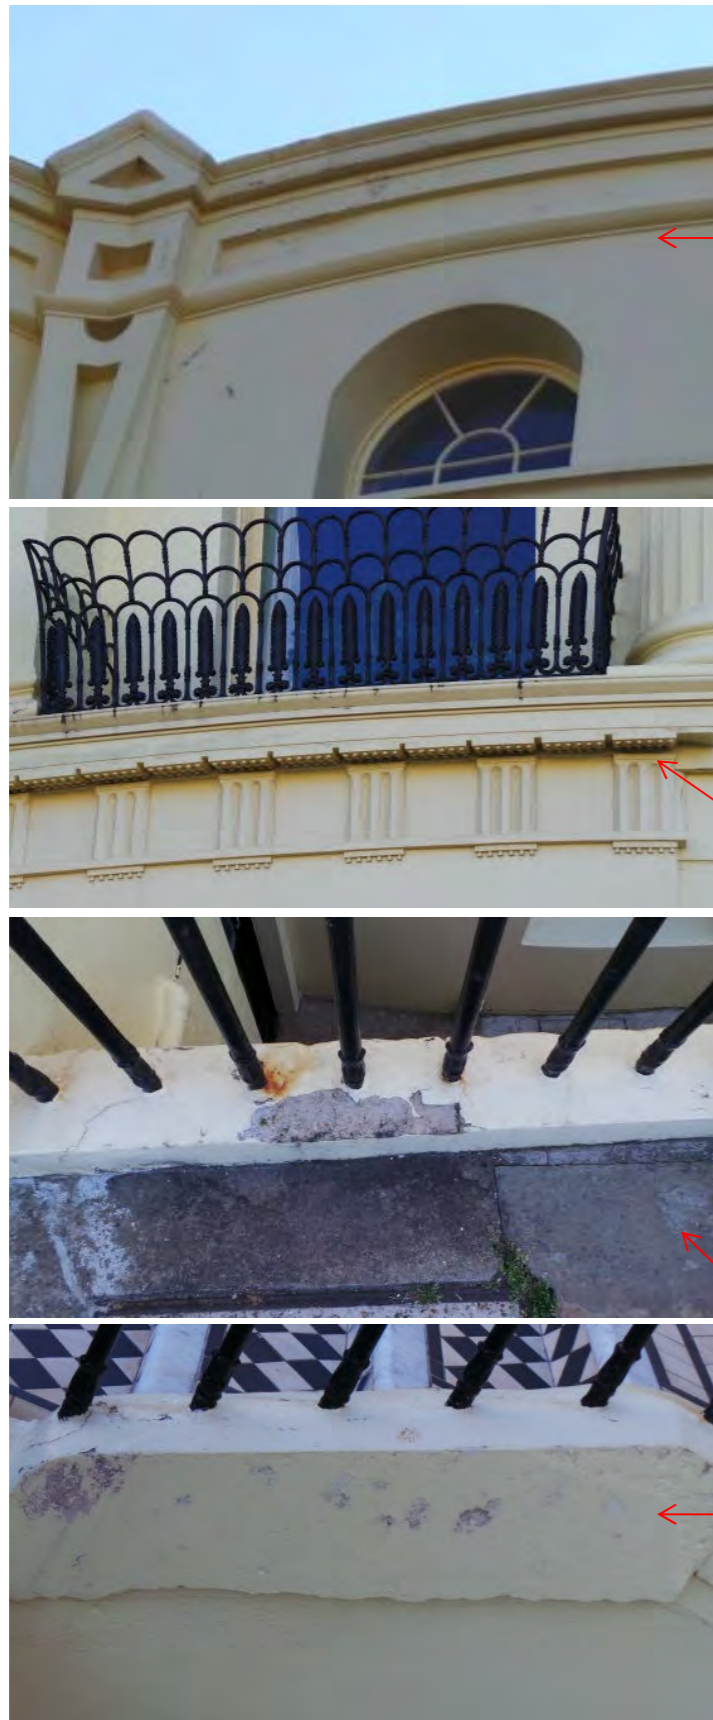
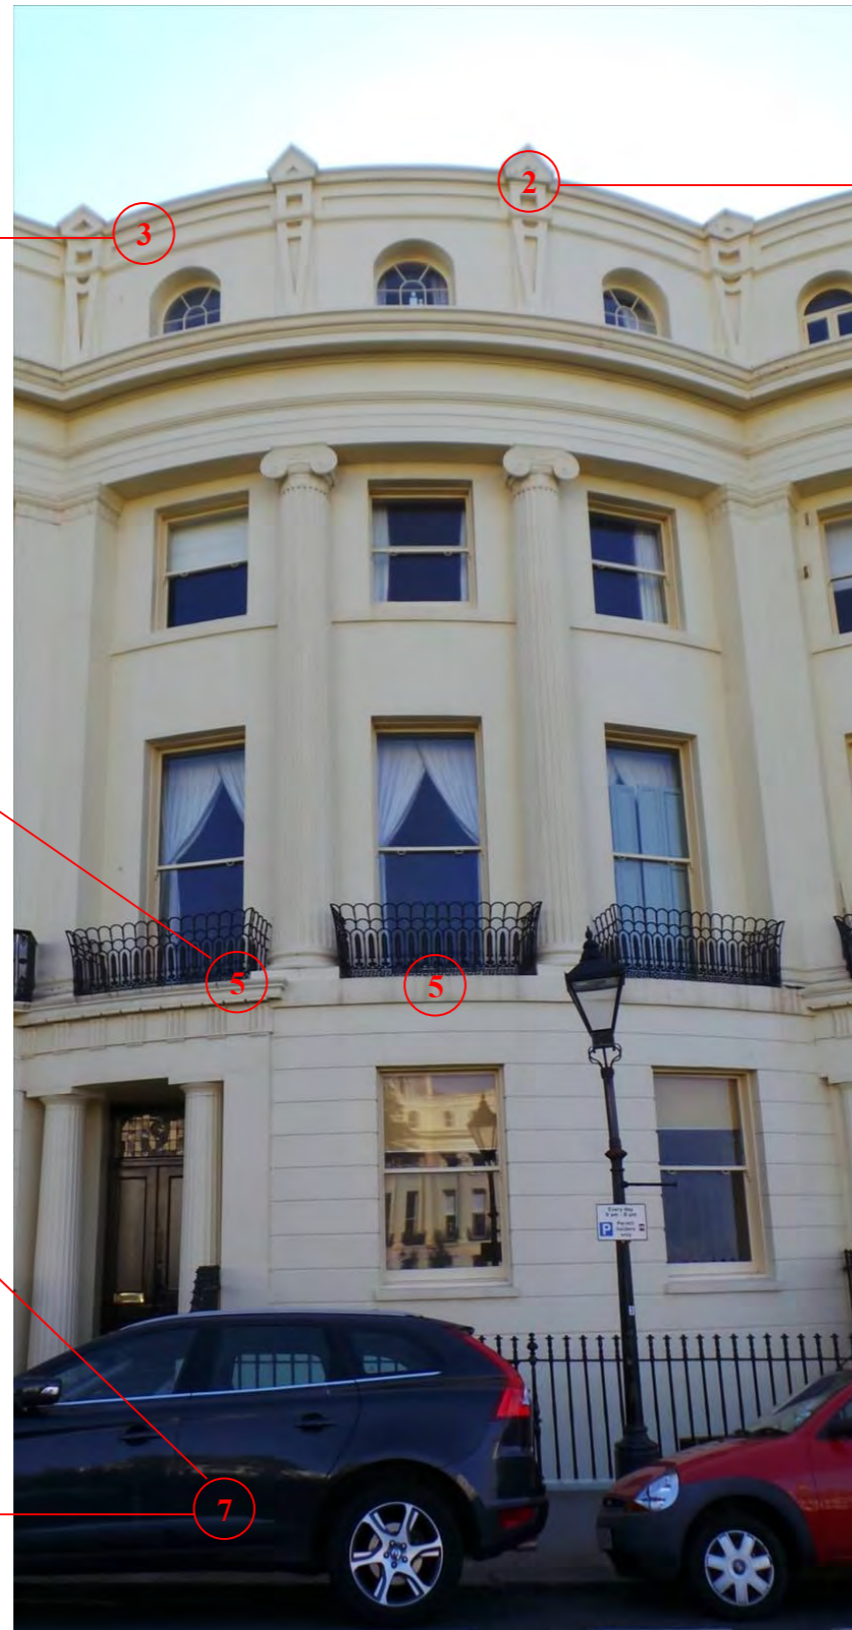
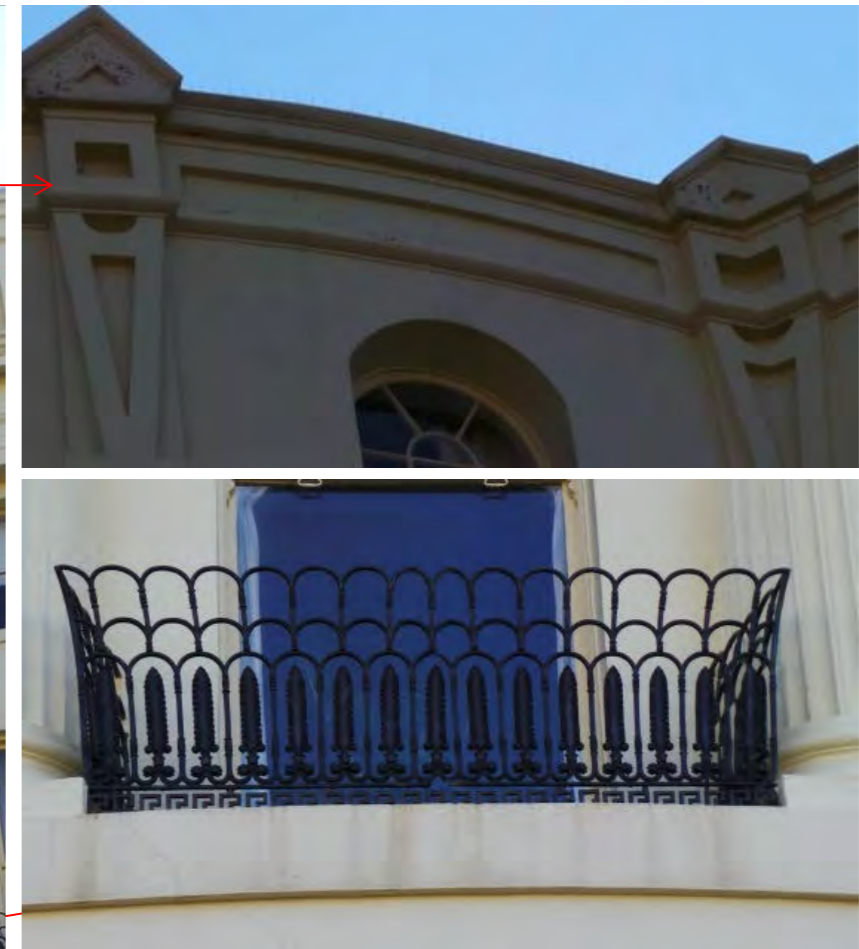
9 Brunswick Square

1. Generally there are historic fractures in the masonry substrate which may have an adverse effect on any painted decoration because of moisture within the substrate;
2. Localised paint flaking on the right hand pediment and the adjacent pediment at parapet level;
3. Localised paint flaking on the left hand side of the central panelling between the pediments at parapet level;
4. Localised flaking and blistering above the central window (second floor level);
5. Staining on the cornice beneath the three balconies;
6. Localised flaking and fine cracks on the left hand side of the left balcony and above the front door;
7. Failing paint on the masonry below the railings adjacent the pavement and front door path;
8. Generally the painted timber work appears to be in reasonably good condition.
