**Investigation of Paint Failure at
Brunswick Estate
Hove
Brighton**

August 2013

**BRUNSWICK ESTATE
HOVE**

The following document investigates the failure of the external paint-system at Brunswick Estate, Hove based on research carried out by Elizabeth Hirst and Rachel Morley of Hirst Conservation between August and November 2013. The work was commissioned by Brighton & Hove City Council.

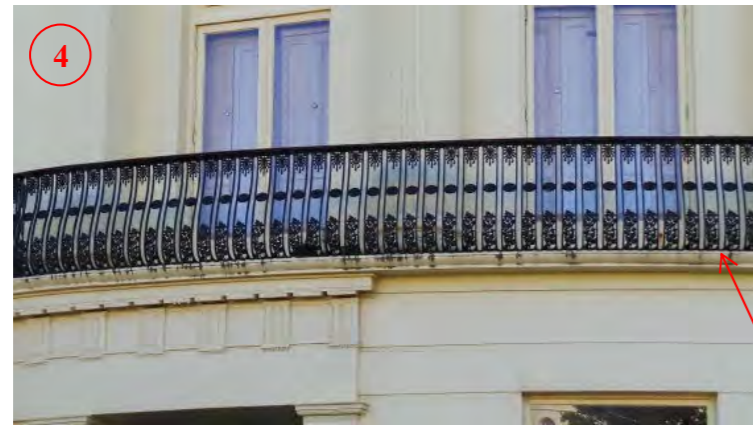
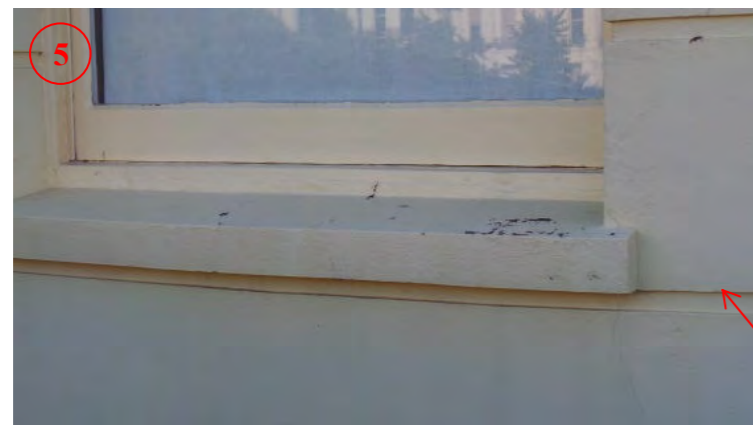
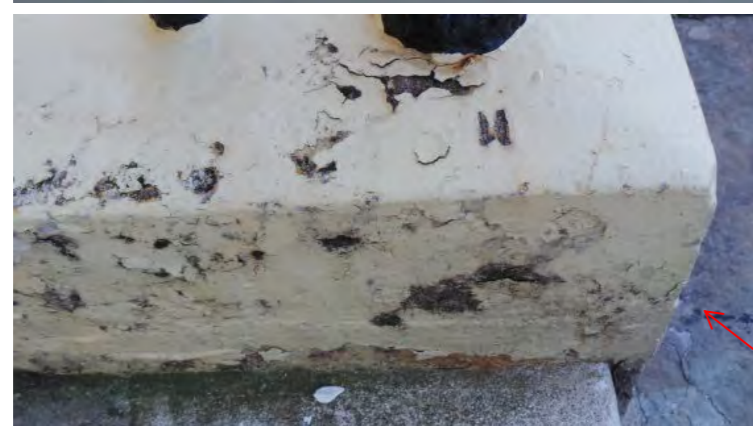
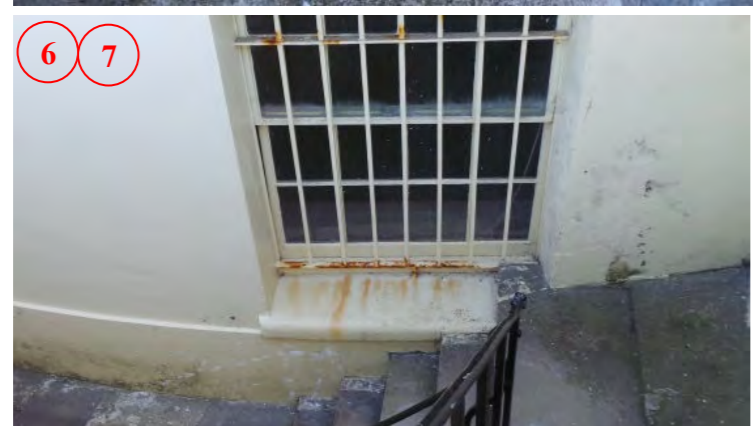
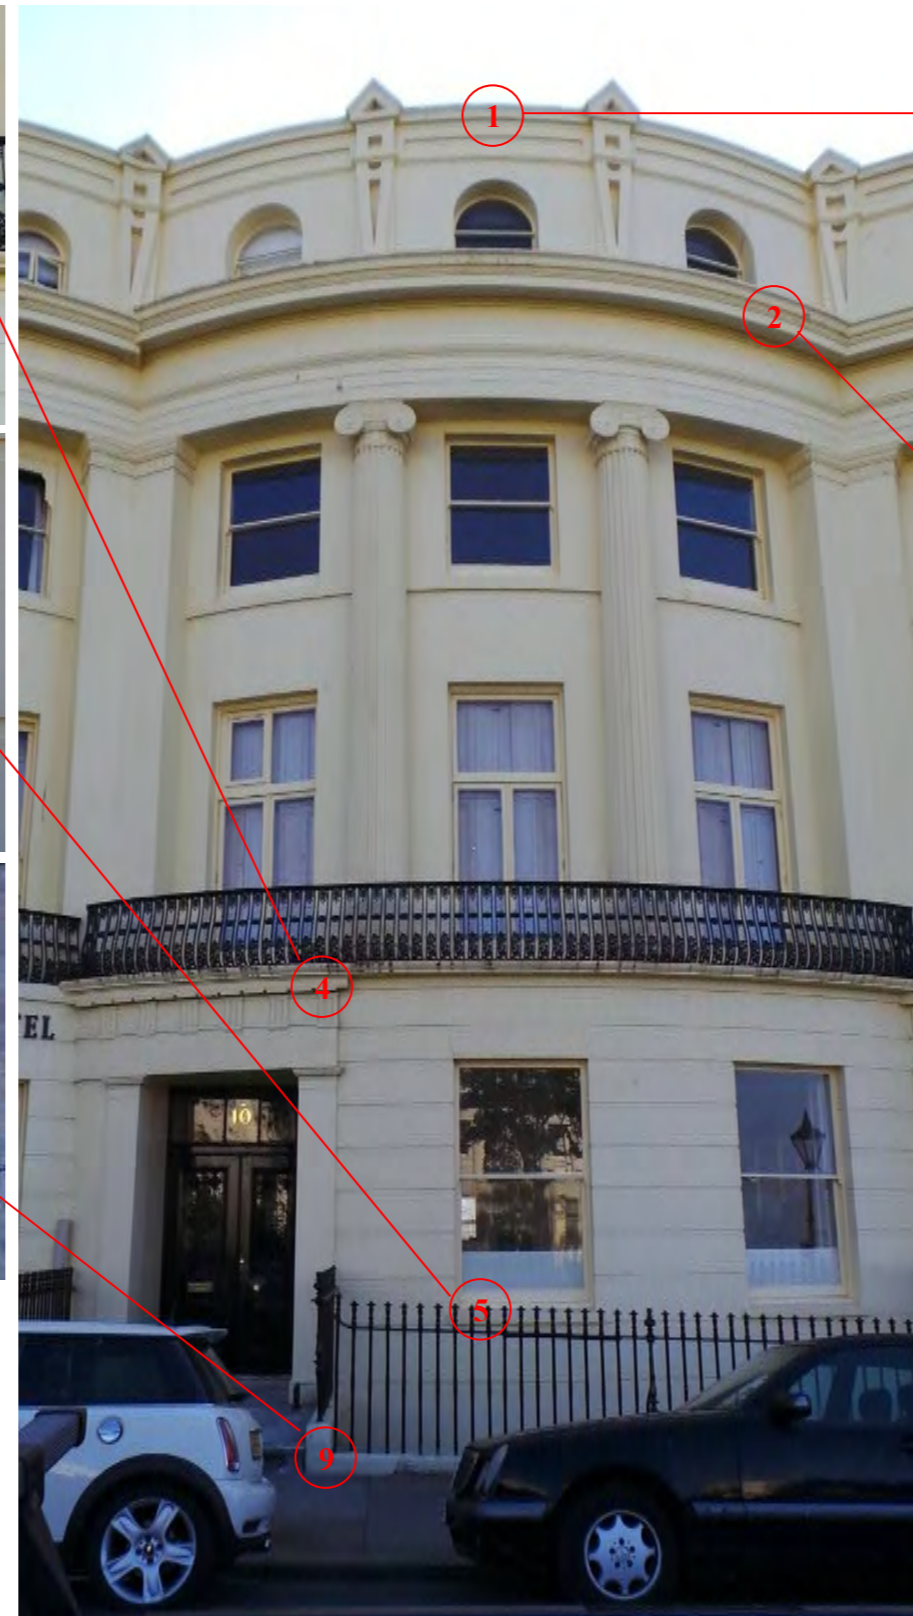
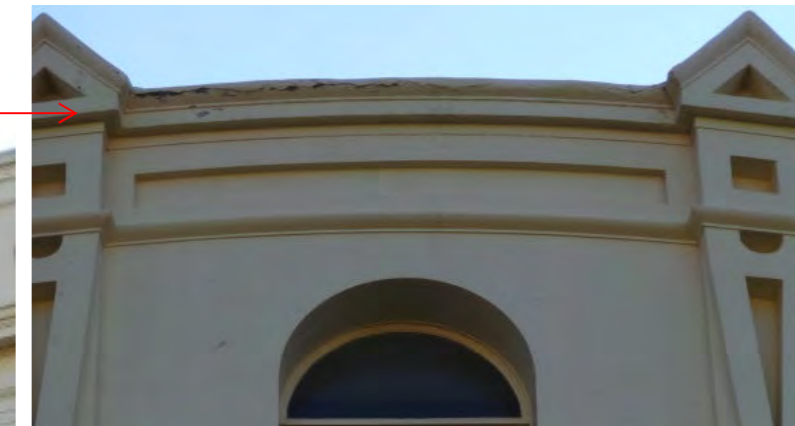
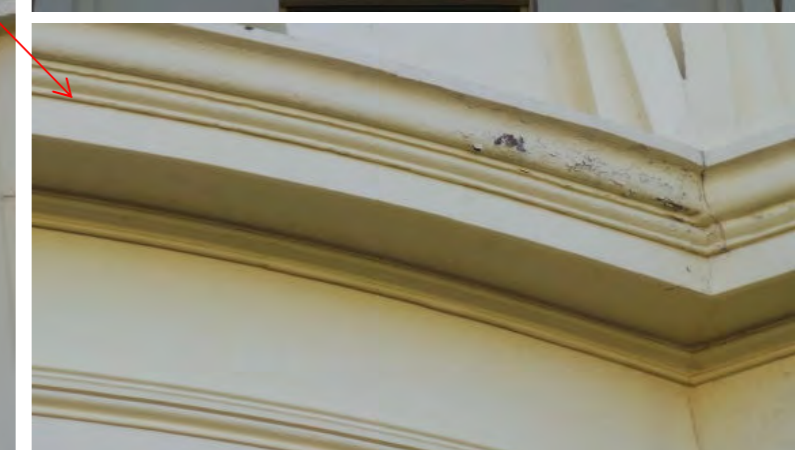
10 Brunswick Square

1. Fracture and localised paint flaking on panelling between the central pediments at parapet level;
2. Extensive paint flaking and blistering on the cornice below the third floor;
3. Staining on the left hand side of the cornice below the third floor;
4. Staining on the cornice beneath balcony;
5. Localised paint flaking on the left hand window sill (ground floor level);
6. Localised paint flaking around the windows at basement level;
7. Ferrous staining on the painted iron saddle bars on the basement windows;
8. Biological growth (mould and algae) and salts on the basement walls indicating excessive moisture within the substrate;
9. Ferrous staining and failing paint on the masonry below the railings adjacent the pavement and front door path.

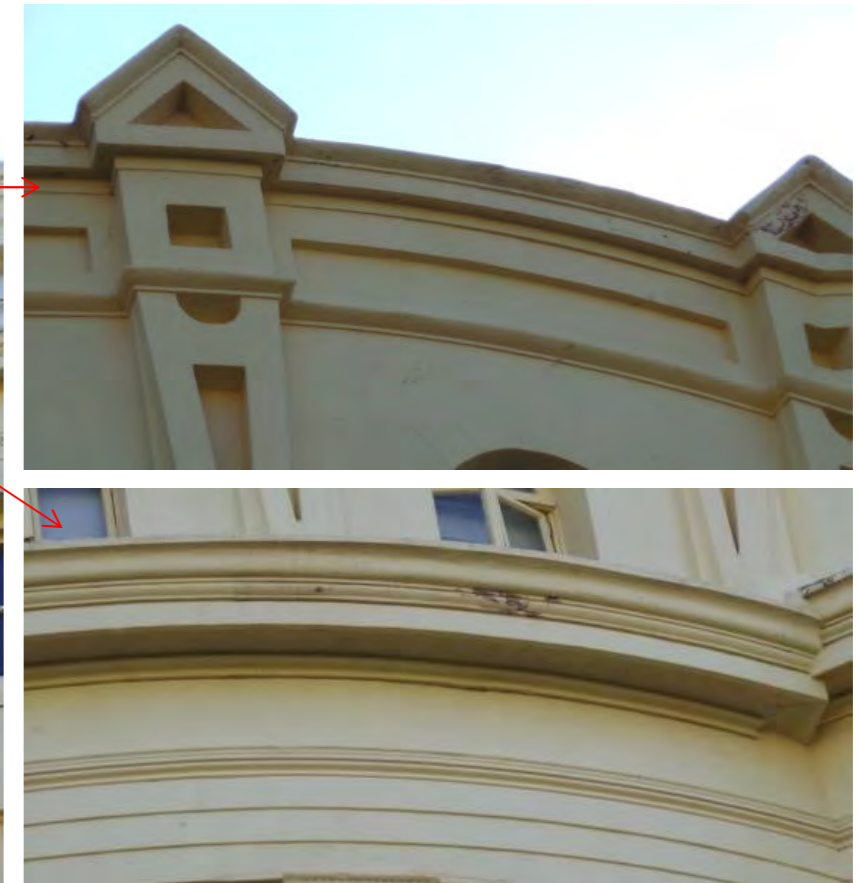
11 Brunswick Square

1. Localised paint flaking on the panelling on the left hand side above left window at parapet level;
2. Localised paint flaking on the right hand pediment at parapet level;
3. Extensive paint flaking and fine cracks to cornice;
4. Localised flaking and blistering above each of the windows on the underside of the cornice;
5. Fracture and localised paint flaking on the left hand column at first floor level;
6. Staining on the cornice beneath balcony;
7. Triglyph decoration to frieze above the doorway has been lost;
8. Localised paint flaking on the column on the left hand side of the front door;
9. Localised paint flaking on the underside of the porch;
10. Failing paint on the masonry below the railings adjacent the pavement and front door path;
11. Biological growth (mould and algae) and localised paint flaking on the basement walls indicating excessive moisture within the substrate

The tenant stated that he had painted the exterior 6 times in 3 months between October and December. The area above the porch is particularly problematic.

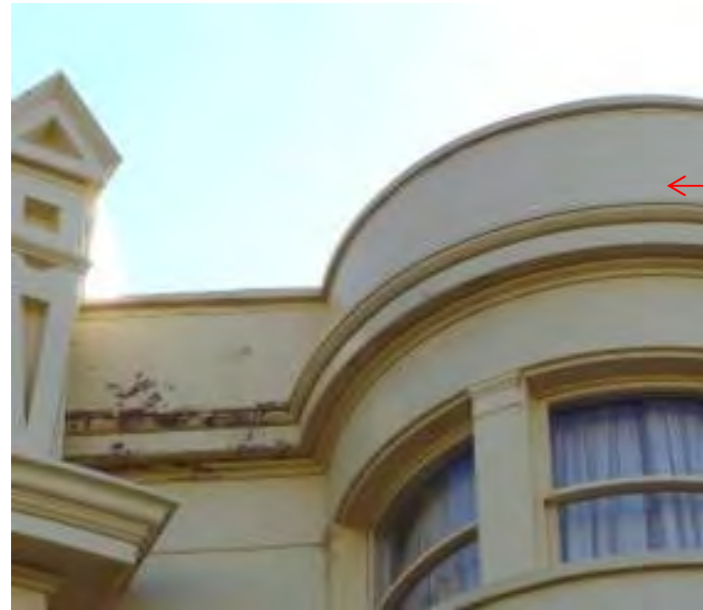
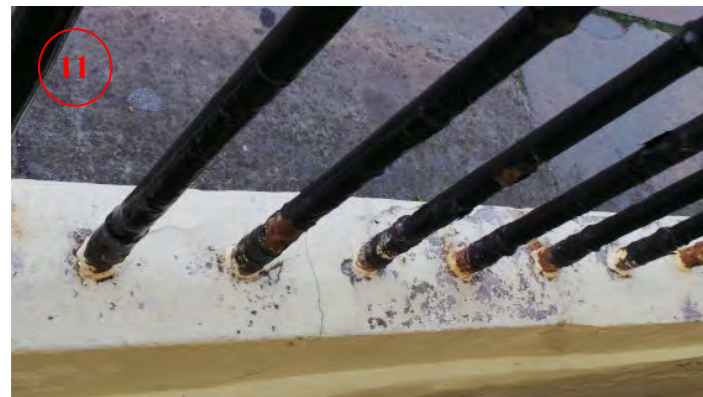
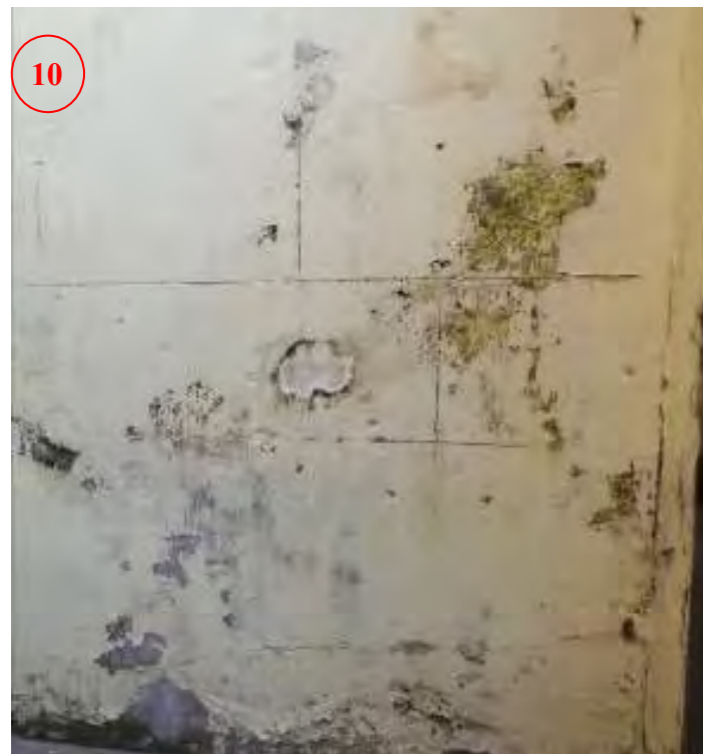
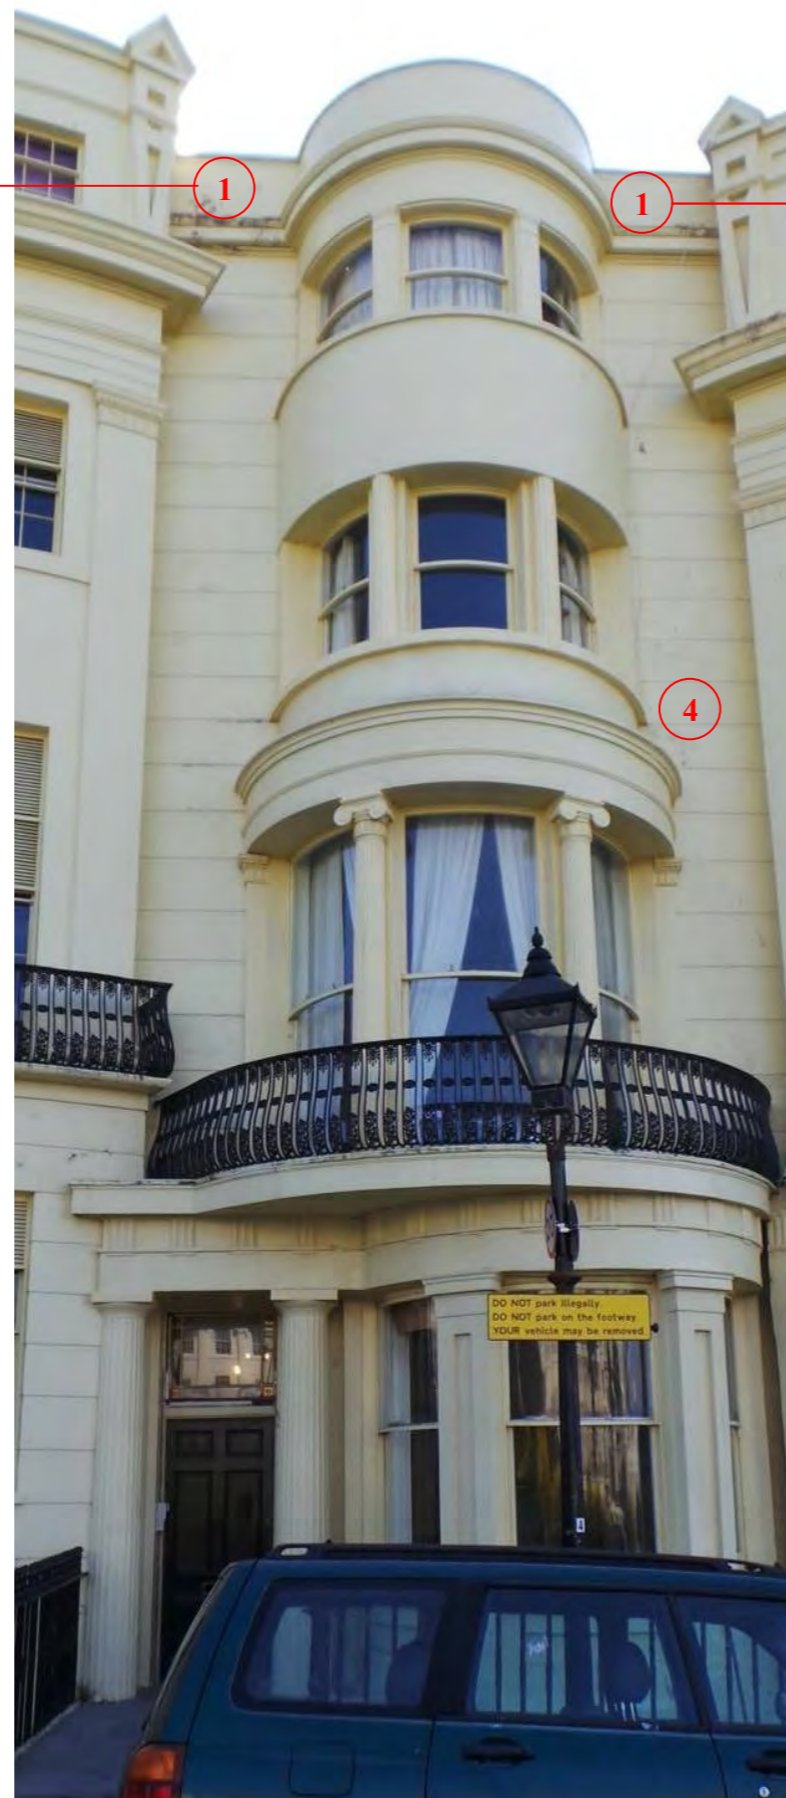
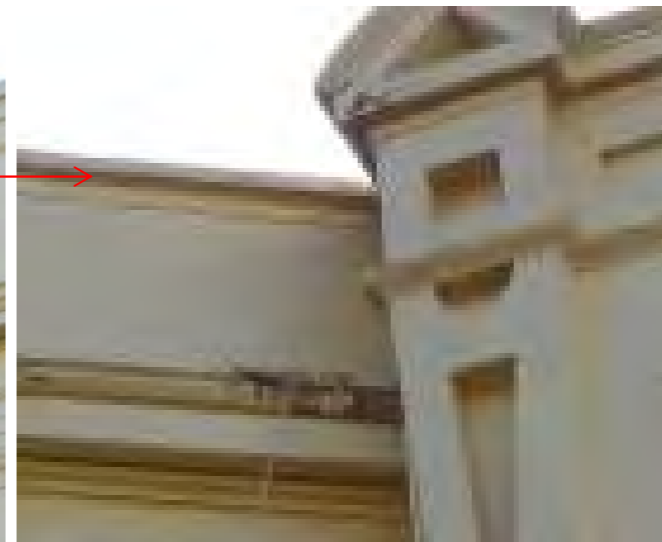
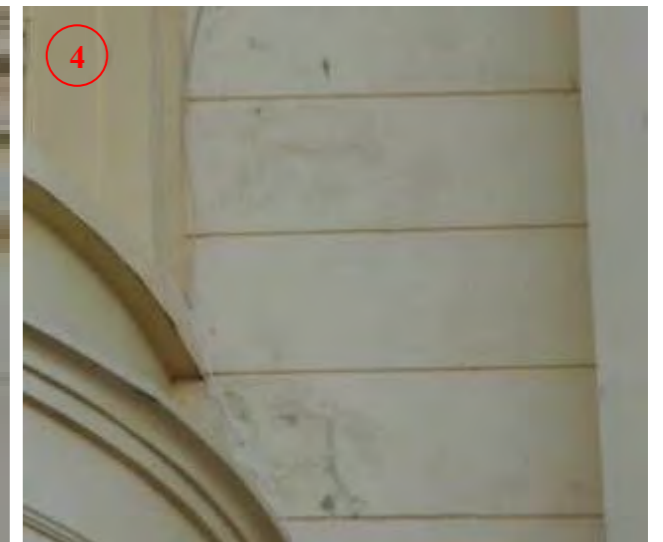
12 Brunswick Square

1. Extensive paint flaking on the flat wall and cornice either side of the bow at parapet level. This is particularly bad on the left hand side;
2. Localised paint flaking above the right hand window within the bow (second floor level);

3. Staining on the cornice between the first and second floor bow windows;
4. Localised paint flaking on the flat wall on the upper right hand side of the bow window (between the first and second floor);

5. Localised paint flaking on the flat wall on the left hand side of the bow window above the balcony;
6. Staining on the cornice beneath balcony;
7. Extensive paint flaking on the door frame and windows sills at ground floor level;

8. Localised staining on the cornice above the square pilaster on the right hand side of the ground floor window;
9. Localised paint flaking and blistering beneath the triglyph decoration on the frieze above the doorway;

10. Biological growth (mould and algae) and salt deliquescence causing extensive paint flaking at basement level (the paint is blistering exposing the substrate) indicating excessive moisture within the substrate;

11. Ferrous staining and failing paint on the masonry below the railings adjacent the pavement

The tenant of No 12 also owns No 11. The owner has attempted to strip the basement walls to expose the substrate using a scraper and torch burner. The paint has not been evenly removed giving a very uneven appearance (leaving islands of paint). This is also inadvisable as earlier paint schemes are likely to contain lead.

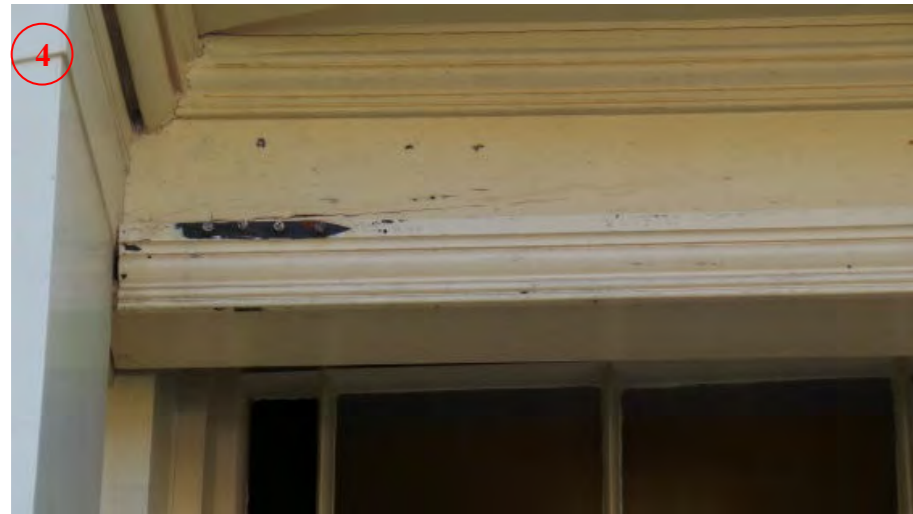
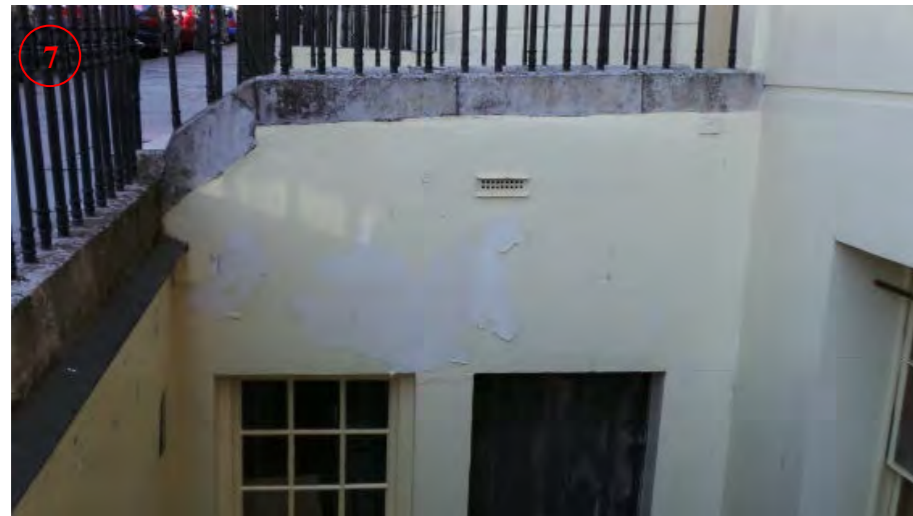
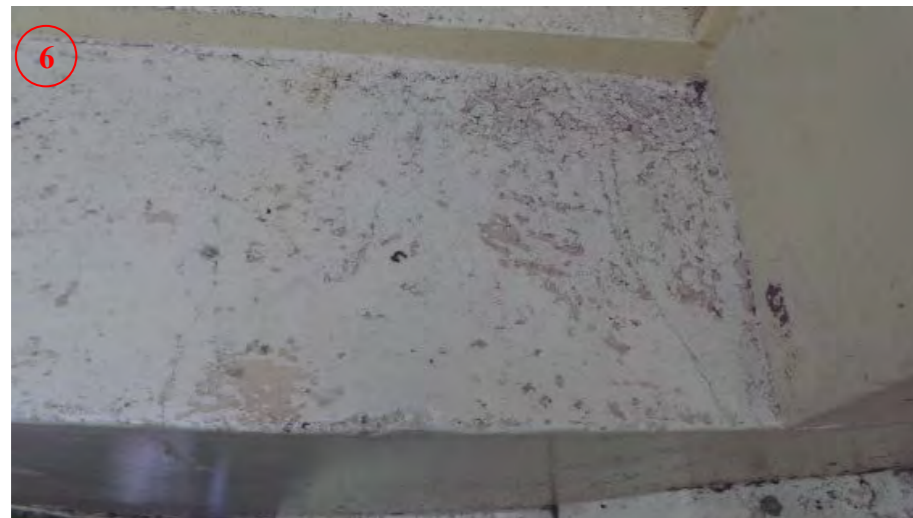
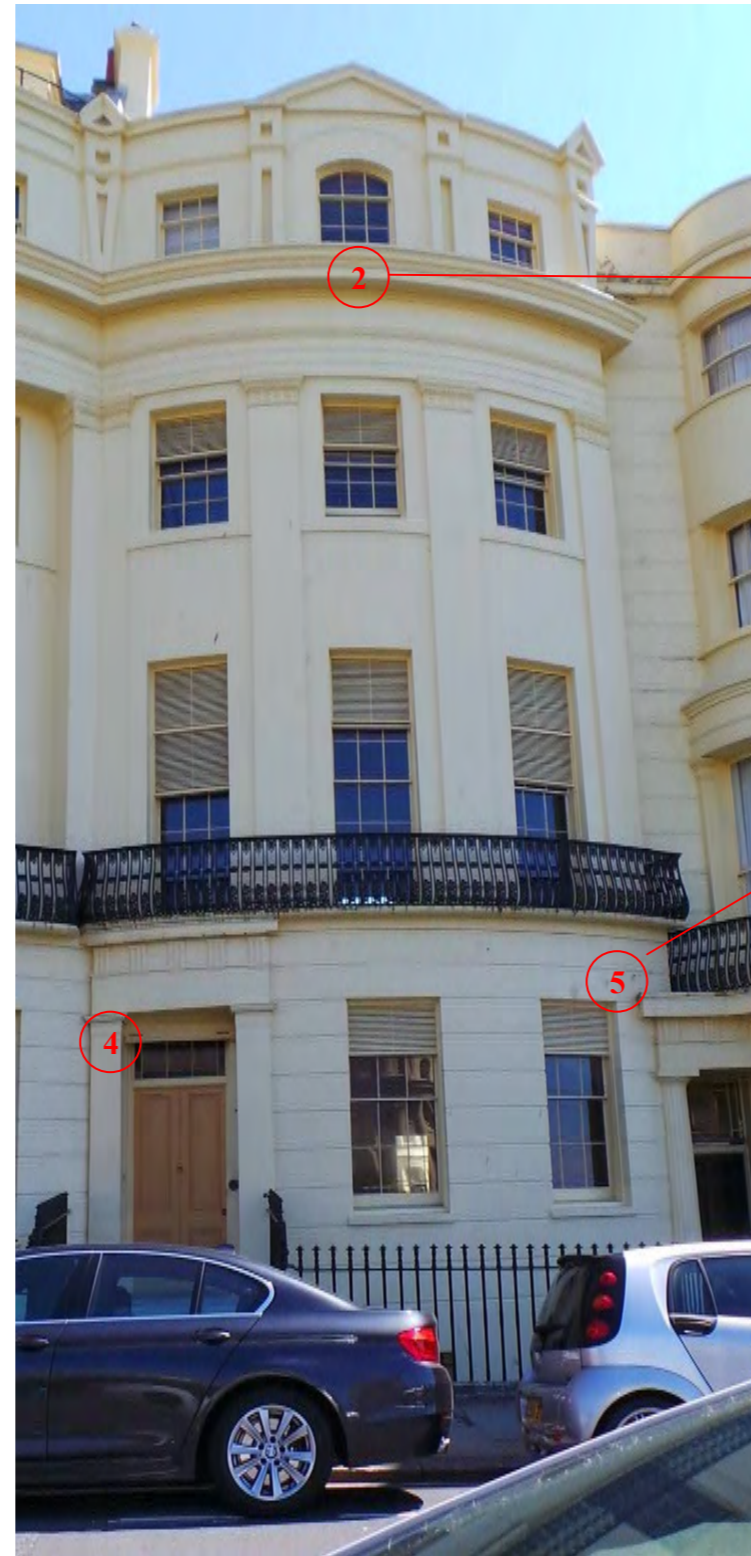
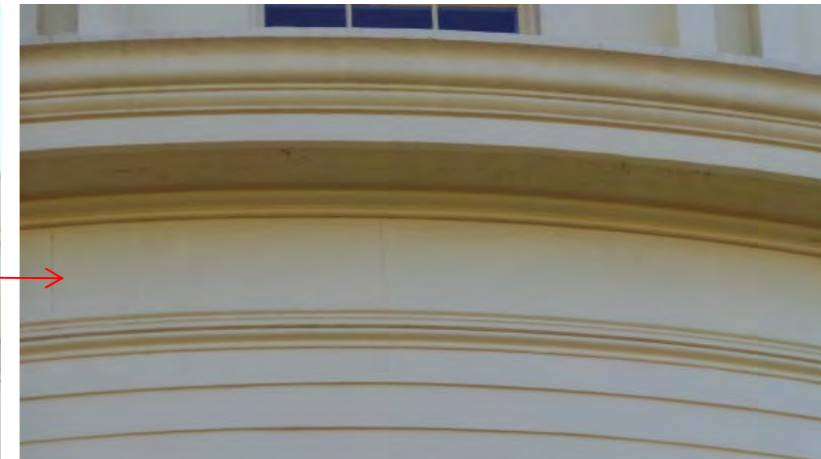
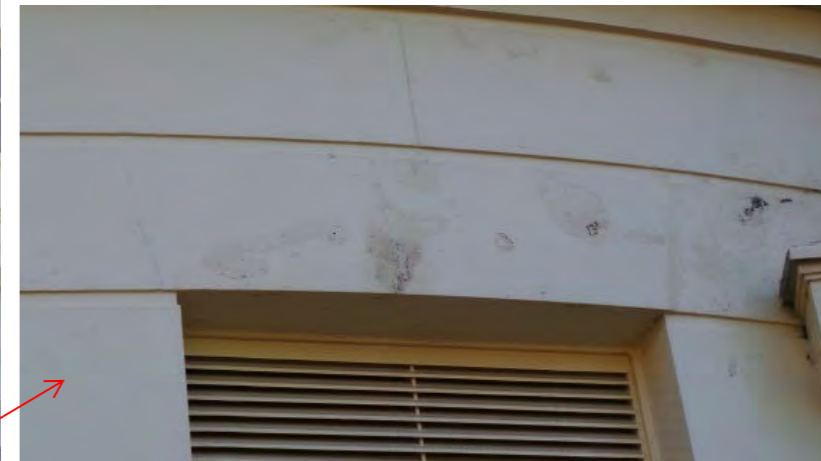
13 Brunswick Square

1. Localised paint flaking on the left hand side of the central window within the arched recess (third floor);
2. Localised paint flaking beneath the central window and on the cornice (third floor);
3. Staining on the cornice beneath balcony (first floor level);
4. Localised paint flaking above doorway;
5. Localised paint flaking and salt deliquescence above the right hand window at ground floor level;
6. Extensive paint flaking and cracking at basement level (walls and timber windows) due to biological growth (mould and algae) and salt deliquescence (the paint is blistering exposing the substrate) indicating excessive moisture within the substrate;
7. Failing paint on the masonry below the railings adjacent the pavement.

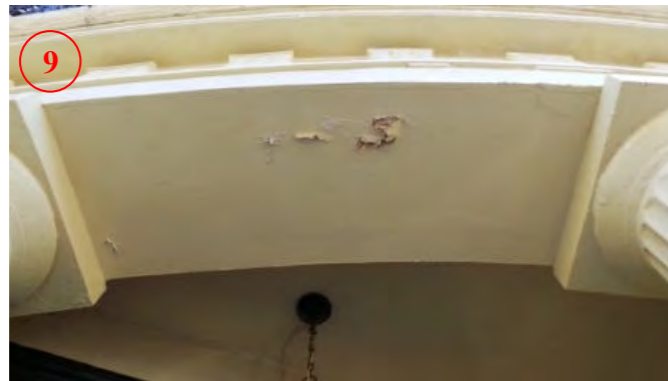
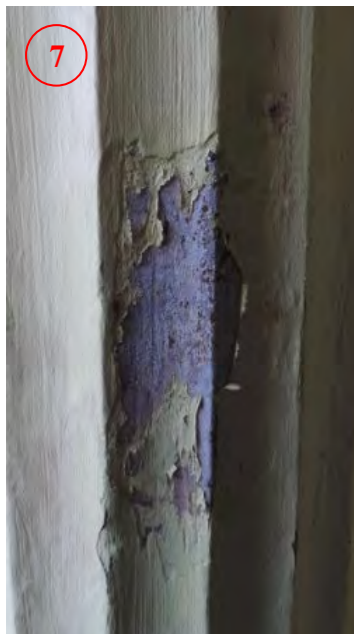
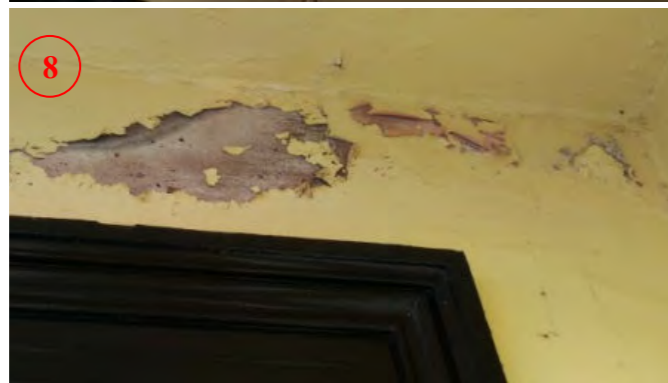
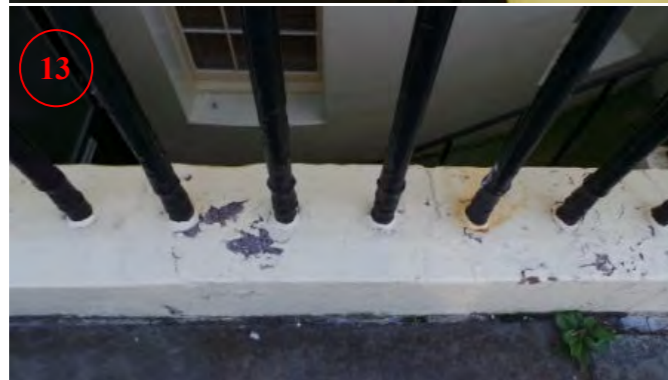
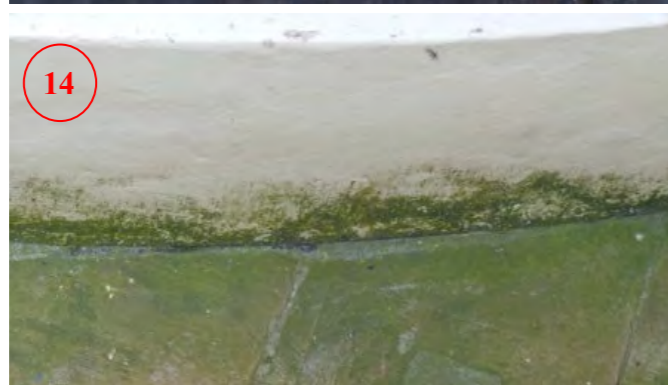
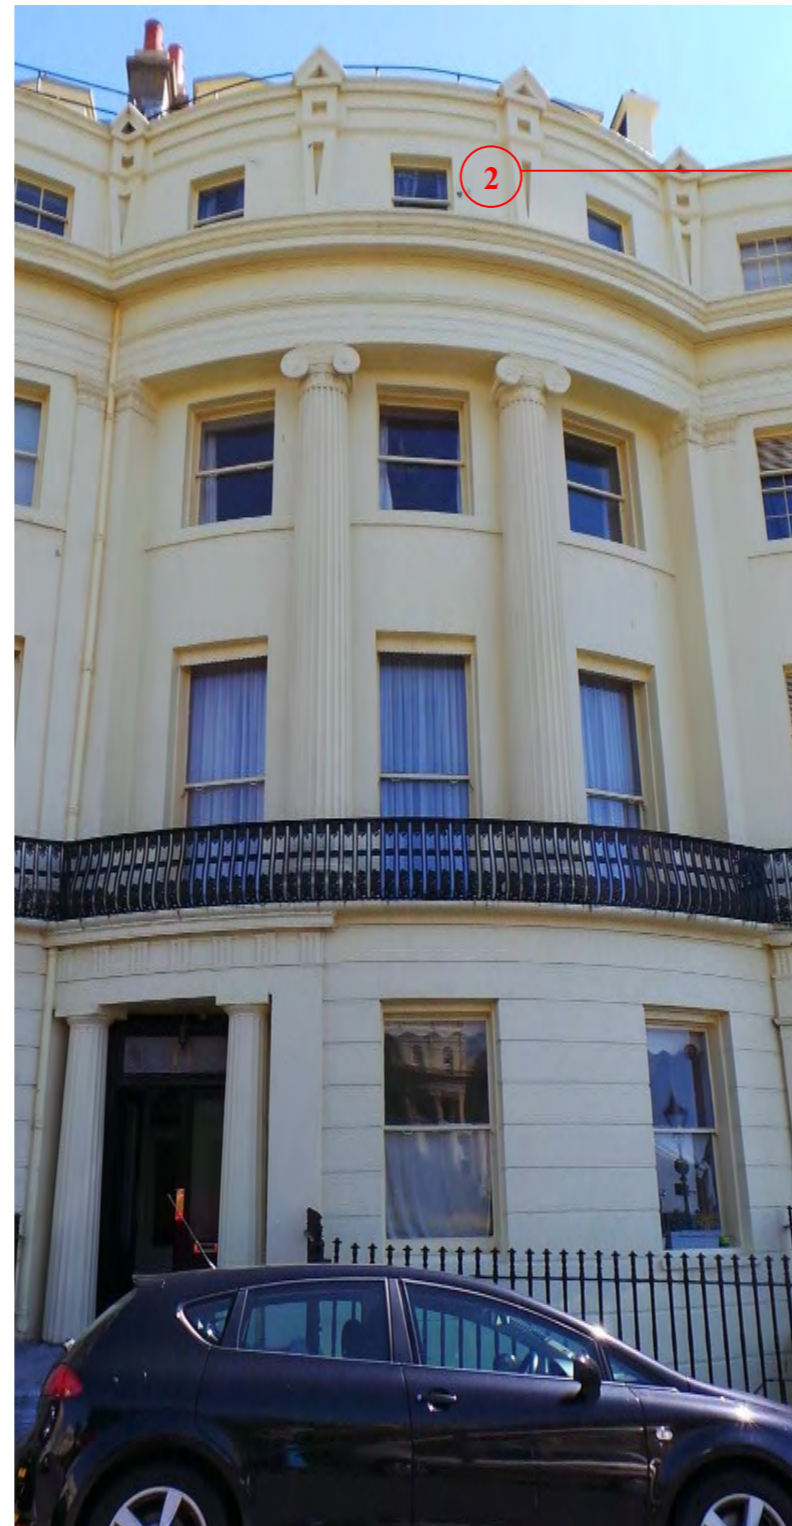
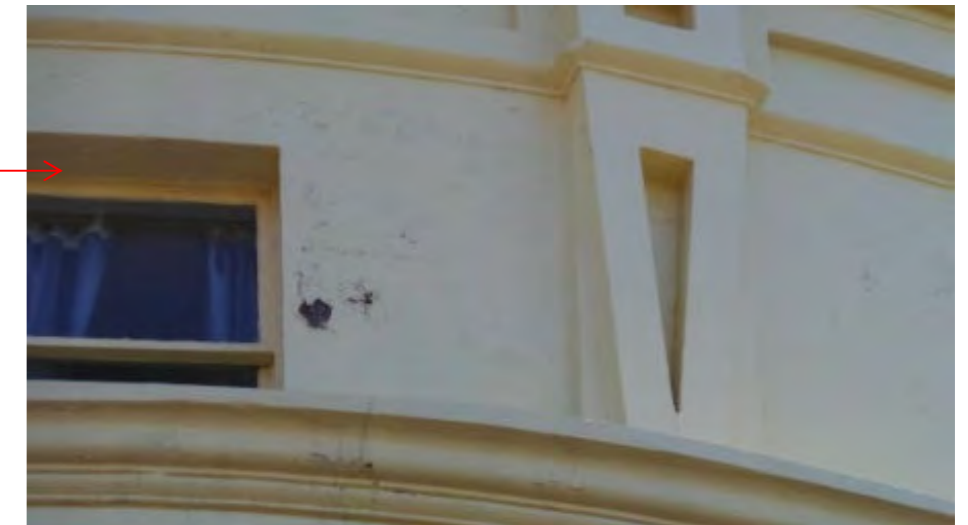
14 Brunswick Square

1. Localised paint flaking and salt effervescence top right hand corner of the left window at parapet level;
2. Localised paint flaking and salt deliquescence on the right hand side of the central window

6. Staining on the cornice beneath the wrought iron balcony (first floor level);
7. Localised paint flaking on the top of the columns either side of the doorway (ground floor level);

8. Localised paint flaking on the right hand side of the door (within the porch);
9. Localised paint flaking and cracks on the underside of the porch;
10. Localised paint flaking and salt deliquescence on the frieze above the doorway;

13. Ferrous staining and failing paint on the masonry below the railings adjacent the pavement;
14. Biological growth (mould and algae) on the basement walls indicating excessive moisture within the substrate.

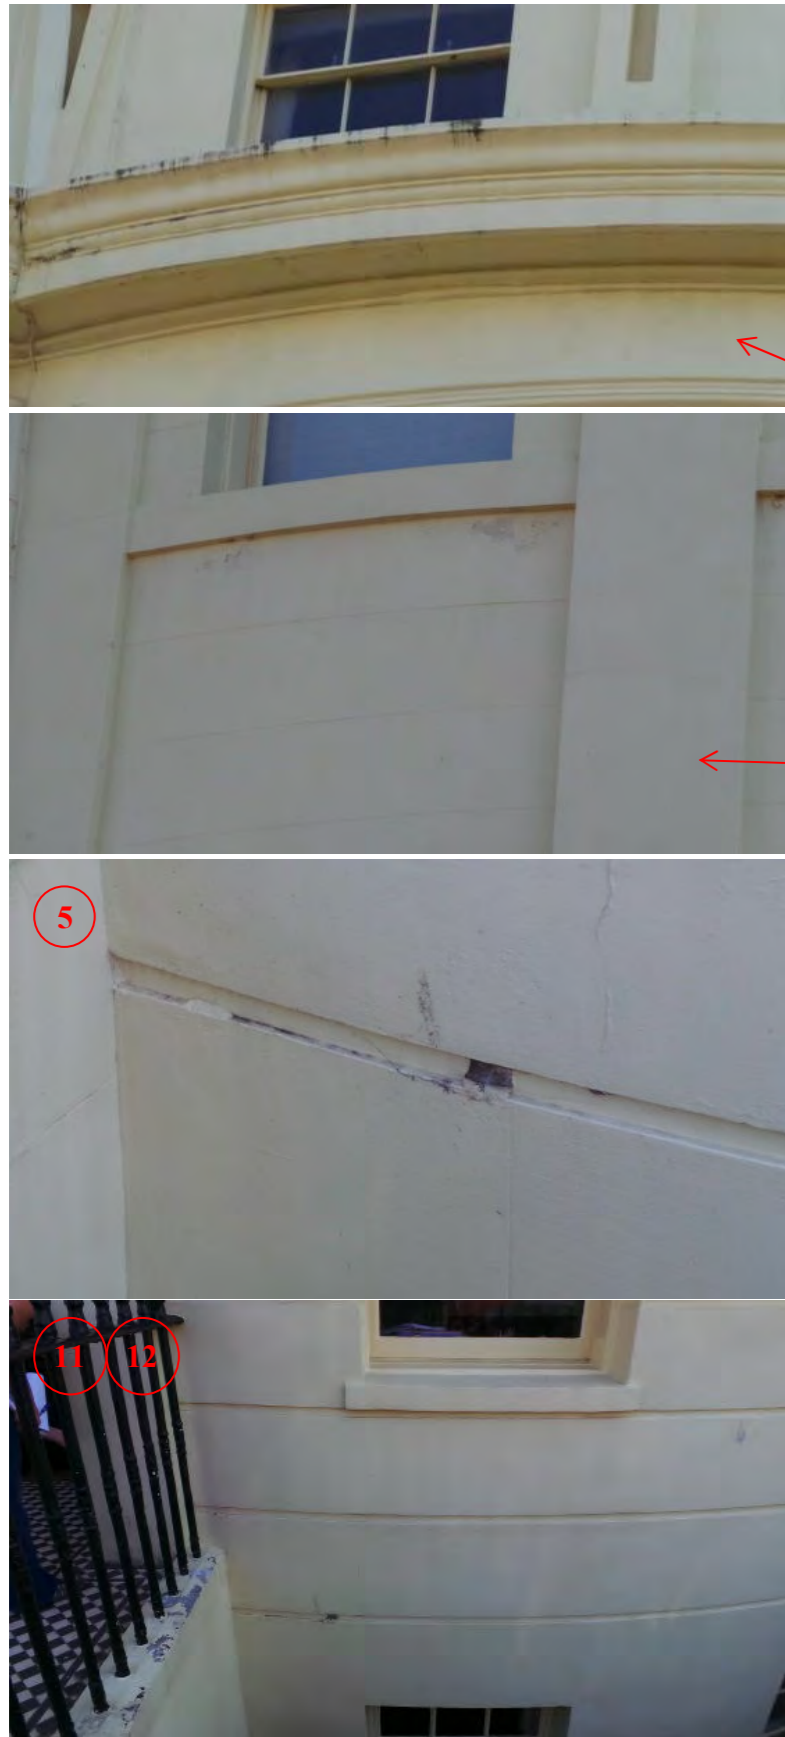
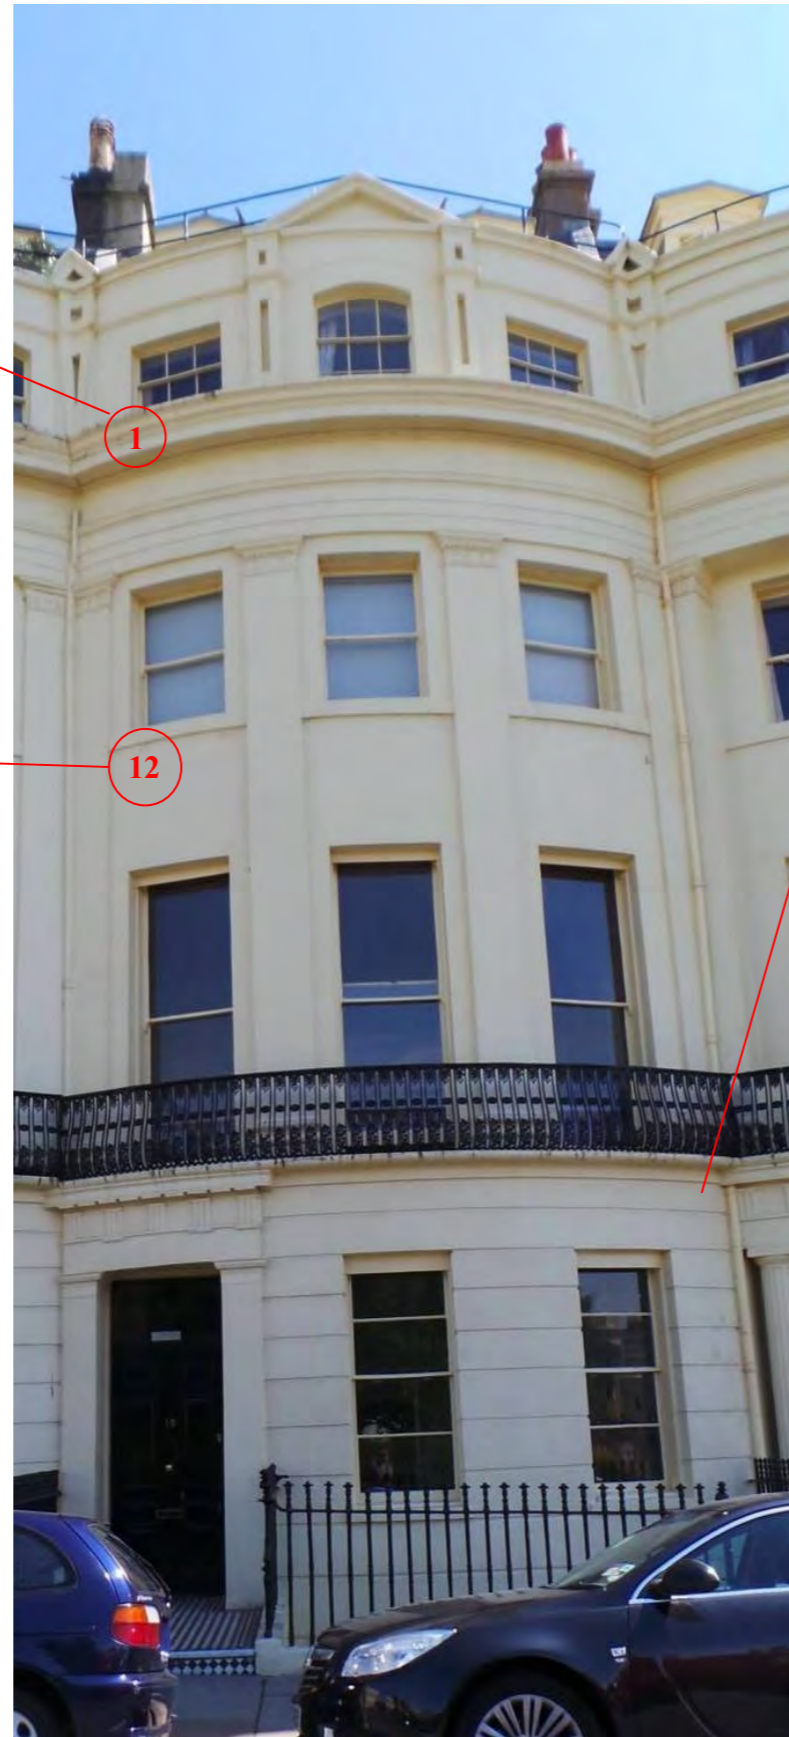
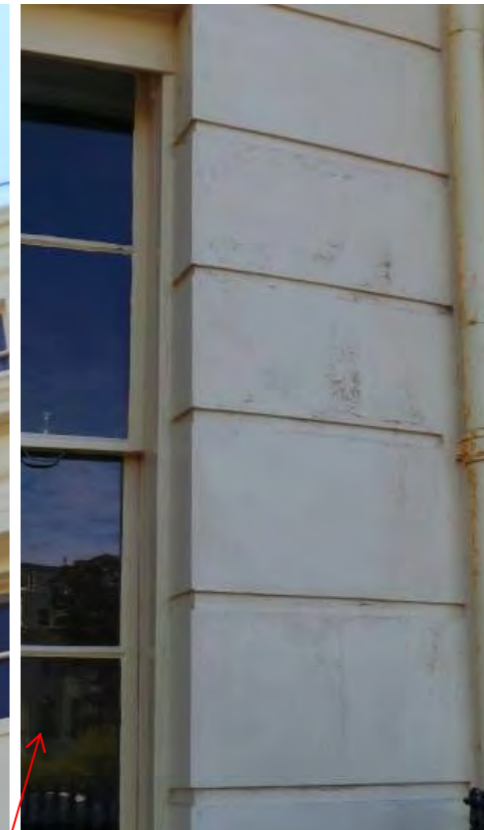
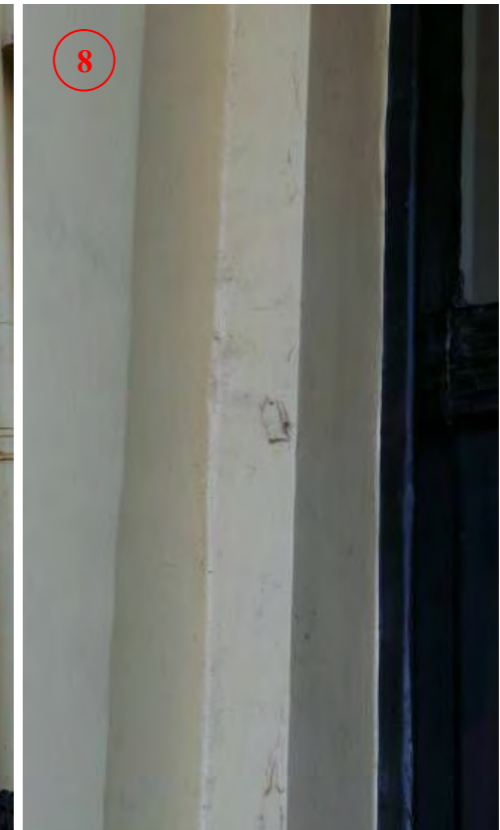
15 Brunswick Square

1. Staining and localised paint flaking on the cornice below the third floor (particularly on the left hand side);
2. Localised paint flaking beneath the cornice below the third floor;

3. Ferrous staining on the right hand of the building due to the downpipe which may be leaking or trapping moisture within the substrate;
4. Localised paint flaking and cracks to second-floor window recesses;

5. Localised paint flaking and cracks on the right hand side of the right window (ground floor);
6. Staining on the cornice beneath balcony;
7. Localised paint flaking on the triglyph decoration on the frieze above the doorway;

9. Salt deliquescence, staining and flaking paint above the left hand window (ground floor);
10. Salt deliquescence, blistering and flaking paint under the left hand window (ground floor level);

11. Failing paint on the masonry below the railings adjacent the pavement;
12. Salt deliquescence and flaking paint under the left hand window (second floor level).

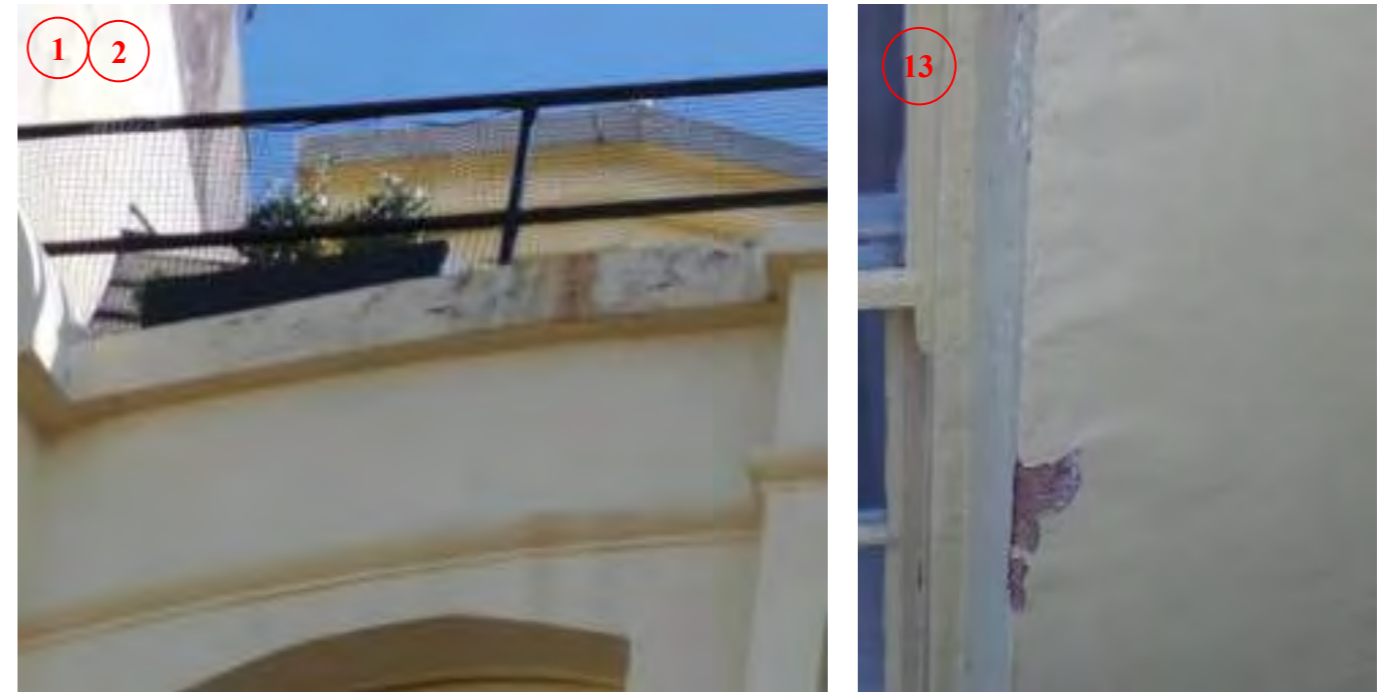
16 Brunswick Square

1. Localised paint flaking on the central pediment at parapet level;
2. Ferrrous staining on the pediment and flaking panelling at parapet level;
3. Localised paint flaking on the underside of the arched recess of the central window (third floor);

4. Staining and localised paint flaking on the cornice below the third floor;
5. Vertical fracture running through the cornice to the left hand side of the central window (second floor);

6. Extensive paint flaking, cracking and salt deliquescence under the cornice above second floor level related to salts and moisture retention;
7. Vertical fracture and paint flaking above the right hand window (first floor);

8. Staining and paint flaking on the cornice beneath balcony;
9. Localised paint flaking on the left hand side of the porch;
10. The adjacent building on the left hand side (No. 17) projects forward. The adjoining wall between the two properties is badly damaged as a result of salt deliquescence. The paint has blistered and there is evidence of salt effervesce beneath the blistering paint;

11. Localised paint flaking and fractures on and beneath the ground floor window sills;
12. Ferrrous staining and flaking paint on the masonry below the railings adjacent the pavement and the front door path. There are also some losses and fractures in the masonry wall;

13. Salt deliquescence, blistering, cracking and flaking paint in the basement (first floor and basement level). This is particularly prevalent around the basement windows;

14. Biological growth (algae and mould) at basement level indicating moisture within the substrate.
