**Investigation of Paint Failure at
Brunswick Estate
Hove
Brighton**

August 2013

**BRUNSWICK ESTATE
HOVE**

The following document investigates the failure of the external paint-system at Brunswick Estate, Hove based on research carried out by Elizabeth Hirst and Rachel Morley of Hirst Conservation between August and November 2013. The work was commissioned by Brighton & Hove City Council.

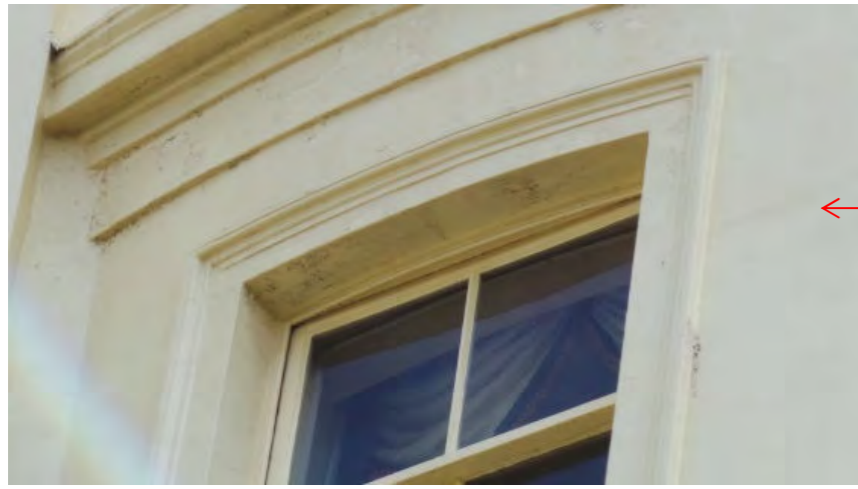
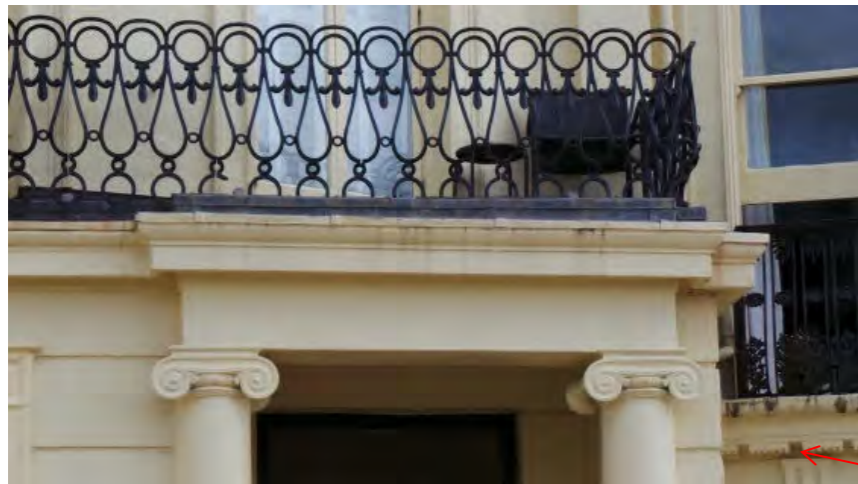
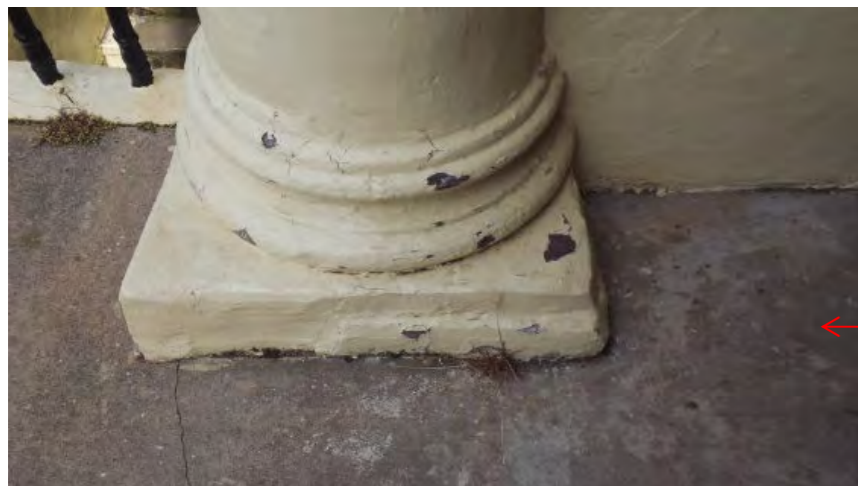
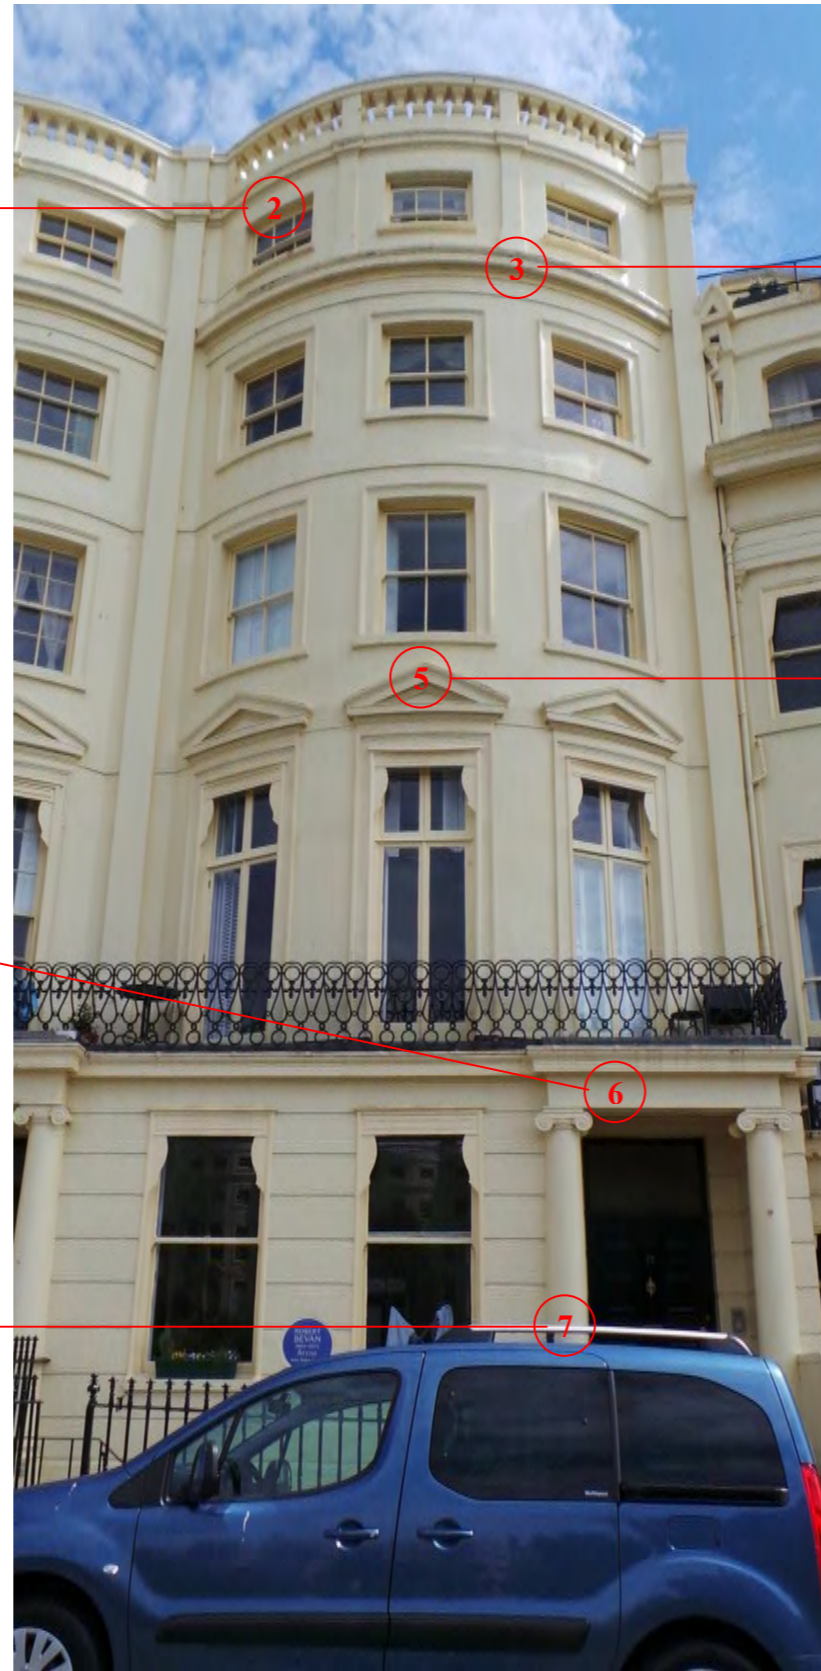
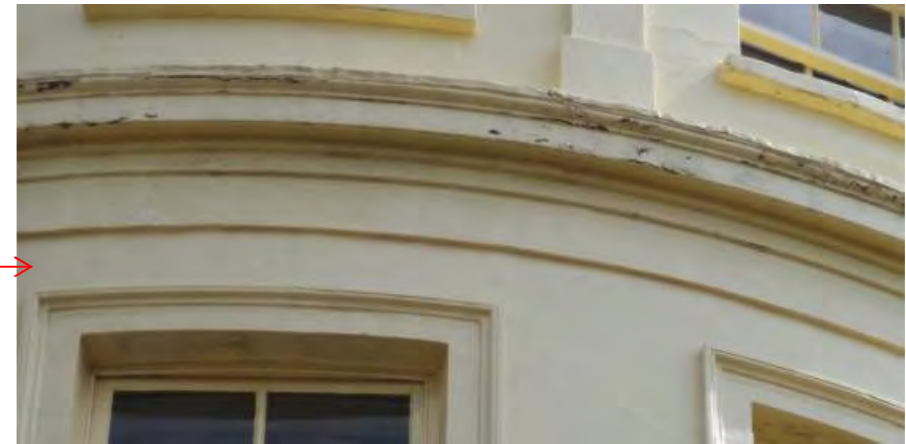
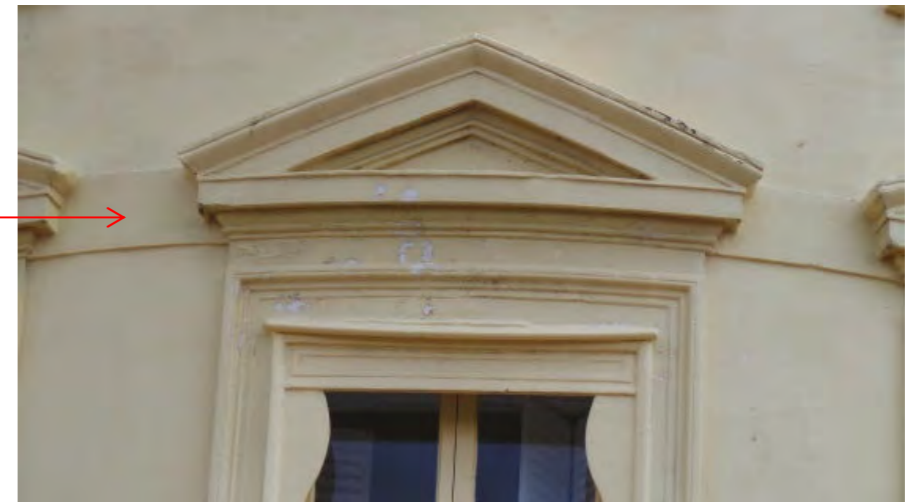
17 Brunswick Square

1. Localised paint flaking on left hand side of the square pilaster (fourth floor level);
2. Extensive paint flaking to fourth floor window sills and recesses, particularly to left hand window;
3. Staining and localised paint flaking on the cornice below fourth floor;
4. Localised paint flaking under the window recesses on each window on the third floor;
5. Localised paint flaking to pediment over central first floor window;
6. Staining to cornice over doorway;
7. Localised paint flaking to left hand side of porch;
8. This property projects forward. The wall which joins this property with No. 16 is badly damaged due to salt deliquescence. The paint has blistered and a white residue is visible underneath.

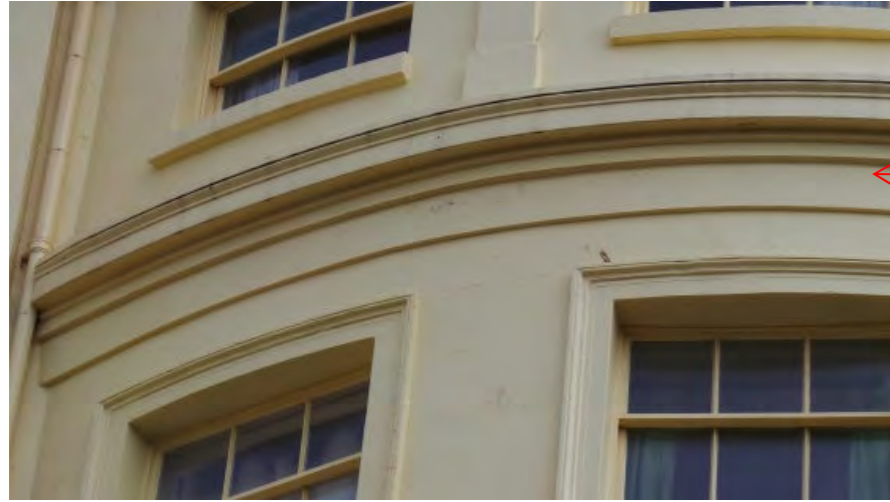
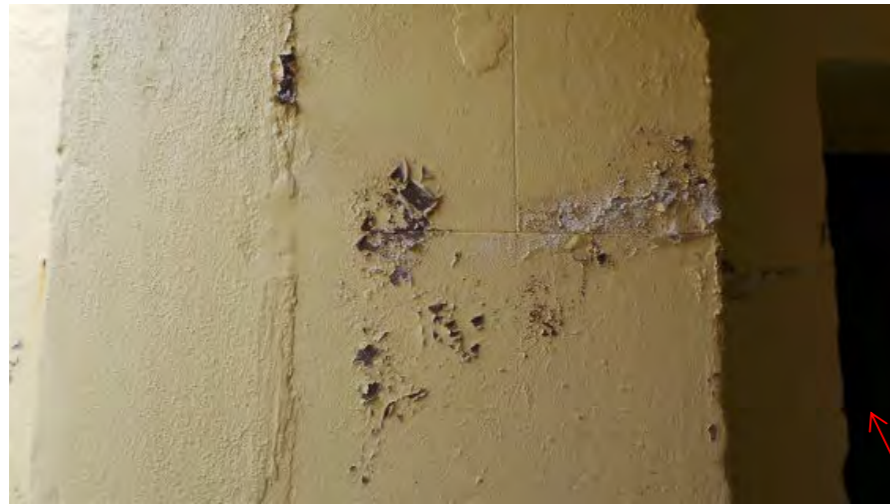
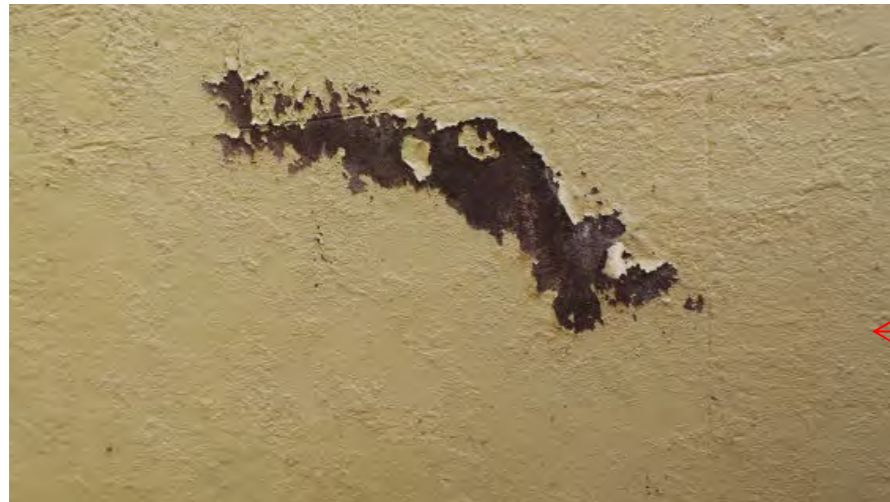
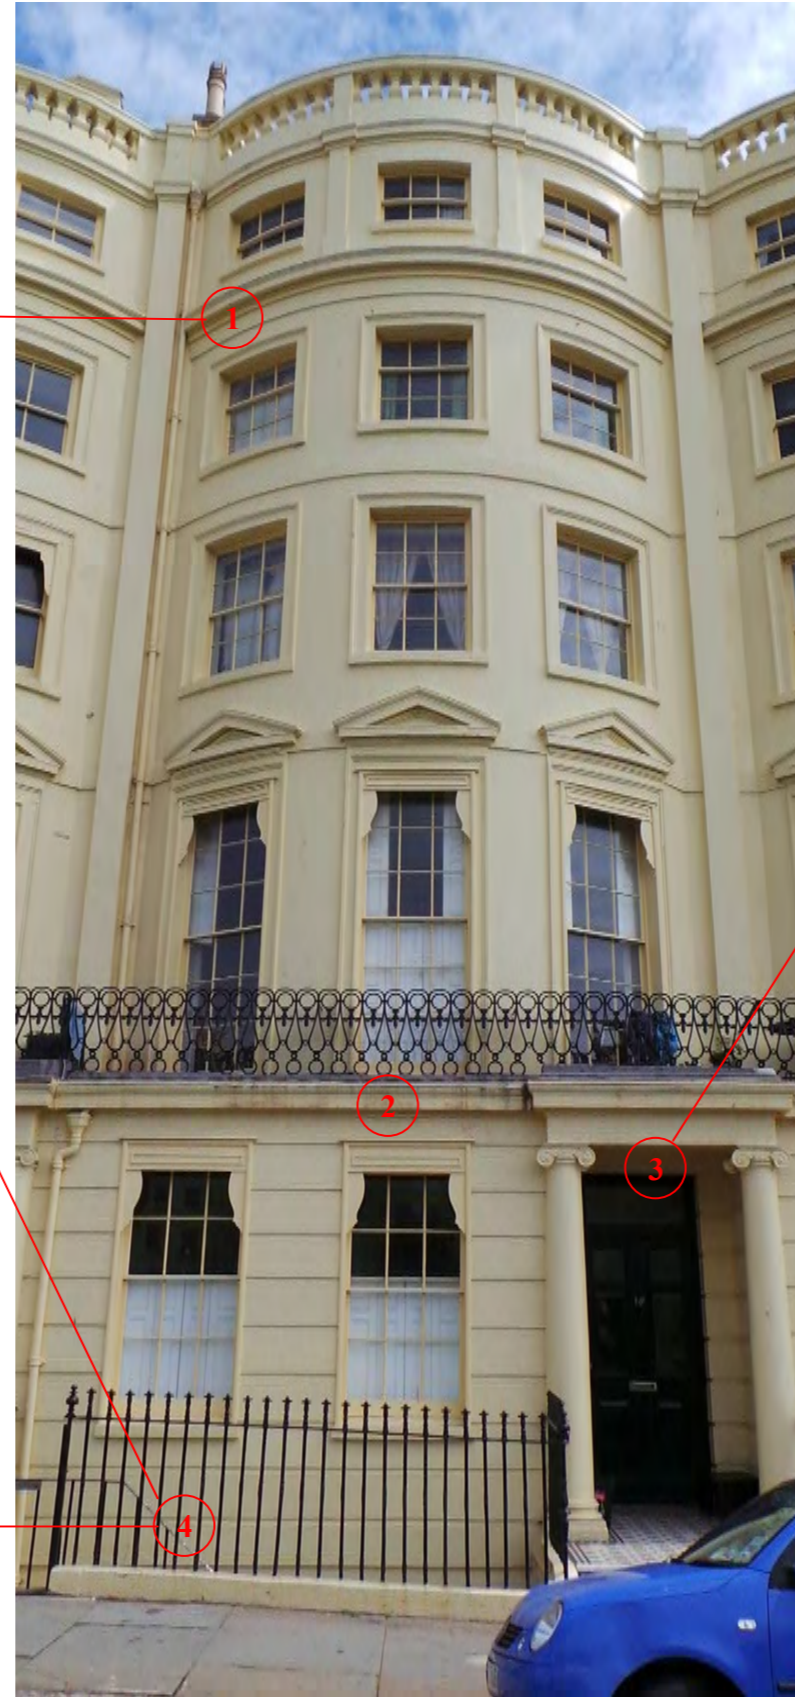
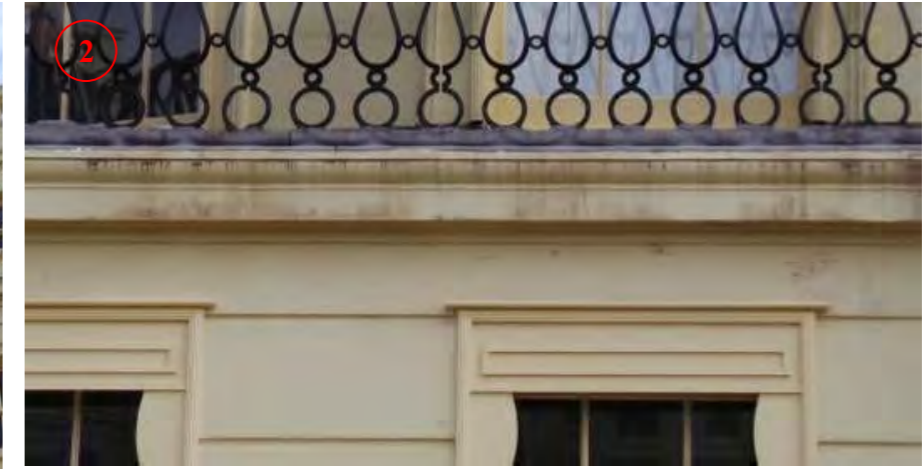
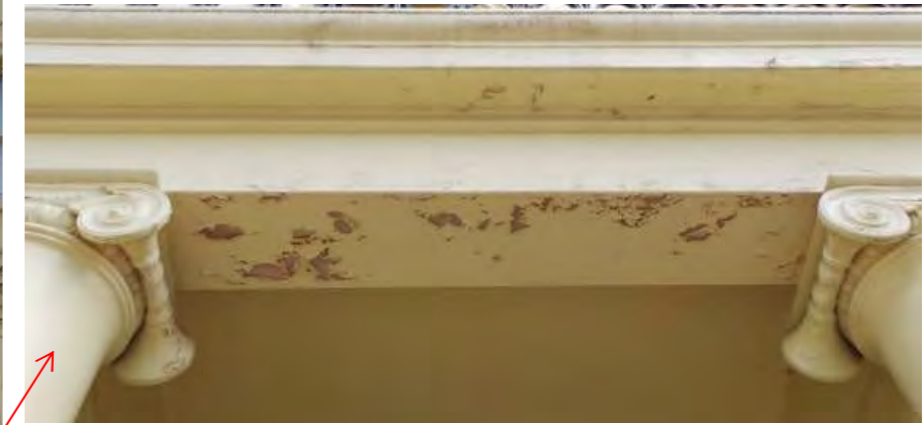
18 Brunswick Square

1. Staining and localised paint flaking to cornice below fourth floor;
2. Staining and paint flaking to cornice under balcony;
3. Localised paint flaking to underside of the porch between capitals;
4. Salt deliquescence and flaking paint to basement walls;
5. Staining to plinth wall.

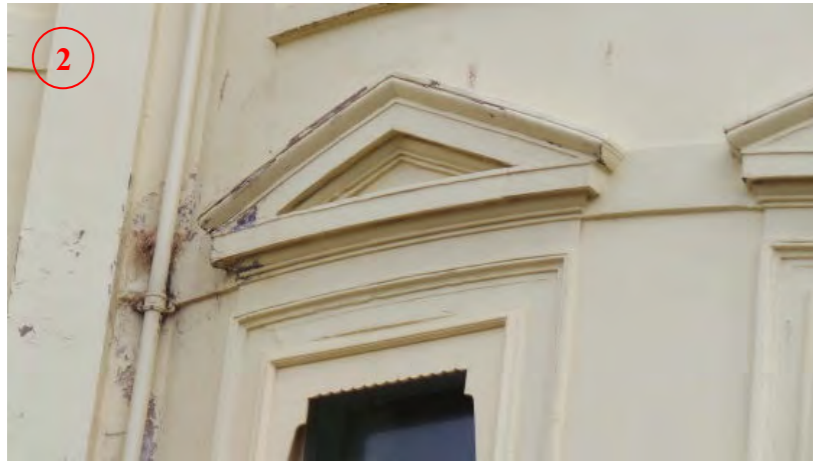
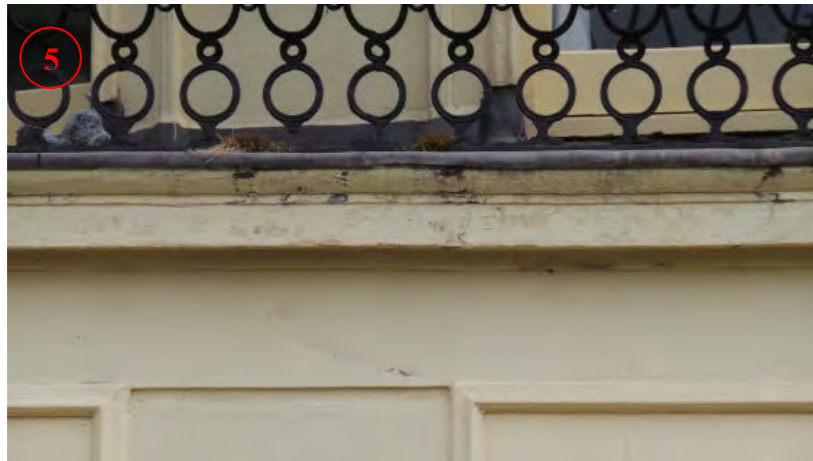
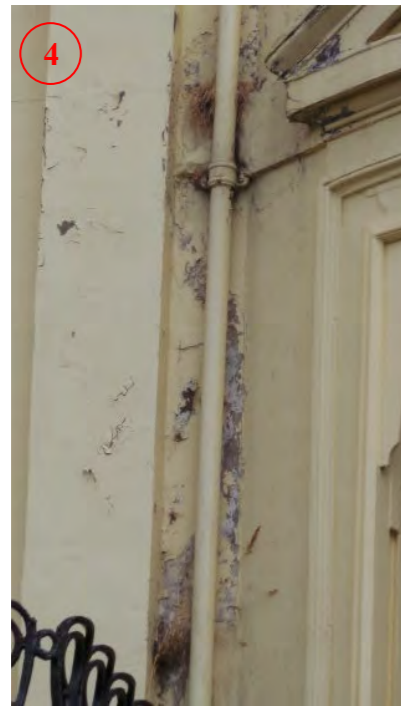
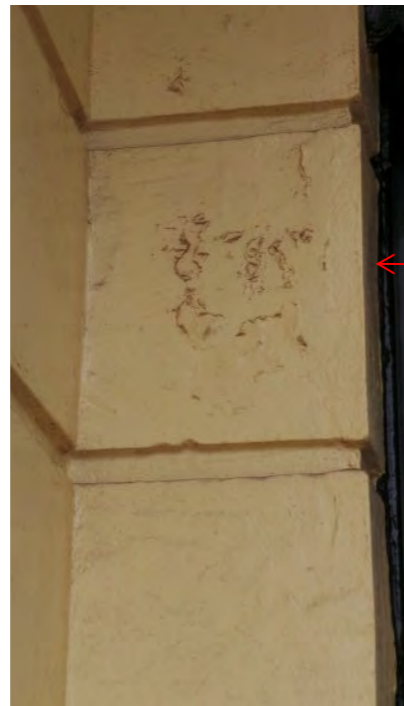
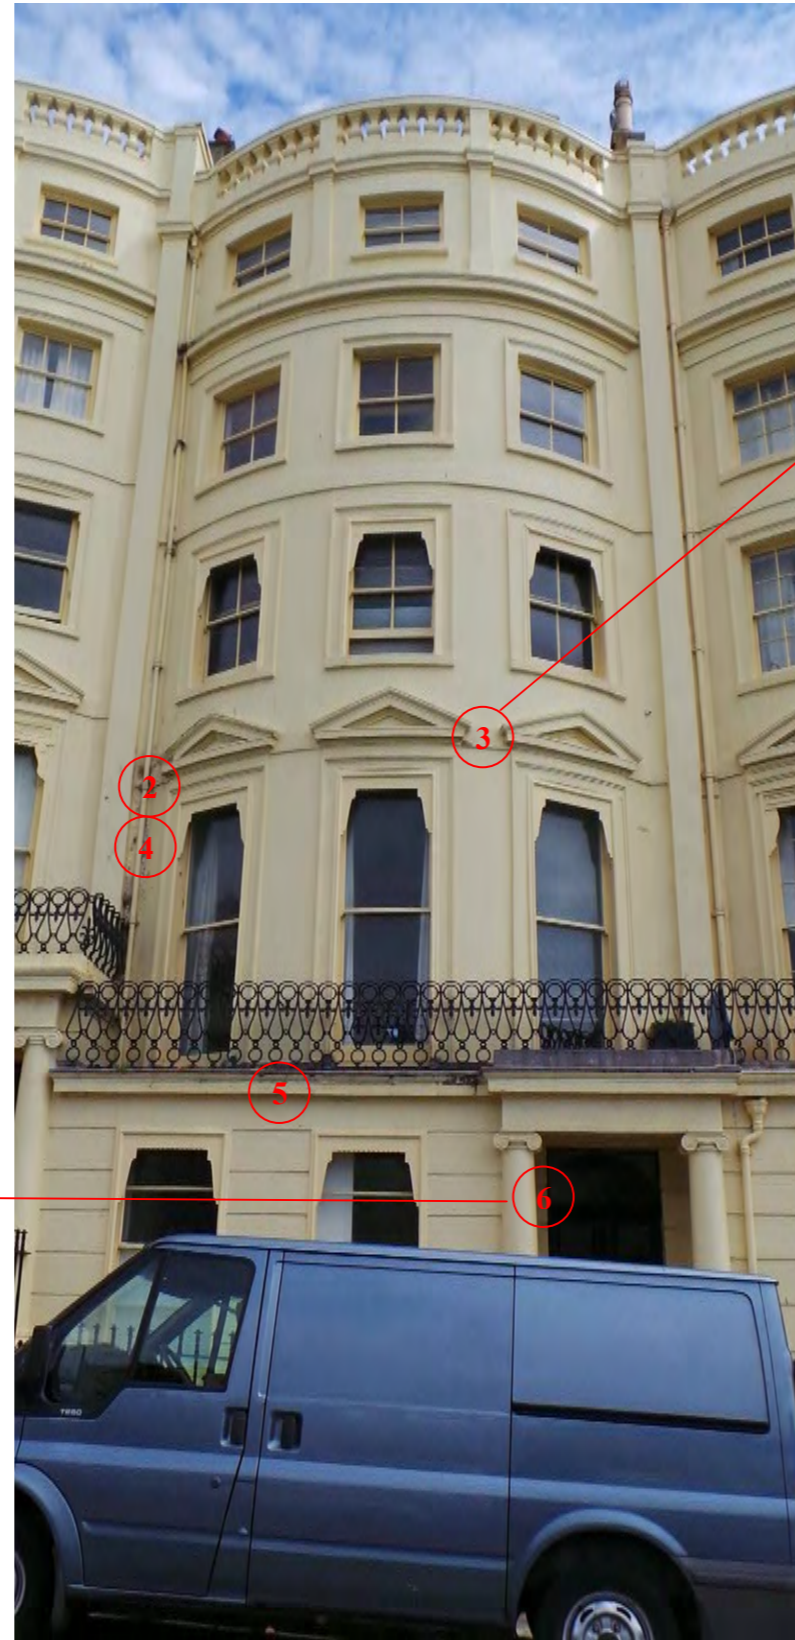
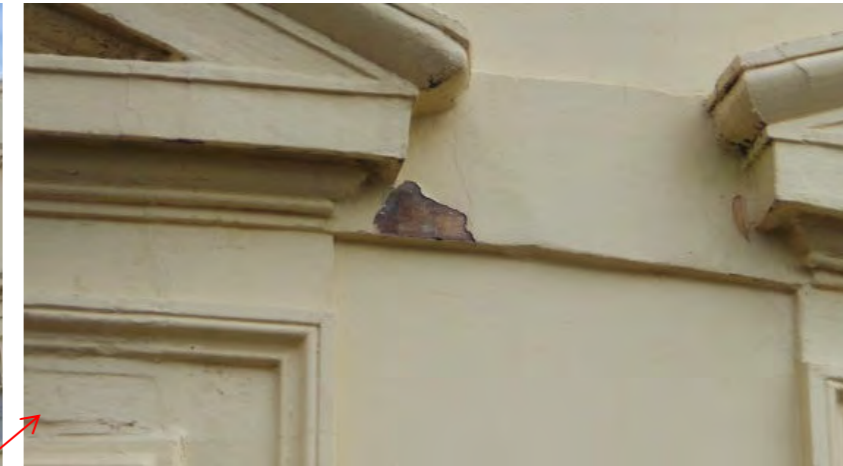
19 Brunswick Square

1. Localised paint flaking to right hand side of the first floor window;
2. Localised paint flaking to pediment above the left hand first floor window;
3. Localised paint flaking to right hand side of the central pediment over first-floor window;
4. Localised ferrous staining and paint flaking along downpipe at first floor level;
5. Staining and paint flaking on the cornice beneath balcony;
6. Localised paint flaking to left of porch.

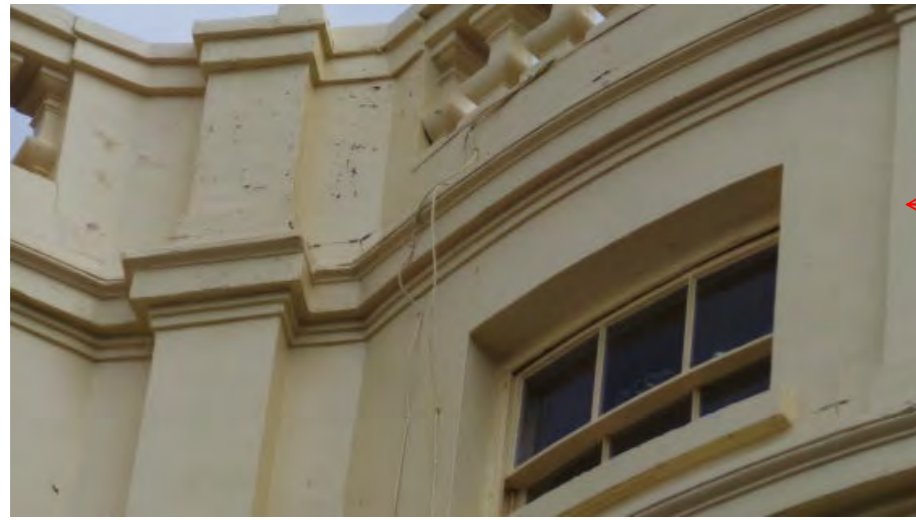
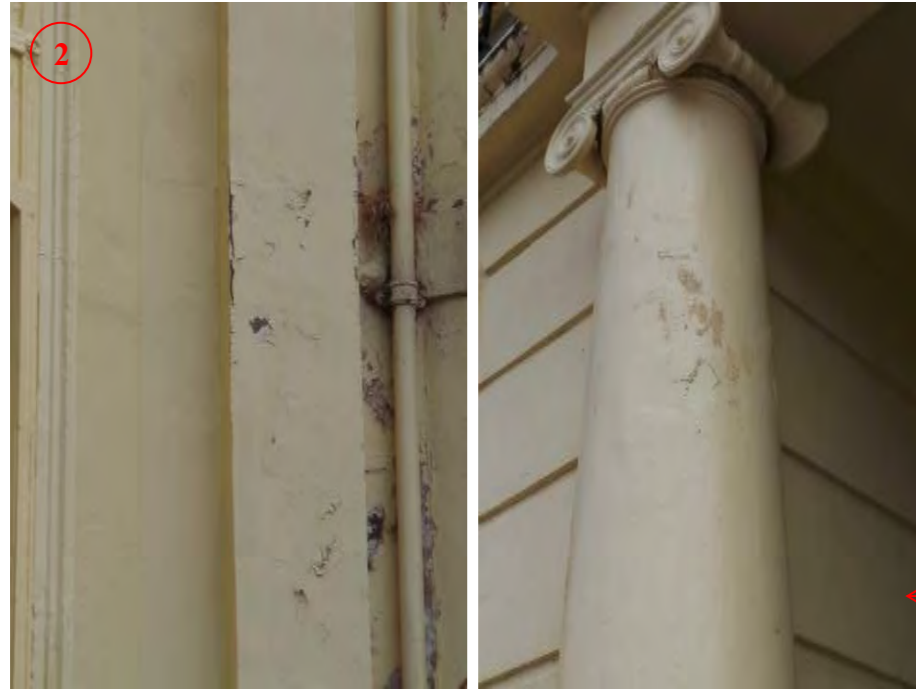
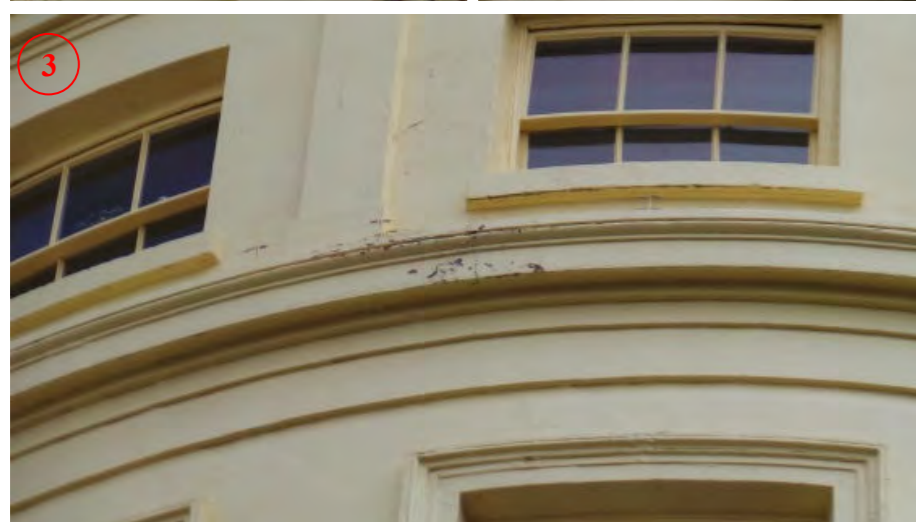
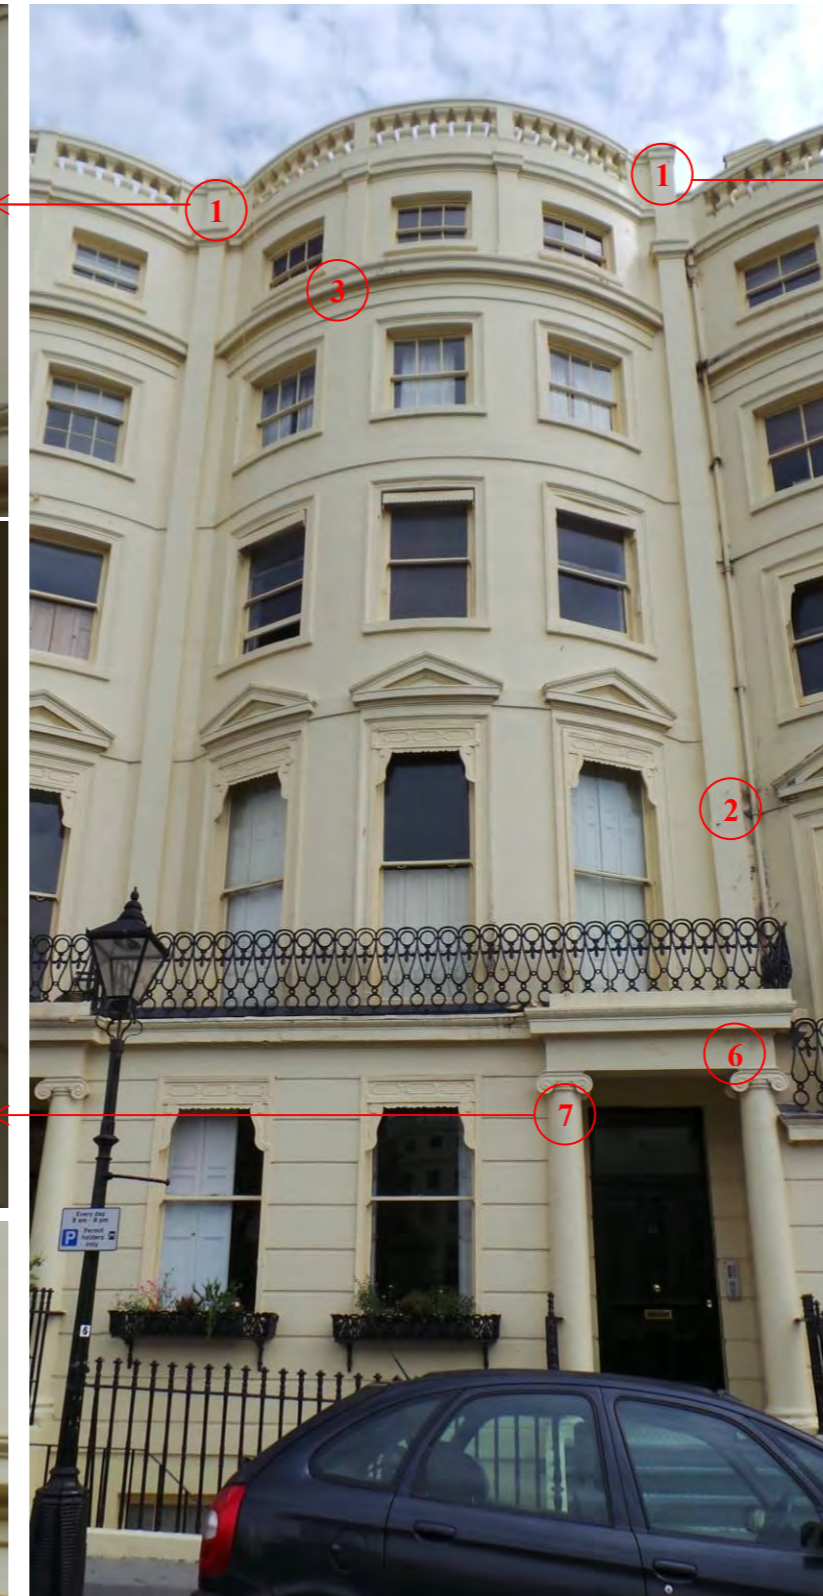
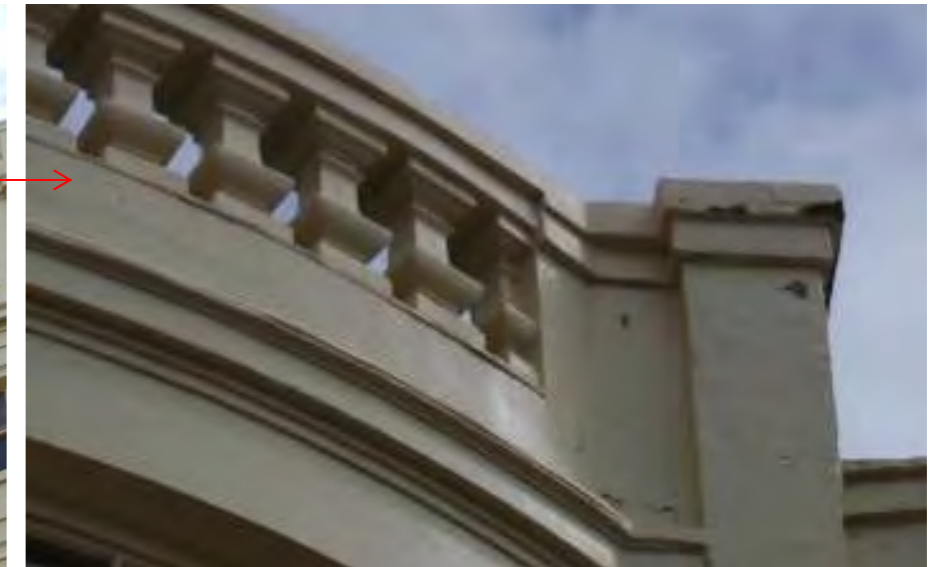
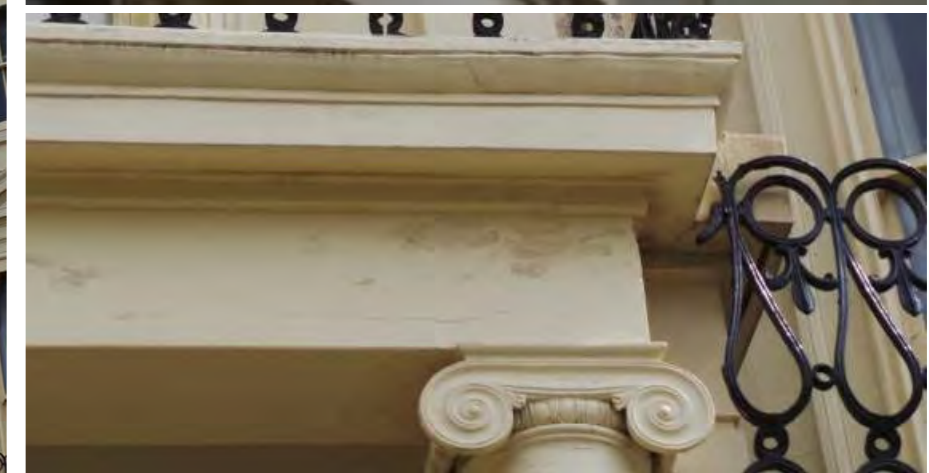
20 Brunswick Square

1. Localised paint flaking to parapet balustrade;
2. Staining, fractures and localised paint flaking to down pipe casing (first floor level);
3. Staining and localised paint flaking to cornice;
4. Localised paint flaking above first floor windows;
5. Staining and paint flaking to cornice beneath balcony;
6. Localised paint flaking to frieze above porch between the capitals;
7. Localised paint flaking to entrance columns;
8. Staining to plinth wall.

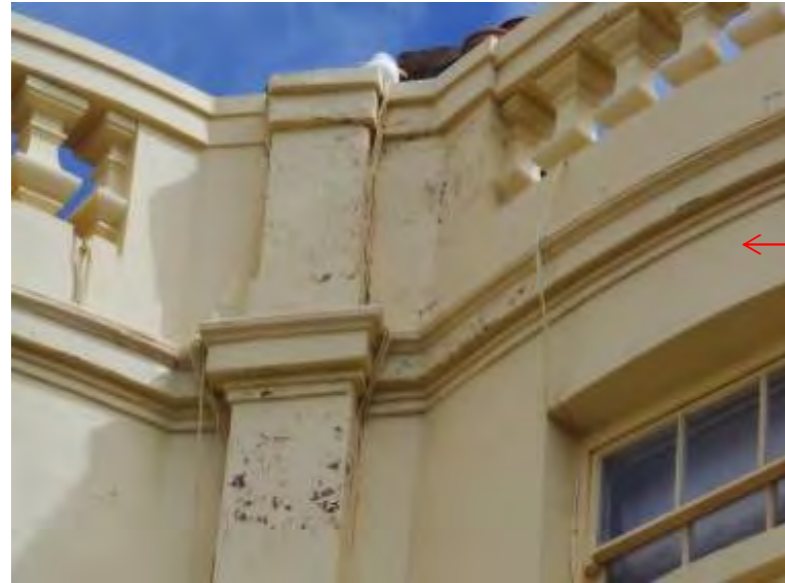
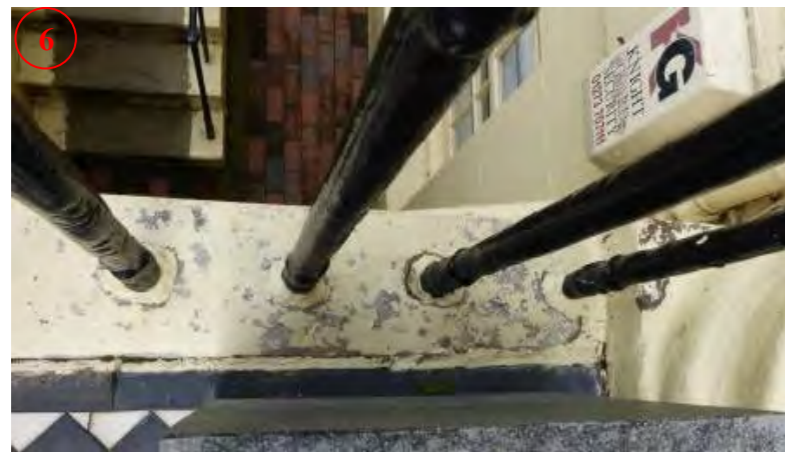
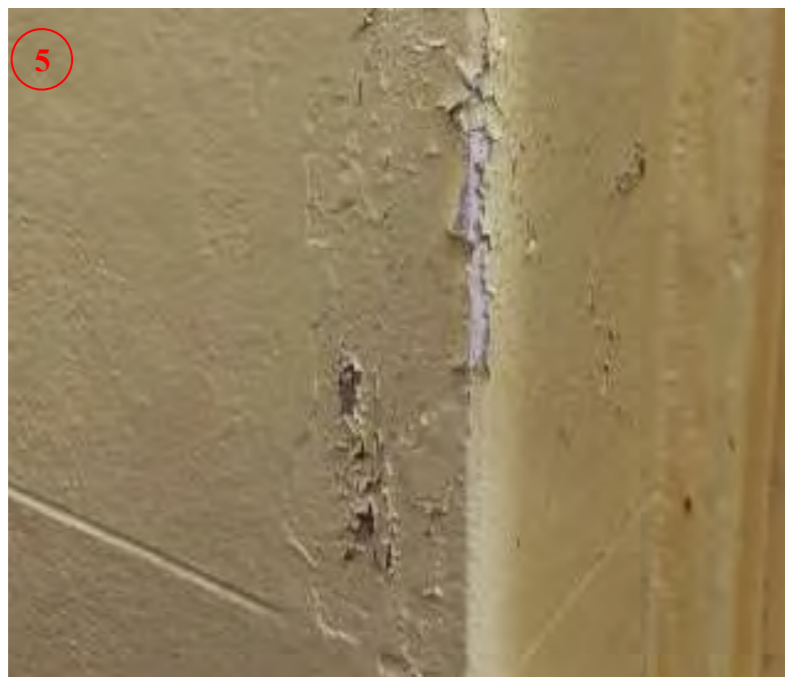
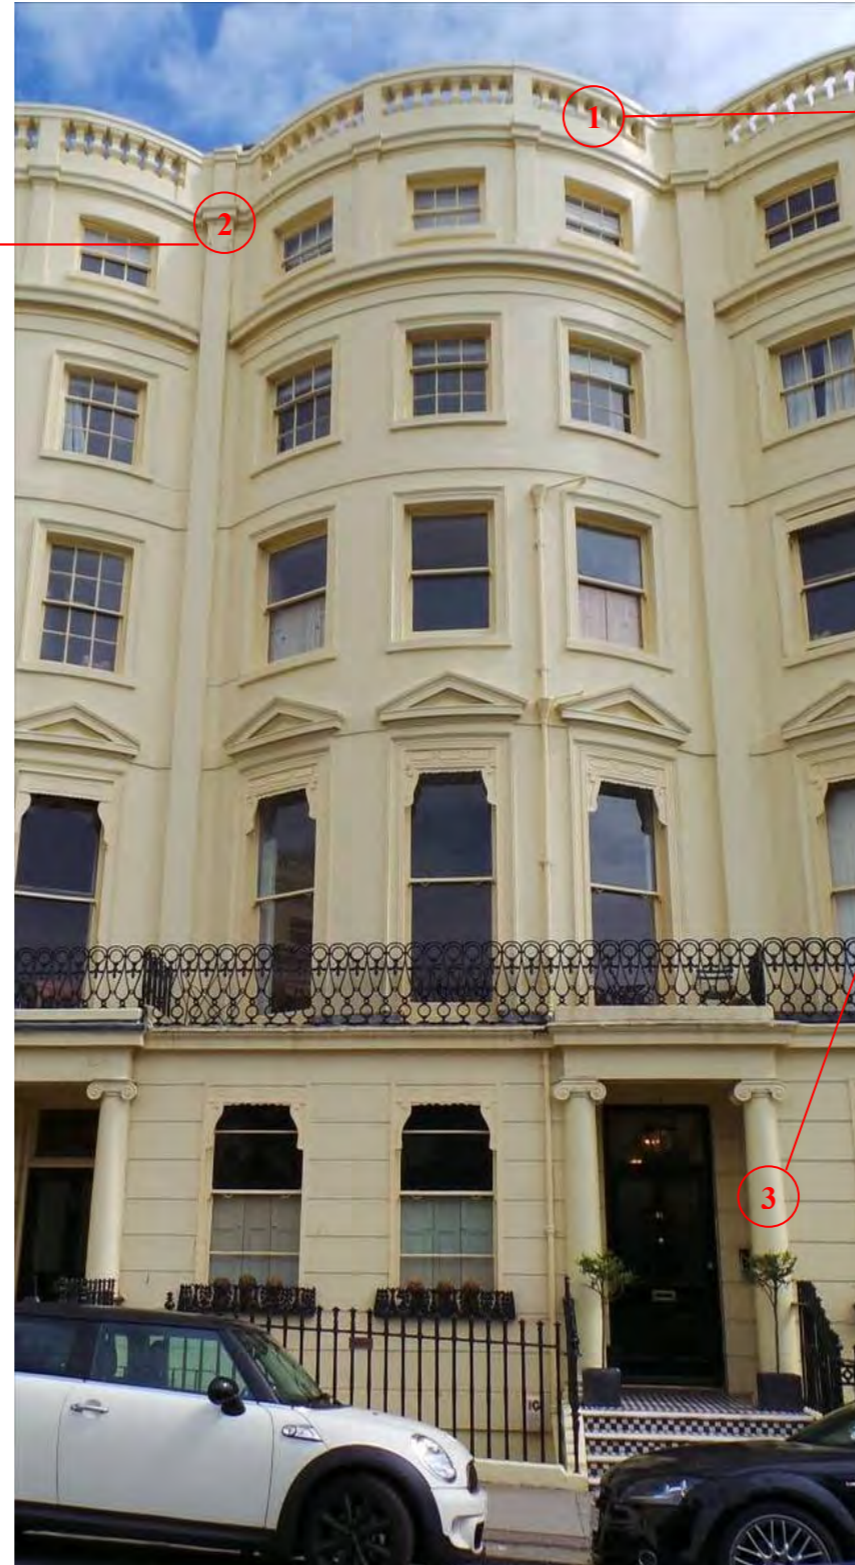
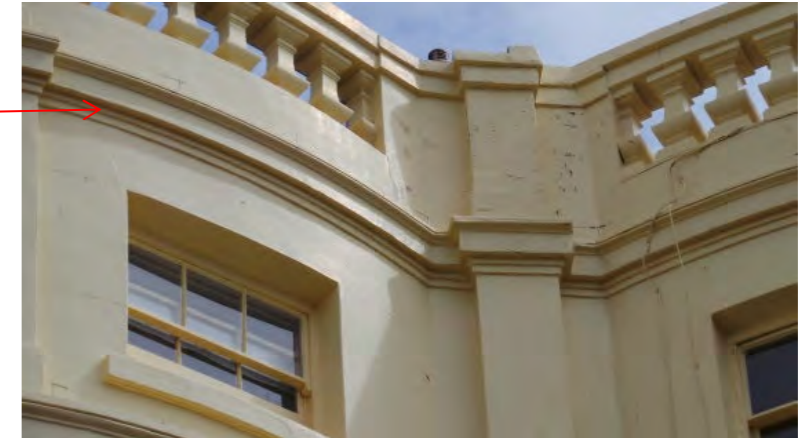
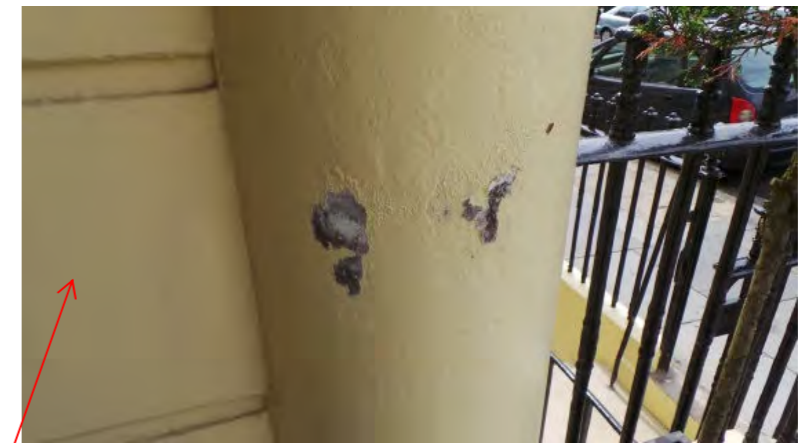
21 Brunswick Square

1. Localised paint flaking to balustraded parapet;
2. Localised paint flaking to downpipe-casing on the left;
3. Salt deliquescence and flaking paint on right hand entrance column;
4. Staining and paint flaking to cornice under balcony;
5. Salt deliquescence and flaking paint to basement walls;
6. Staining to plinth wall.

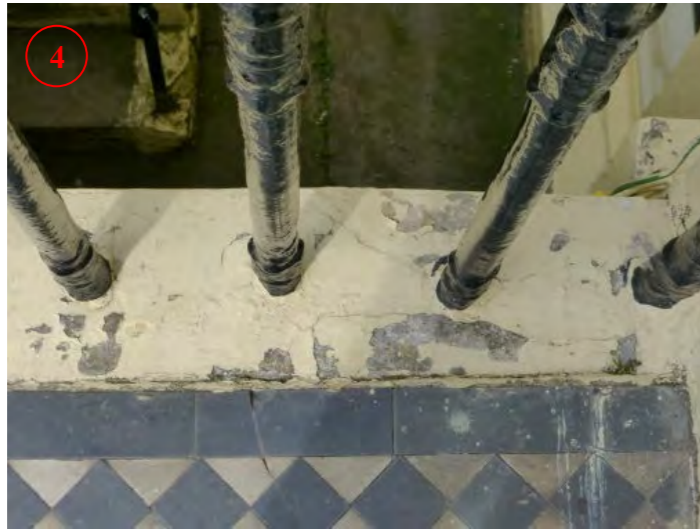
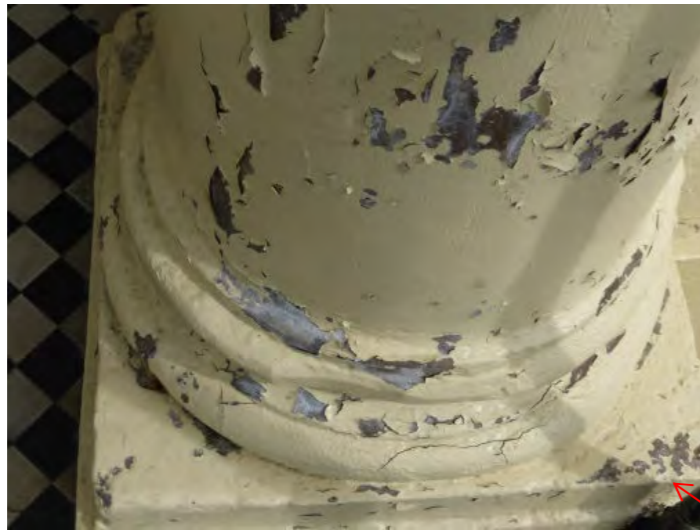
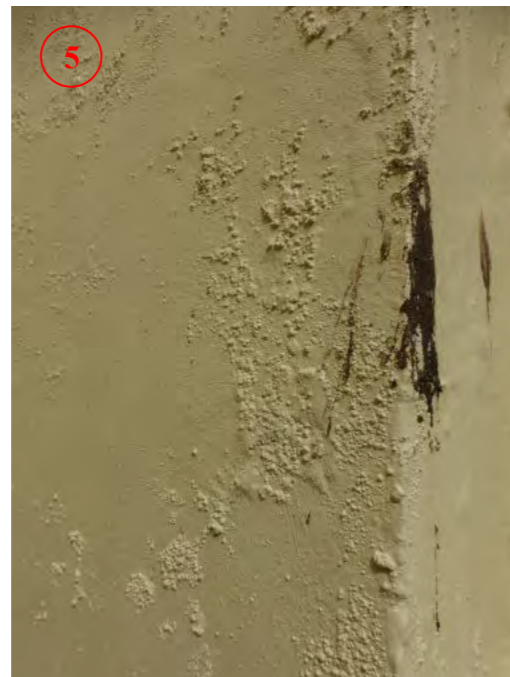
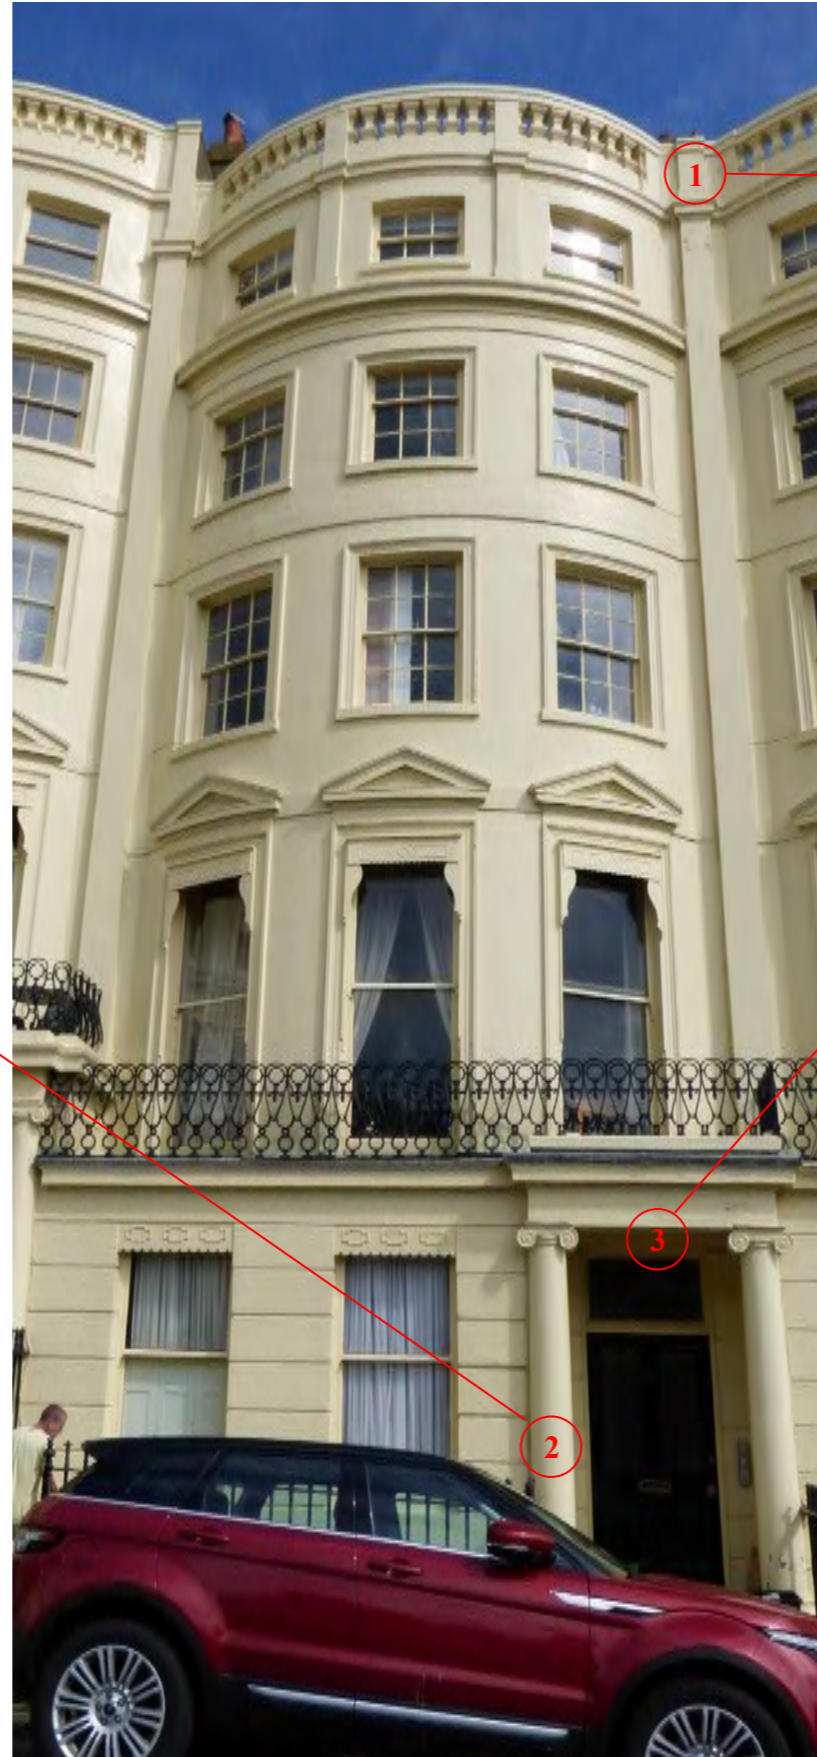
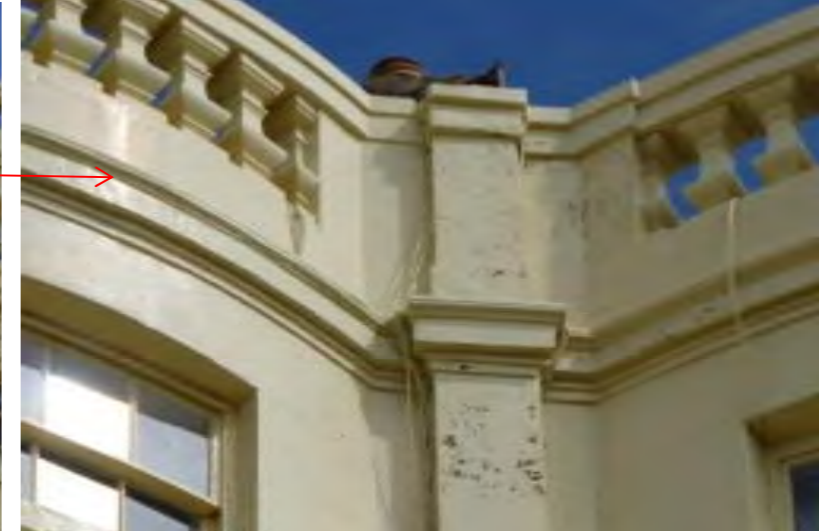
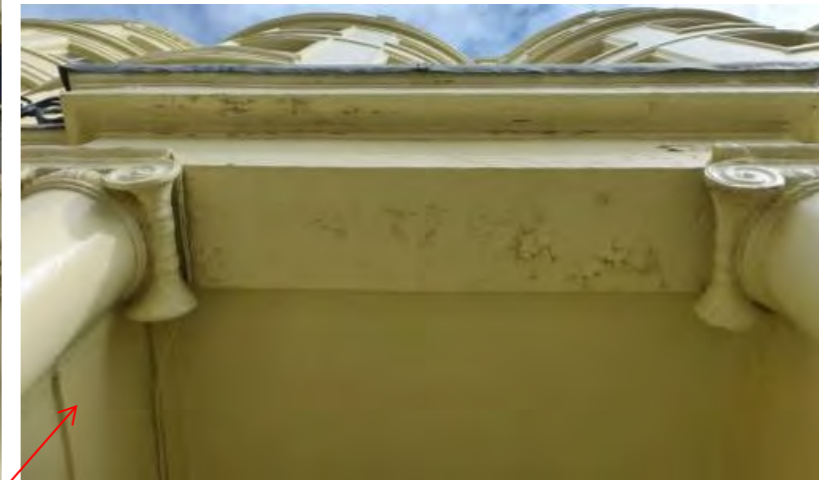
1. Localised paint flaking to right of balustraded parapet and to downpipe casing;
2. Extensive paint flaking to entrance columns;
3. Localised paint flaking to porch – underside and frieze;
4. Failing paint to plinth wall;
5. Salt deliquescence and flaking paint to basement walls.
