**Investigation of Paint Failure at
Brunswick Estate
Hove
Brighton**

August 2013

**BRUNSWICK ESTATE
HOVE**

The following document investigates the failure of the external paint-system at Brunswick Estate, Hove based on research carried out by Elizabeth Hirst and Rachel Morley of Hirst Conservation between August and November 2013. The work was commissioned by Brighton & Hove City Council.

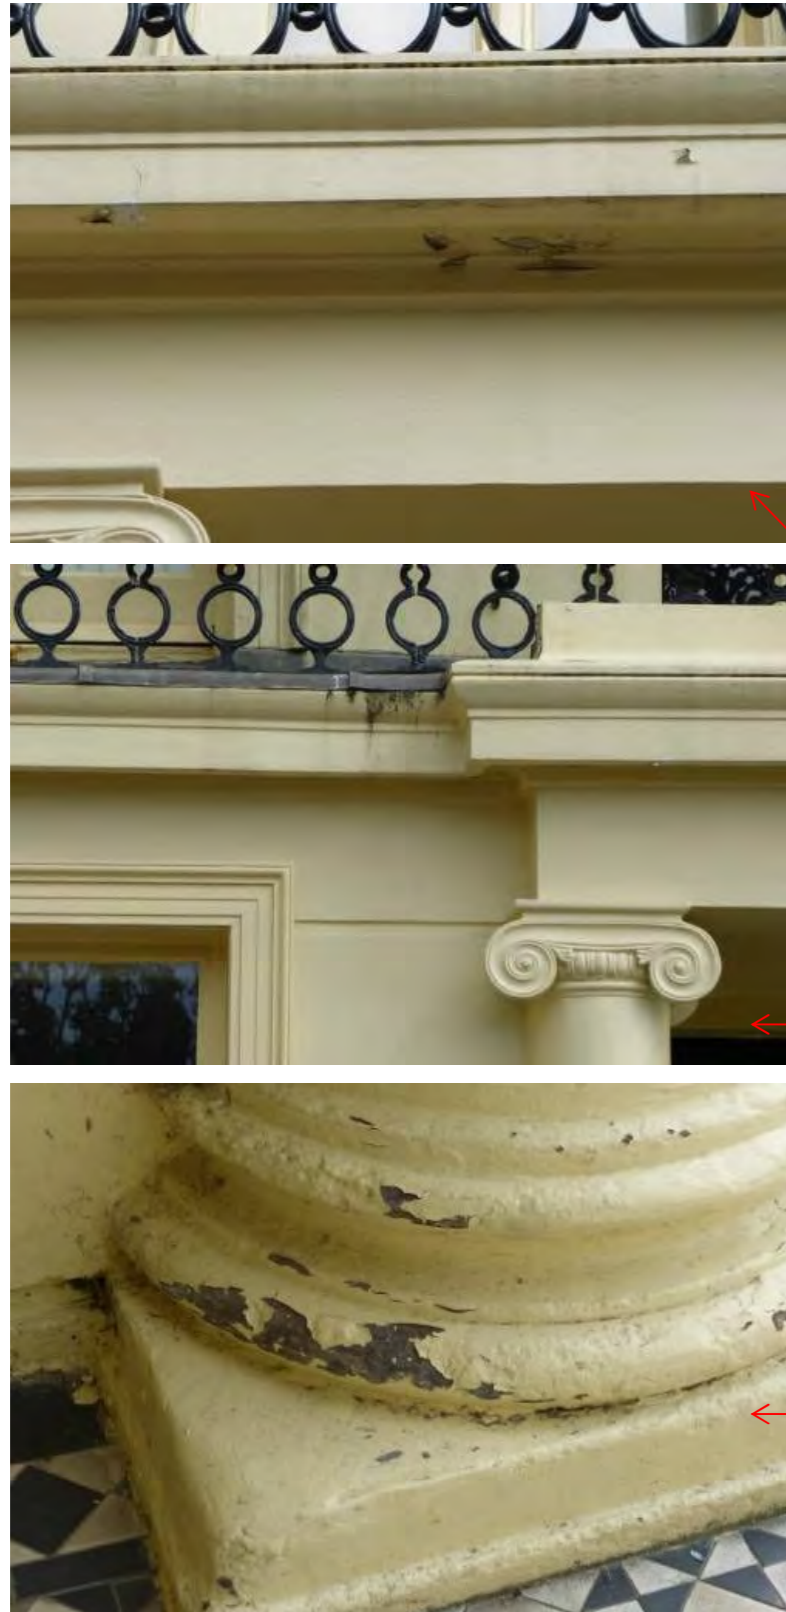
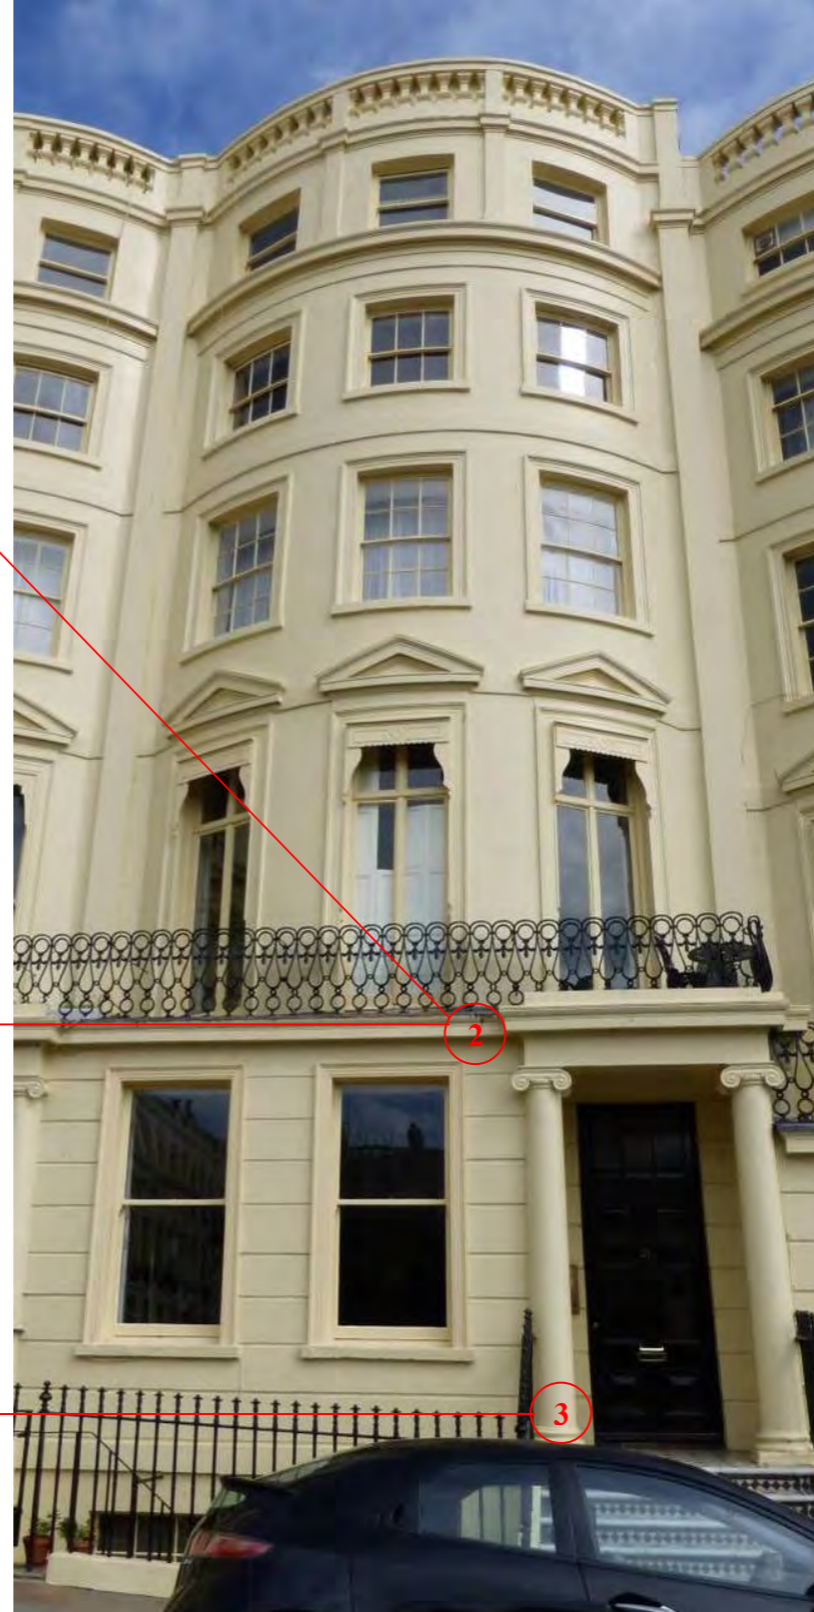
23 Brunswick Square

1. Generally the façade appears to be in reasonably good condition;
2. Staining and paint flaking the cornice beneath balcony;
3. Localised paint flaking to base of the column on right hand side of the doorway;
4. Localised paint flaking to underside of the porch.

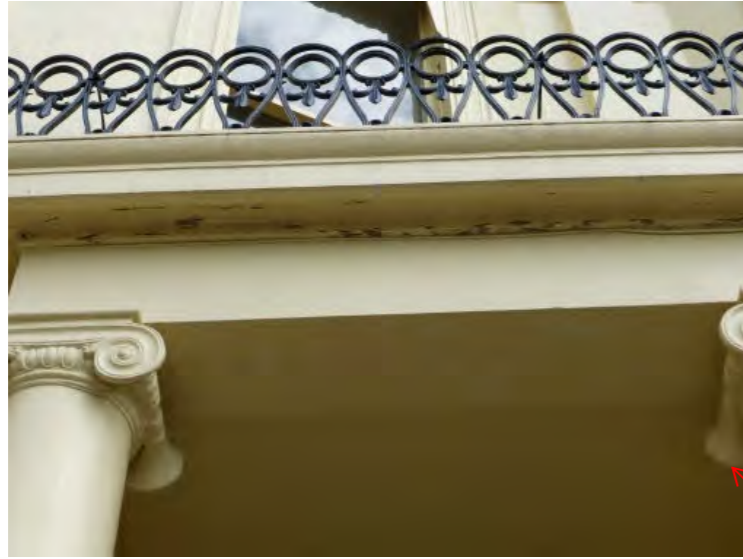
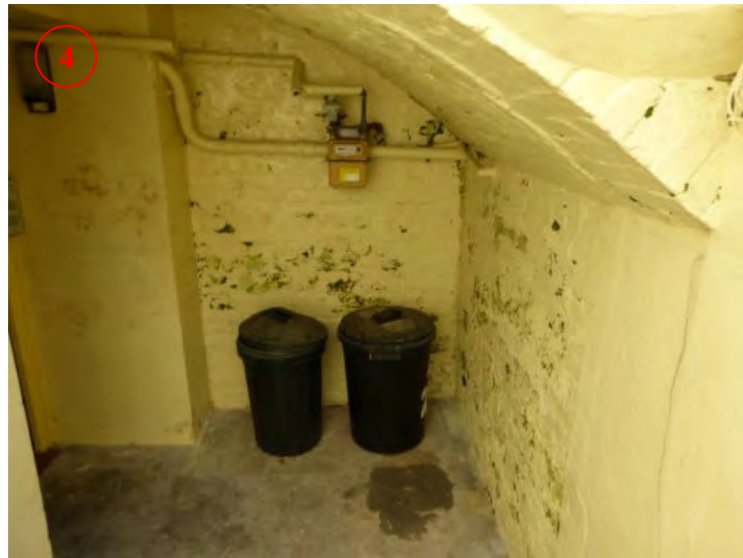
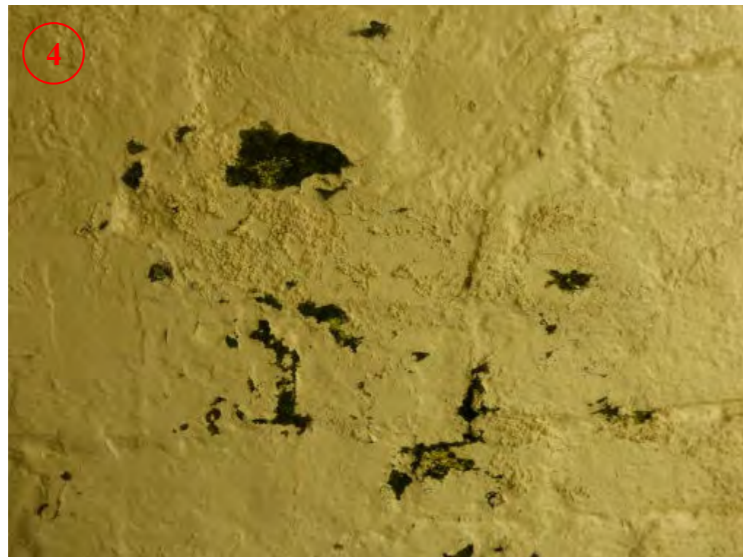
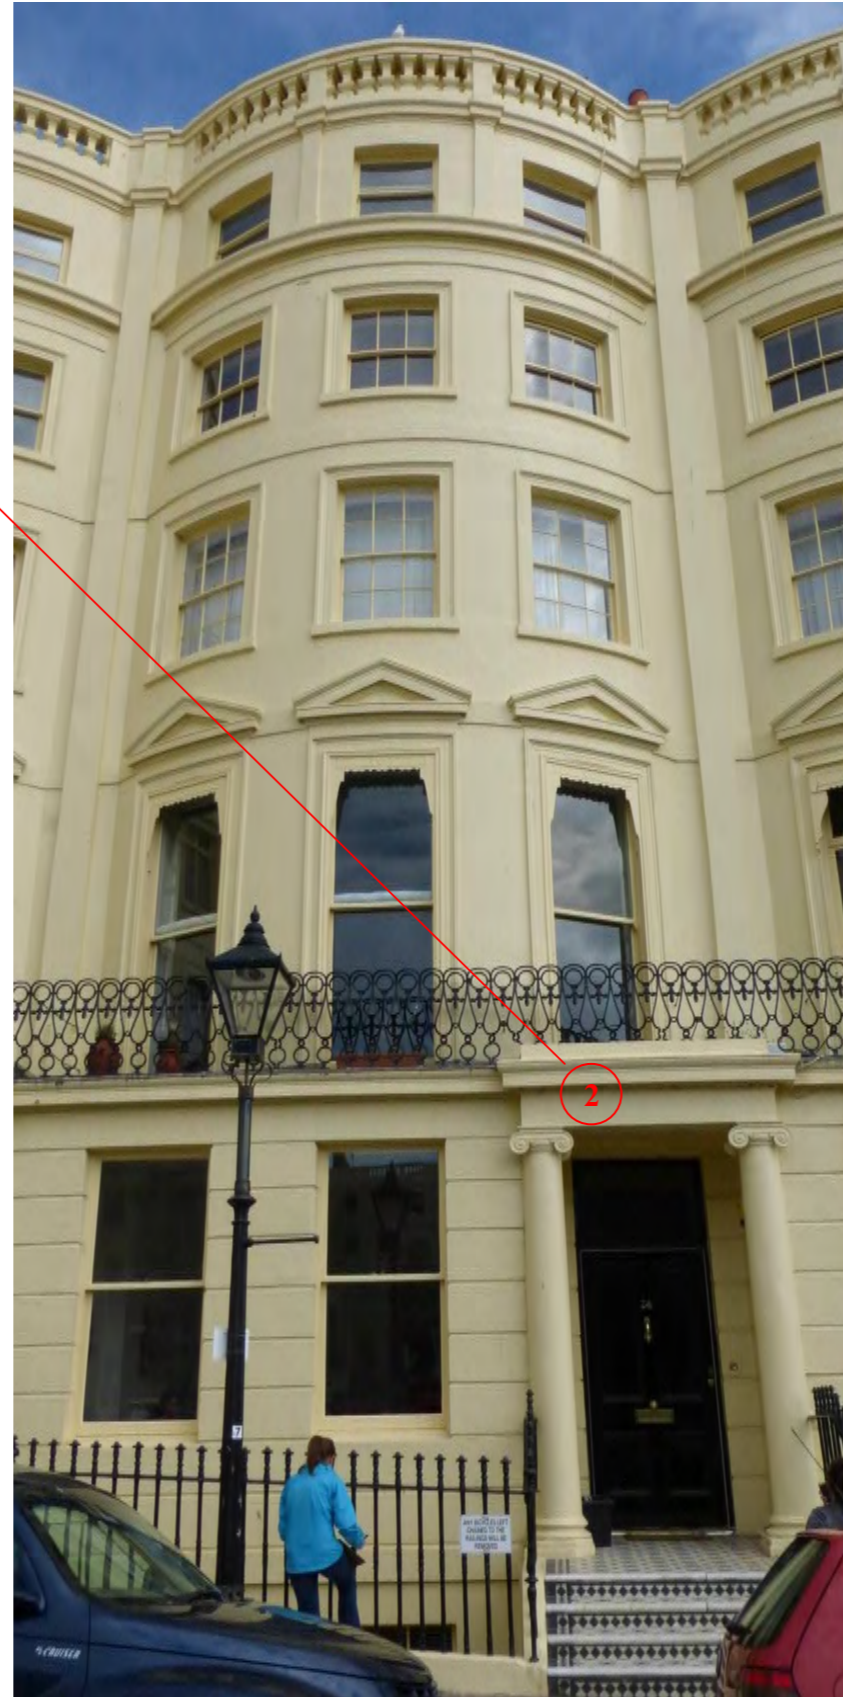
24 Brunswick Square

1. Generally the façade appears to be in reasonably good condition;
2. Staining and localised flaking to cornice beneath balcony. This is particularly prevalent on the on the left;
3. Localised paint flaking to underside of porch;
4. Biological growth (algae and mould) at basement level indicating moisture within the substrate.

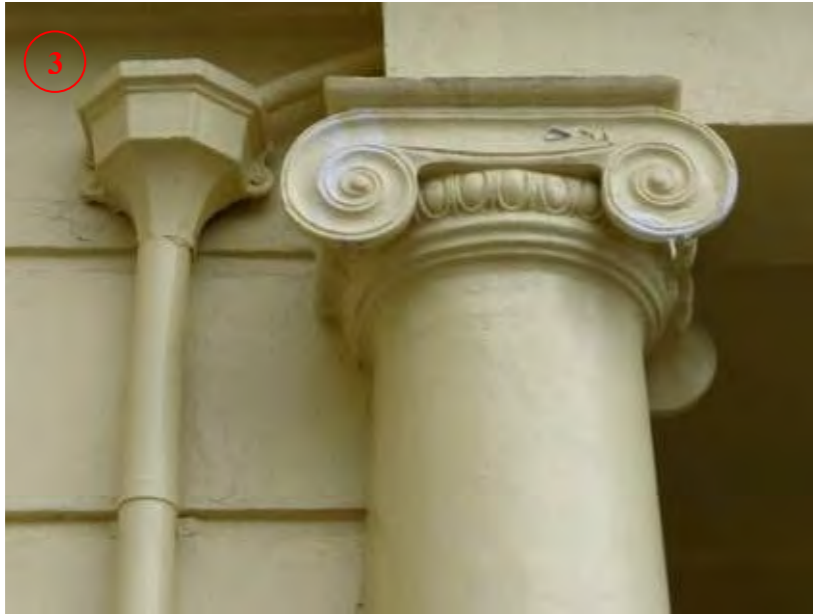
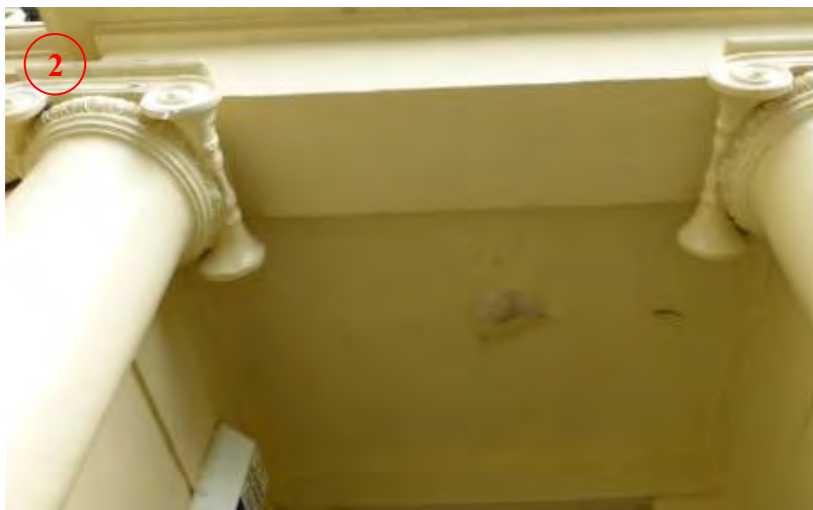
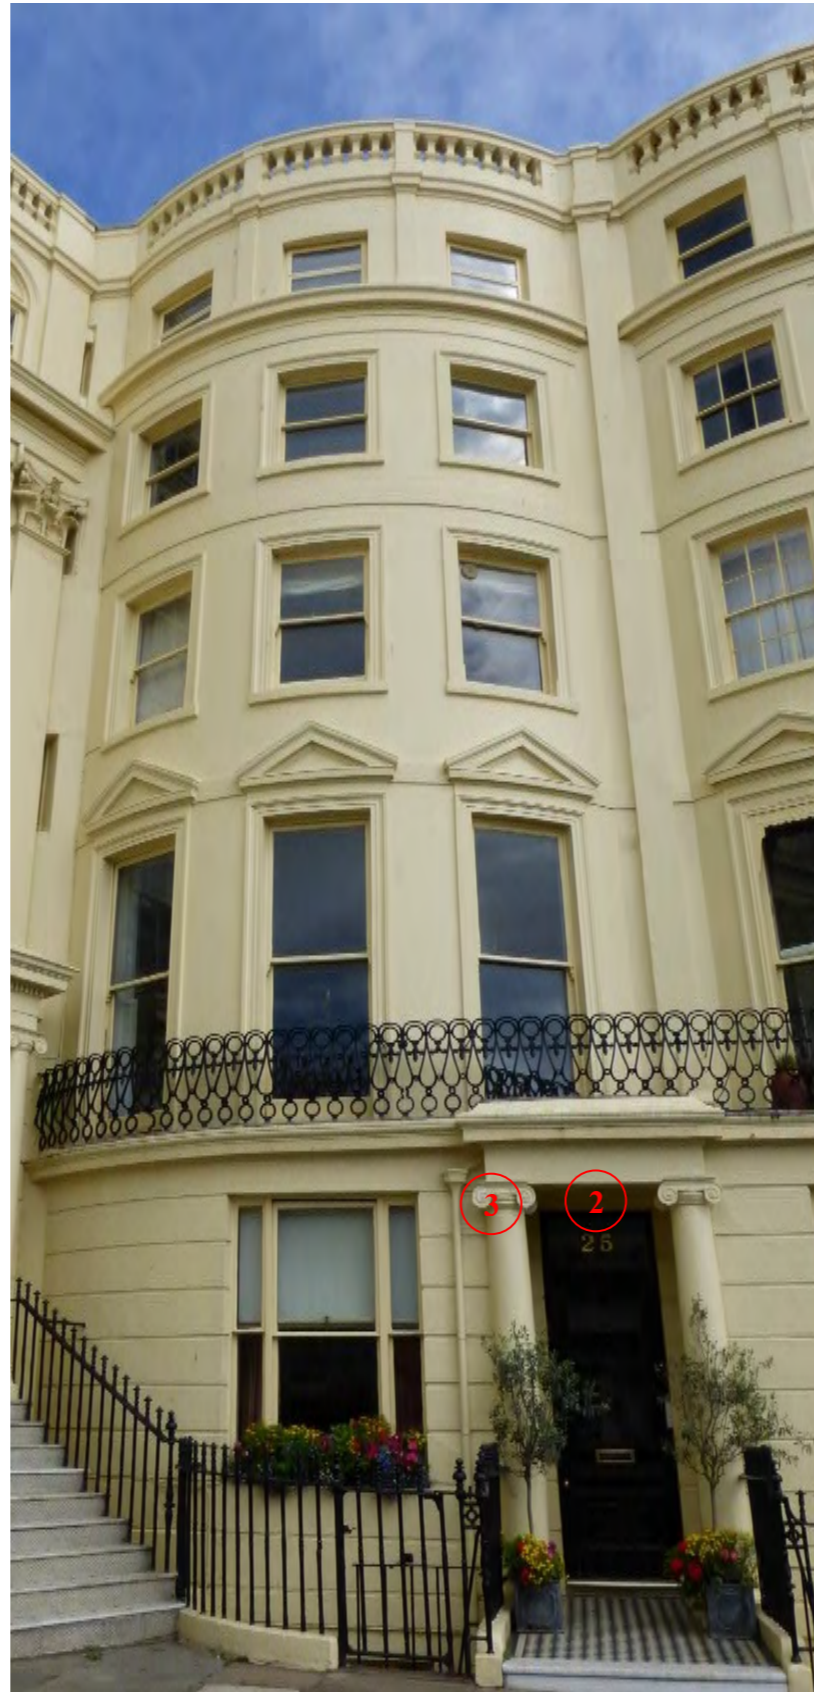
25 Brunswick Square

1. Generally the façade appears to be in good condition;
2. Localised paint flaking to underside of the porch;
3. Localised paint flaking to left hand side capital.

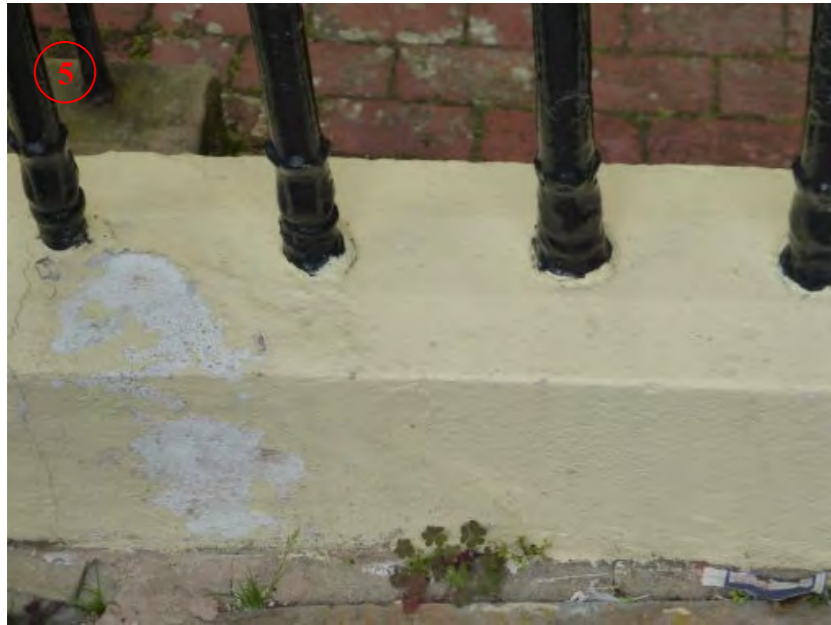
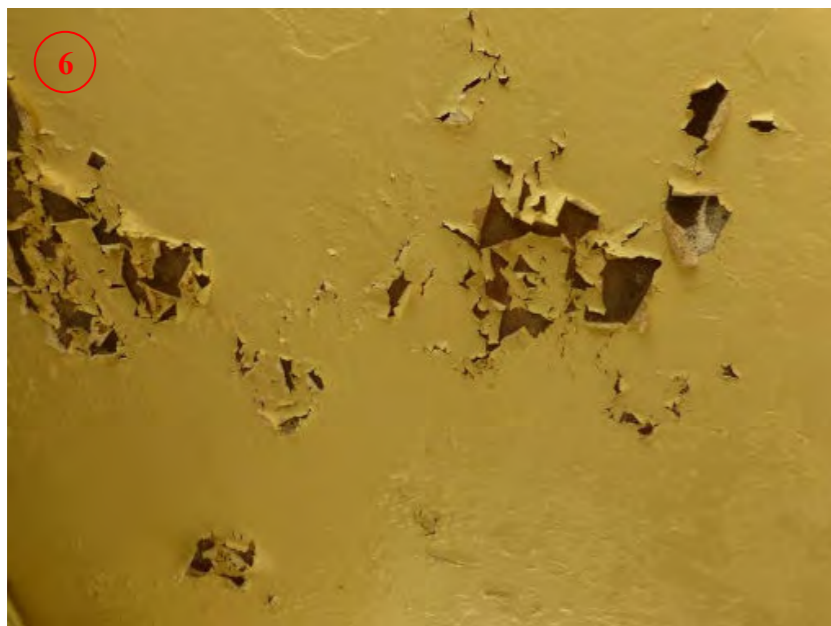
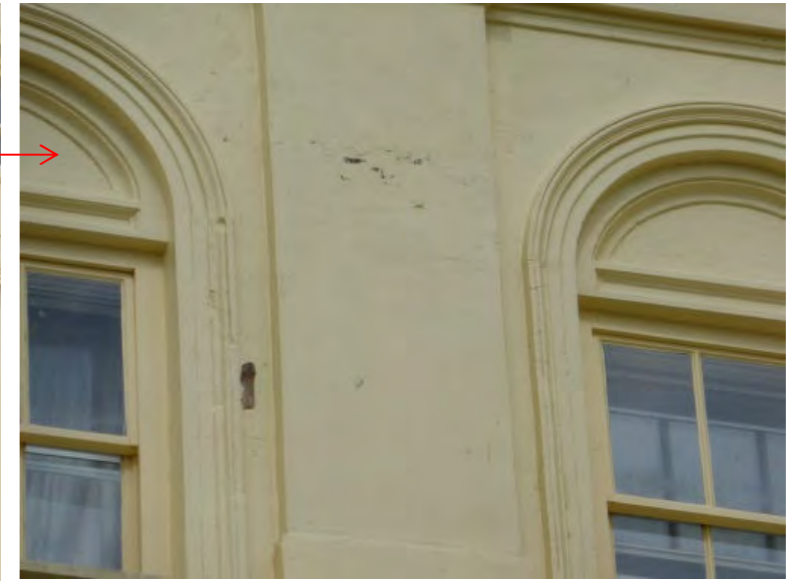
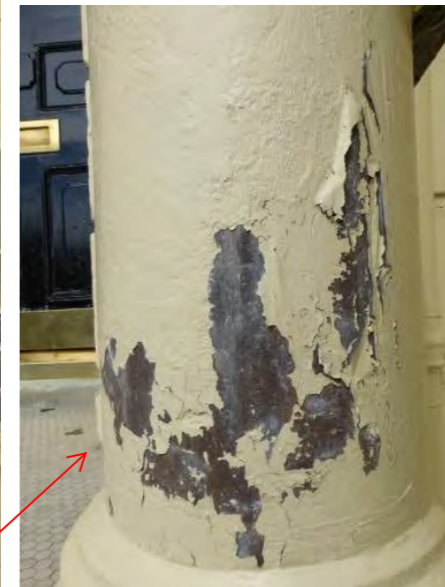
26 Brunswick Square

1. Generally the façade appears to be in reasonably good condition;
2. Localised paint flaking to right hand square pilaster at parapet level;
3. Localised paint flaking to underside of the porch. The paint has blistered and there is evidence of salt effervesce beneath the blistering paint;
4. Localised paint flaking on the column bases either side of doorway;
5. Failing paint to plinth wall;
6. Salt deliquescence and flaking paint to basement.

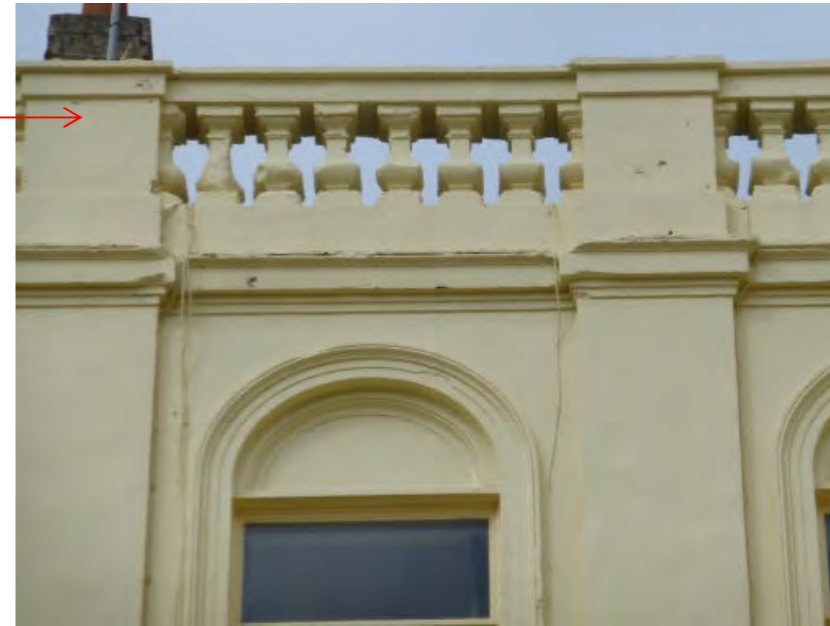
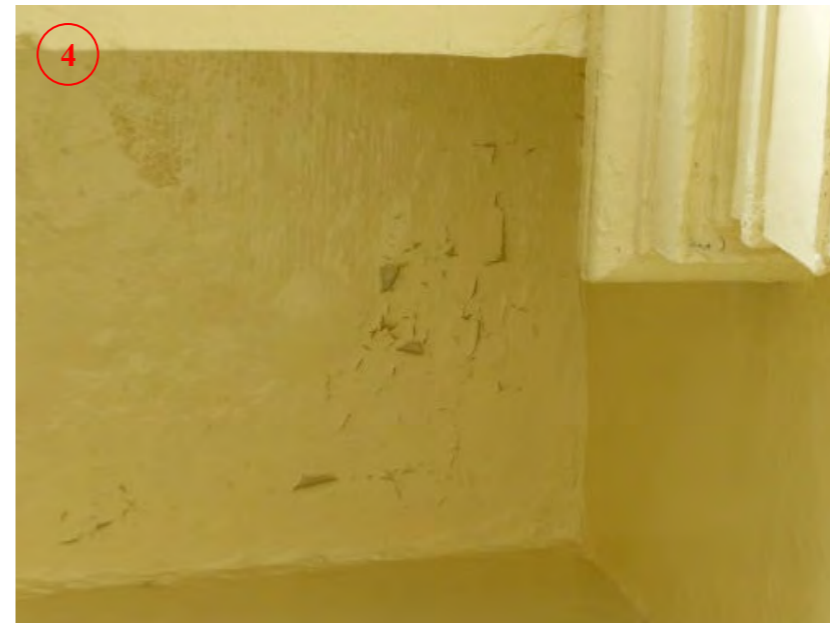
27 Brunswick Square

1. Generally the façade appears to be in reasonably good condition;
2. Localised paint flaking to cornice below balustraded parapet;
3. Staining to right hand side of the frieze beneath balcony;
4. Localised paint flaking to underside of the porch;
5. Failing paint to plinth wall.

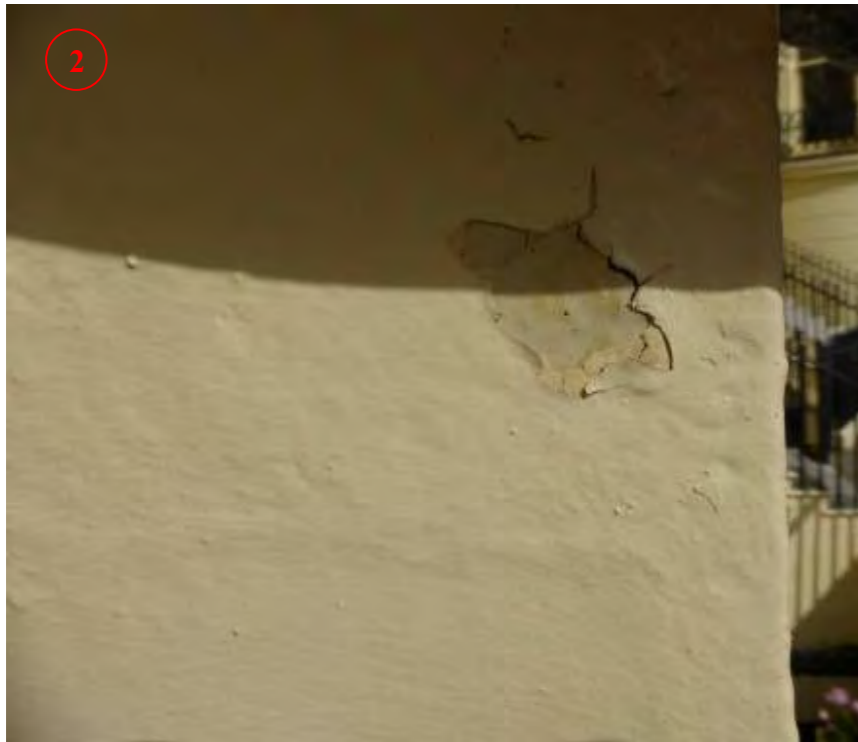
28 Brunswick Square

1. Generally the façade appears to be in reasonably good condition;
2. Localised paint flaking to square column to the right hand side of doorway.

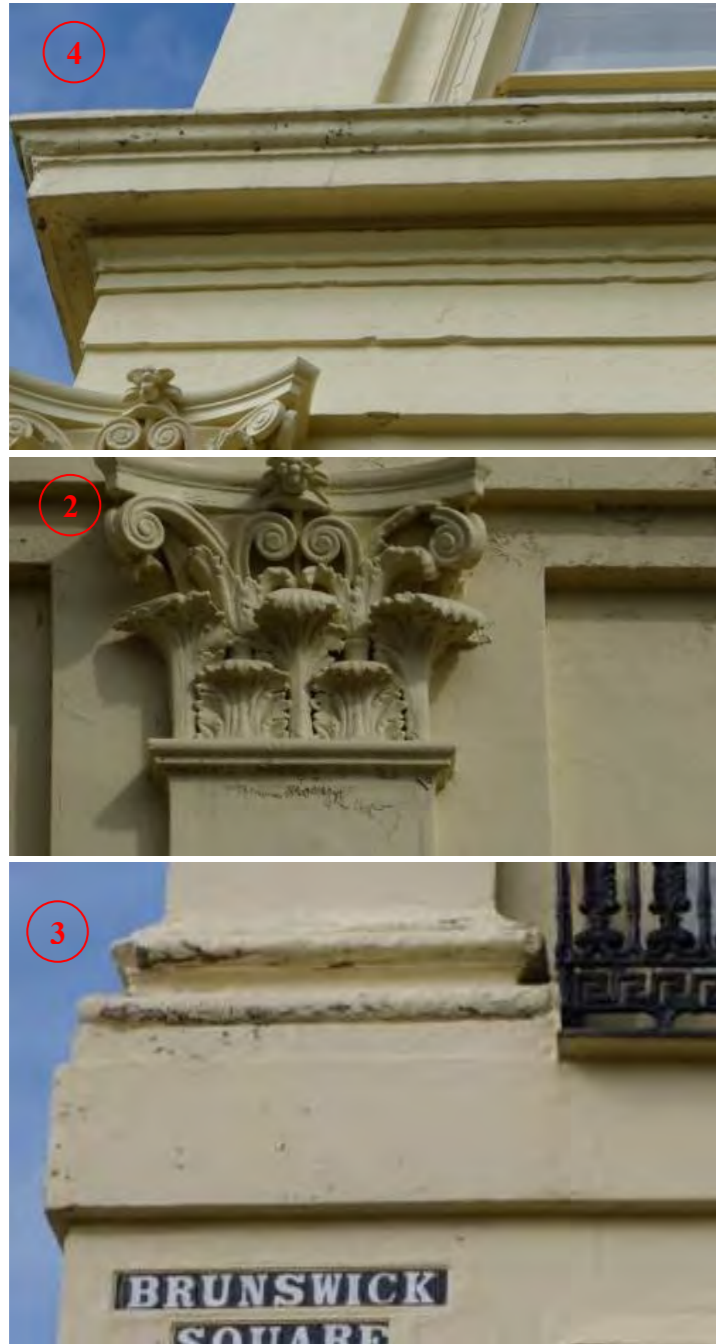
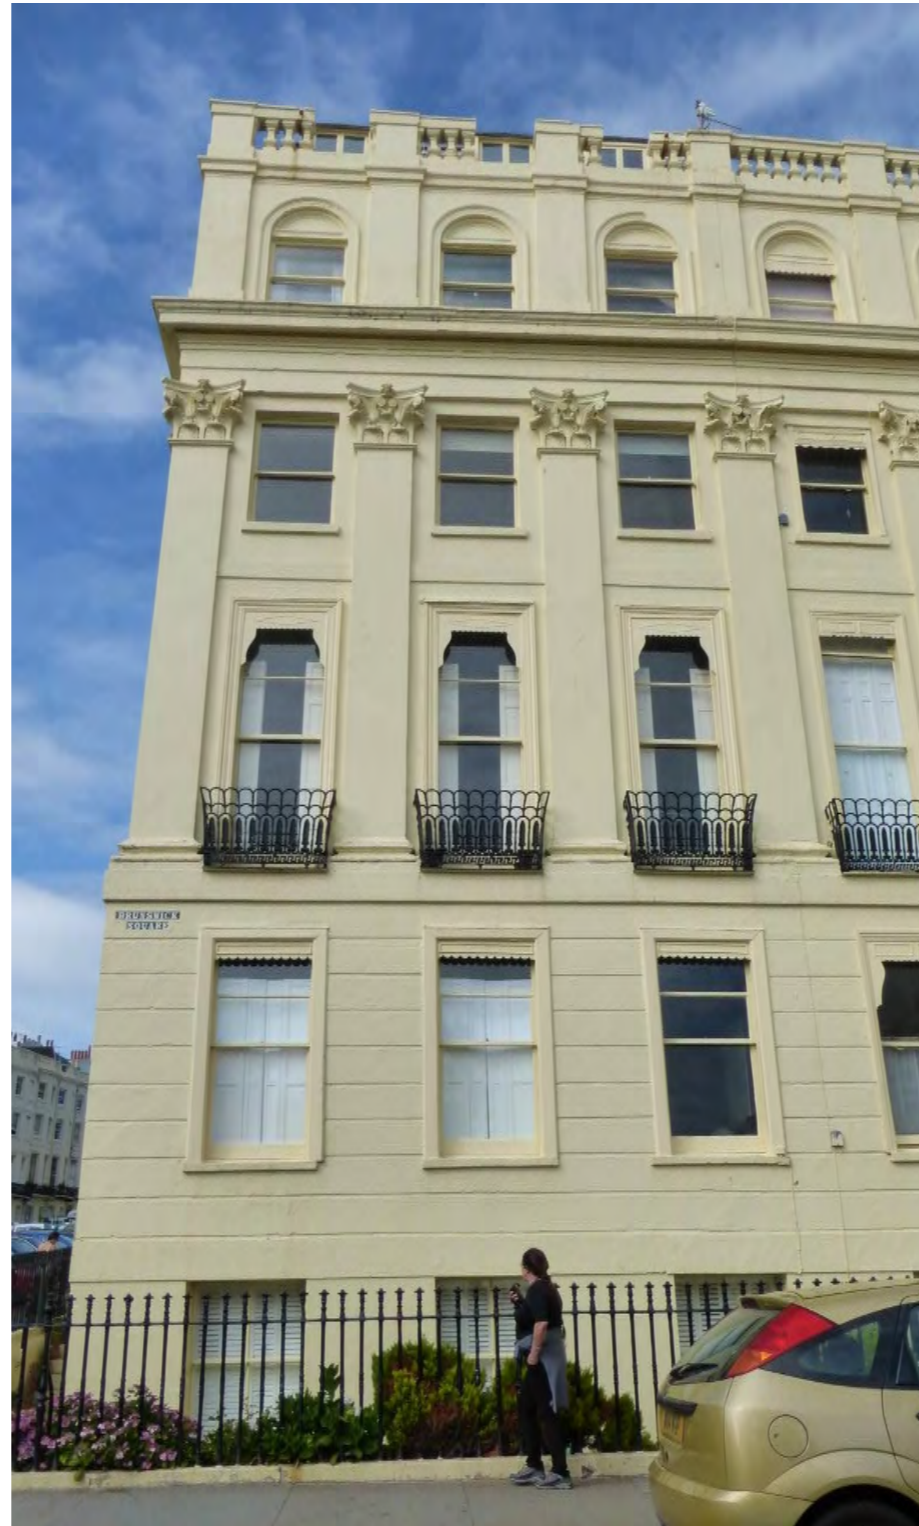
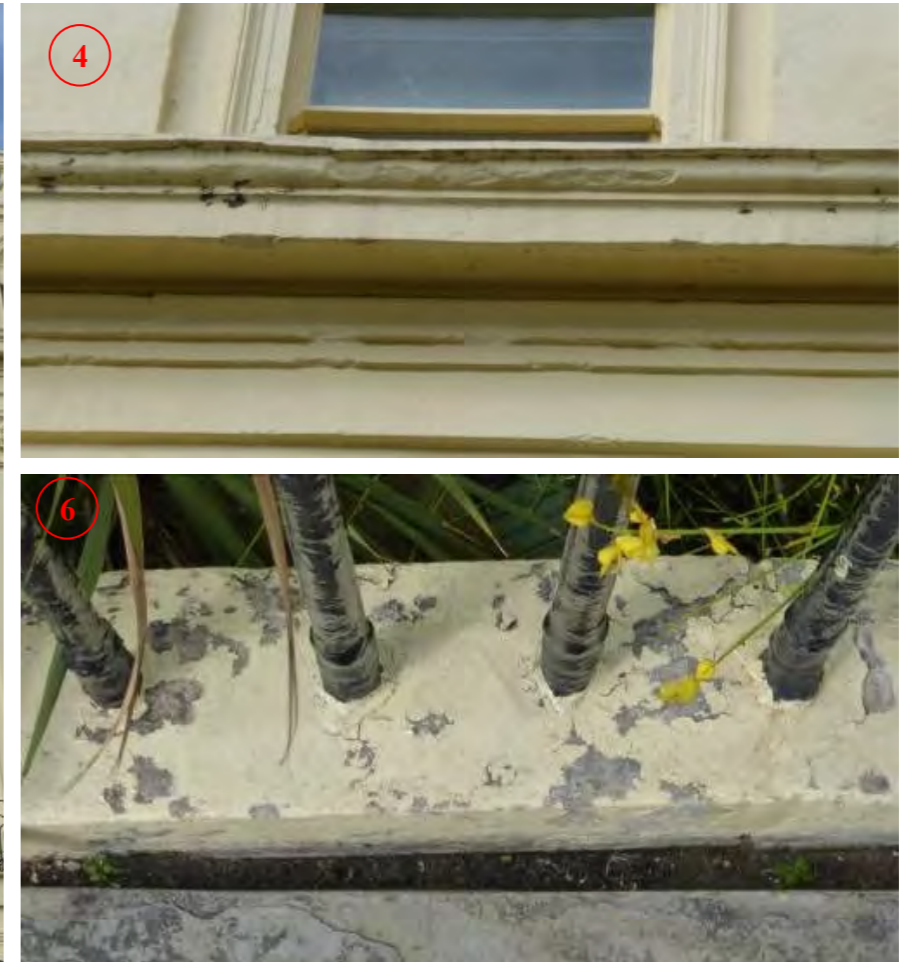
29 Brunswick Square

1. Localised ferrous staining to top-level cornice;
2. Localised paint flaking to columns (beneath the capitals) flanking third floor windows
3. Localised paint flaking to base of columns flanking balconies at second floor level;
4. Localised paint flaking and damage to cornice beneath third floor level;
5. Localised paint flaking at basement level particularly in areas where render is smooth;
6. Staining and paint flaking to plinth wall;
7. Generally painted timber work appears in reasonably good condition.

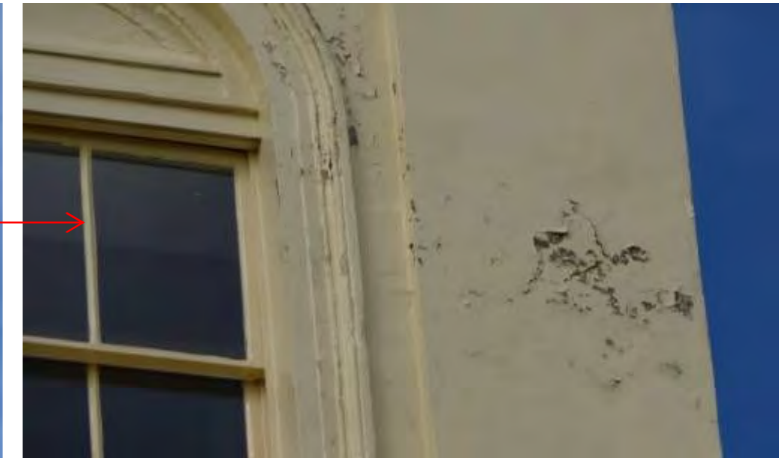
30 Brunswick Square

1. Localised paint flaking to cornice beneath parapet;
2. Localised paint flaking to cornice below the fourth floor;
3. Localised paint flaking to pilasters either side of the fourth floor windows;
4. Localised paint flaking to flat band beneath the third floor windows;
5. Localised paint flaking to bases of the square pilasters (second floor level);
6. Localised salt deliquescence and paint flaking to rusticated wall between the first floor and basement level;
7. Failing paint to plinth wall.

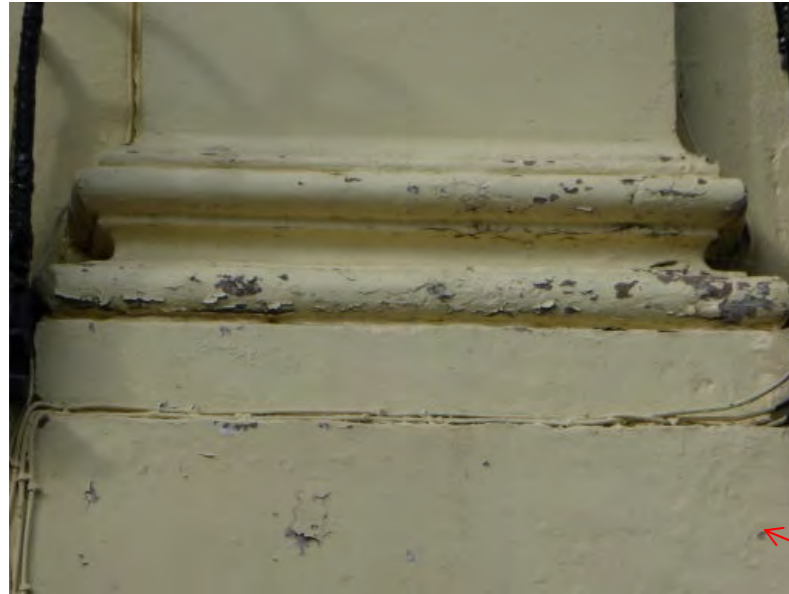
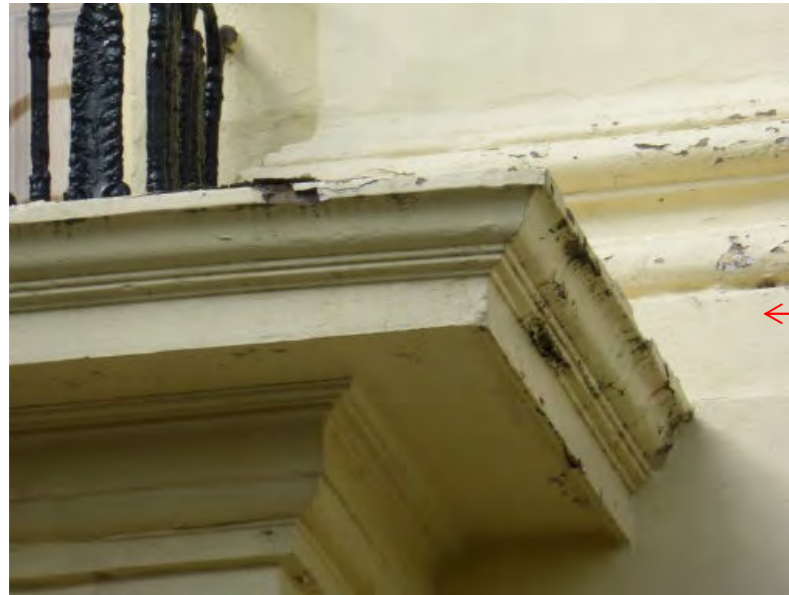
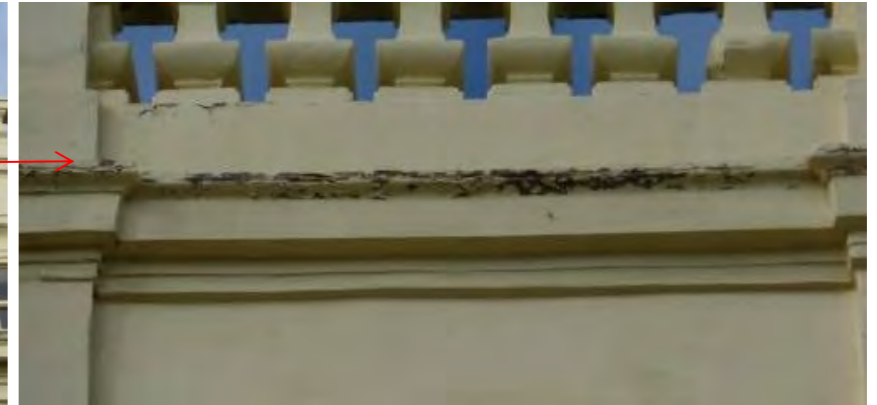
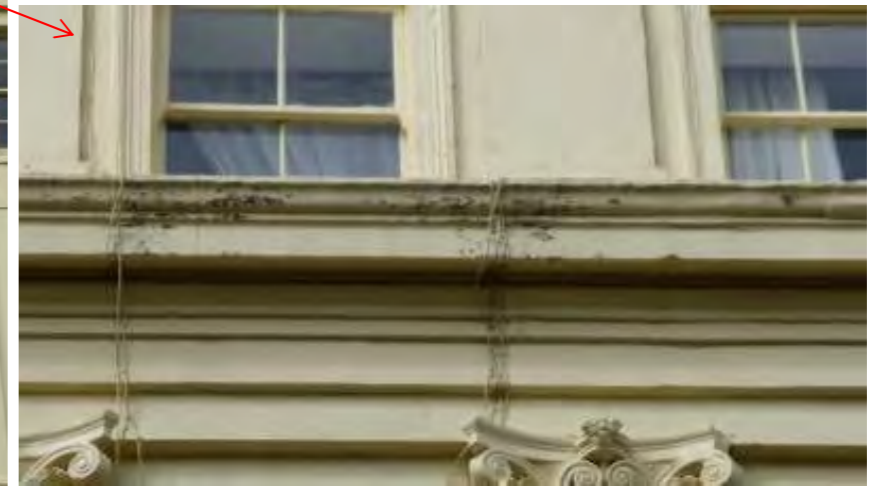
31 Brunswick Square

1. Extensive paint flaking to cornice below parapet;
2. Extensive paint flaking to cornice below the fourth floor;
3. Localised paint flaking to bases of the square pilasters (second floor level) flanking the balconies;
4. Localised paint flaking to cornice of porch;
5. Localised staining on the frieze above the doorway (right hand side);
6. Localised paint flaking to bases of entrance columns.

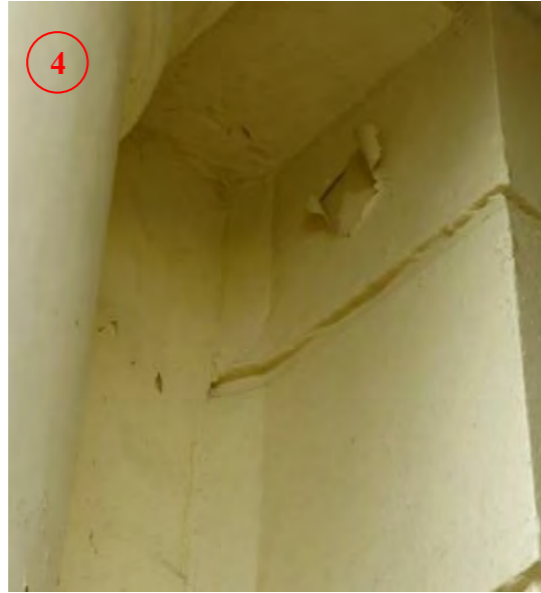
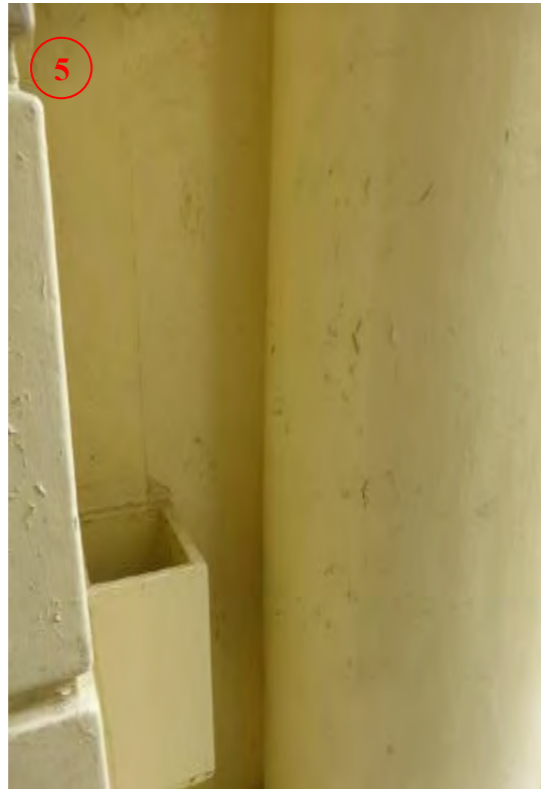
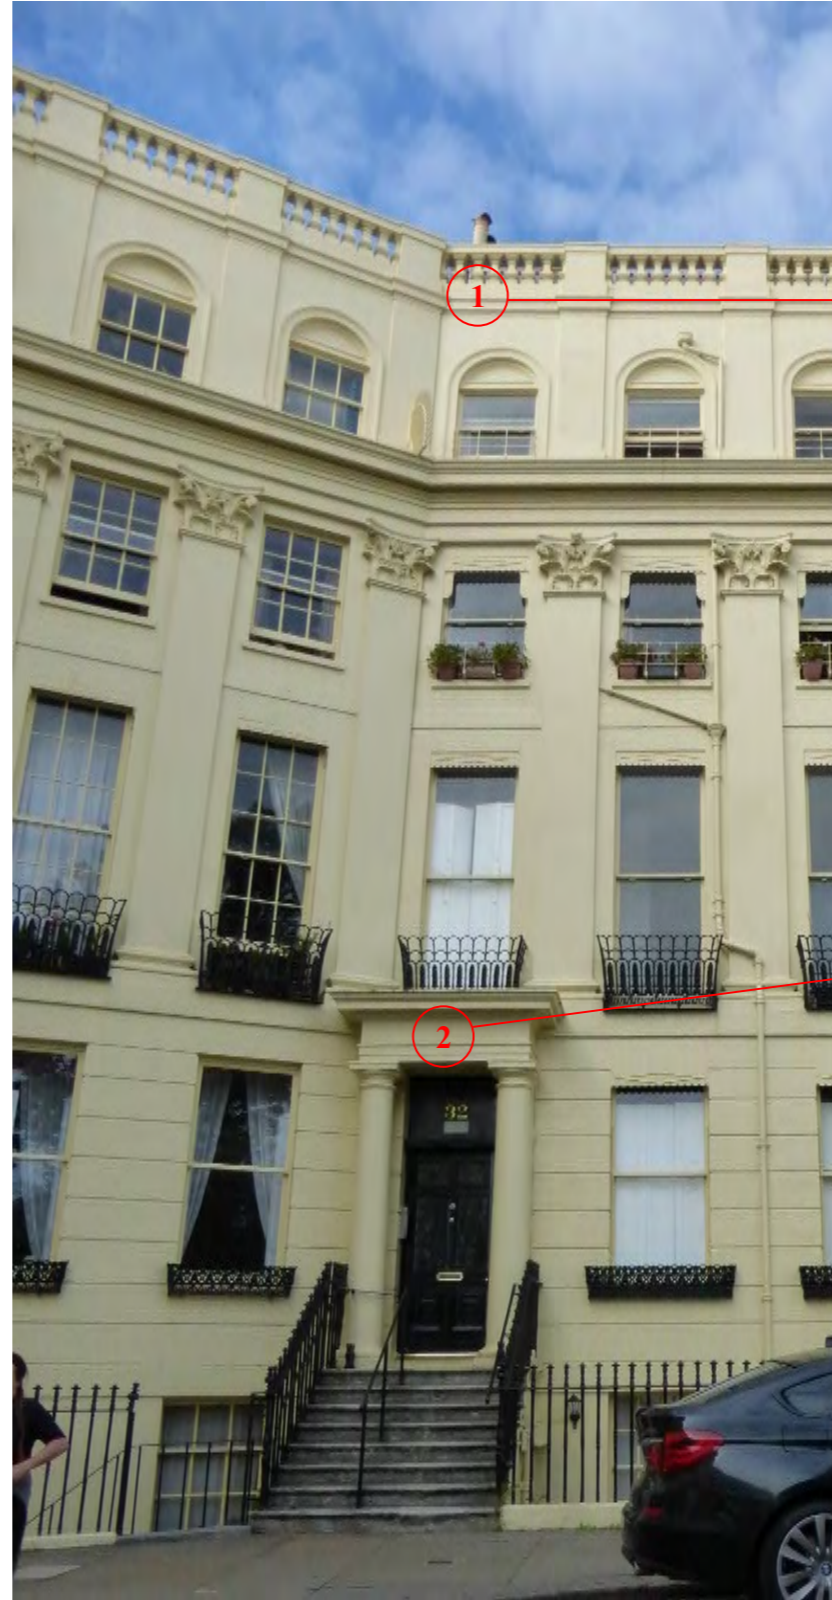
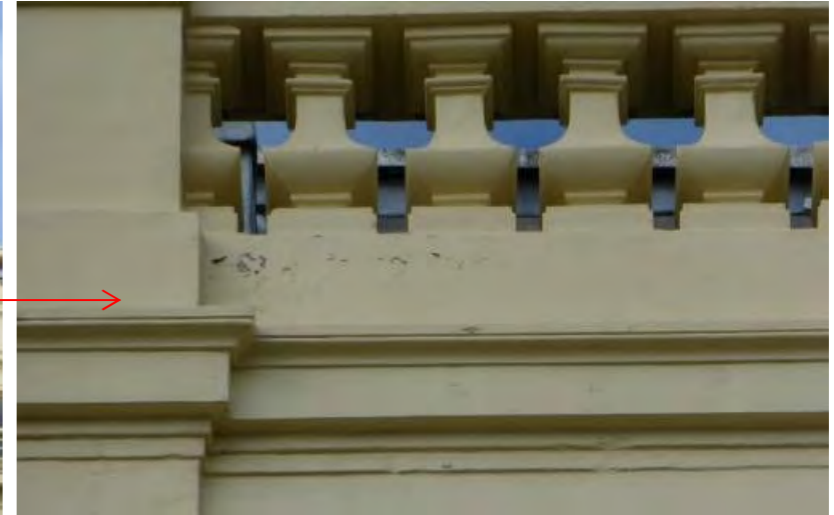
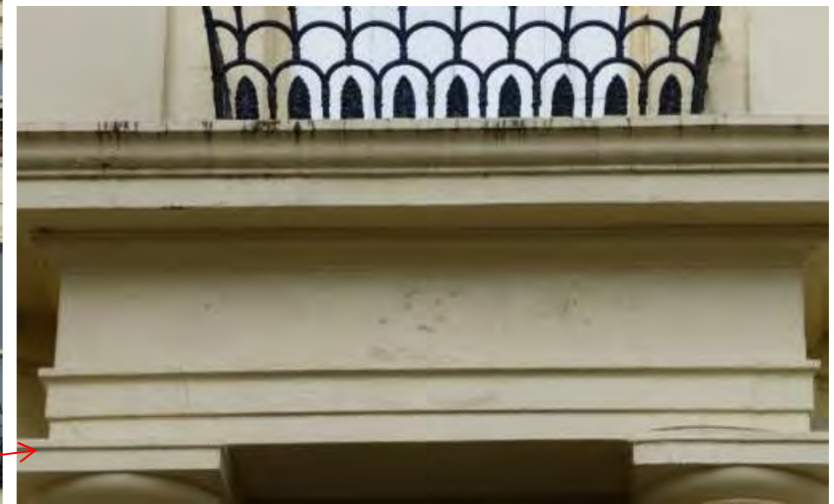
32 Brunswick Square

1. Localised paint flaking to cornice below parapet level;
2. Staining on the cornice above the porch;
3. Localised paint flaking to flat frieze between entrance columns;
4. Localised paint flaking to upper left hand corner inside the porch;
5. Localised salt deliquescence and paint flaking to right hand column flanking the doorway.

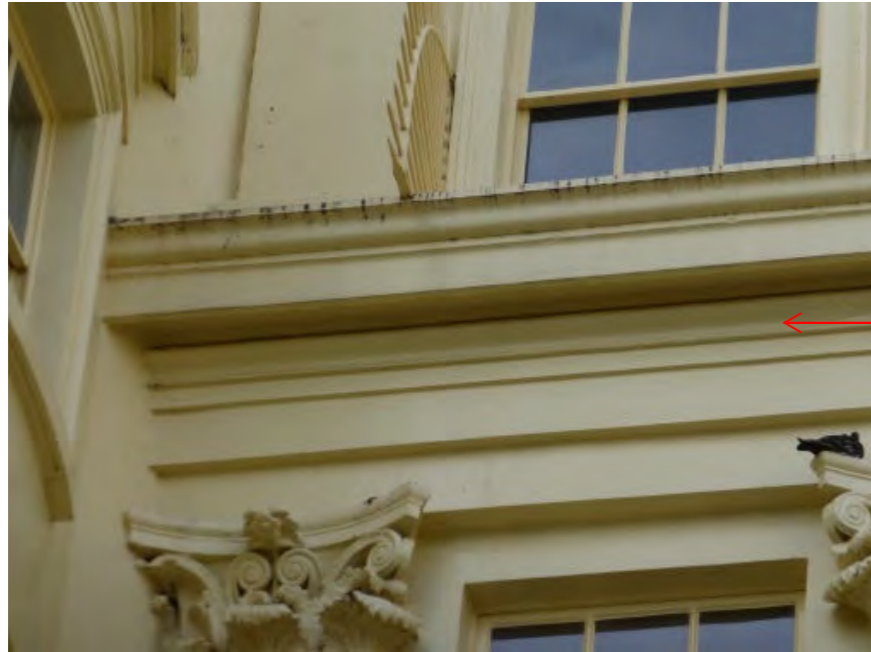
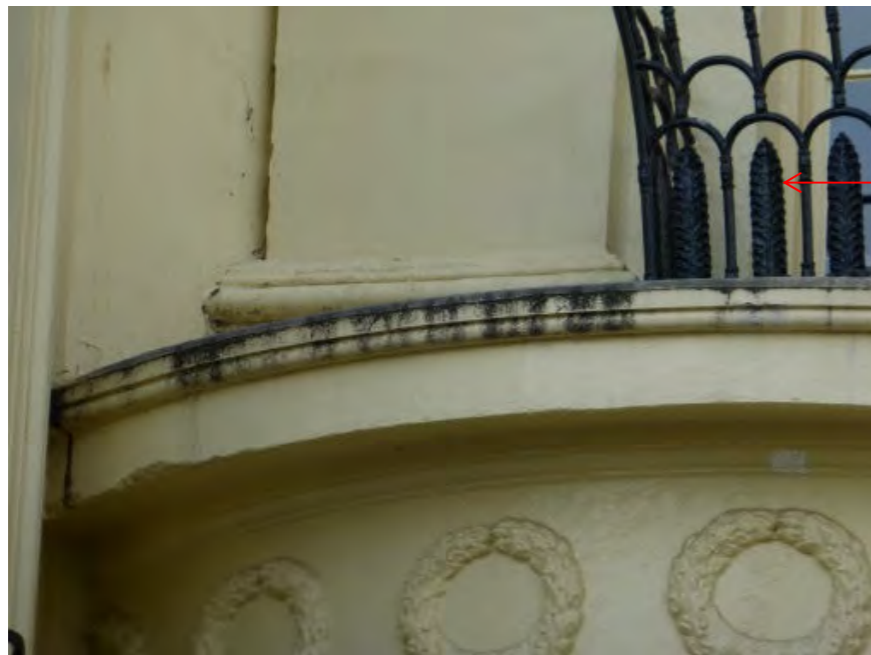
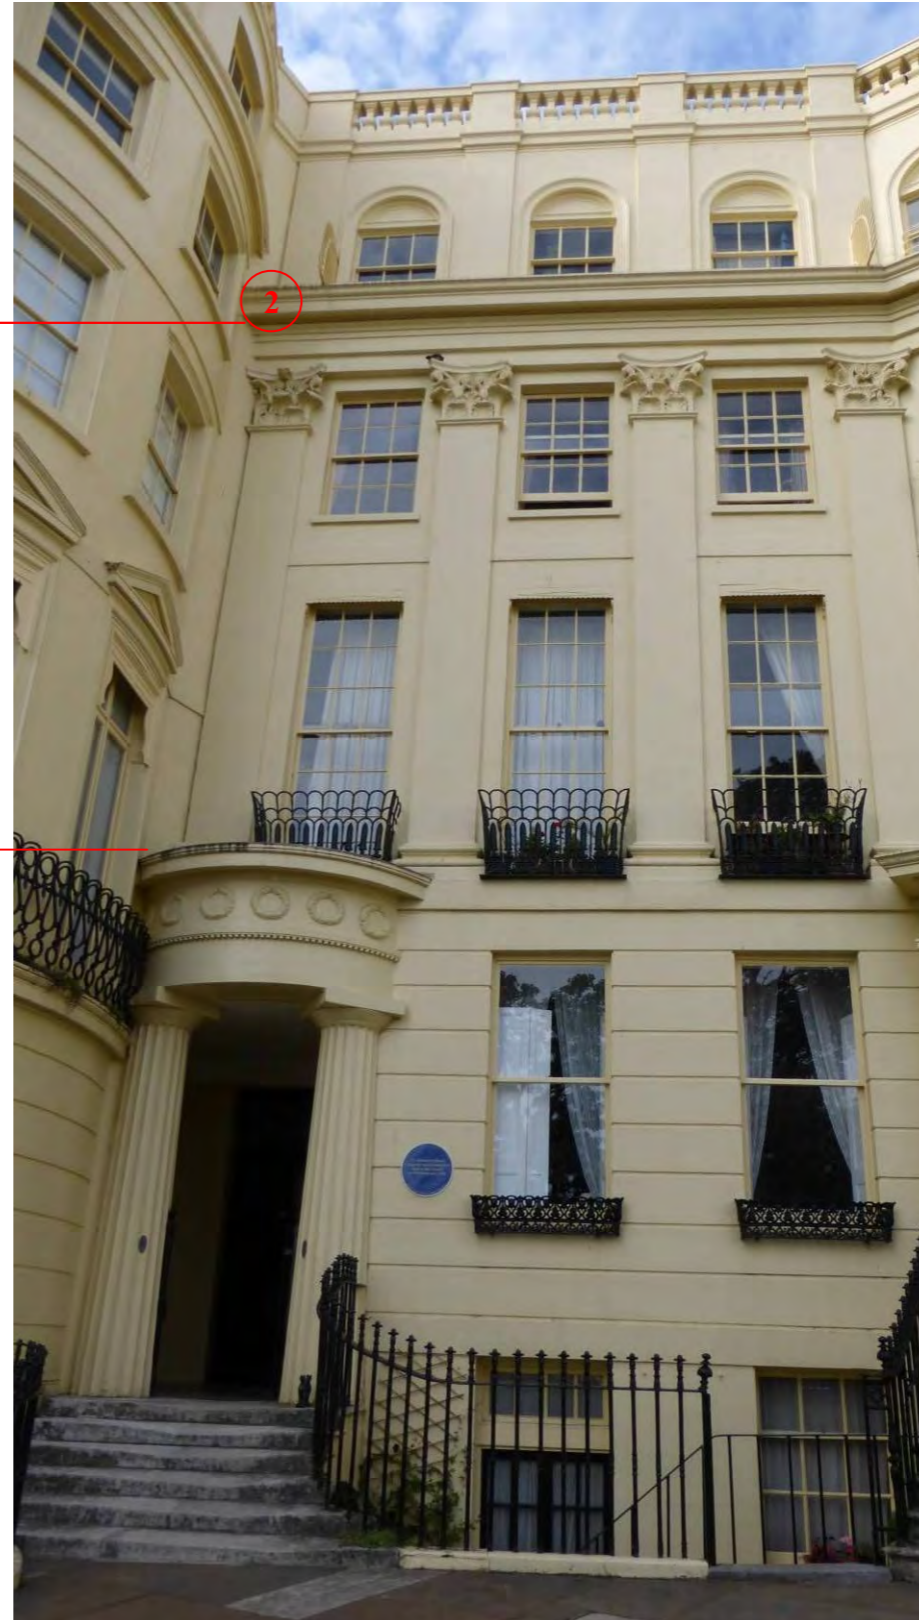
33 Brunswick Square

1. Generally the façade appears to be in reasonably good condition.
2. Staining to left hand side of the cornice below the third floor;
3. Staining to cornice above porch;
4. Failing paint to plinth wall.
