**Investigation of Paint Failure at
Brunswick Estate
Hove
Brighton**

August 2013

**BRUNSWICK ESTATE
HOVE**

The following document investigates the failure of the external paint-system at Brunswick Estate, Hove based on research carried out by Elizabeth Hirst and Rachel Morley of Hirst Conservation between August and November 2013. The work was commissioned by Brighton & Hove City Council.

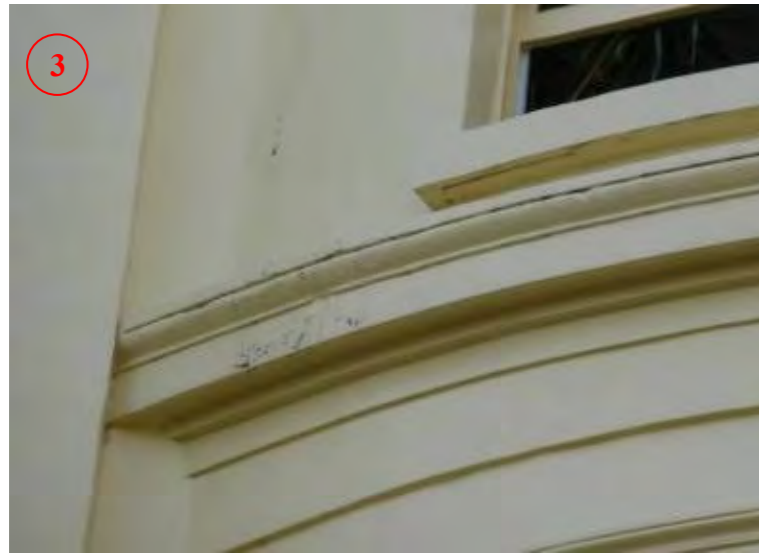
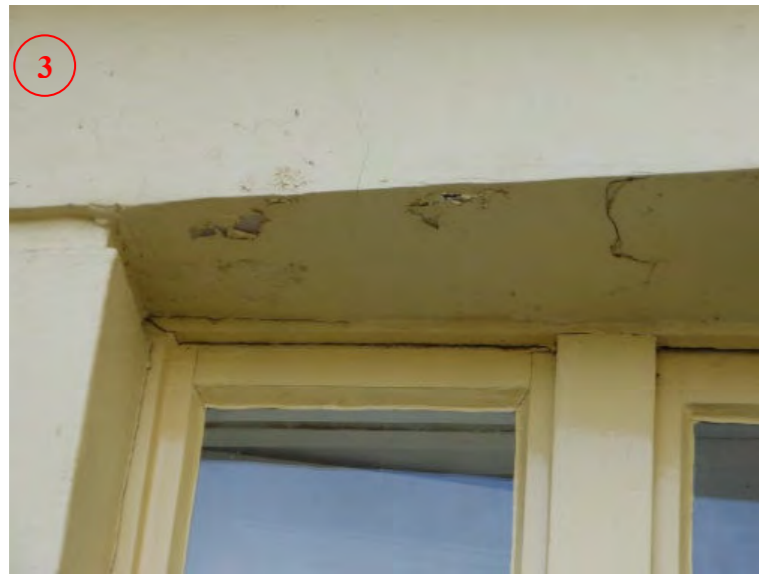
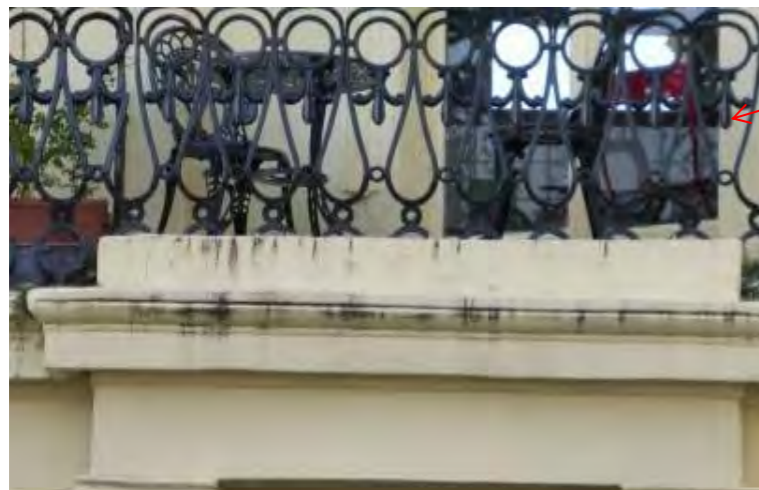
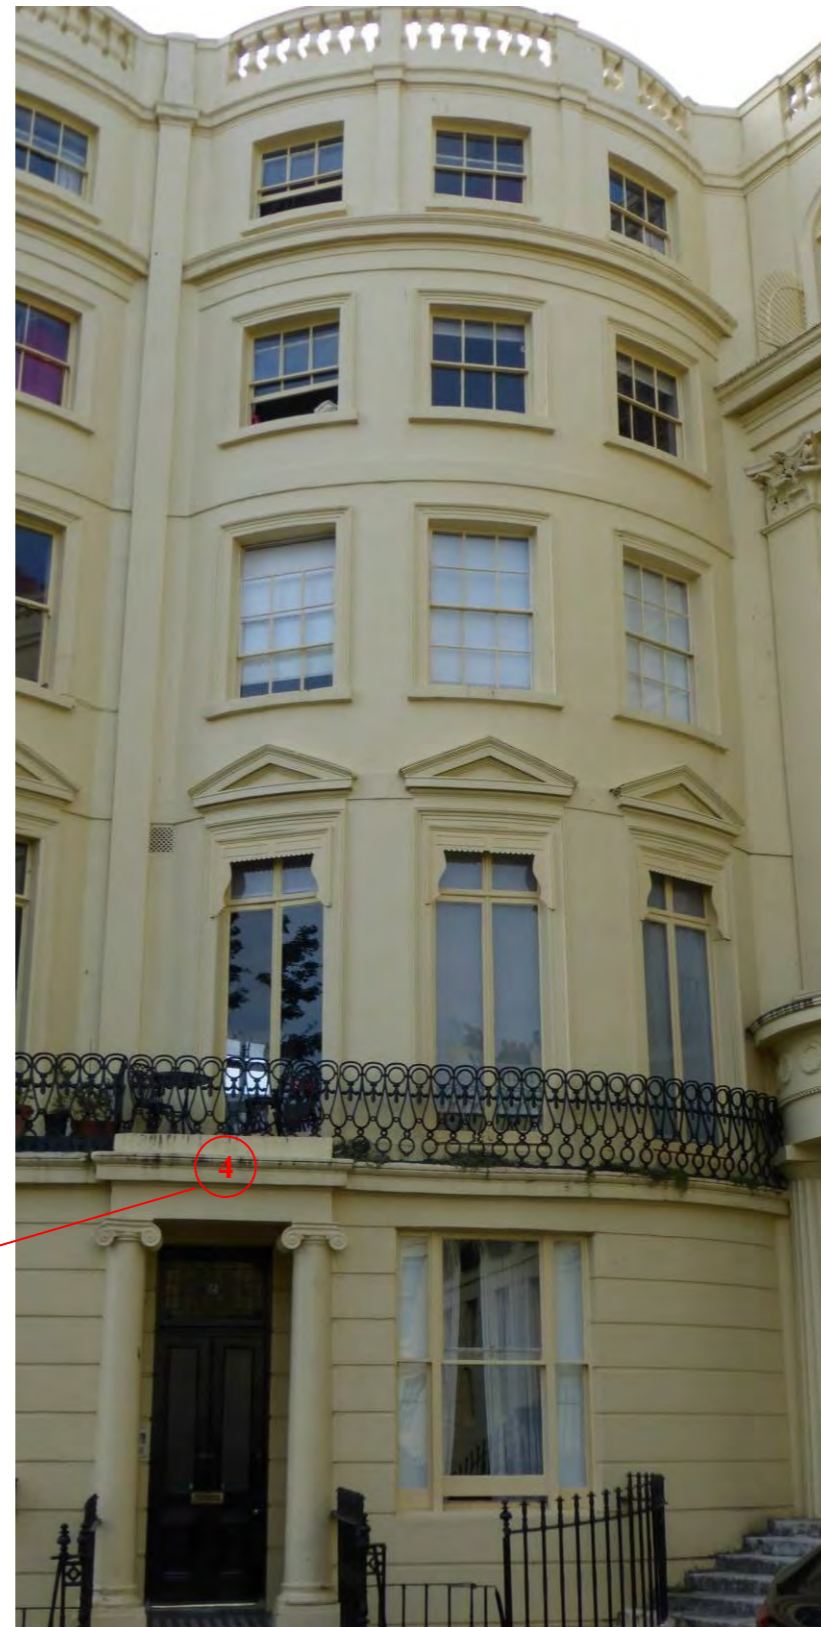
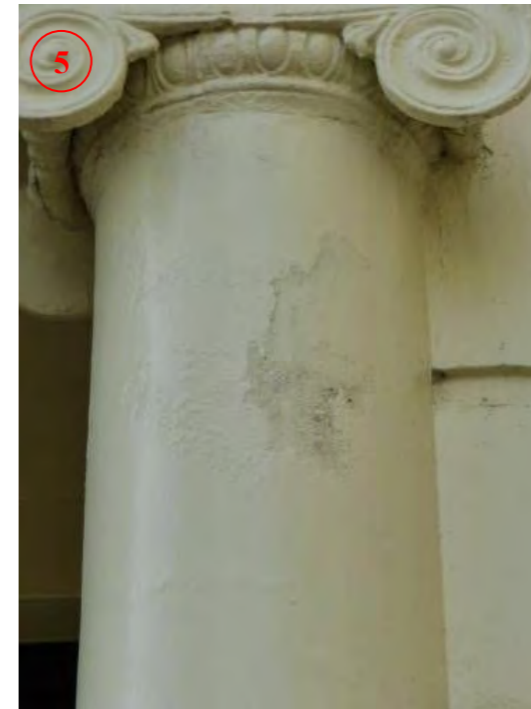
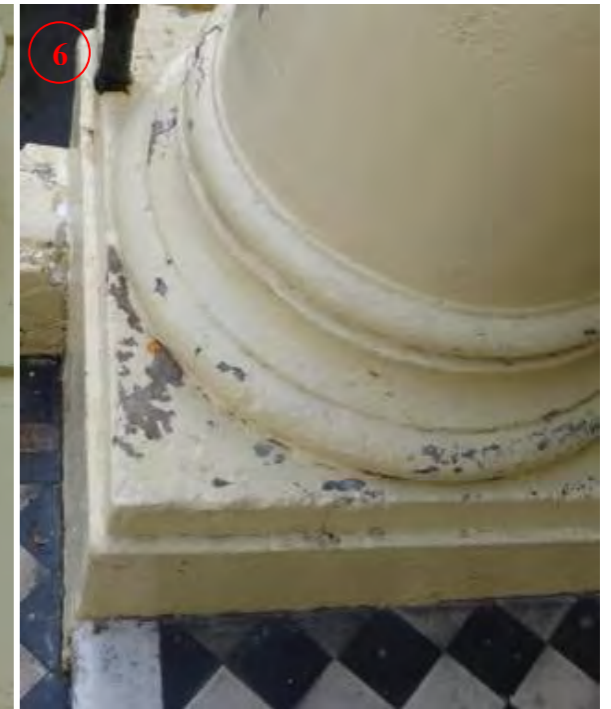
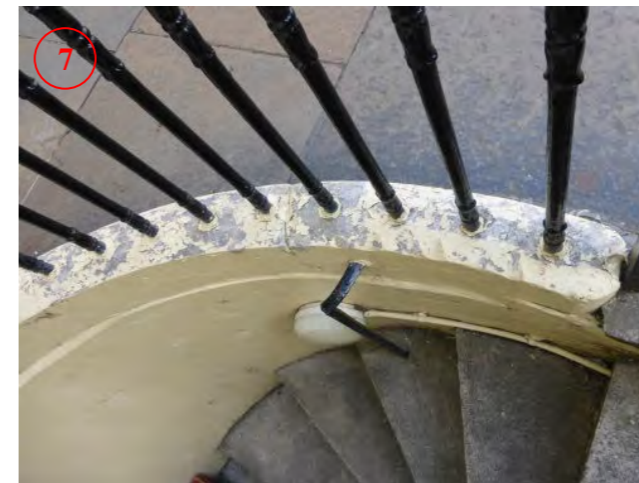
34 Brunswick Square

1. Generally the façade appears to be in reasonably good condition;
2. Paint flaking to parapet;
3. Localised paint flaking above the second floor bow window;
4. Extensive staining to cornice beneath balcony;
5. Localised salt deliquescence and paint flaking entrance columns;
6. Localised paint flaking to base of entrance columns;
7. Paint flaking to plinth wall.

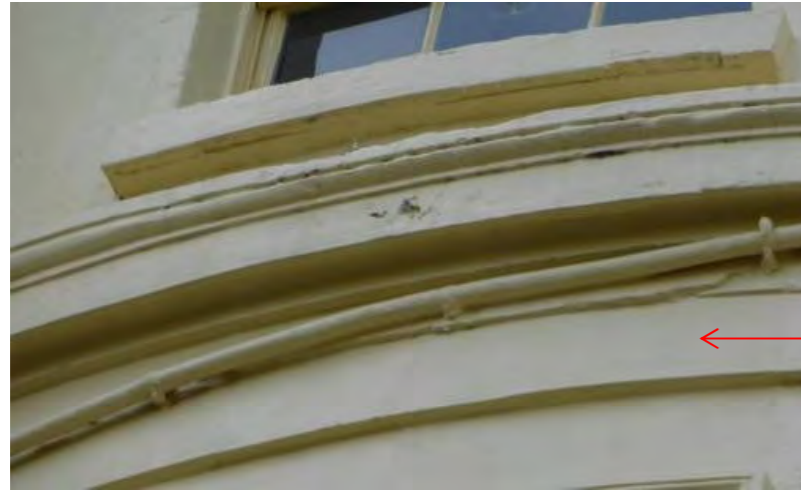
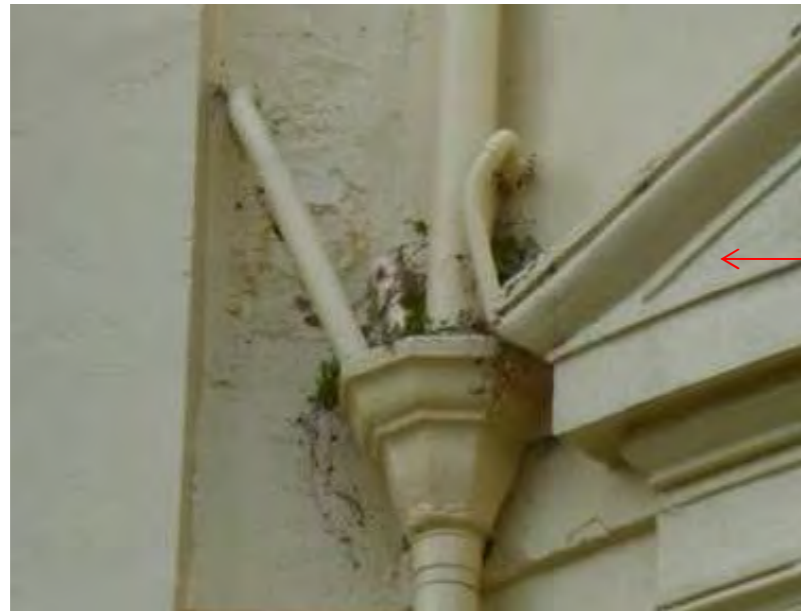
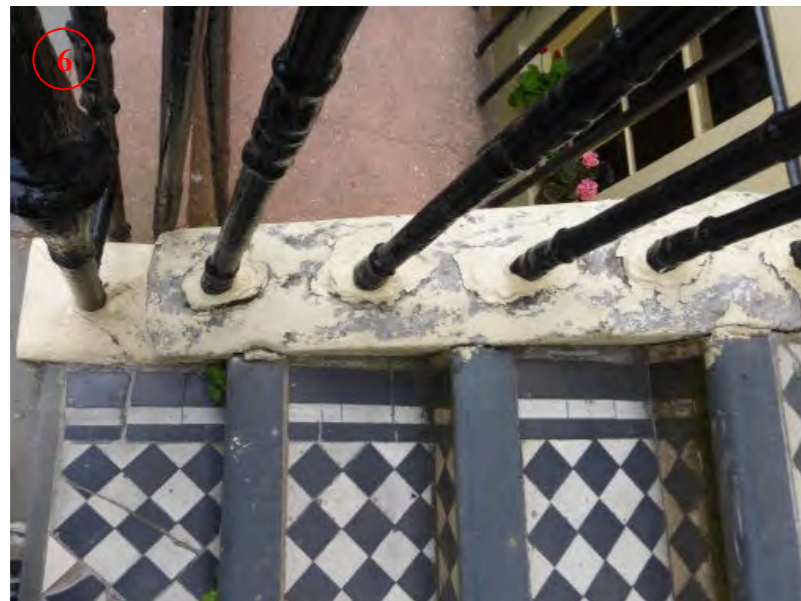
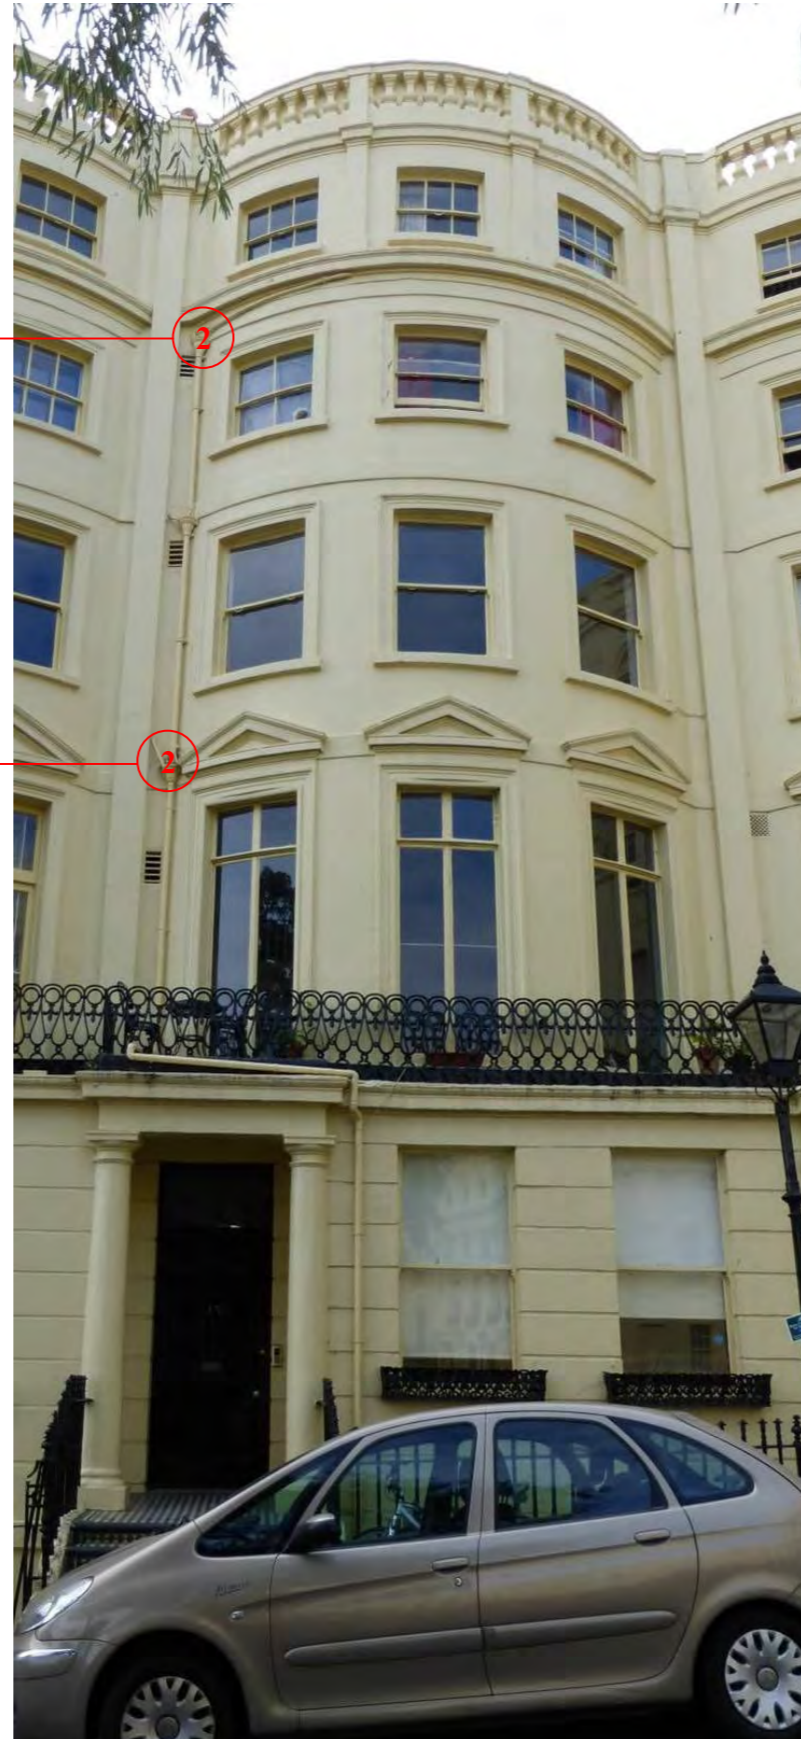
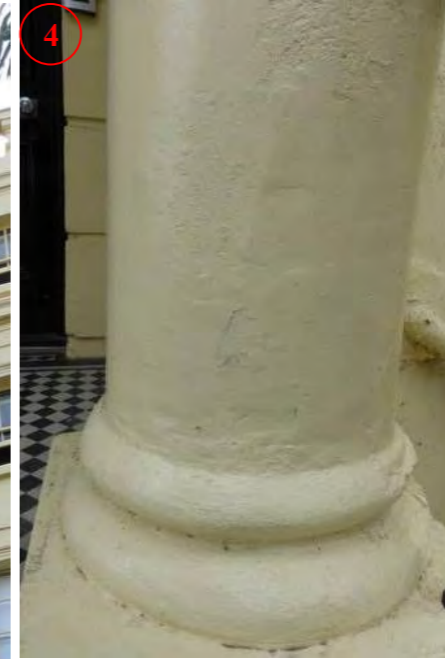
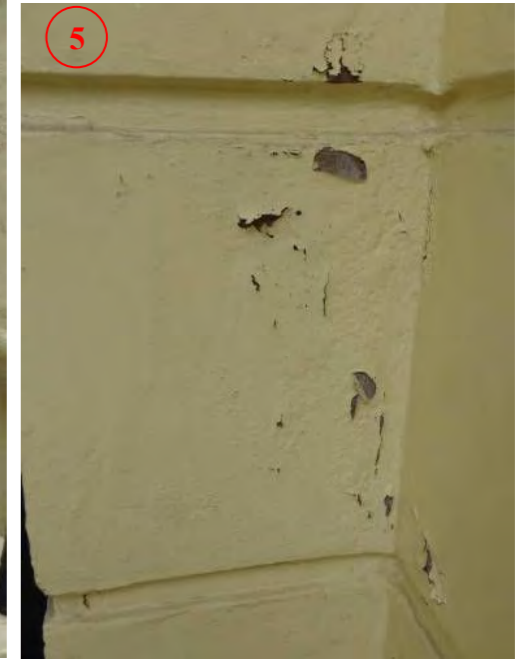
35 Brunswick Square

1. Generally the façade appears to be in reasonably good condition;
2. Paint flaking to the left hand side of the cornice and around the hopper and down pipe at parapet level;
3. Extensive staining to cornice beneath balcony and over porch;
4. Localised salt deliquescence to entrance columns;
5. Salt deliquescence and paint flaking within the porch;
6. Paint flaking to plinth wall.

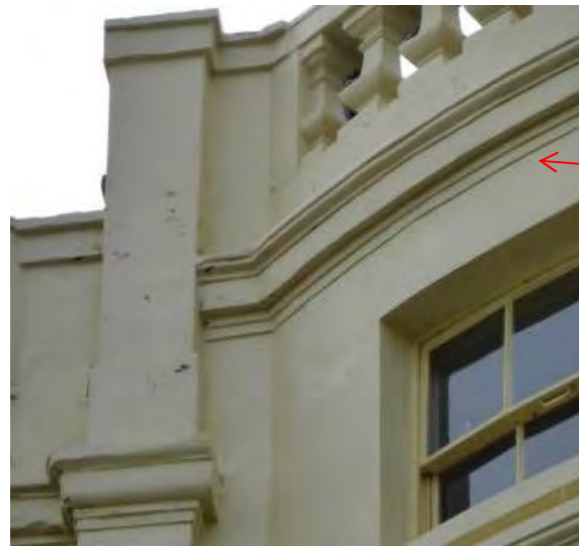
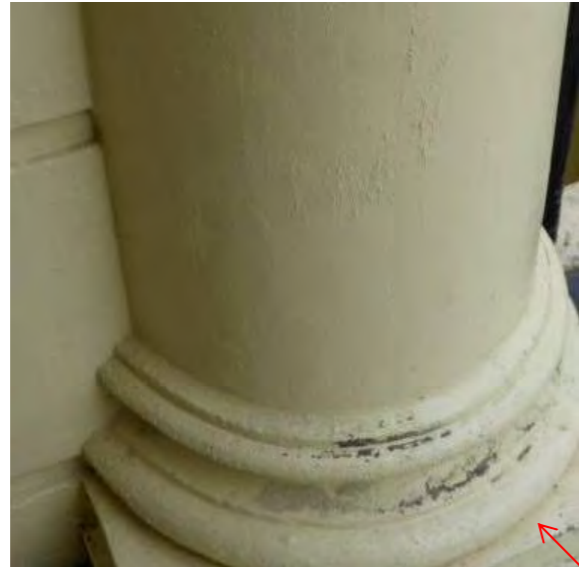
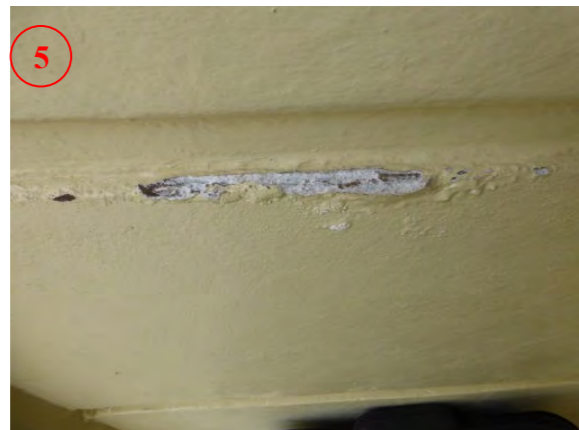
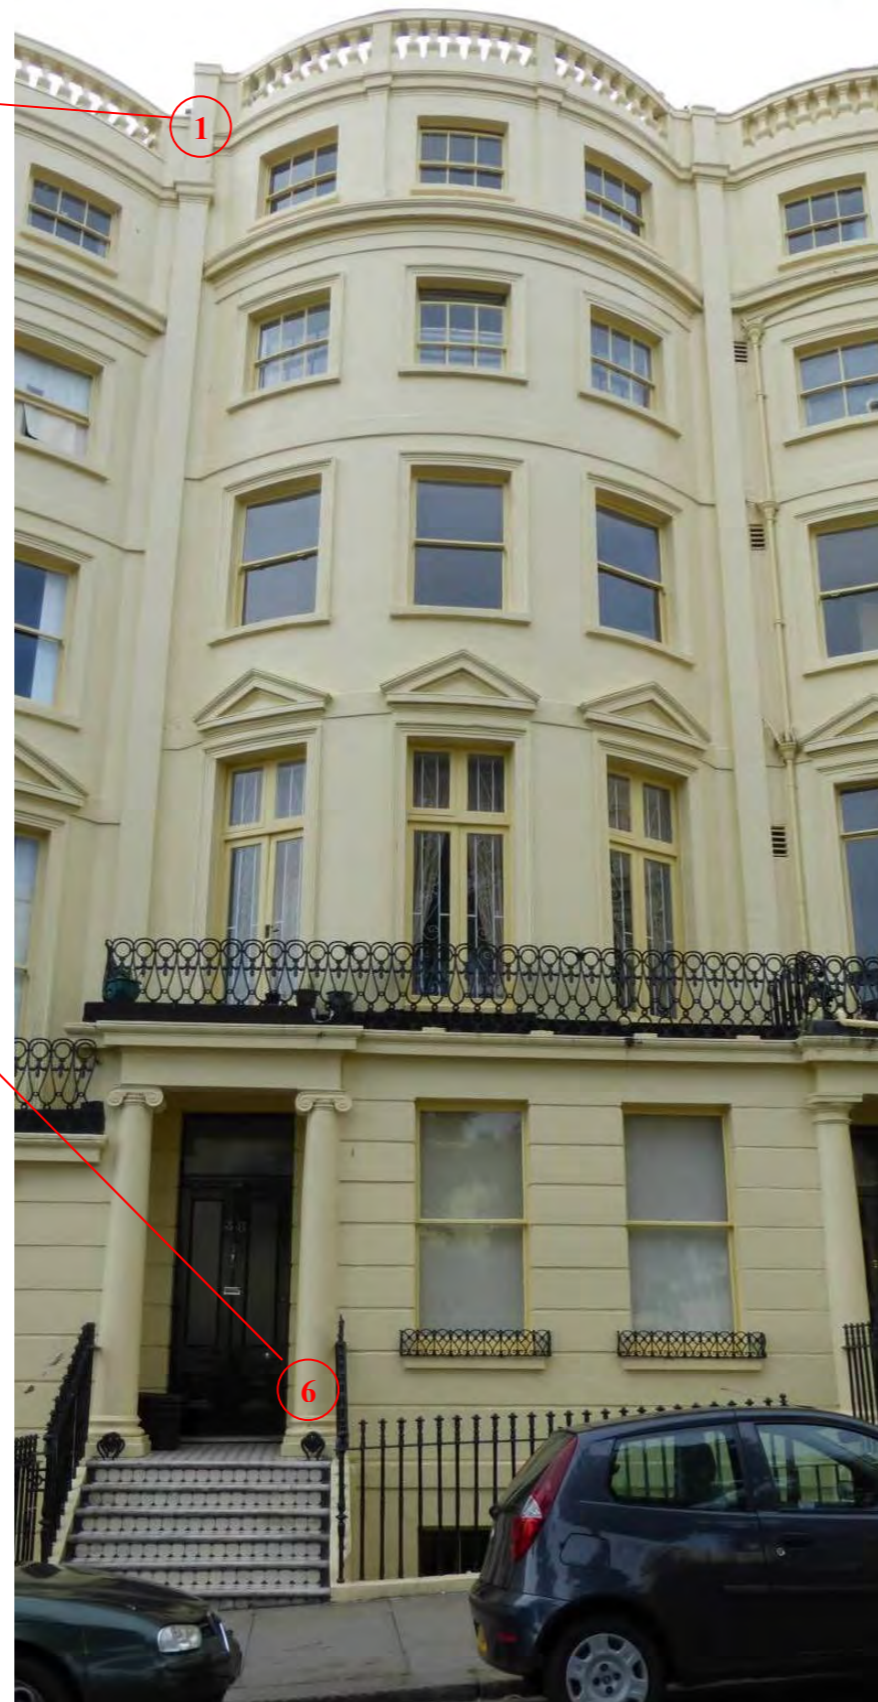
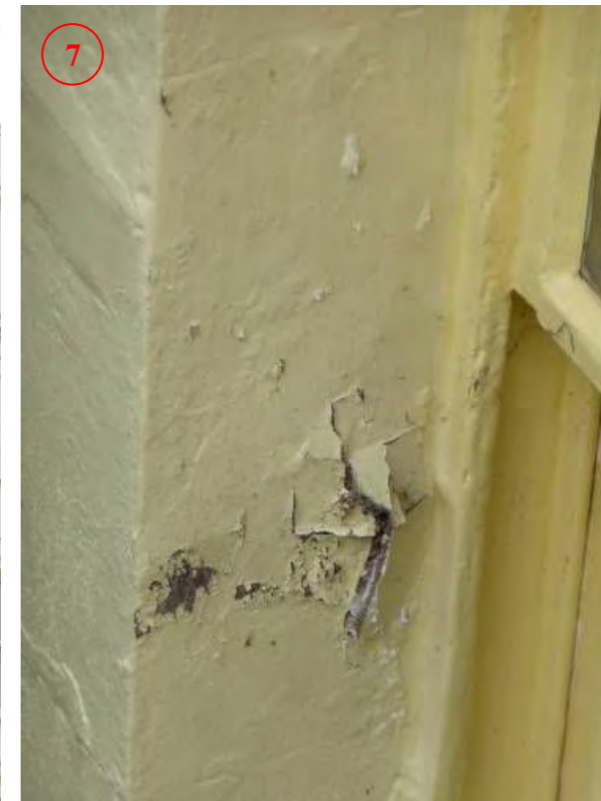
36 Brunswick Square

1. Generally the facades appears to be in good condition;
2. Paint flaking on the left hand side of parapet;
3. Paint flaking to left hand side of the cornice at parapet level;
4. Localised staining to cornice beneath balcony;
5. Localised salt deliquescence and paint flaking inside the porch;
6. Localised paint flaking on the base of entrance columns;
7. Localised salt deliquescence and paint flaking to left hand side recess of the left basement window;
8. Paint flaking to plinth wall.

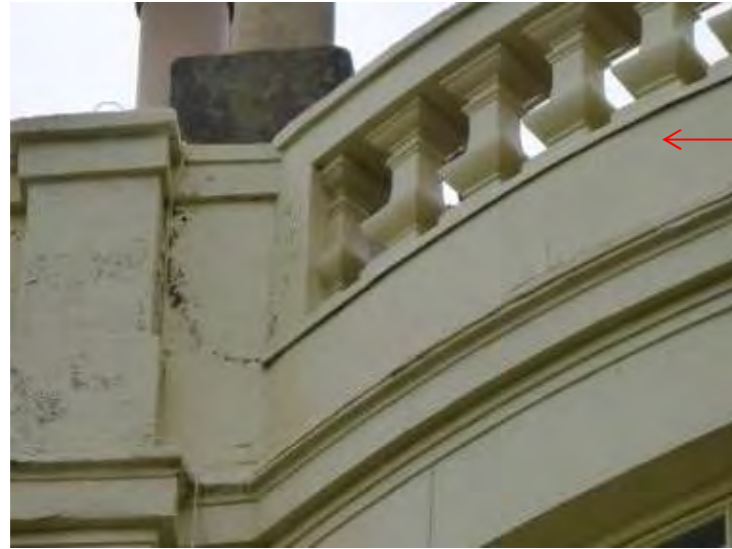
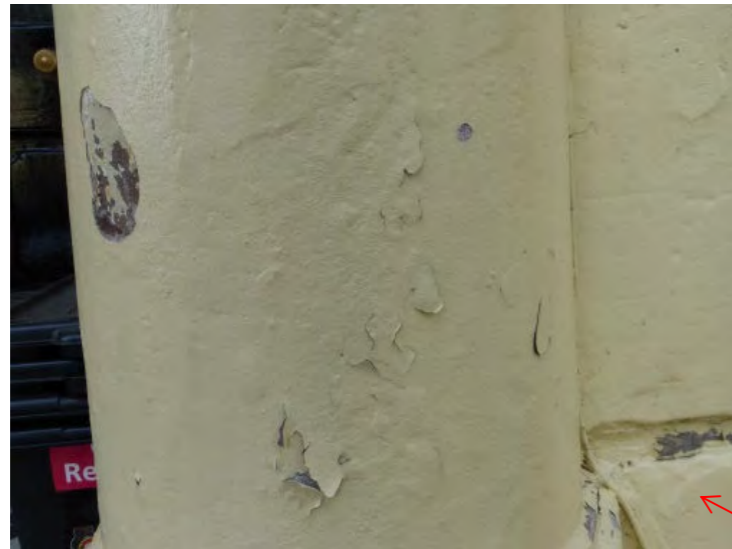
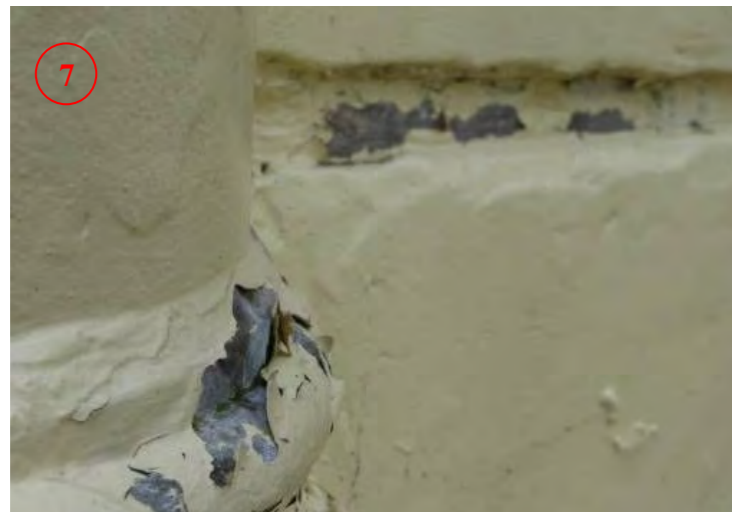
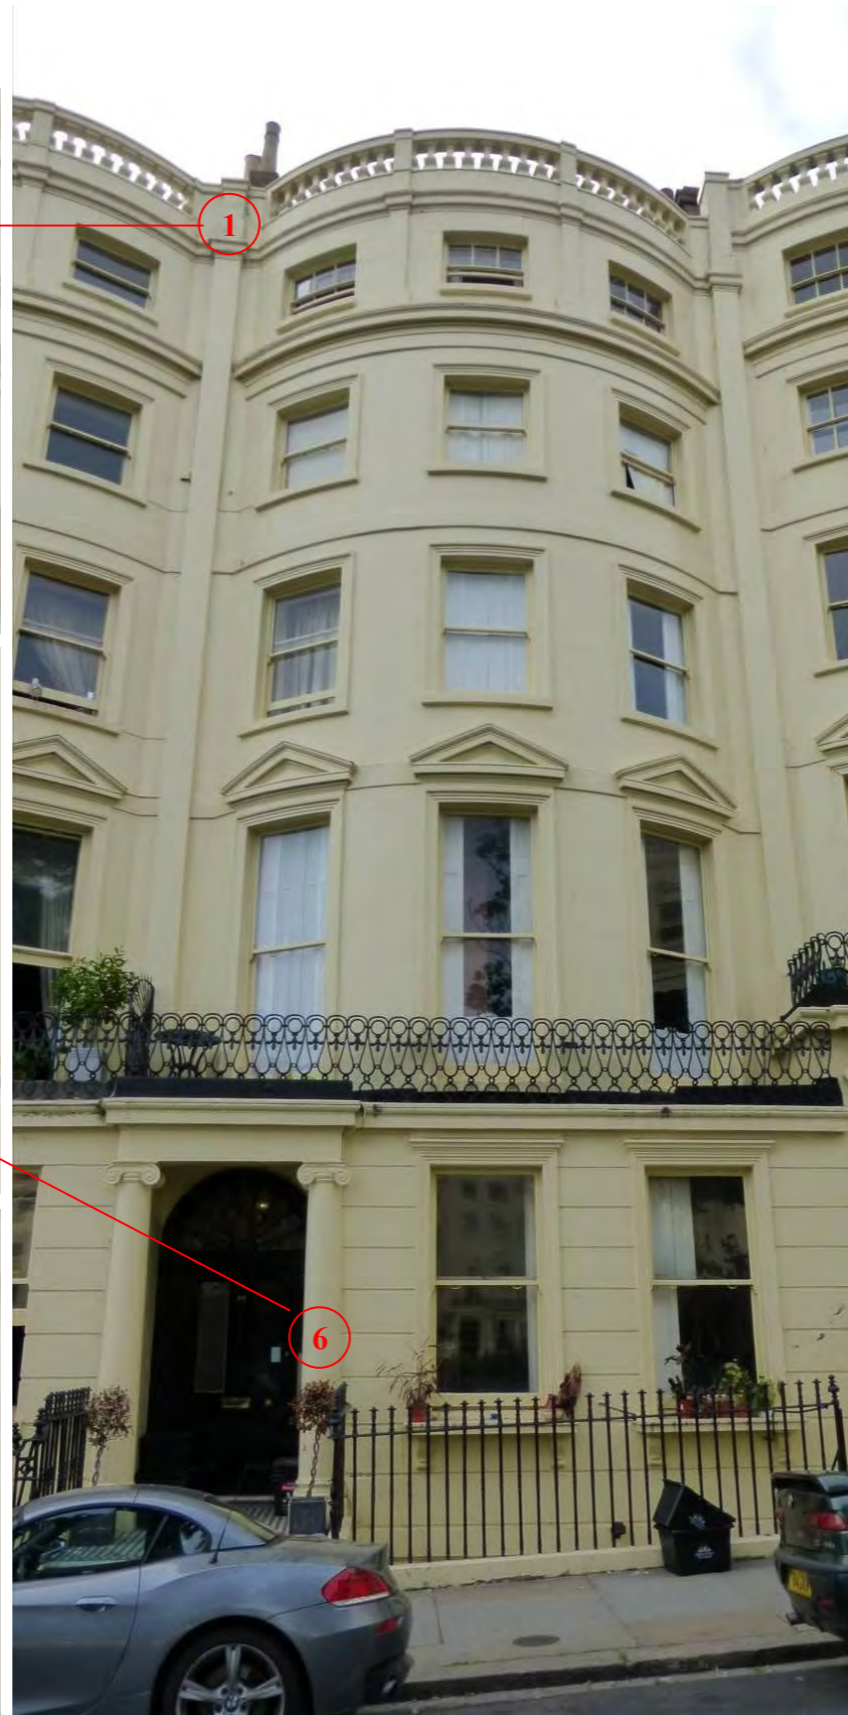
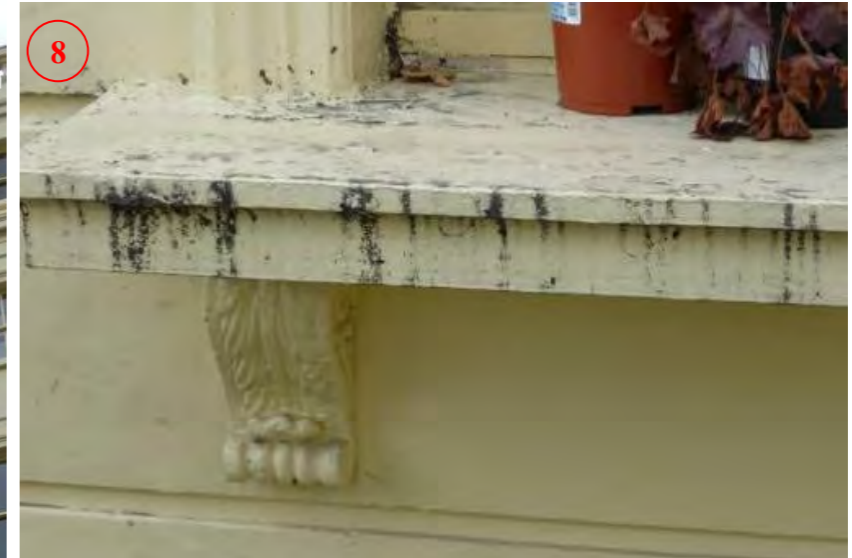
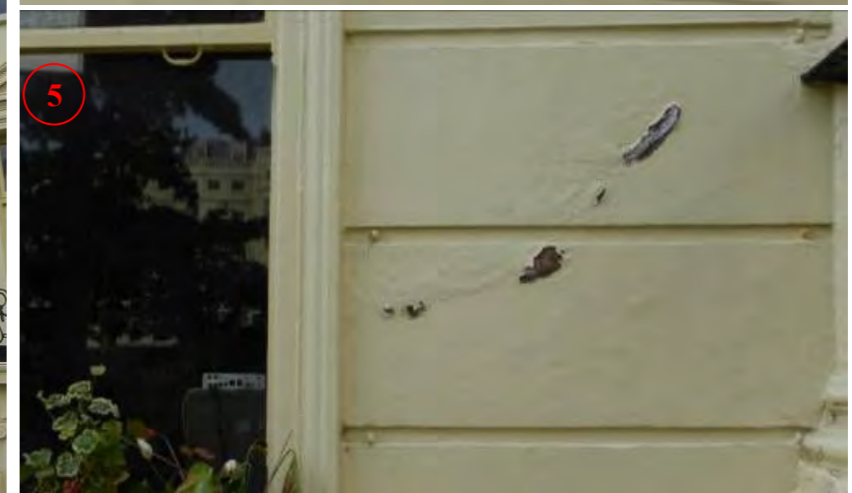
37 Brunswick Square

1. Paint flaking to left hand side of parapet;
2. Paint flaking to centre of the cornice at parapet level;
3. Localised paint flaking to flat of right hand side of left pediment (first floor level);
4. Localised staining and paint flaking to cornice and under balcony;
5. Localised paint flaking to right hand side of the right window (ground floor level);
6. Extensive salt deliquescence and paint flaking to entrance columns;
7. Localised paint flaking to base of entrance columns;
8. Extensive salt deliquescence and staining to walls and window ledge at basement level;
9. Paint flaking to plinth wall.

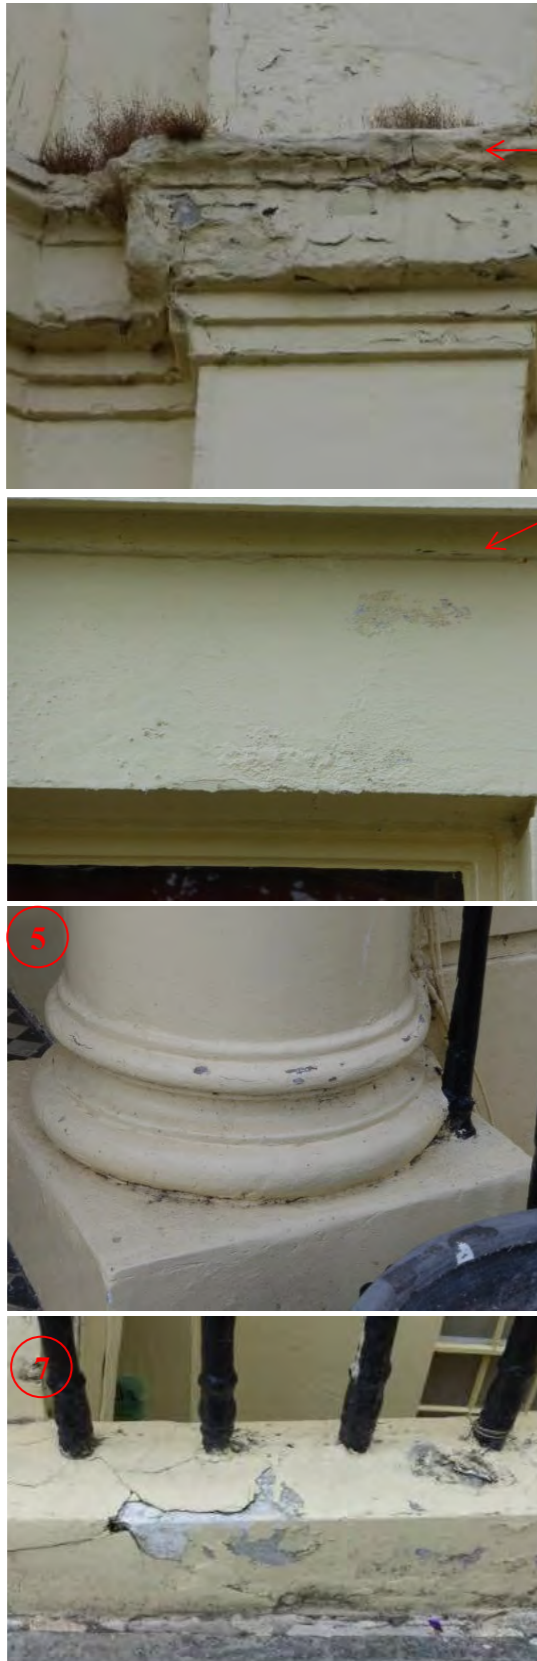
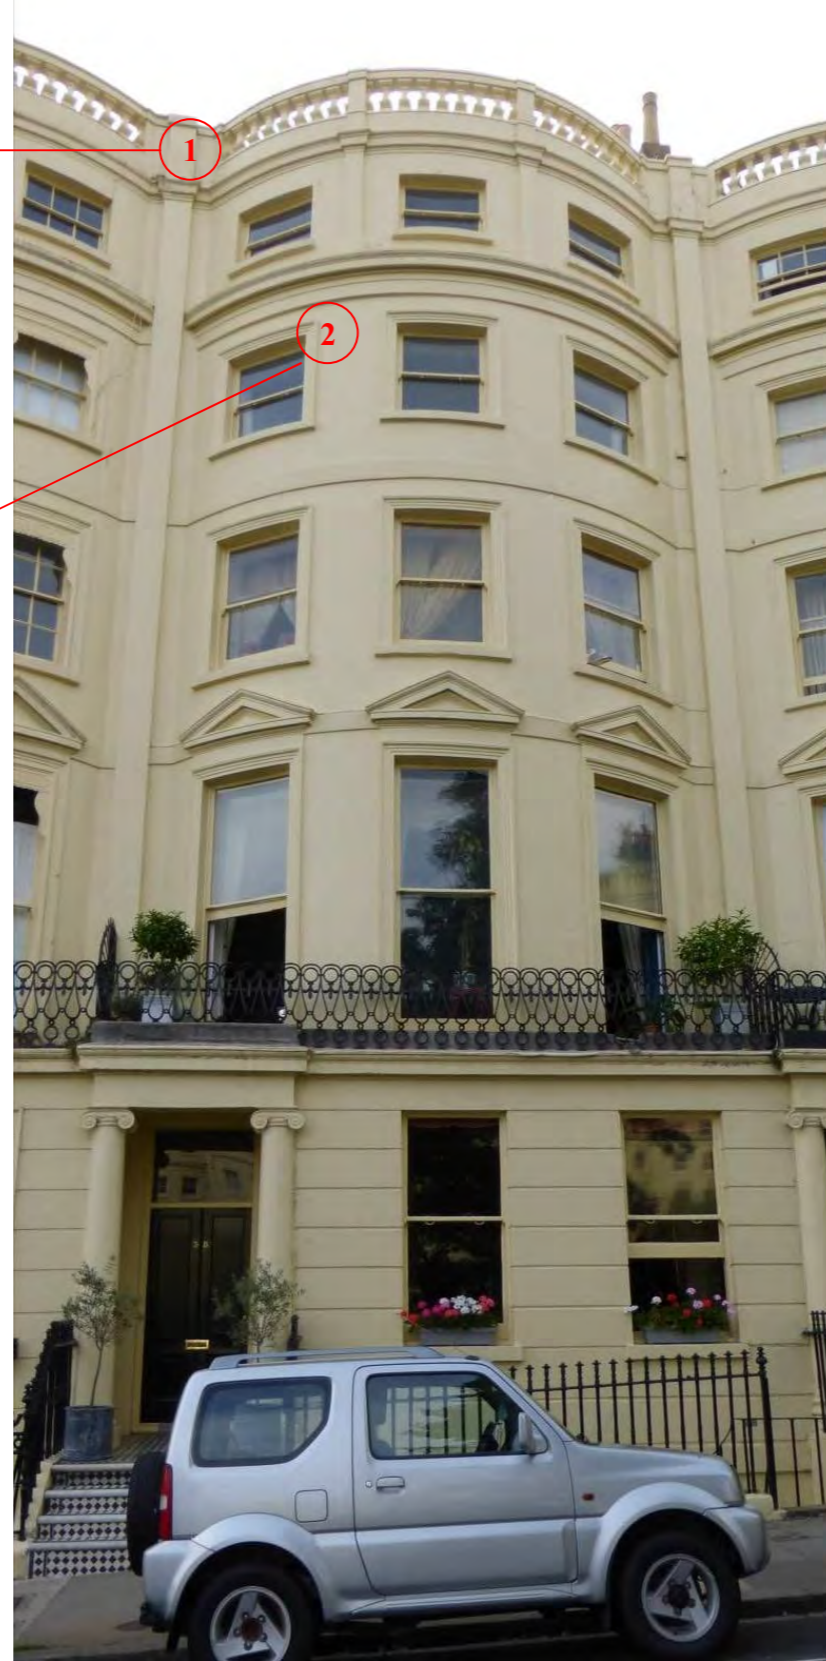
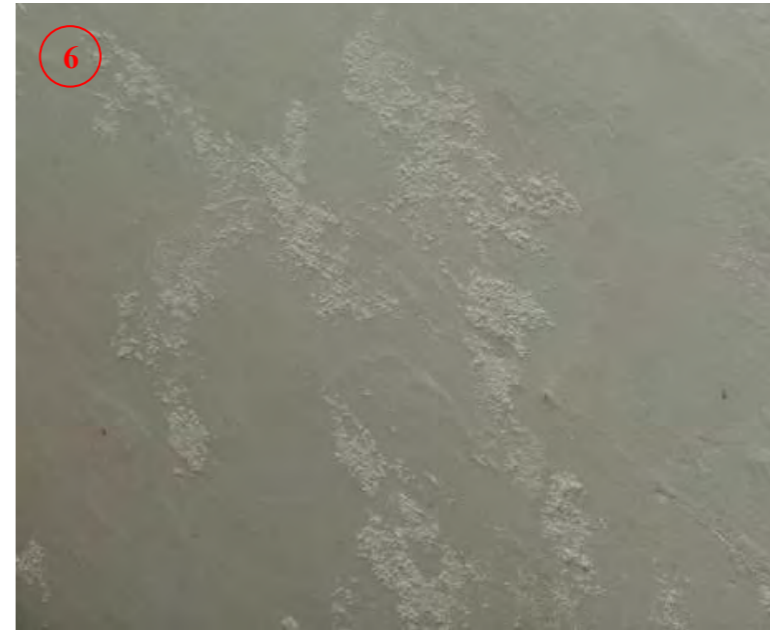
38 Brunswick Square

1. Paint flaking on the left and right hand side of parapet;
2. Paint flaking and salt deliquescence above the left hand window (right side) at third floor level;
3. Localised staining, vegetation and paint flaking on the cornice beneath balcony;
4. Salt deliquescence and paint flaking to interior porch wall (left hand side);
5. Localised paint flaking to base of entrance columns;
6. Extensive salt deliquescence on the basement walls;
7. Paint flaking to plinth wall.

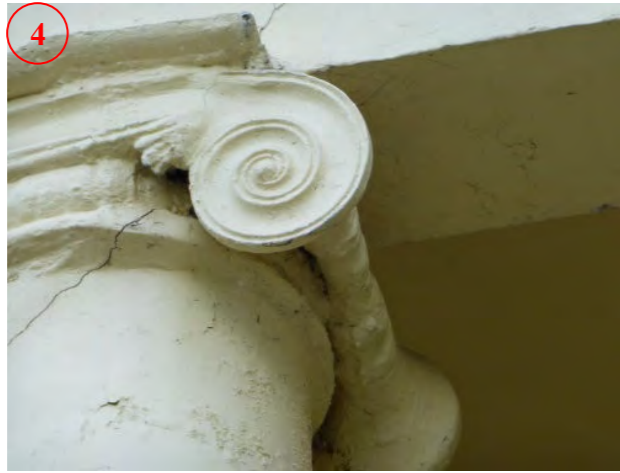
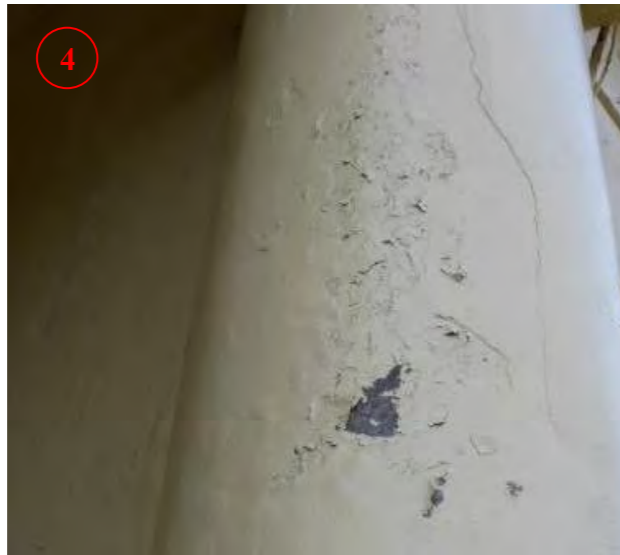
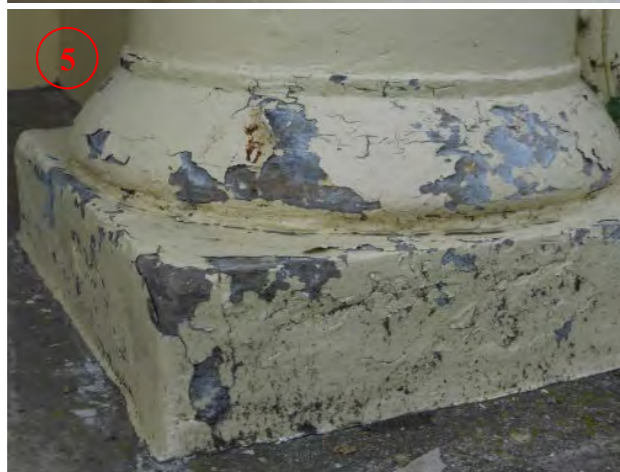
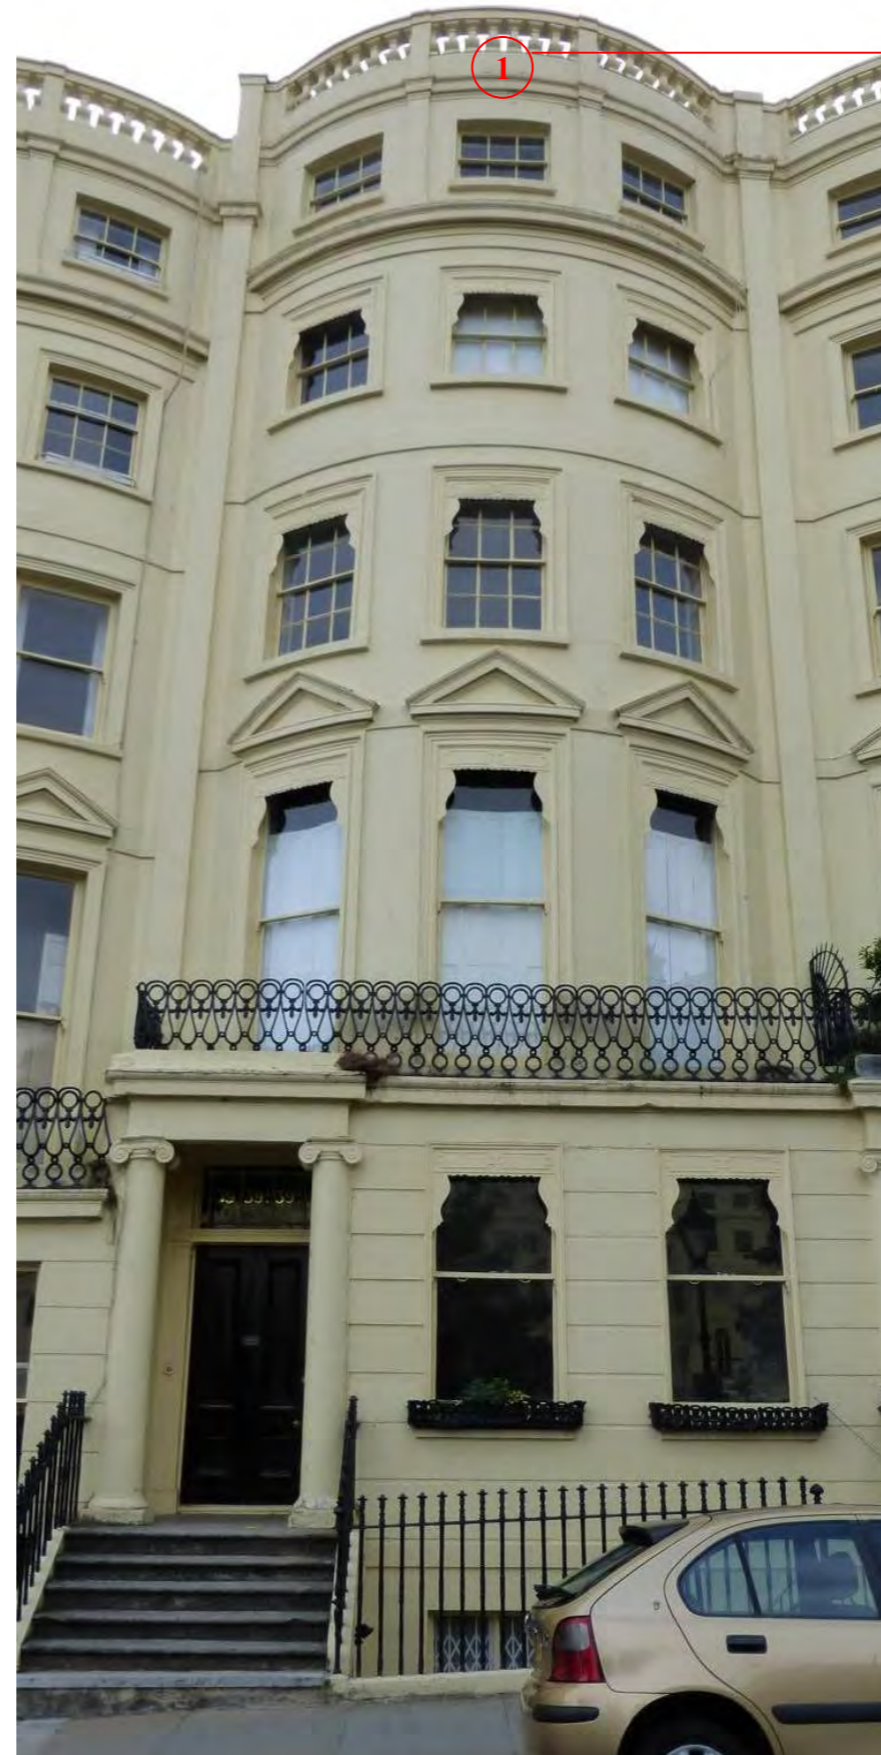
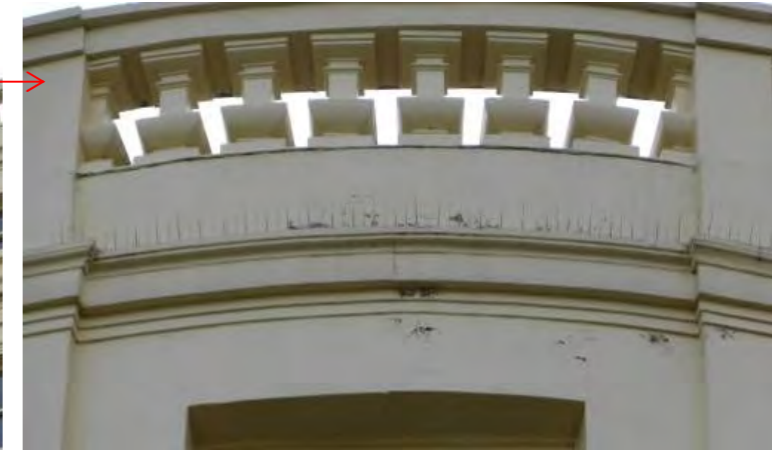
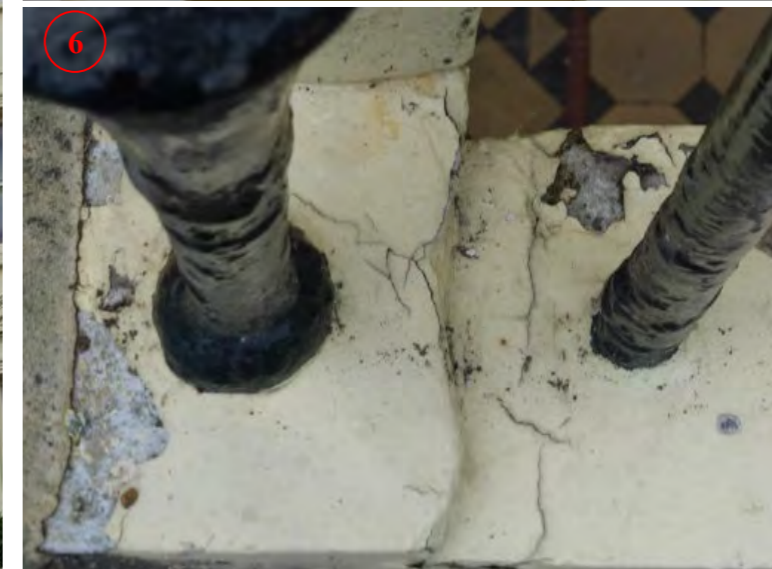
39 Brunswick Square

1. Paint flaking to centre of cornice at parapet level;
2. Localised staining, paint flaking and vegetation on the cornice beneath balcony;
3. Localised paint flaking to wall between the ground floor windows;
4. Extensive salt deliquescence and paint flaking to entrance columns and adjacent wall beneath the wrought iron window box;
5. Extensive paint flaking to base of entrance columns;
6. Paint flaking to plinth wall.

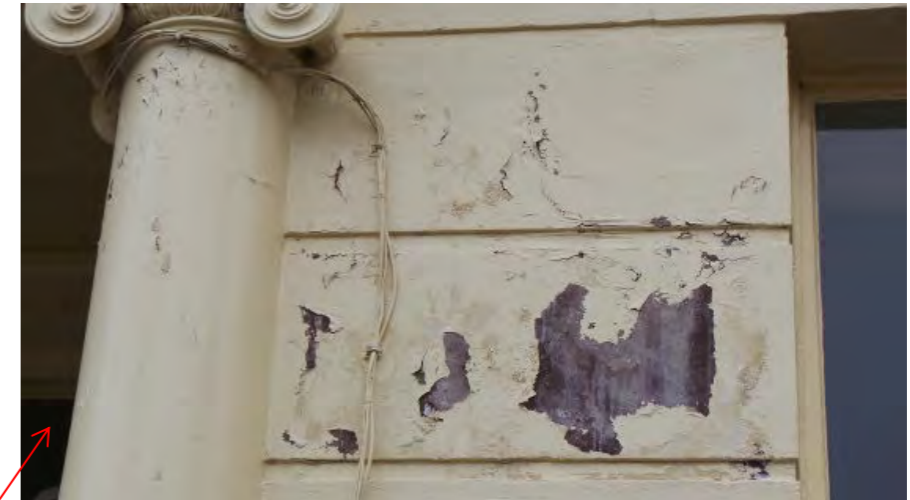
40 Brunswick Square

1. Paint flaking on the left hand side of parapet;
2. Paint flaking to right hand side of the cornice at parapet level;
3. Localised staining and paint flaking to cornice beneath balcony;
4. Extensive paint flaking to right hand side of the right column;
5. Extensive salt deliquescence and paint flaking to entrance columns;
6. Localised paint flaking to base of entrance columns.
