**Investigation of Paint Failure at
Brunswick Estate
Hove
Brighton**

August 2013

**BRUNSWICK ESTATE
HOVE**

The following document investigates the failure of the external paint-system at Brunswick Estate, Hove based on research carried out by Elizabeth Hirst and Rachel Morley of Hirst Conservation between August and November 2013. The work was commissioned by Brighton & Hove City Council.

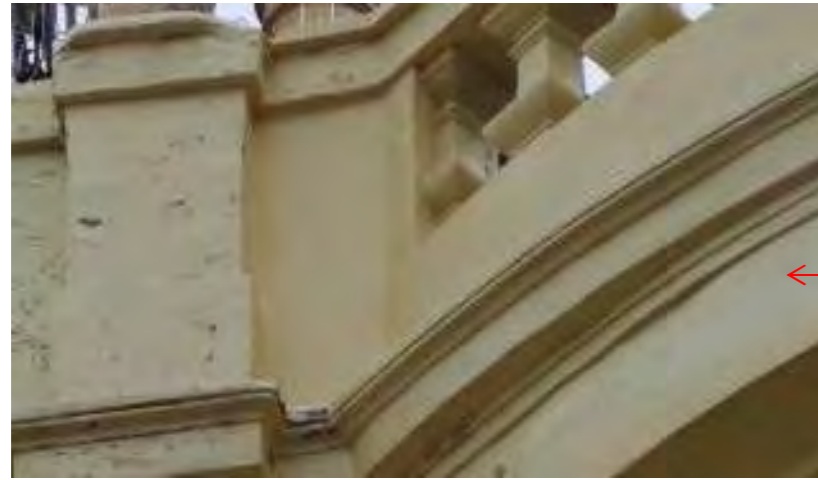
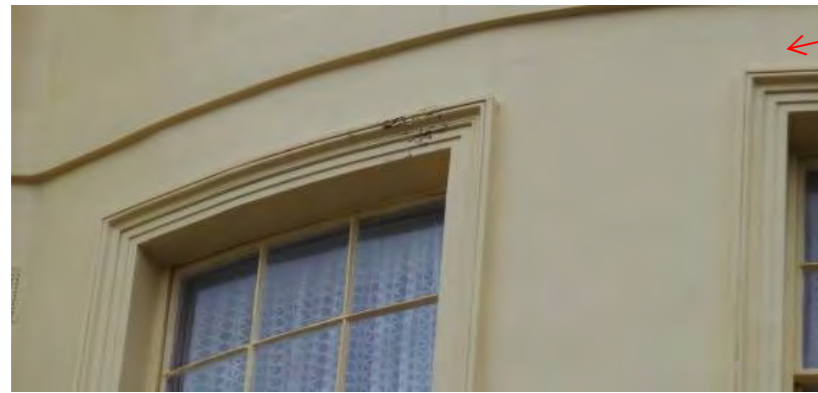
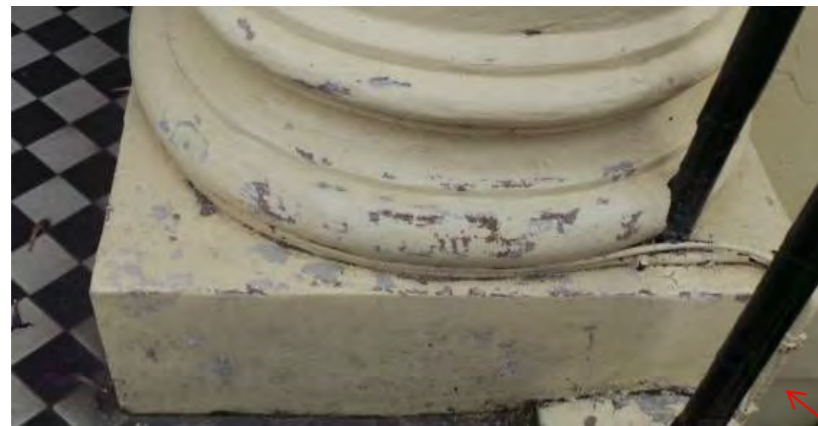
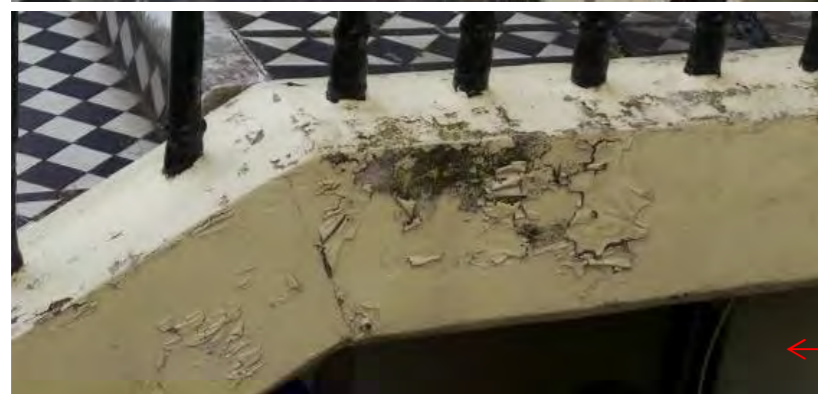
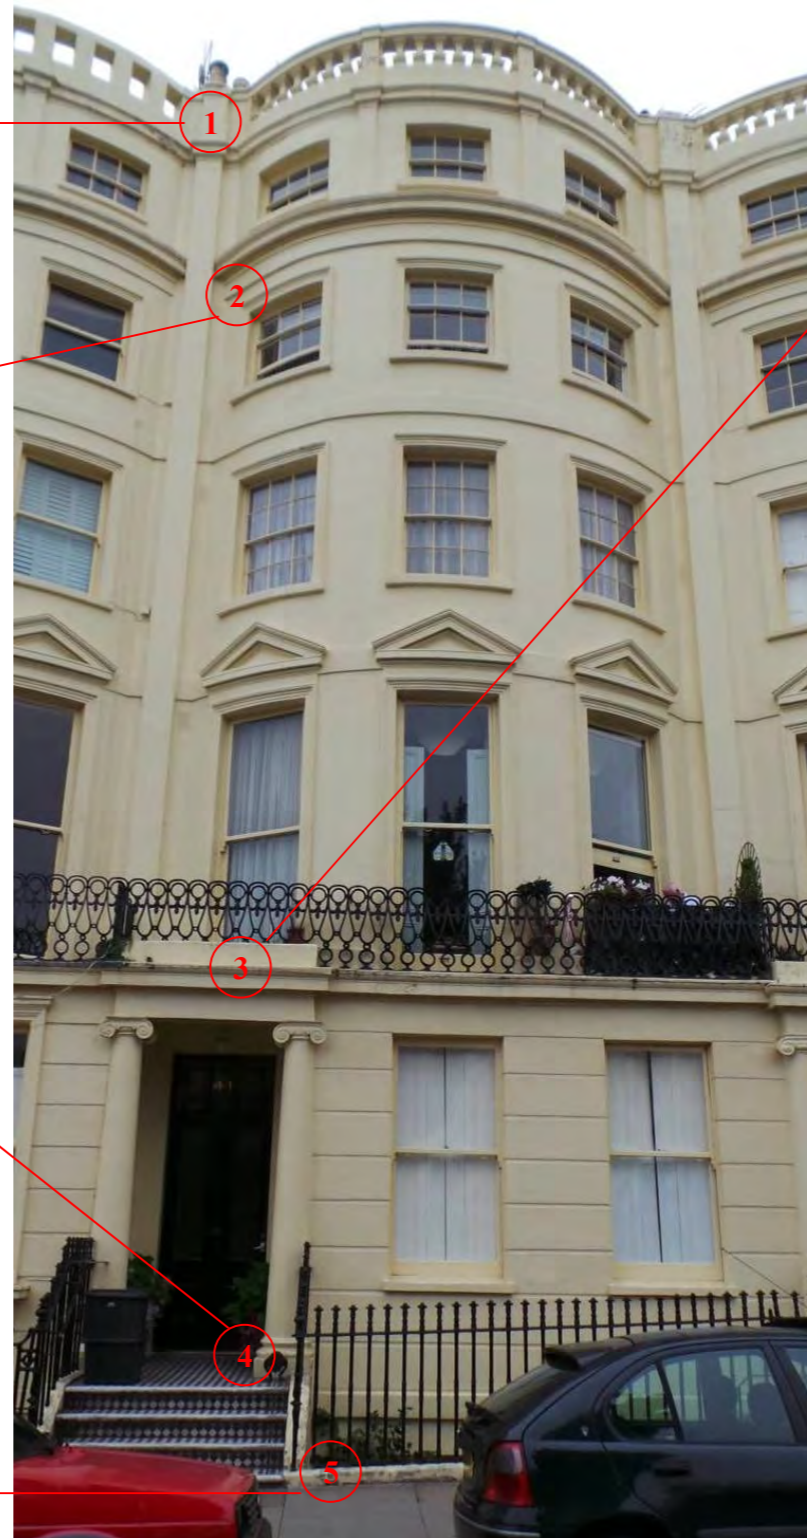
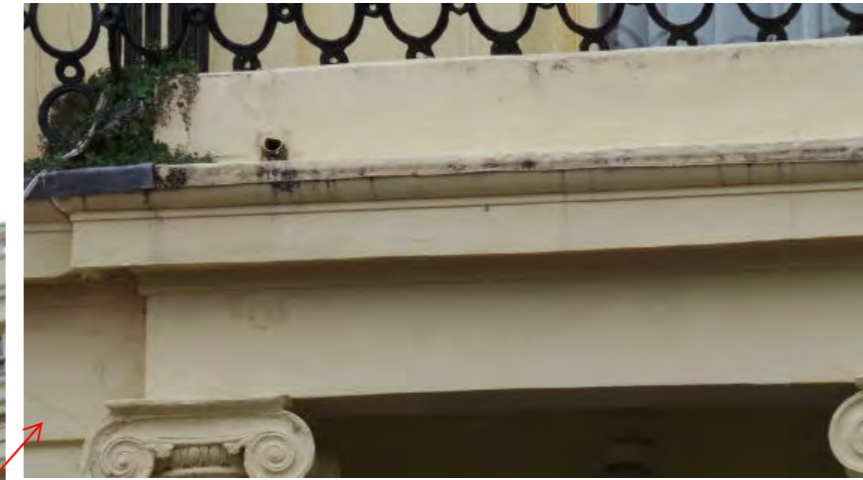
41 Brunswick Square

1. Paint flaking on the balustrade at parapet level;
2. Localised paint flaking to right hand side of left window (third floor level);
3. Localised staining and paint flaking to cornice beneath balcony;
4. Extensive paint flaking to base of entrance columns;
5. Paint flaking to plinth wall.

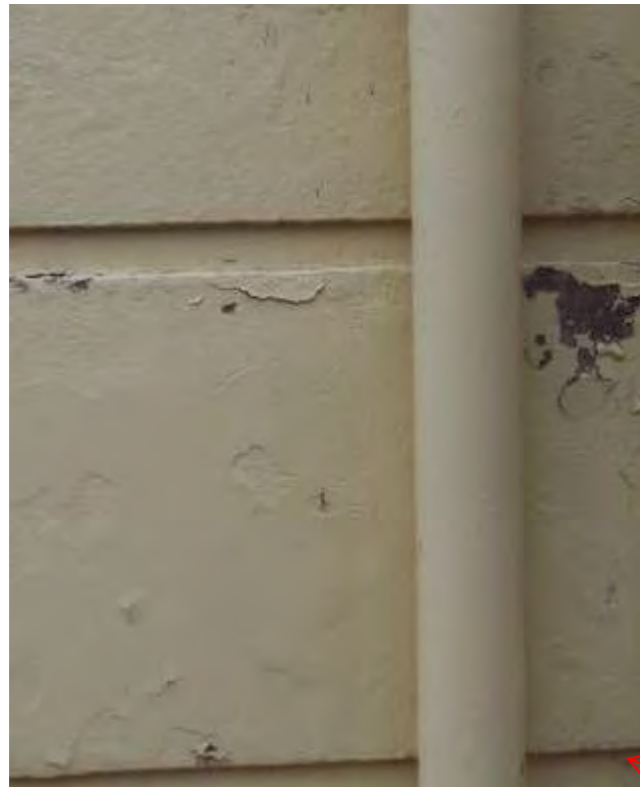
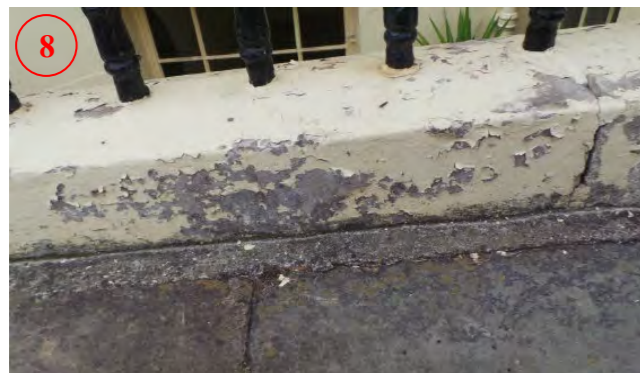
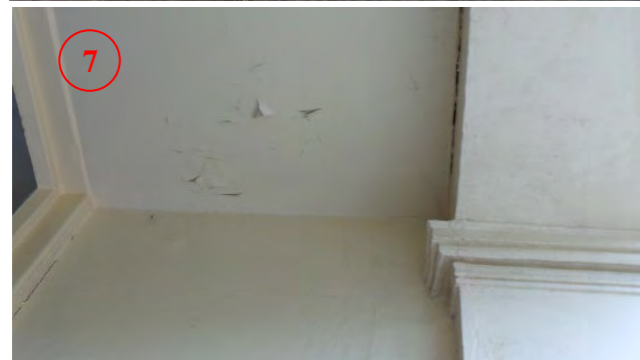
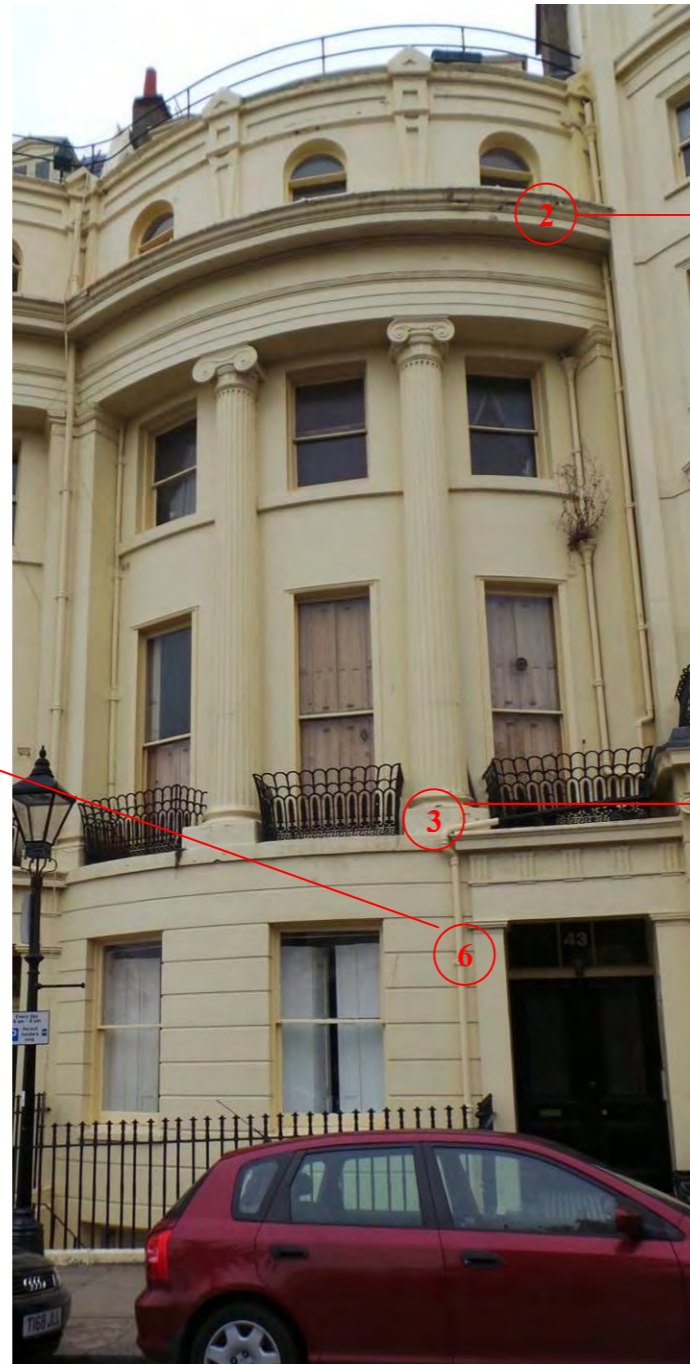
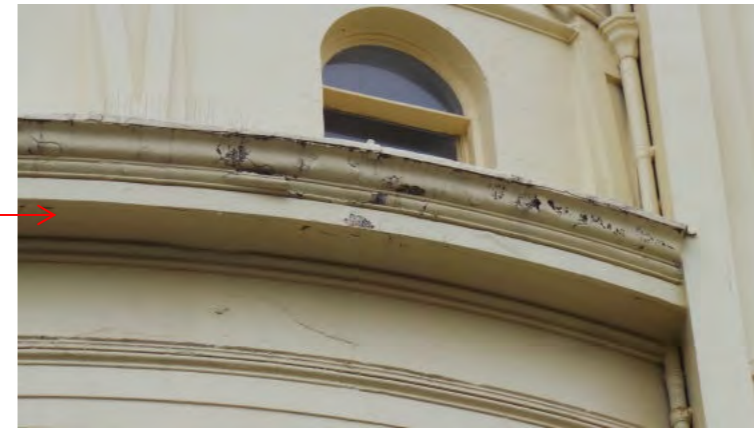
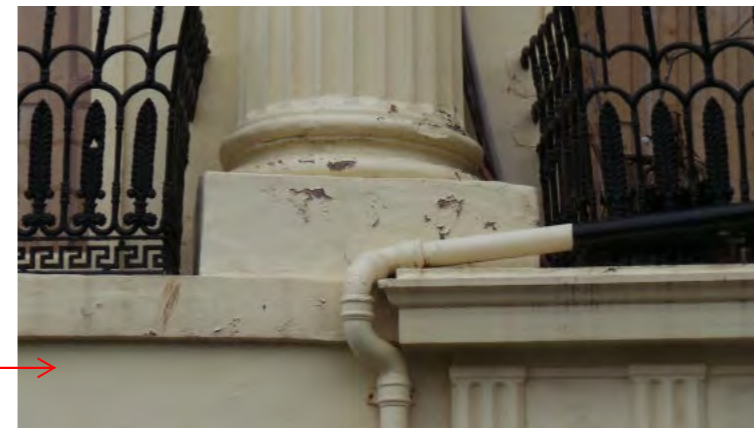
43 Brunswick Square

1. Paint flaking to right hand side of parapet;
2. Paint flaking to cornice at parapet level;
3. Localised paint flaking to base of the right hand side column (first floor level);
4. Localised staining to cornice beneath balcony;
5. Localised salt deliquescence and paint flaking on frieze between the triglyph decoration;
6. Localised paint flaking to ground floor wall next to the downpipe on the left hand side of the doorway;
7. Localised paint flaking to underside of the porch;
8. Paint flaking on the masonry below the railings adjacent the front door and the pavement.

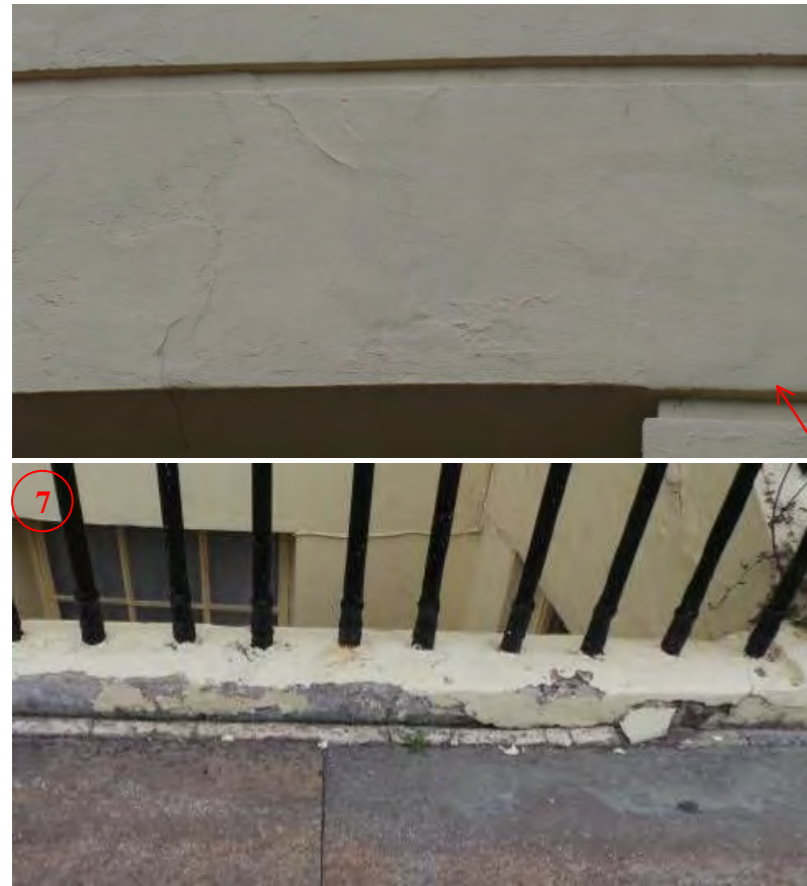
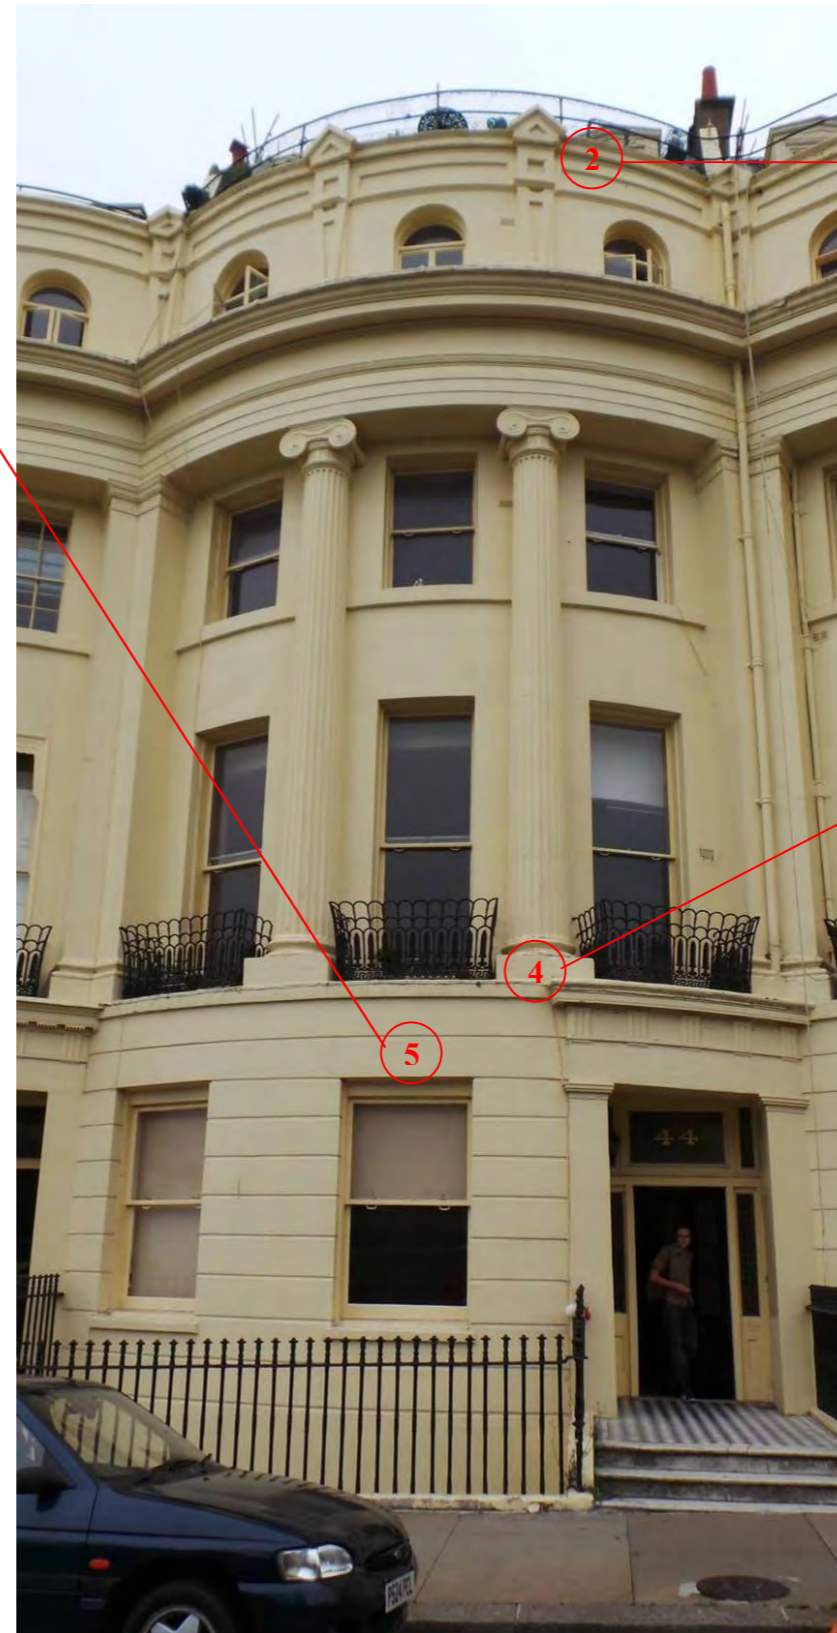
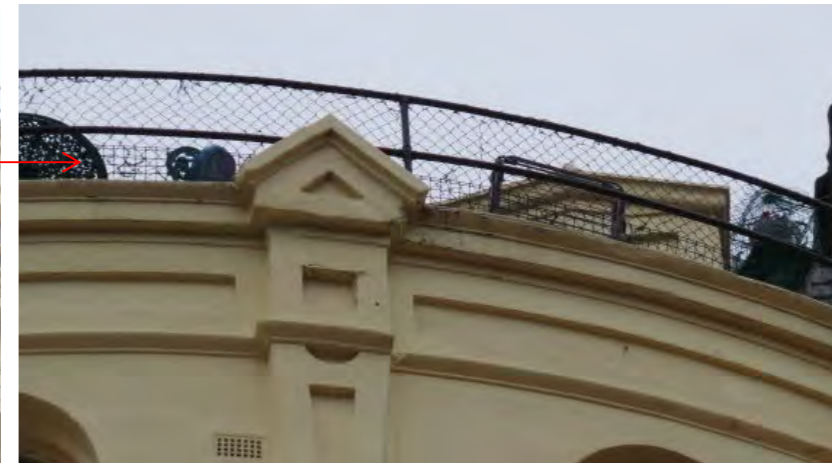
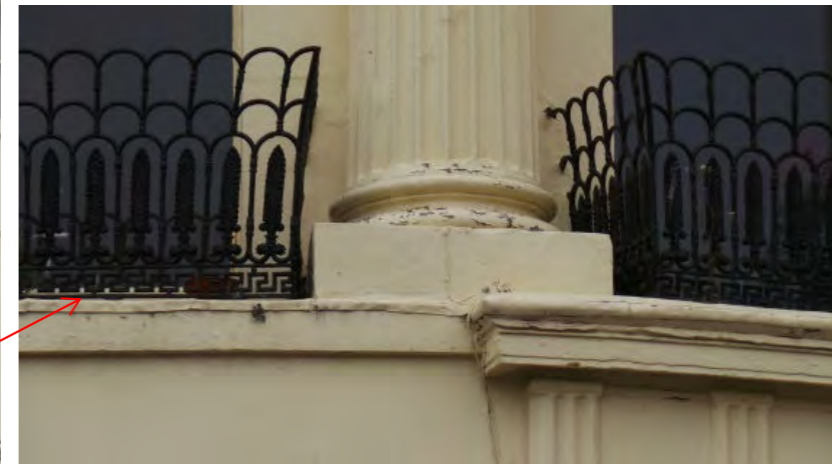
44 Brunswick Square

1. Generally the façade appears to be in reasonably good condition;
2. Paint flaking to right hand side of right pediment at parapet level;
3. Extensive staining to cornice beneath the balconies;
4. Localised salt deliquescence to base of right hand column (first floor level);
5. Salt deliquescence around right hand window next to the porch;
6. Extensive biological growth (mould and algae) and vegetation at basement level);
7. Paint flaking on the masonry below the railings adjacent the front door and the pavement

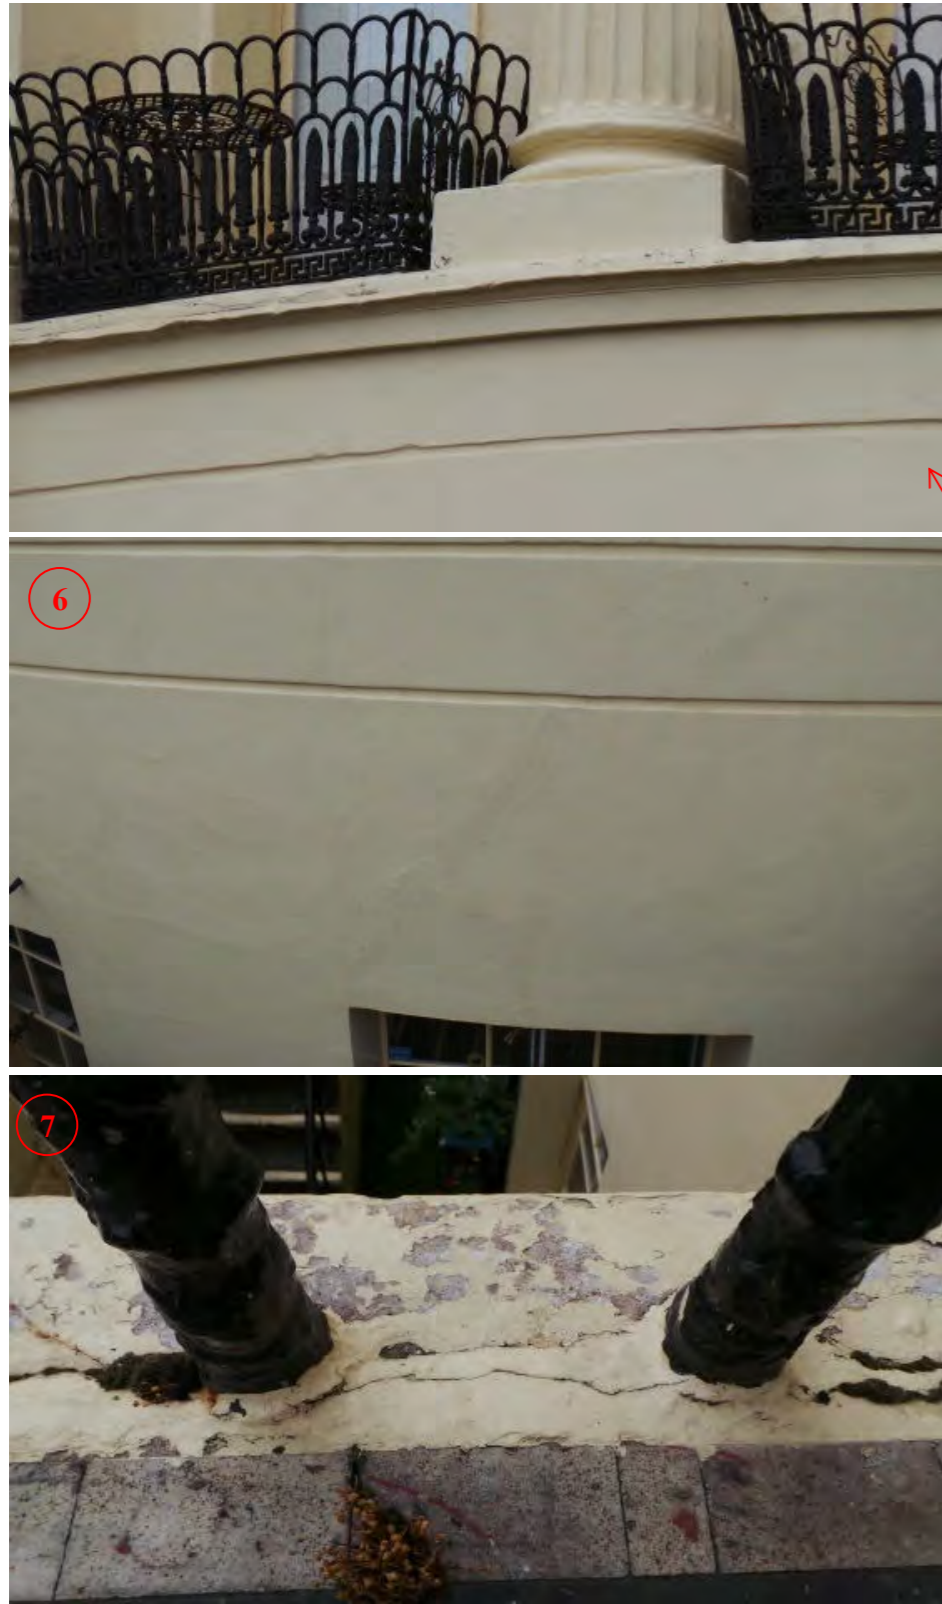
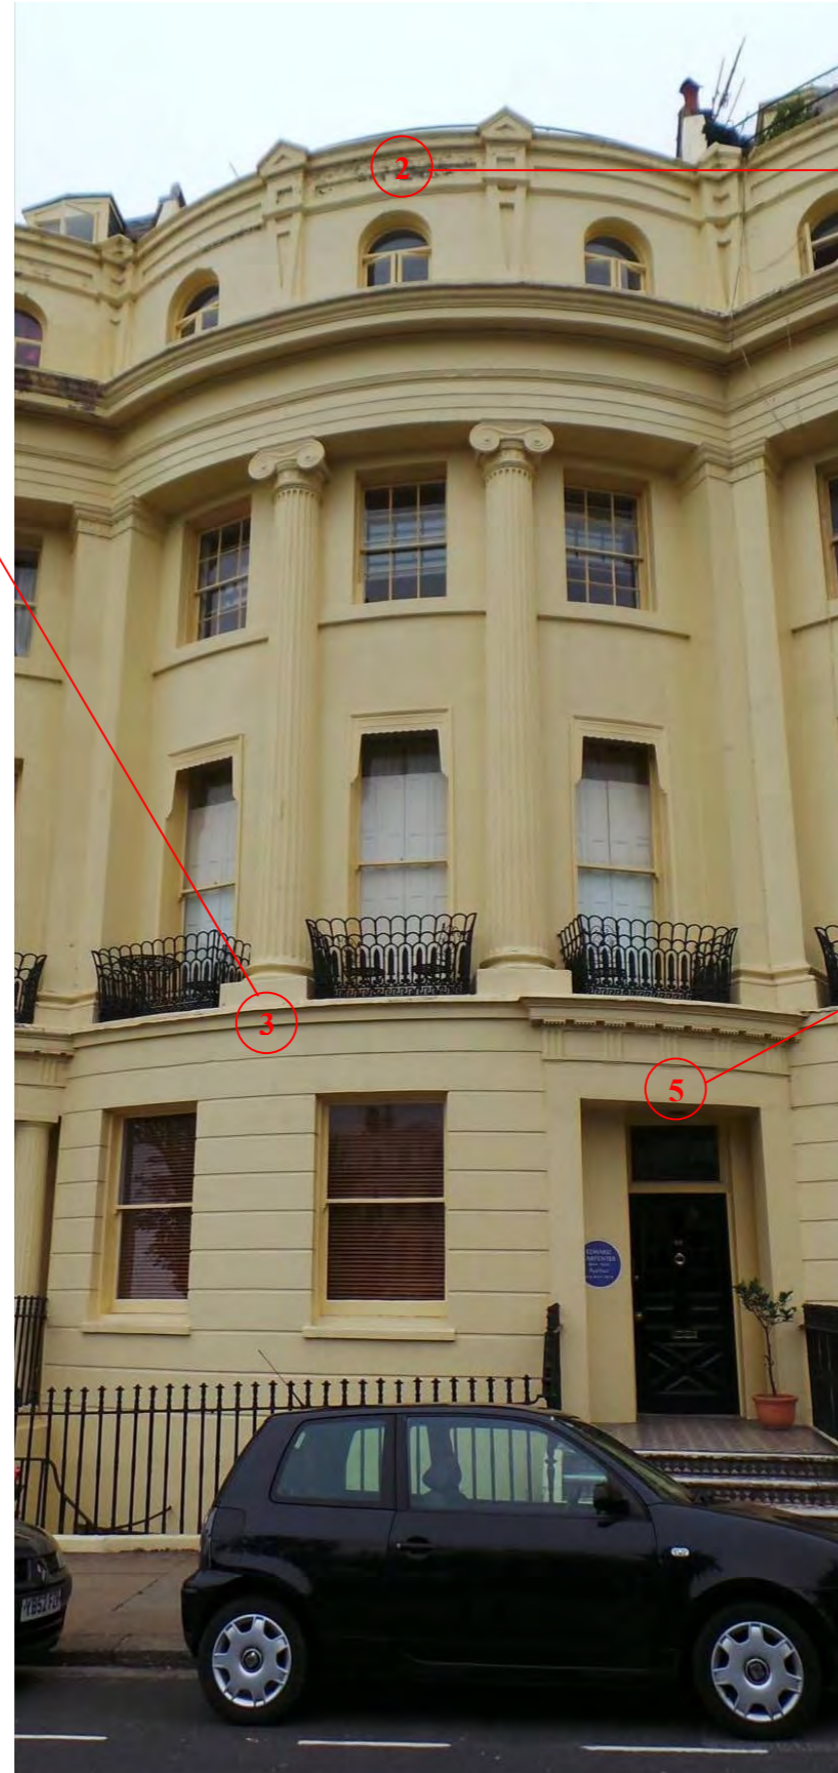
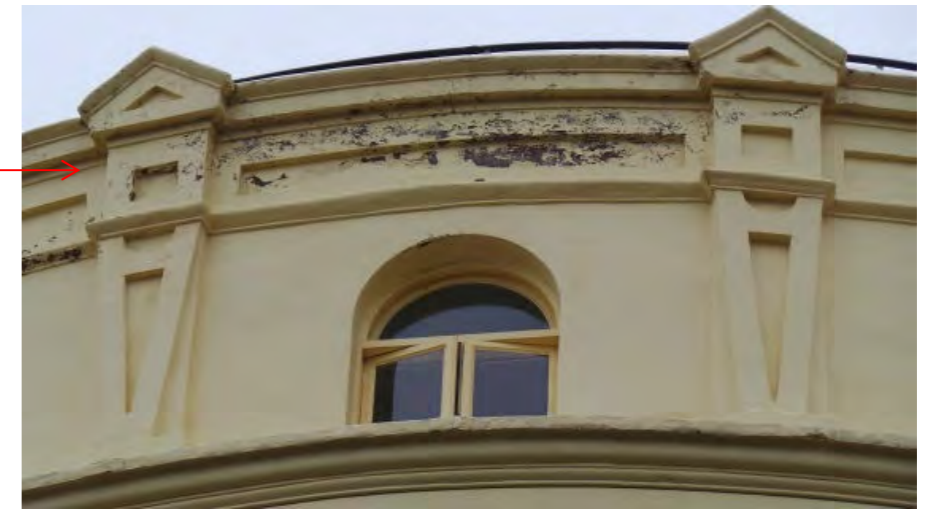
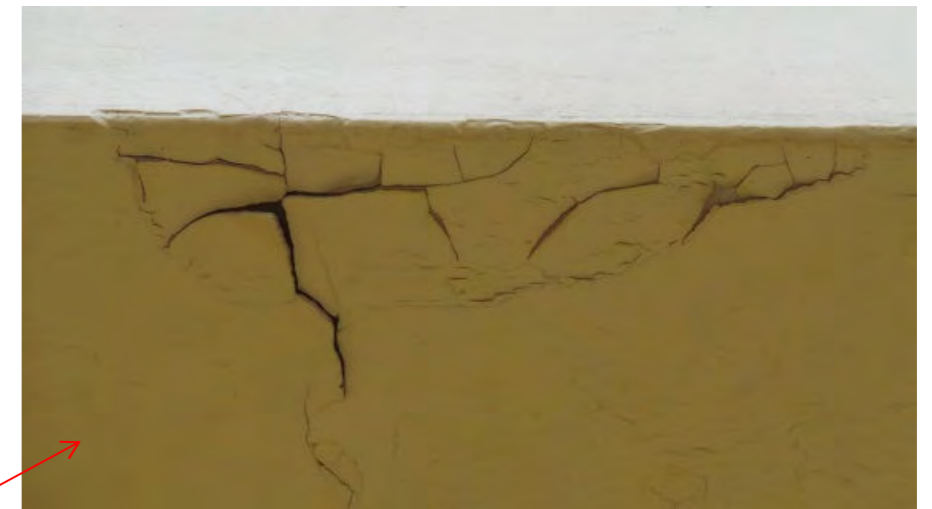
45 Brunswick Square

1. Generally the façade appears to be in reasonably good condition;
2. Extensive paint flaking to centre panel at parapet level;
3. Staining and paint flaking to cornice beneath balconies;
4. Localised salt deliquescence to base of right hand column (first floor level);
5. Paint flaking to underside of porch;
6. Salt deliquescence above the basement right hand window;
7. Paint flaking on the masonry below the railings adjacent the front door and the pavement

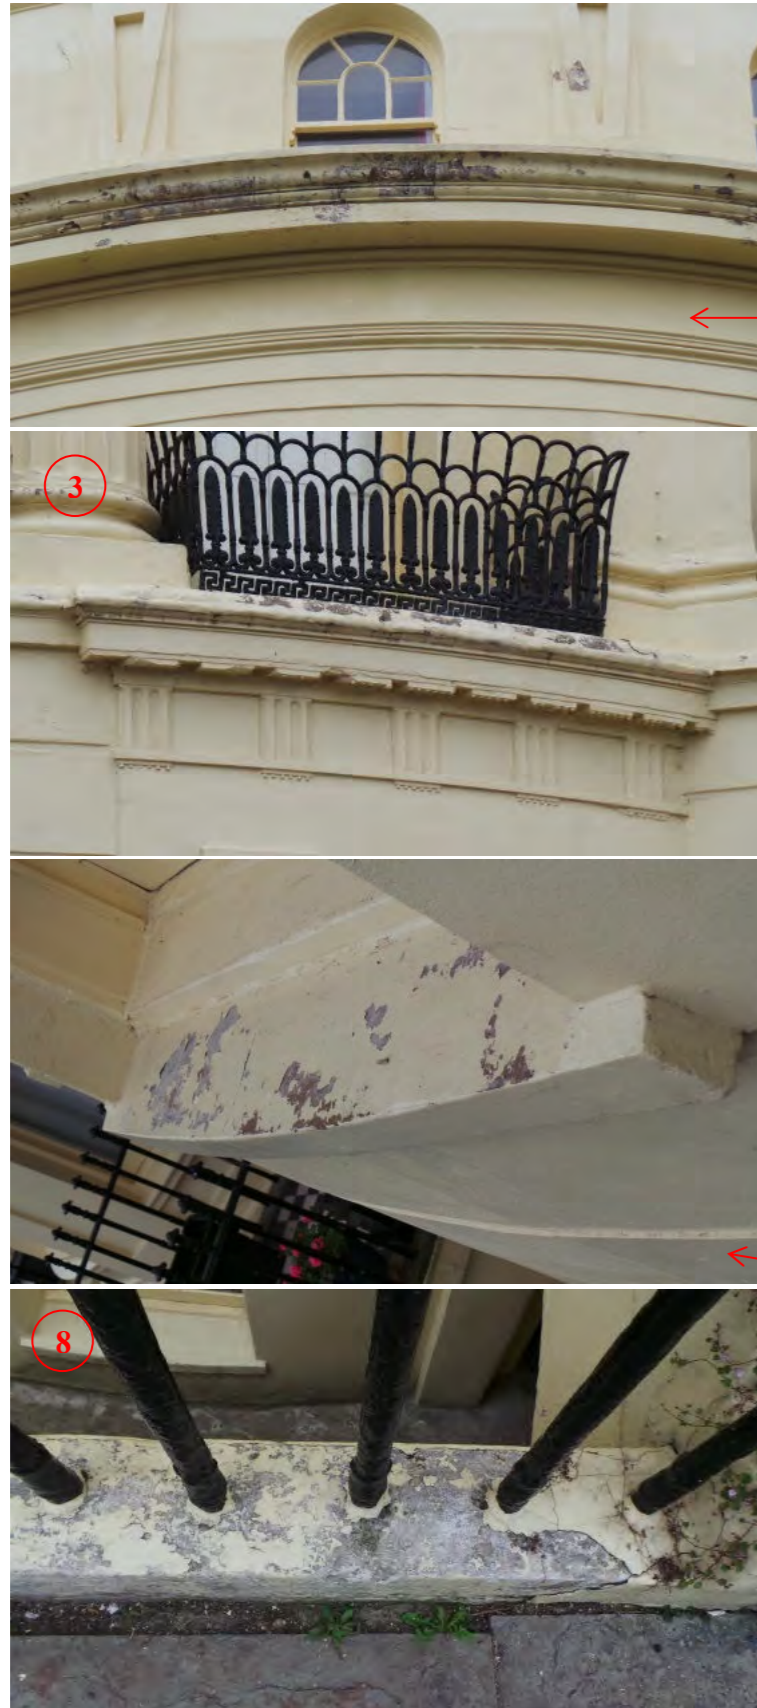
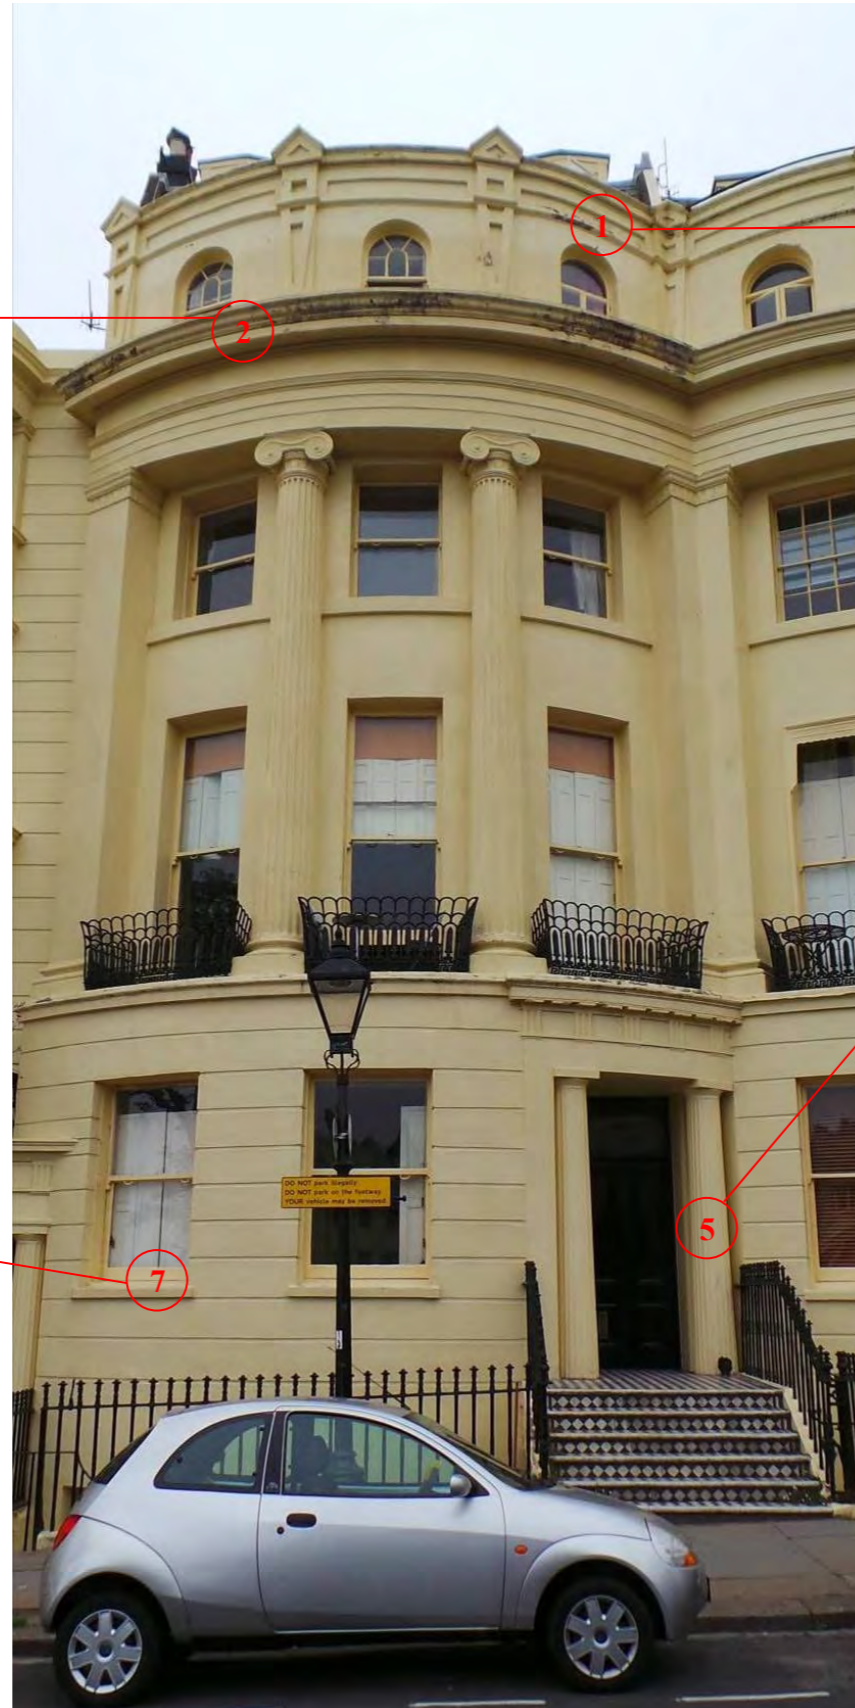
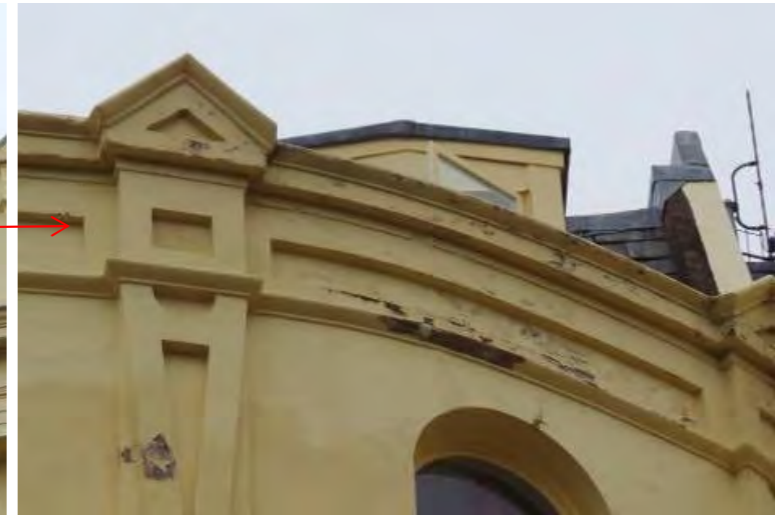
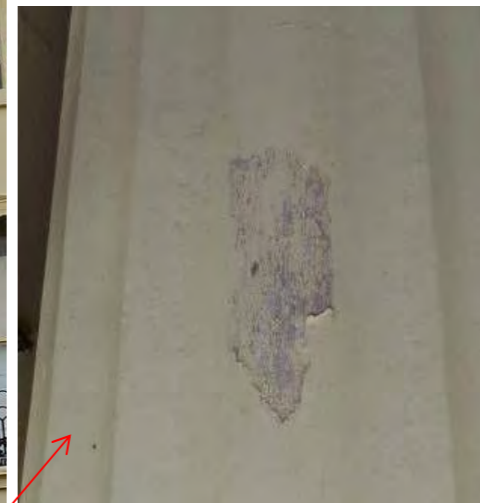
46 Brunswick Square

1. Extensive paint flaking to panelling at parapet level;
2. Extensive paint flaking to cornice at parapet level;
3. Staining and paint flaking to cornice beneath balconies;
4. Localised salt deliquescence to base of left hand column (first floor level);
5. Paint flaking underneath the porch frieze;
6. Paint flaking to right hand side of entrance column;
7. Paint flaking to ground floor window ledge;
8. Paint flaking on the masonry below the railings adjacent the front door and the pavement.

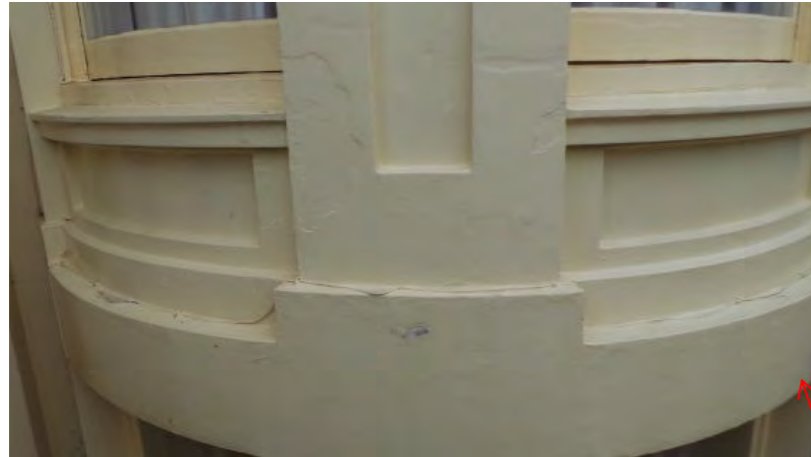
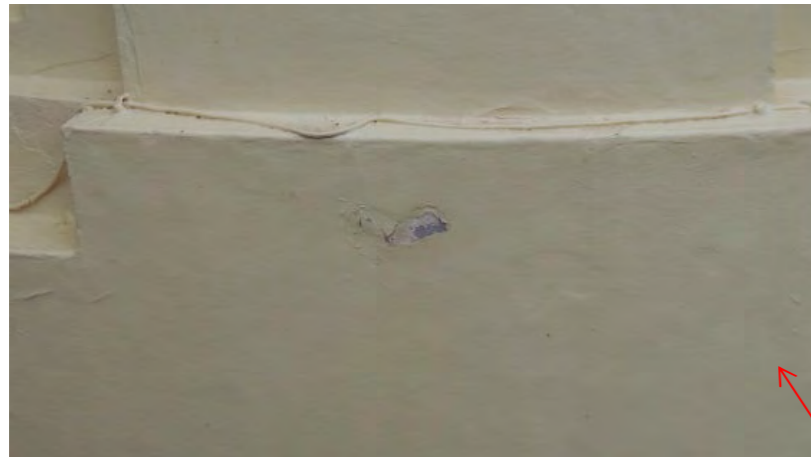
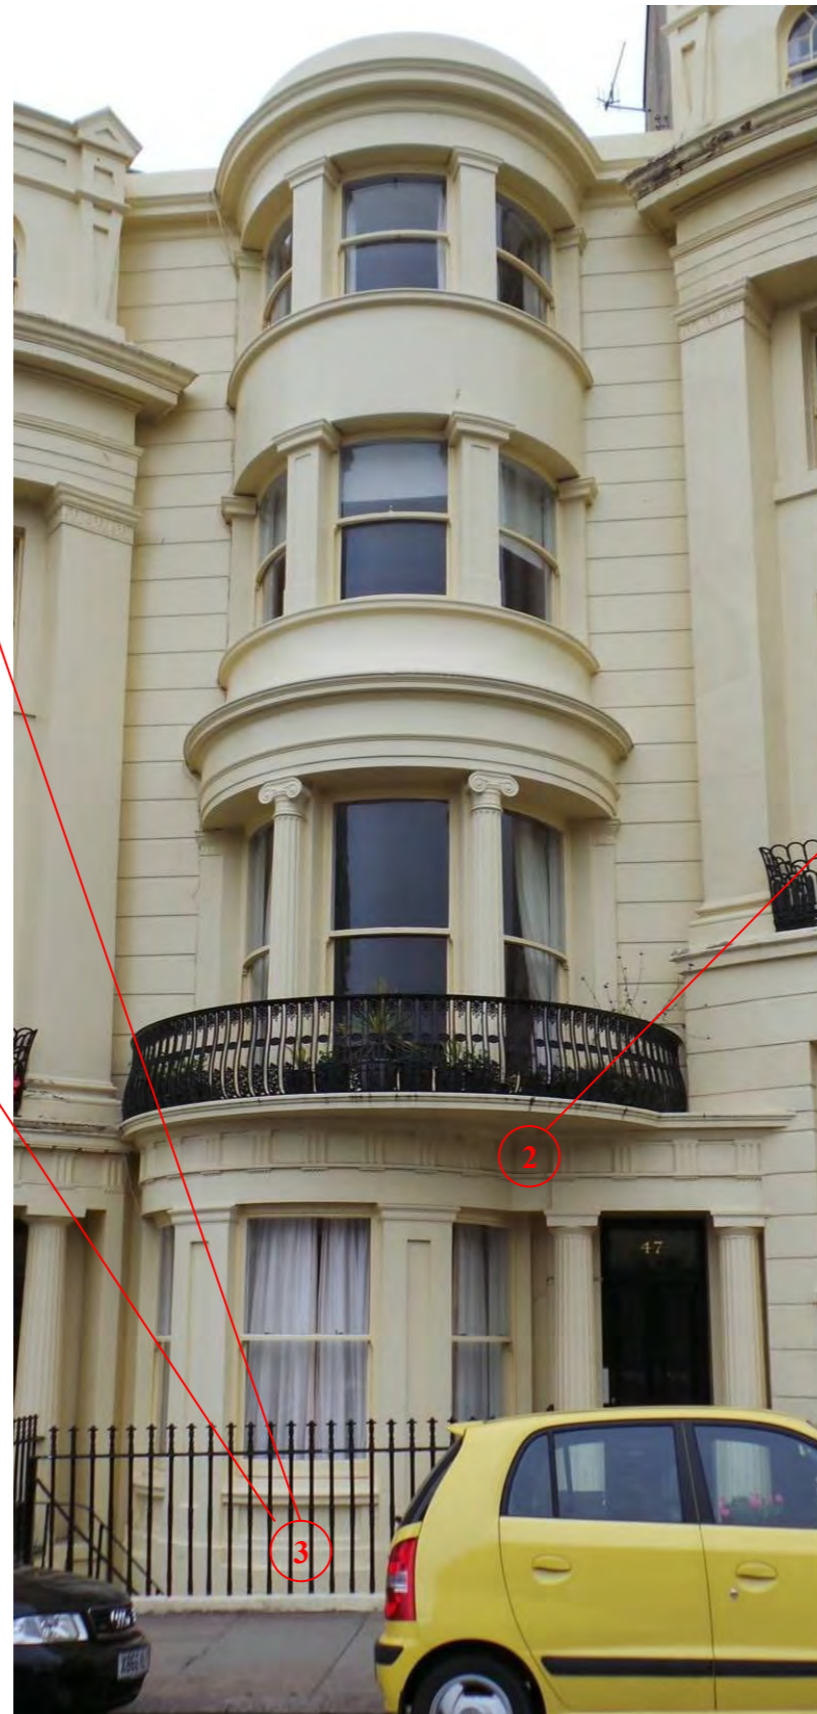
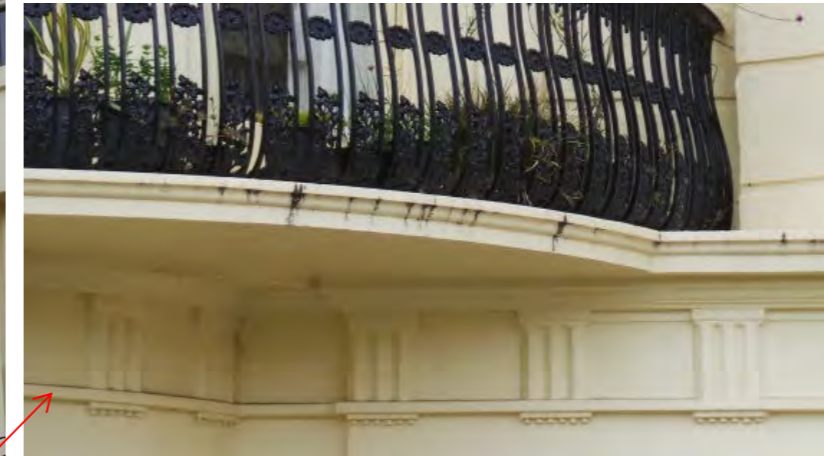
47 Brunswick Square

1. Generally the façade appears to be in reasonably good condition;
2. Extensive staining to cornice beneath balcony;
3. Localised salt deliquescence and paint flaking to panelling beneath the bay window (ground floor level).

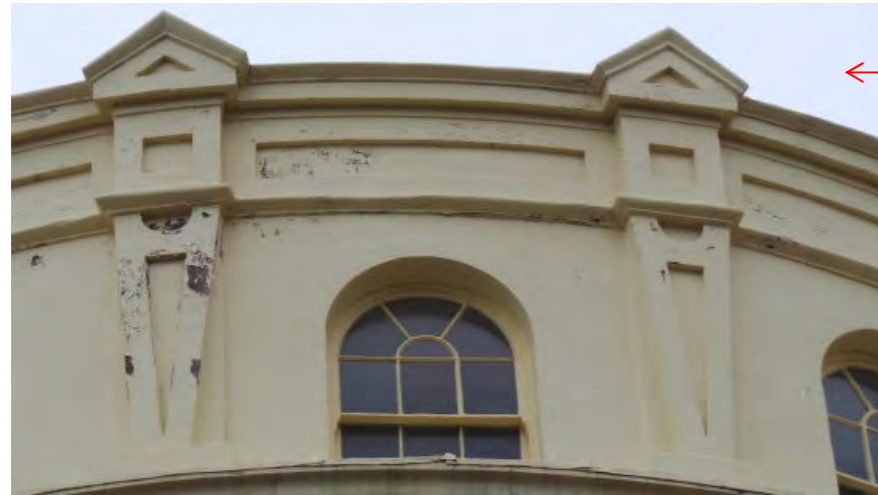
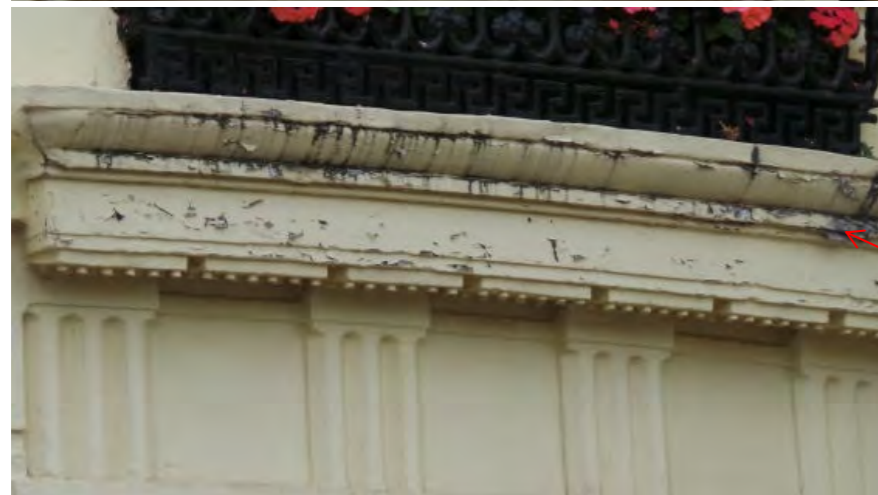
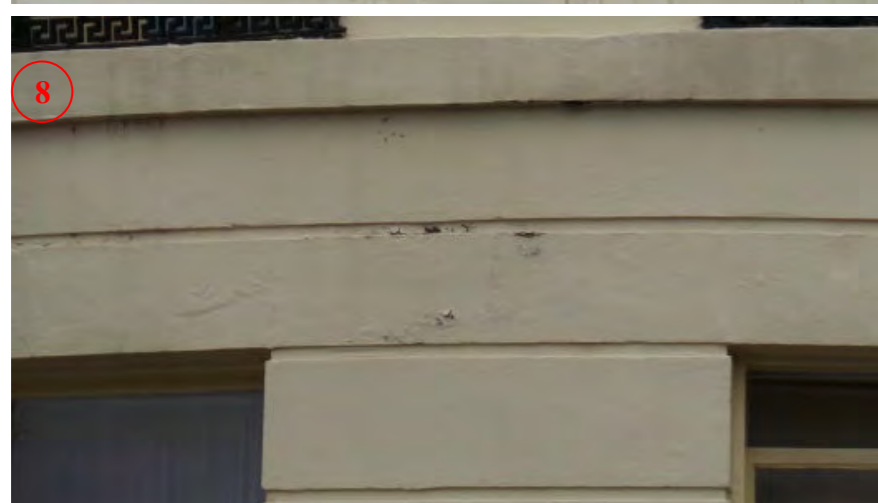
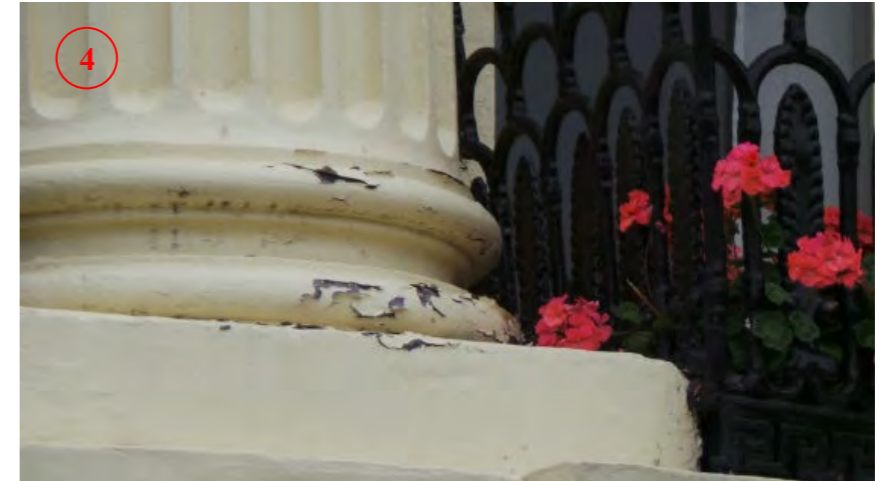
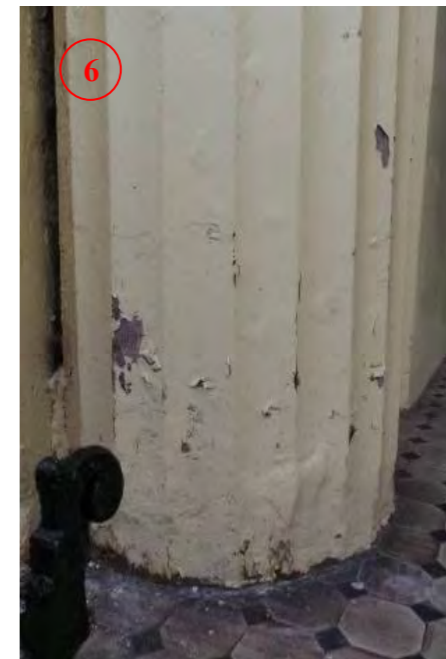
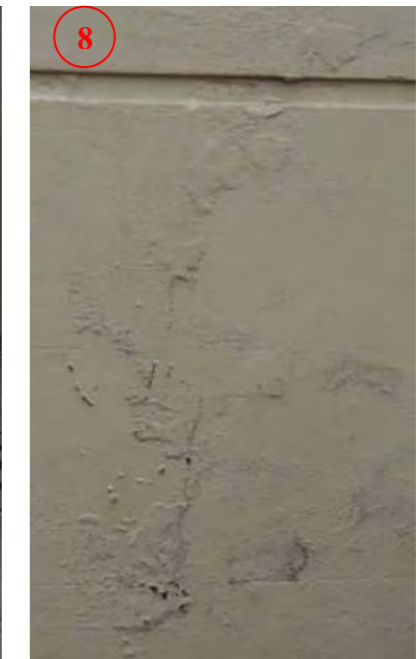
48 Brunswick Square

1. Extensive paint flaking to panelling at parapet level;
2. Extensive paint flaking to cornice at parapet level;
3. Staining and paint flaking to cornice beneath balconies;
4. Localised salt deliquescence and paint flaking to base of the right hand column (first floor level);
5. Paint flaking underneath the entablature above the second floor central window;
6. Paint flaking to entrance columns and adjacent wall;
7. Paint flaking and salt deliquescence above the ground floor windows;
8. Paint flaking and salt deliquescence to walls at basement and ground floor level.
