**Investigation of Paint Failure at
Brunswick Estate
Hove
Brighton**

August 2013

**BRUNSWICK ESTATE
HOVE**

The following document investigates the failure of the external paint-system at Brunswick Estate, Hove based on research carried out by Elizabeth Hirst and Rachel Morley of Hirst Conservation between August and November 2013. The work was commissioned by Brighton & Hove City Council.

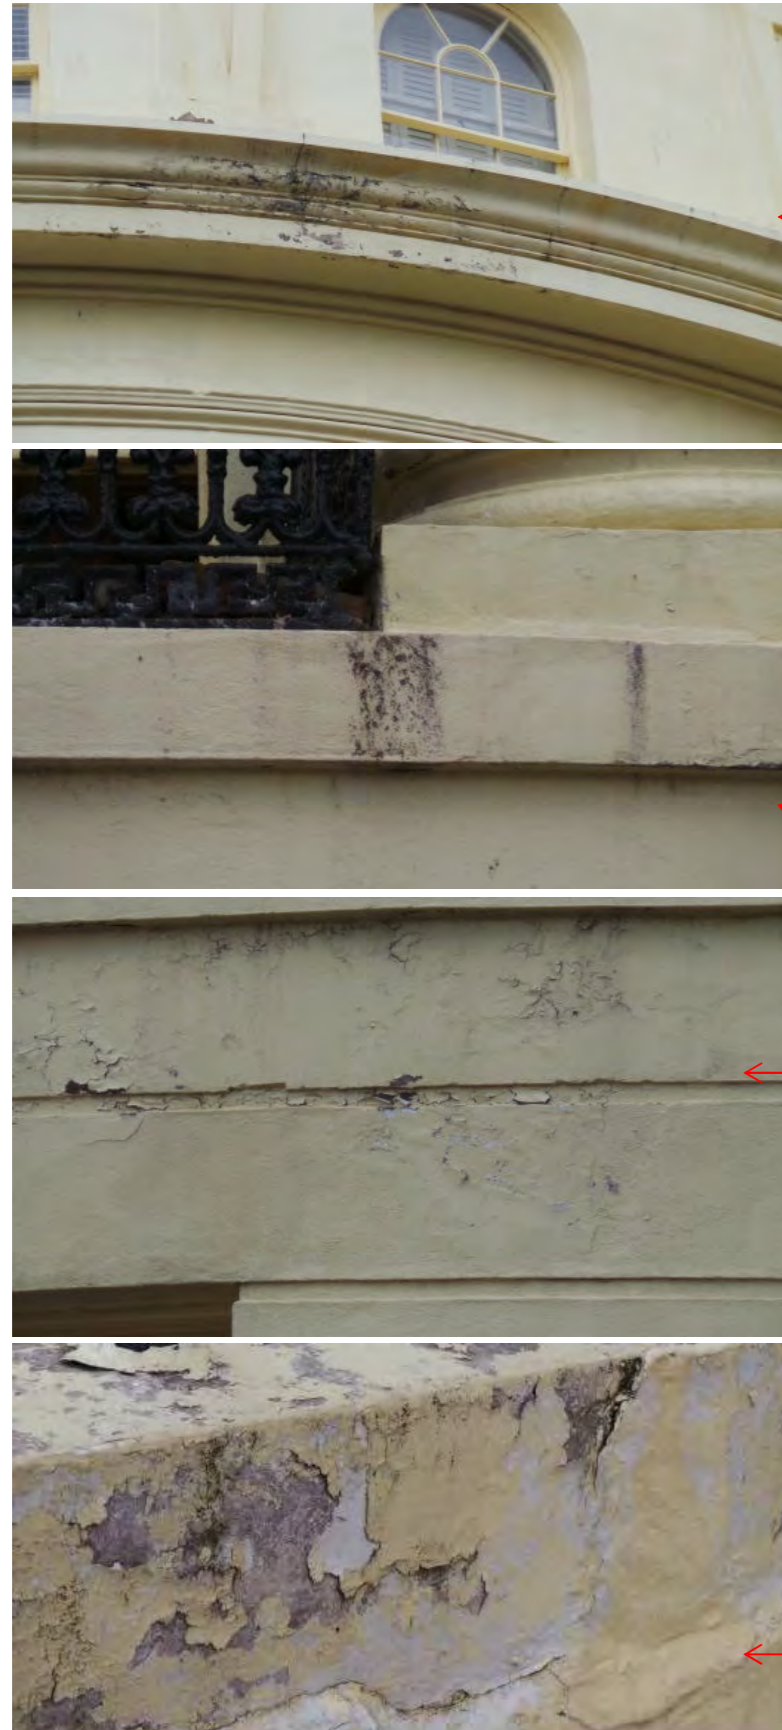
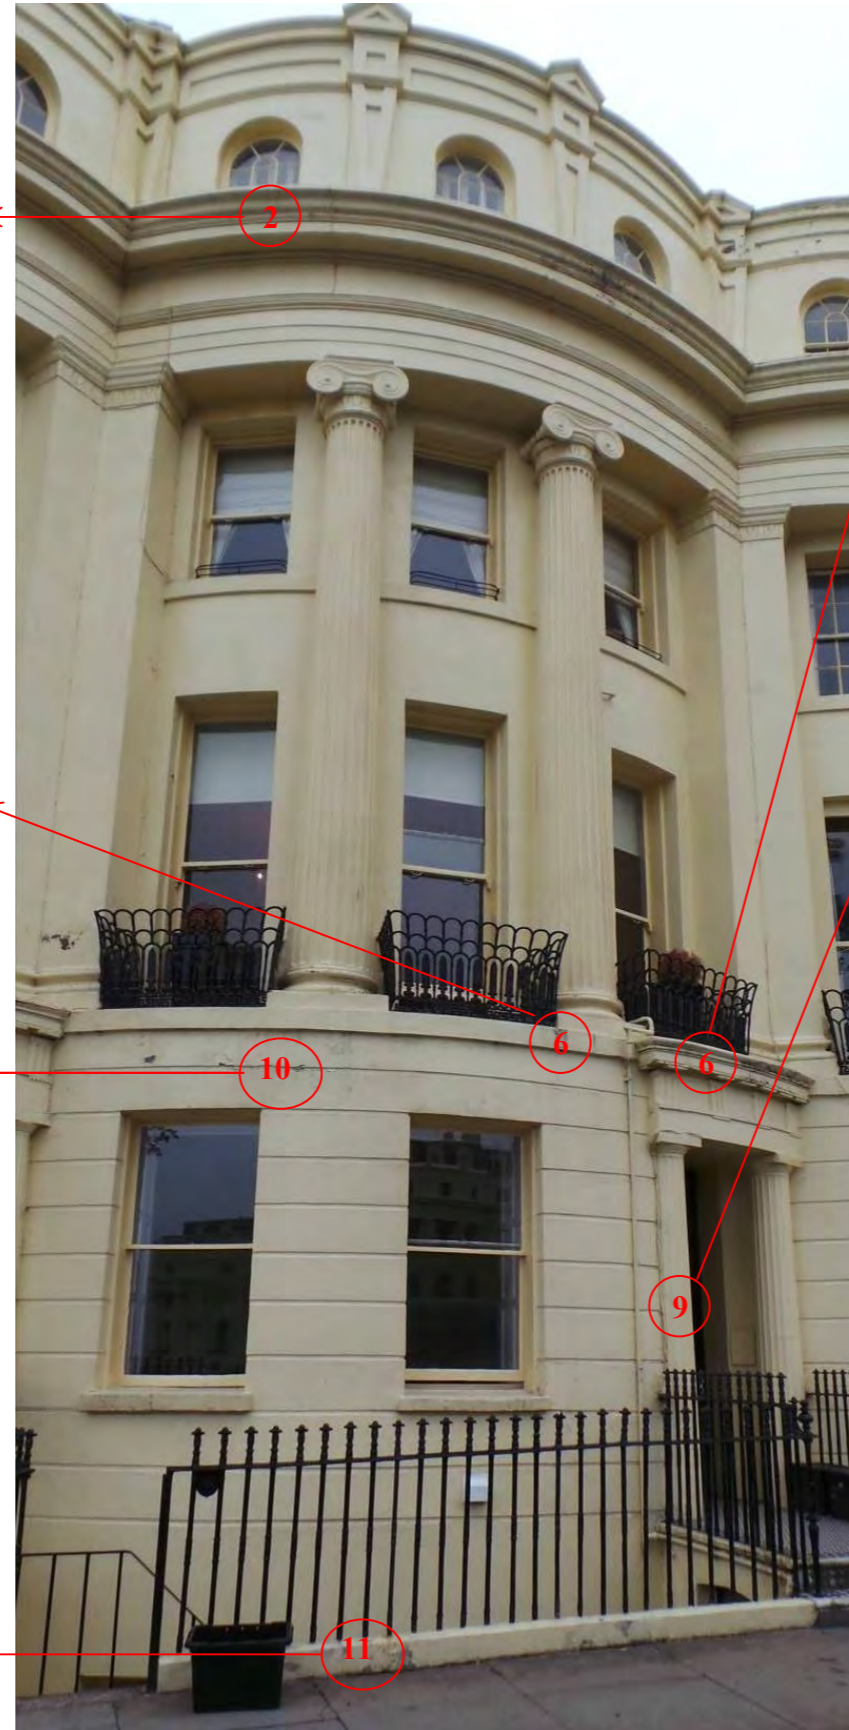
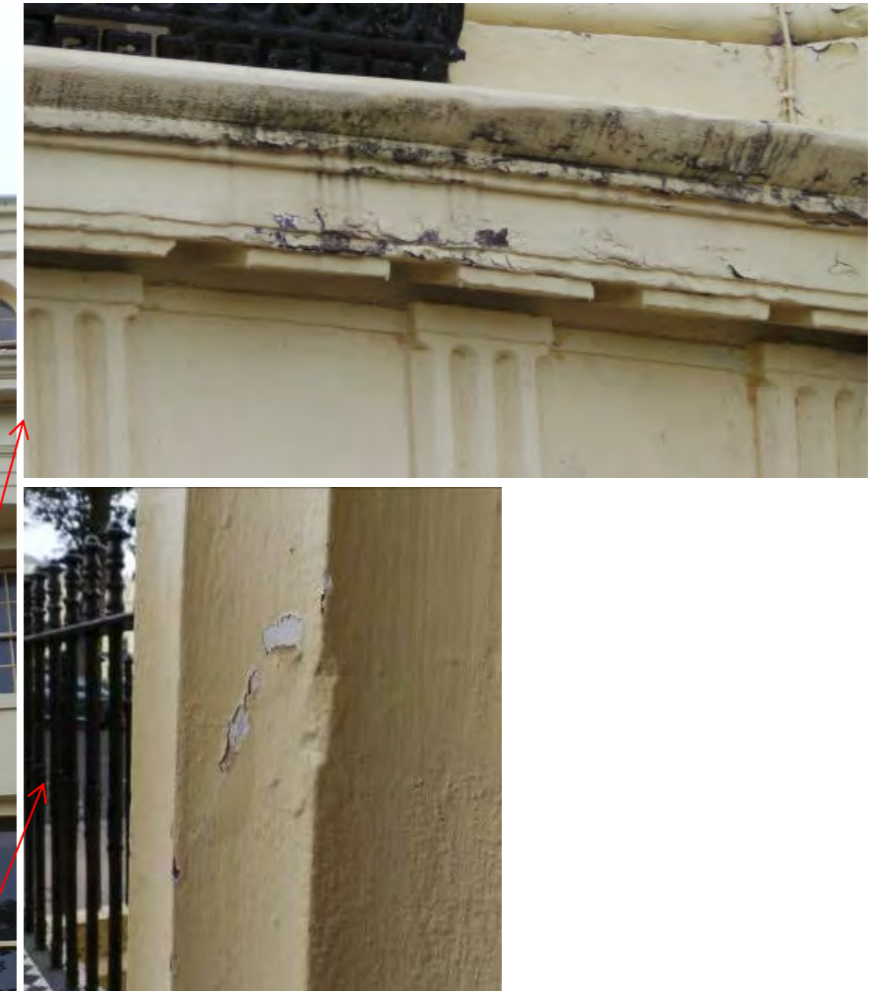
49 Brunswick Square

1. Extensive paint flaking to right hand pediment and panelling below at parapet level;
2. Extensive paint flaking to cornice;
3. Paint flaking to central window rebate under the entablature (second floor level);
4. Patch of yellow-beige re-touching in right hand corner of the right window and above the left hand window (second floor level);
5. Staining to left hand side of the left hand side balcony;
6. Staining and paint flaking to cornice beneath balconies;
7. Localised salt deliquescence and flaking to base of the left hand column (first floor level);
8. Patch of yellow beige re-touching and paint runs on the capital at the top of the right hand side column;
9. Paint flaking to left hand side entrance column;
10. Extensive paint flaking and salt deliquescence above the ground floor windows;
11. Paint flaking to plinth wall.

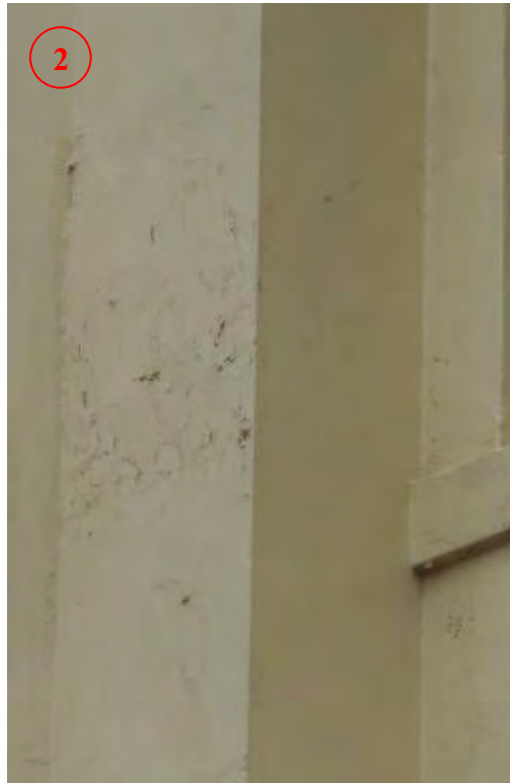
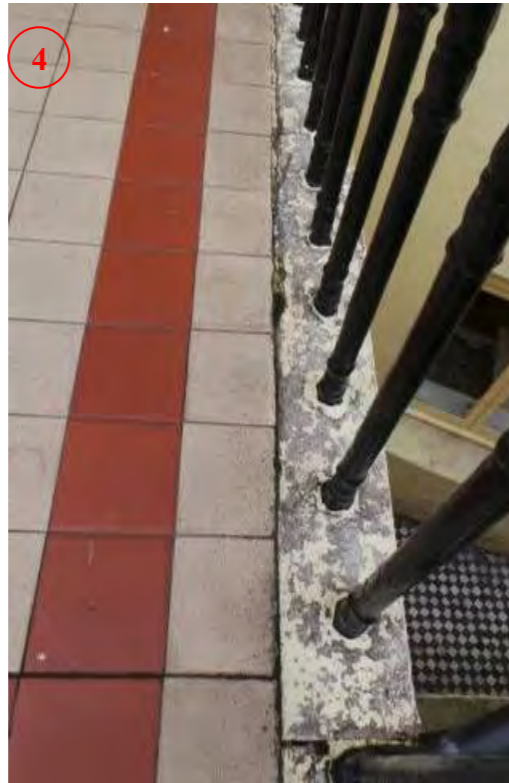
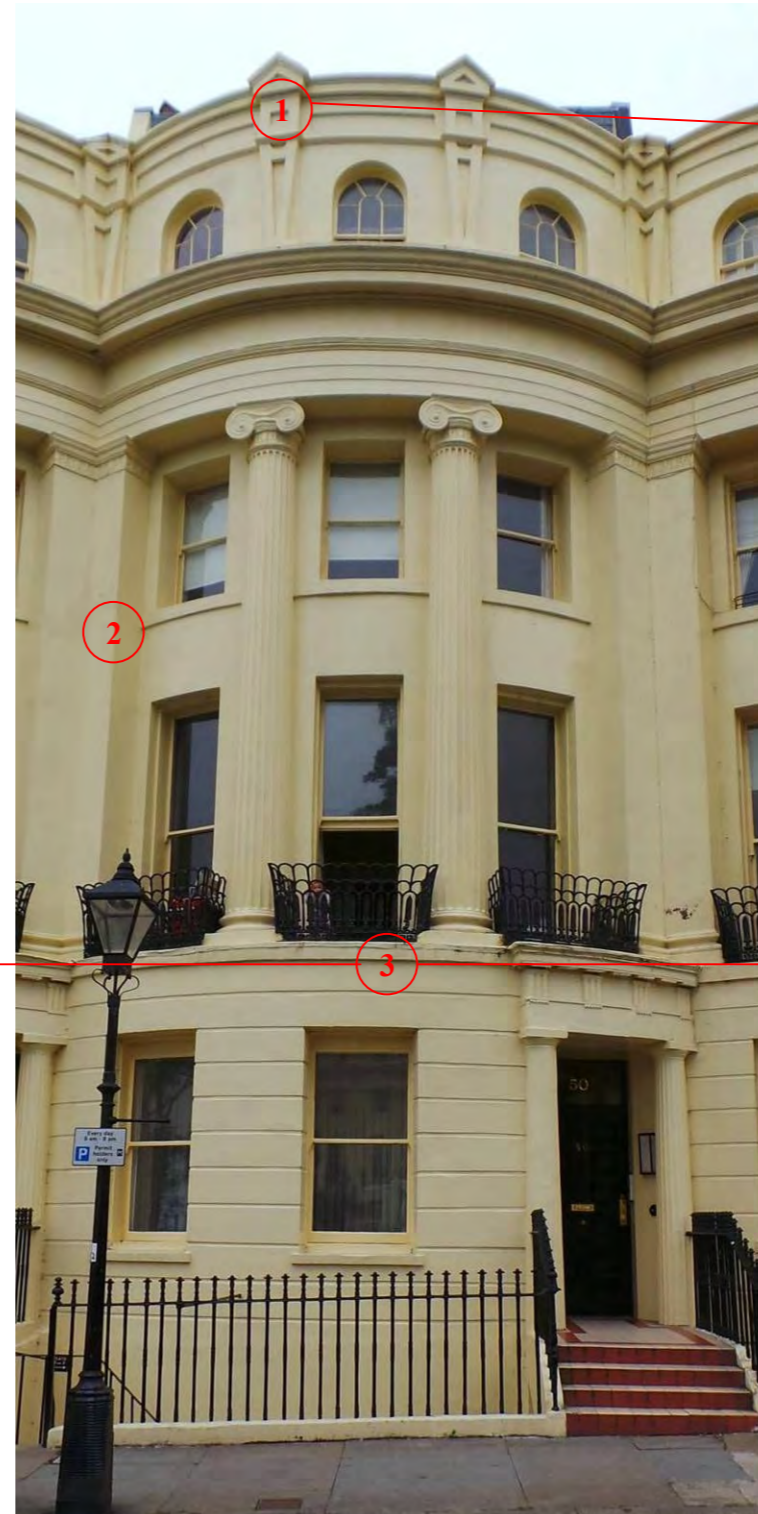
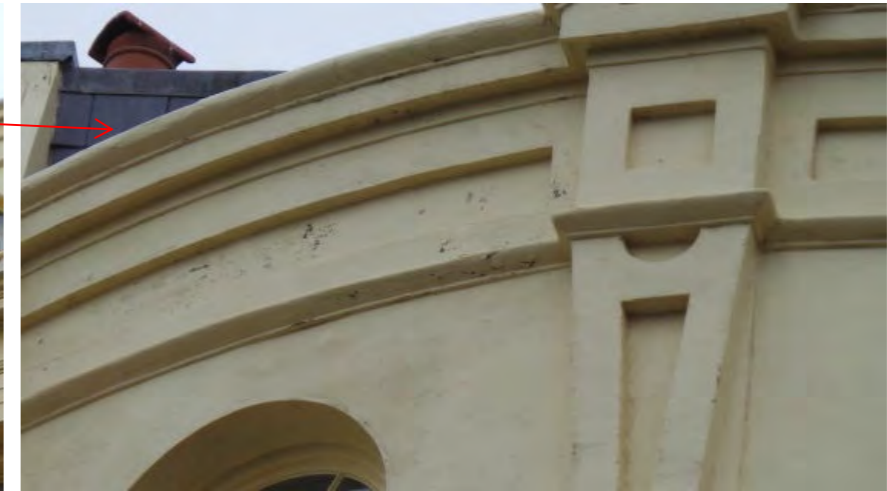
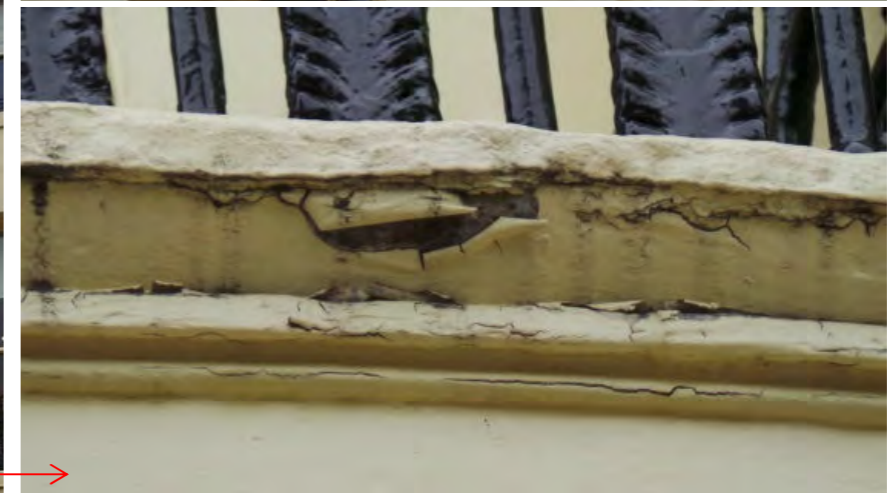
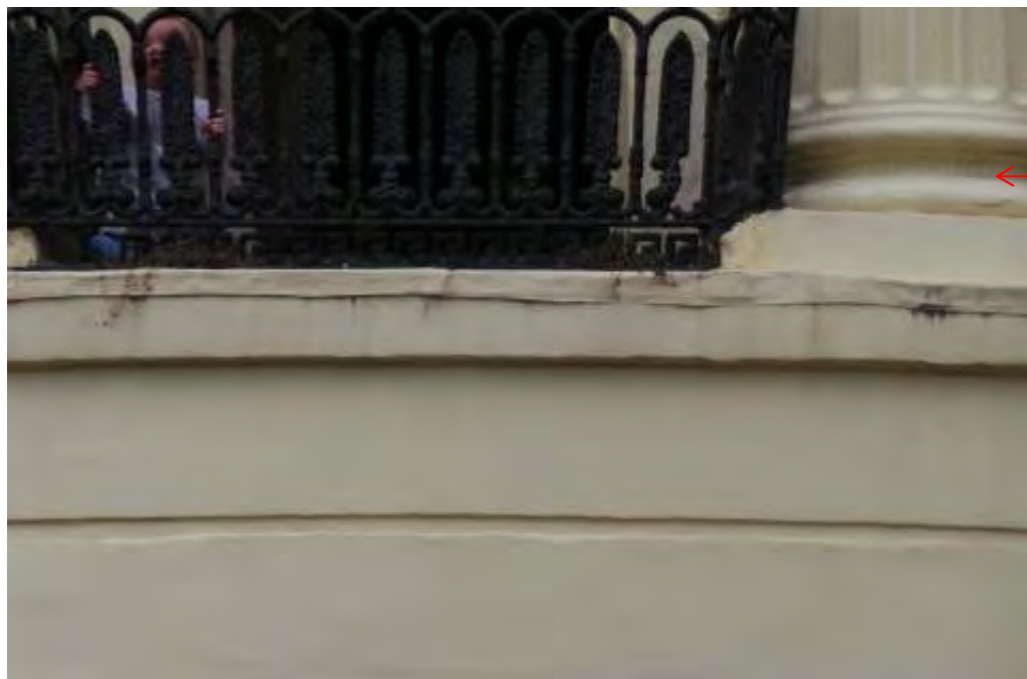
50 Brunswick Square

1. Localised paint flaking on the panelling at parapet level;
2. Extensive paint flaking and salt deliquescence to square pilaster on the left hand side (third floor level);
3. Staining and paint flaking to cornice beneath balconies;
4. Paint flaking to plinth wall.

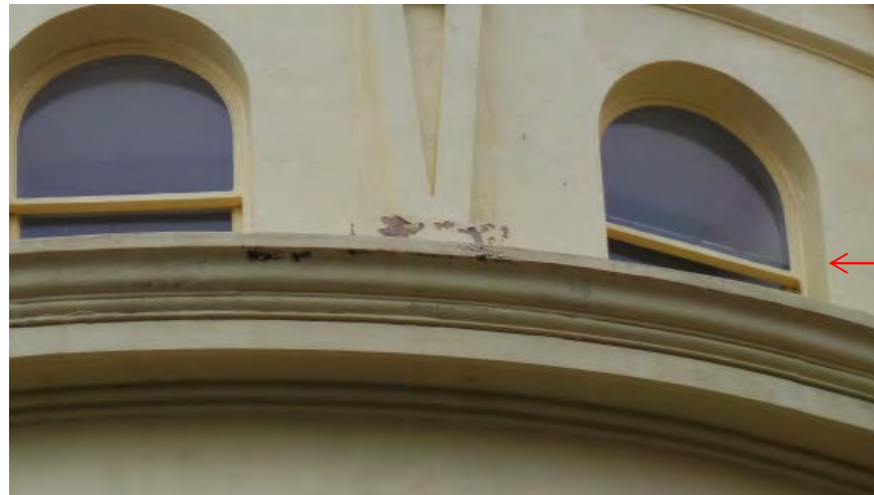
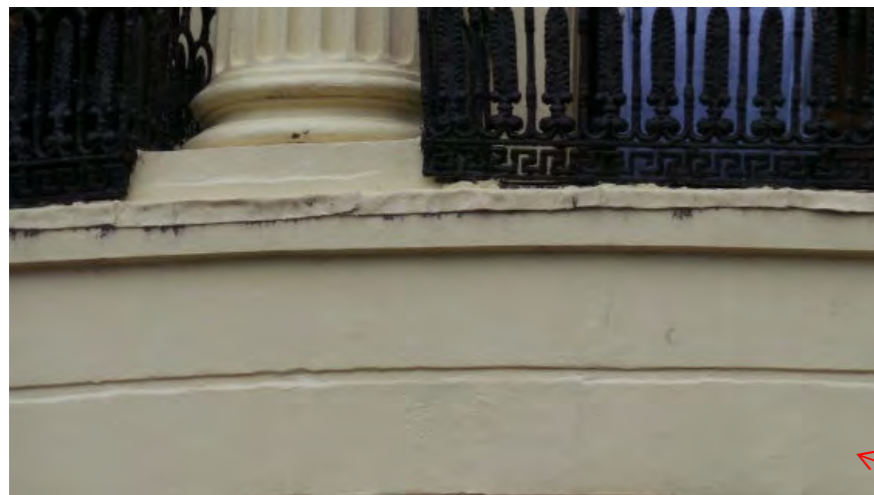
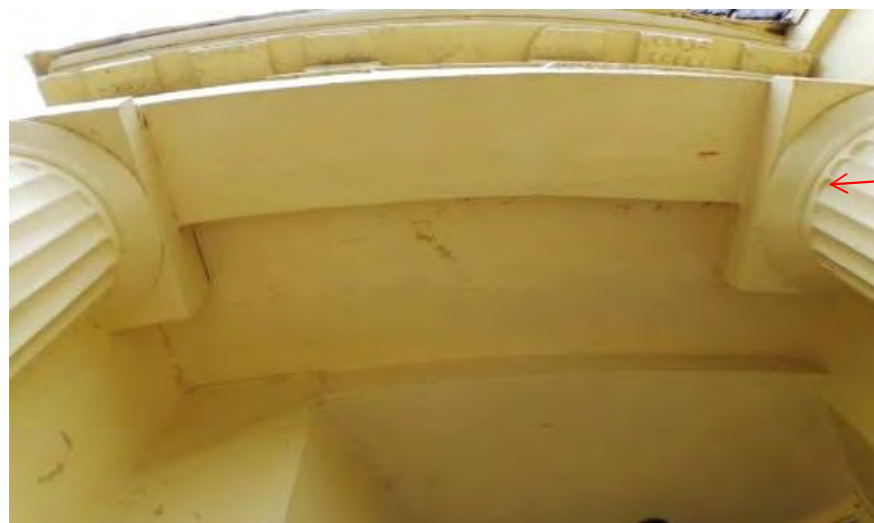
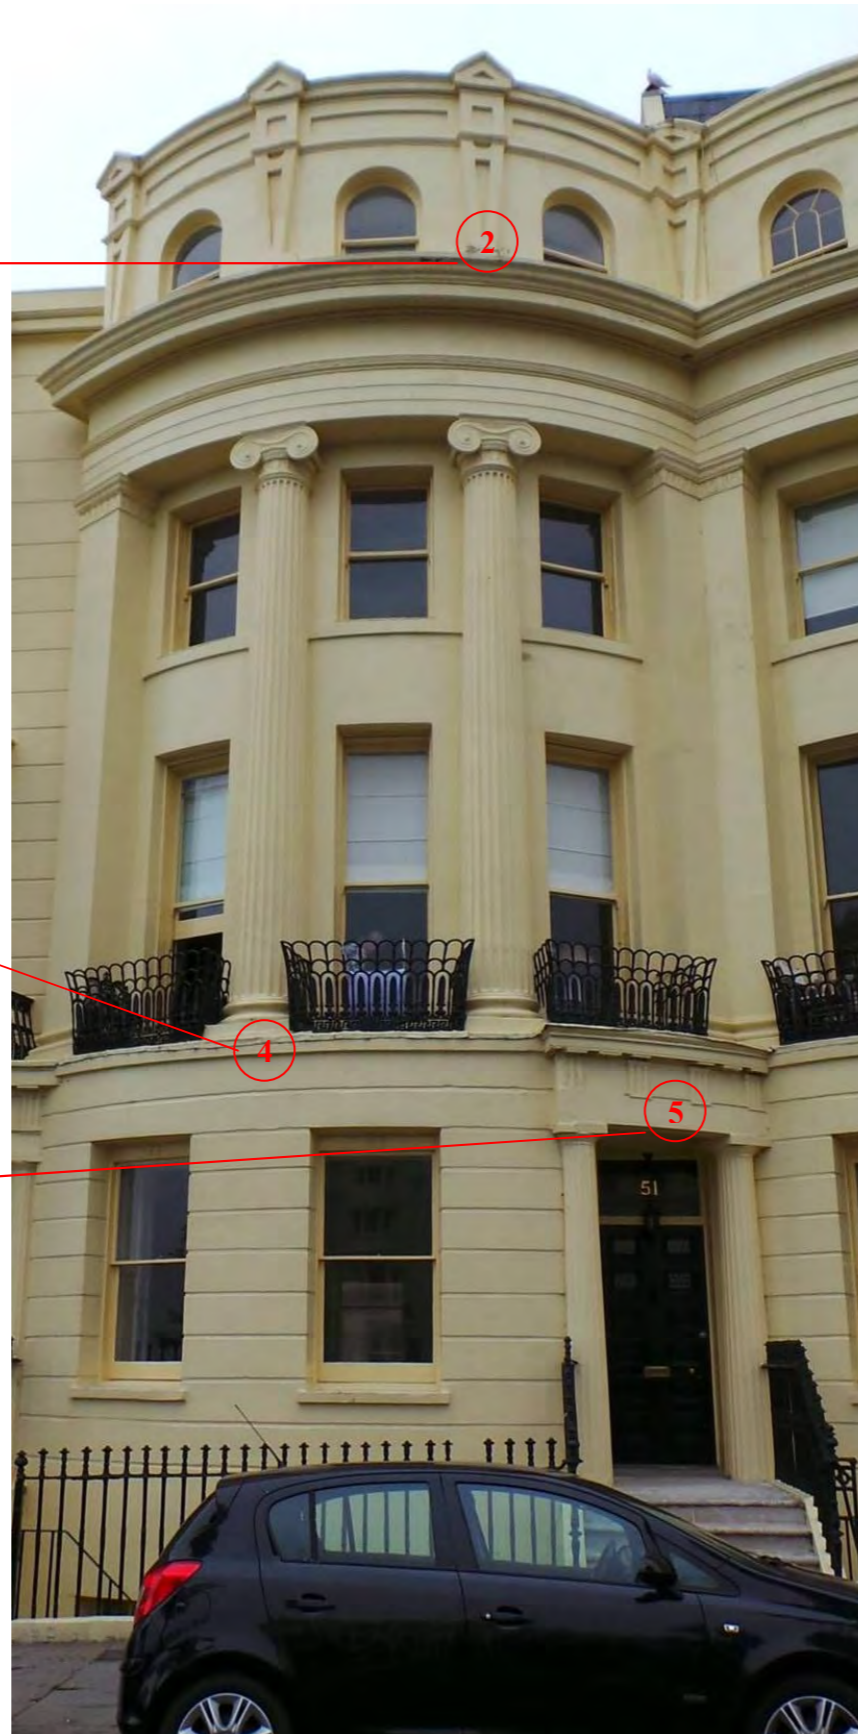
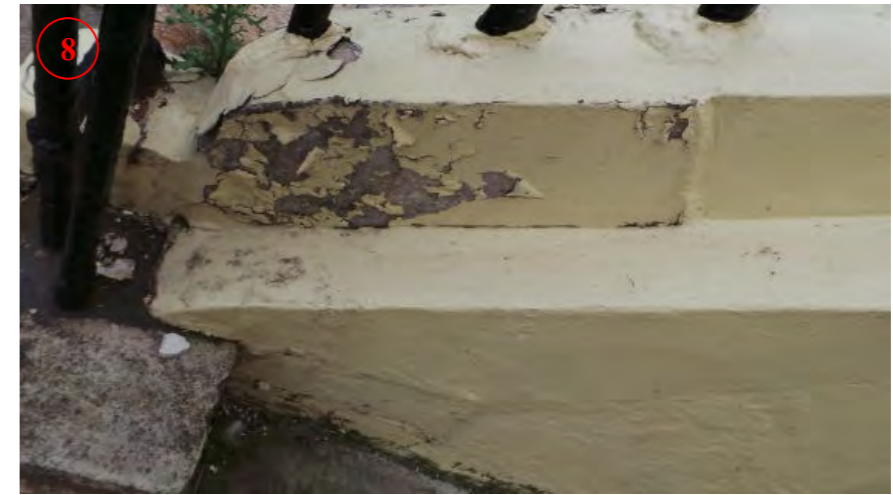
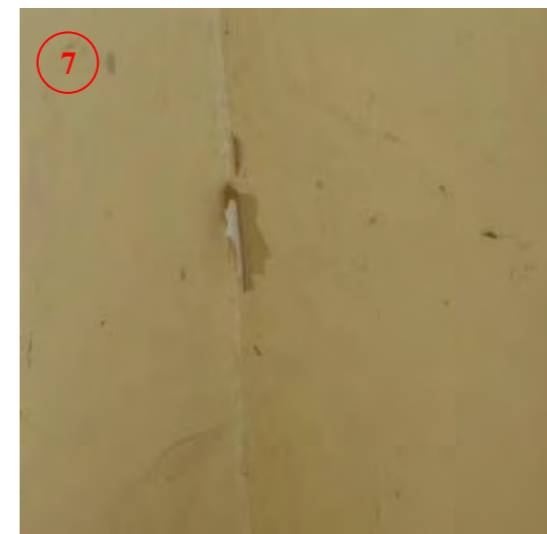
51 Brunswick Square

1. Paint flaking to left hand side panelling at parapet level;
2. Paint flaking to base of the right hand side of column of parapet;
3. Paint flaking to front and underside of right hand side cornice;
4. Paint flaking to cornice beneath balconies;
5. Paint flaking to underside of porch;
6. Localised paint flaking to right hand window ledge (ground floor level);
7. Paint flaking and salt deliquescence at basement level;
8. Paint flaking to plinth wall.

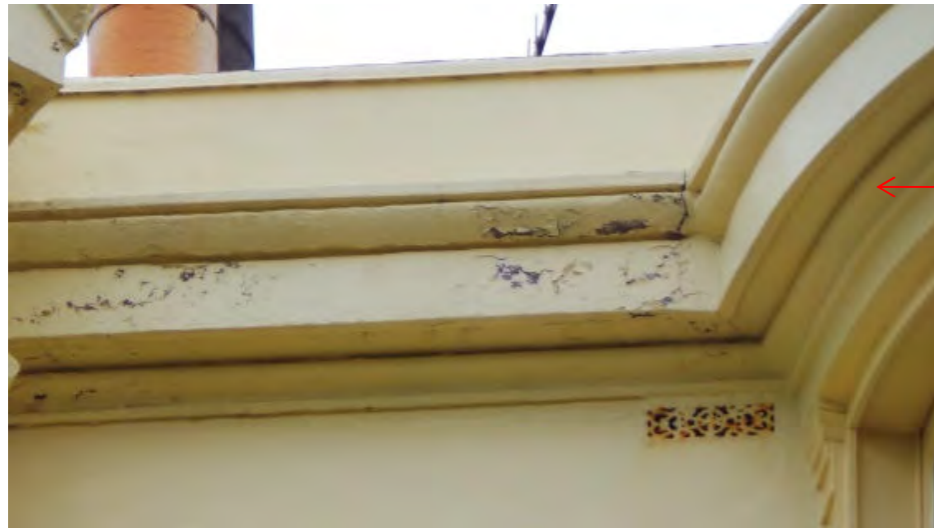
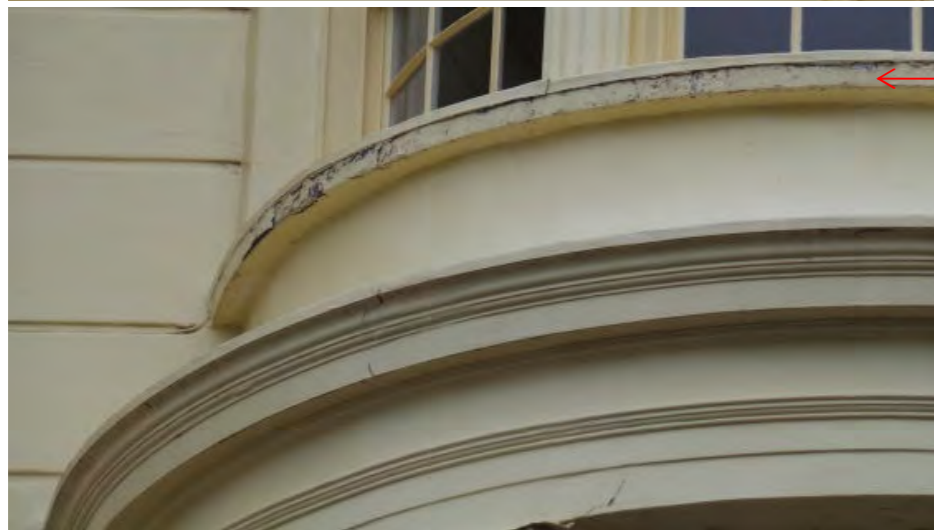
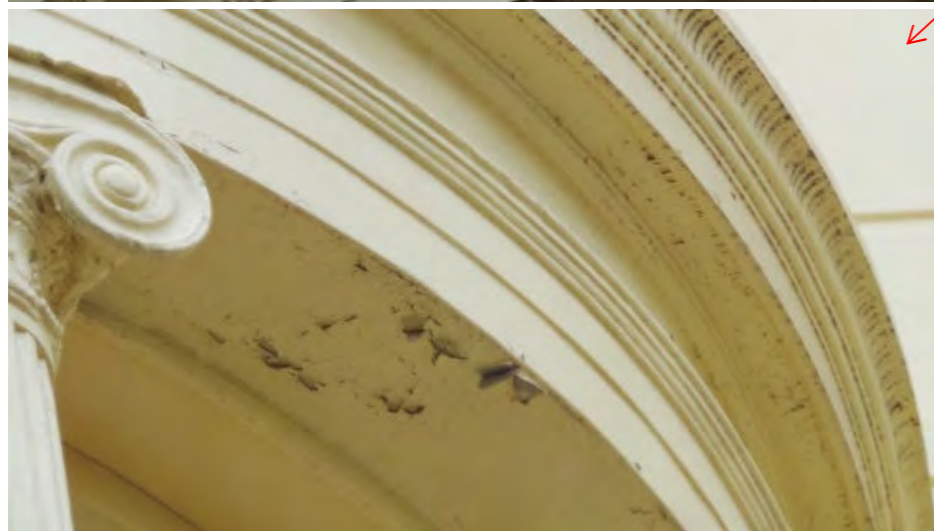
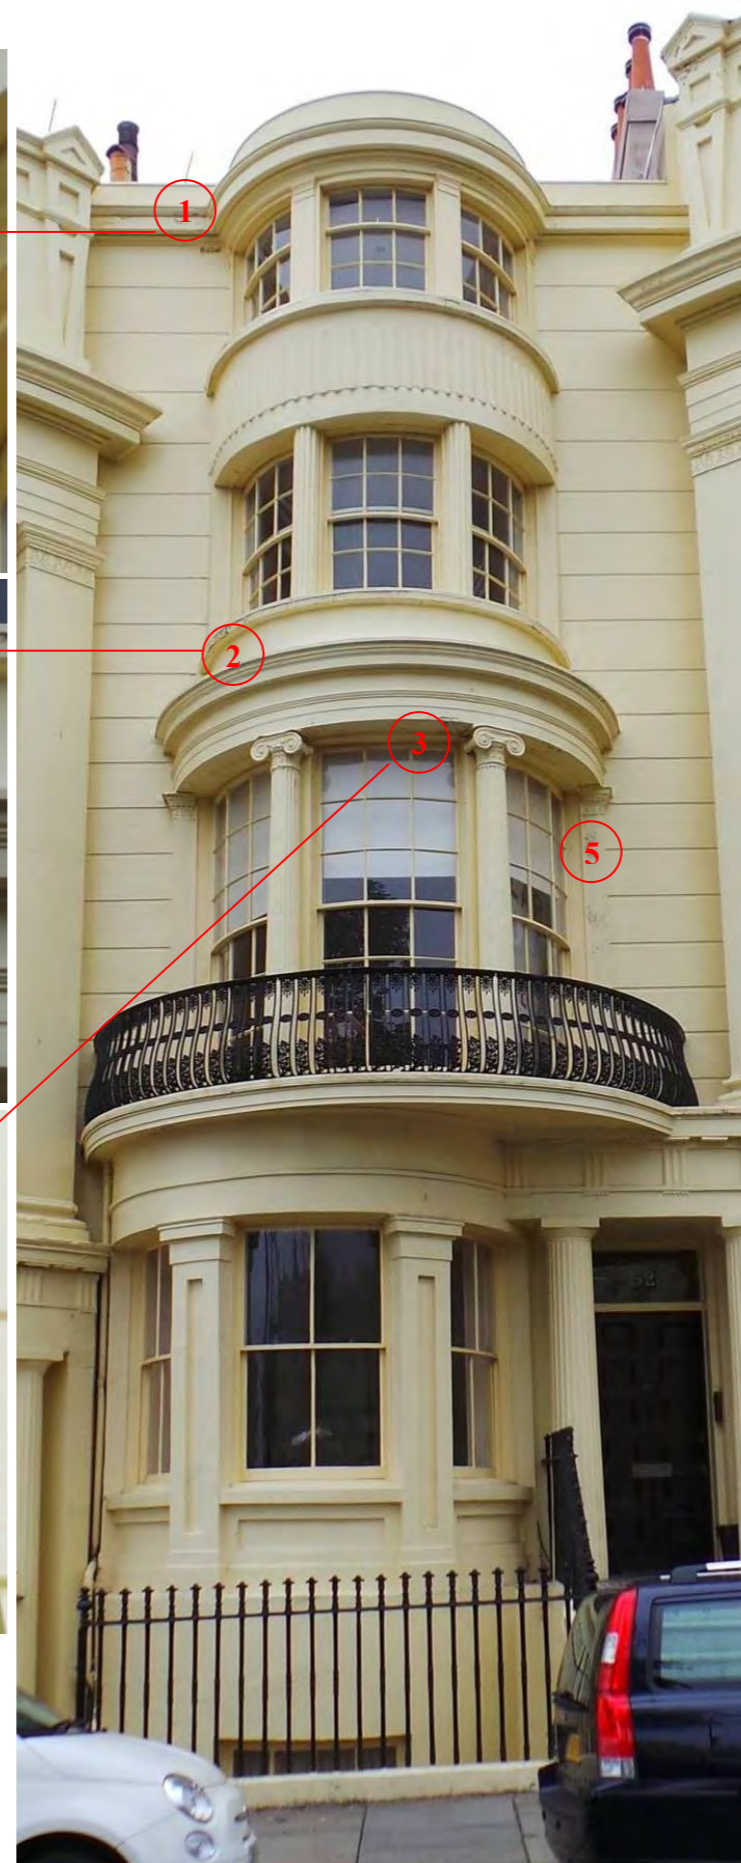
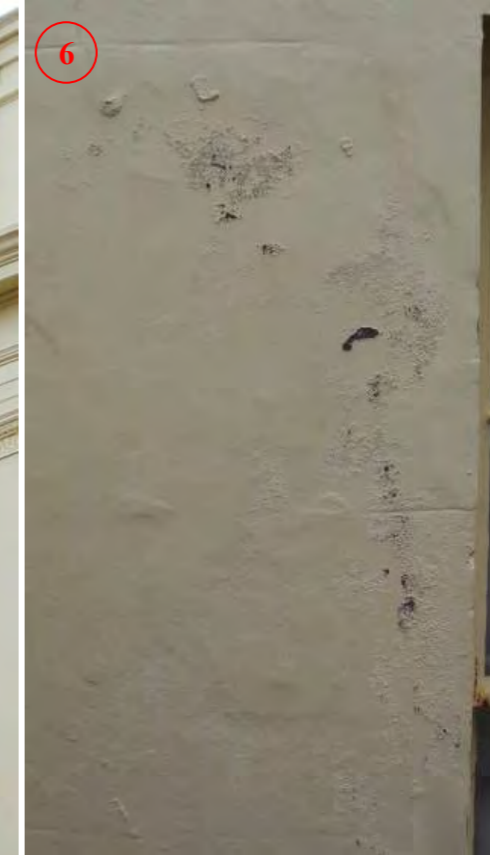
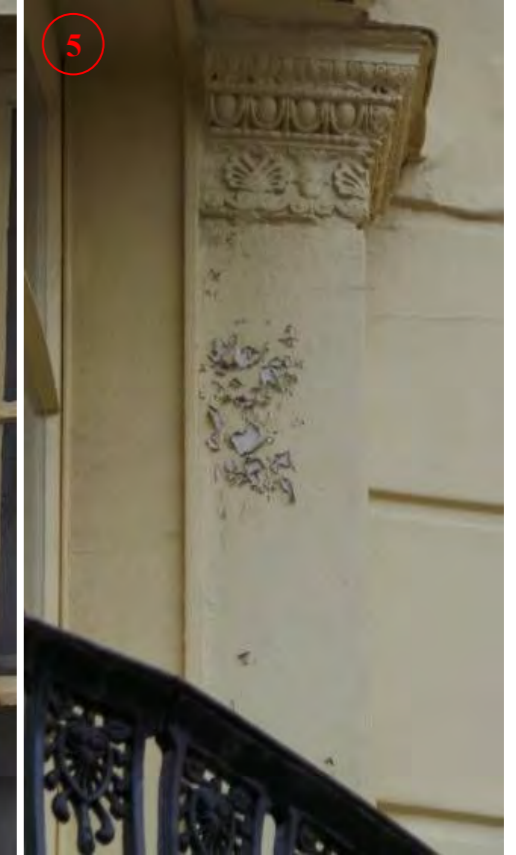
52 Brunswick Square

1. Paint flaking to left and right hand side of the cornice either side of the bowed window at third floor level;
2. Staining and paint flaking to bowed window ledge (second floor level);
3. Localised salt deliquescence and paint flaking to underside of the entablature between the first and second floor ;
4. Staining and paint flaking to cornice beneath balcony;
5. Salt deliquescence to right hand side of first floor window;
6. Extensive paint flaking and salt deliquescence at basement level;
7. Paint flaking to plinth.

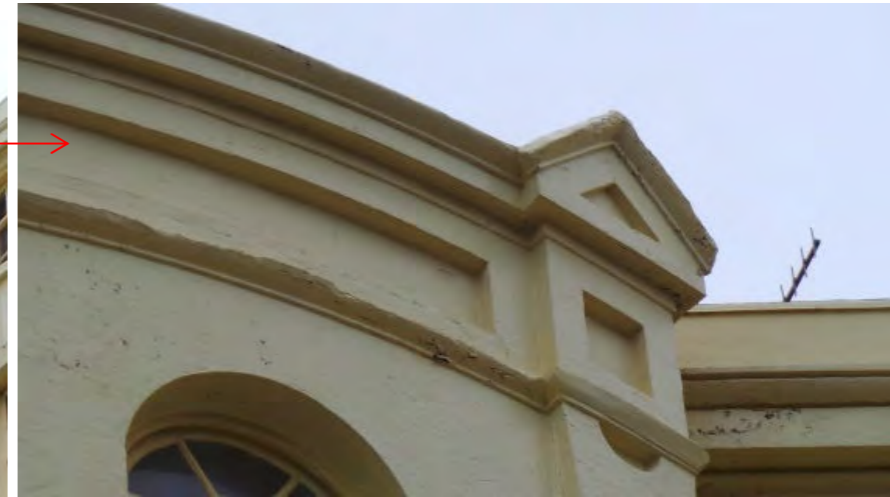
53 Brunswick Square

1. Generally the façade appears to be in reasonably good condition;
2. Paint flaking to right hand side panelling at parapet level (third floor level);
3. Salt deliquescence to centre of the cornice;
4. Damaged and partly missing scroll detail on the right hand side of the left ionic capital (second floor level);
5. Localised salt deliquescence on the wall beneath the ground floor windows (first floor level);

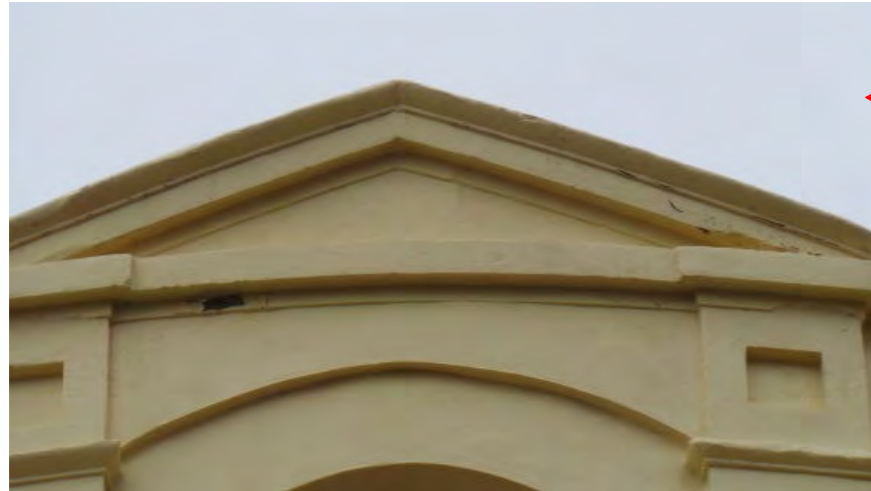
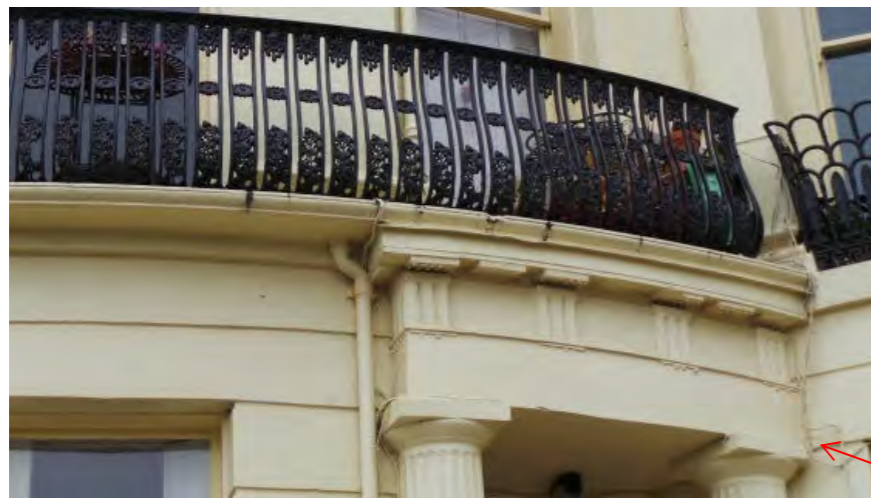
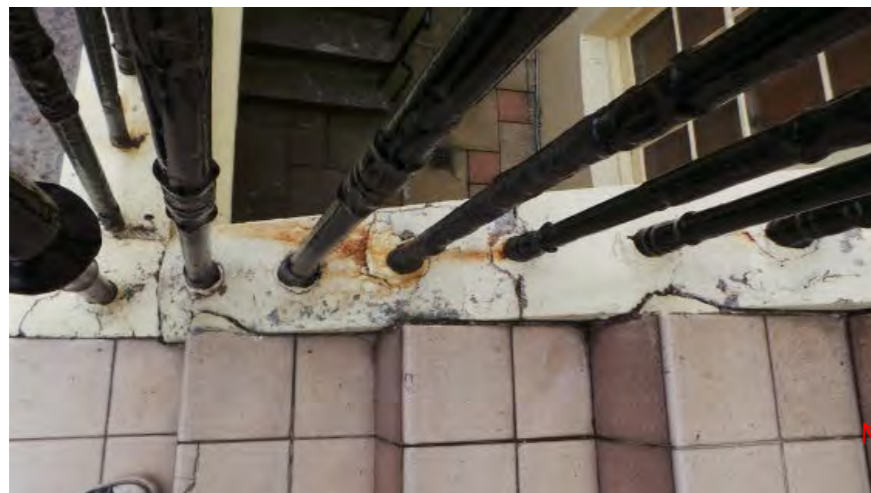
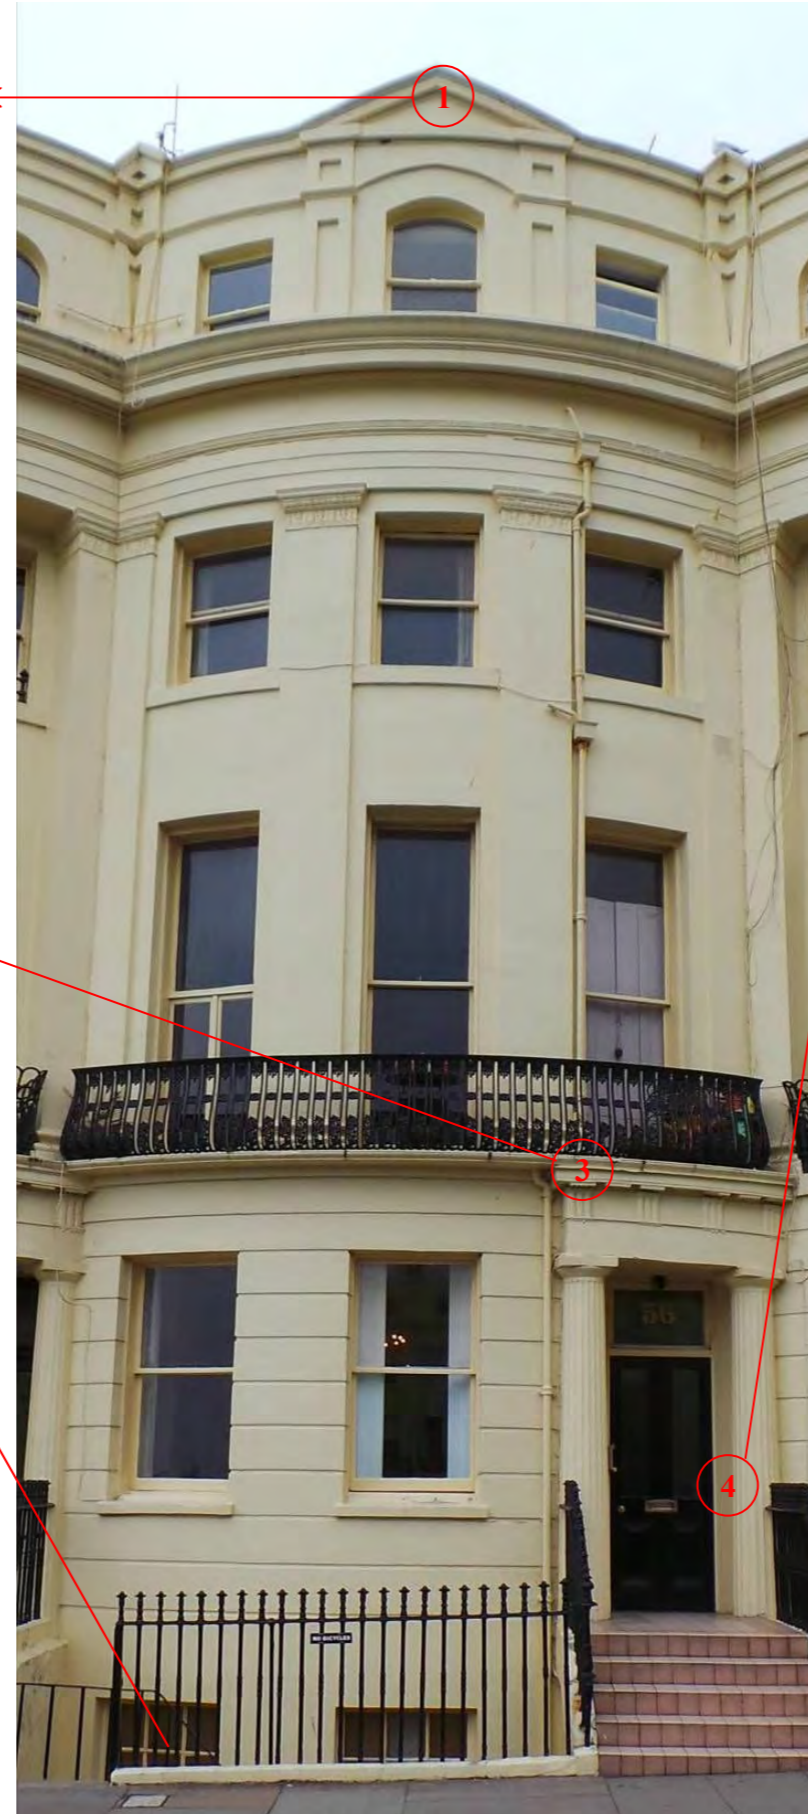
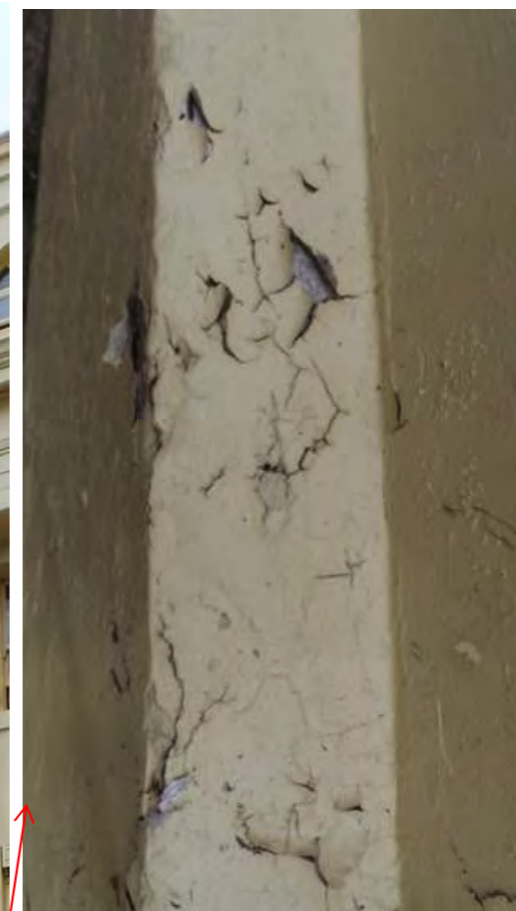
56 Brunswick Square

1. Generally the façade appears to be in reasonably good condition;
2. Paint flaking on the bottom of the left hand side of the pediment at parapet level;
3. Staining to cornice beneath balcony;
4. Salt deliquescence and paint flaking on the interior of the porch;
5. Ferrous staining and paint flaking on the masonry below the railings adjacent the front door and the pavement.

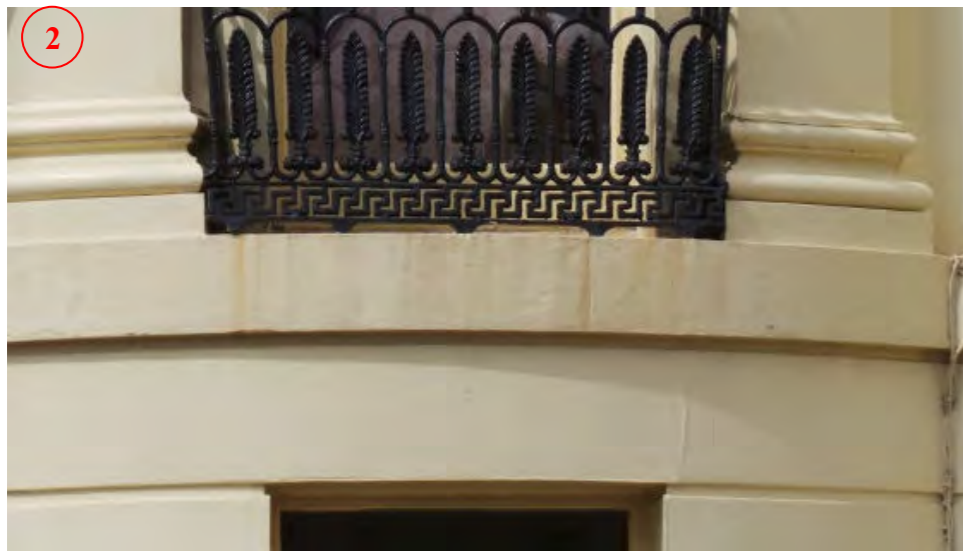
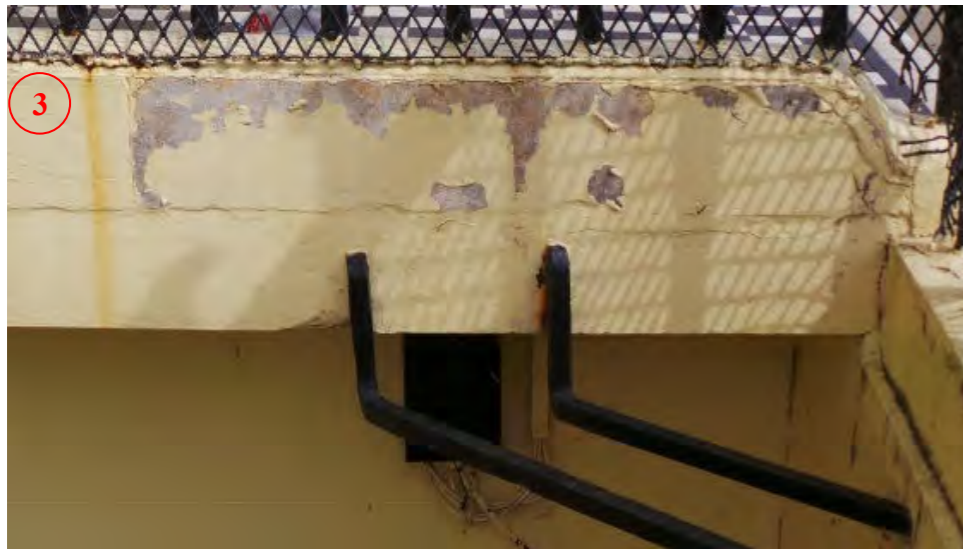
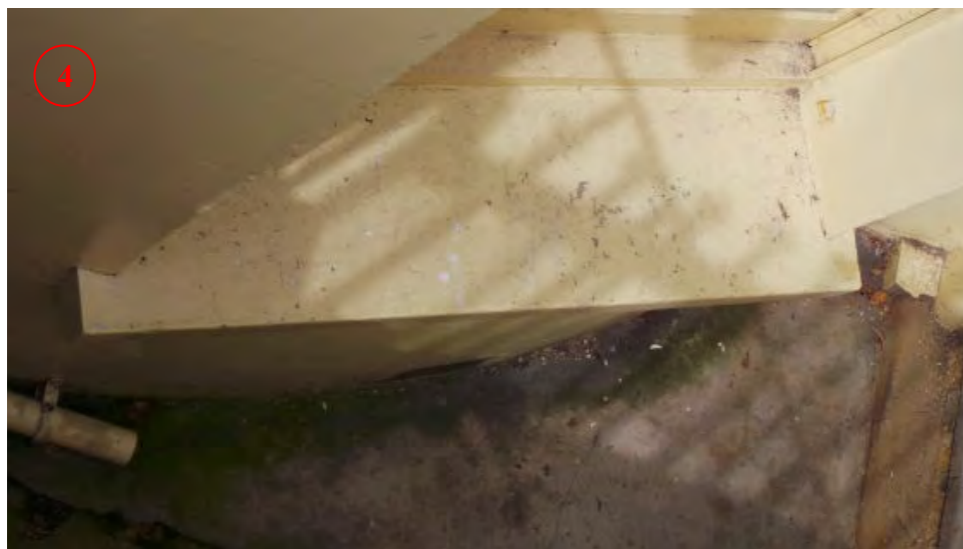
58 Brunswick Square

1. Generally the façade appears to be in reasonably good condition.
2. Ferrous staining under the central and flanking left hand side window beneath balconies;
3. Paint flaking on the masonry below the railings adjacent the front door and the pavement;
4. Paint flaking on the basement window ledges.
