**Investigation of Paint Failure at
Brunswick Estate
Hove
Brighton**

August 2013

**BRUNSWICK ESTATE
HOVE**

The following document investigates the failure of the external paint-system at Brunswick Estate, Hove based on research carried out by Elizabeth Hirst and Rachel Morley of Hirst Conservation between August and November 2013. The work was commissioned by Brighton & Hove City Council.

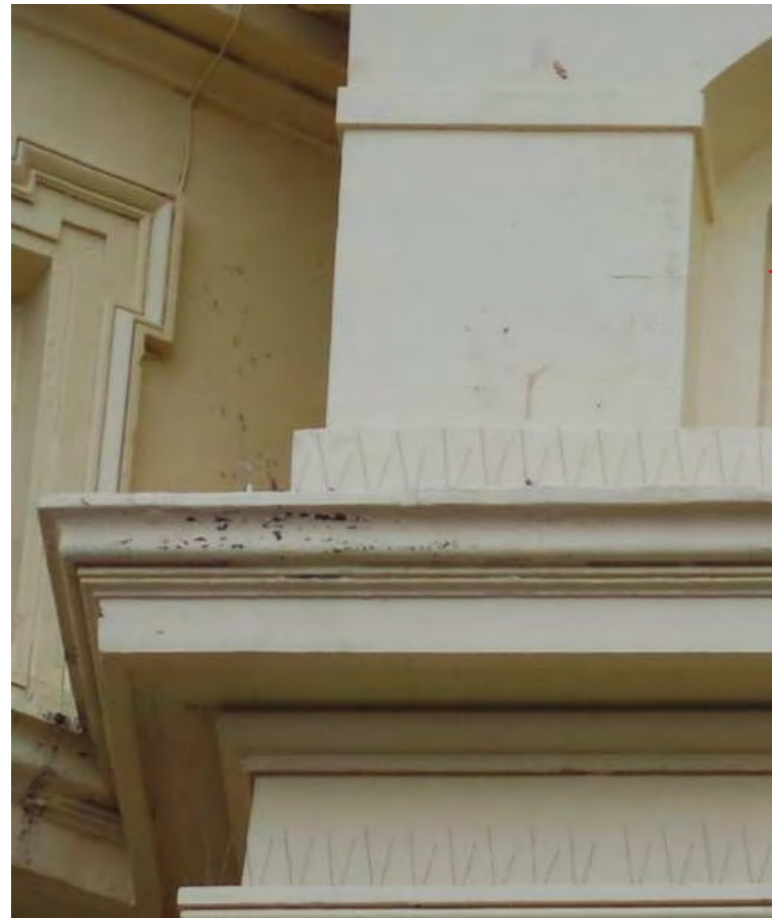
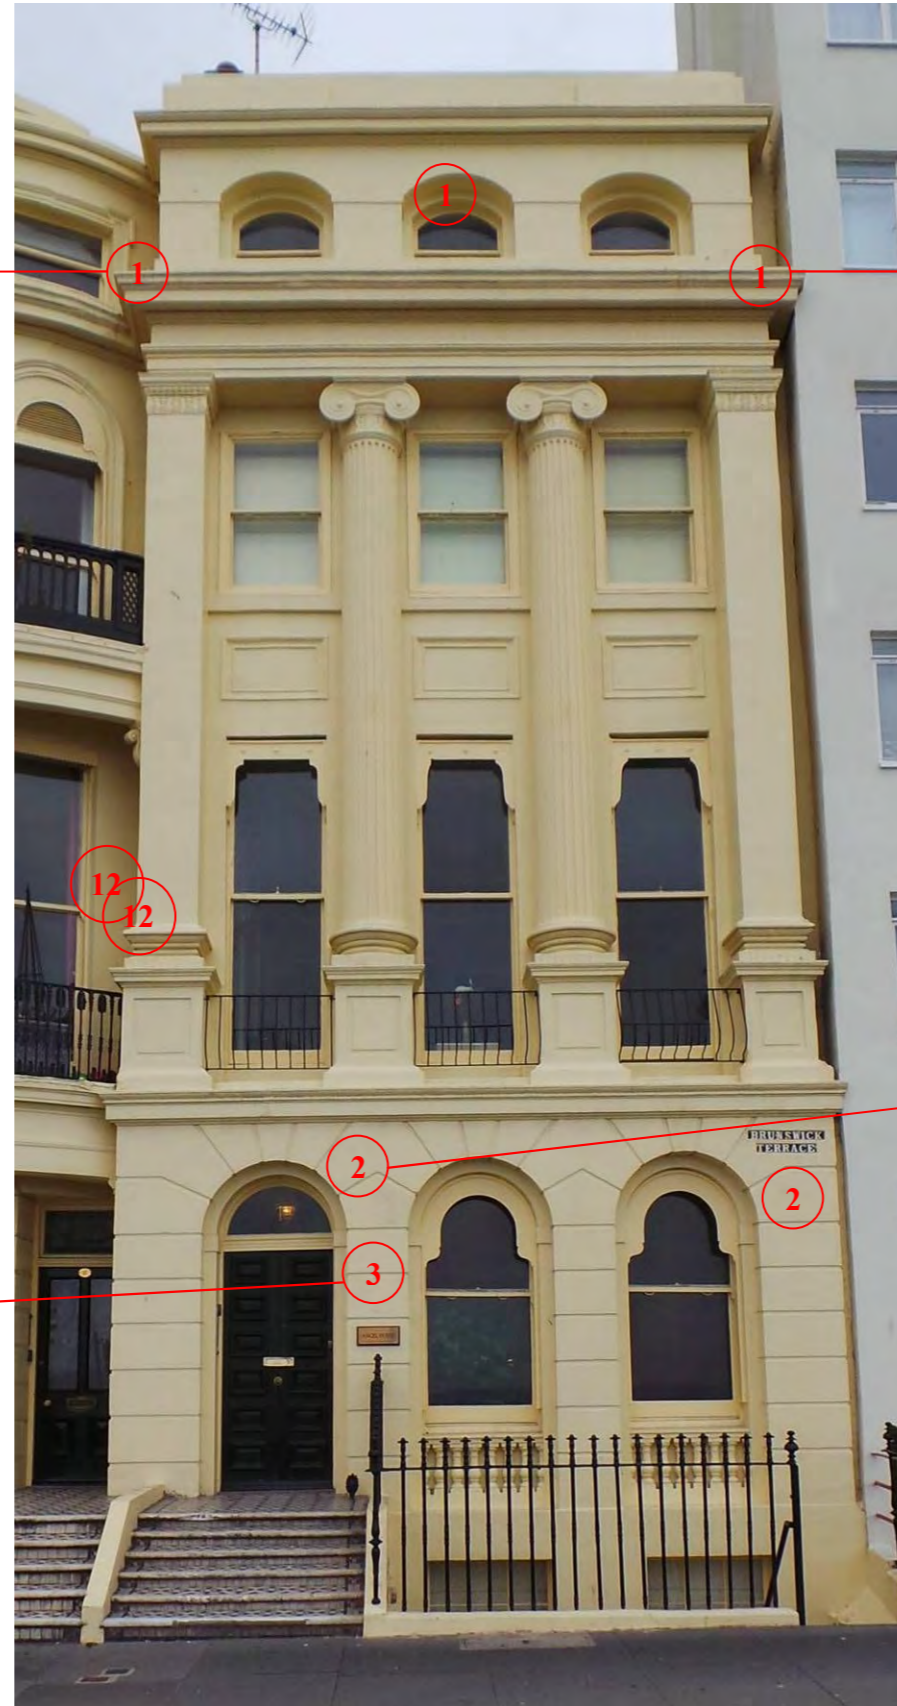
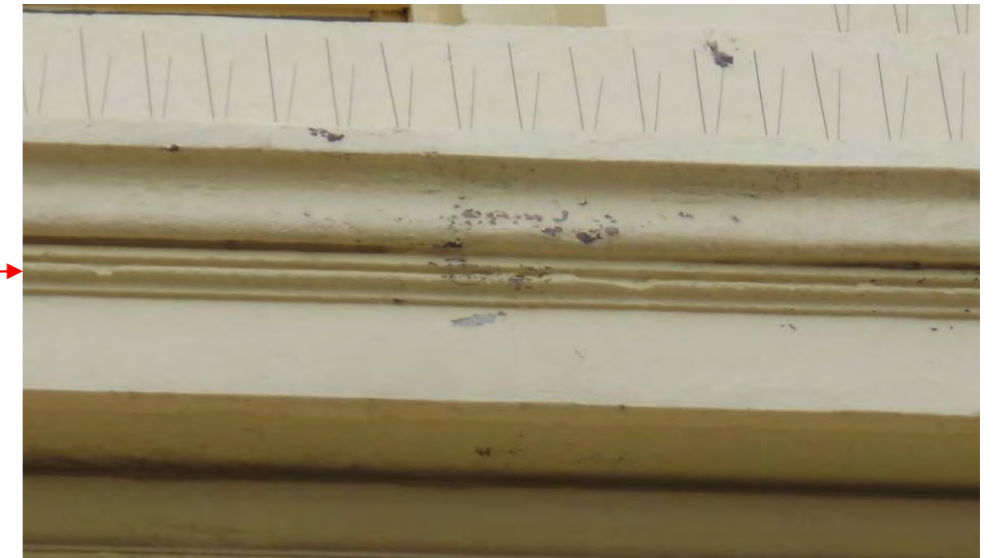
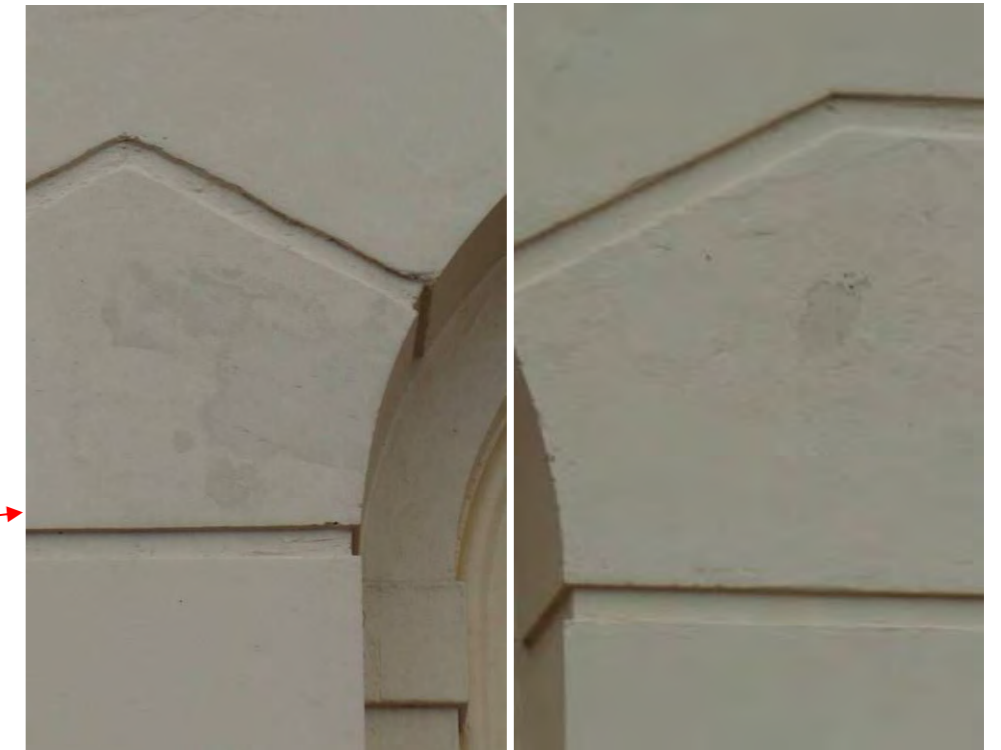
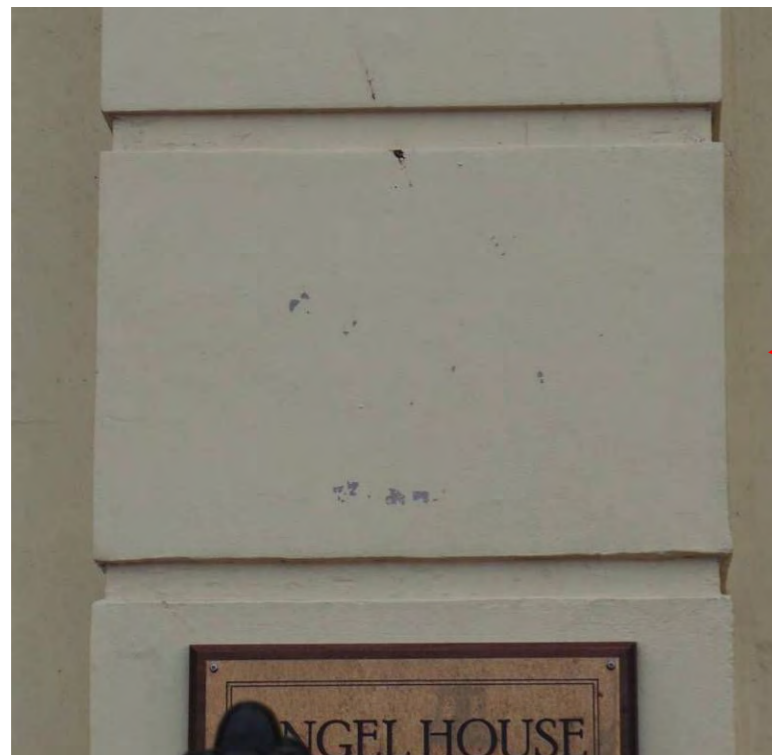
4.2 1 Brunswick Terrace

1. Minor losses and flaking to cornice moulding;
2. Localised flaking and discoloration, evidence of previous repairs;
3. Minor losses around doorway;
4. Basement and plinth wall generally in good order.

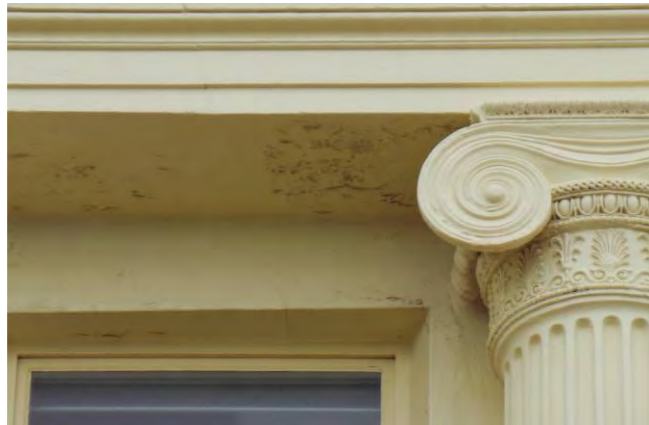
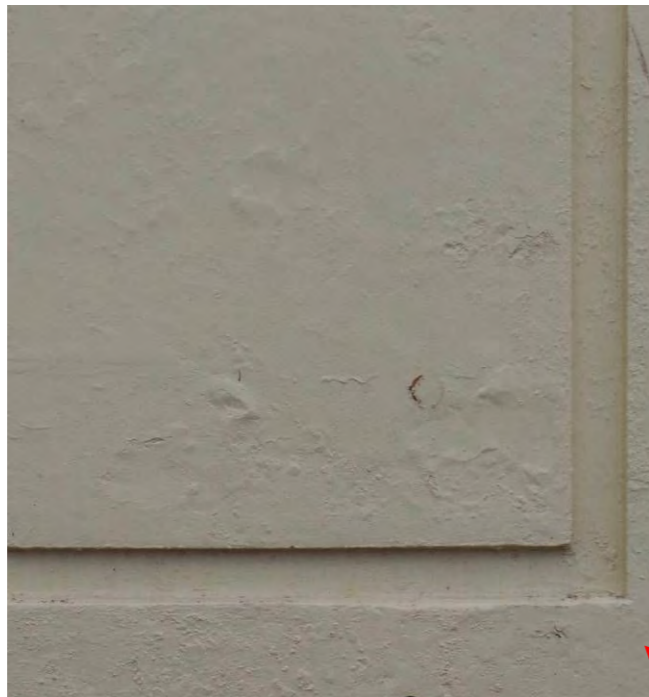
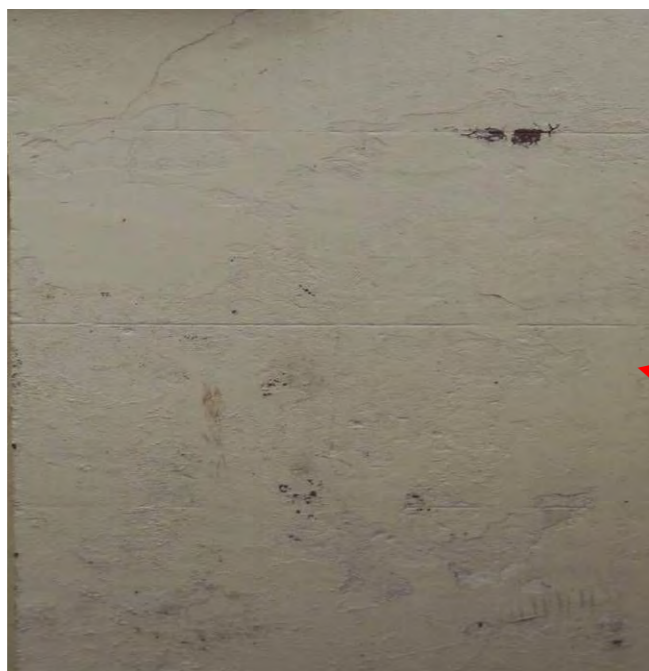
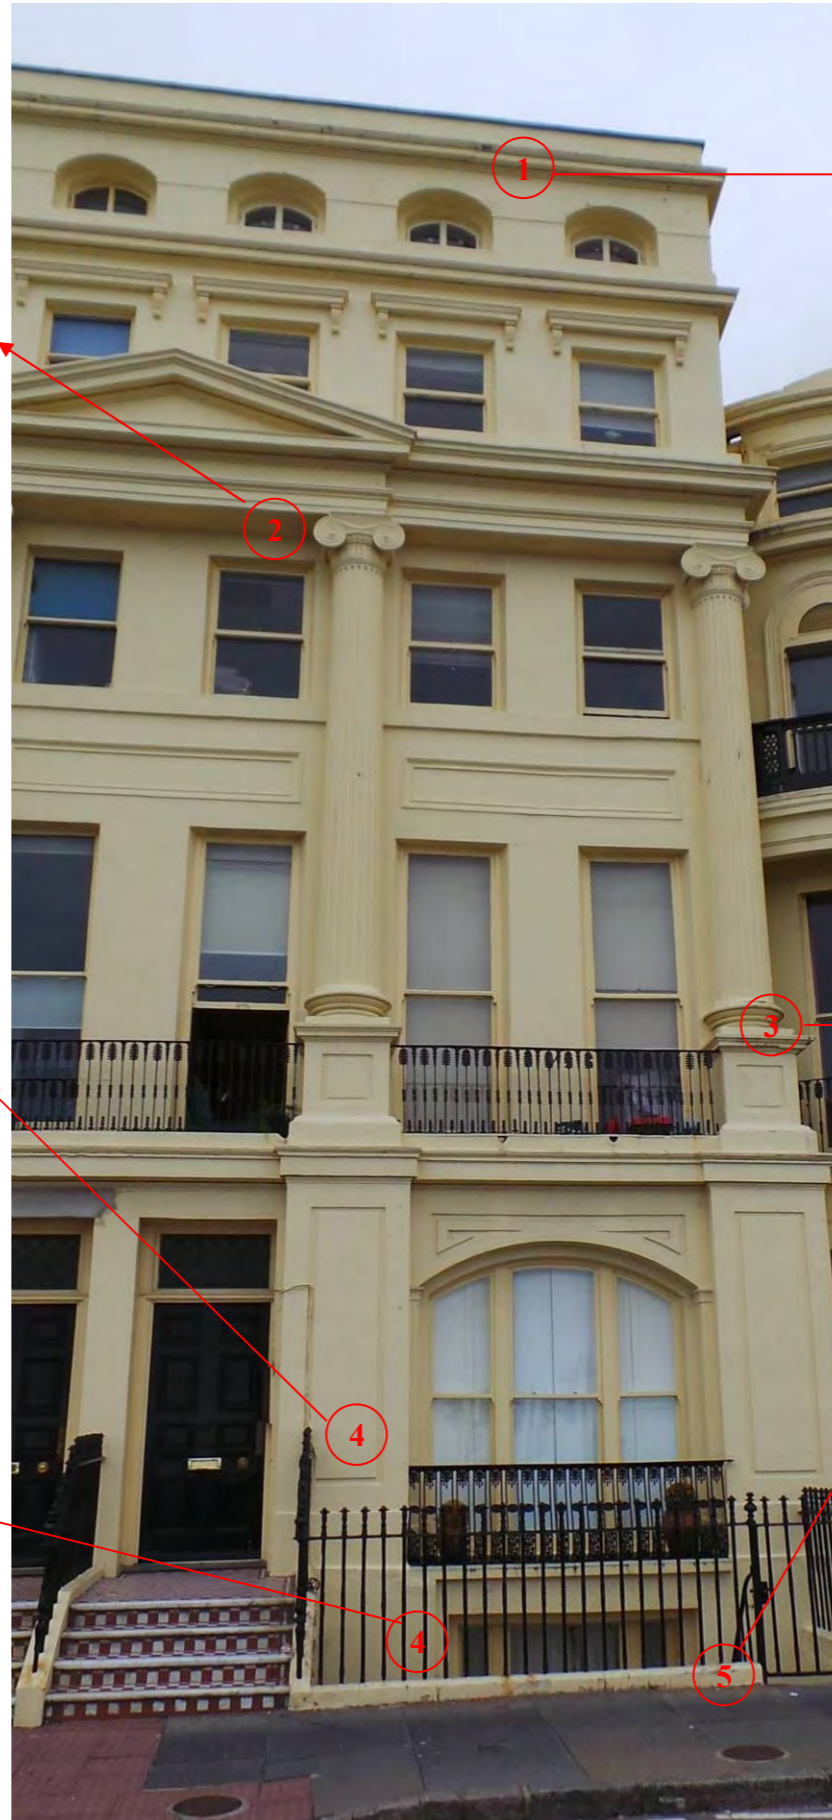
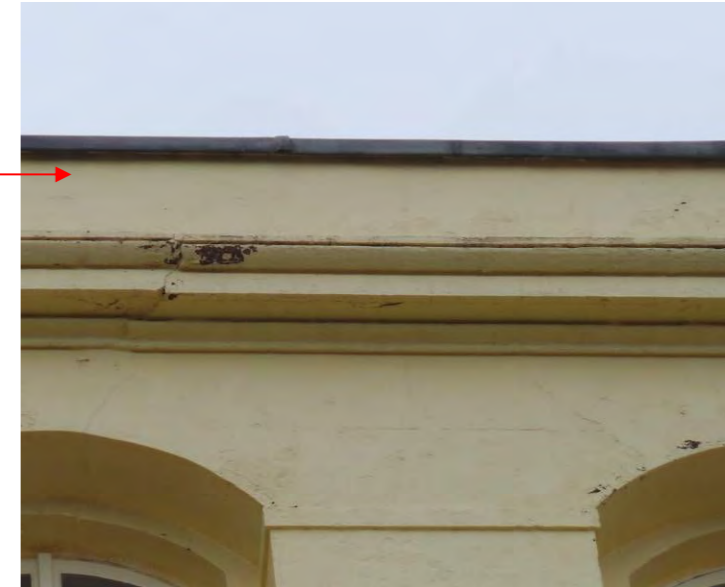
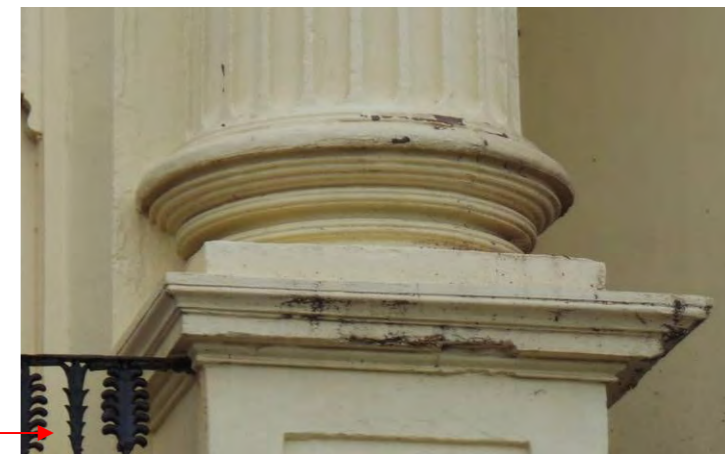
3 Brunswick Terrace

1. Small, localised losses along parapet moulding;
2. Failure to recess of pediment and cornice over second floor;
3. Localised losses to columns, with base to far right column significantly worse;
4. Losses, salt blistering and flaking across ground and basement levels;
5. Losses, flaking and ferrous staining to plinth wall.

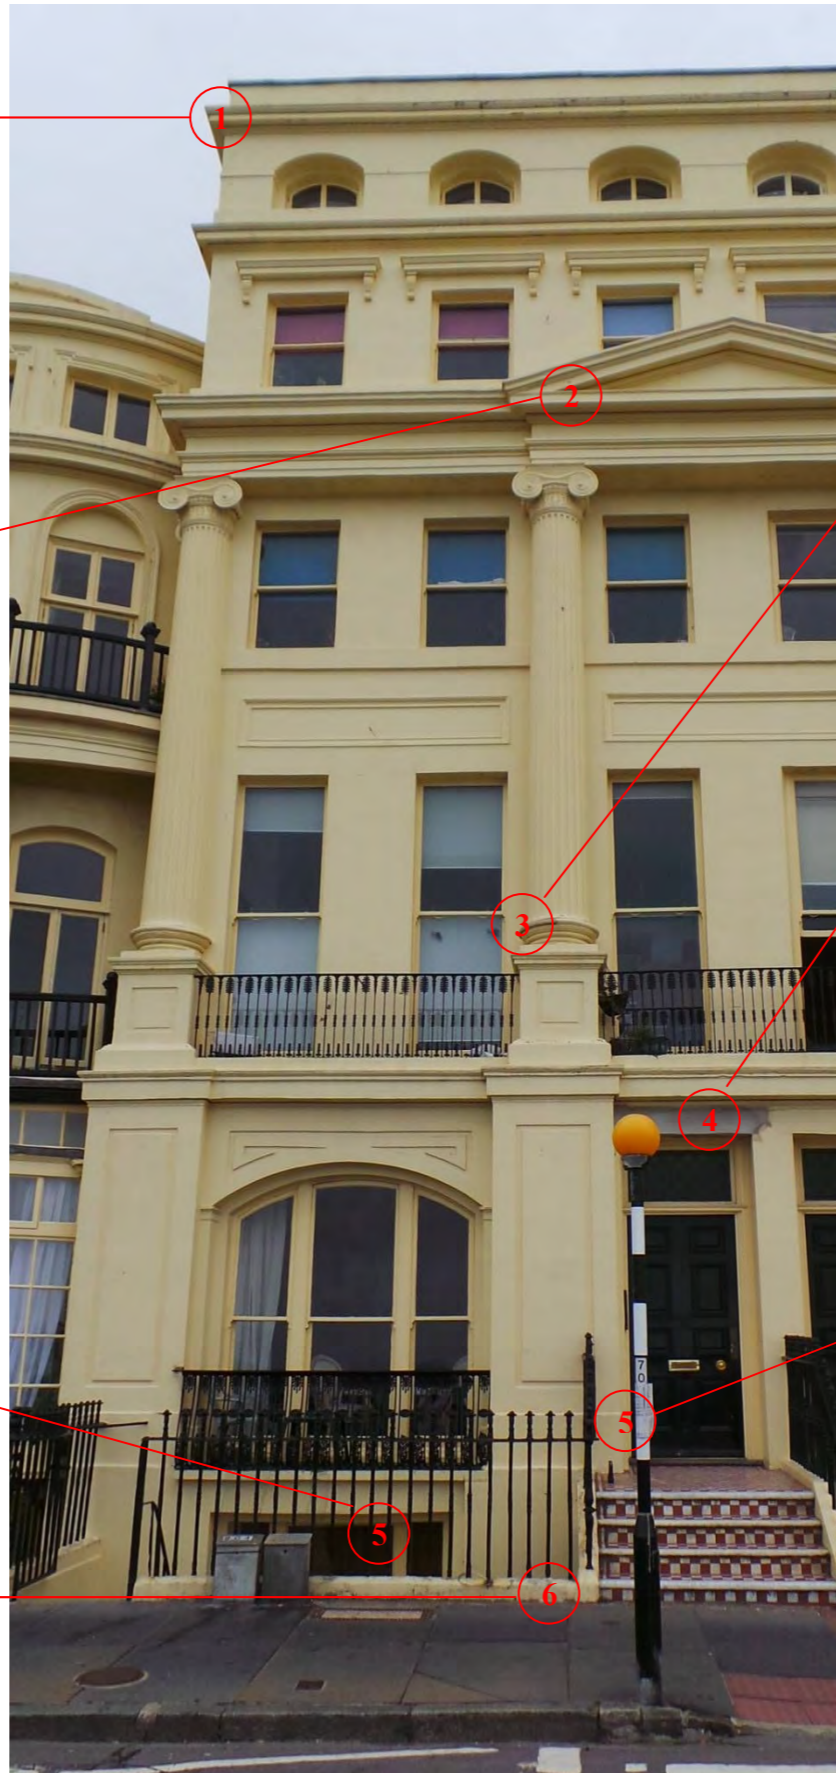
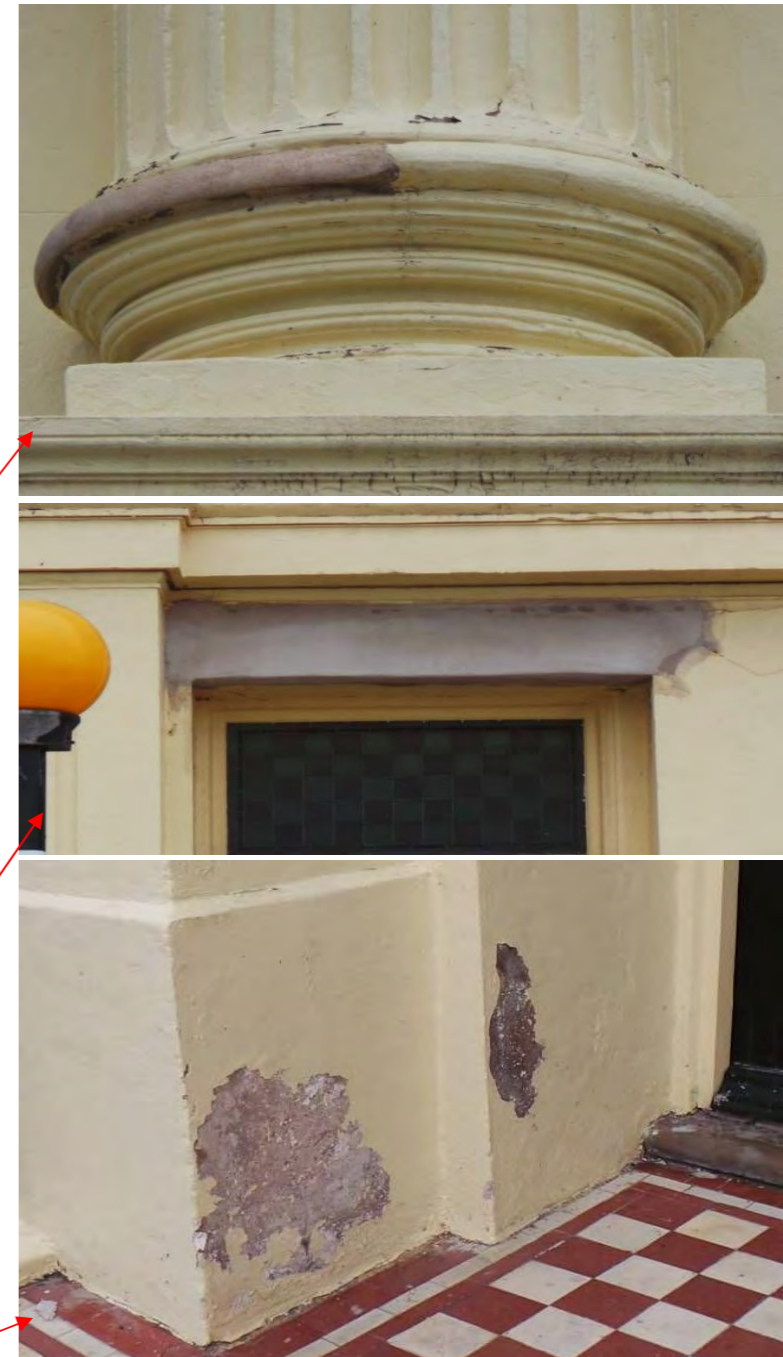
4 Brunswick Terrace

1. Minor losses along top edge of parapet moulding;
2. Minor, localised losses and flaking in recesses of pediment and cornice over second floor;
3. Flaking to column bases;
4. Replacement concrete lintel/render installed over entrance;
5. Significant losses to entrance and basement with some evidence of salting;
6. Moderate losses, ferrous staining and flaking to plinth wall.

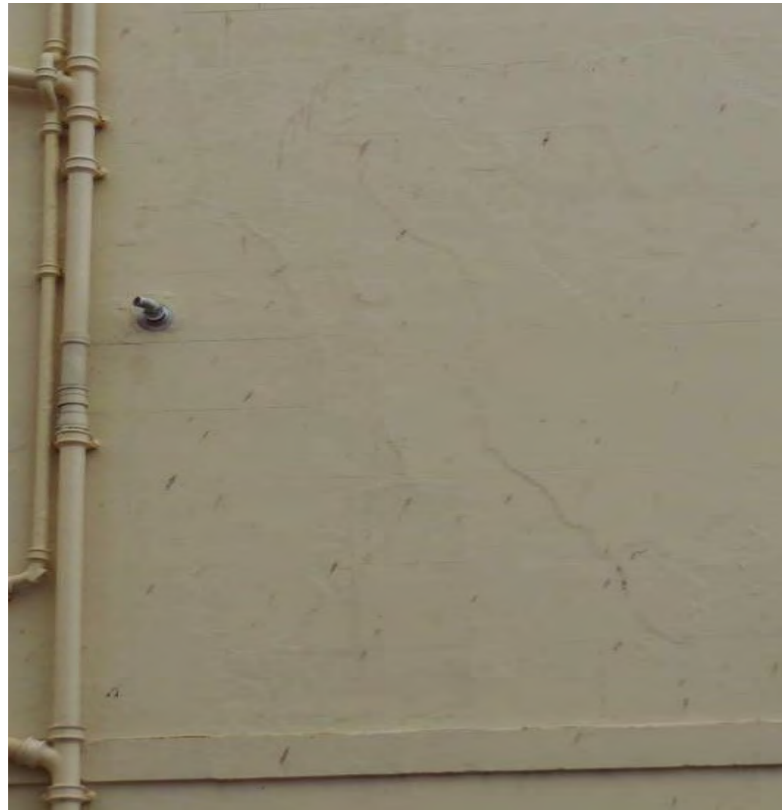
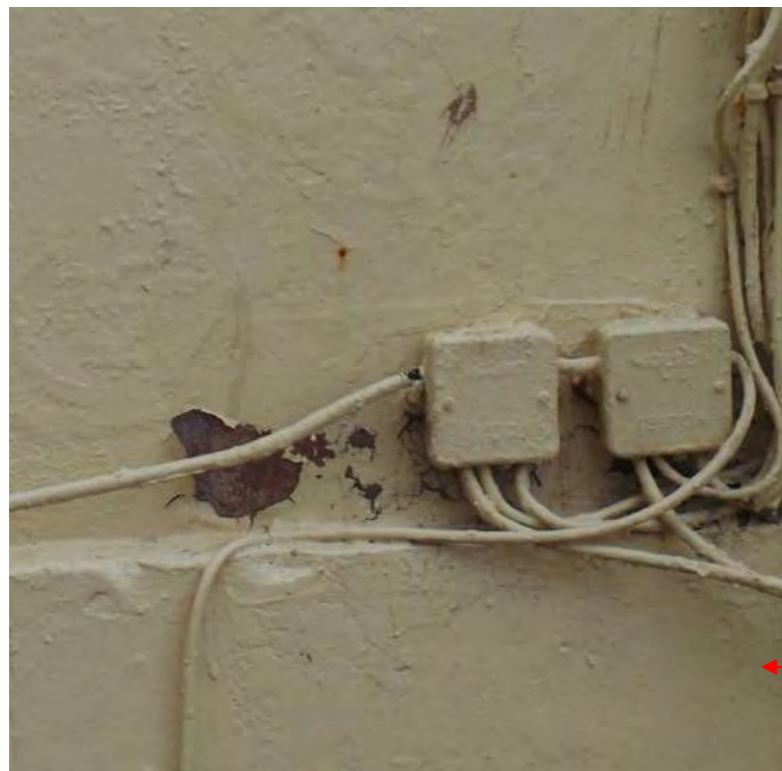
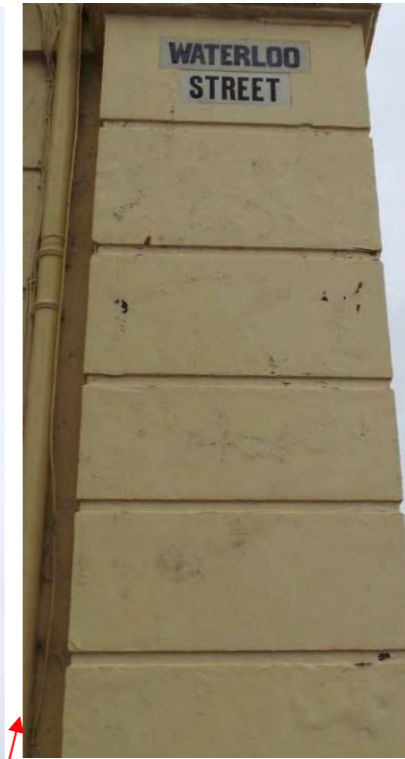
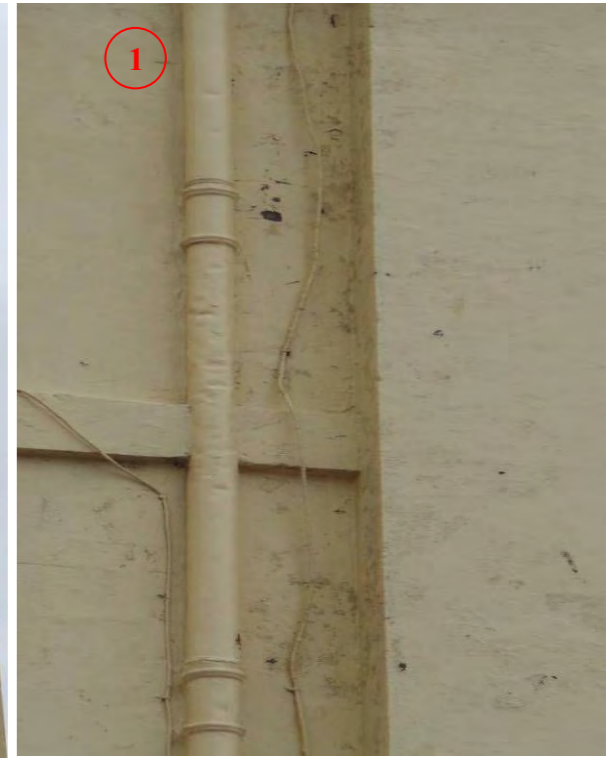
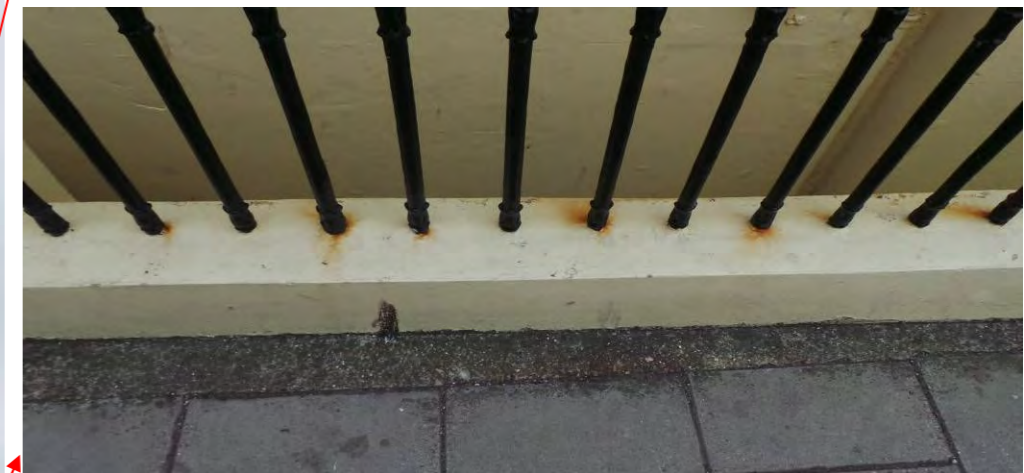
6 Brunswick Terrace (Waterloo Street Elevation)

1. Drain-pipe and wiring systems exhibiting failure to surrounding areas;
2. Evidence of previous repairs to flat surface of first-floor;
3. Blistering and minor losses to projecting rusticated column base;
4. Slight ferrous staining to plinth wall.

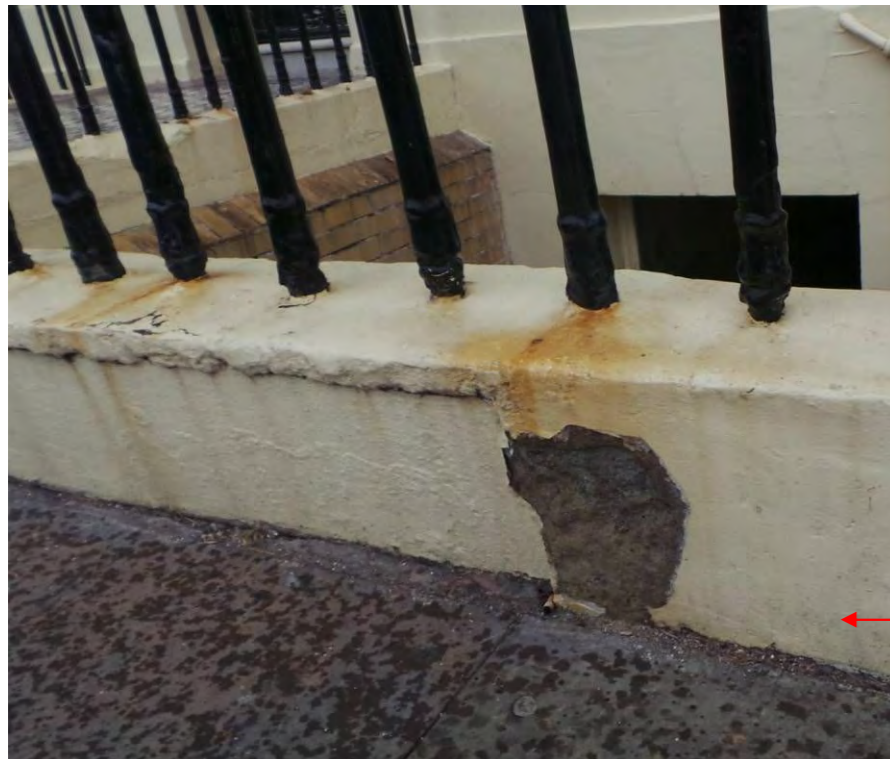
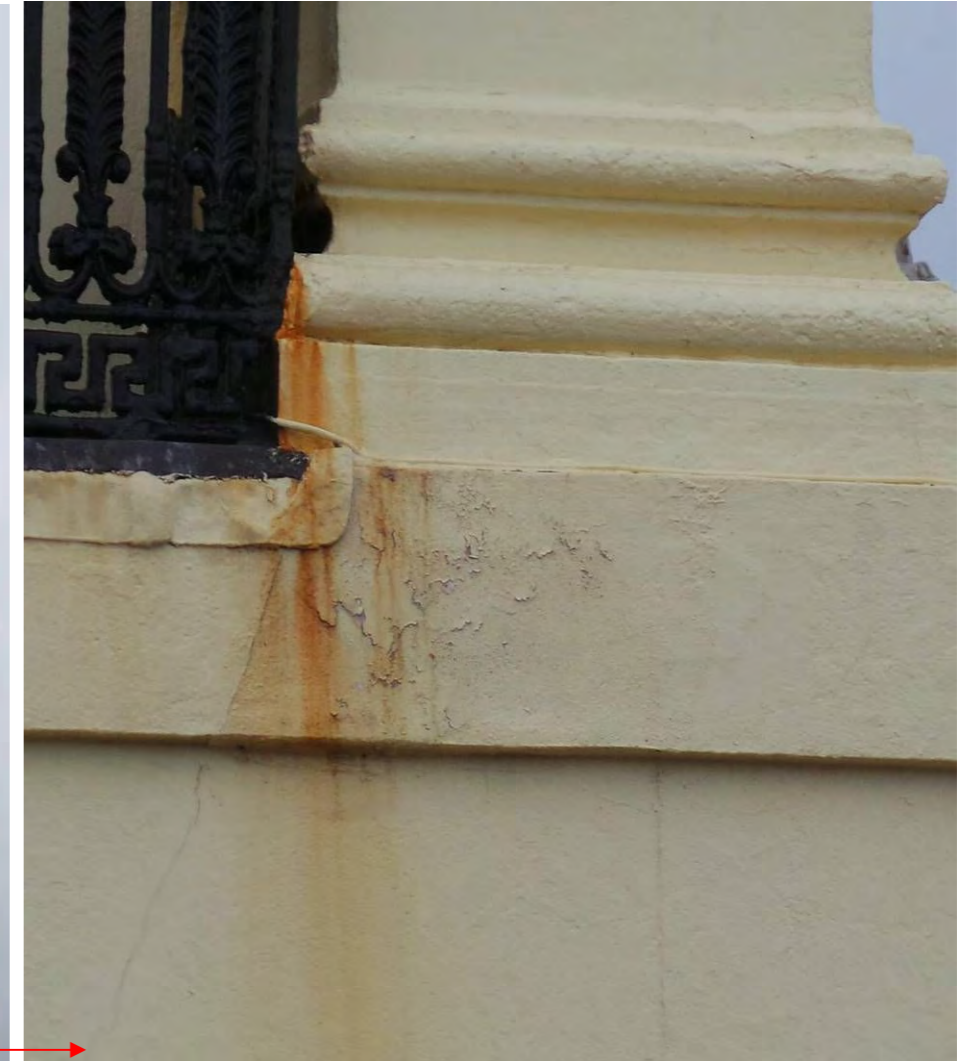
7 Brunswick Terrace (Brunswick Terrace Elevation)

1. Slight ferrous staining from balustrade and cracking to first floor balcony areas;
2. Minor ferrous staining and losses to low plinth wall;
3. Basement generally good.

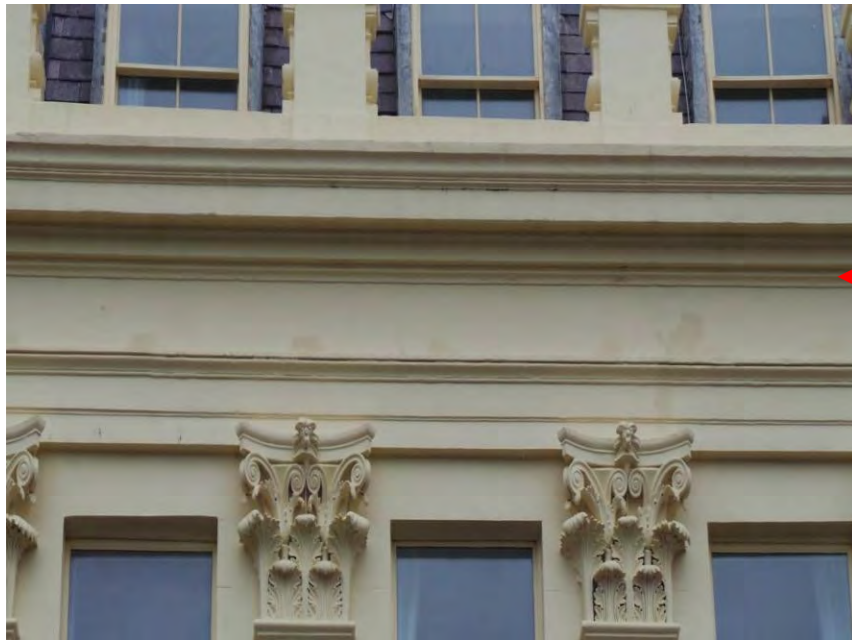
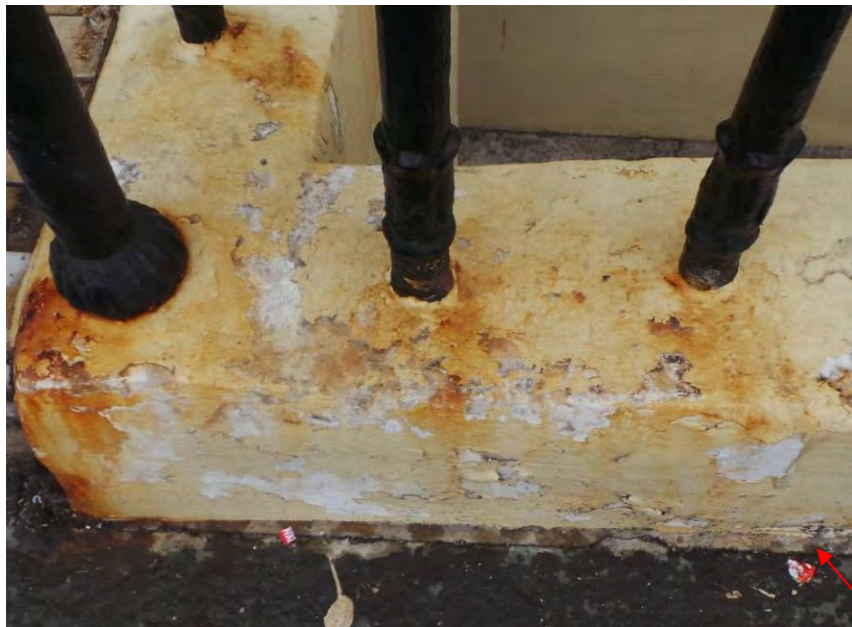
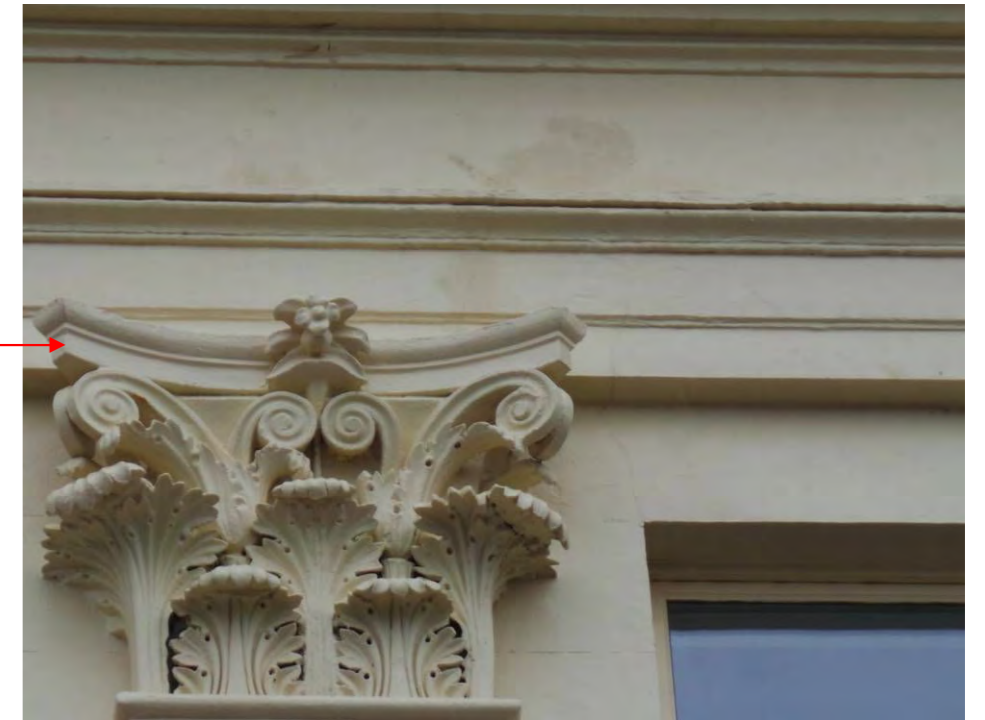
10 Brunswick Terrace

1. Patchy colouring to flat section immediately above columns and along centre right column;
1. Ferrous staining and losses to plinth wall;

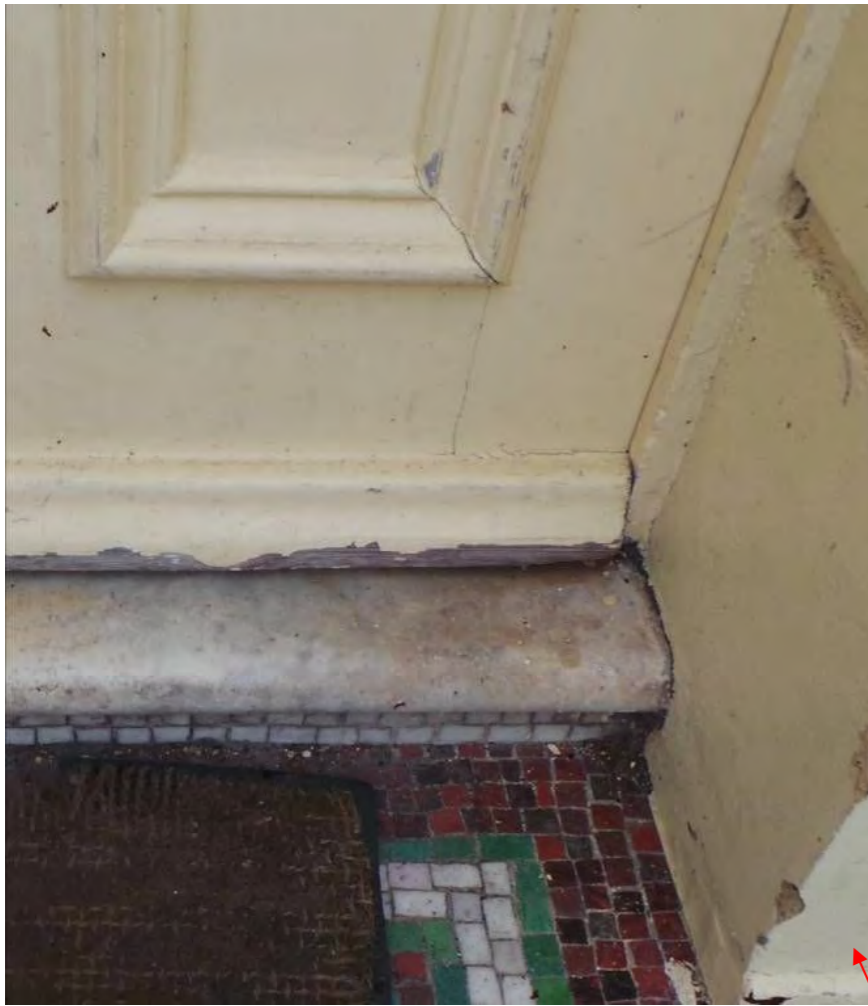
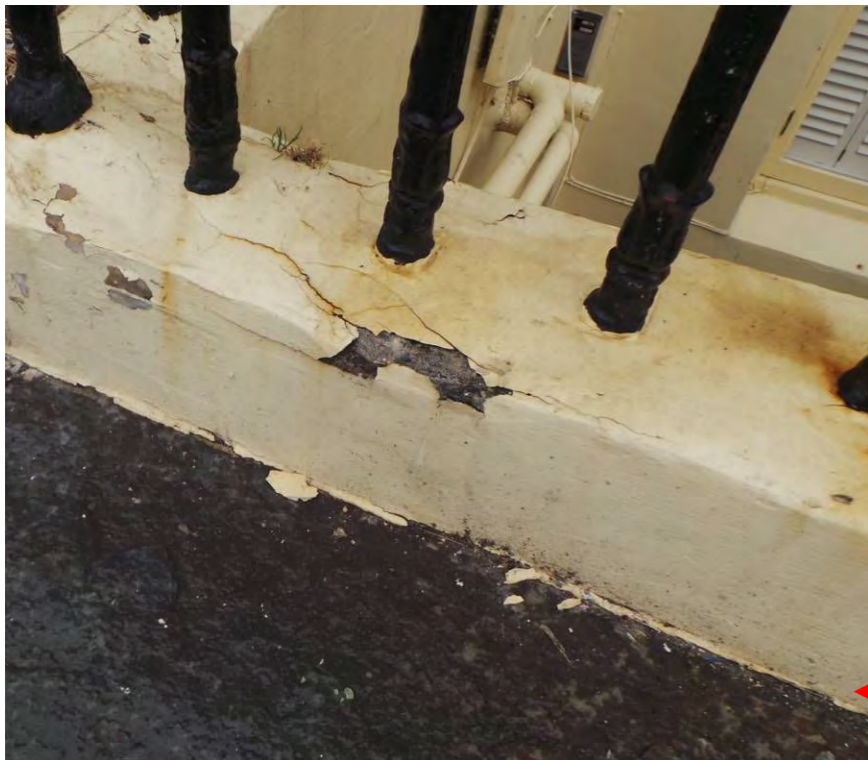
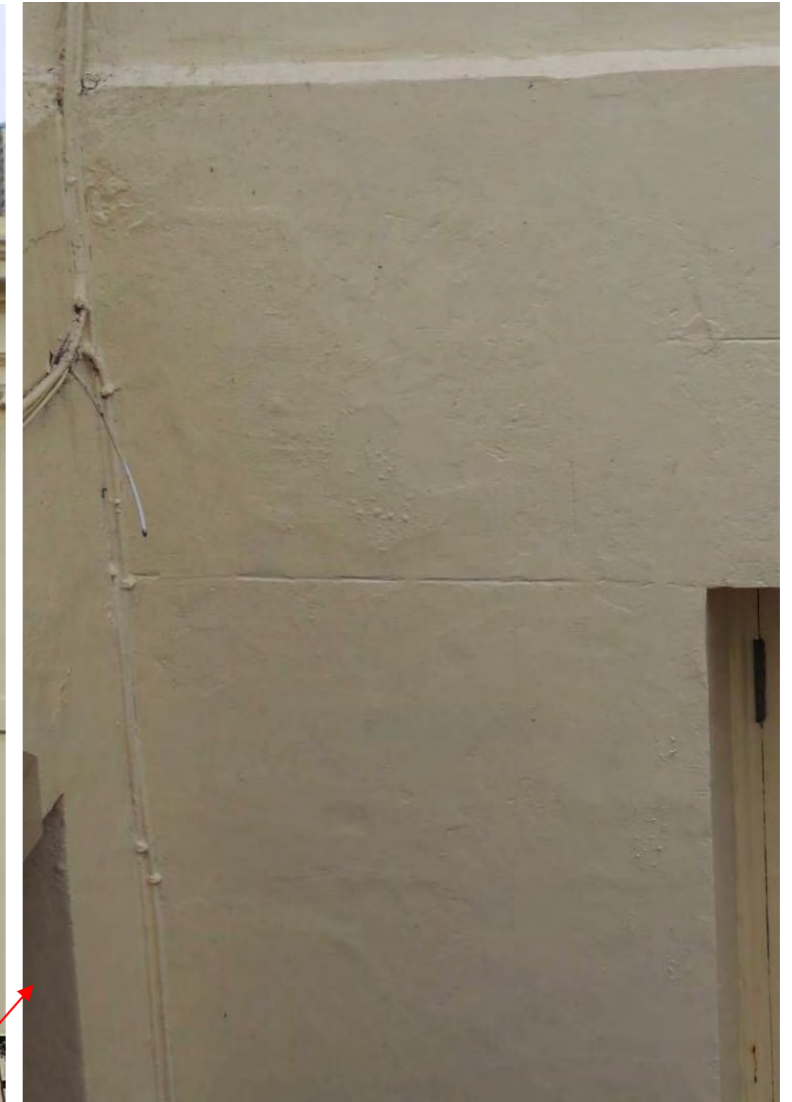
11 Brunswick Terrace

2. Losses due to wear to base of door – to be expected;
3. Ferrous staining and losses to plinth wall;
4. Salts blistering through at basement level.

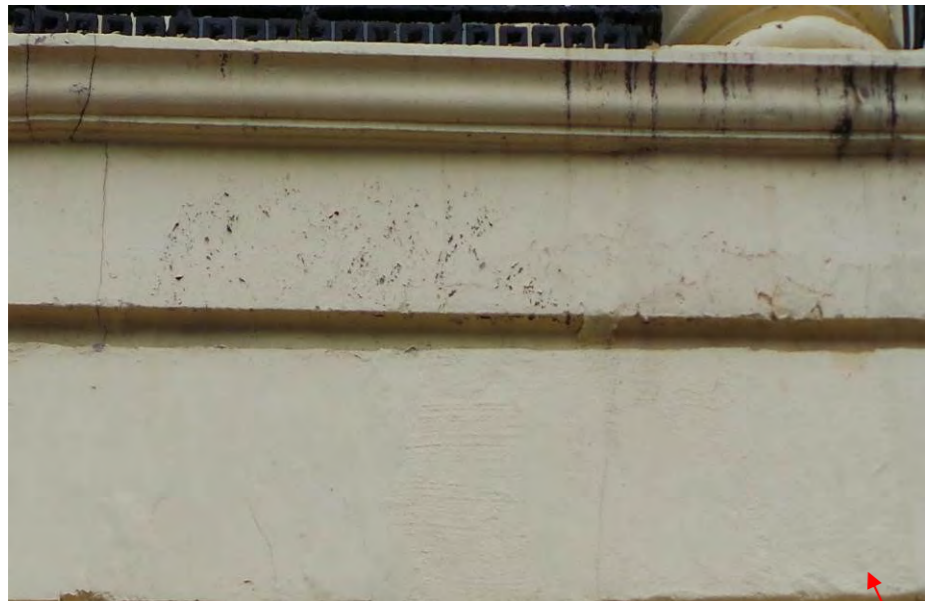
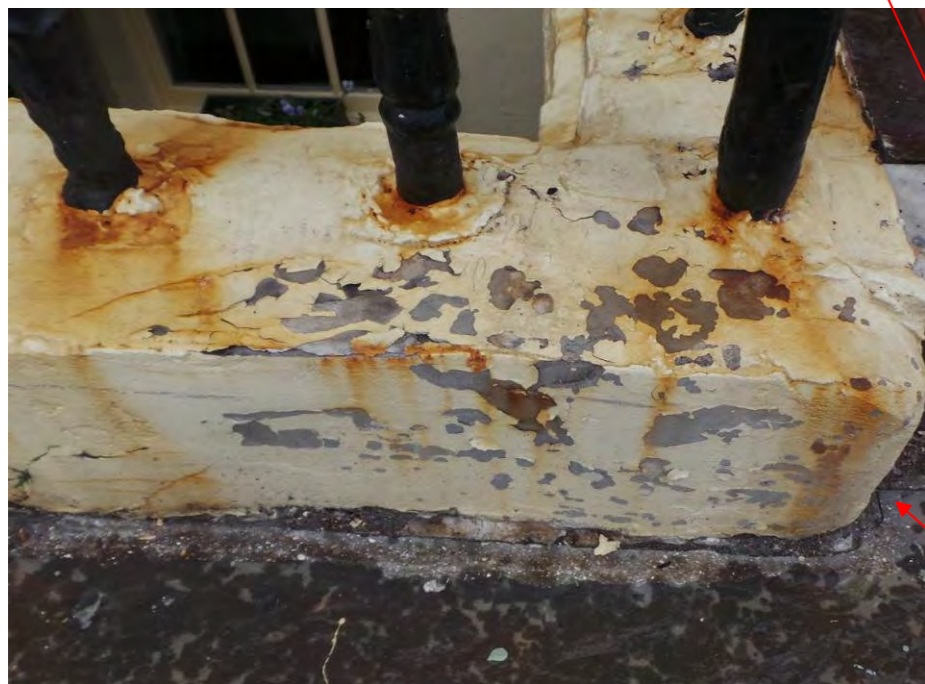
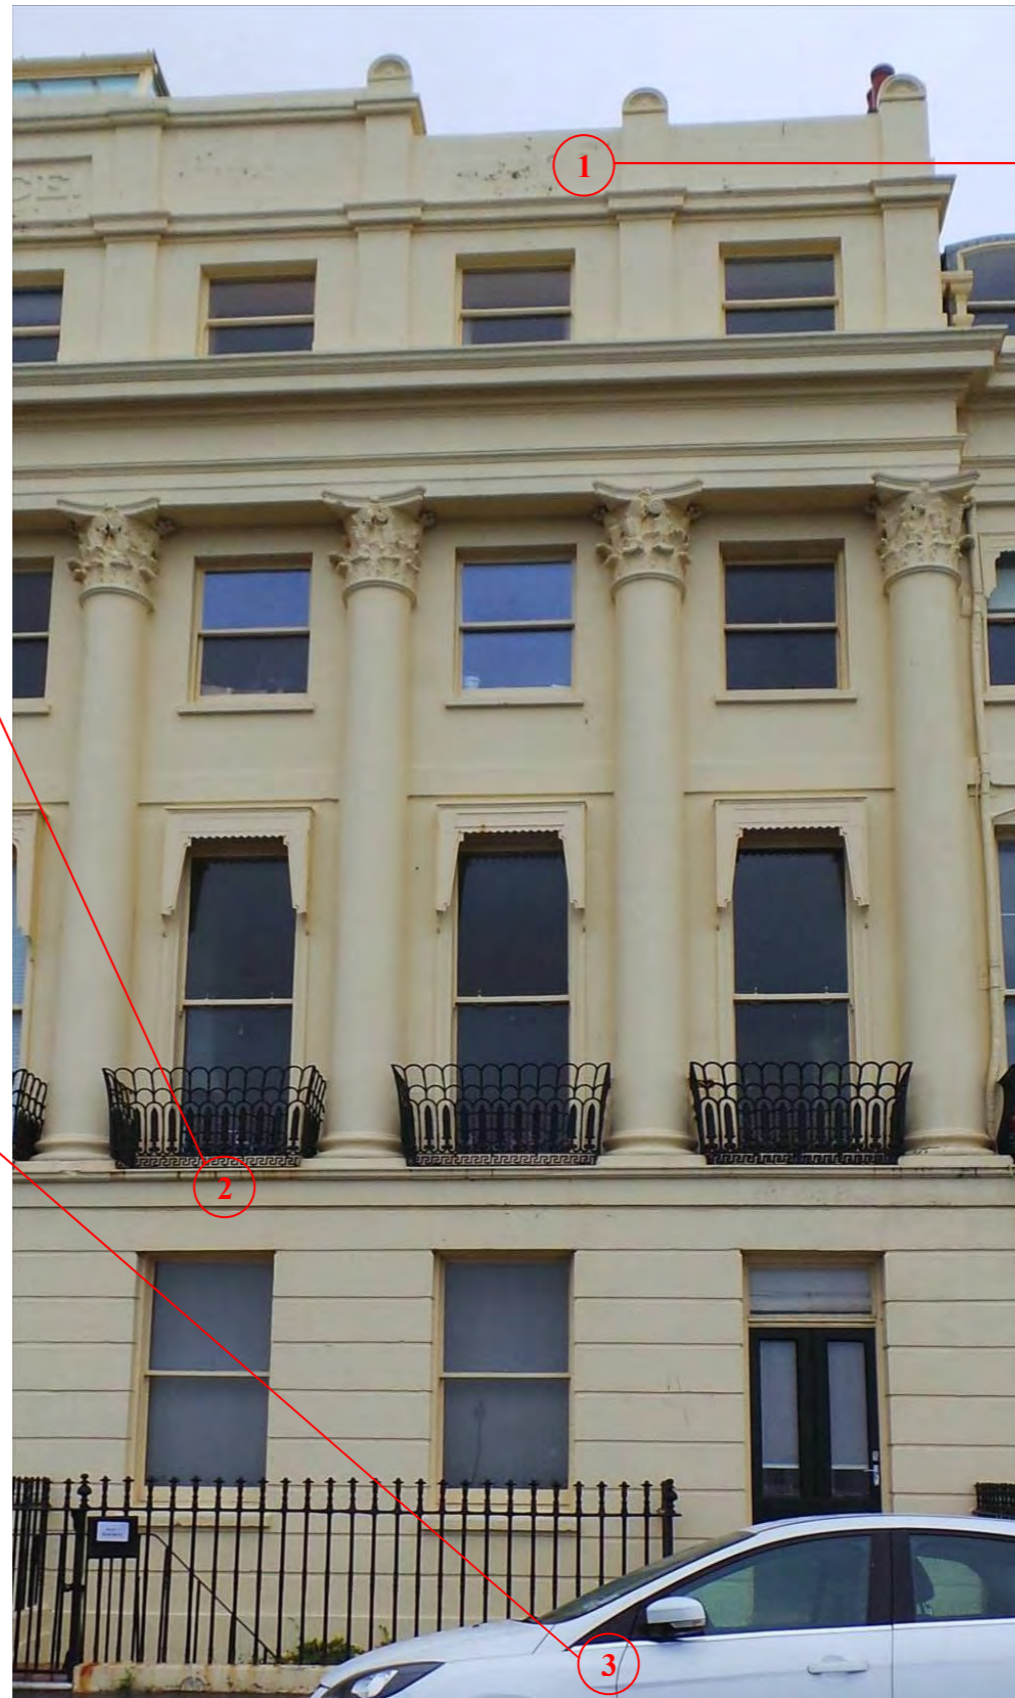
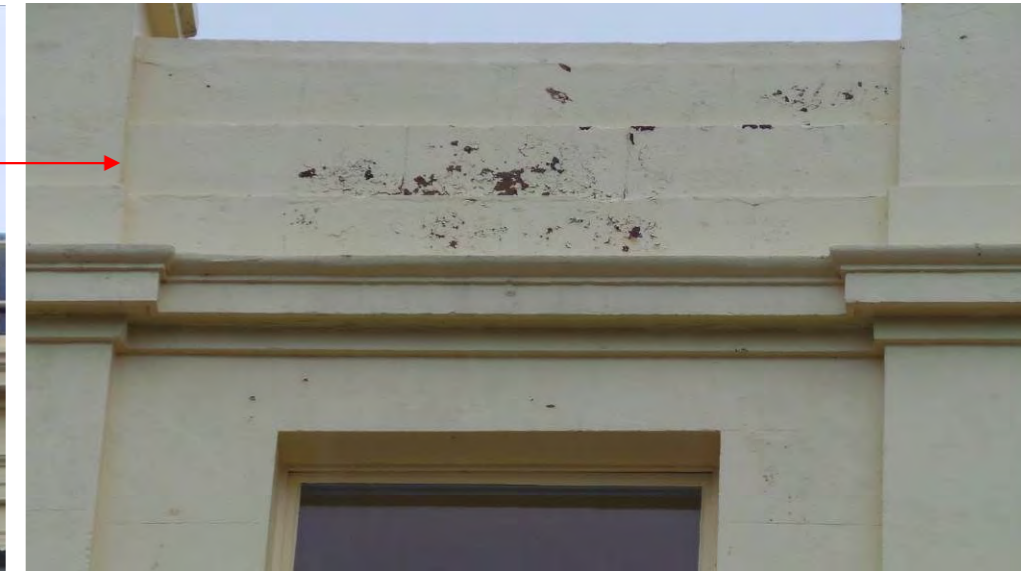
12 Brunswick Terrace

1. Clusters of minor losses to parapet;
2. Flaking to rustication above ground-floor windows;
3. Ferrous staining and losses to plinth wall.
