**Investigation of Paint Failure at
Brunswick Estate
Hove
Brighton**

August 2013

**BRUNSWICK ESTATE
HOVE**

The following document investigates the failure of the external paint-system at Brunswick Estate, Hove based on research carried out by Elizabeth Hirst and Rachel Morley of Hirst Conservation between August and November 2013. The work was commissioned by Brighton & Hove City Council.

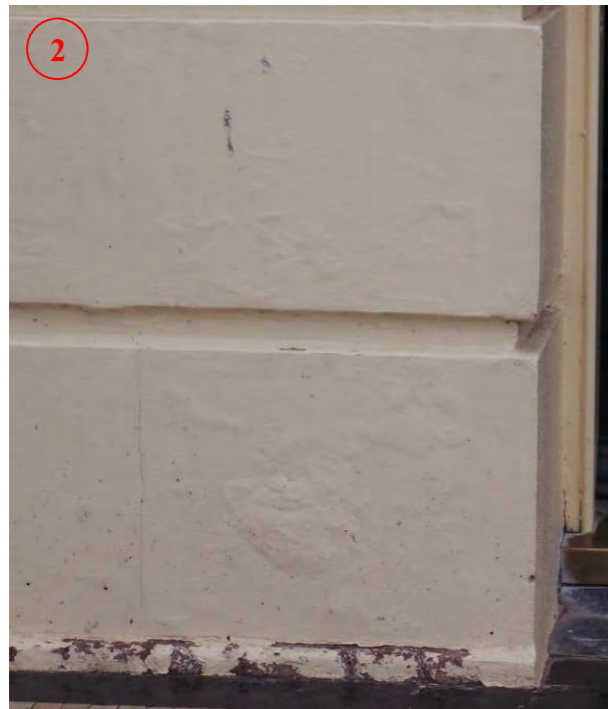
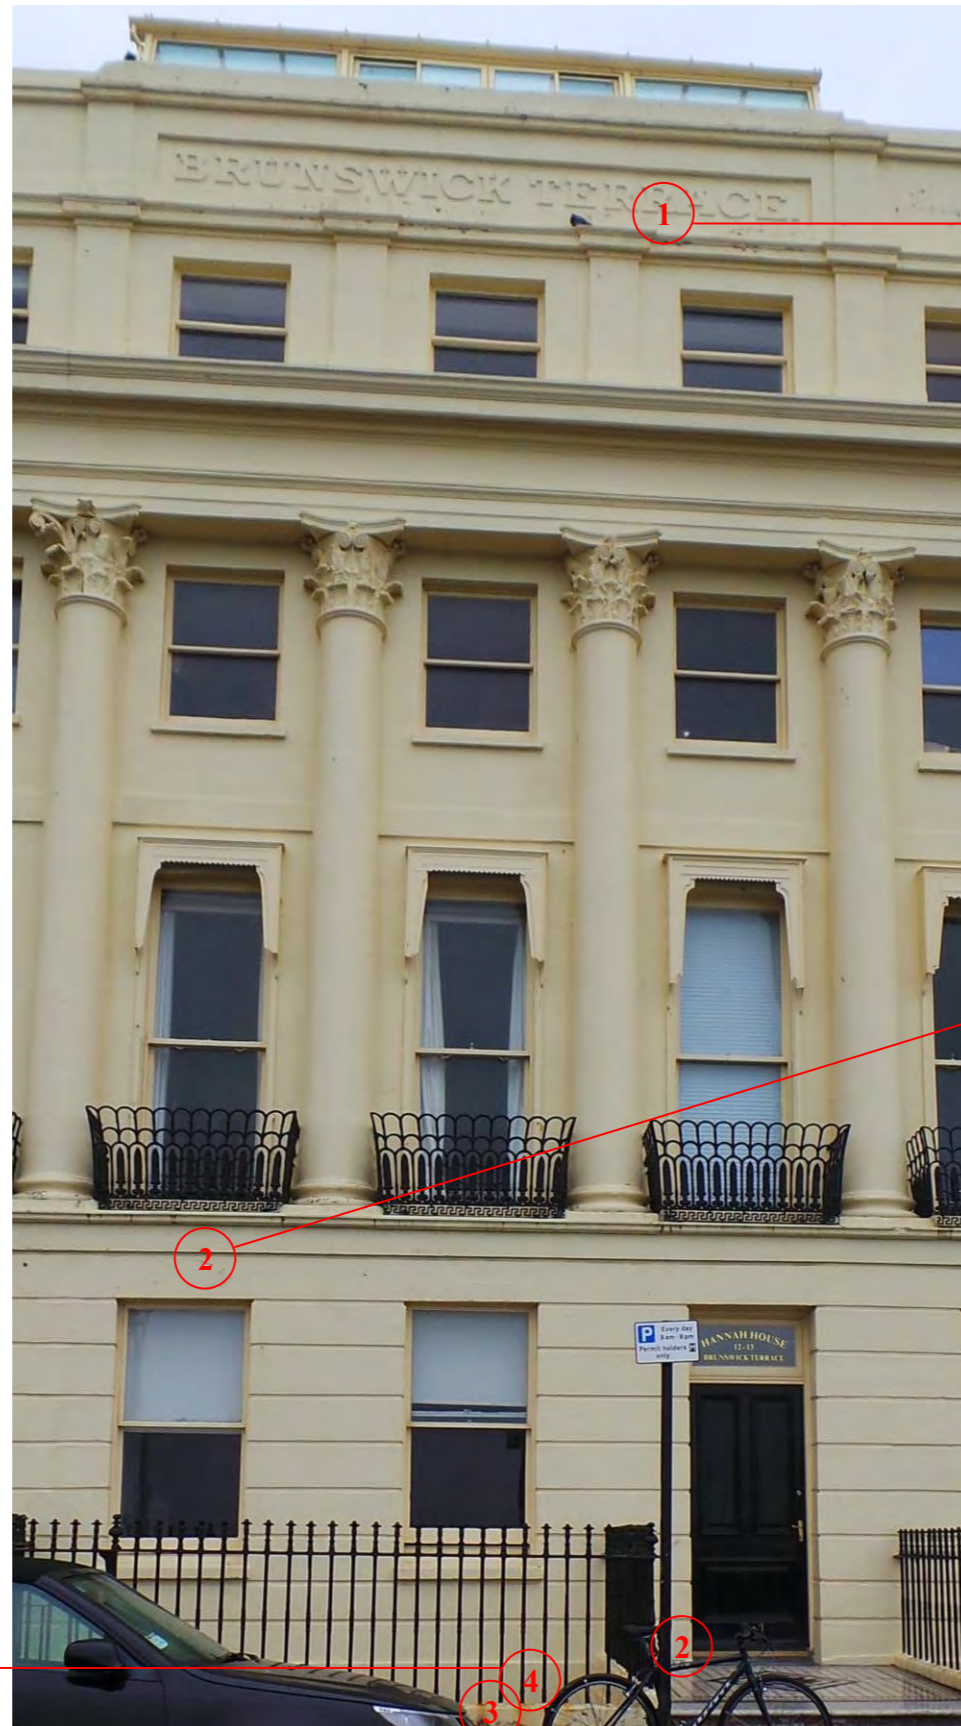
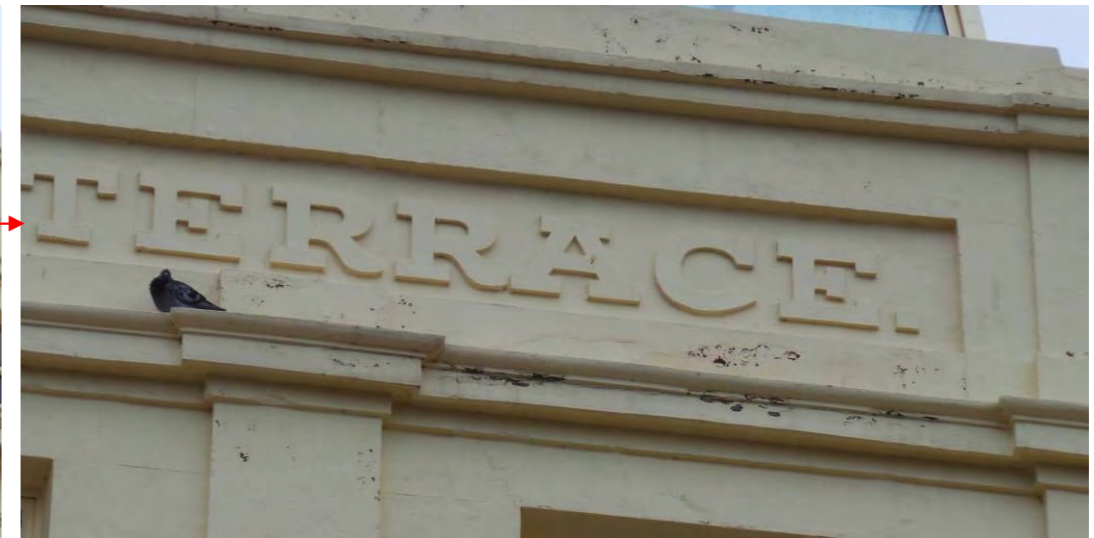
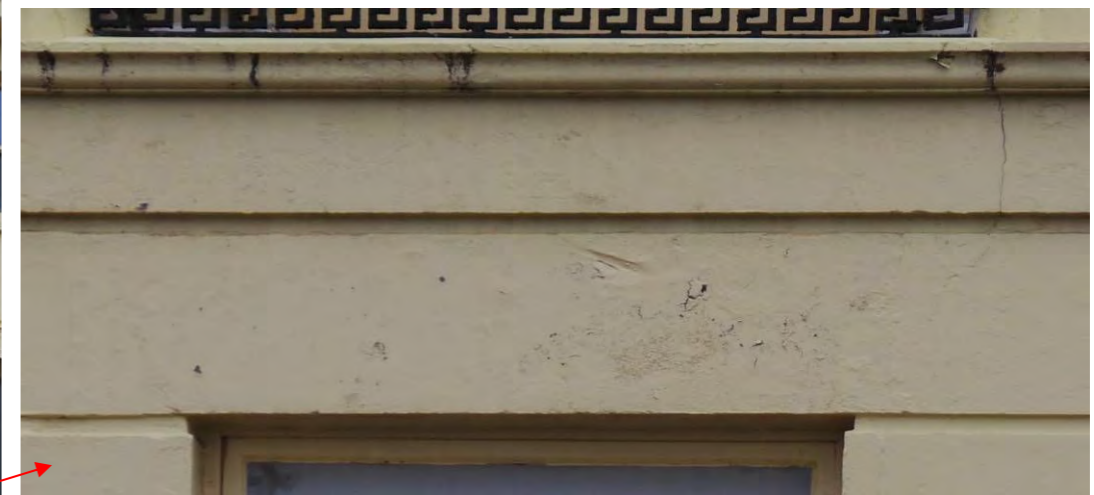
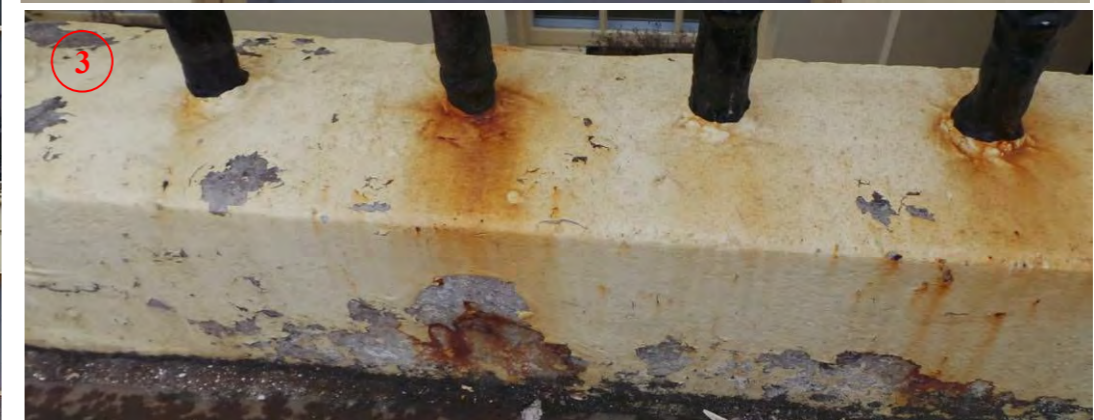
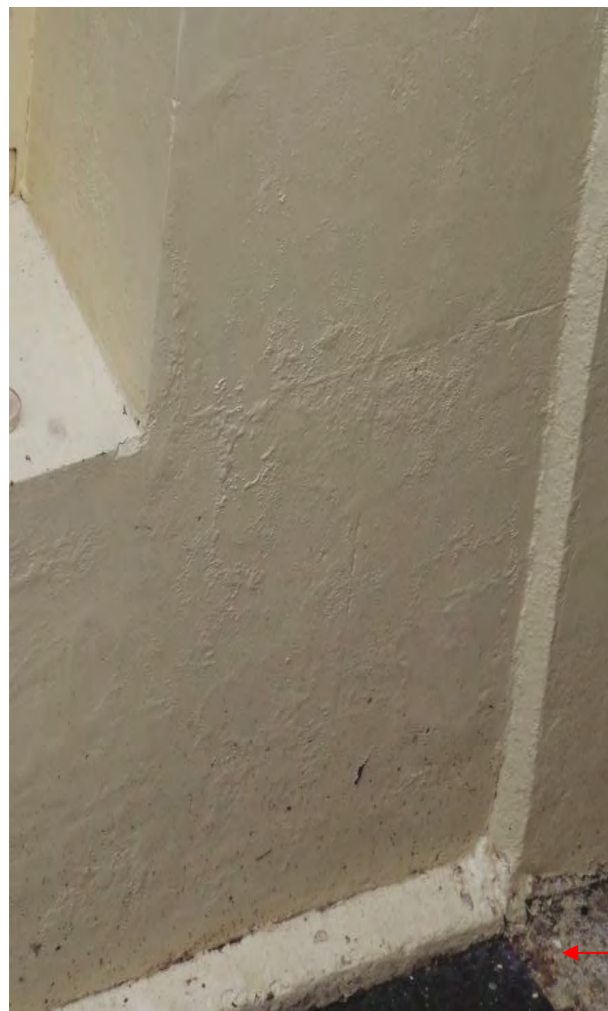
13 Brunswick Terrace

1. Flaking to flat and detailed areas at high level;
2. Minor losses and blistering, possibly due to salt action, over ground-floor windows and around doorway;
3. Small losses and ferrous staining to plinth wall;
4. Localised salt blistering to basement level.

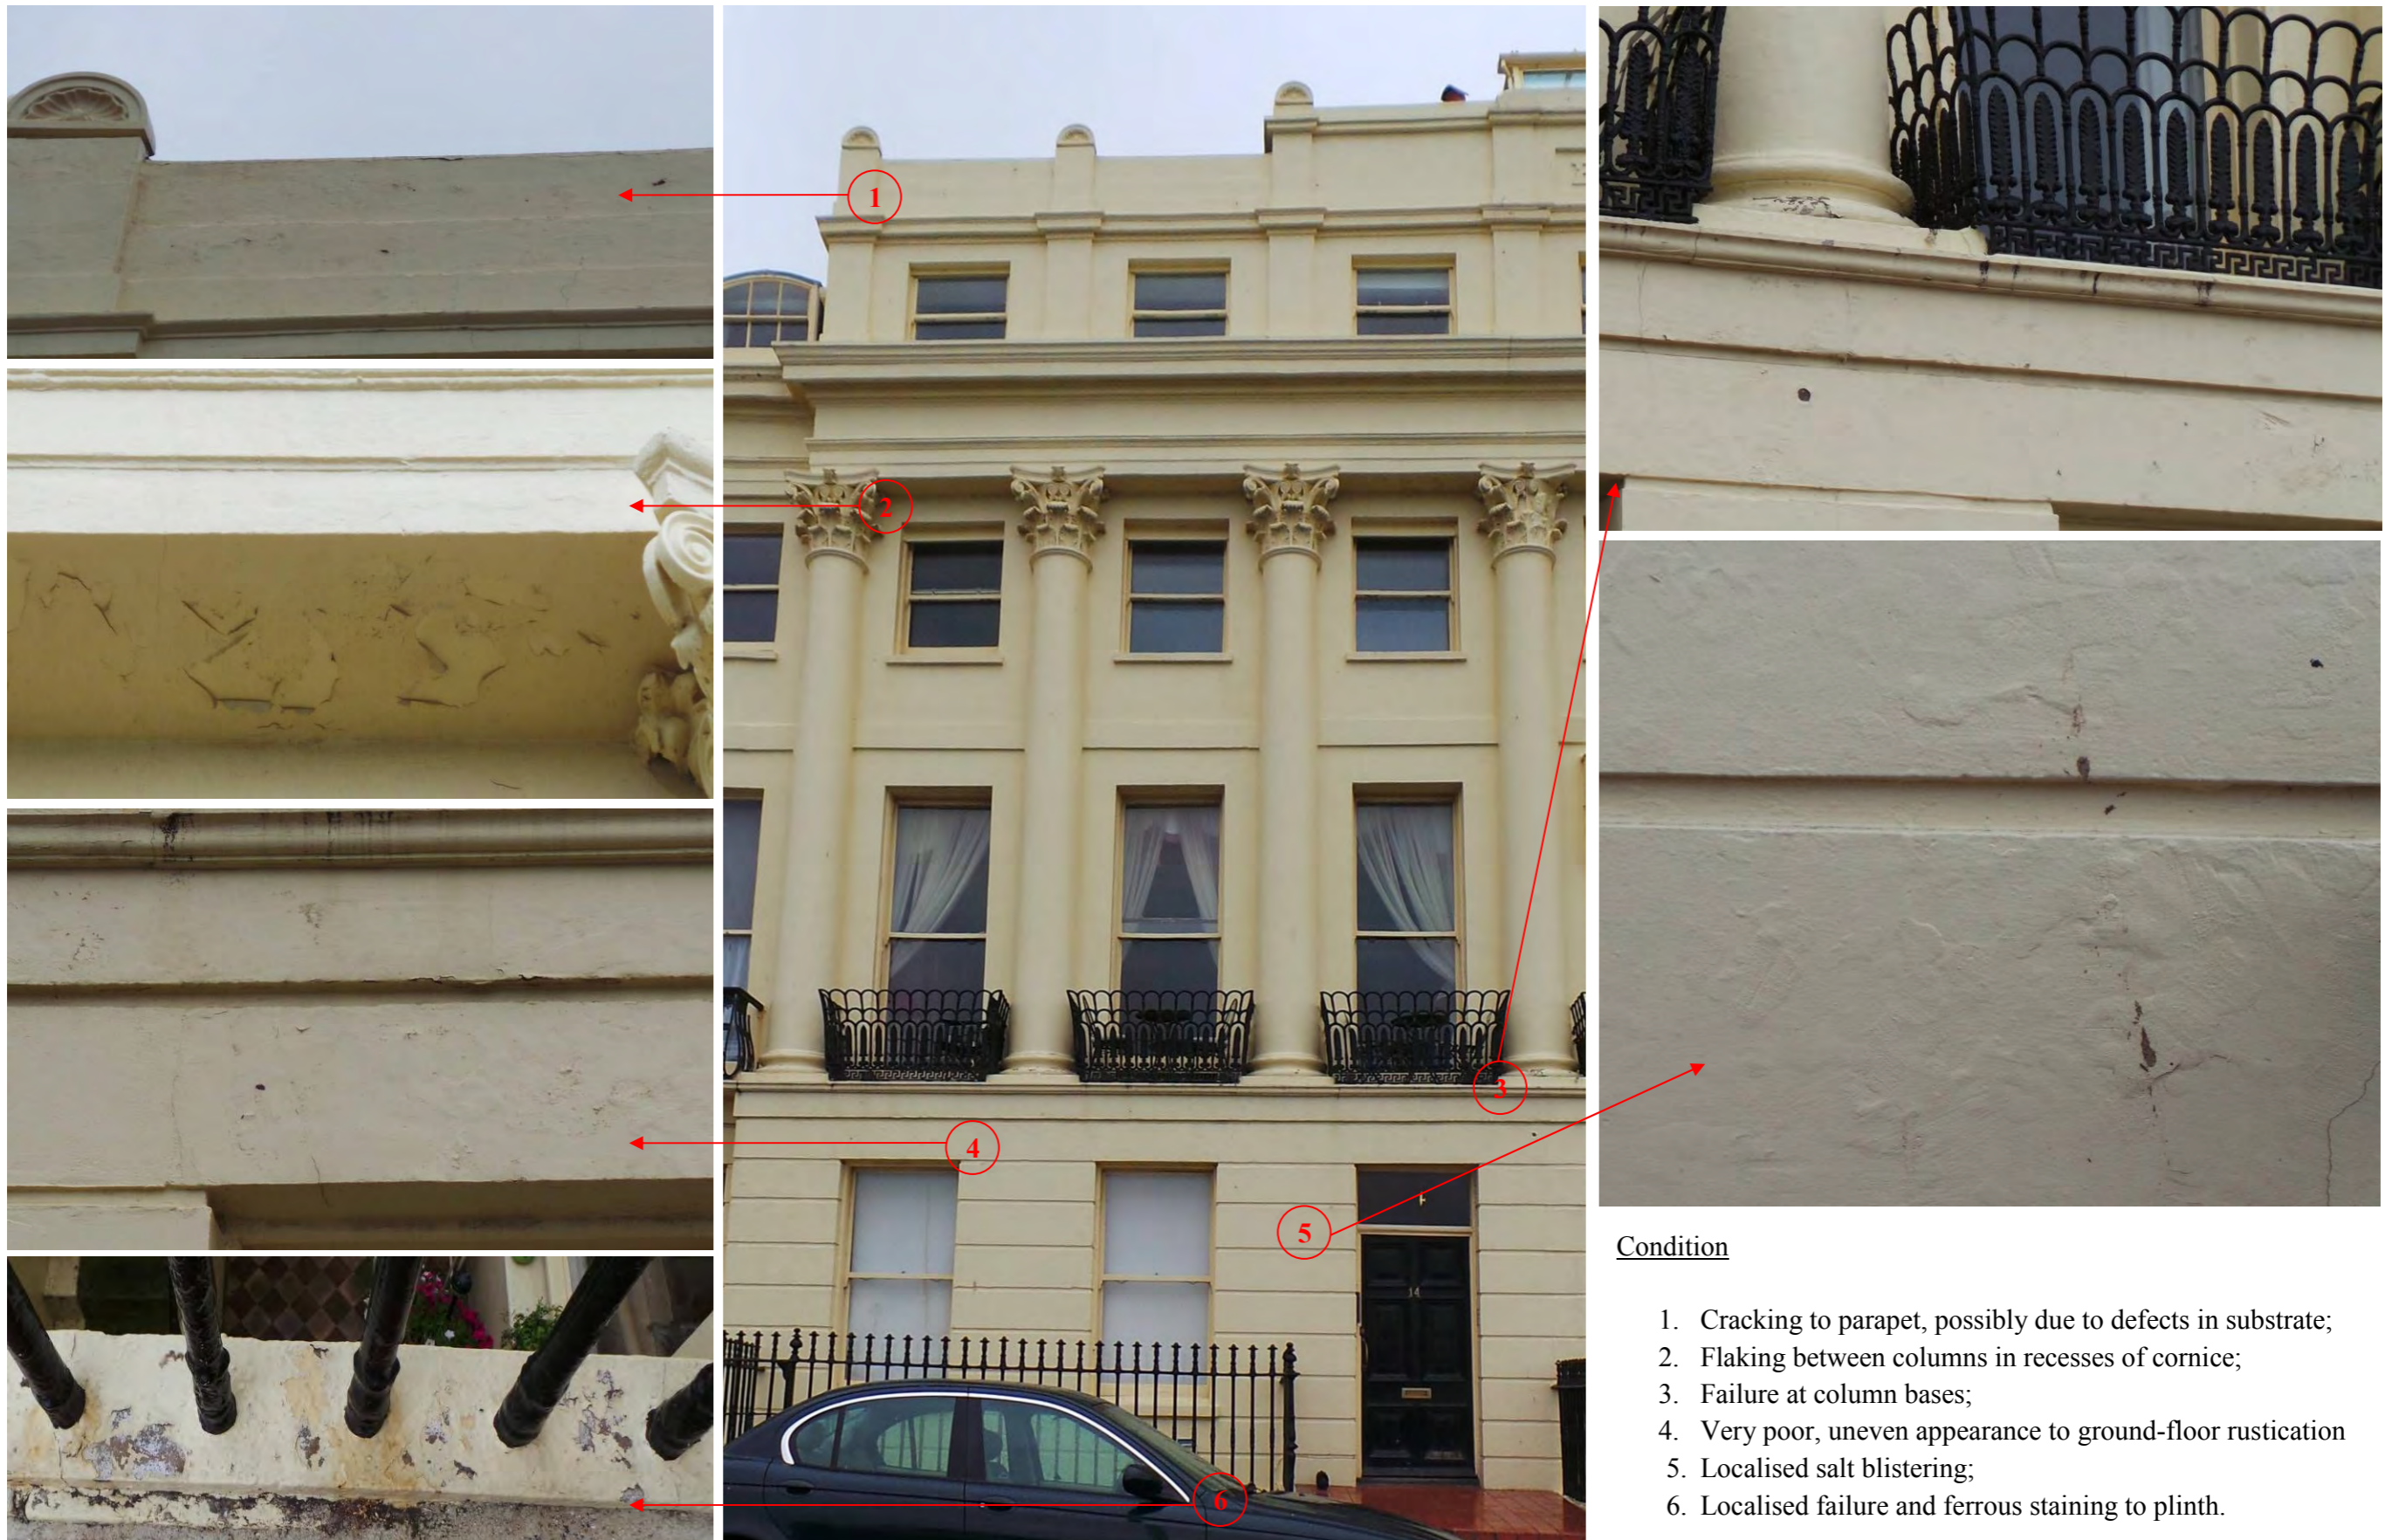
14 Brunswick Terrace

1. Cracking to parapet, possibly due to defects in substrate;
2. Flaking between columns in recesses of cornice;
3. Failure at column bases;
4. Very poor, uneven appearance to ground-floor rustication
5. Localised salt blistering;
6. Localised failure and ferrous staining to plinth.

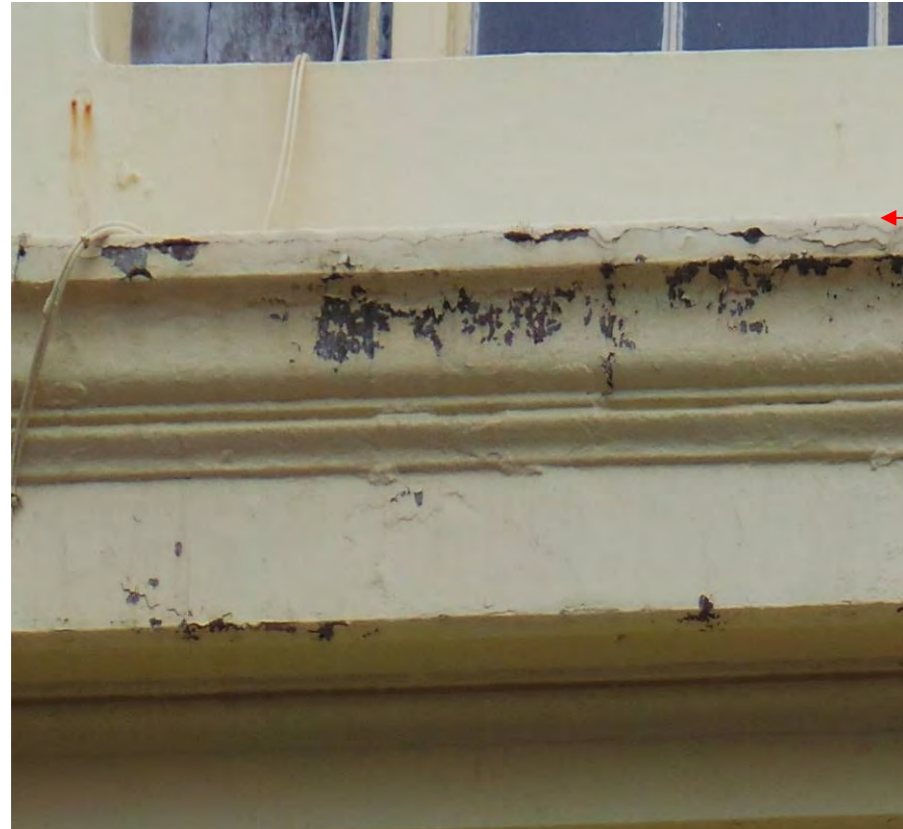
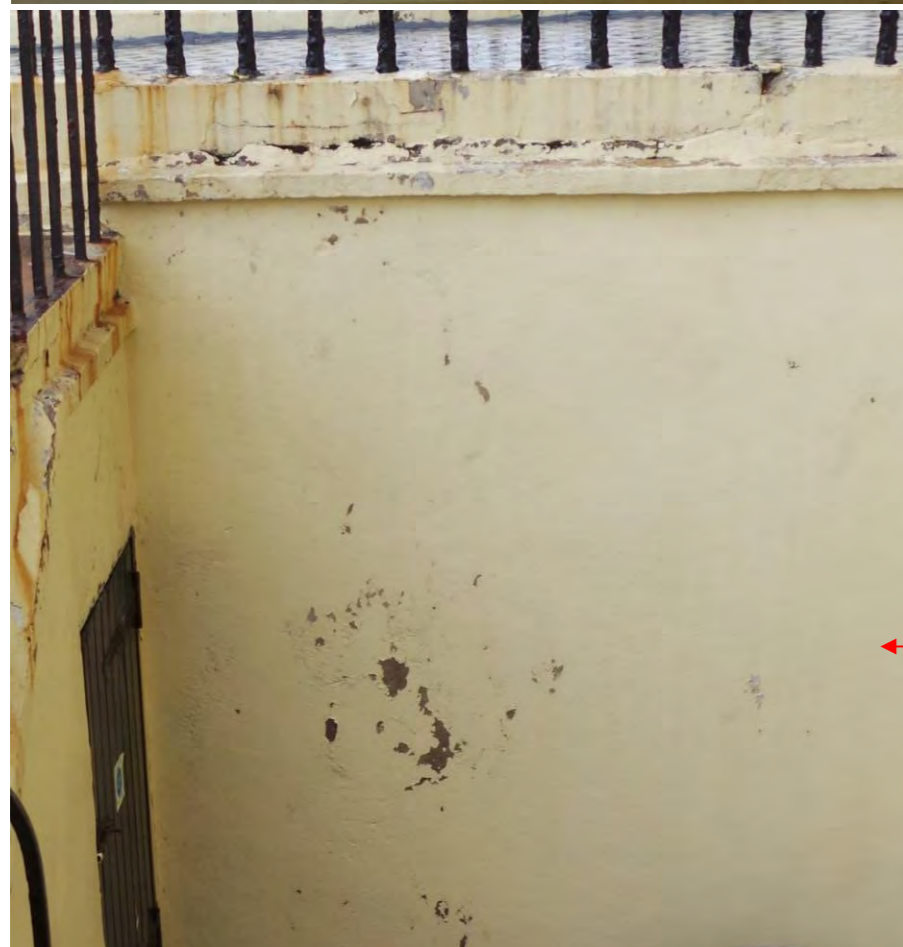
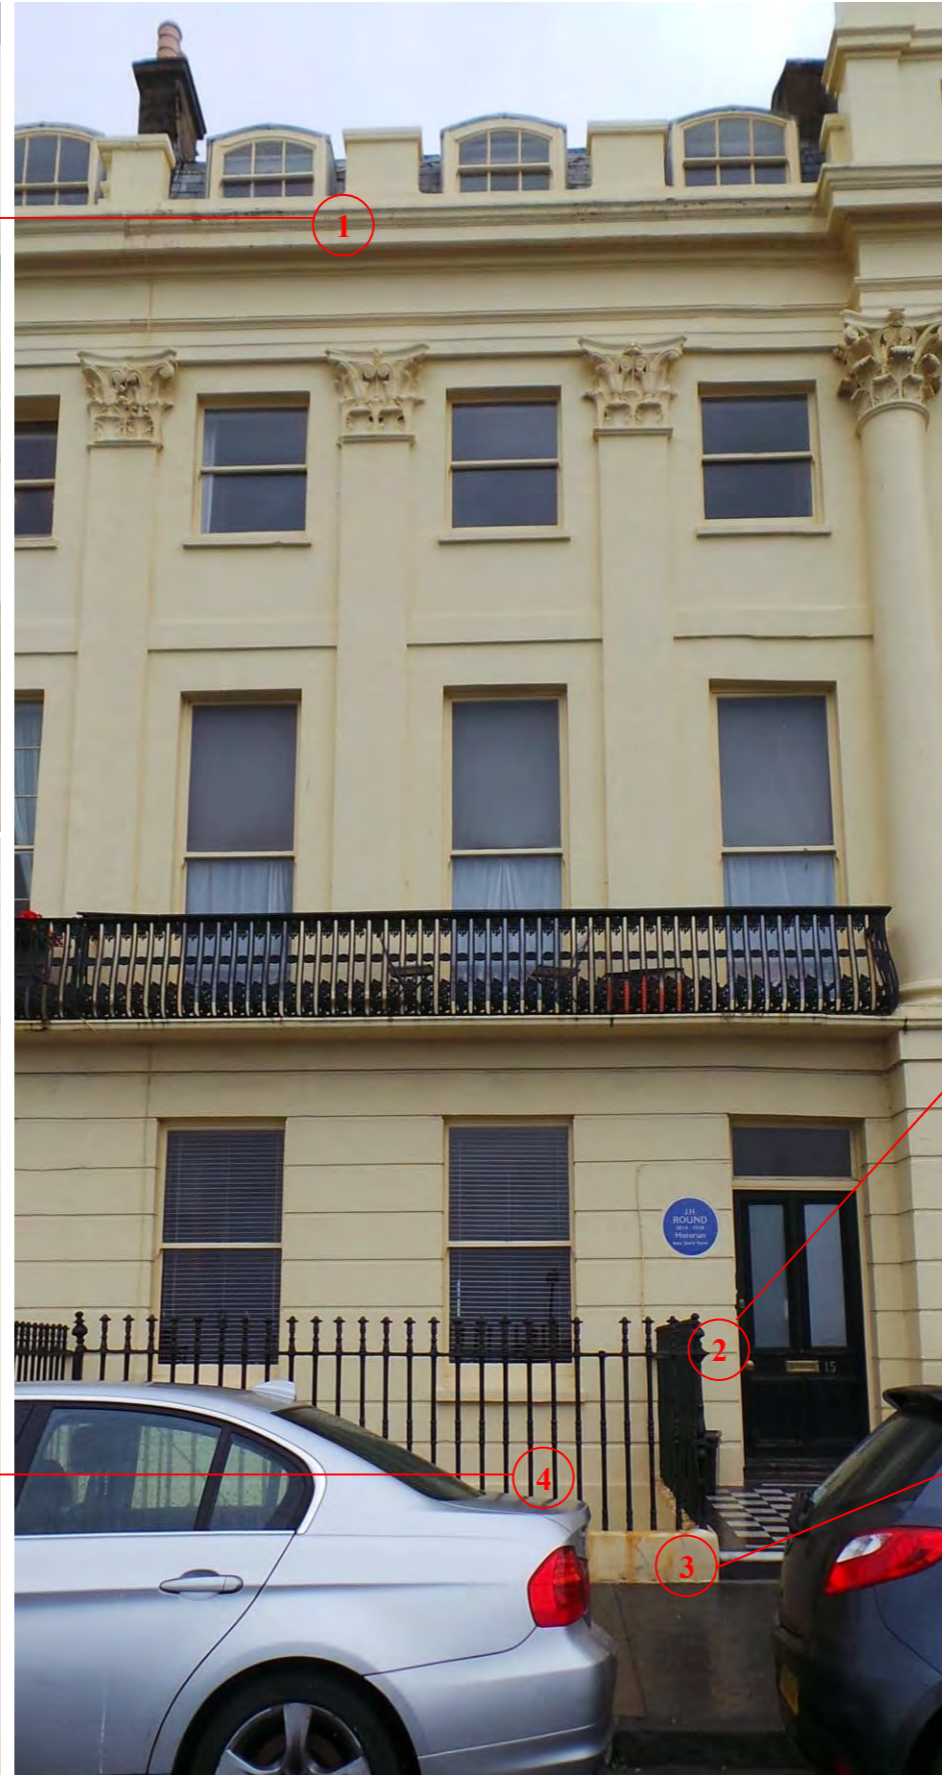
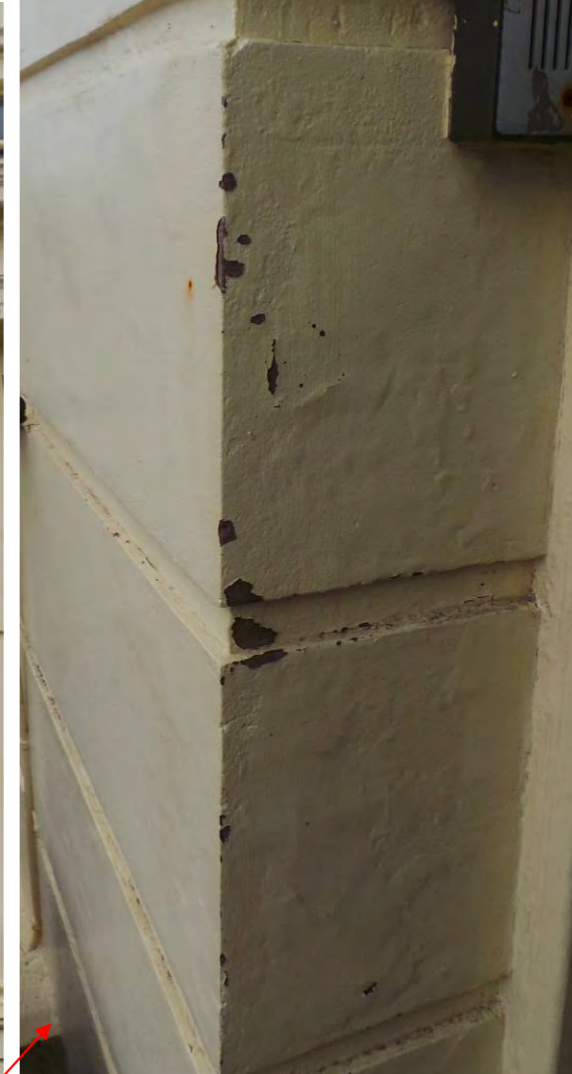
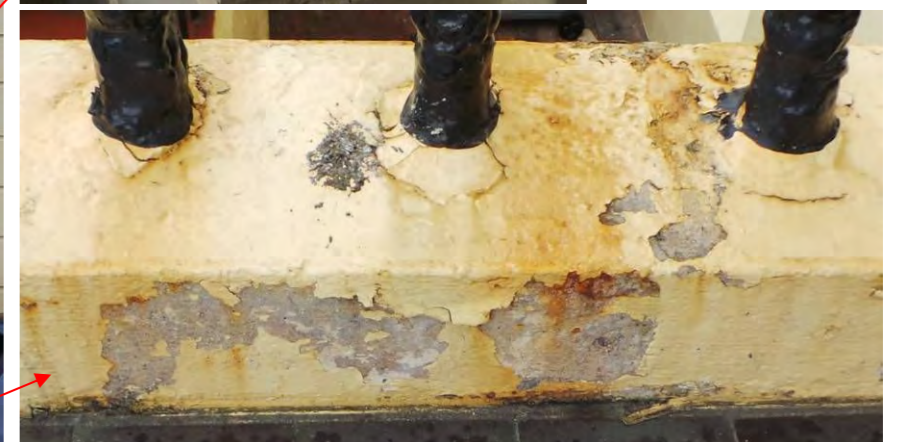
15 Brunswick Terrace

1. Flaking to high-level cornice, possibly due to defects in stucco-work;
2. Localised blistering and losses, particularly to entrance;
3. Losses and ferrous staining to plinth wall;
4. Losses at basement level.

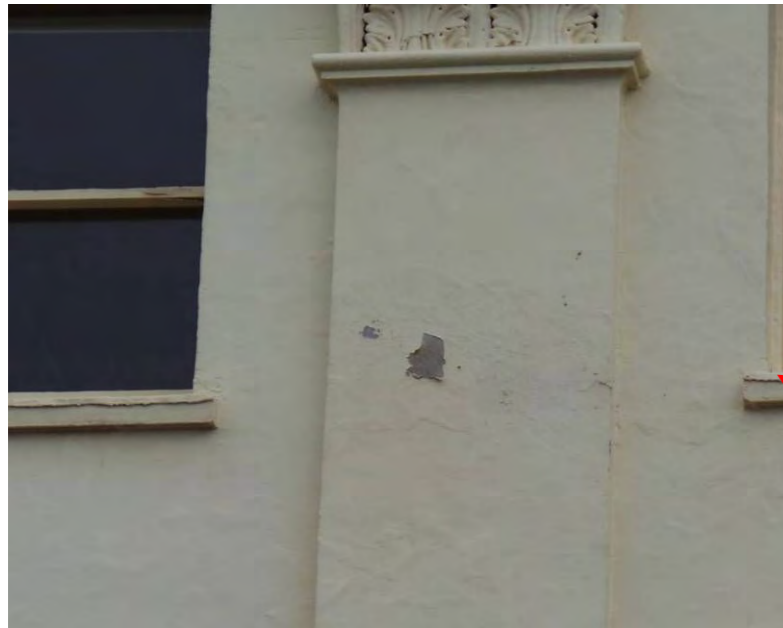
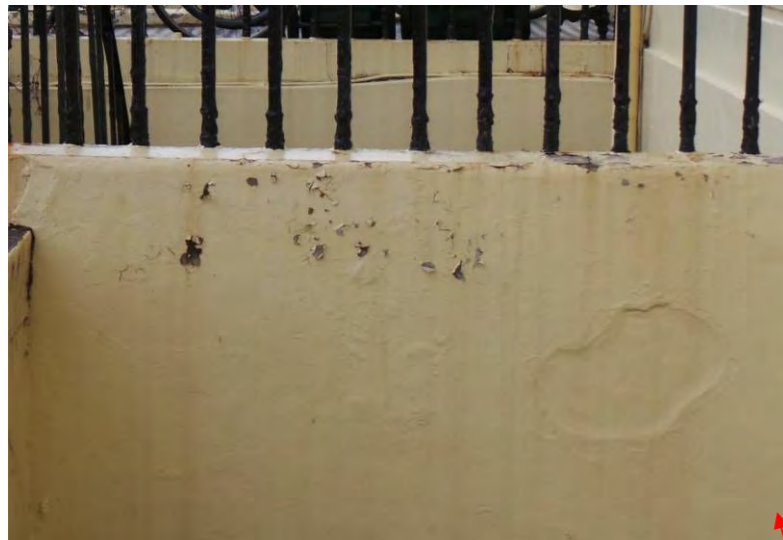
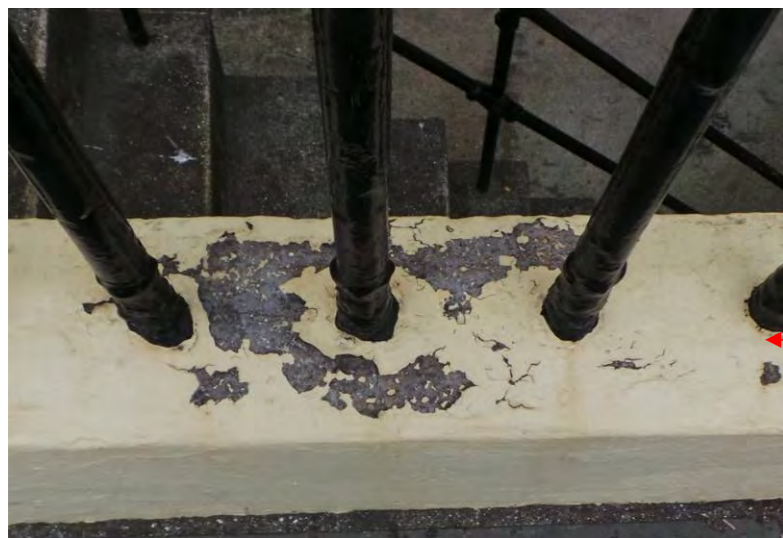
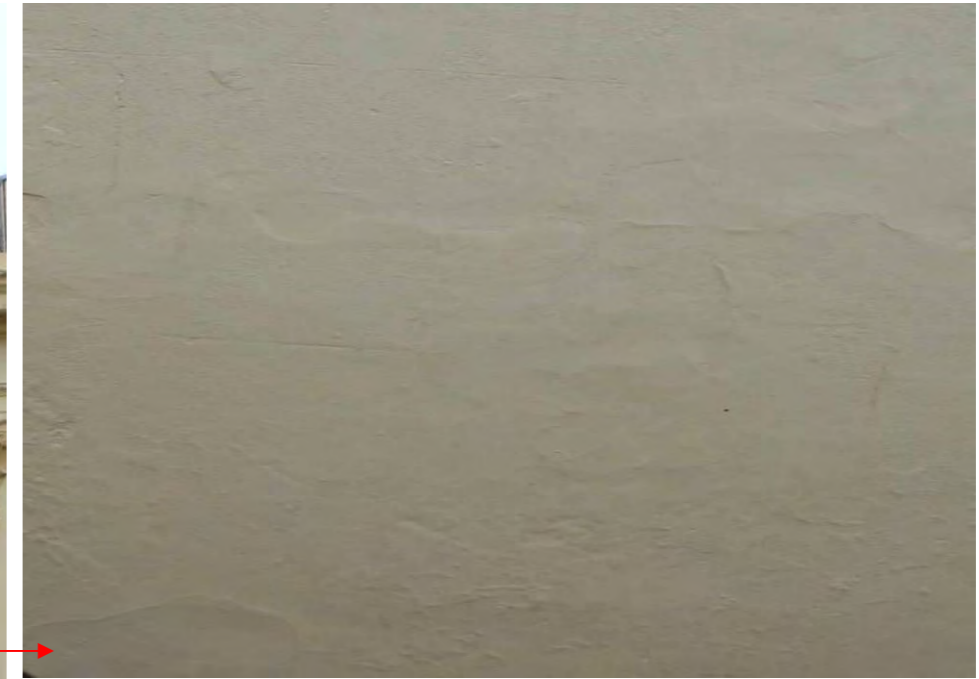
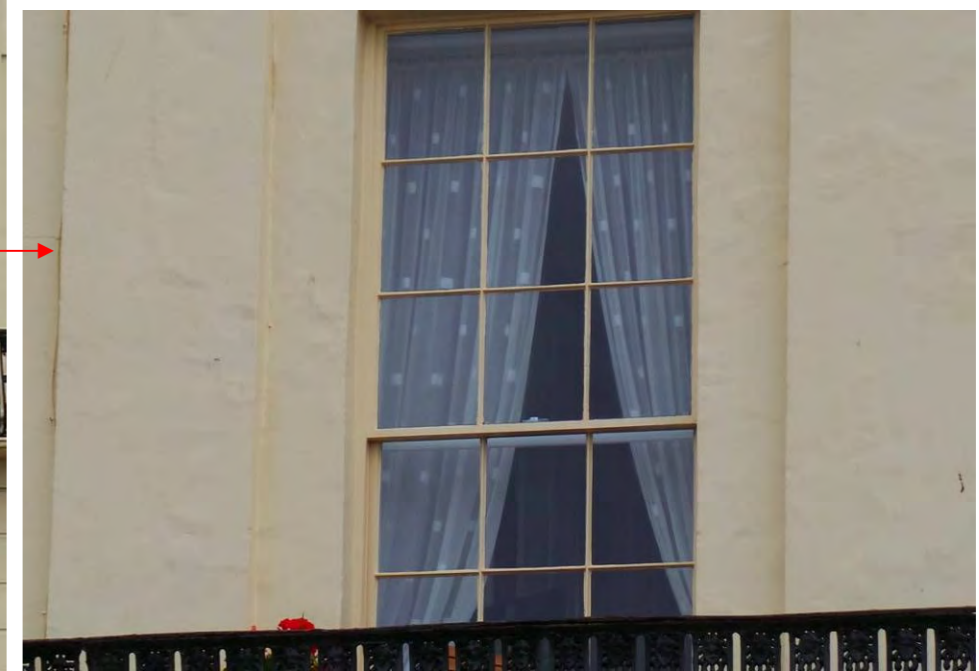
16 Brunswick Terrace

Generally good at high level;

1. Isolated loss to centre-left column at second-floor level;
2. Uneven surface across entire first and second floors;
3. Ferrous staining and losses to plinth wall;
4. Losses and blistering at basement level.

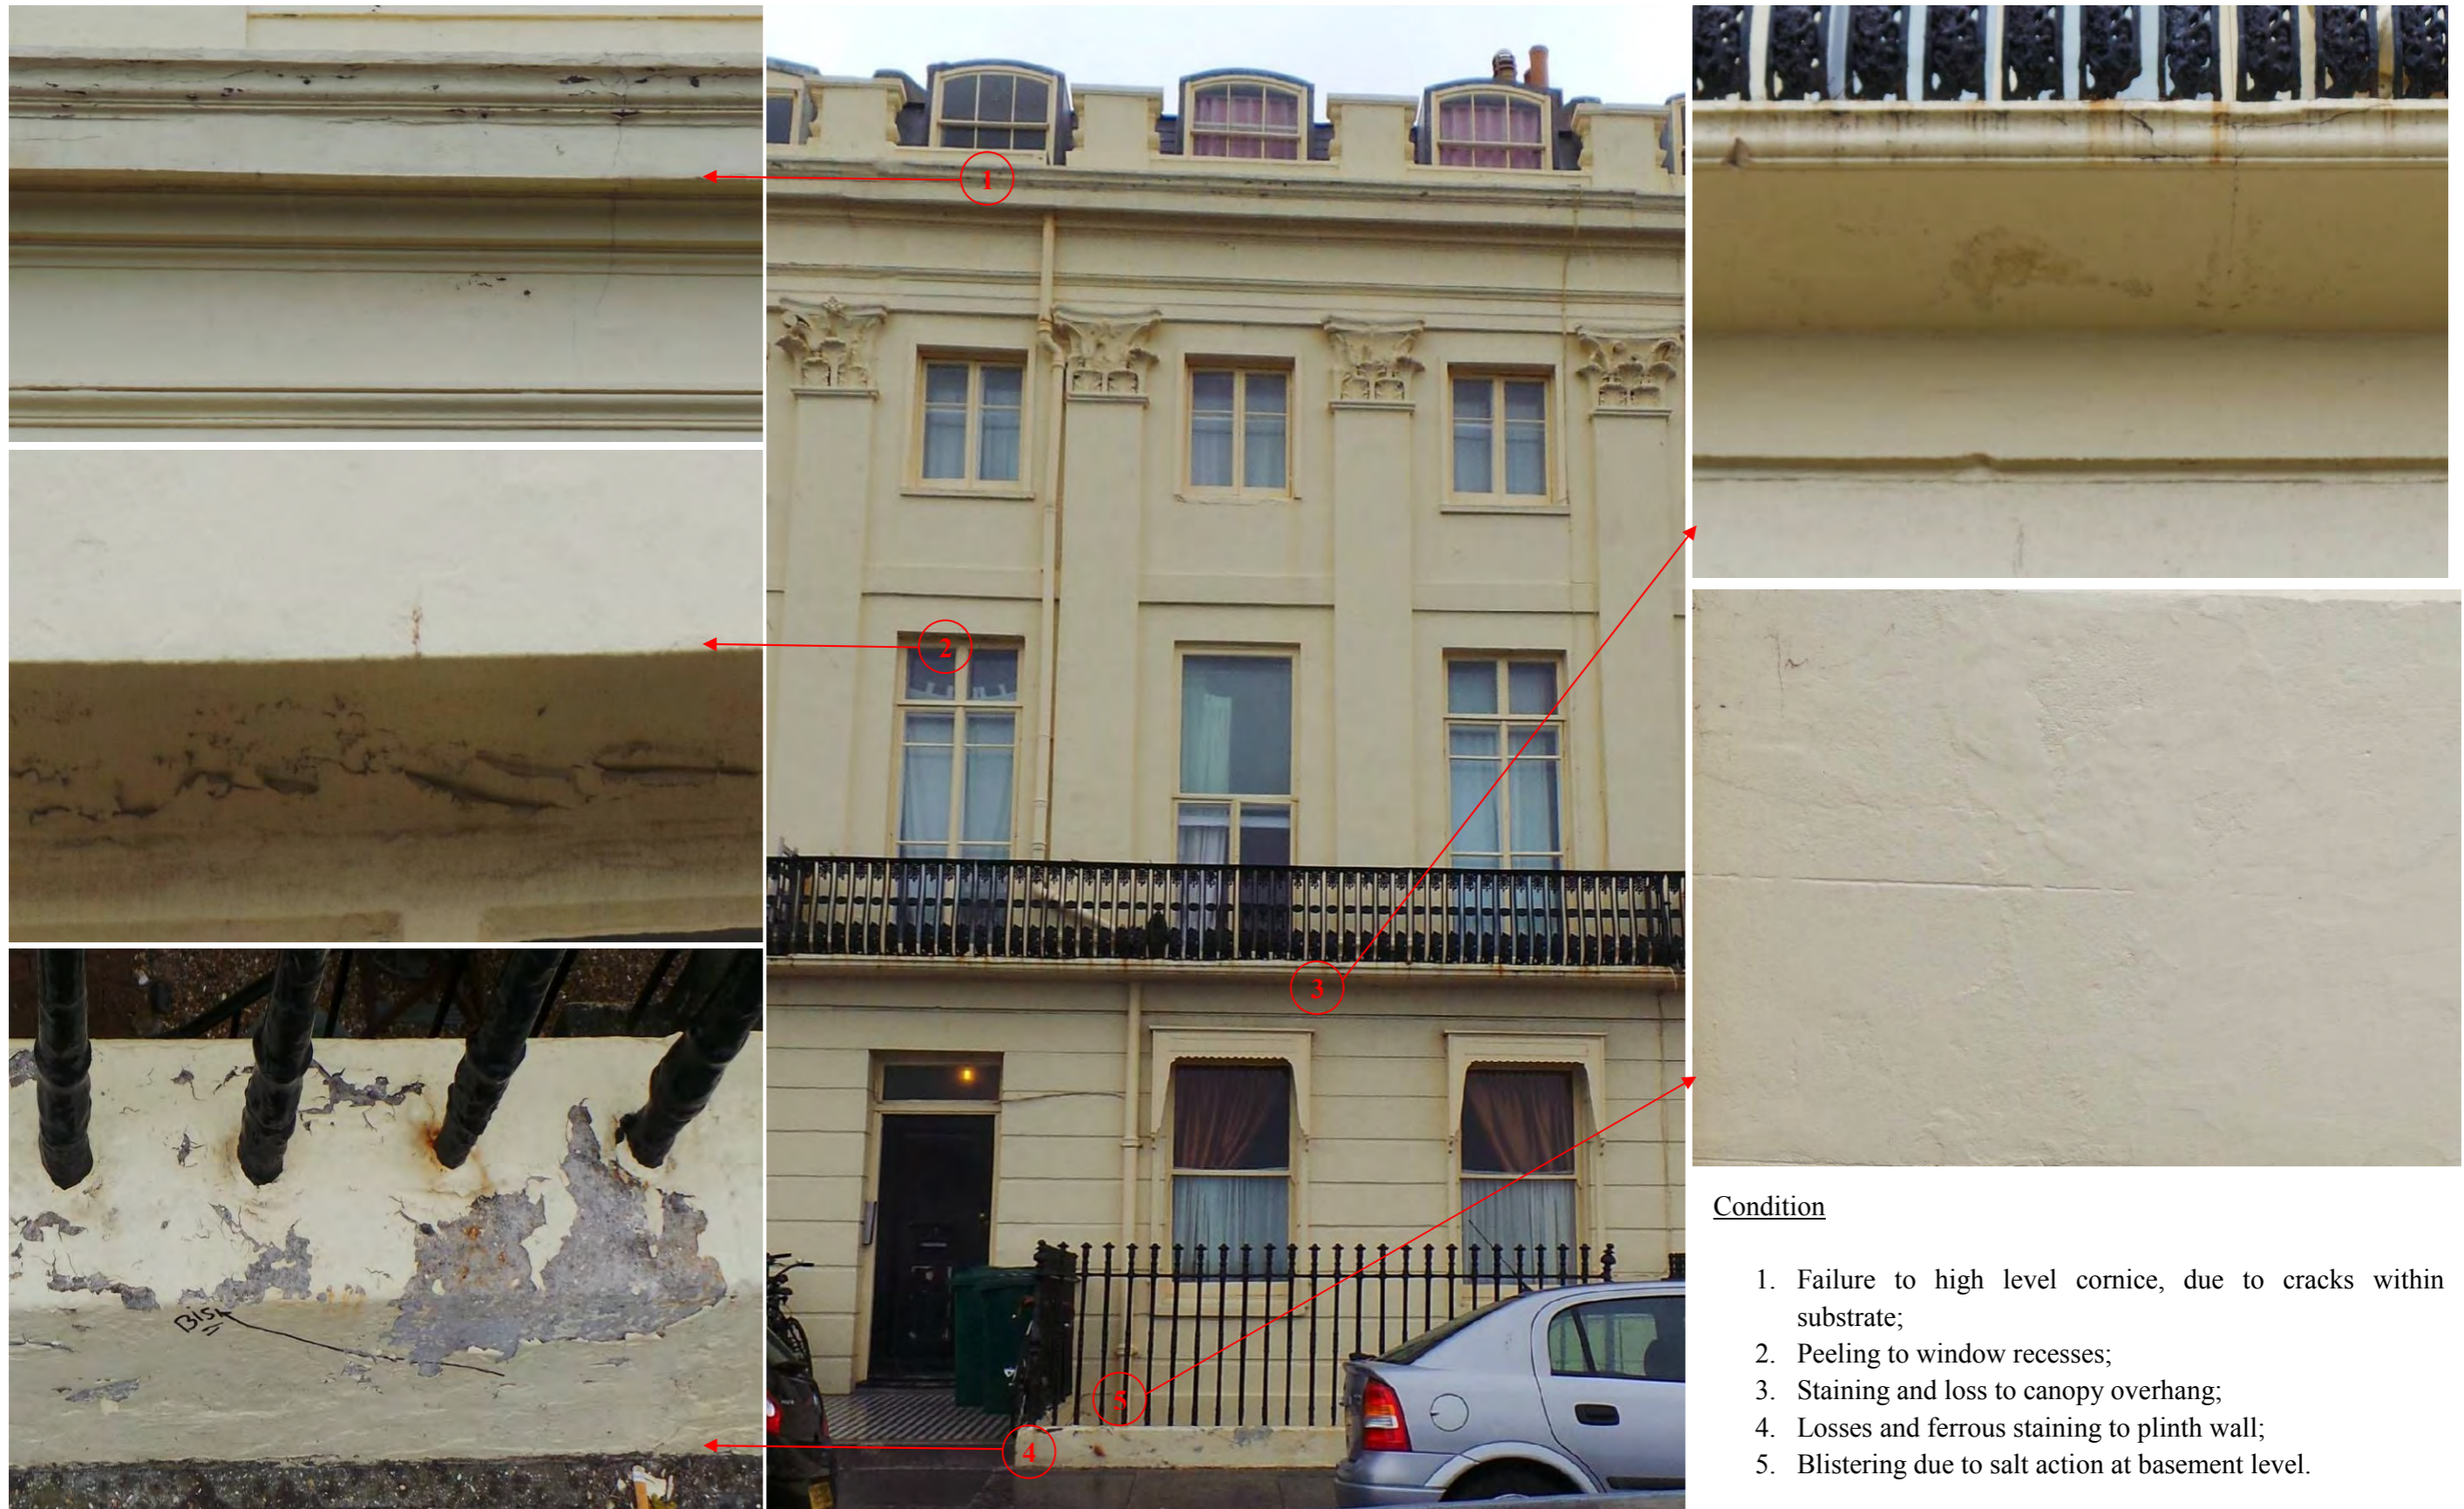
17 Brunswick Terrace

1. Failure to high level cornice, due to cracks within substrate;
2. Peeling to window recesses;
3. Staining and loss to canopy overhang;
4. Losses and ferrous staining to plinth wall;
5. Blistering due to salt action at basement level.
