**Investigation of Paint Failure at
Brunswick Estate
Hove
Brighton**

August 2013

**BRUNSWICK ESTATE
HOVE**

The following document investigates the failure of the external paint-system at Brunswick Estate, Hove based on research carried out by Elizabeth Hirst and Rachel Morley of Hirst Conservation between August and November 2013. The work was commissioned by Brighton & Hove City Council.

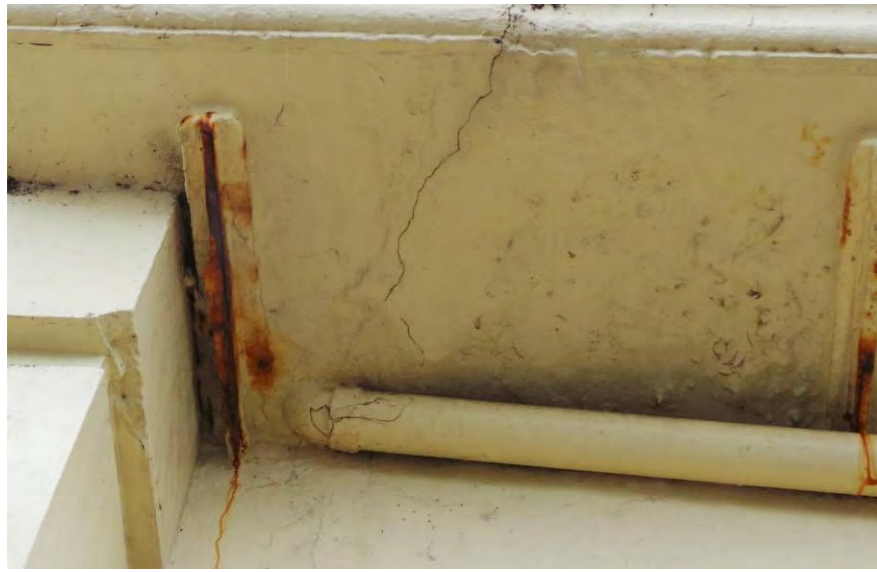
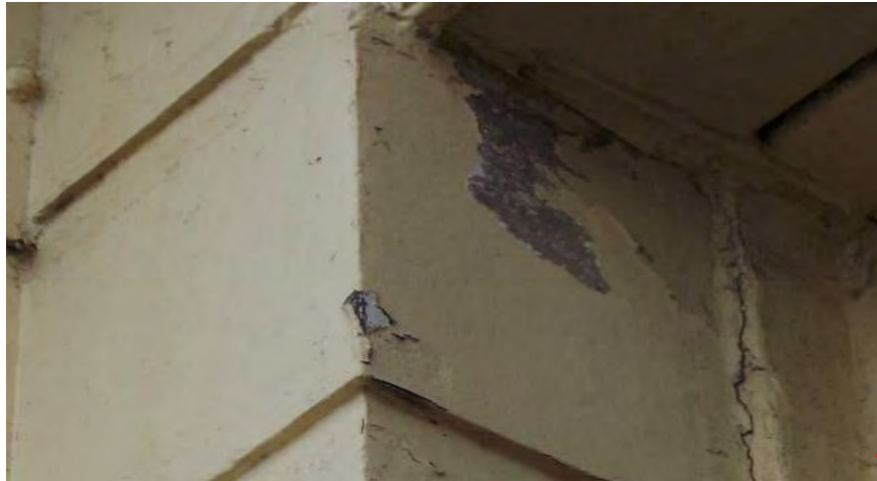
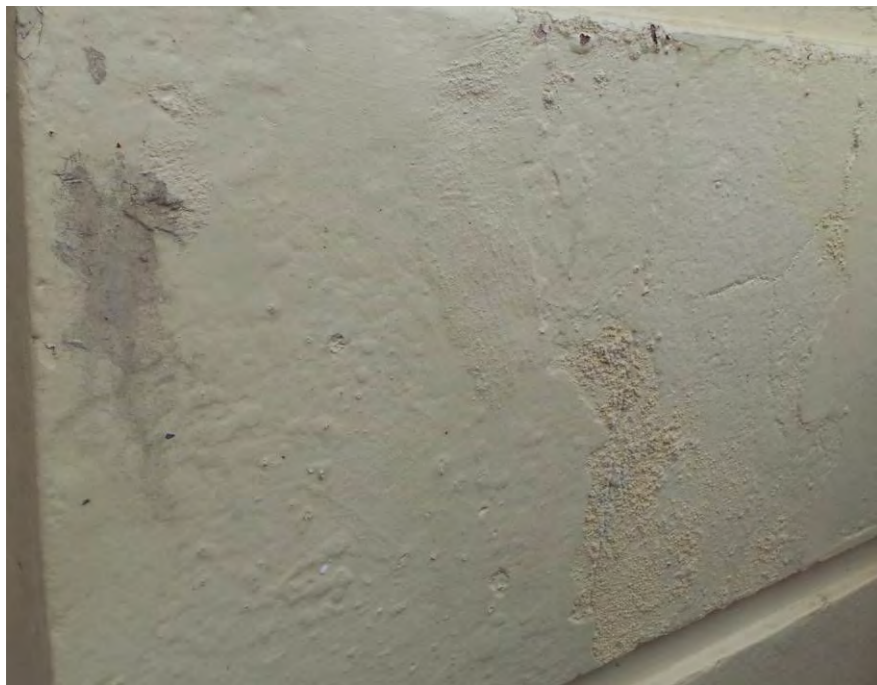
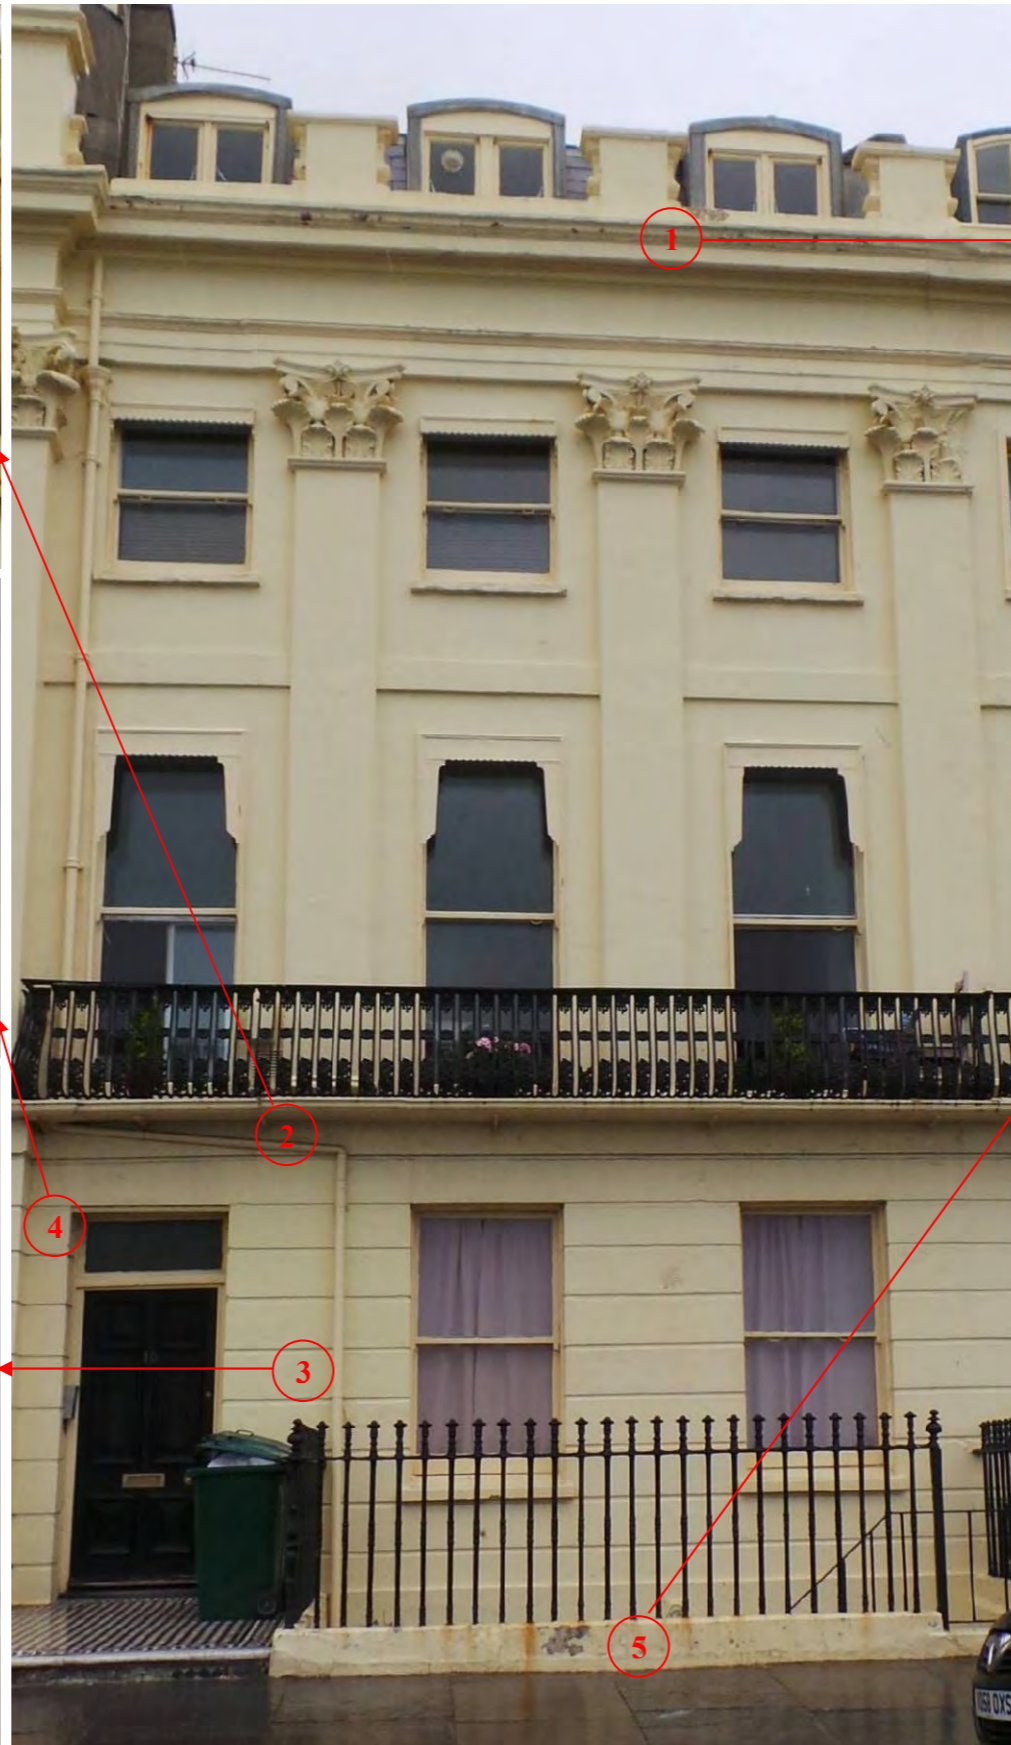
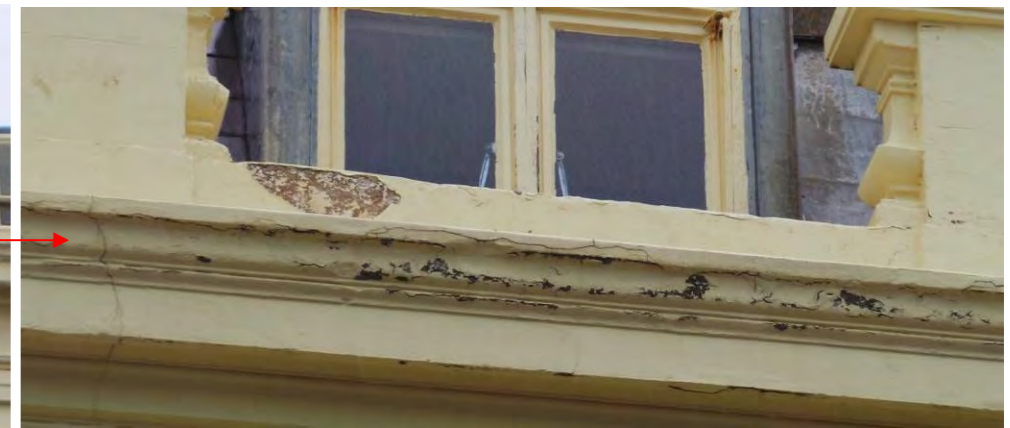
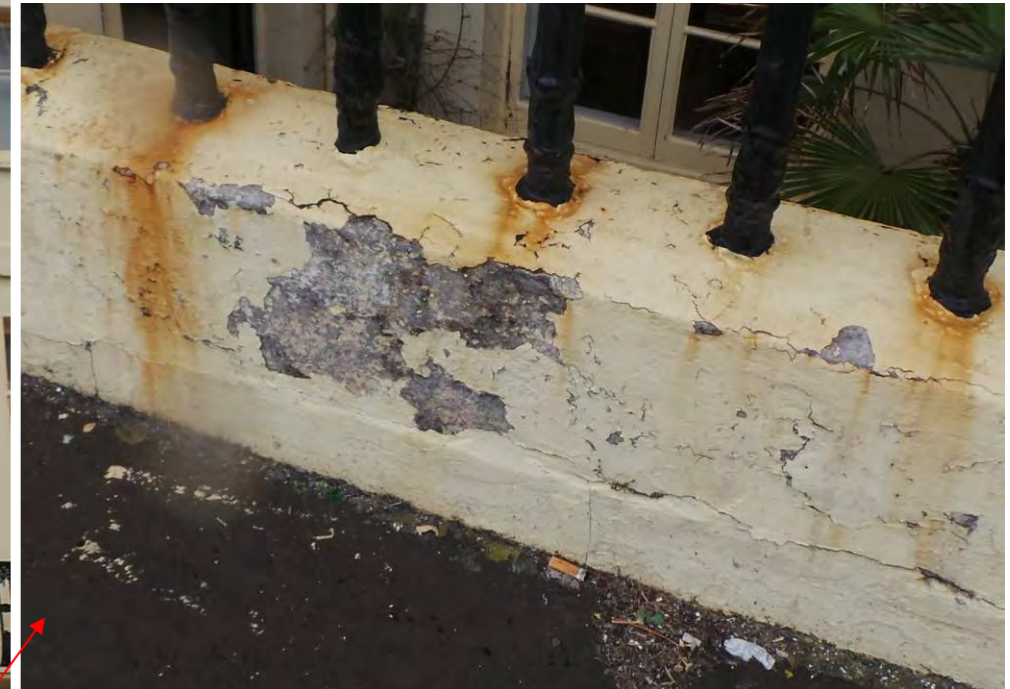
18 Brunswick Terrace

1. Failure to high level cornice, due to cracks within substrate;
2. Cracking and staining to underside of balcony;
3. Ground floor rustication very uneven appearance;
4. Losses, flaking, salt blistering at ground-floor and basement level – particularly around entrance;
5. Losses and ferrous staining to plinth wall;

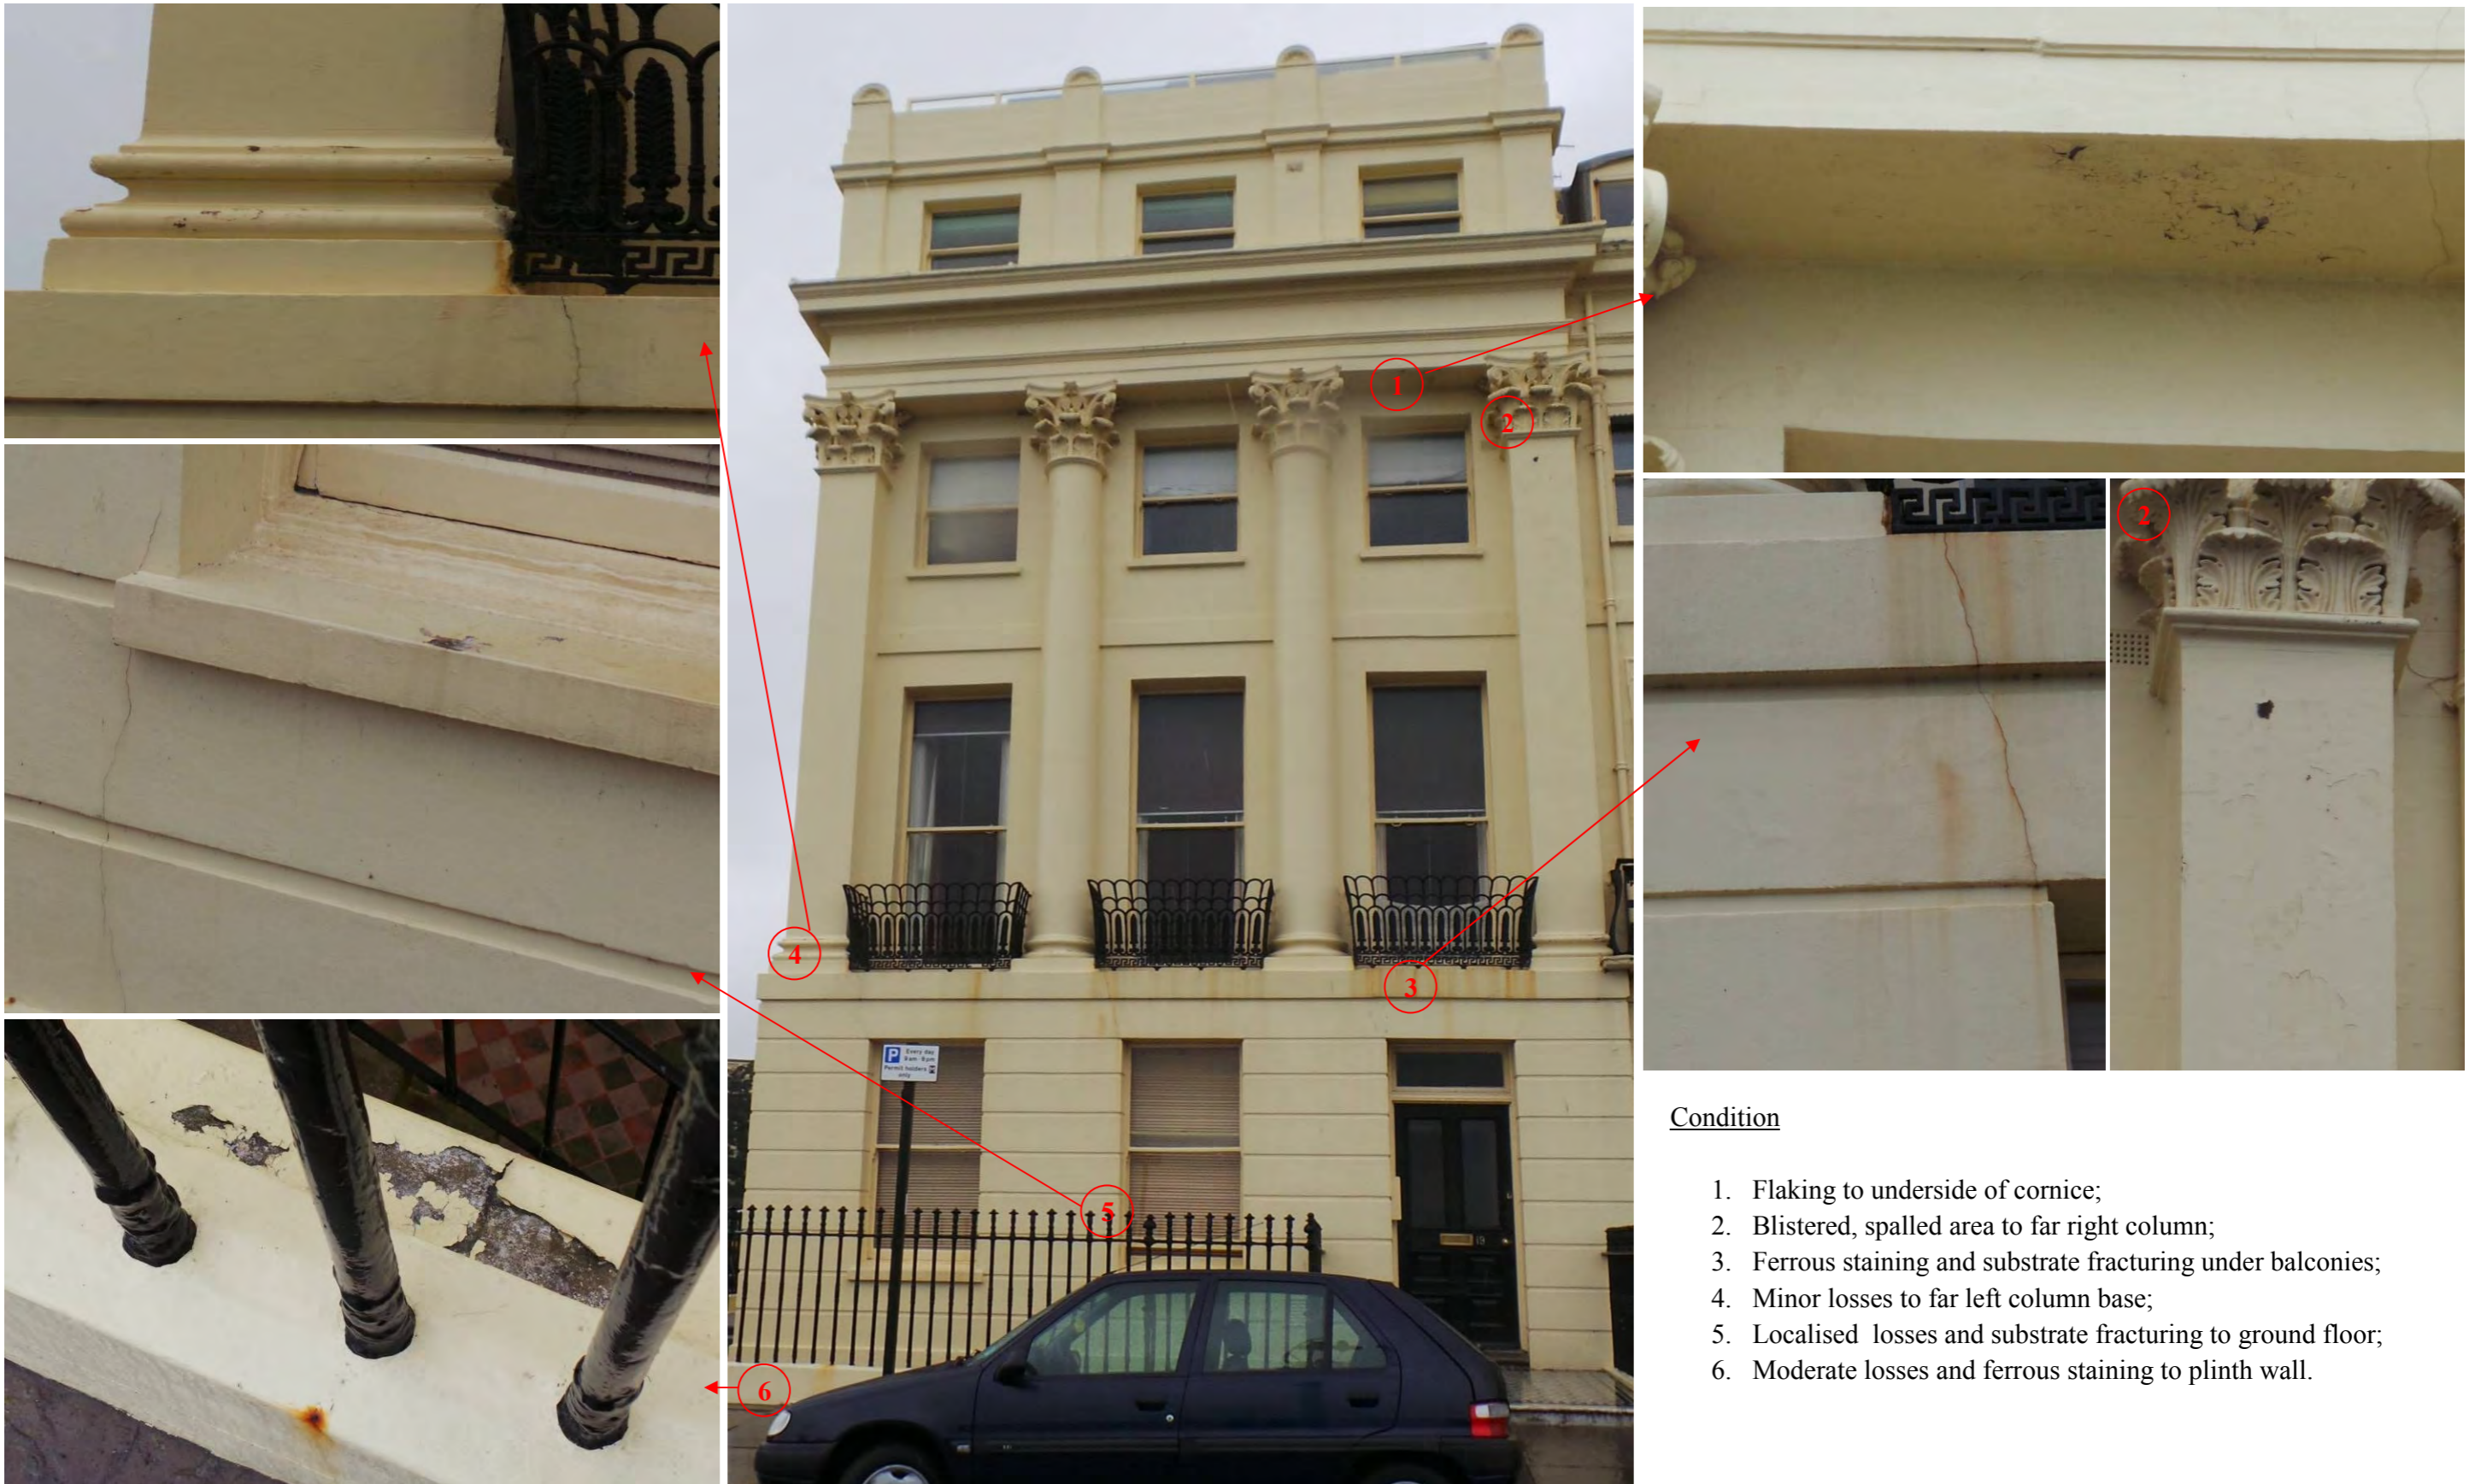
19 Brunswick Terrace (Brunswick Terrace Elevation)

1. Flaking to underside of cornice;
2. Blistered, spalled area to far right column;
3. Ferrous staining and substrate fracturing under balconies;
4. Minor losses to far left column base;
5. Localised losses and substrate fracturing to ground floor;
6. Moderate losses and ferrous staining to plinth wall.

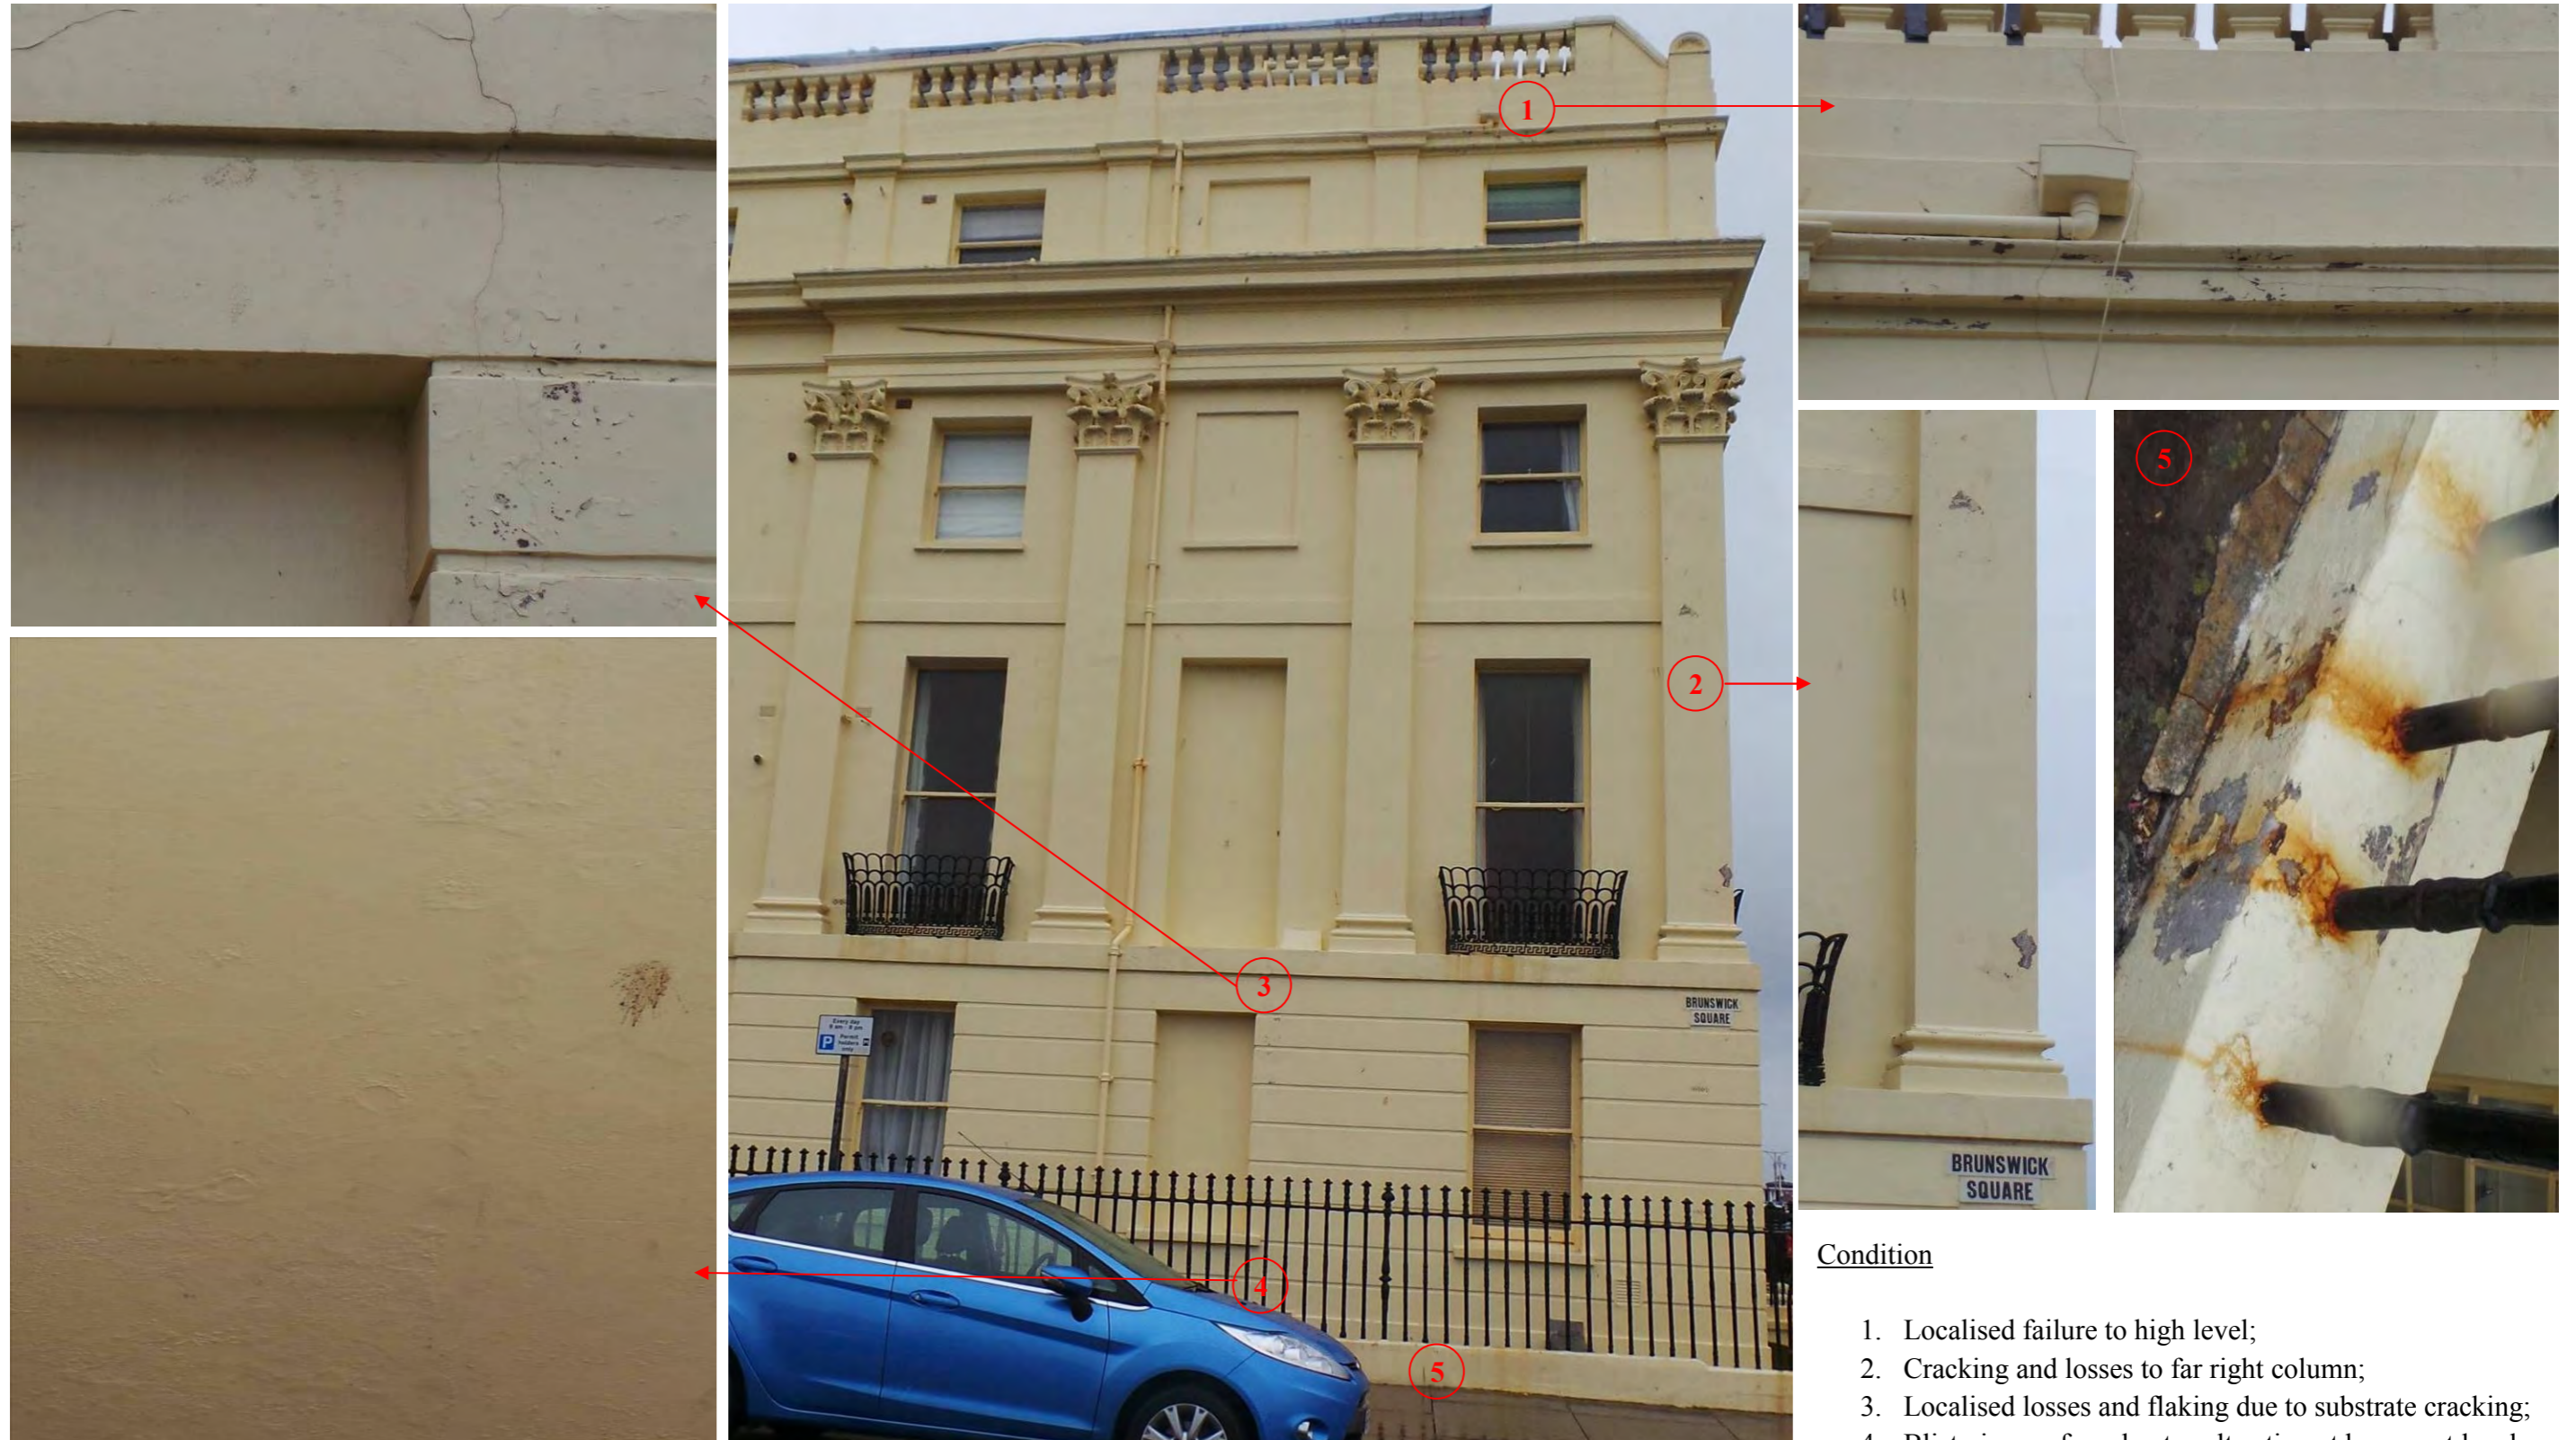
19 Brunswick Terrace (Brunswick Square Elevation)

1. Localised failure to high level;
2. Cracking and losses to far right column;
3. Localised losses and flaking due to substrate cracking;
4. Blistering surface due to salt action at basement level;
5. Moderate losses and ferrous staining to plinth wall.

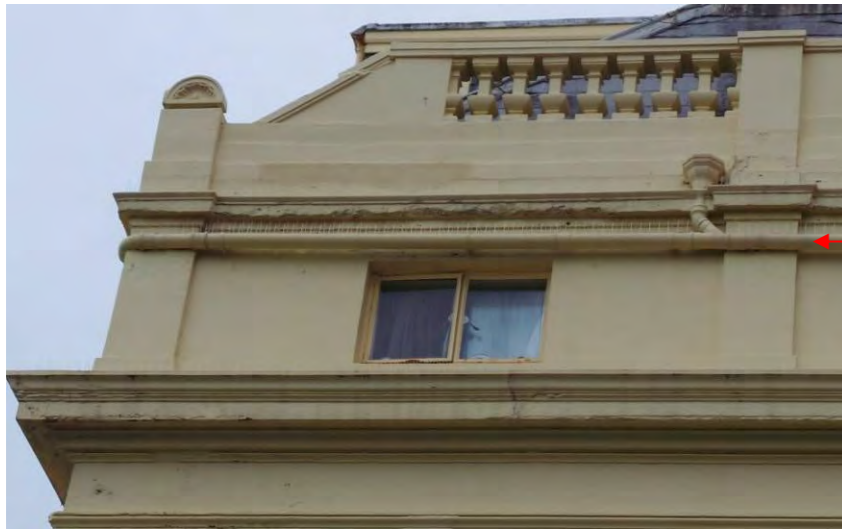
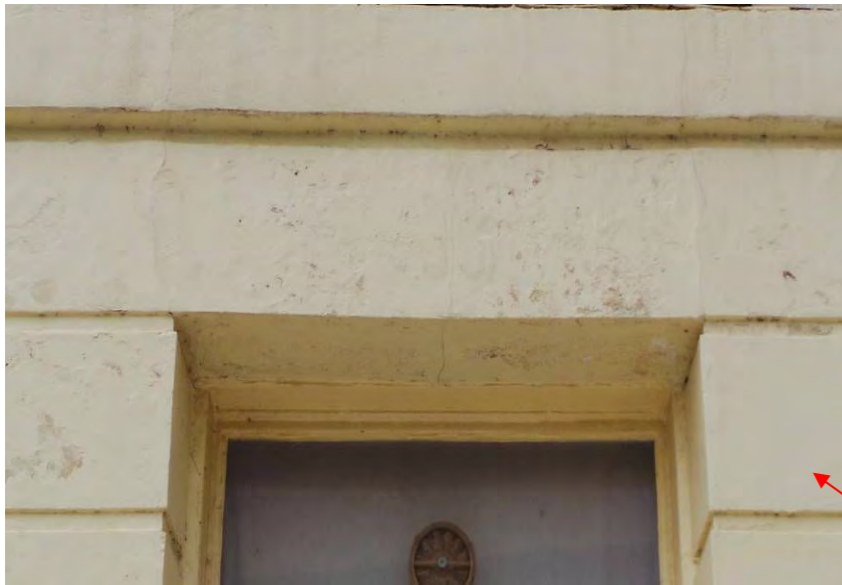
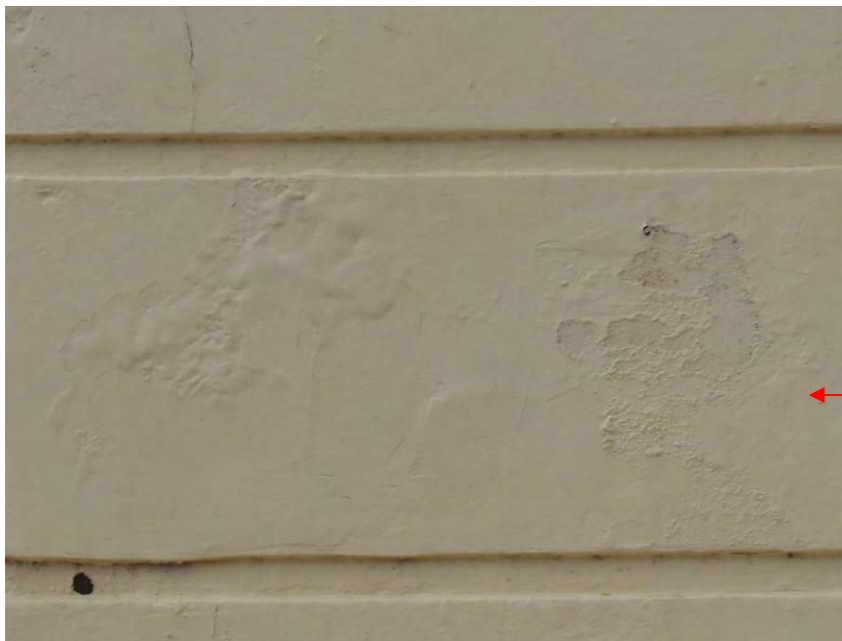
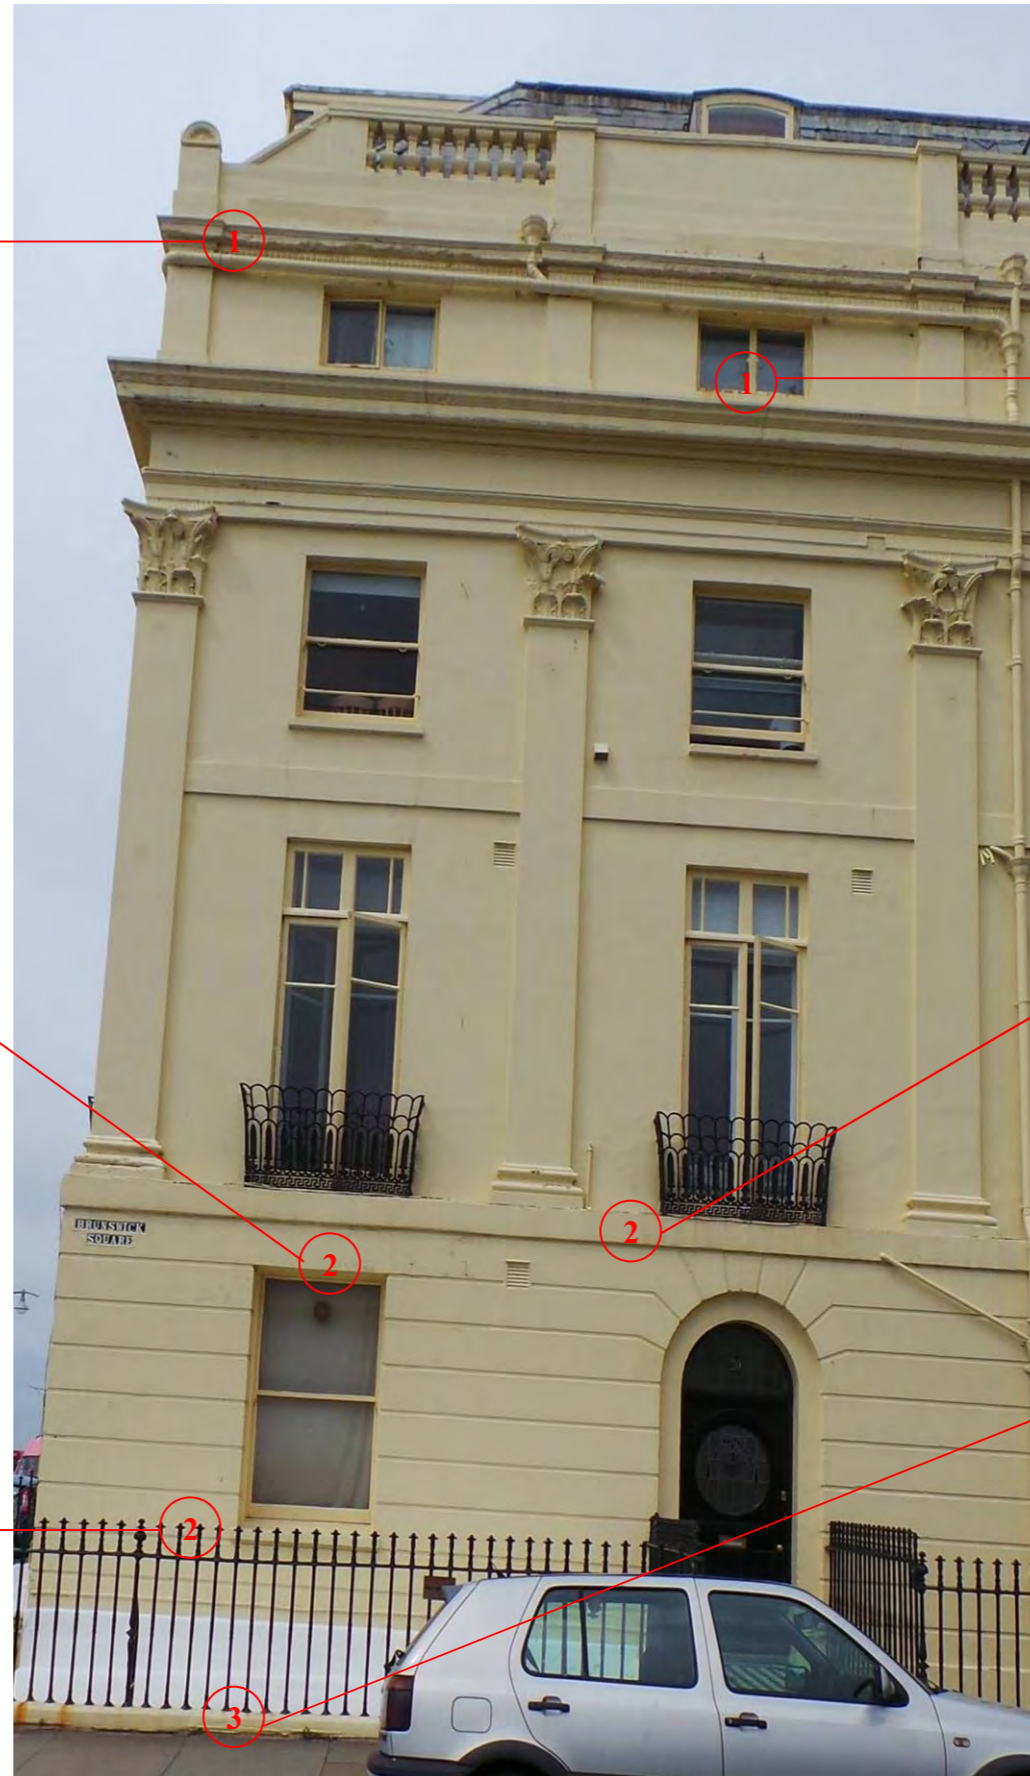
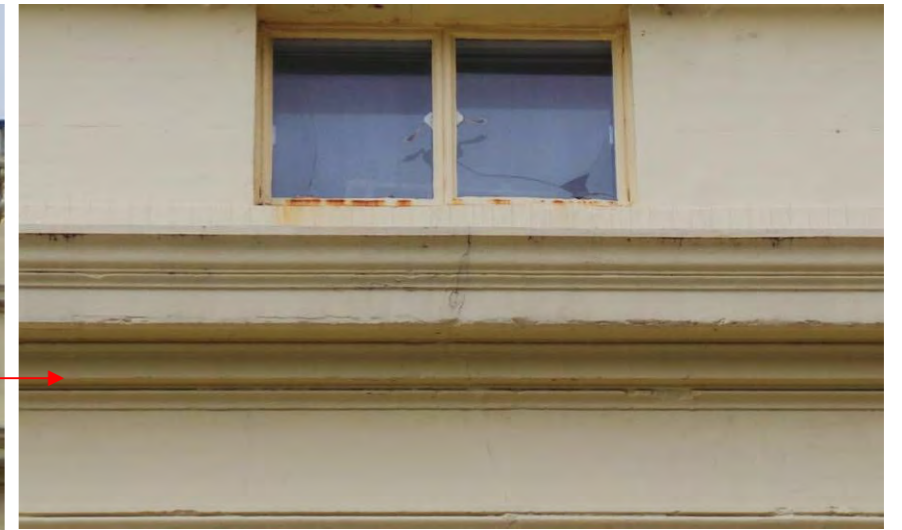
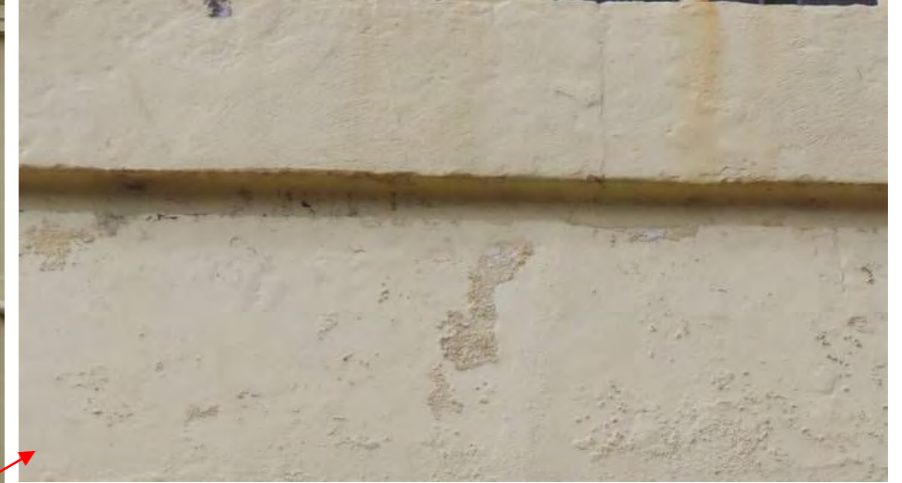
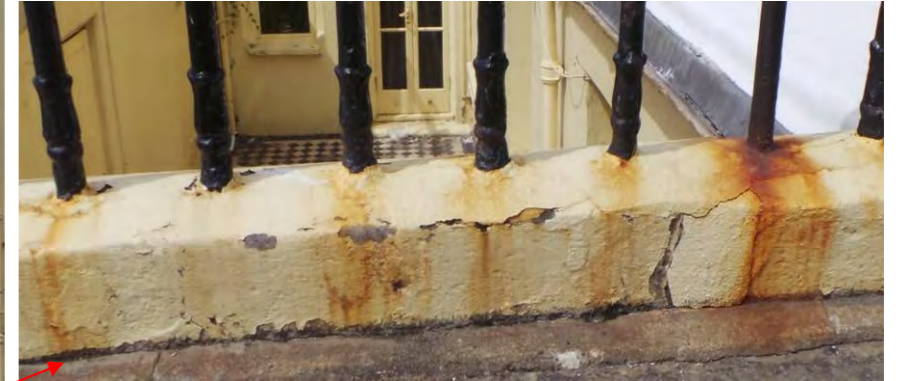
20 Brunswick Terrace (Brunswick Square Elevation)

1. Losses to cornice and string-course detail due to substrate cracking – evidence of previous repairs;
2. Ground-floor and basement levels riddled with blisters, flaking paint and losses as a result of salt action;
3. Minor losses and ferrous staining to plinth wall.

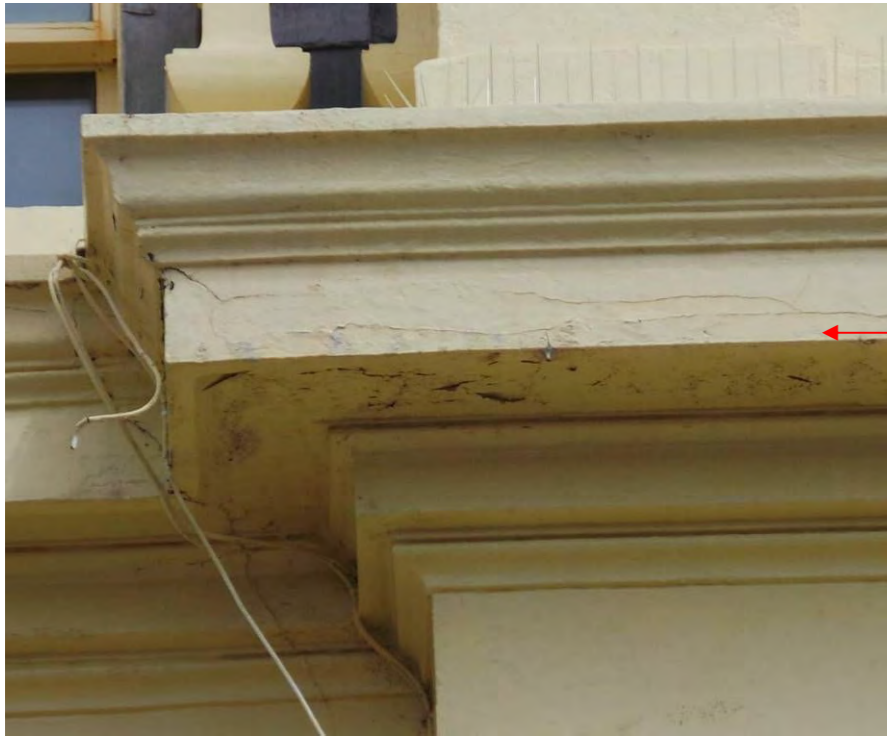
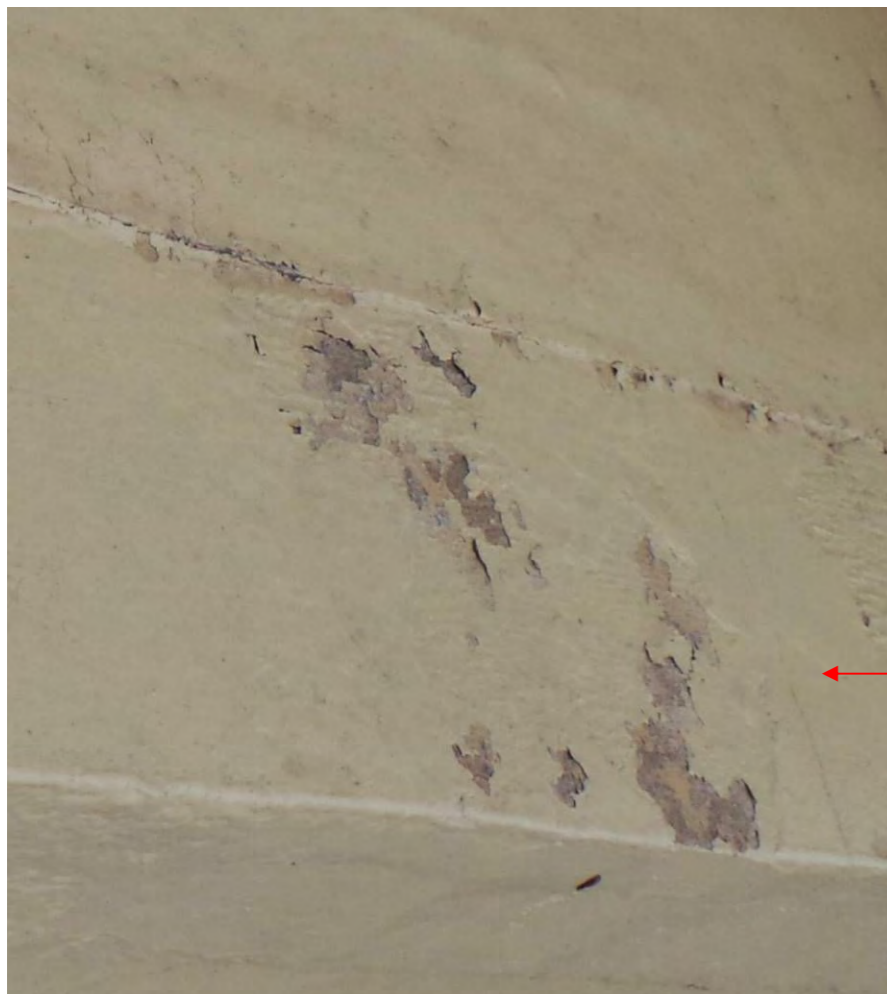
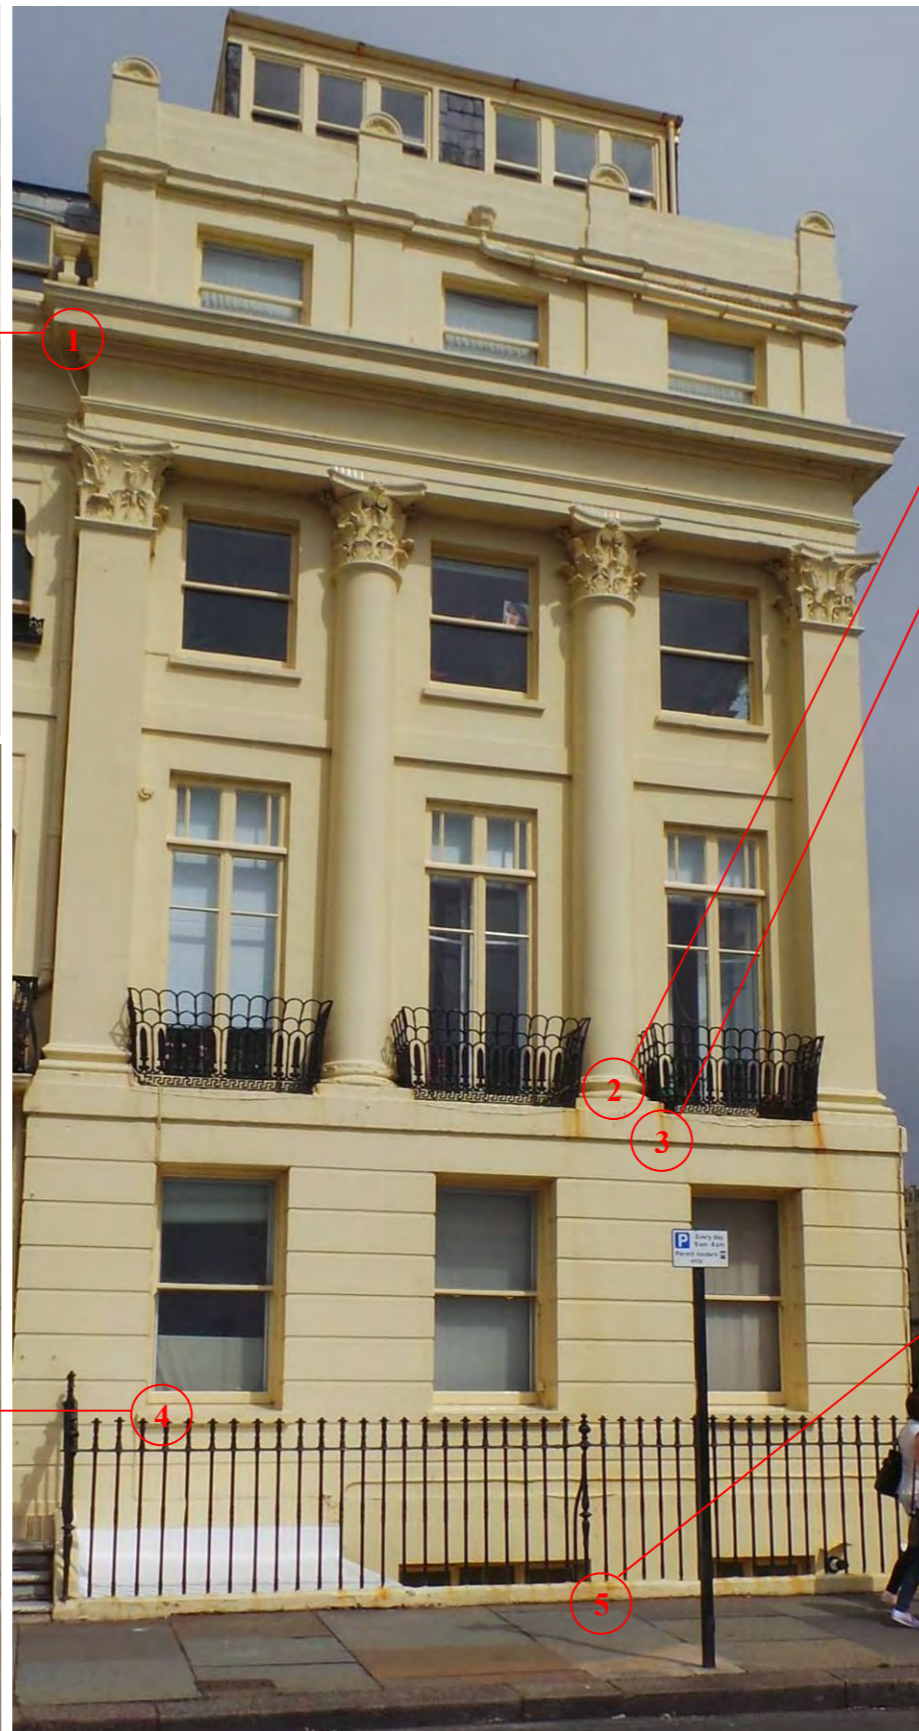
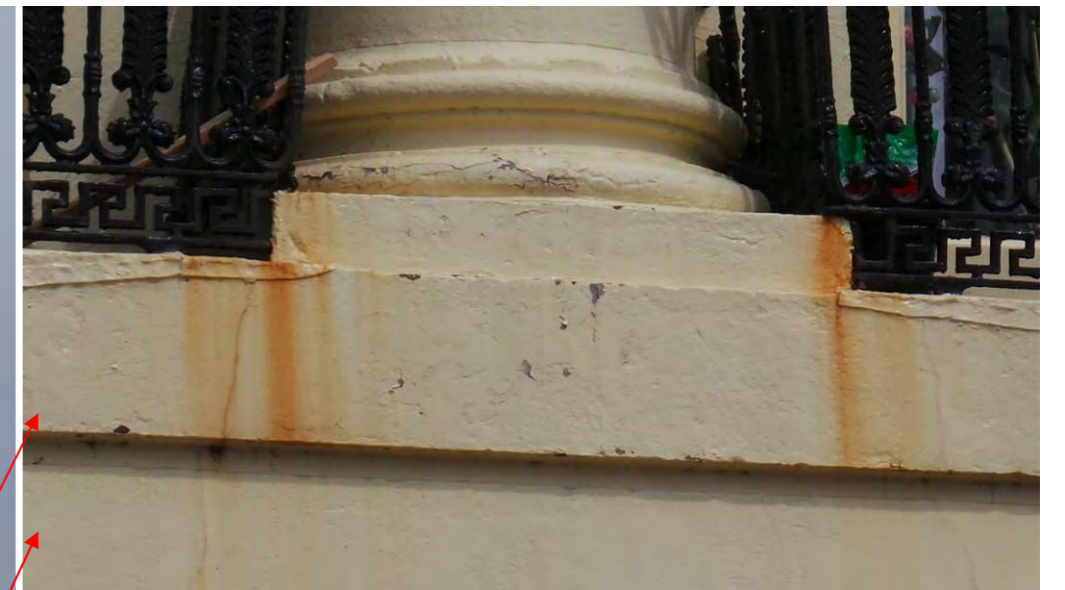
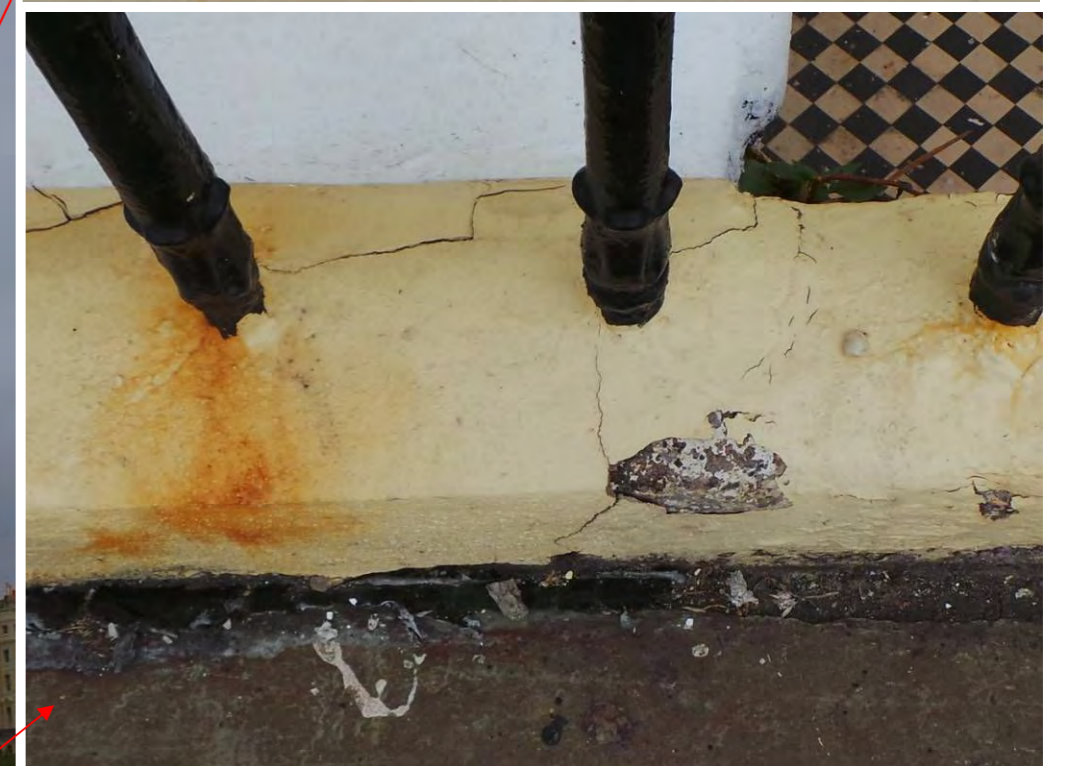
20 Brunswick Terrace (Brunswick Terrace Elevation)

1. Cracks, fissures and minor flaking to stepped cornice and string-course detail at high levels;
2. Very minor losses to all column bases;
3. Some ferrous staining run-off from iron balcony;
4. Minor losses to ground-floor window cills;
5. Substrate cracking, minor losses and ferrous staining to plinth wall.
