**Investigation of Paint Failure at
Brunswick Estate
Hove
Brighton**

August 2013

**BRUNSWICK ESTATE
HOVE**

The following document investigates the failure of the external paint-system at Brunswick Estate, Hove based on research carried out by Elizabeth Hirst and Rachel Morley of Hirst Conservation between August and November 2013. The work was commissioned by Brighton & Hove City Council.

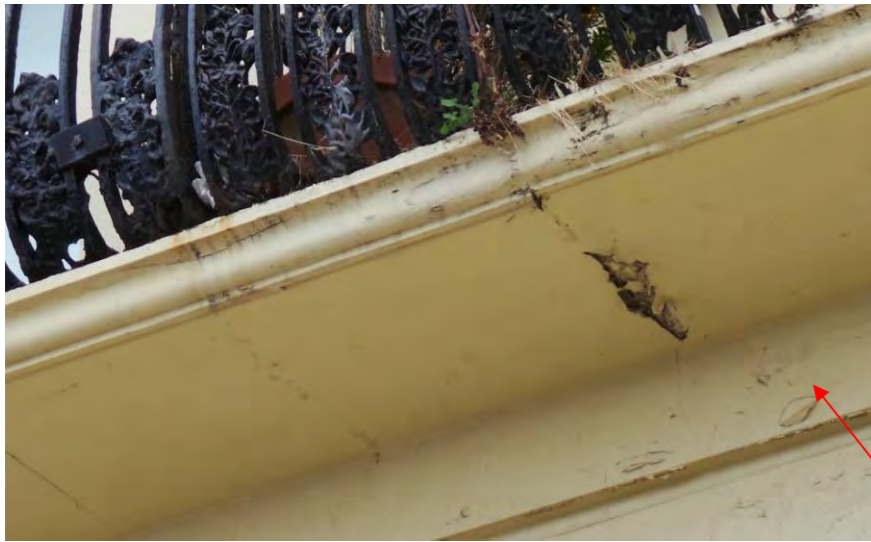
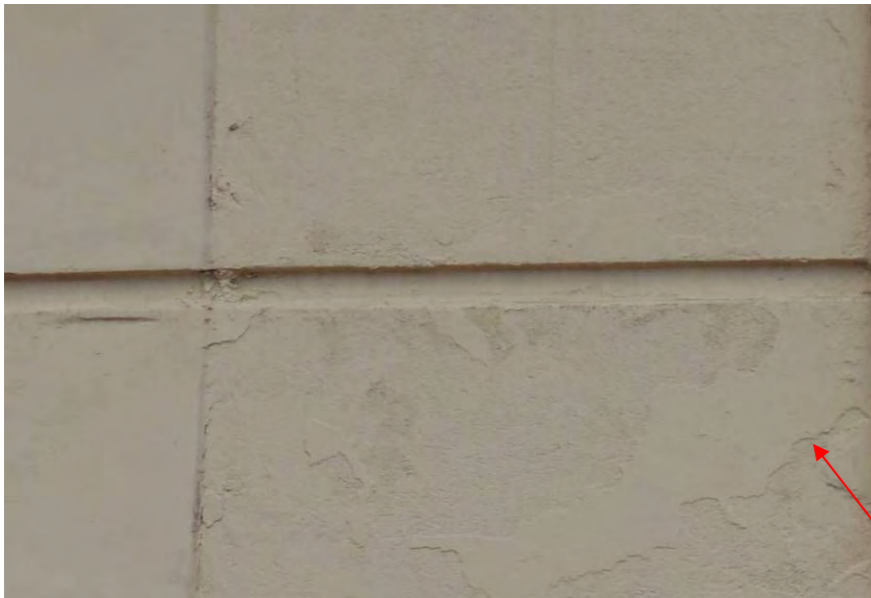
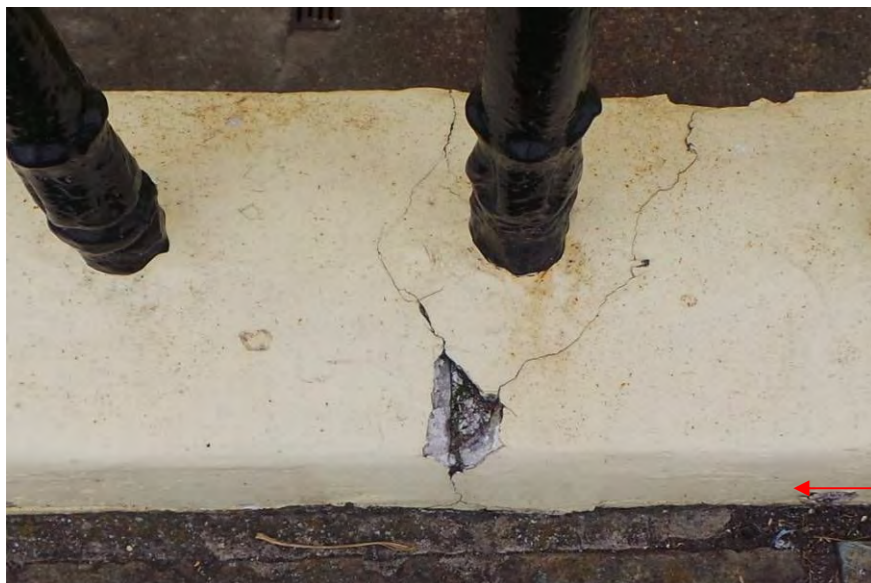
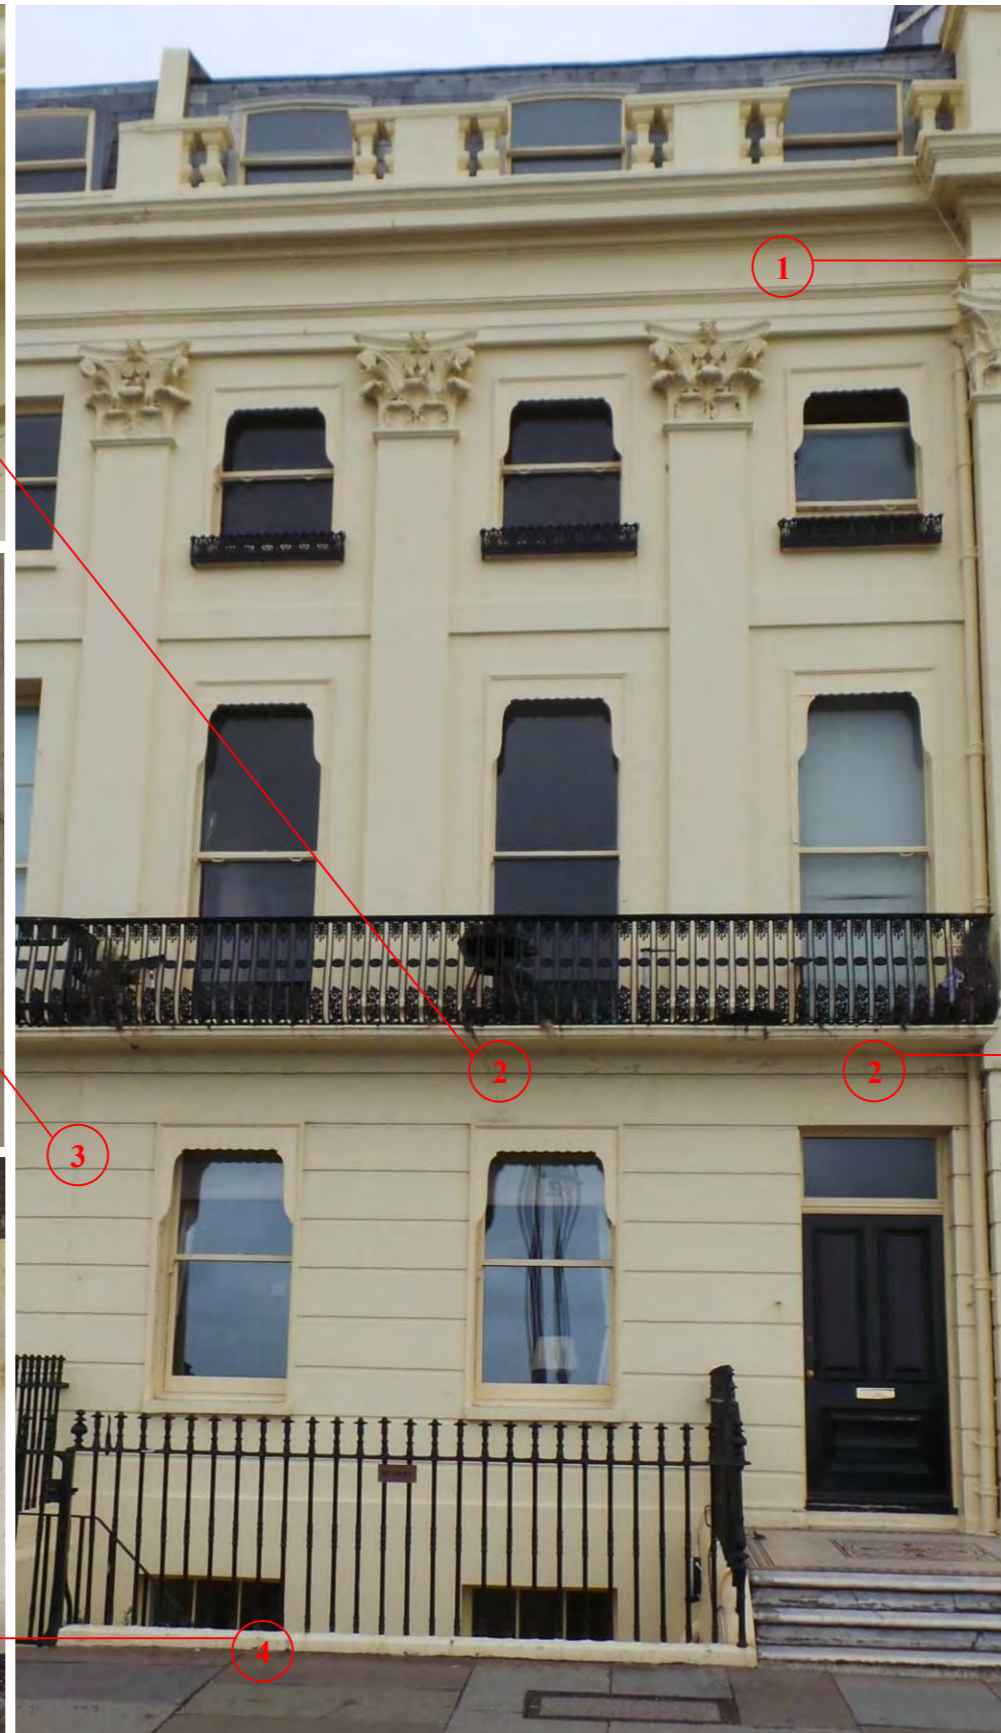
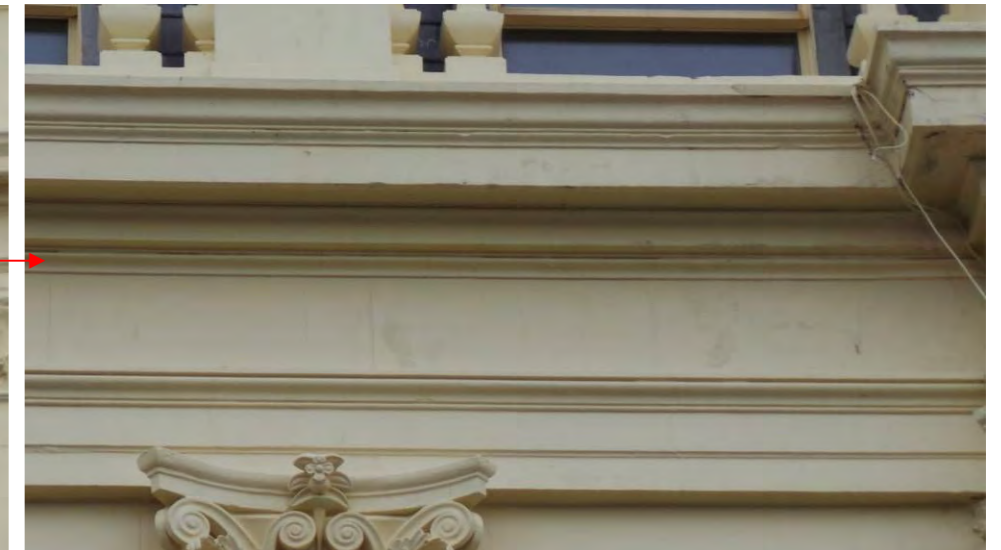
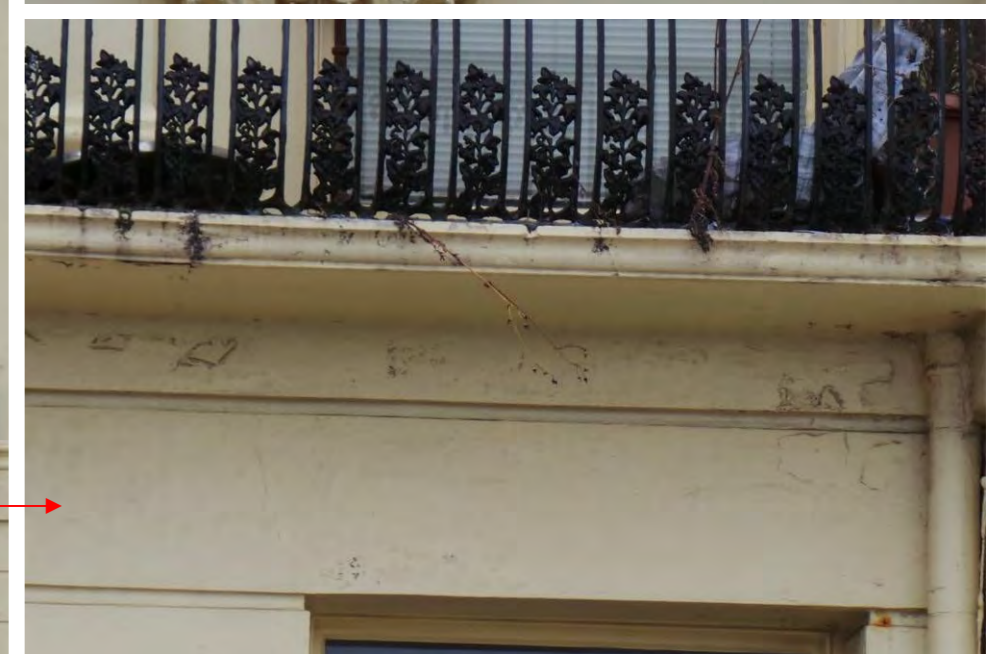
21 Brunswick Terrace

1. Patchy surface to cornice;
2. Flaking and staining to underside of balcony and upper section of ground-floor rustication;
3. Uneven surface, possibly due to salt action, around ground-floor windows, historic losses evident;
4. Very minor losses and substrate cracking to plinth wall.

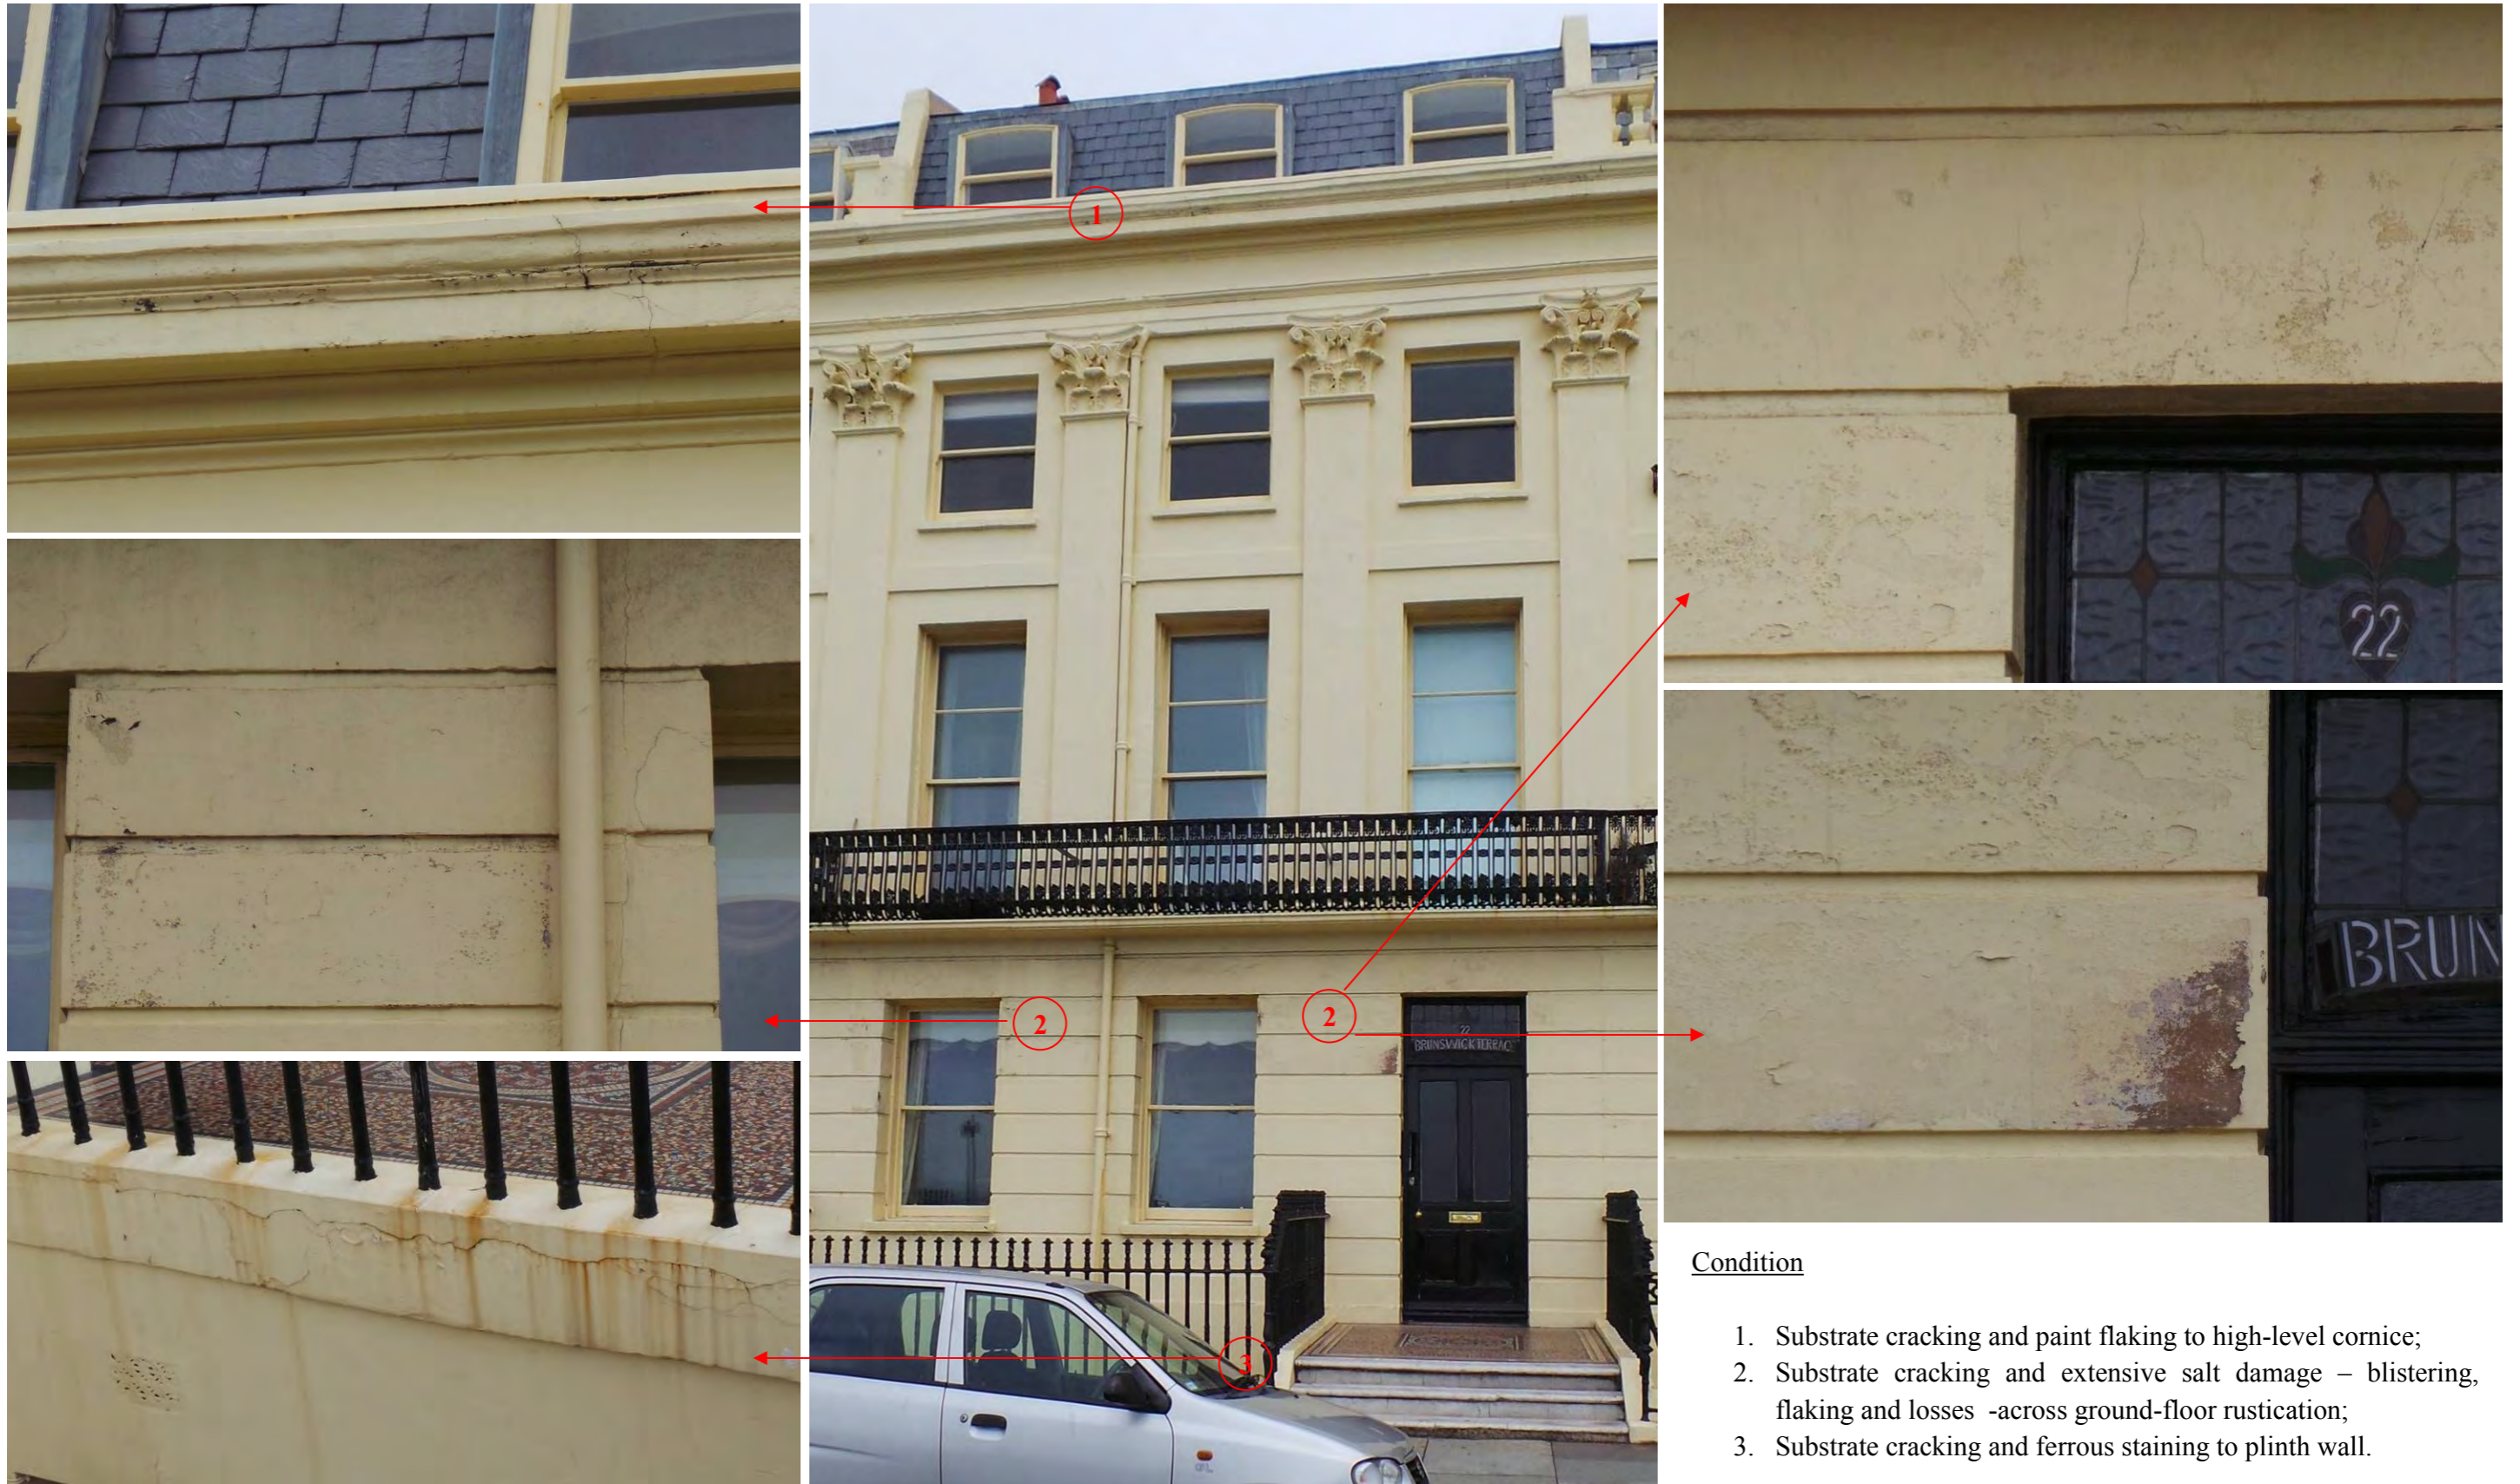
22 Brunswick Terrace

- 1. Substrate cracking and paint flaking to high-level cornice;
- 2. Substrate cracking and extensive salt damage – blistering, flaking and losses -across ground-floor rustication;
- 3. Substrate cracking and ferrous staining to plinth wall.

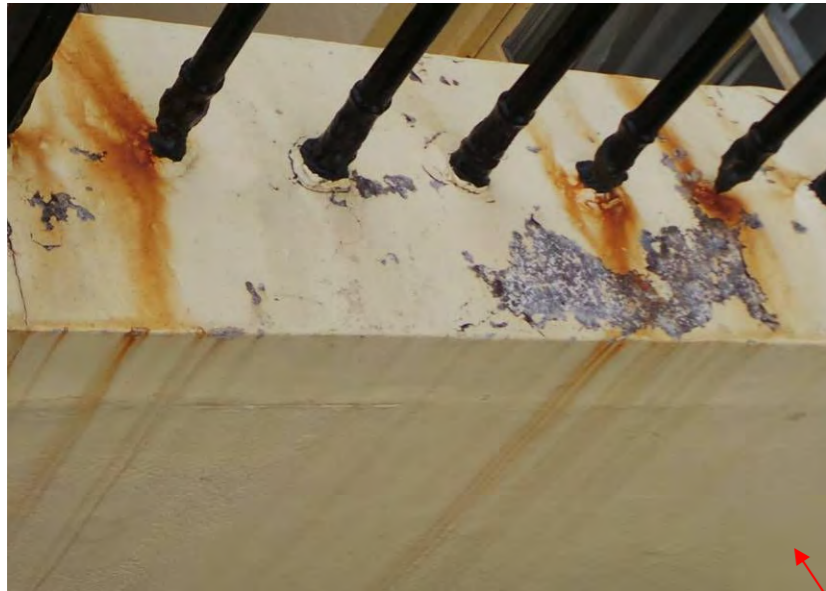
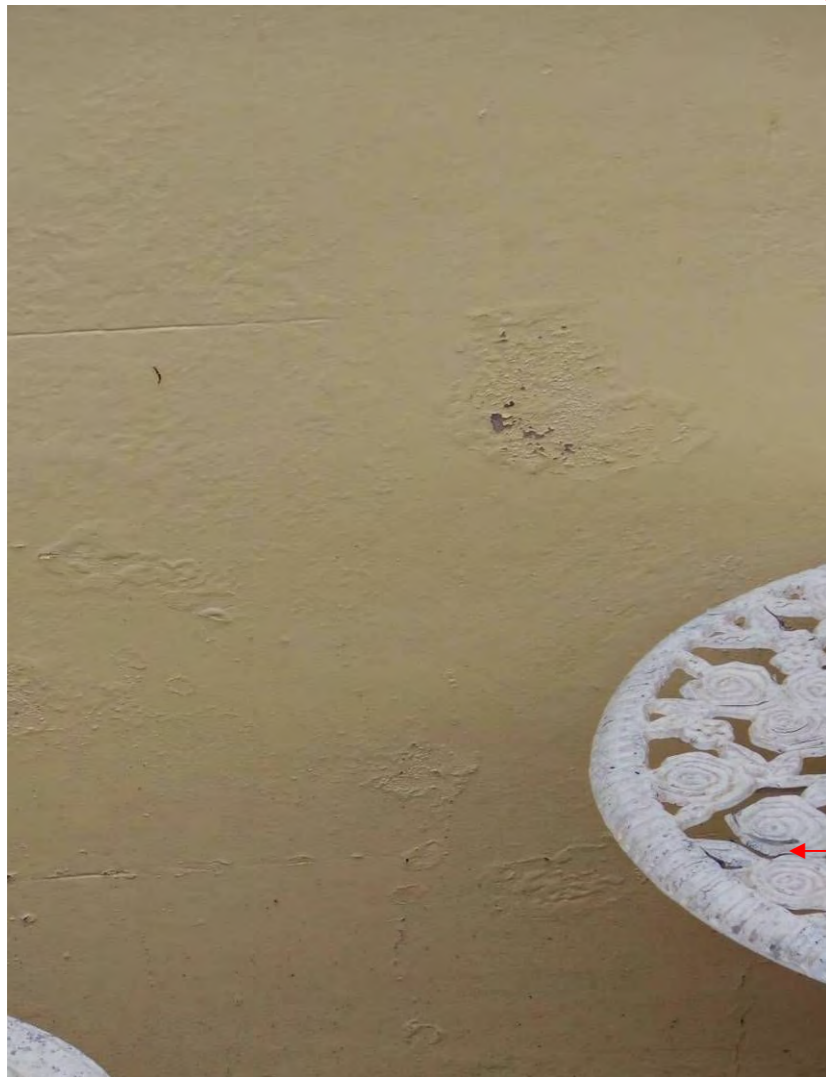
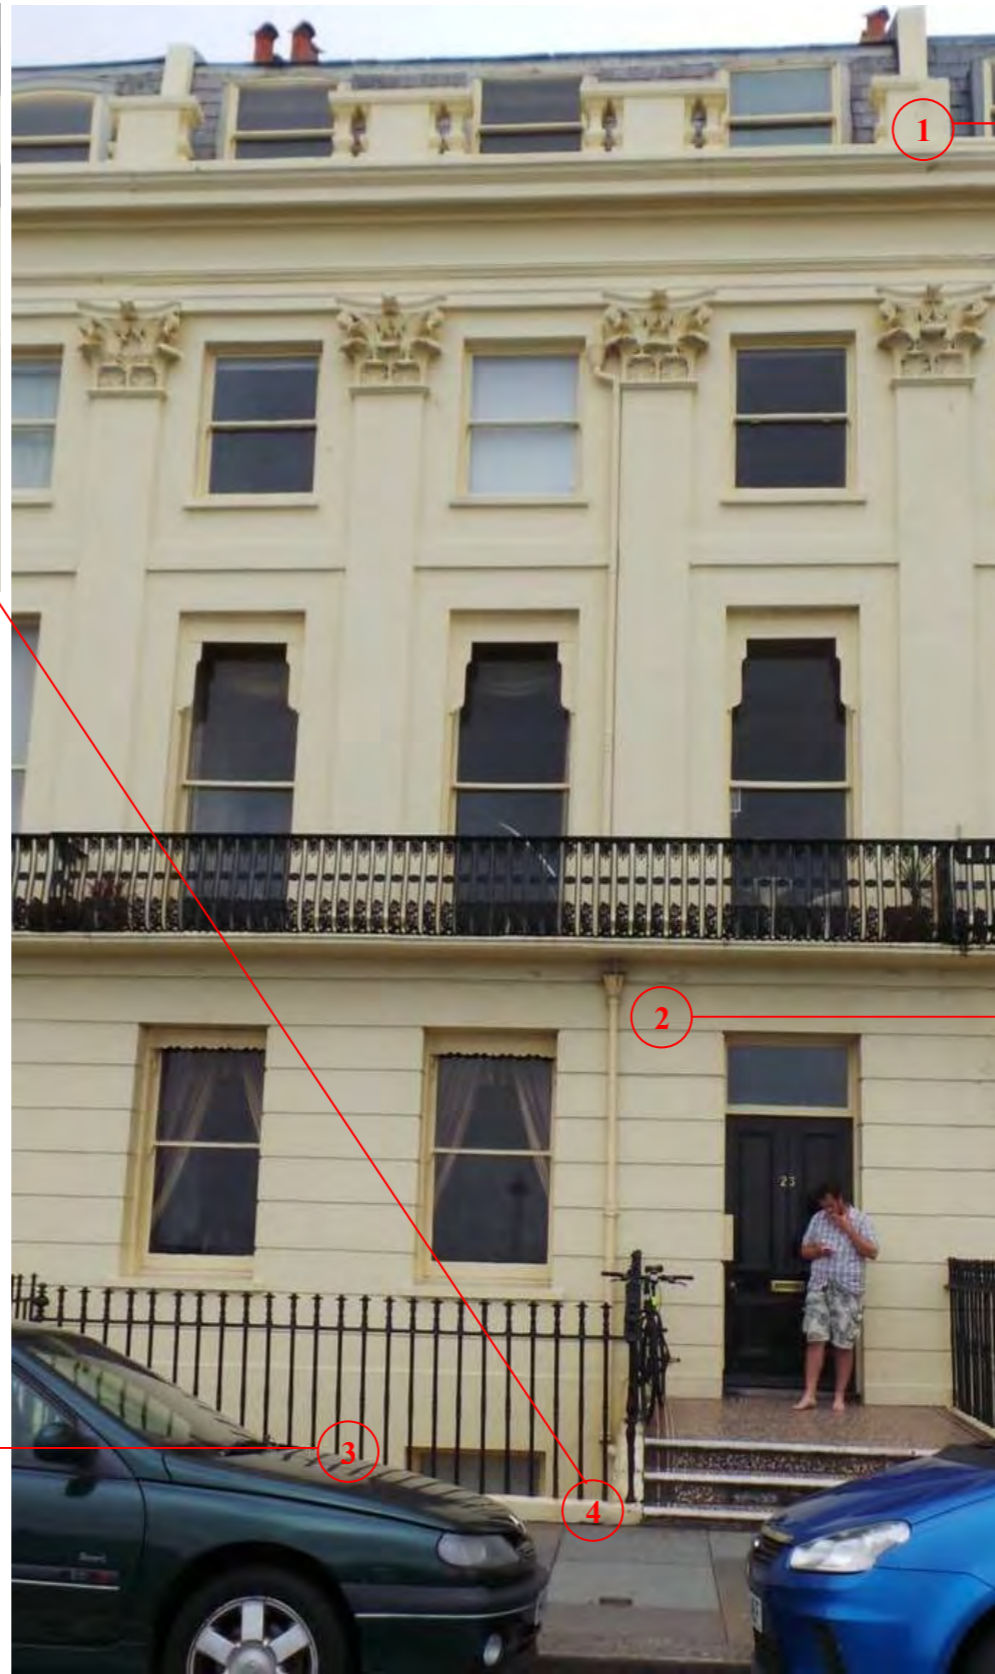
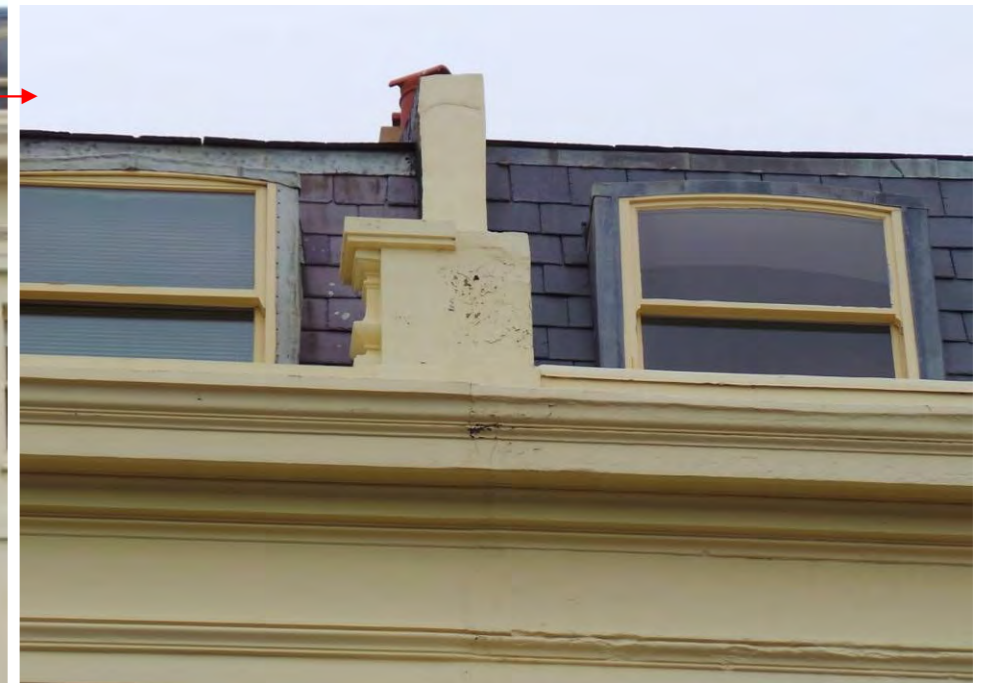
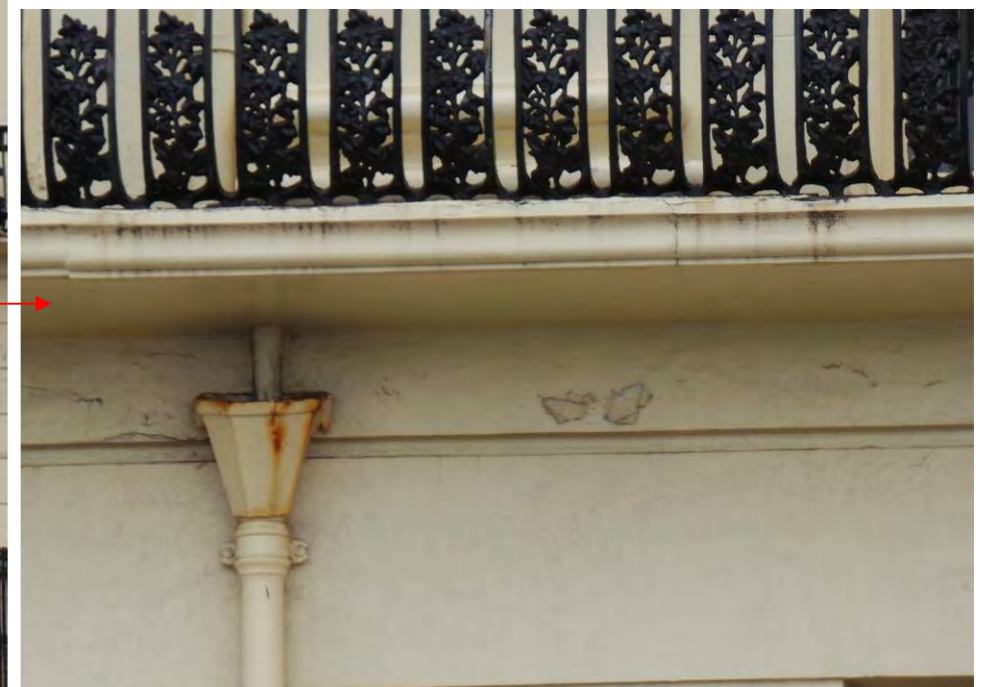
23 Brunswick Terrace

1. Localised cracking and flaking to parapet;
2. Staining and flaking to ground-floor rustication immediately under balcony;
3. Salt blistering to basement level;
4. Losses ferrous staining to plinth wall.

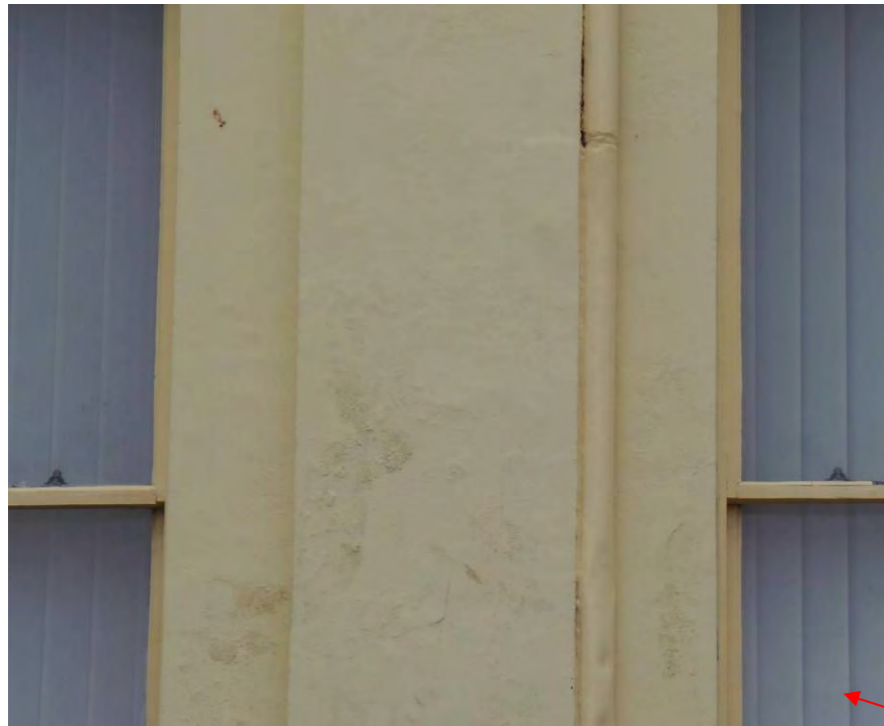
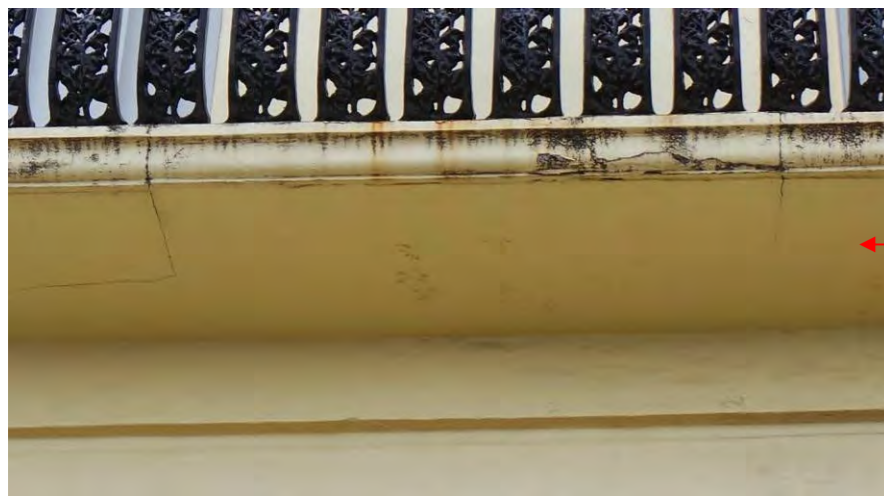
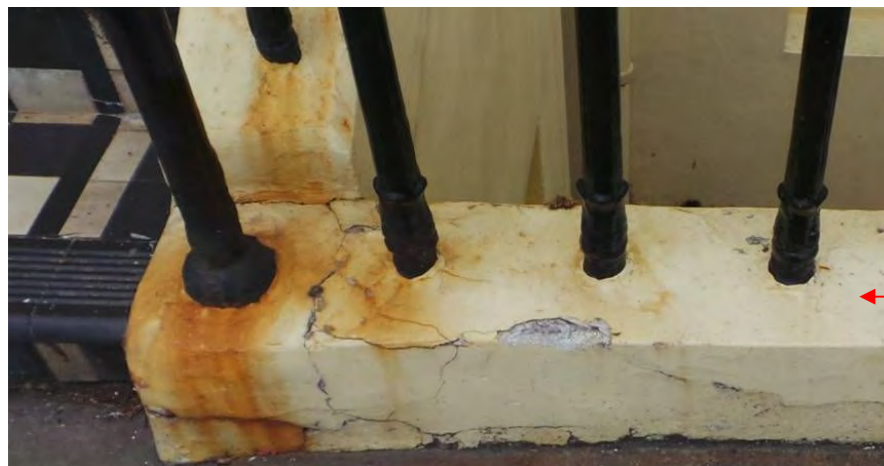
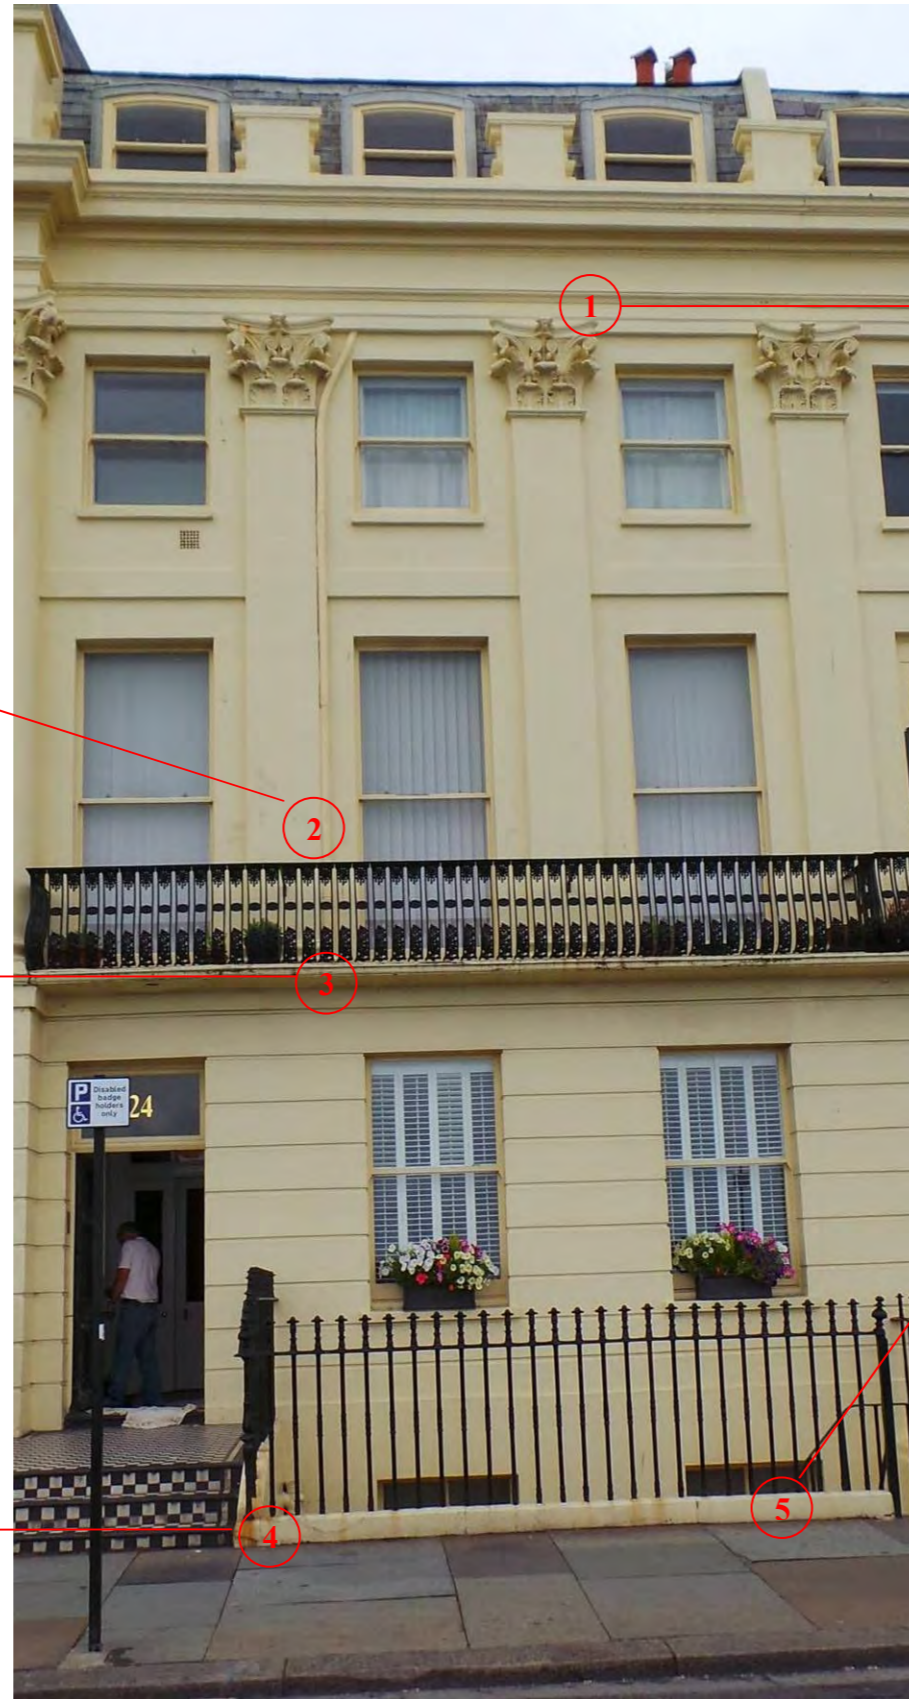
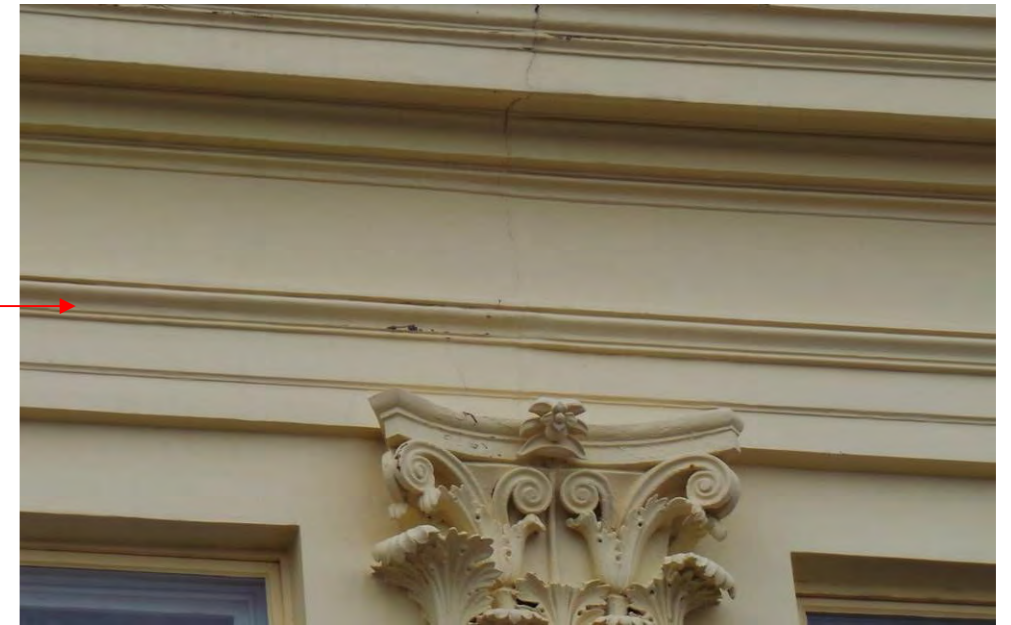
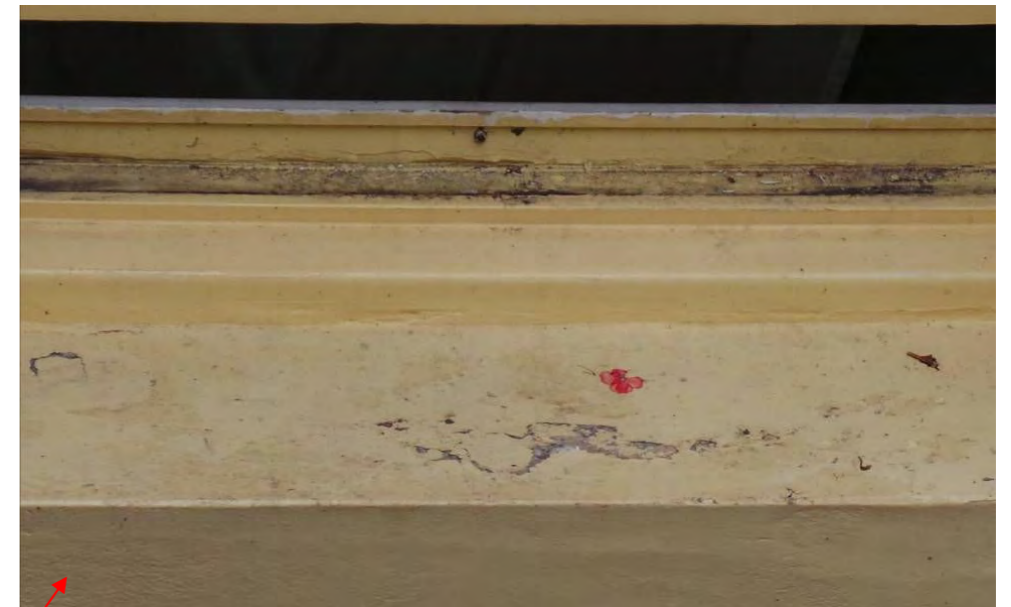
24 Brunswick Terrace

1. Minor cracking to cornice with subsequent flaking;
2. Patchy, salt-blistered surface to left-hand column;
3. Substrate cracking, staining and flaking to underside of canopy;
4. Substrate cracking, losses and ferrous staining to plinth wall;
5. Cracking and losses to window cill at basement level.

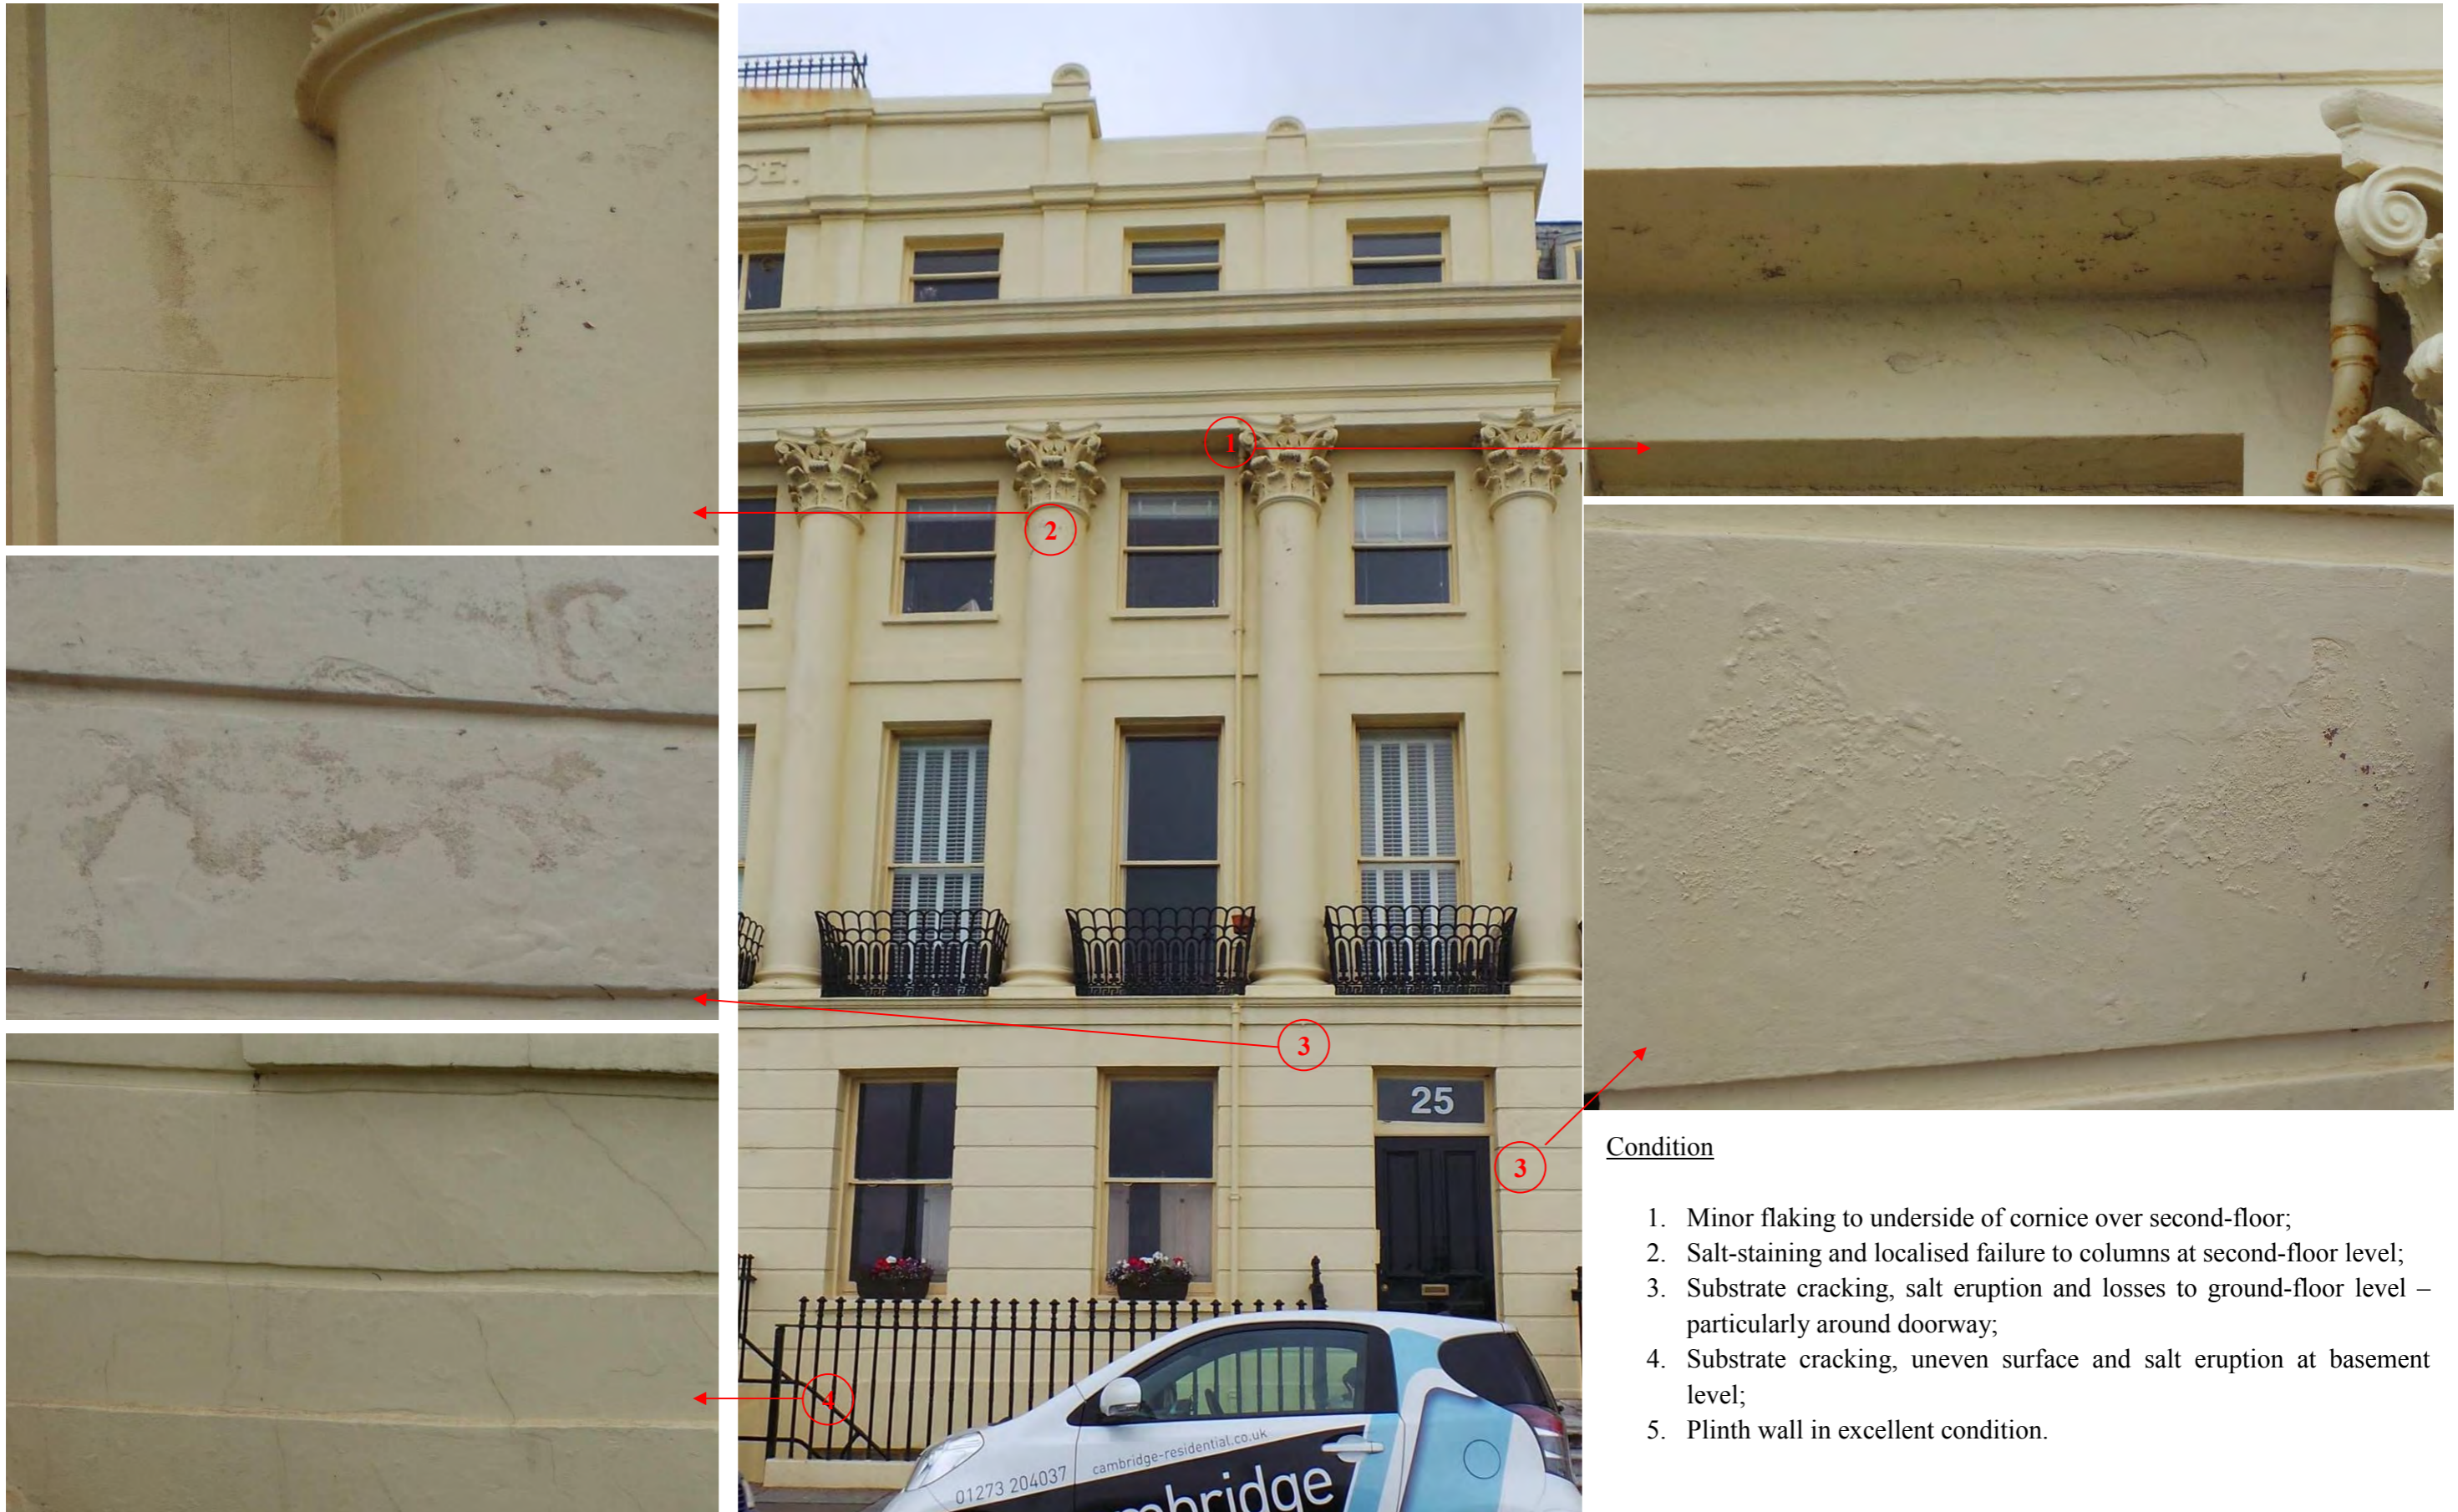
25 Brunswick Terrace

1. Minor flaking to underside of cornice over second-floor;
2. Salt-staining and localised failure to columns at second-floor level;
3. Substrate cracking, salt eruption and losses to ground-floor level – particularly around doorway;
4. Substrate cracking, uneven surface and salt eruption at basement level;
5. Plinth wall in excellent condition.
