**Investigation of Paint Failure at
Brunswick Estate
Hove
Brighton**

August 2013

**BRUNSWICK ESTATE
HOVE**

The following document investigates the failure of the external paint-system at Brunswick Estate, Hove based on research carried out by Elizabeth Hirst and Rachel Morley of Hirst Conservation between August and November 2013. The work was commissioned by Brighton & Hove City Council.

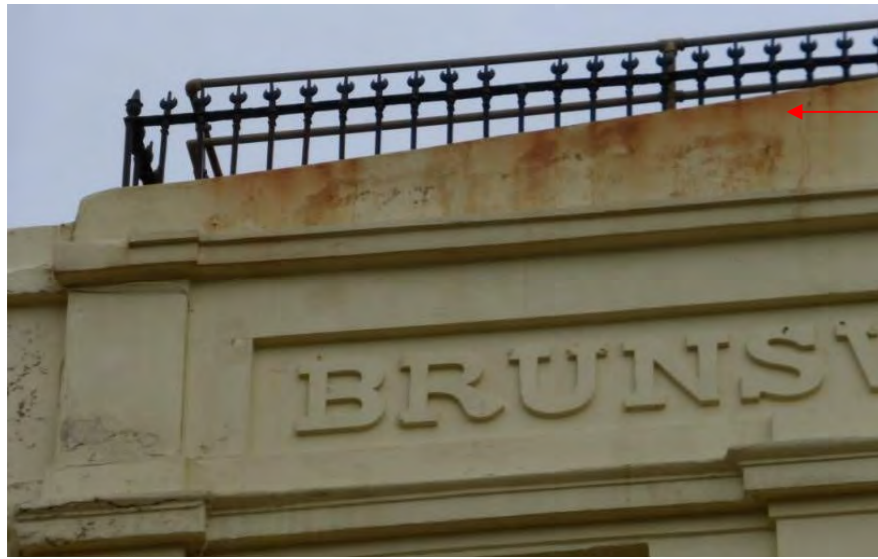
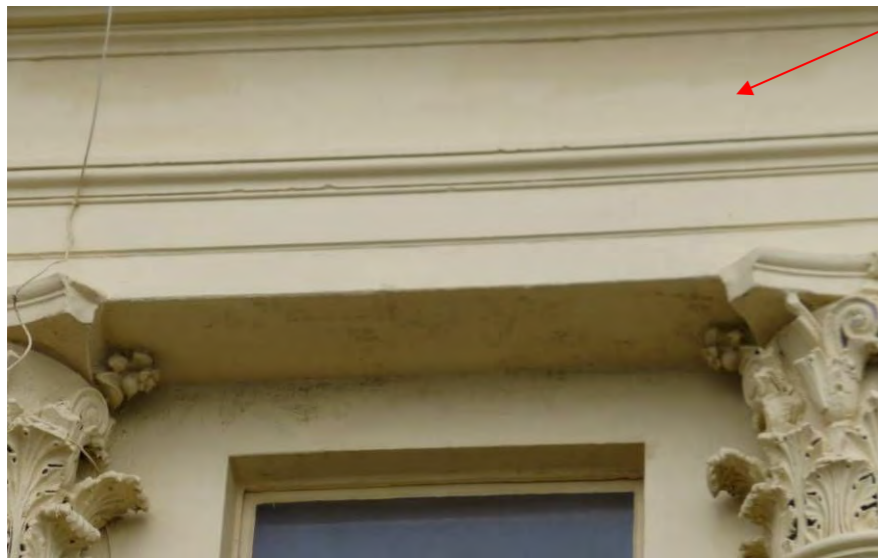
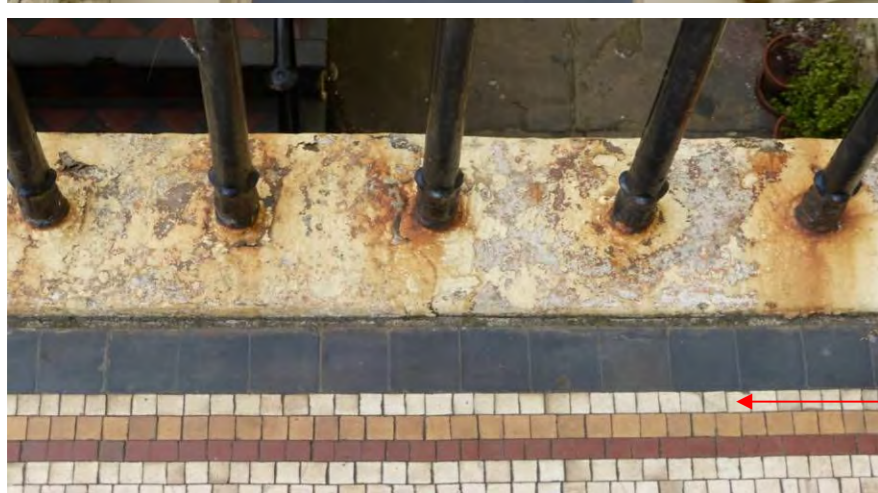
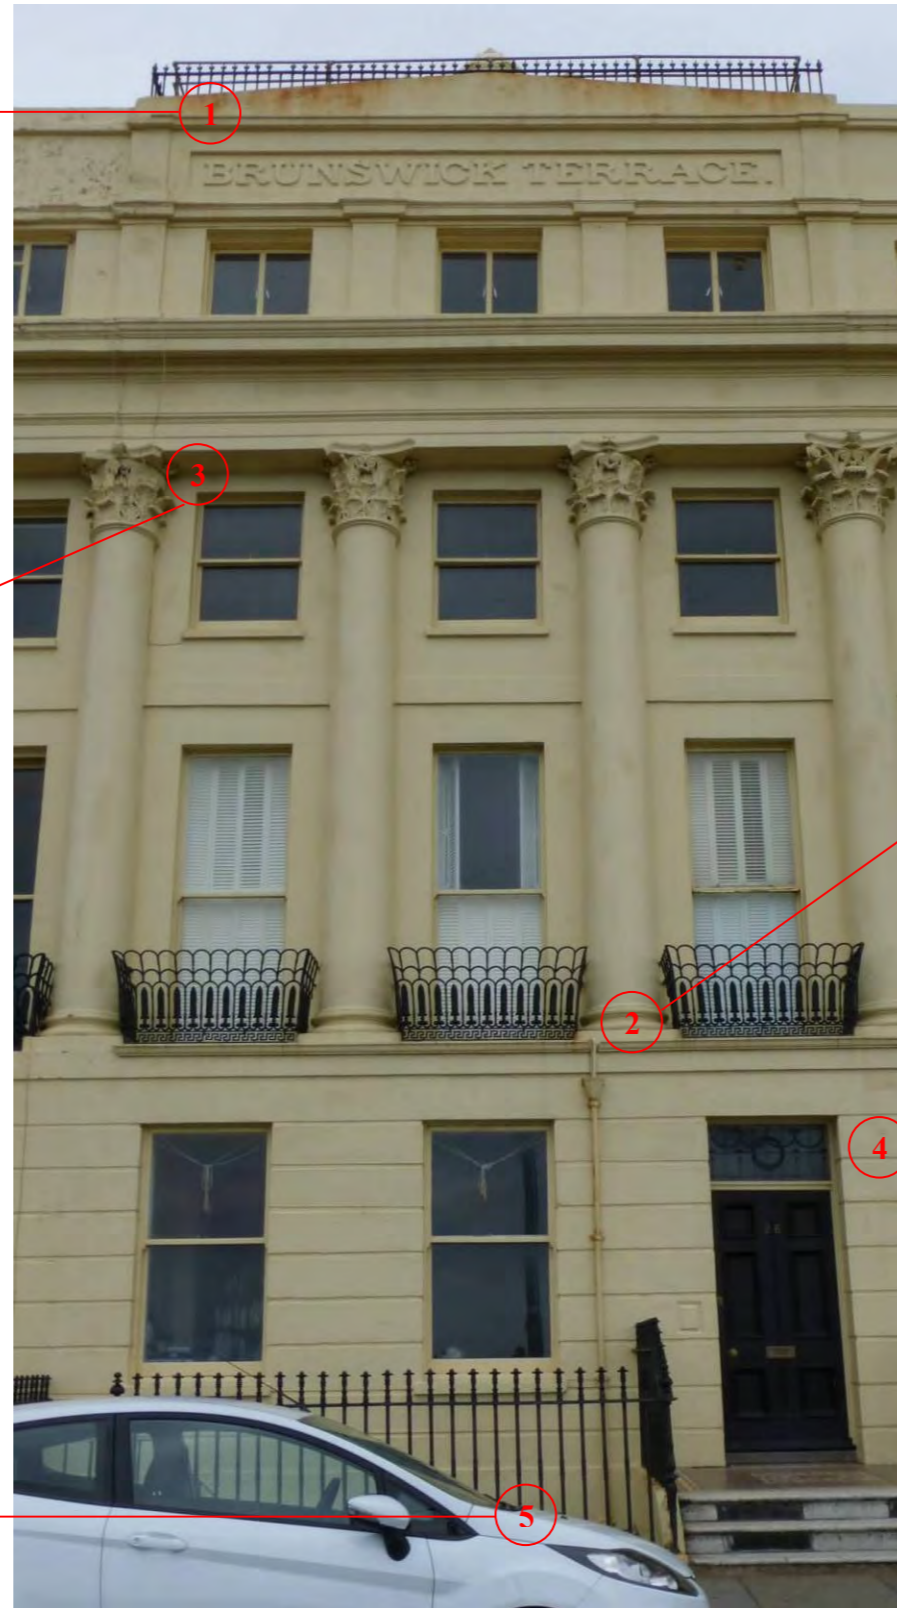
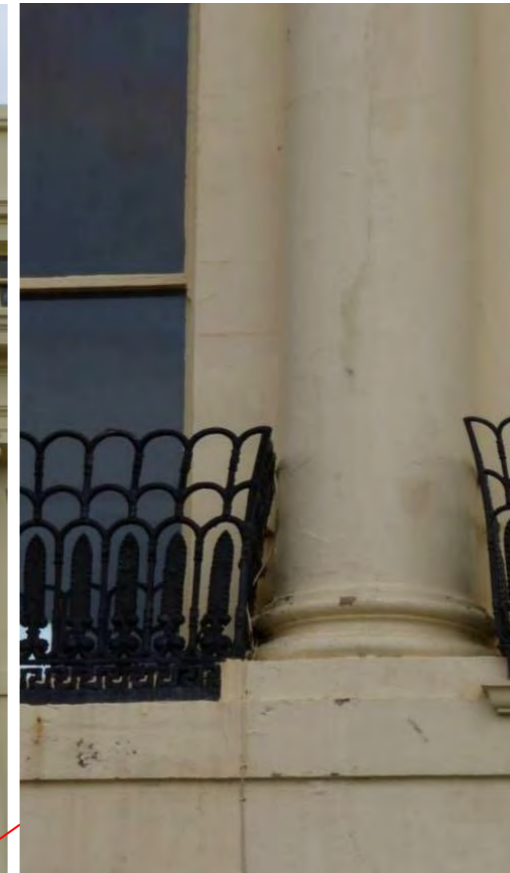
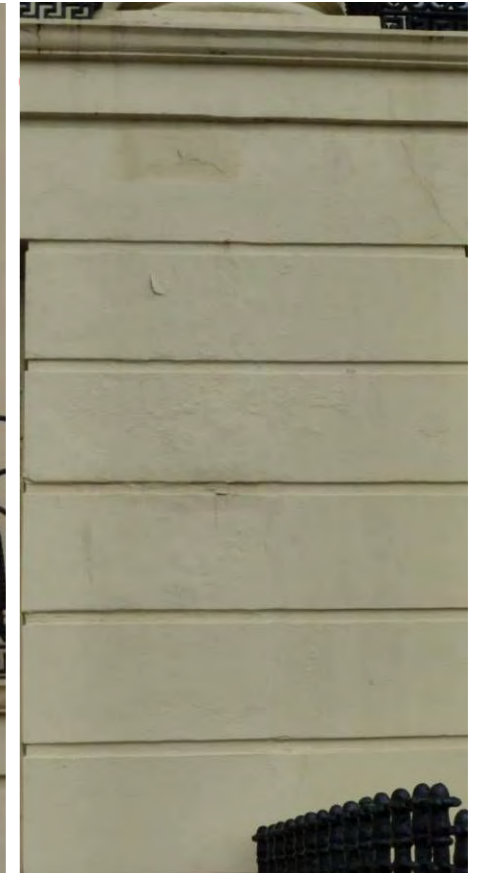
26 Brunswick Terrace

1. Staining at high-level due to railing behind pediment parapet;
2. Substrate cracking and staining to far right column, with minor losses at base;
3. Flaking and staining to cornice overhang and window reveals to second-floor;
4. Flaking to right of doorway may relate to run-off from column above; generally, patchy, uneven surface due to salt eruptions at ground-floor level;
5. Ferrous staining and losses to plinth wall; worse than others, possibly not painted during last decorative phase.

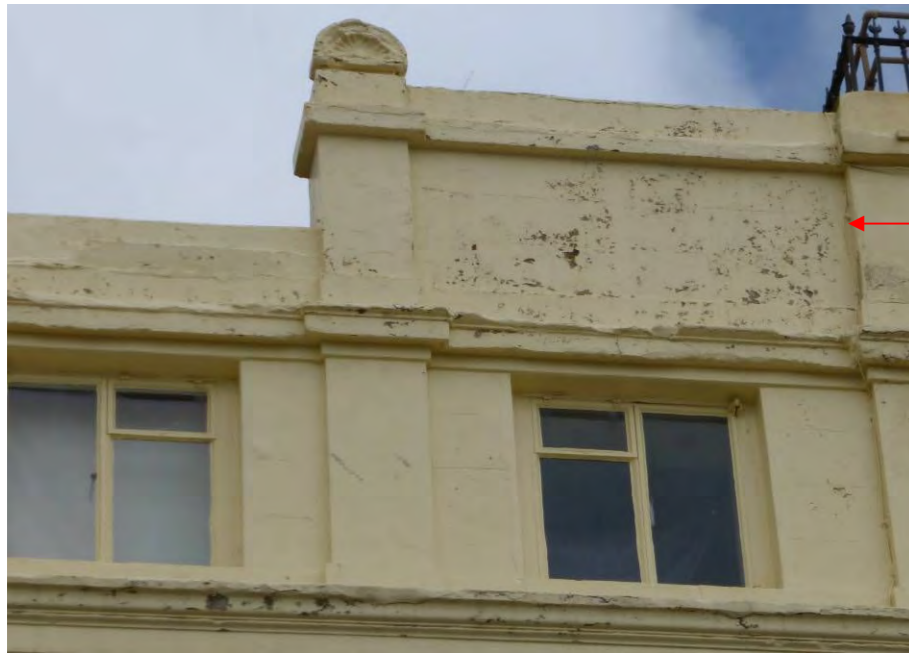
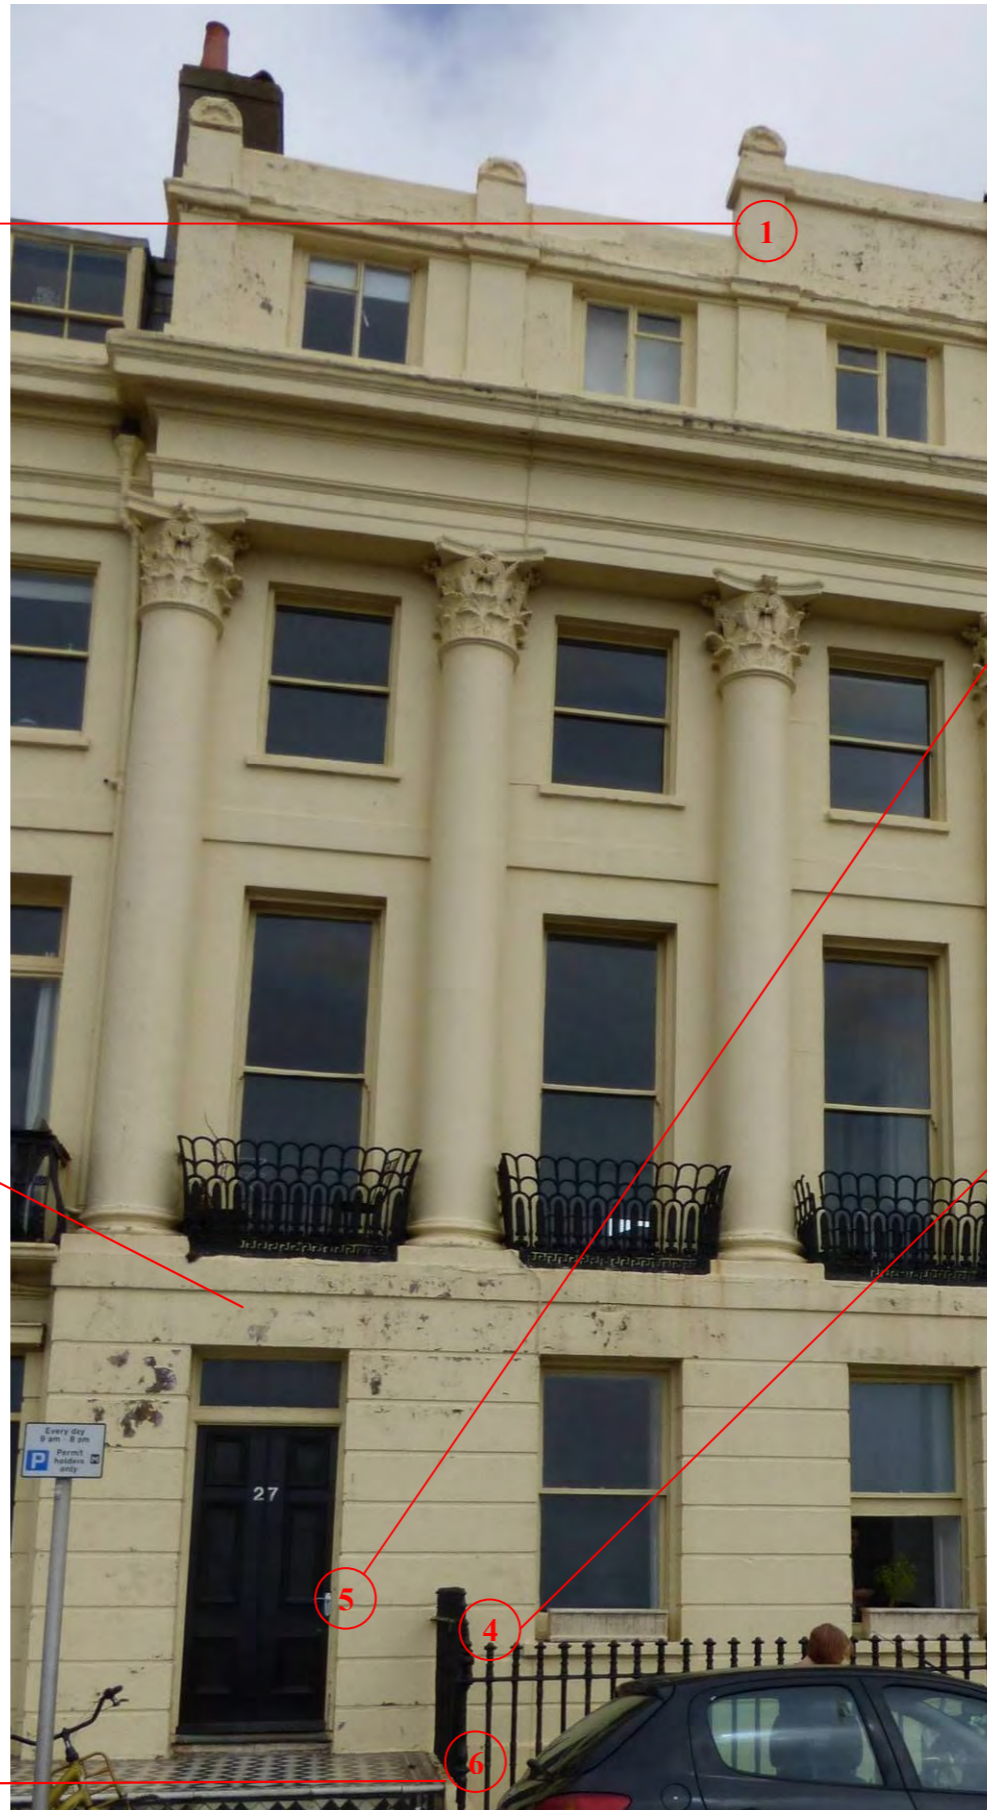
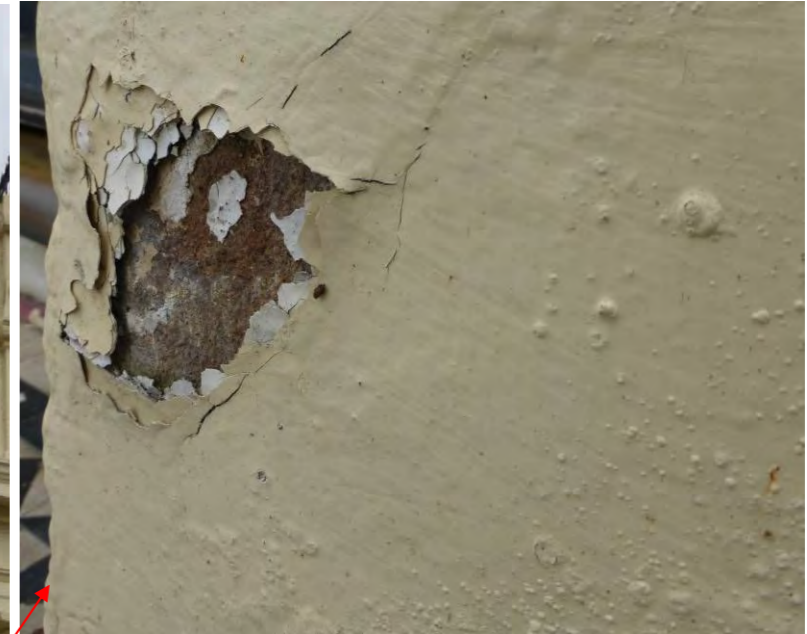
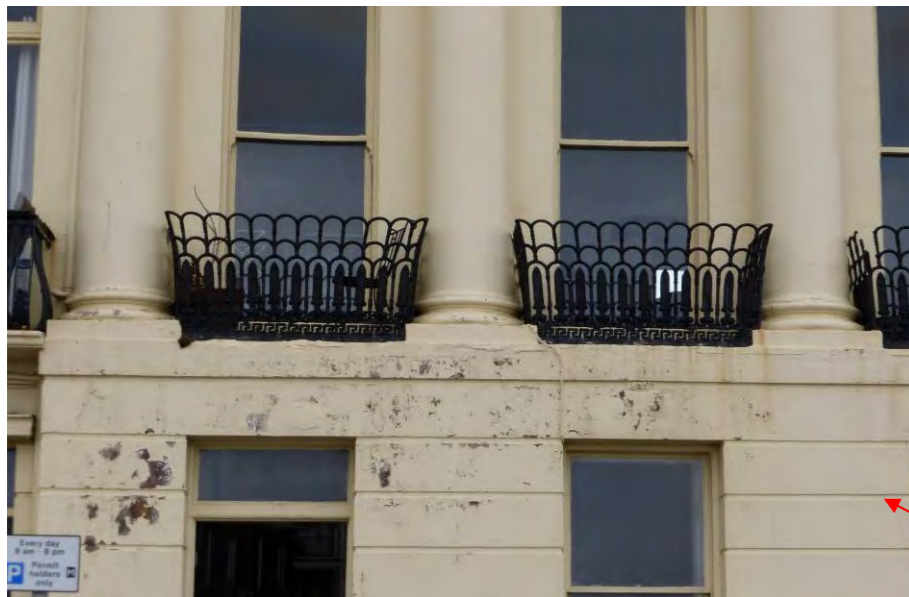
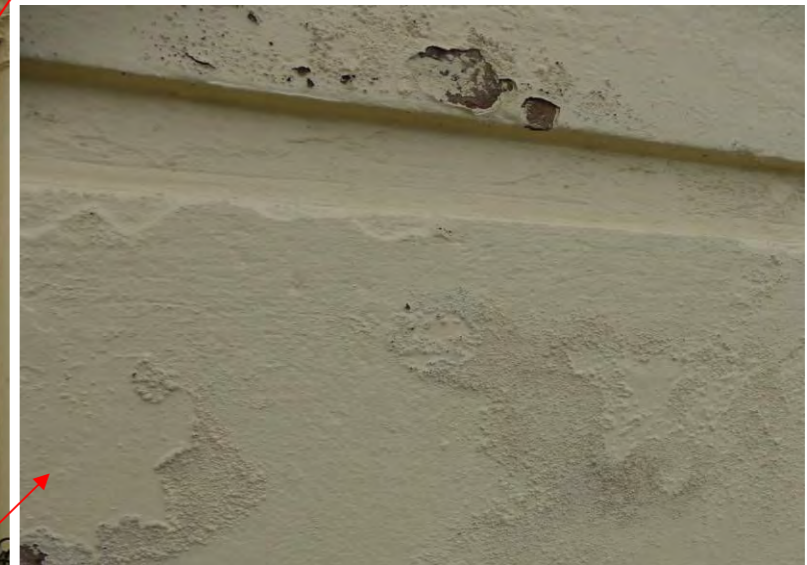
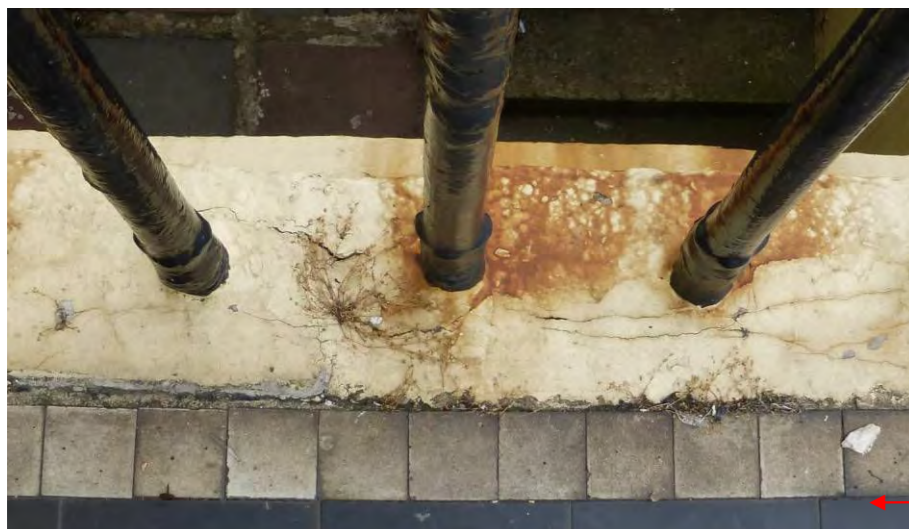
27 Brunswick Terrace

1. Failure generally across parapet and third-floor - possibly exacerbated by substrate cracking to upper cornice and damaged flashing;
2. Localised, minor losses across first and second floors;
3. Extensive losses to column bases and ground-floor rustication;
4. Flaking and salt eruptions to ground-floor and basement levels;
5. Islands of paint appearing to retain earlier layers revealed around entrance, but many areas stripped to substrate – possibly attempted to achieve thick and thin films when painting;
6. Ferrous staining and losses to plinth wall.

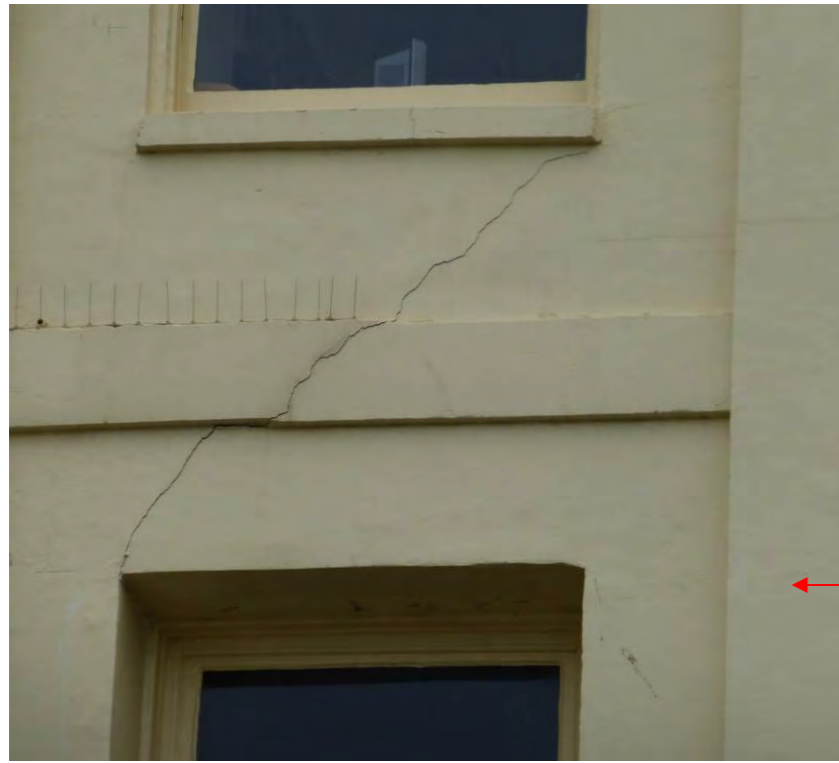
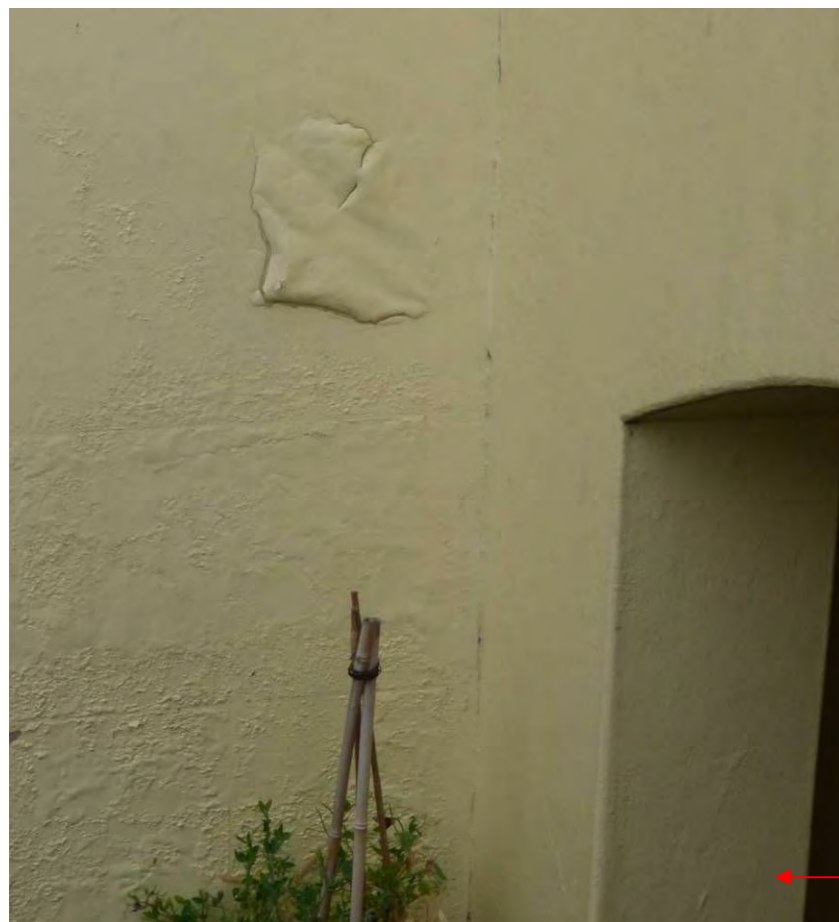
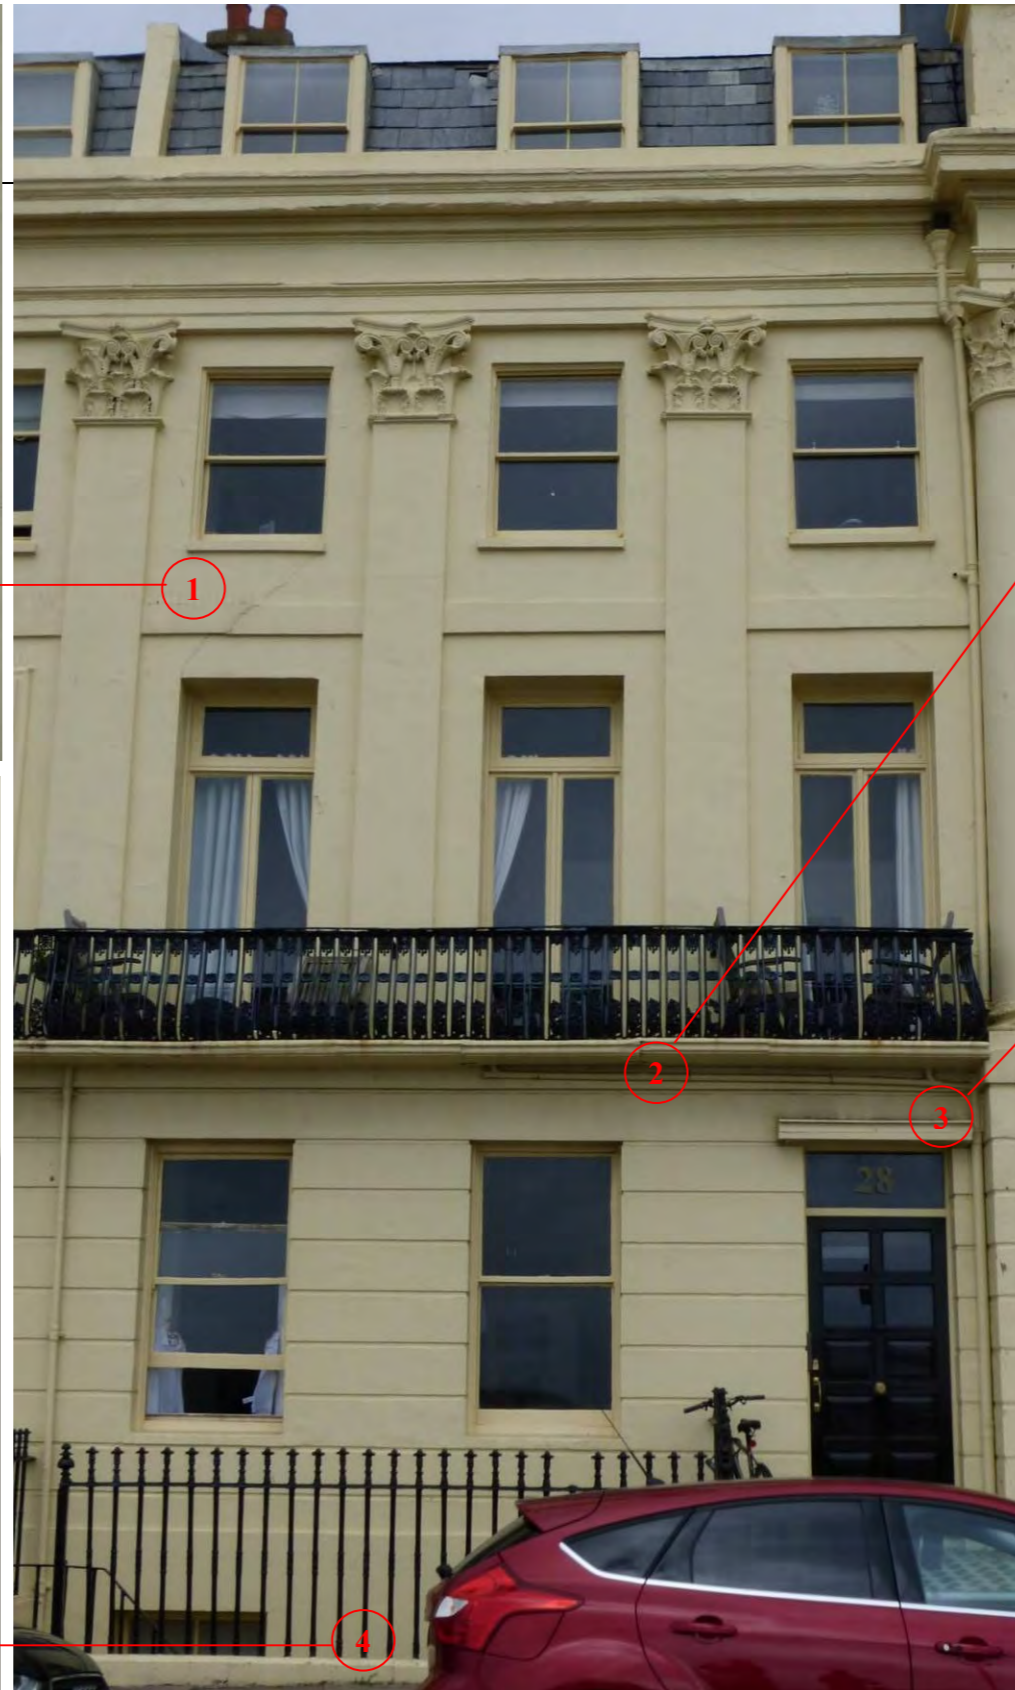
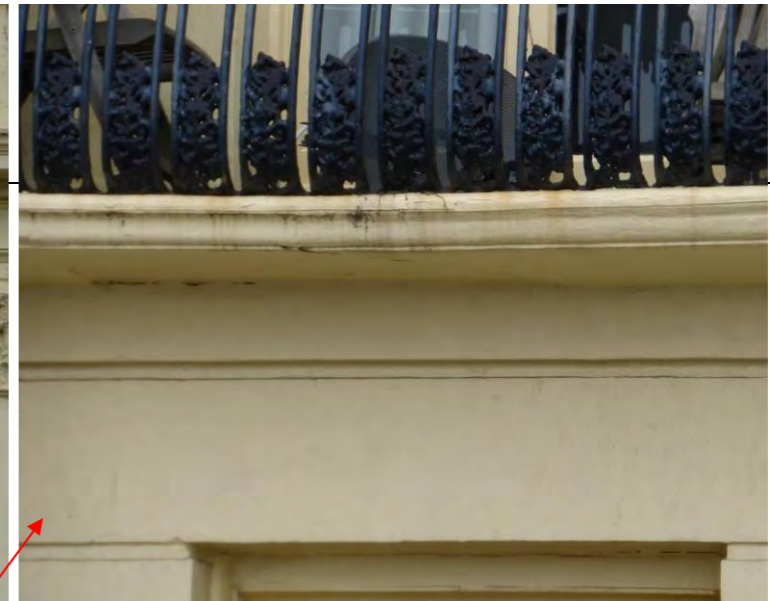
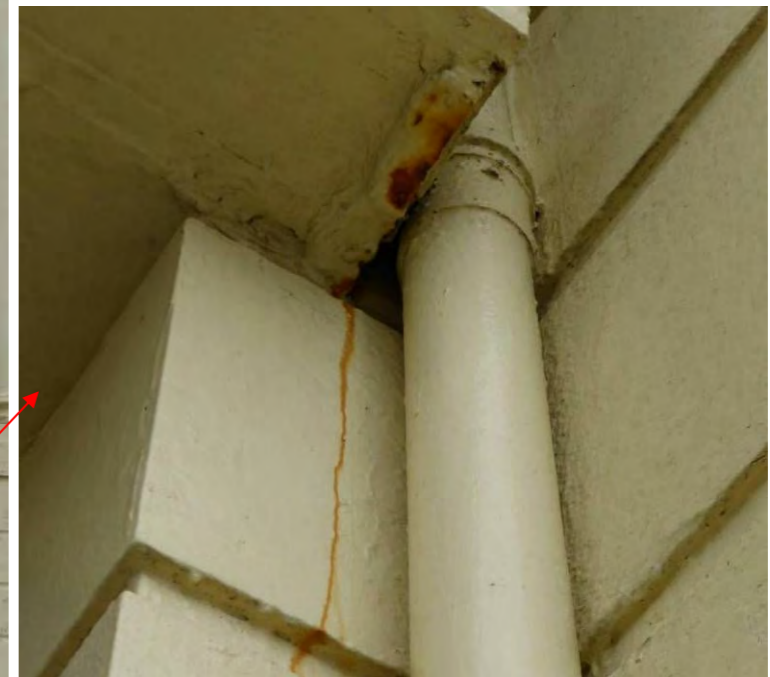
28 Brunswick Terrace

1. Diagonal crack extending from cill of far left window to second-floor to lintel of second-floor window beneath – not causing paint disruption at present;
2. Staining run-off along edge of balcony and over doorway;
3. Ferrous staining from downpipe to right-hand side;
4. Flaking and salt-eruption across basement level;
5. Very slight flaking to plinth wall – generally excellent.

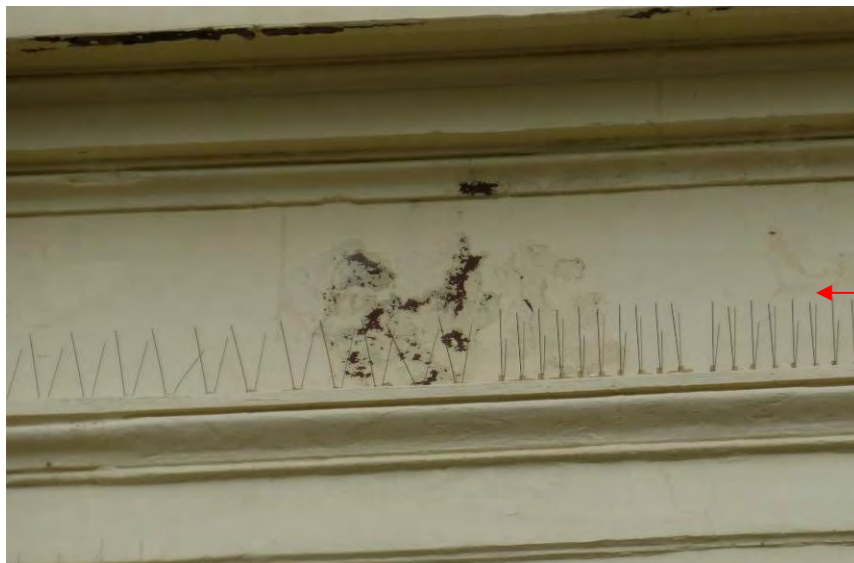
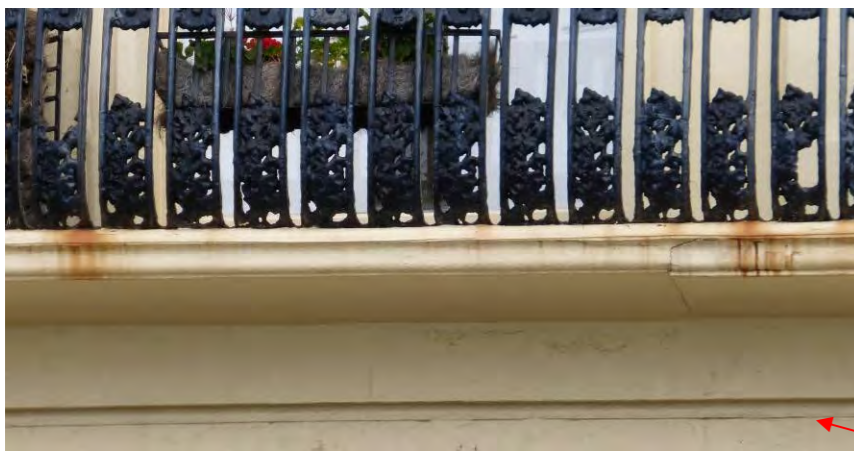
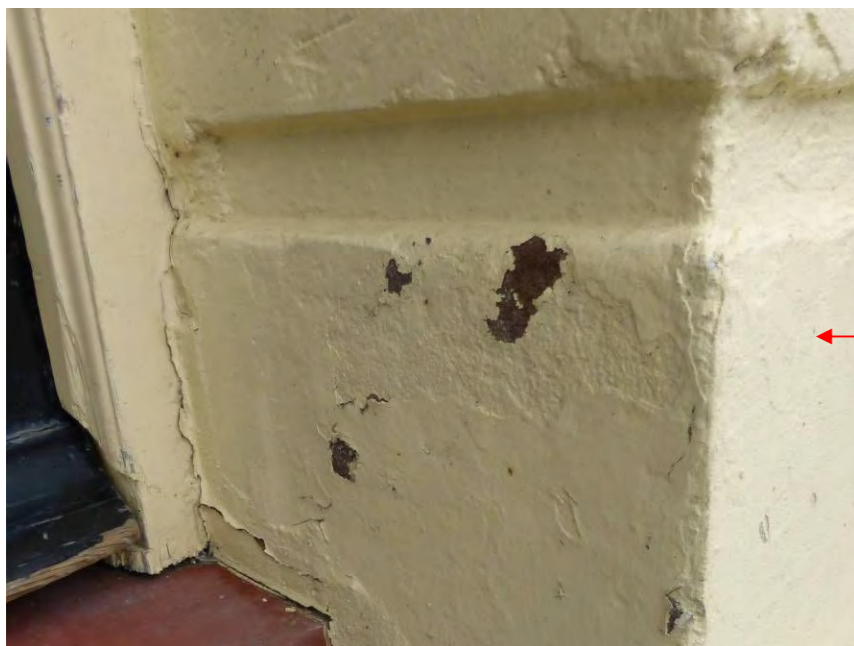
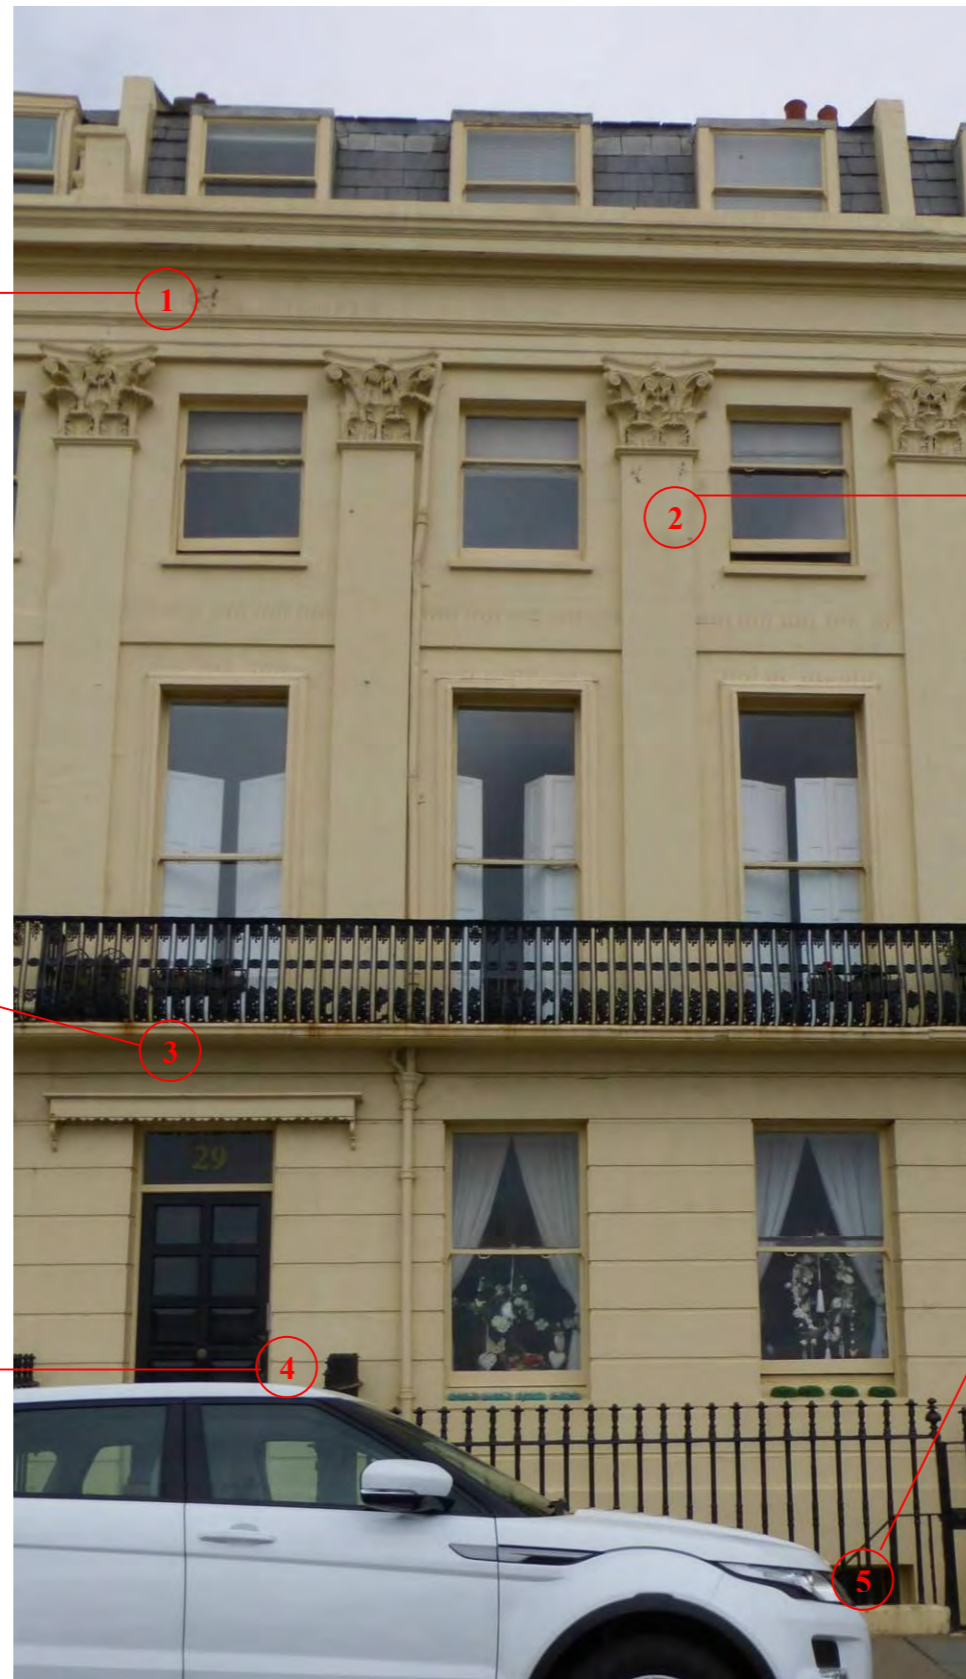
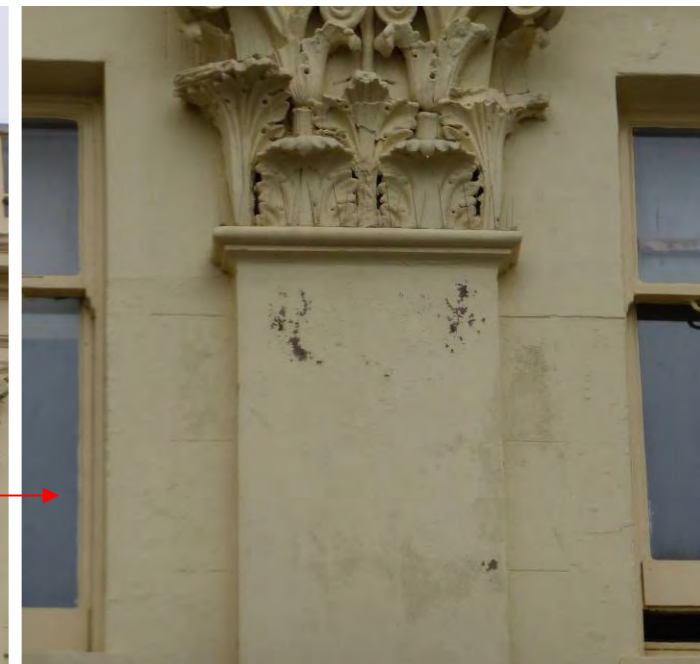
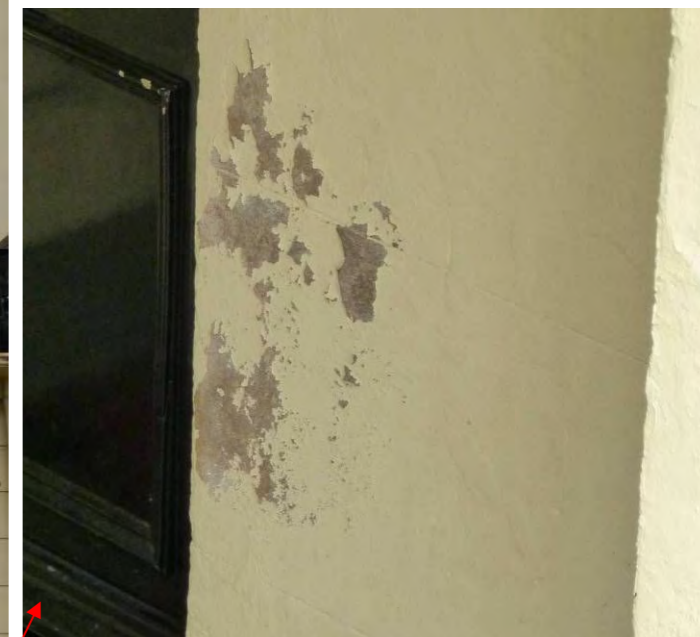
29 Brunswick Terrace

1. Localised failure and loss from eaves-detail to column capitals at second-floor level;
2. Patchy, salt-erupted surface with localised losses to columns;
3. Ferrous staining and slight substrate fracturing under balconies;
4. Islands of thicker paint around entrance with minor losses to bare substrate;
5. Large patch of flaking and lost paint to under-croft;
6. Slight ferrous run-off from railings to plinth, but generally very good condition.

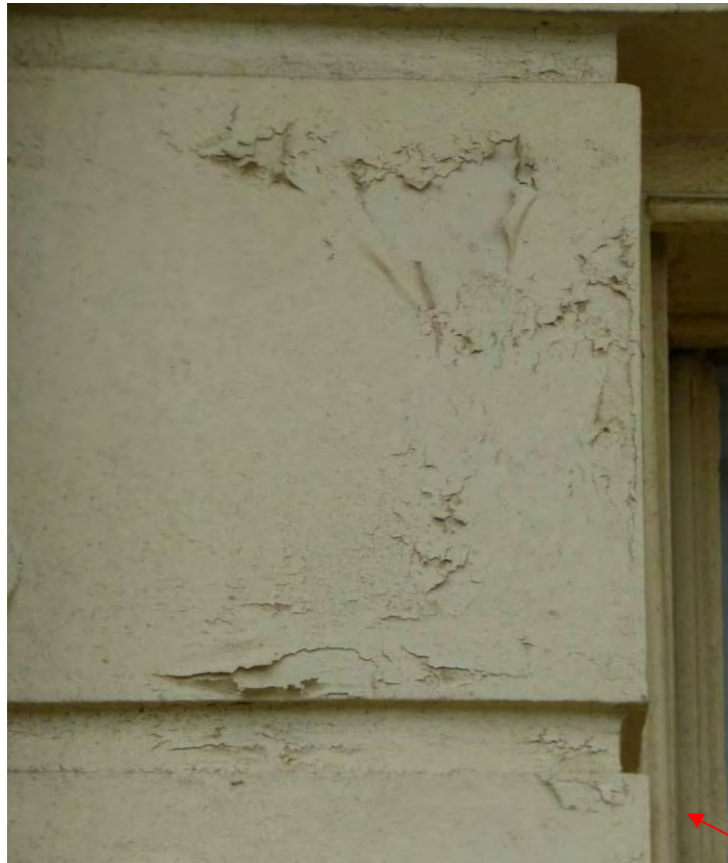
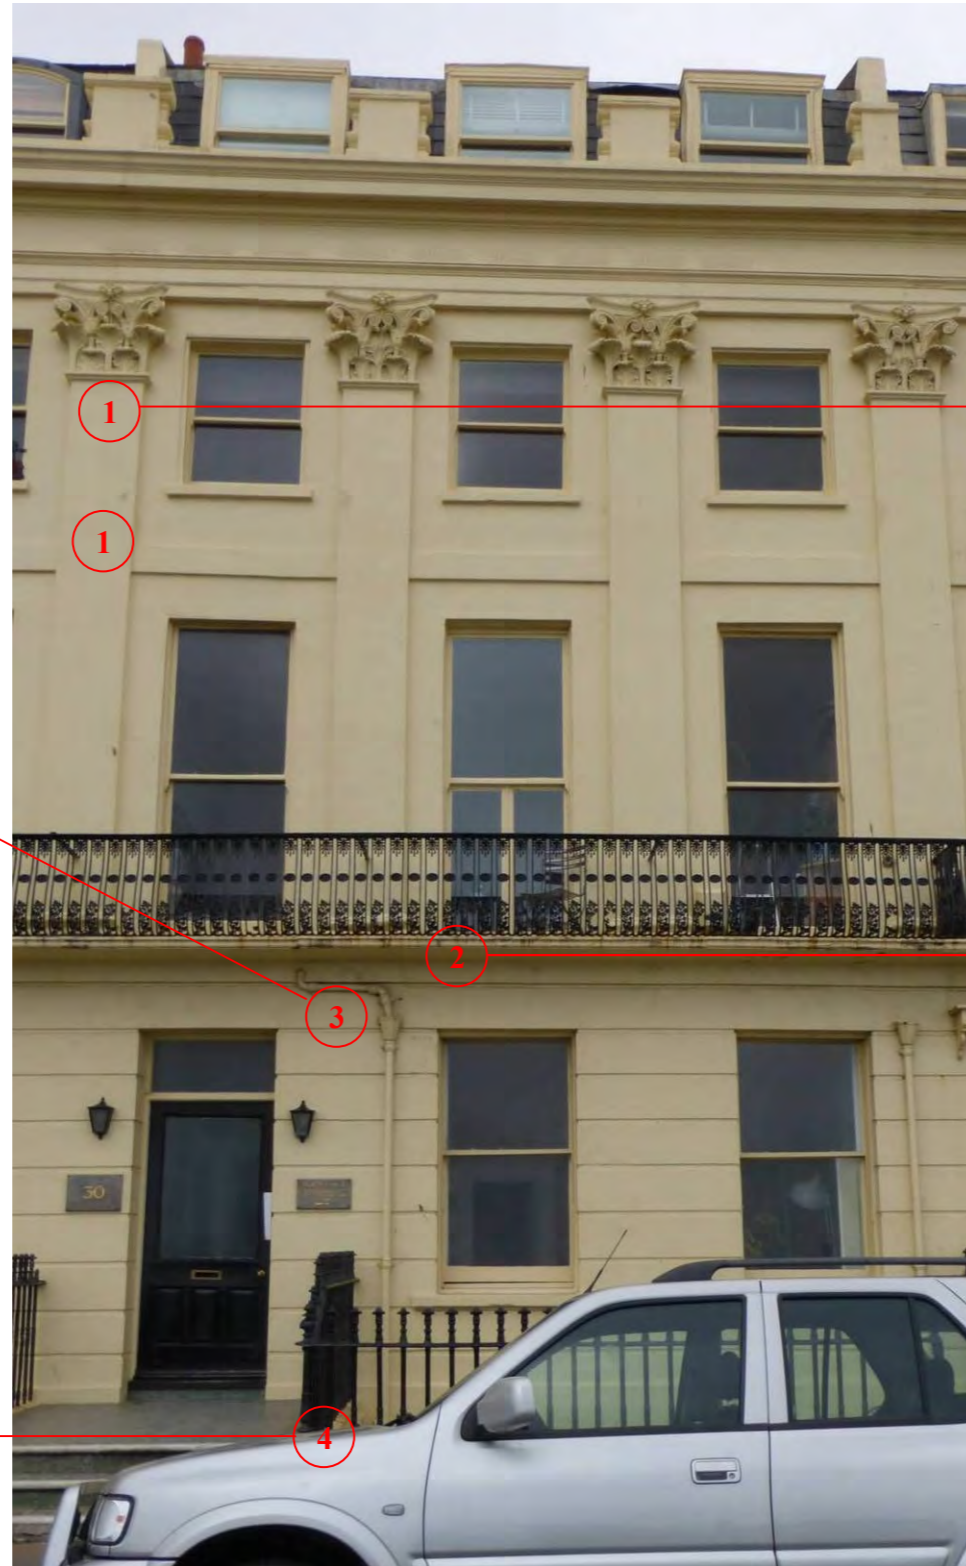
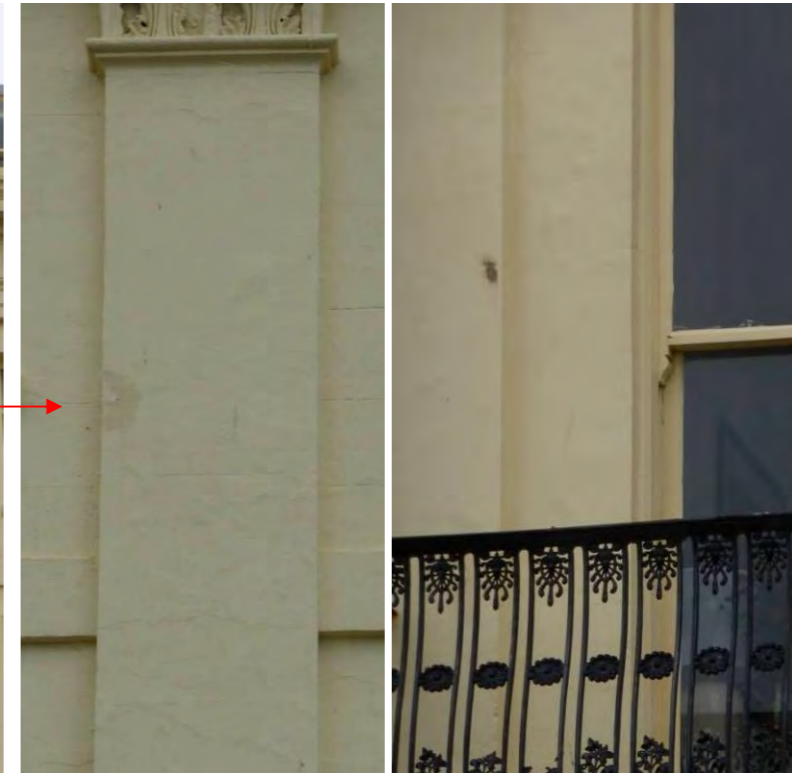
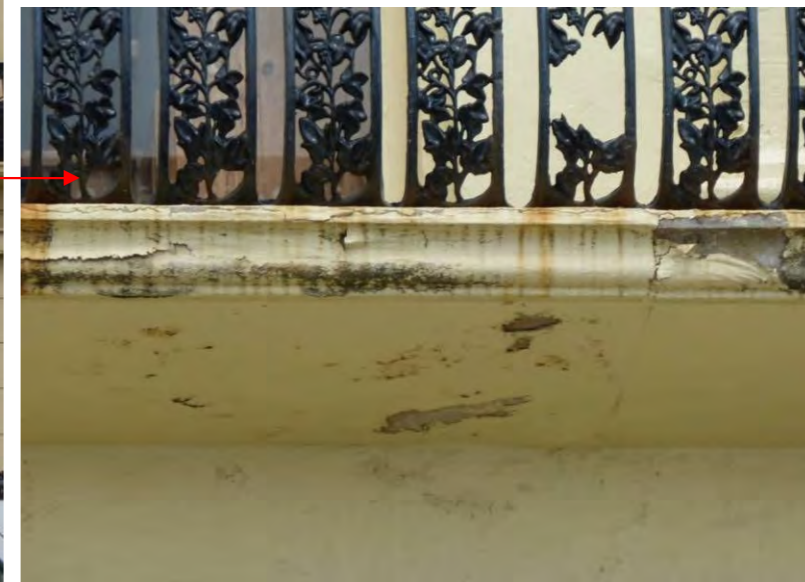
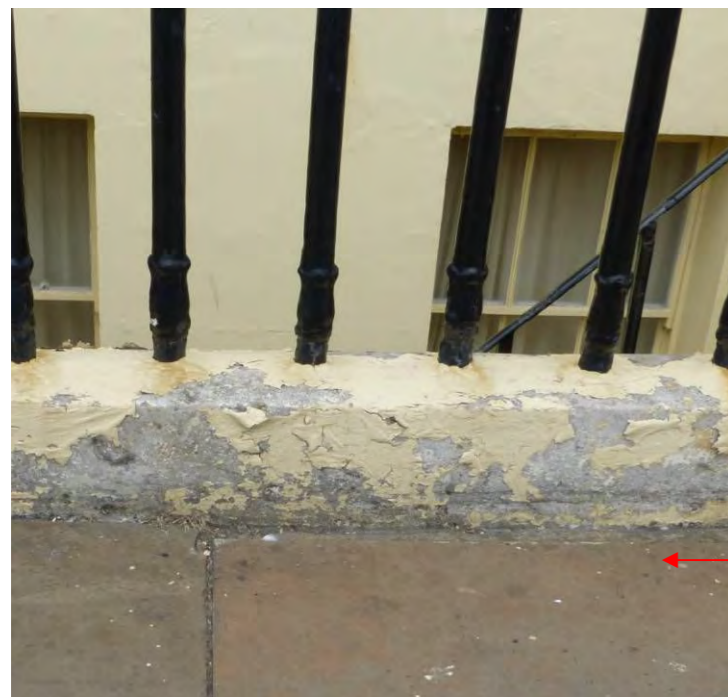
30 Brunswick Terrace

1. Patches of discoloration to columns, with minor losses to far left column;
2. Fracturing, staining and flaking under balcony – nos. 28 and 29 have flashing to underside of balcony, but appears to be missing from this property;
3. Flaking to ground-level generally located around downpipe;
4. Extensive losses to plinth revealing bare substrate.
