**Investigation of Paint Failure at
Brunswick Estate
Hove
Brighton**

August 2013

**BRUNSWICK ESTATE
HOVE**

The following document investigates the failure of the external paint-system at Brunswick Estate, Hove based on research carried out by Elizabeth Hirst and Rachel Morley of Hirst Conservation between August and November 2013. The work was commissioned by Brighton & Hove City Council.

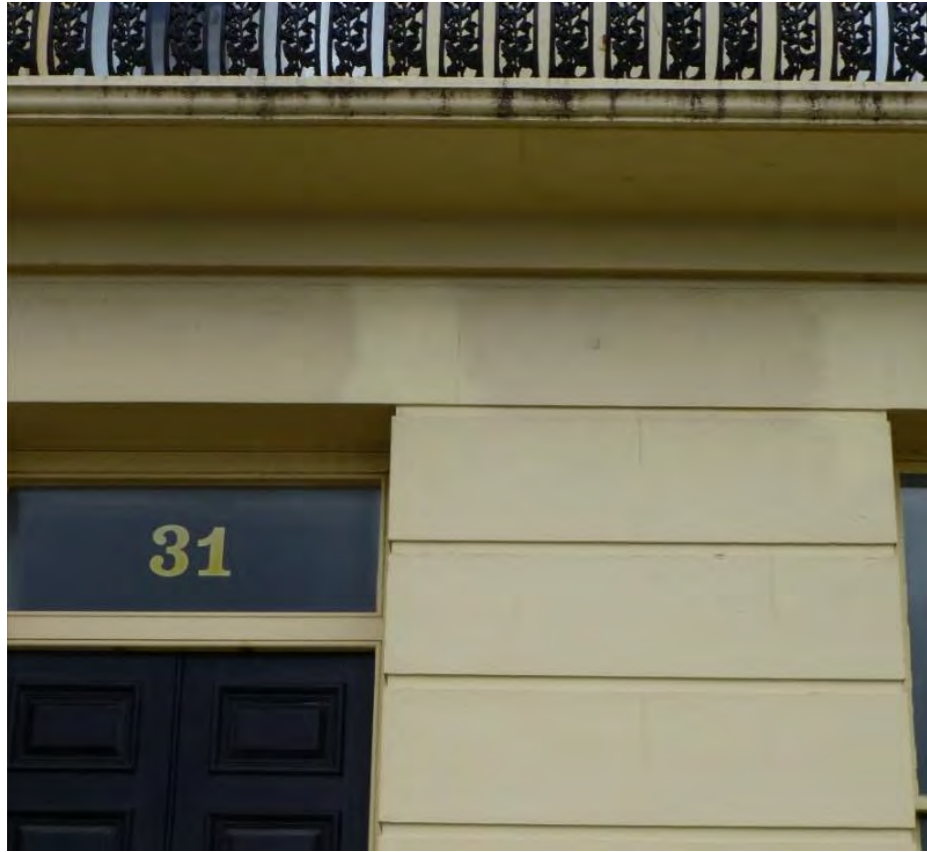
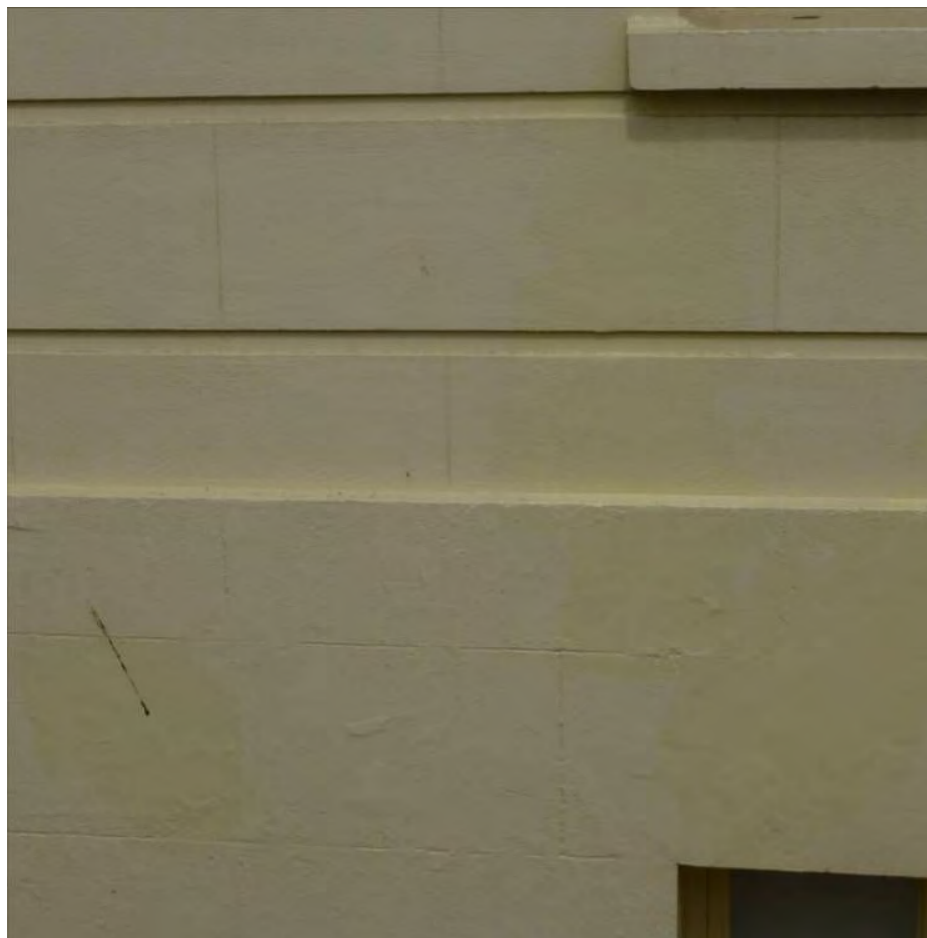
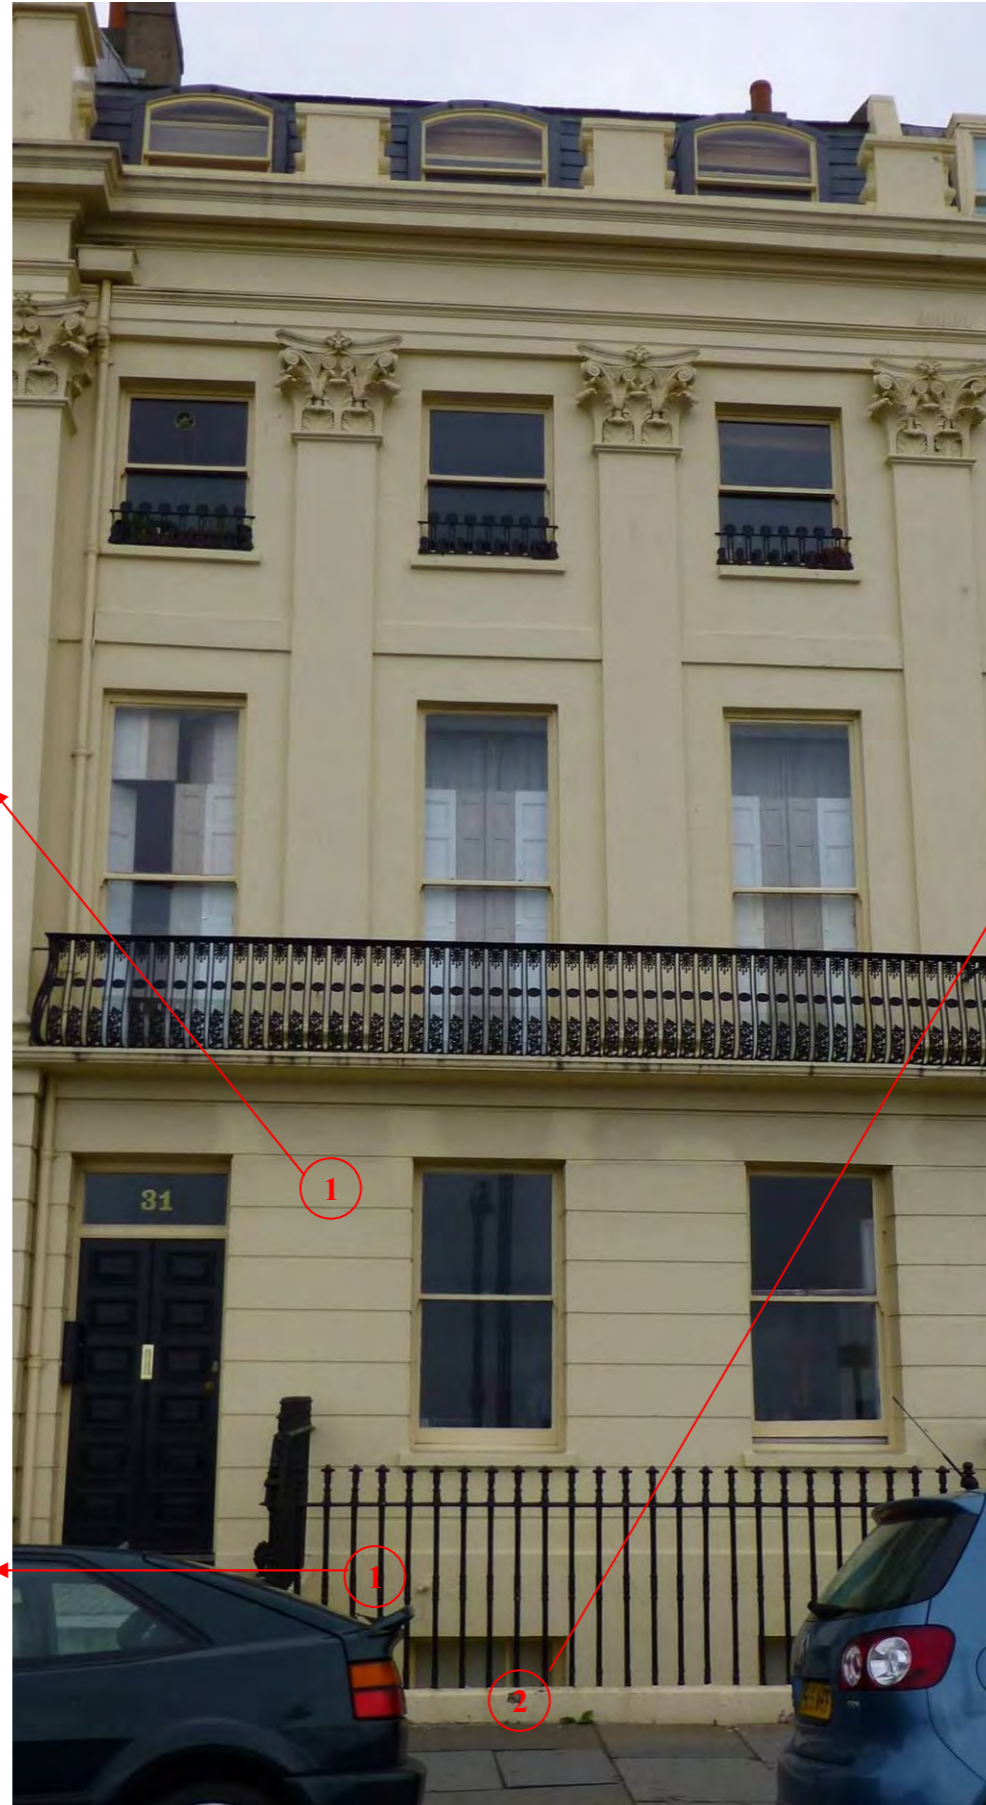
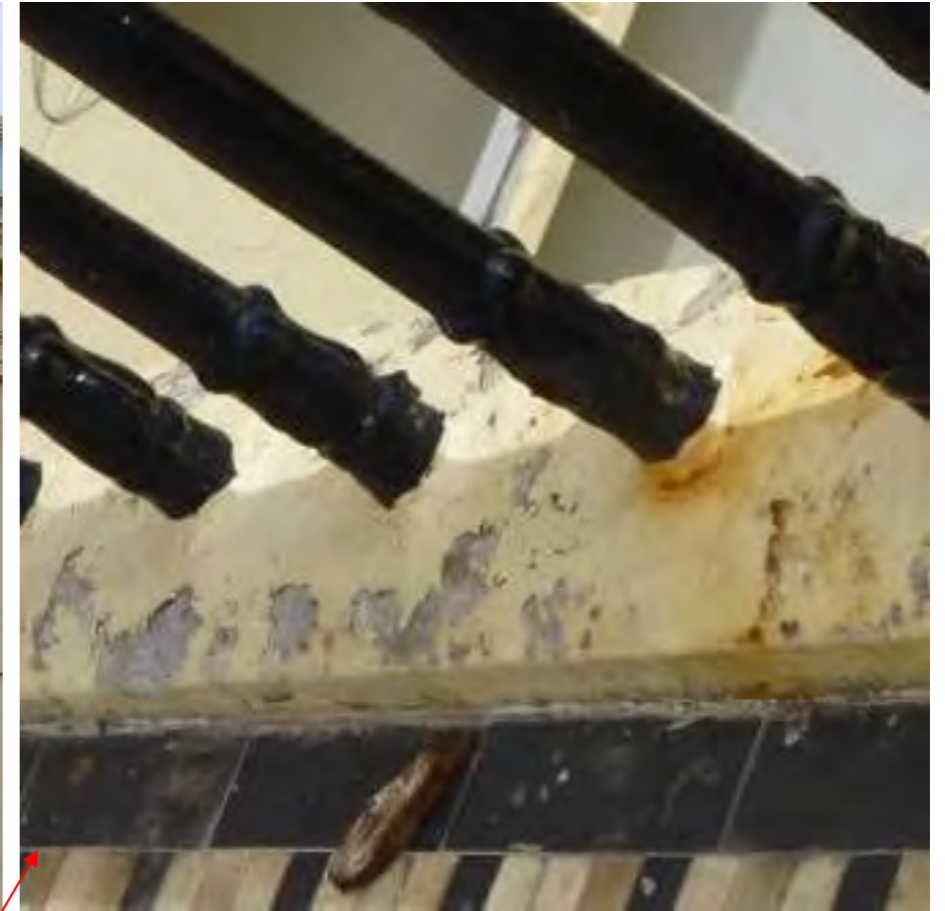
31 Brunswick Terrace

1. Very patchy appearance across ground and basement levels – seems to have been touched in with different shades
2. Minor losses and slight ferrous staining to plinth wall.

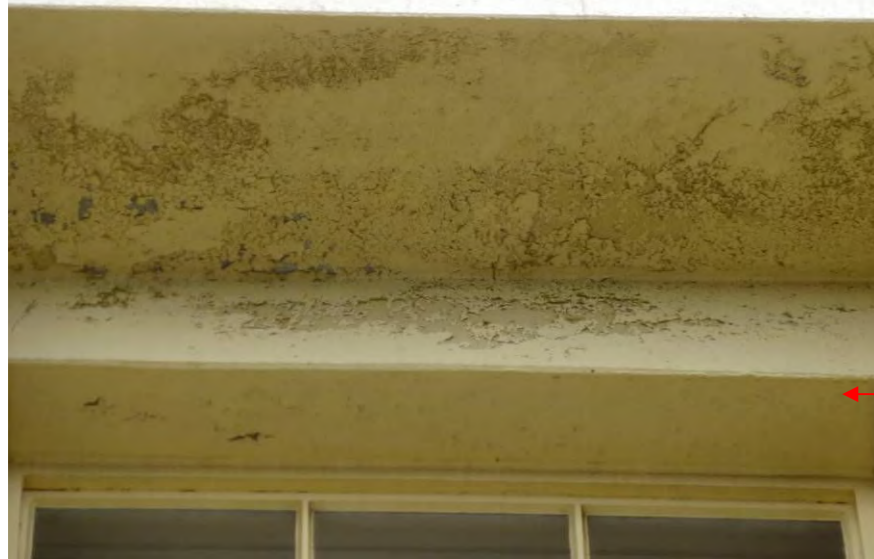
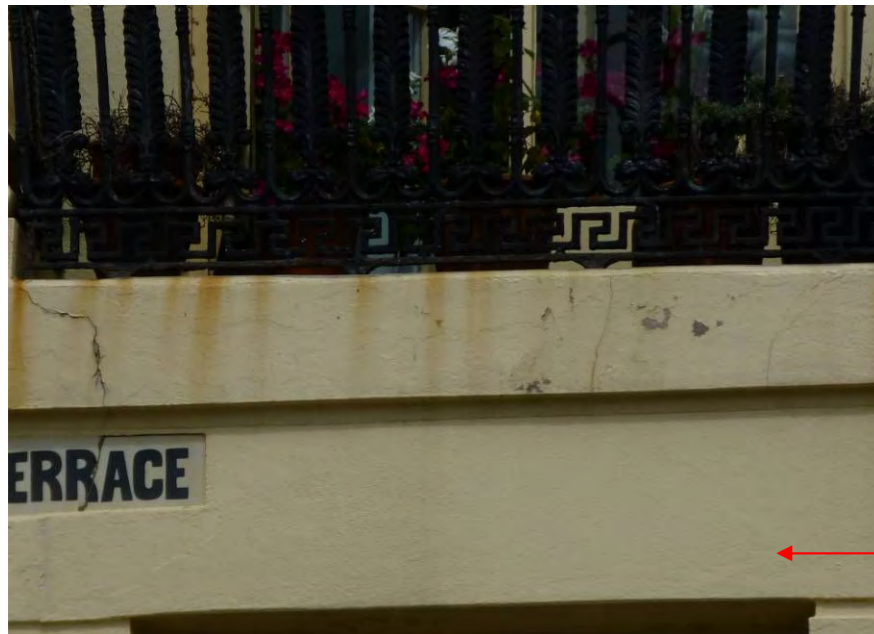
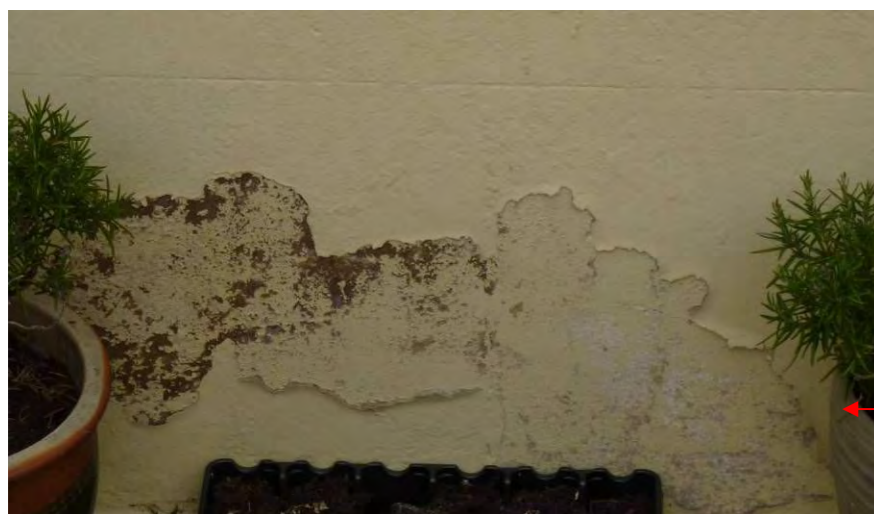
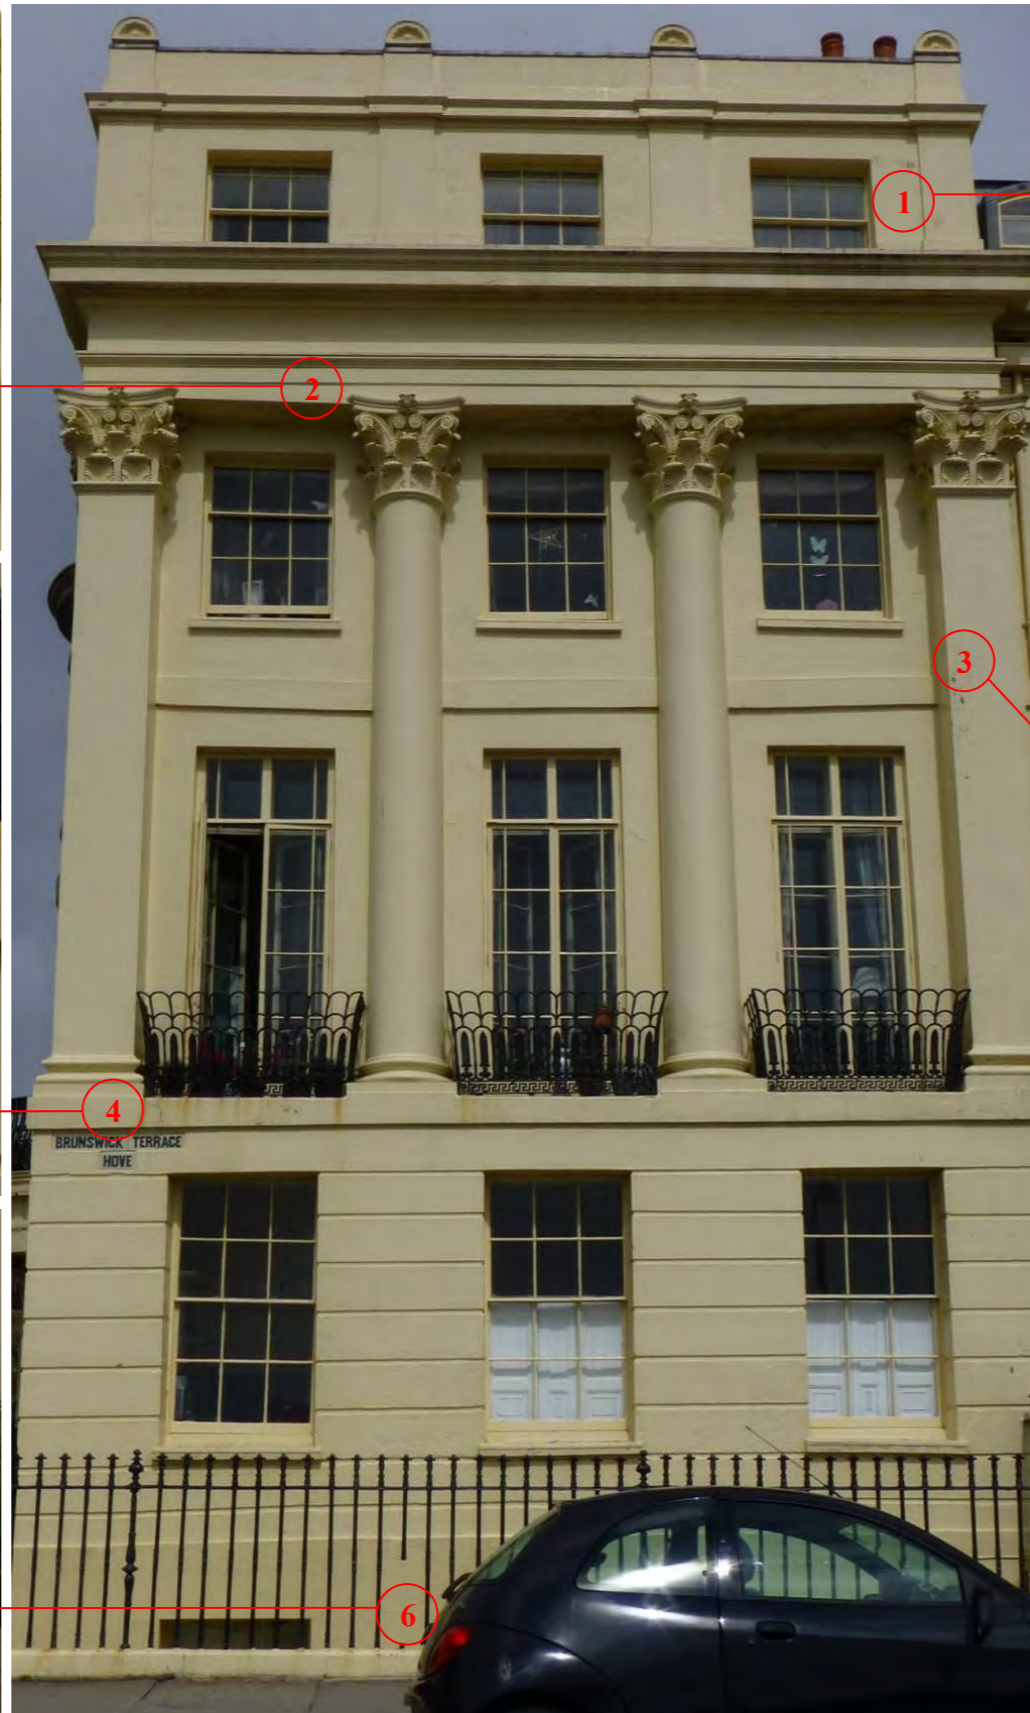
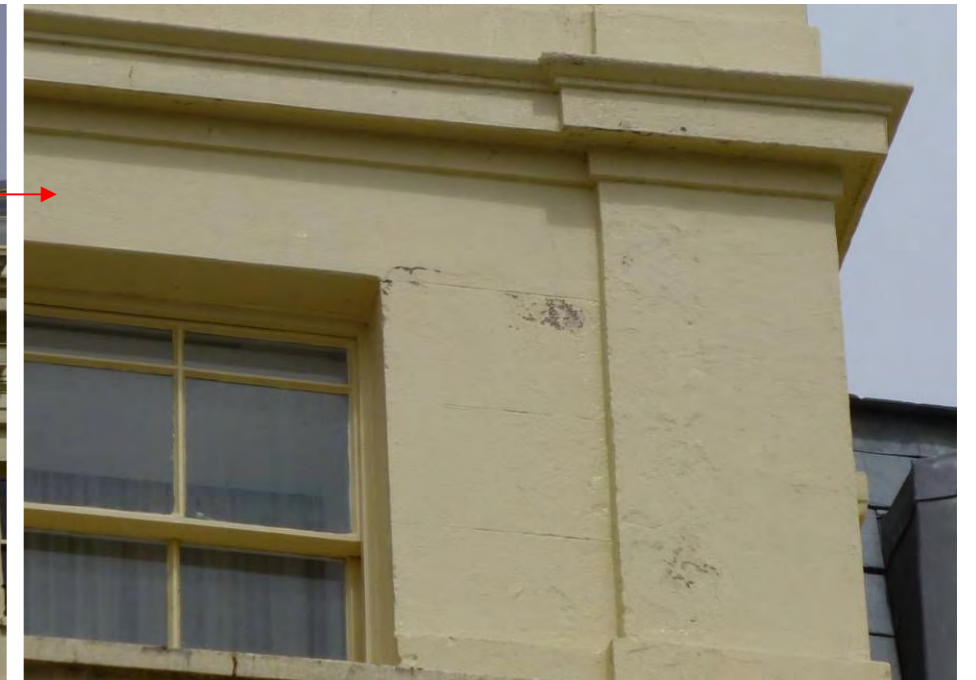
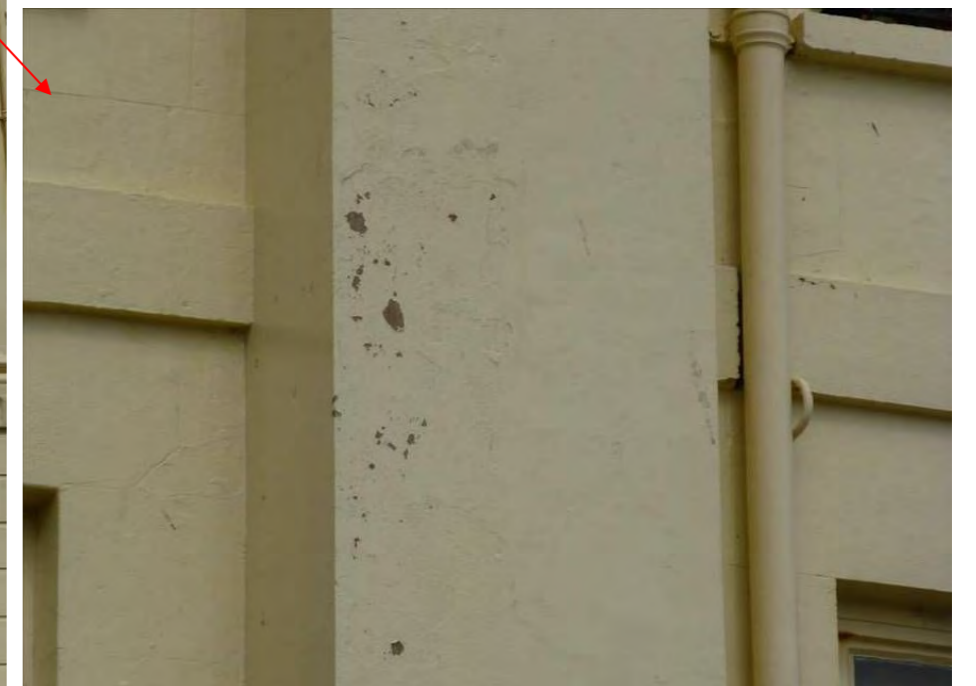
32 Brunswick Terrace (Brunswick Terrace Elevation)

1. Substrate cracking evident at high level with areas of paint loss;
2. Extensive flaking to all recesses of stepped cornice;
3. Uneven surface and losses to far right column;
4. Fractures, minor losses and ferrous staining to balcony;
5. Substrate fractures and flaking to ground-floor level;
6. Localised flaking to basement area;
7. Slight ferrous staining and losses to plinth wall, but generally quite good.

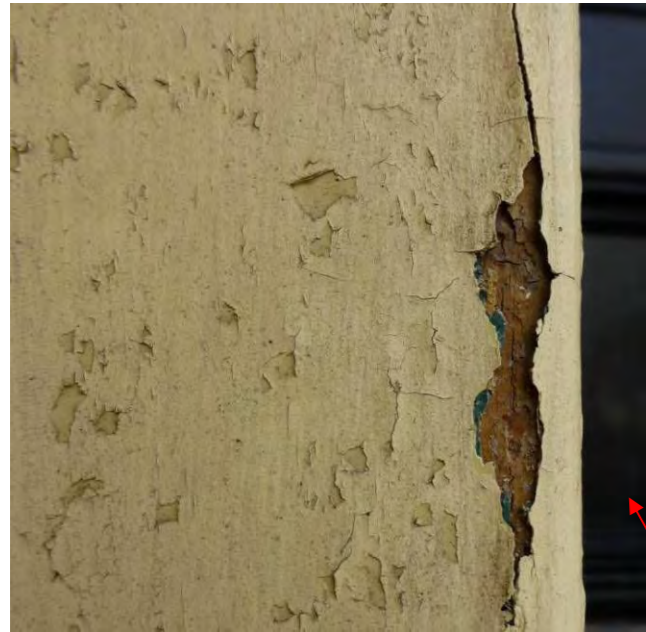
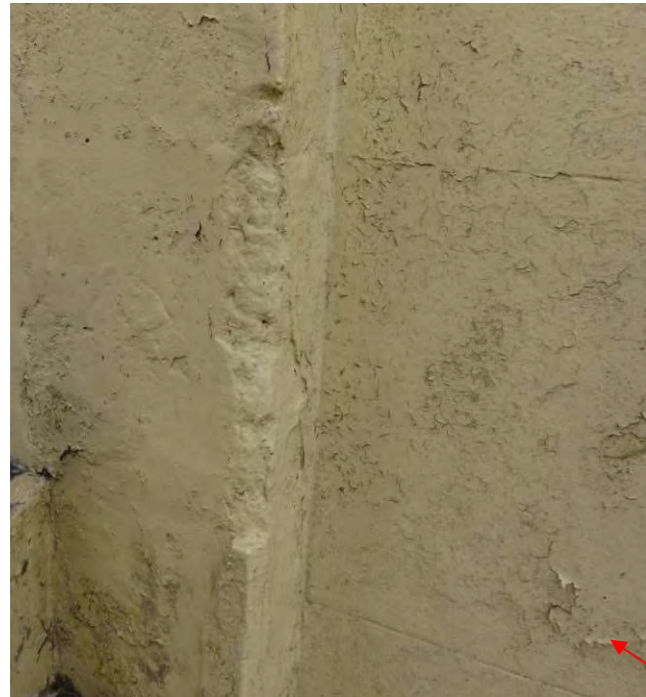
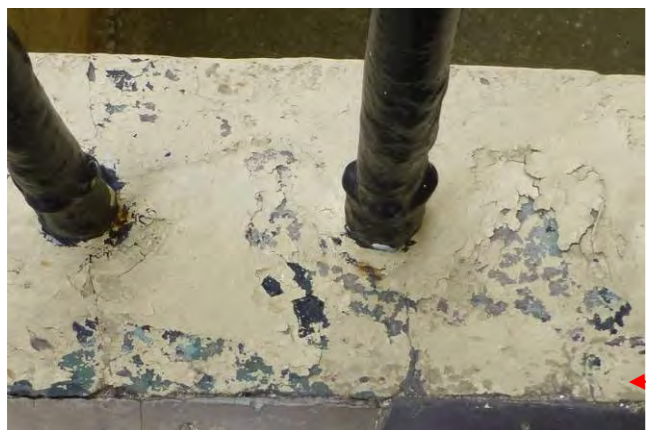
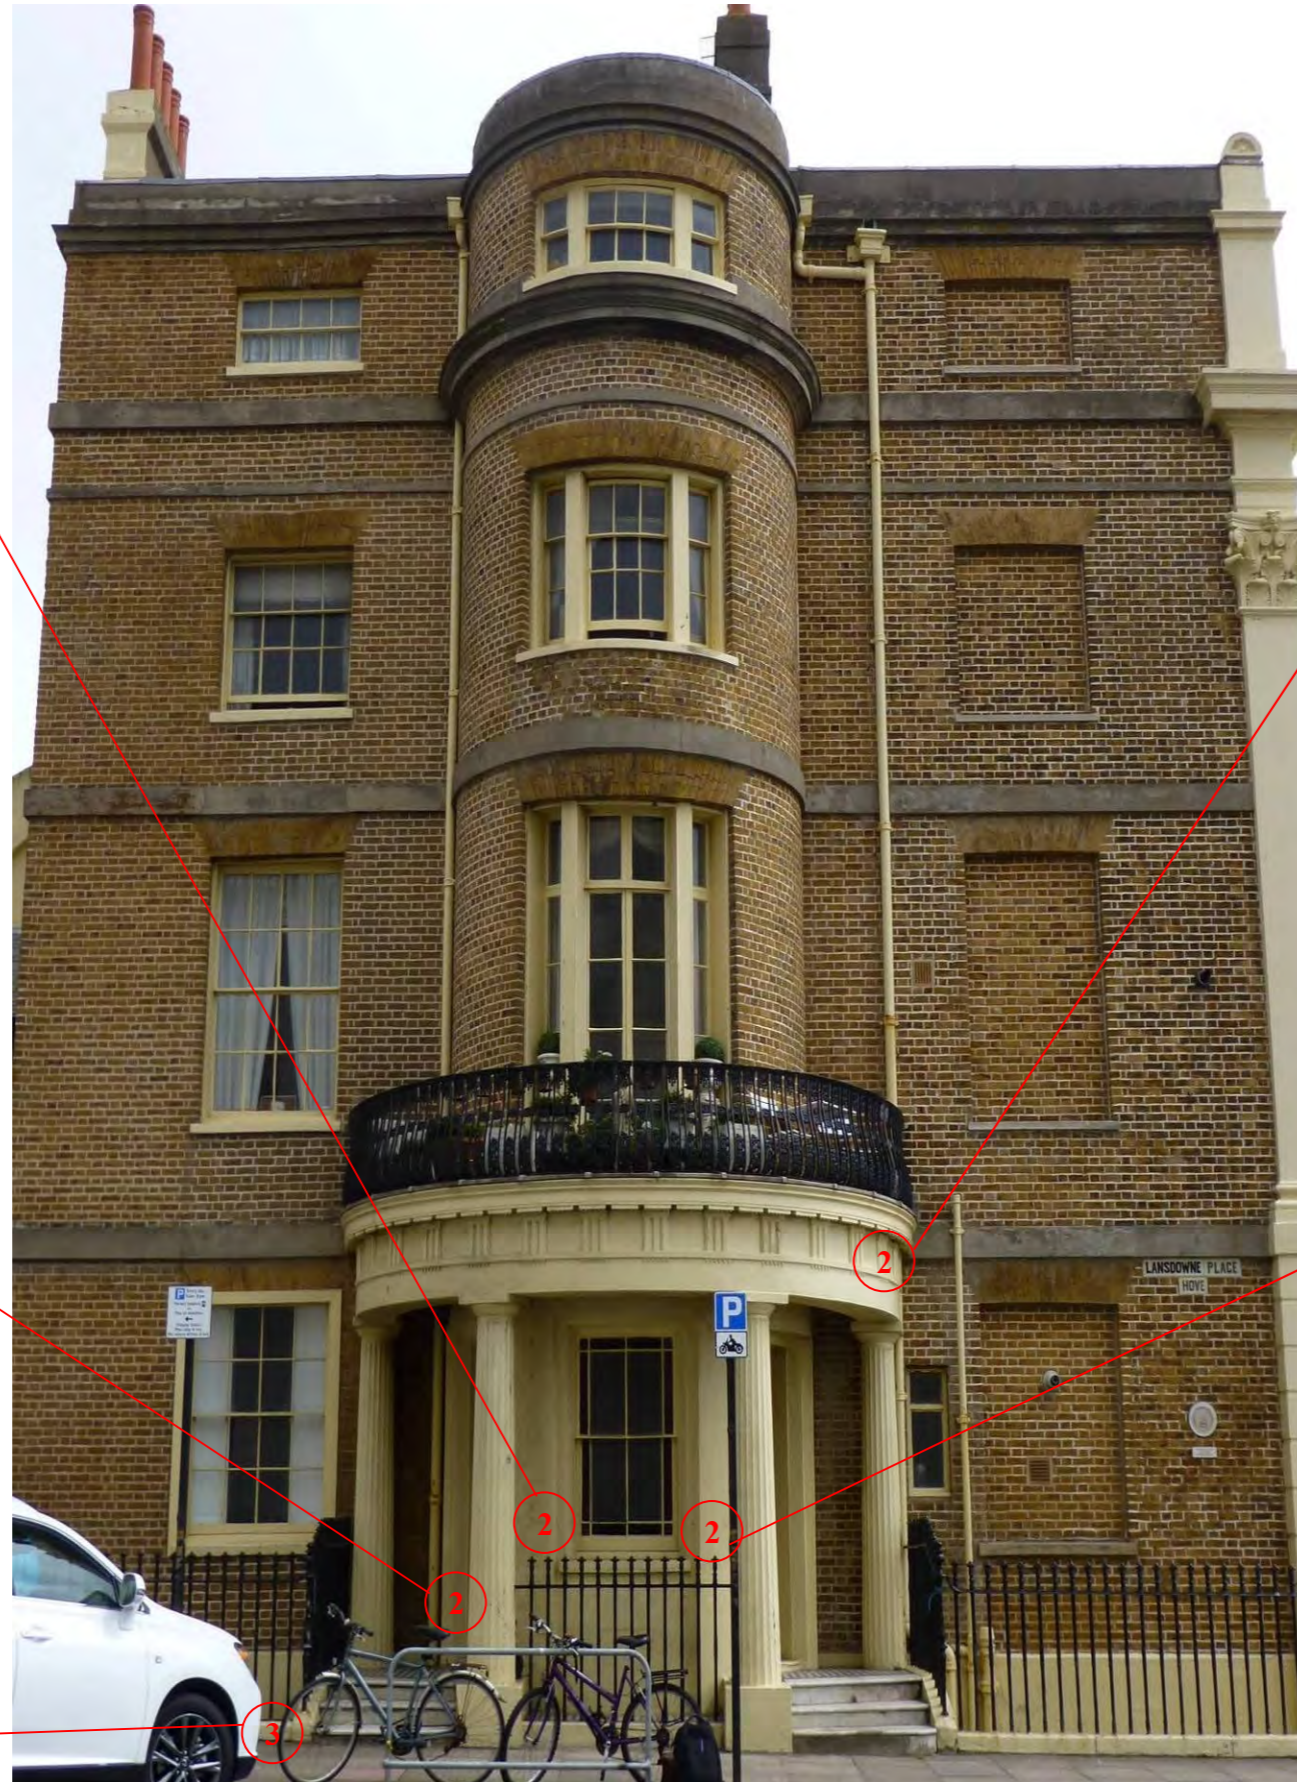
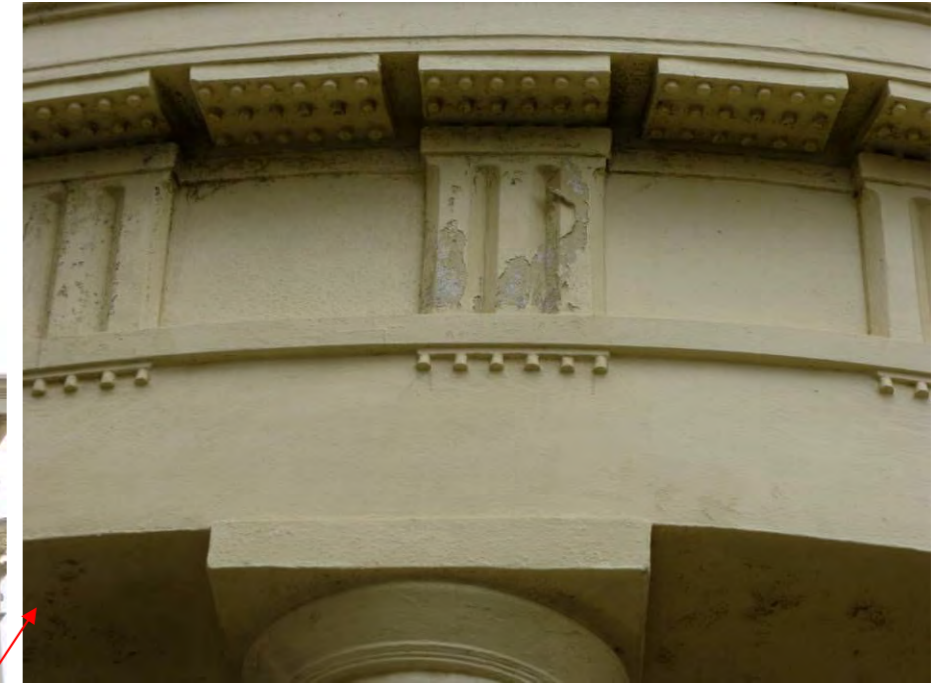
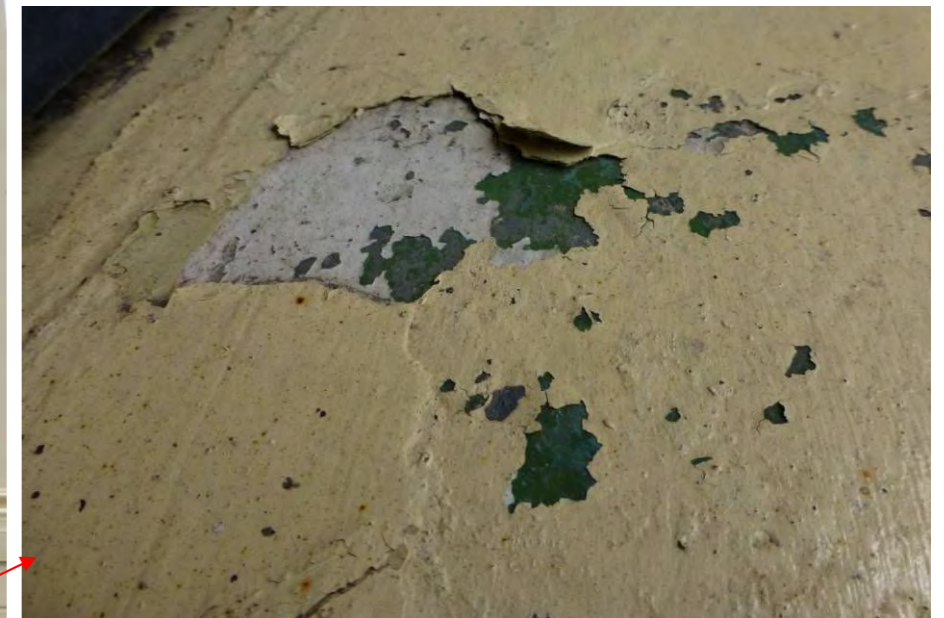
32 Brunswick Terrace (Lansdowne Place Elevation)

1. Flaking to underside of cornice wrapping around from Brunswick Terrace elevation;
2. Extensive failure and loss to entire bow porch entrance, this is presumably due to water ingress from balcony above and salt action;
3. Minor flaking and staining to plinth wall.

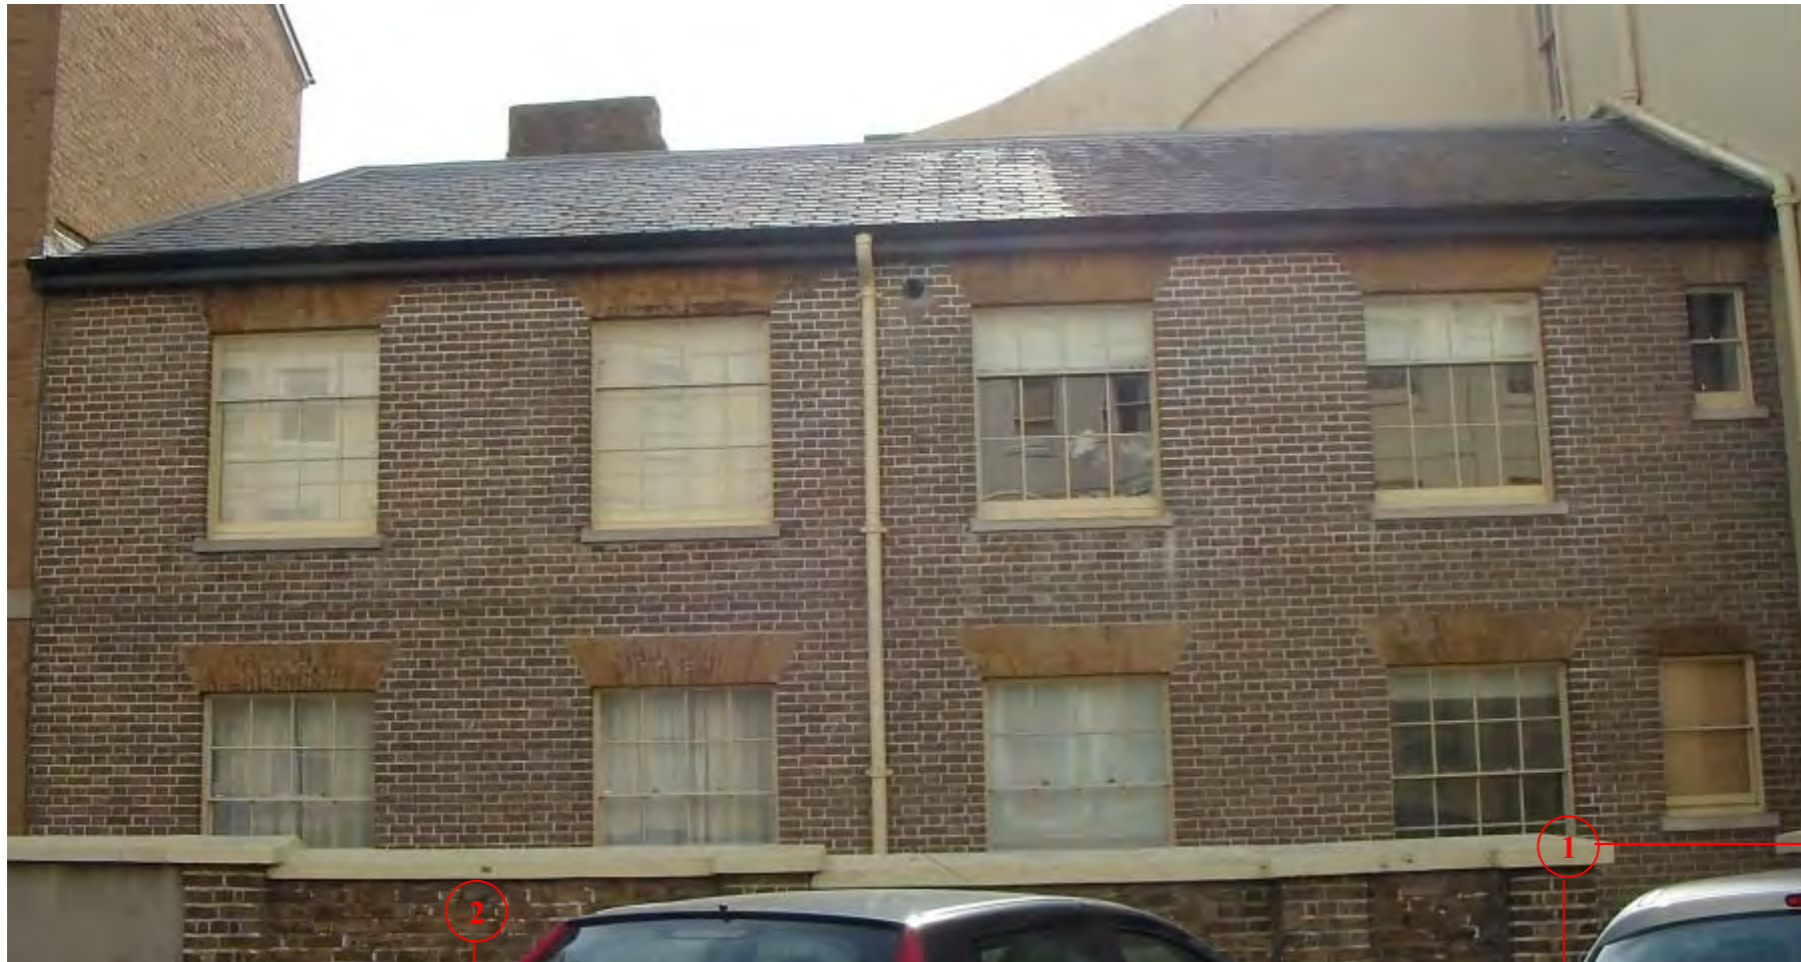
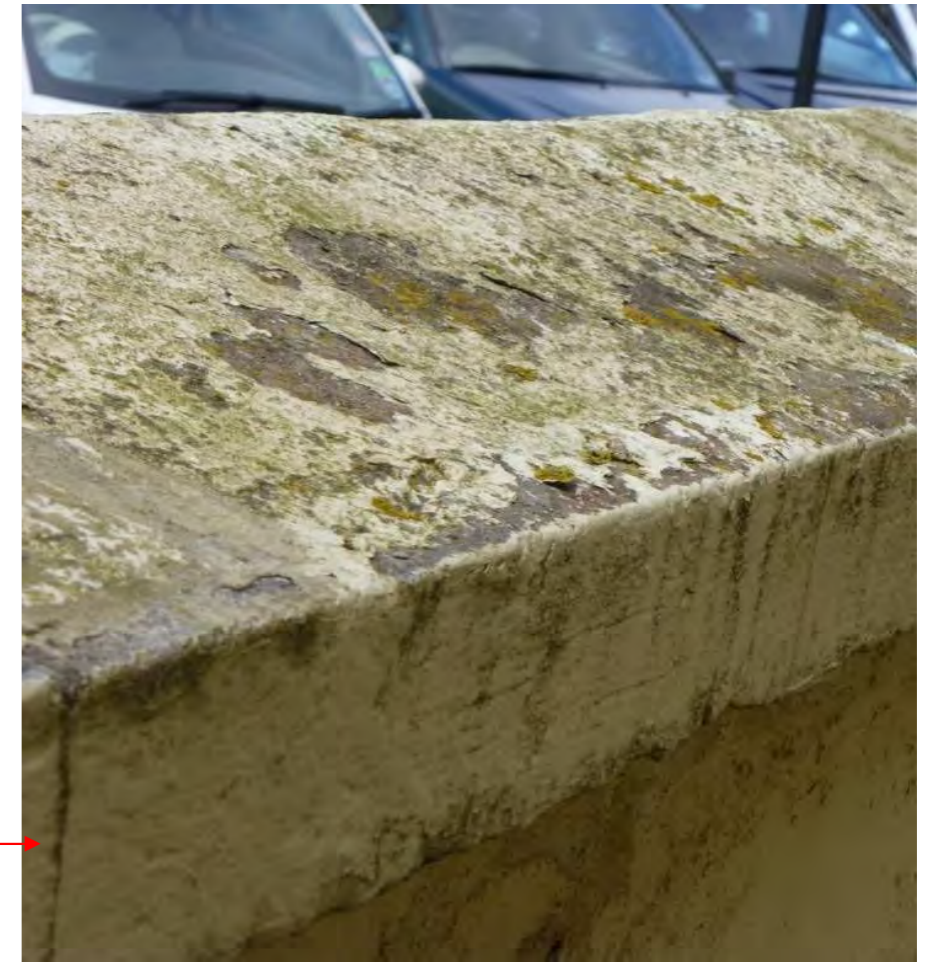
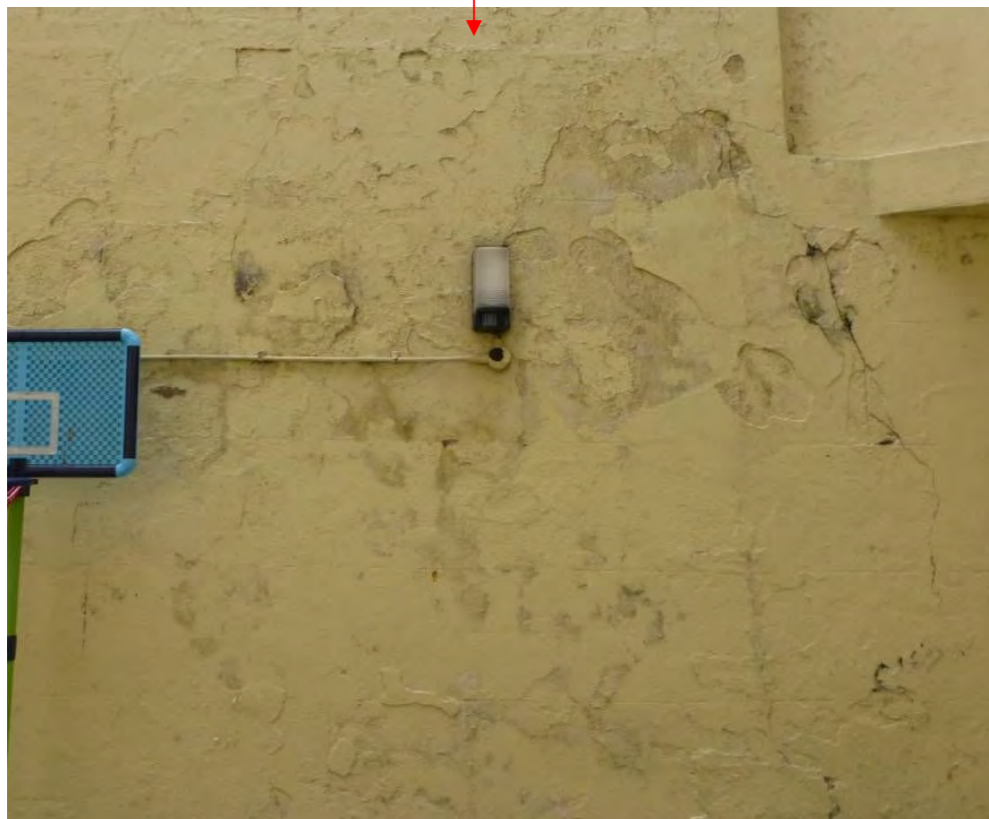
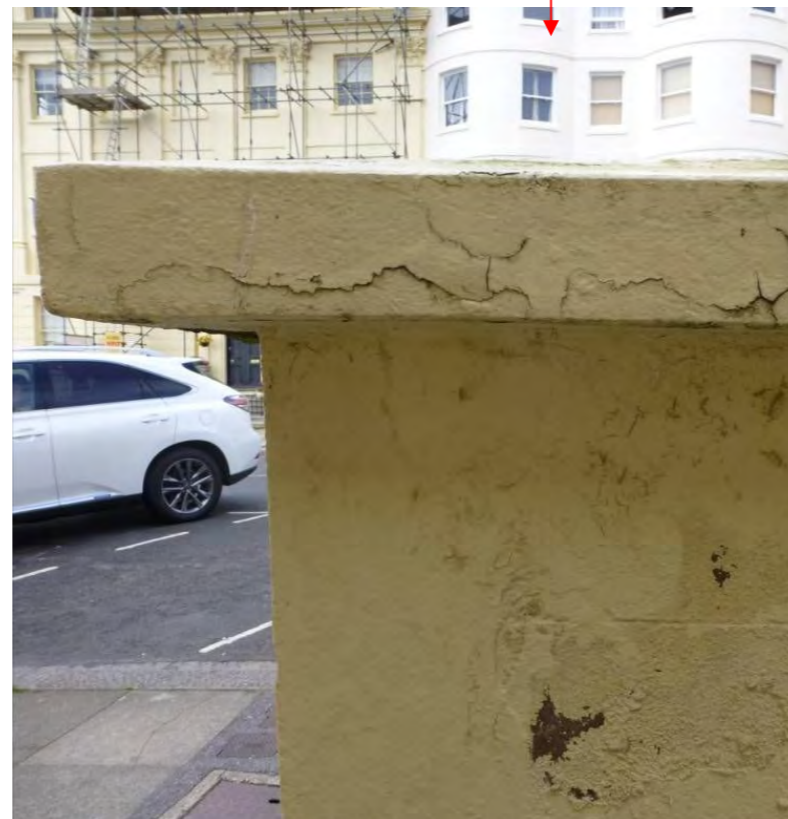
32 Brunswick Terrace (Lansdowne Place Elevation contd.)

1. Boundary wall to lower level extension exhibiting extensive cracking, flaking, loss and algae growth;
2. Vast patches of salt eruption at basement level.

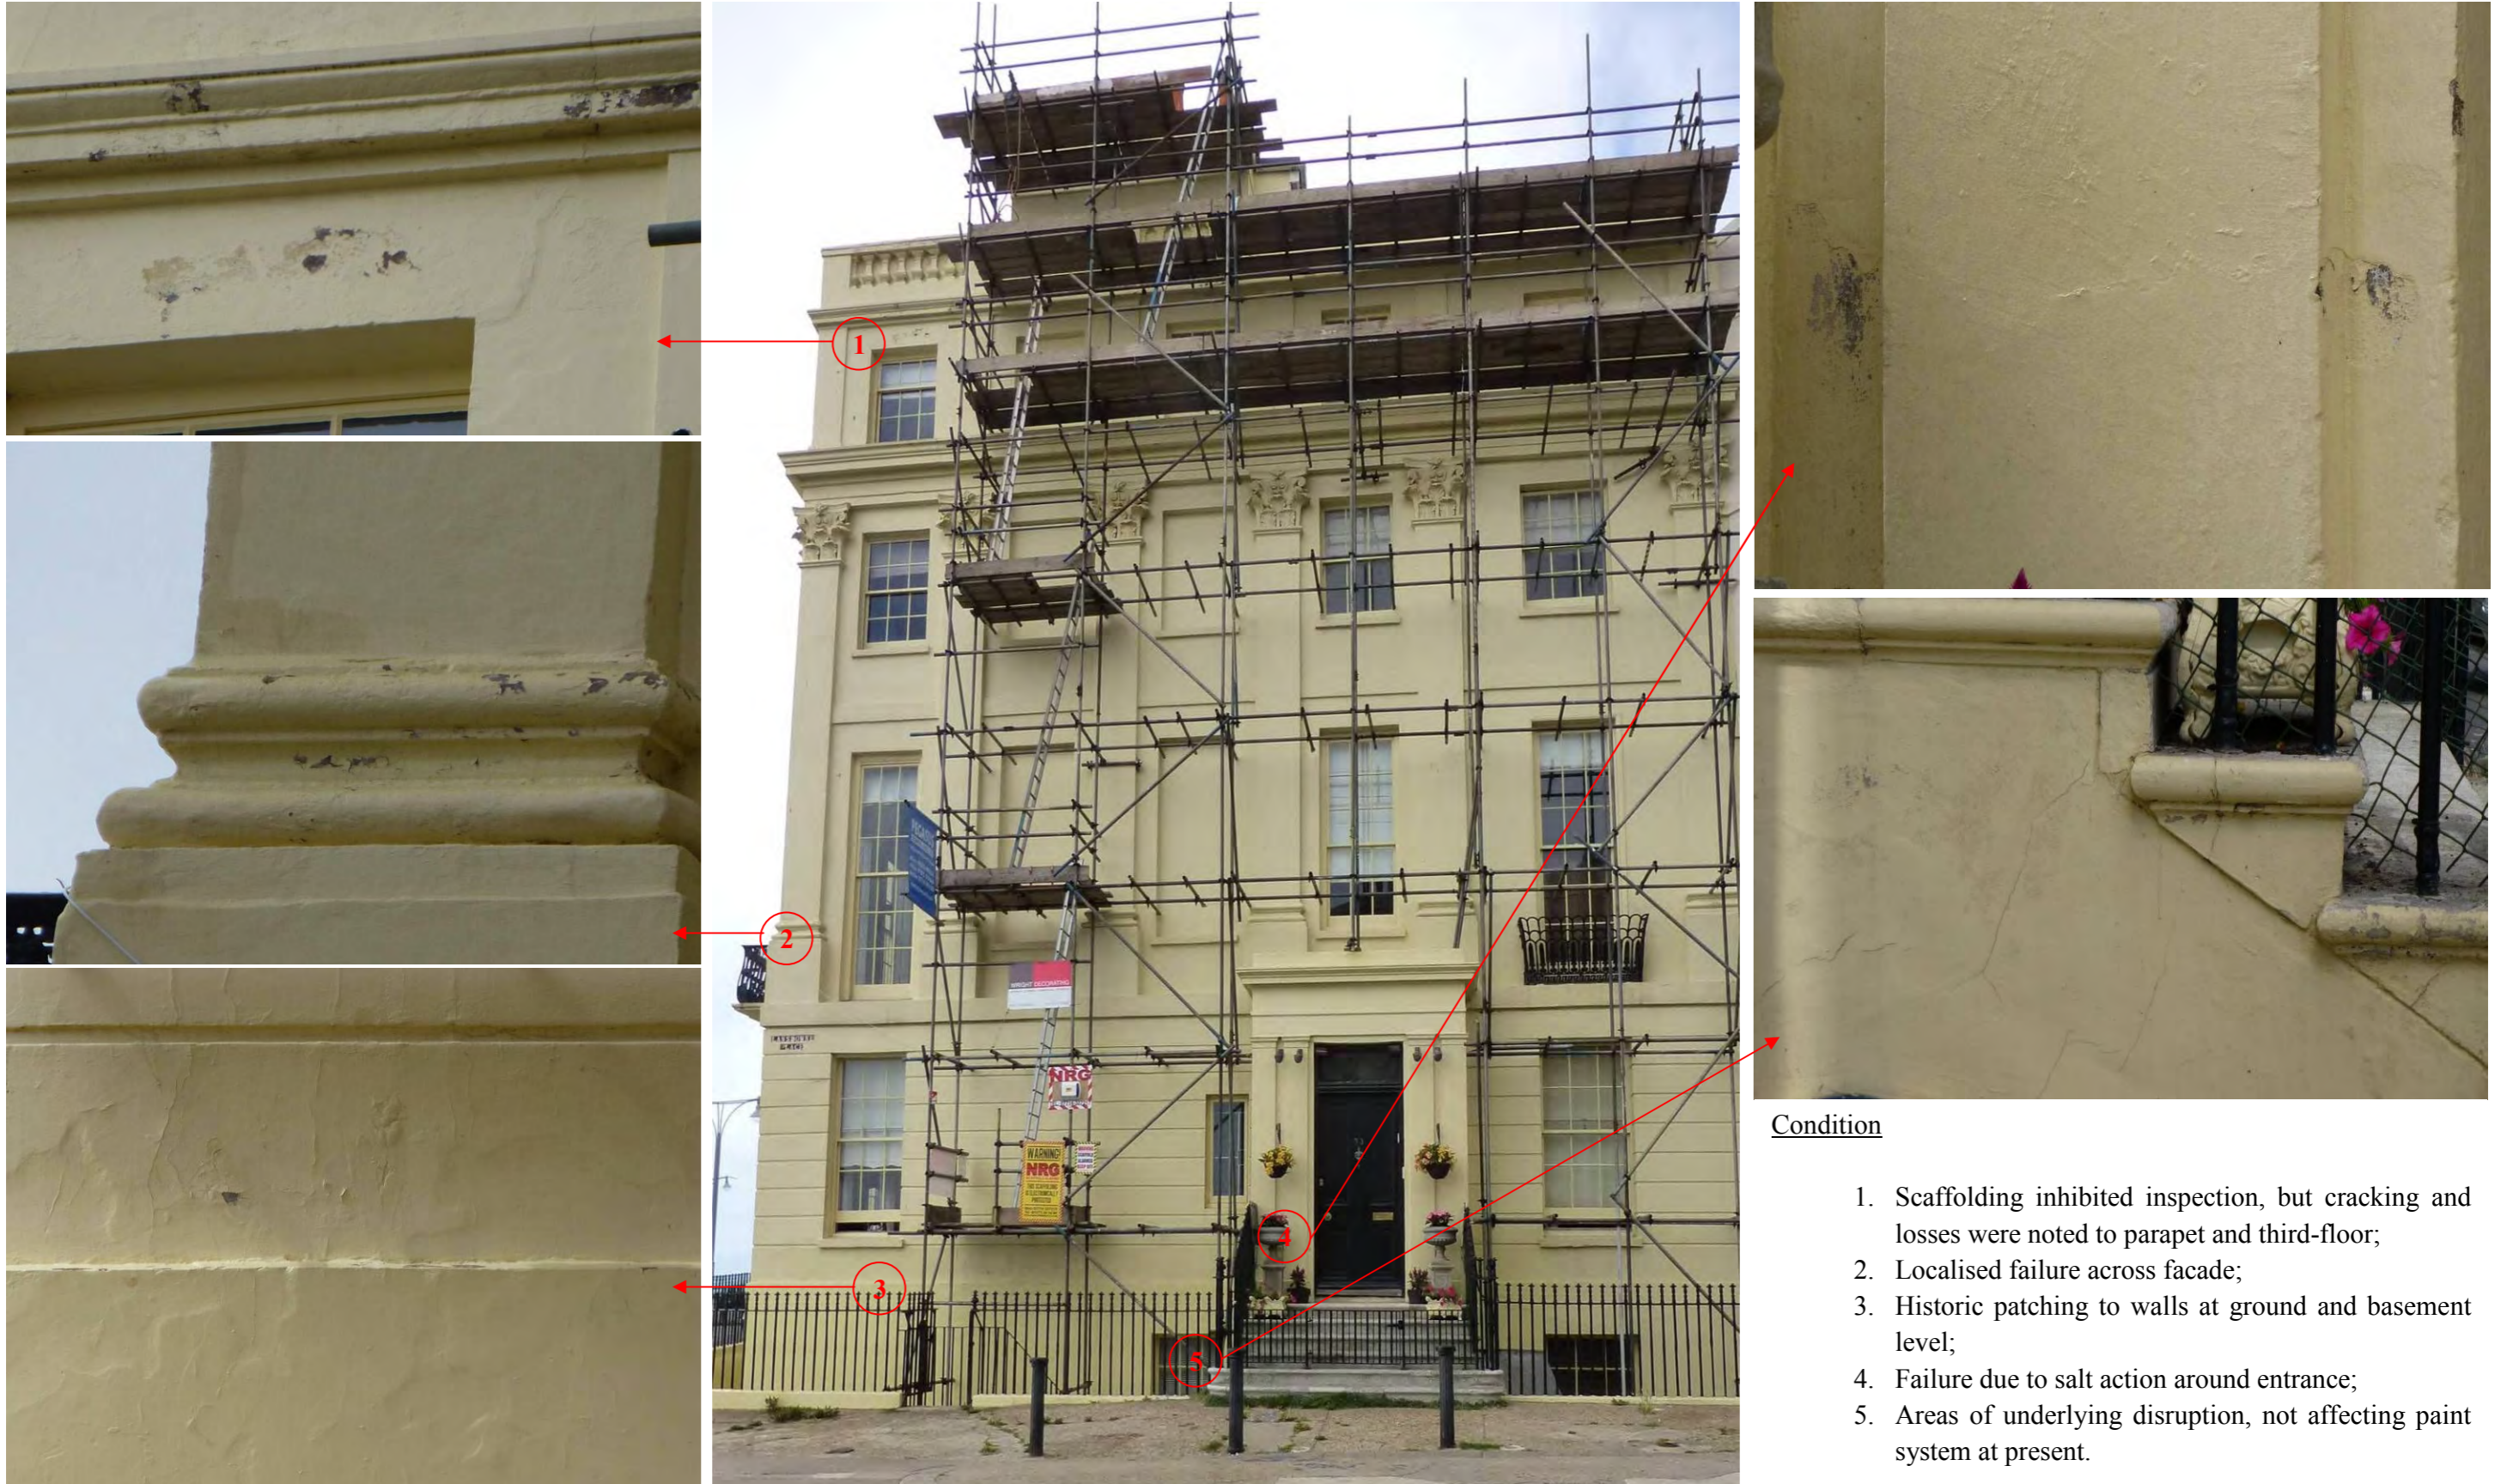
33 Brunswick Terrace (Lansdowne Place Elevation)

- 1. Scaffolding inhibited inspection, but cracking and losses were noted to parapet and third-floor;
- 2. Localised failure across facade;
- 3. Historic patching to walls at ground and basement level;
- 4. Failure due to salt action around entrance;
- 5. Areas of underlying disruption, not affecting paint system at present.
