**Investigation of Paint Failure at
Brunswick Estate
Hove
Brighton**

August 2013

**BRUNSWICK ESTATE
HOVE**

The following document investigates the failure of the external paint-system at Brunswick Estate, Hove based on research carried out by Elizabeth Hirst and Rachel Morley of Hirst Conservation between August and November 2013. The work was commissioned by Brighton & Hove City Council.

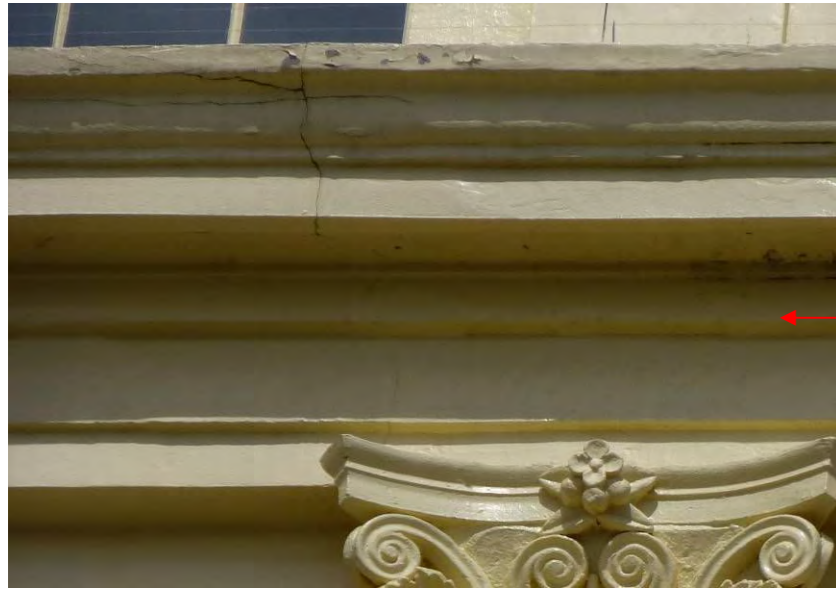
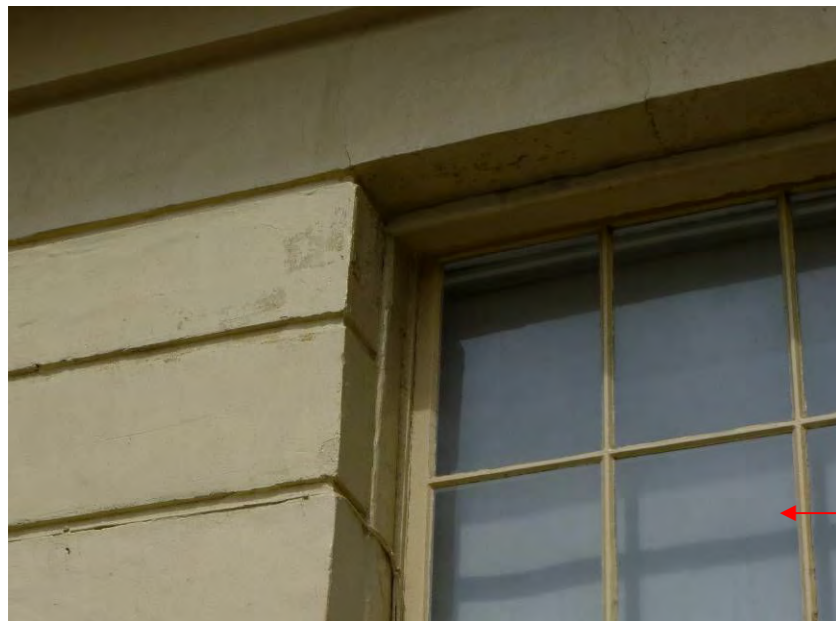
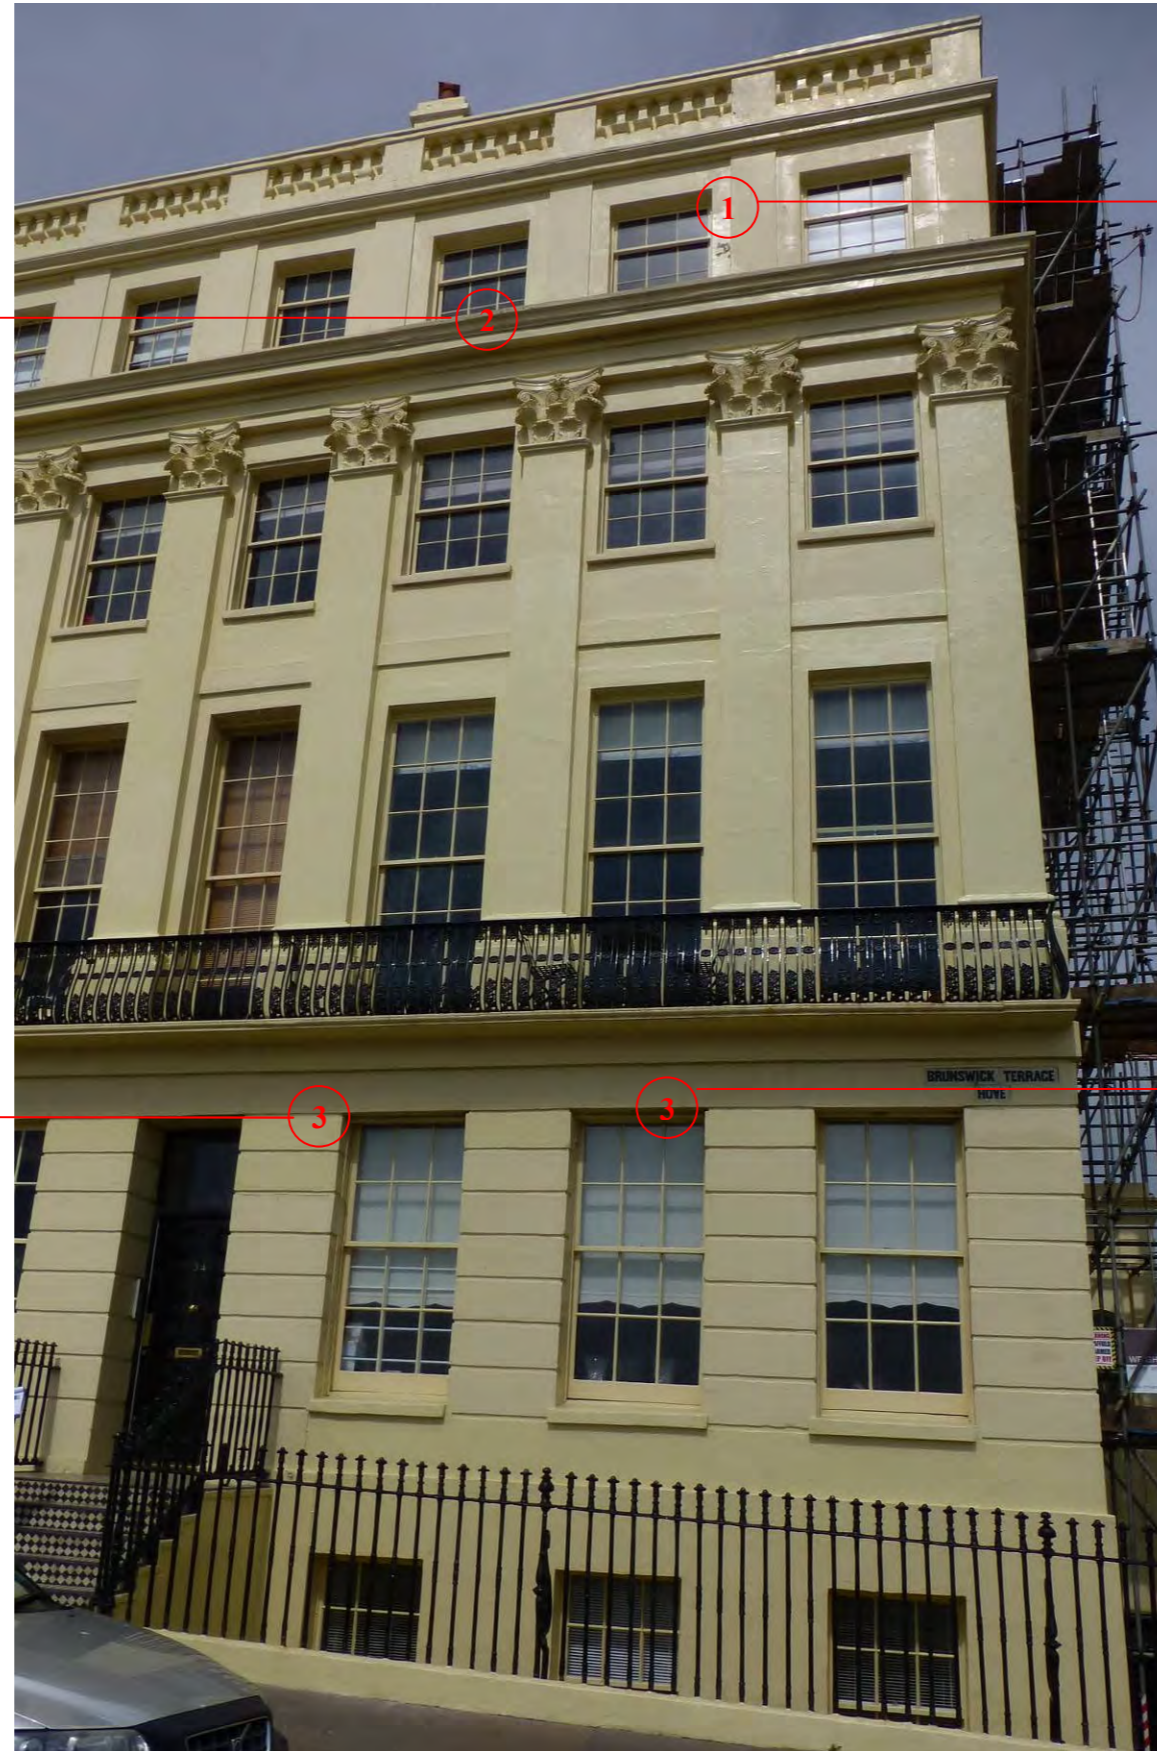
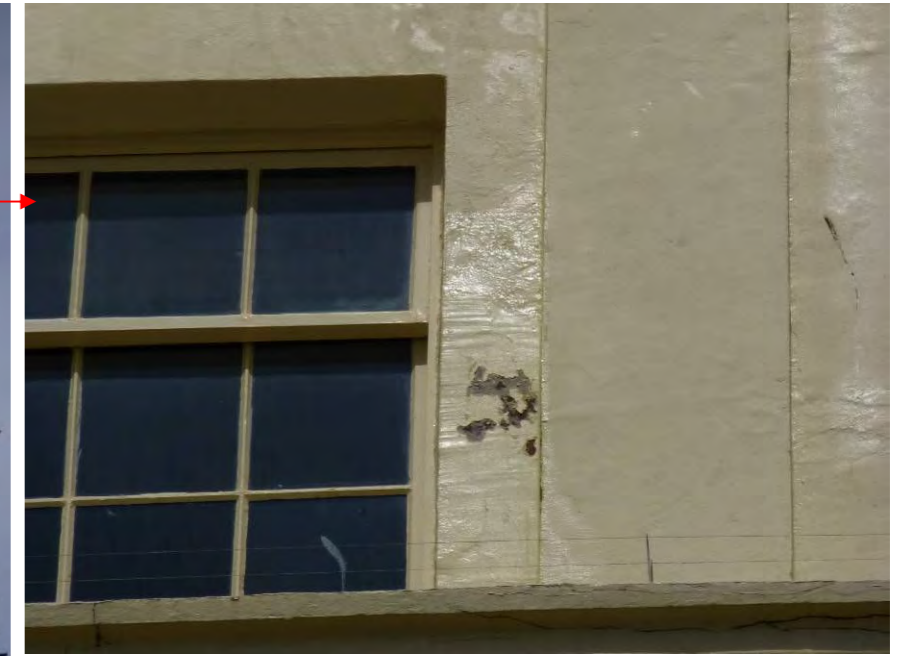
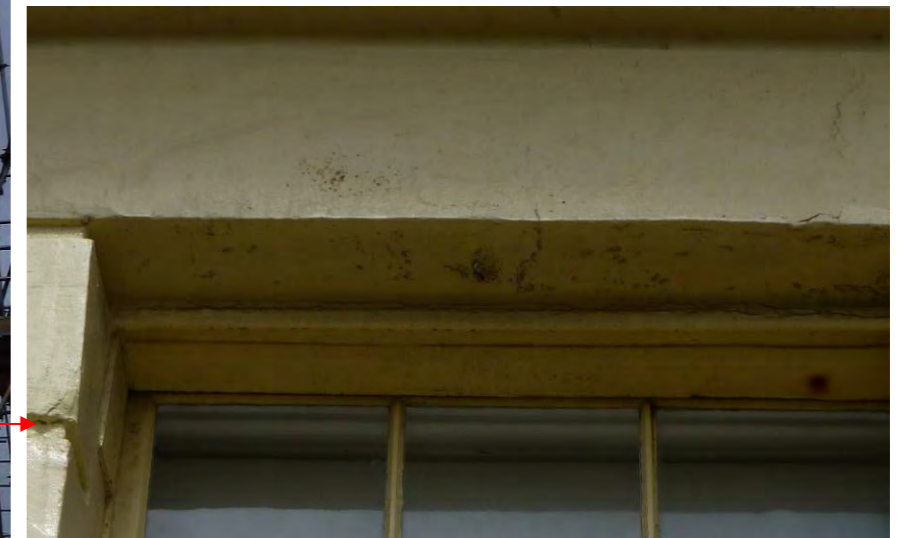
33 Brunswick Terrace (Brunswick Terrace Elevation)

1. Minor localised loss to third-floor;
2. Cracking through cornice – very minor losses at present;
3. Flaking, fissures and salt-eruption to upper section of ground-floor rustication – particularly to window reveals;

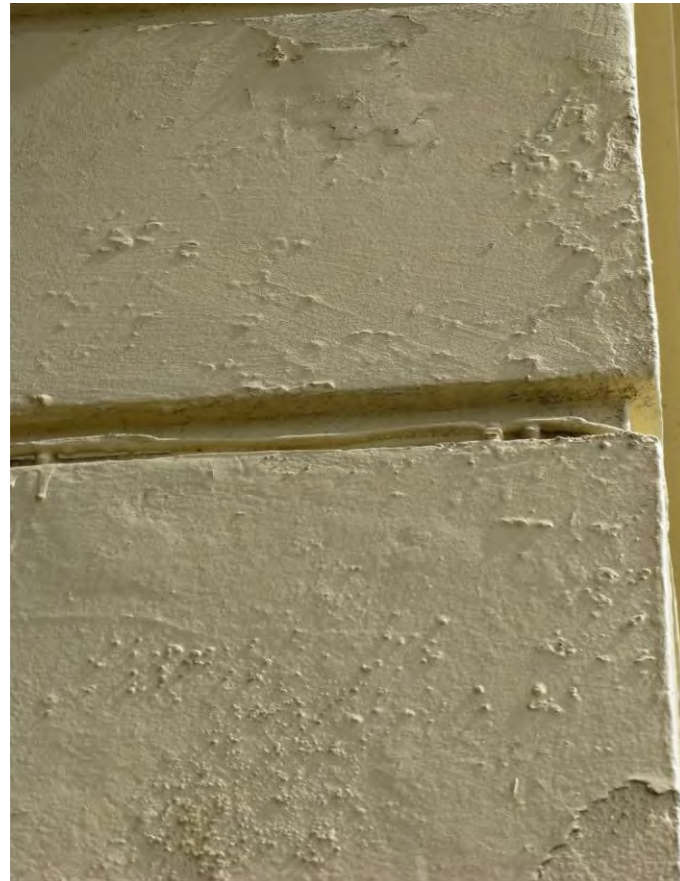
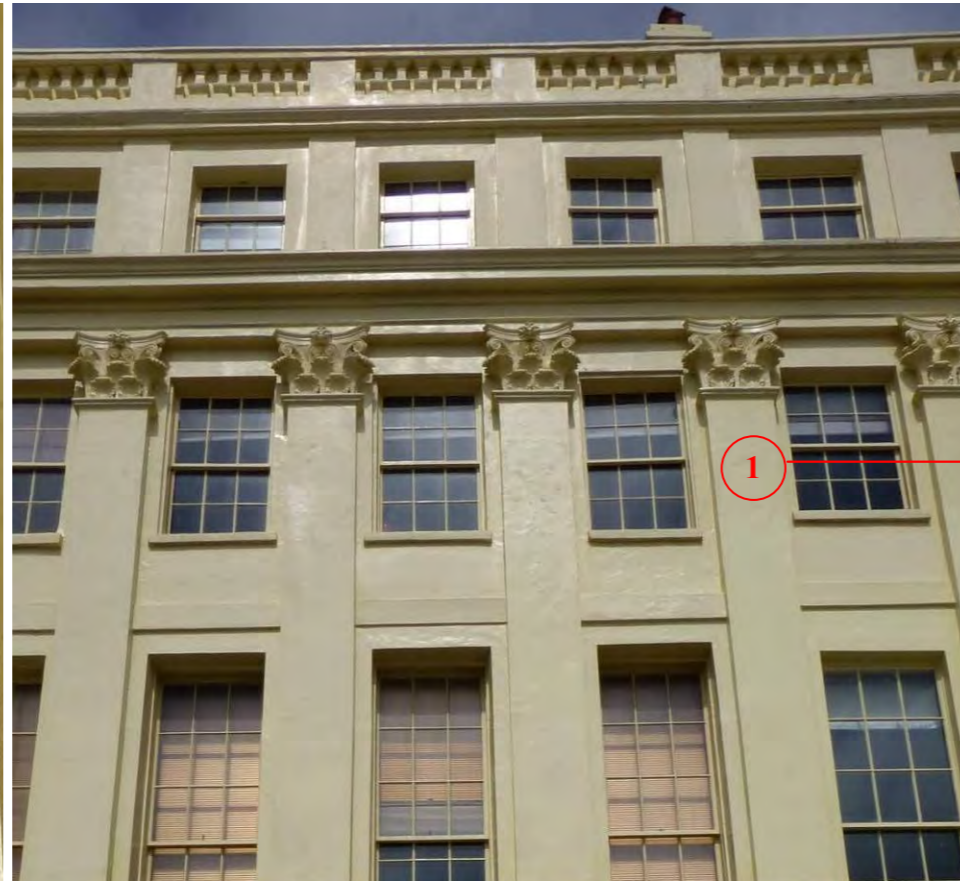
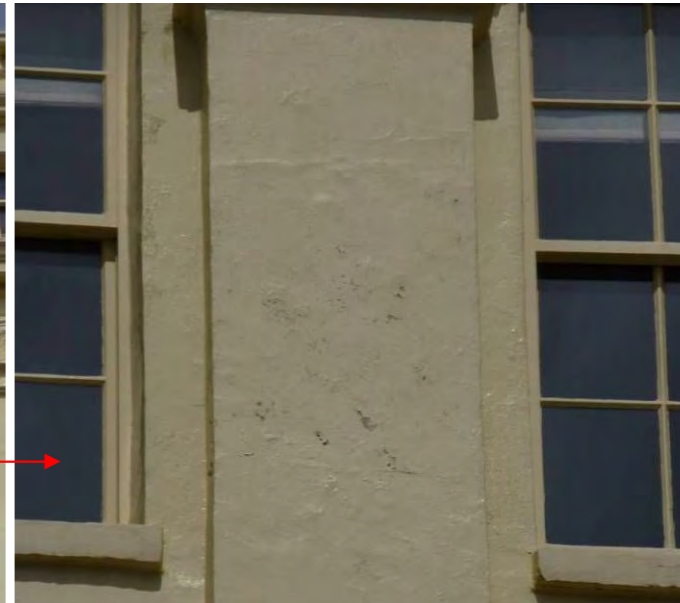
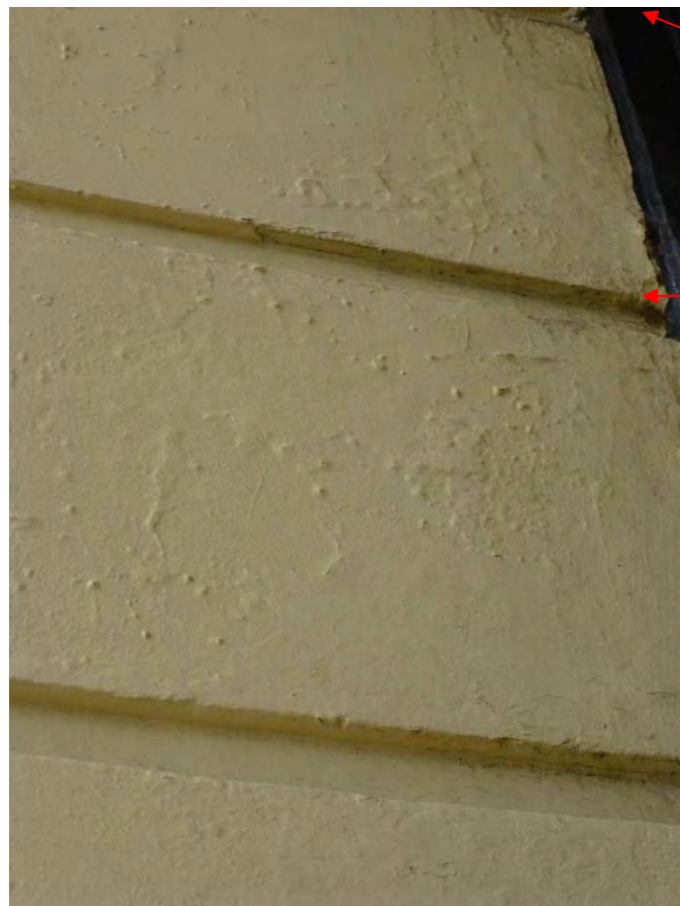
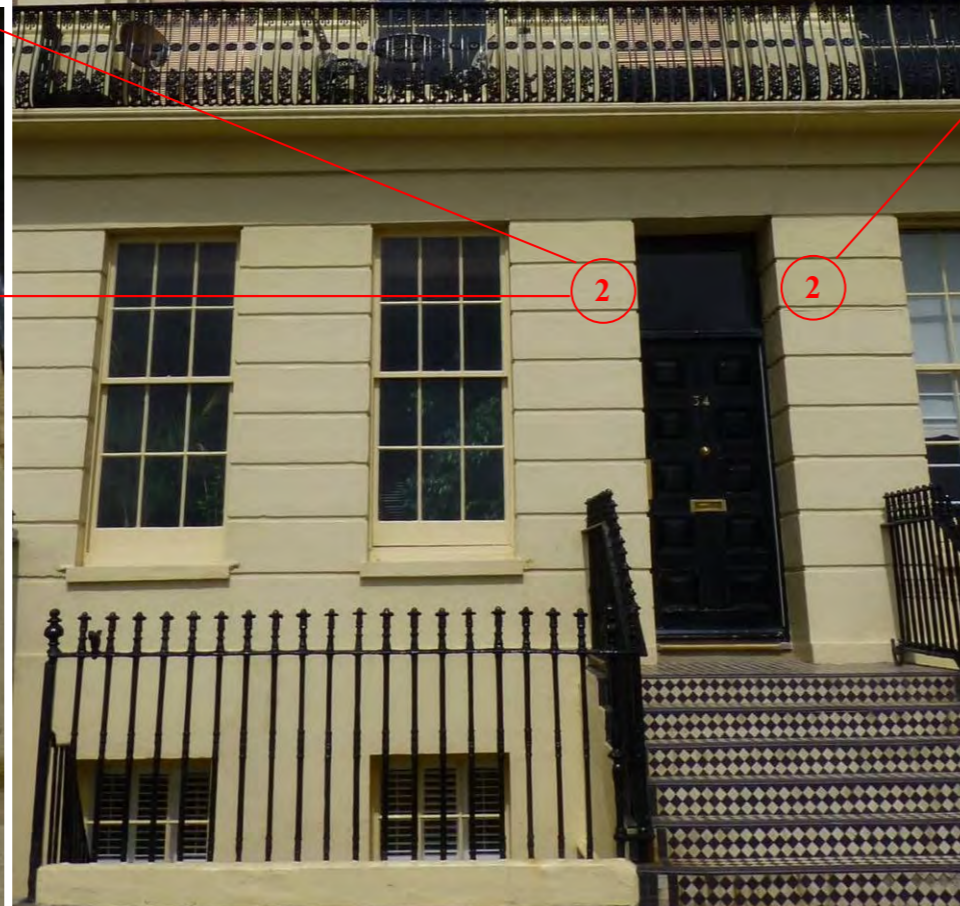
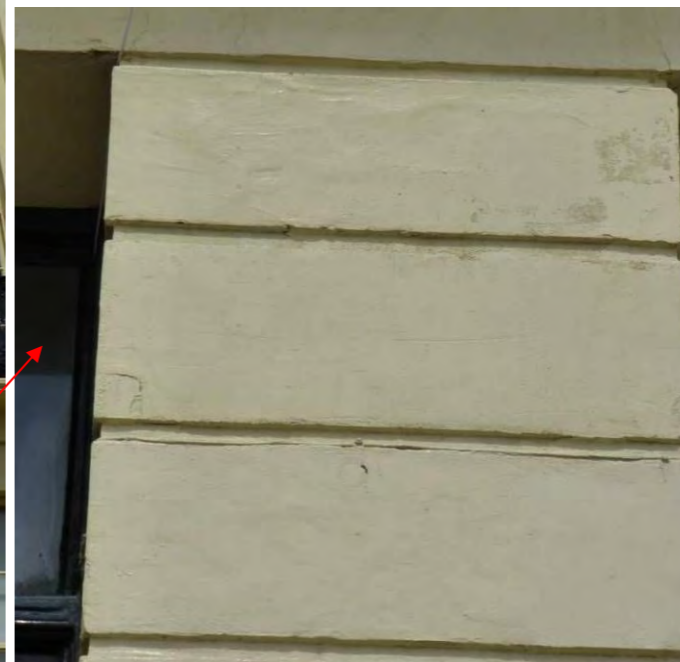
34 Brunswick Terrace

1. Uneven, salt-disrupted surface to central-right column with minor losses;
2. Salt-eruption, flaking and losses to entrance.

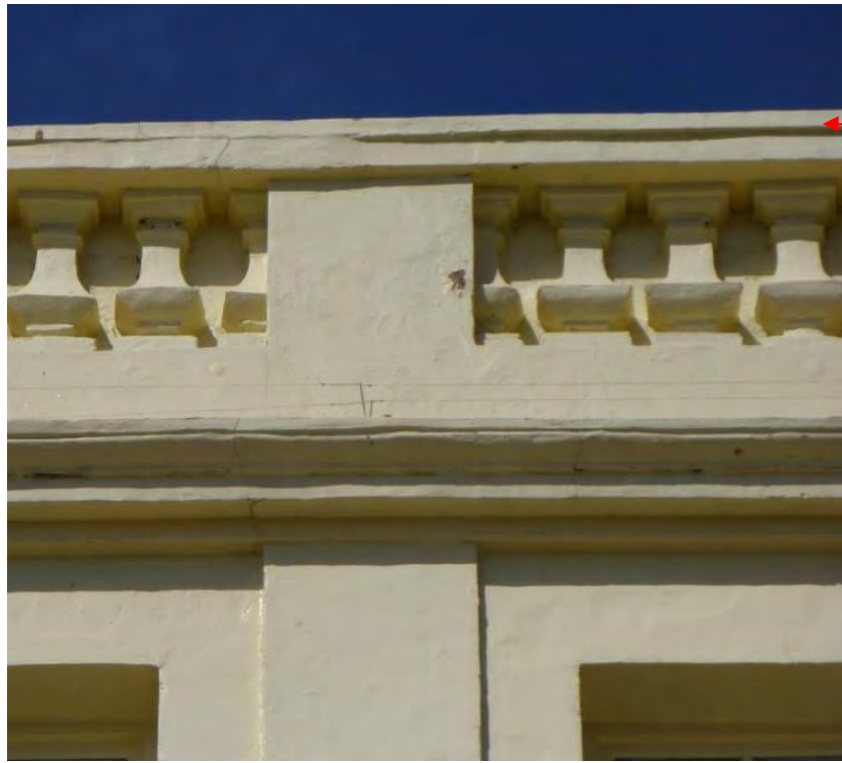
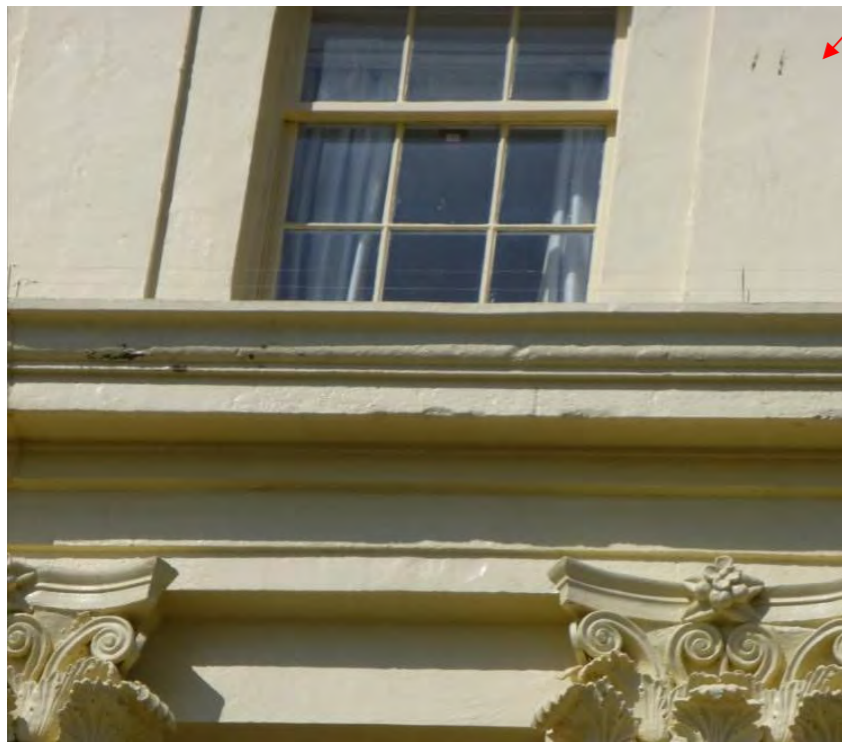
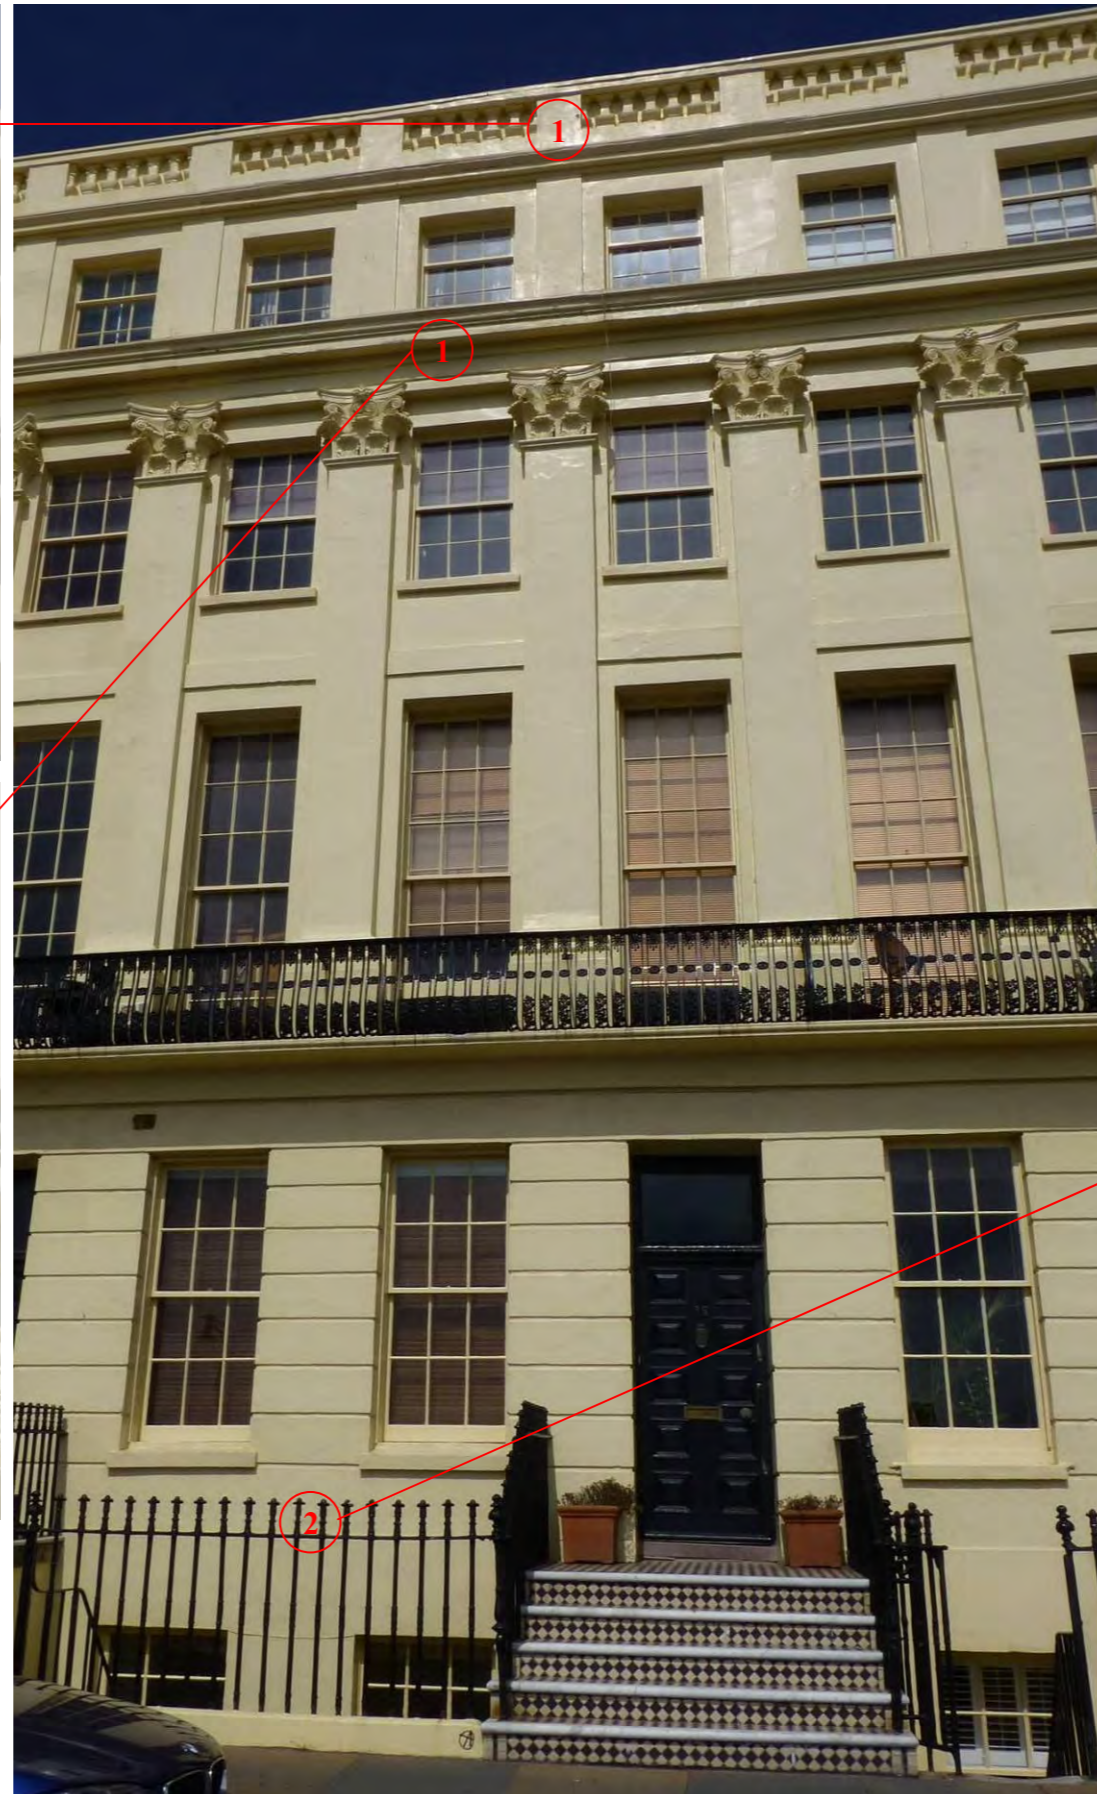
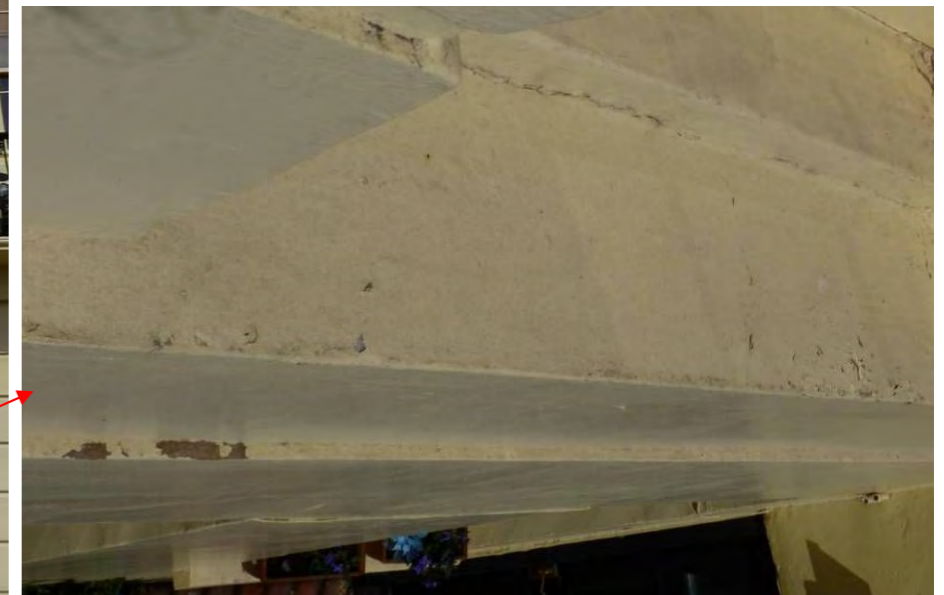
35 Brunswick Terrace

1. High level good with localised failures only;
2. Some failure to left-hand window to ground-floor;
3. Minor salting at mid-wall level between ground-floor and basement – paints appear thinner here.

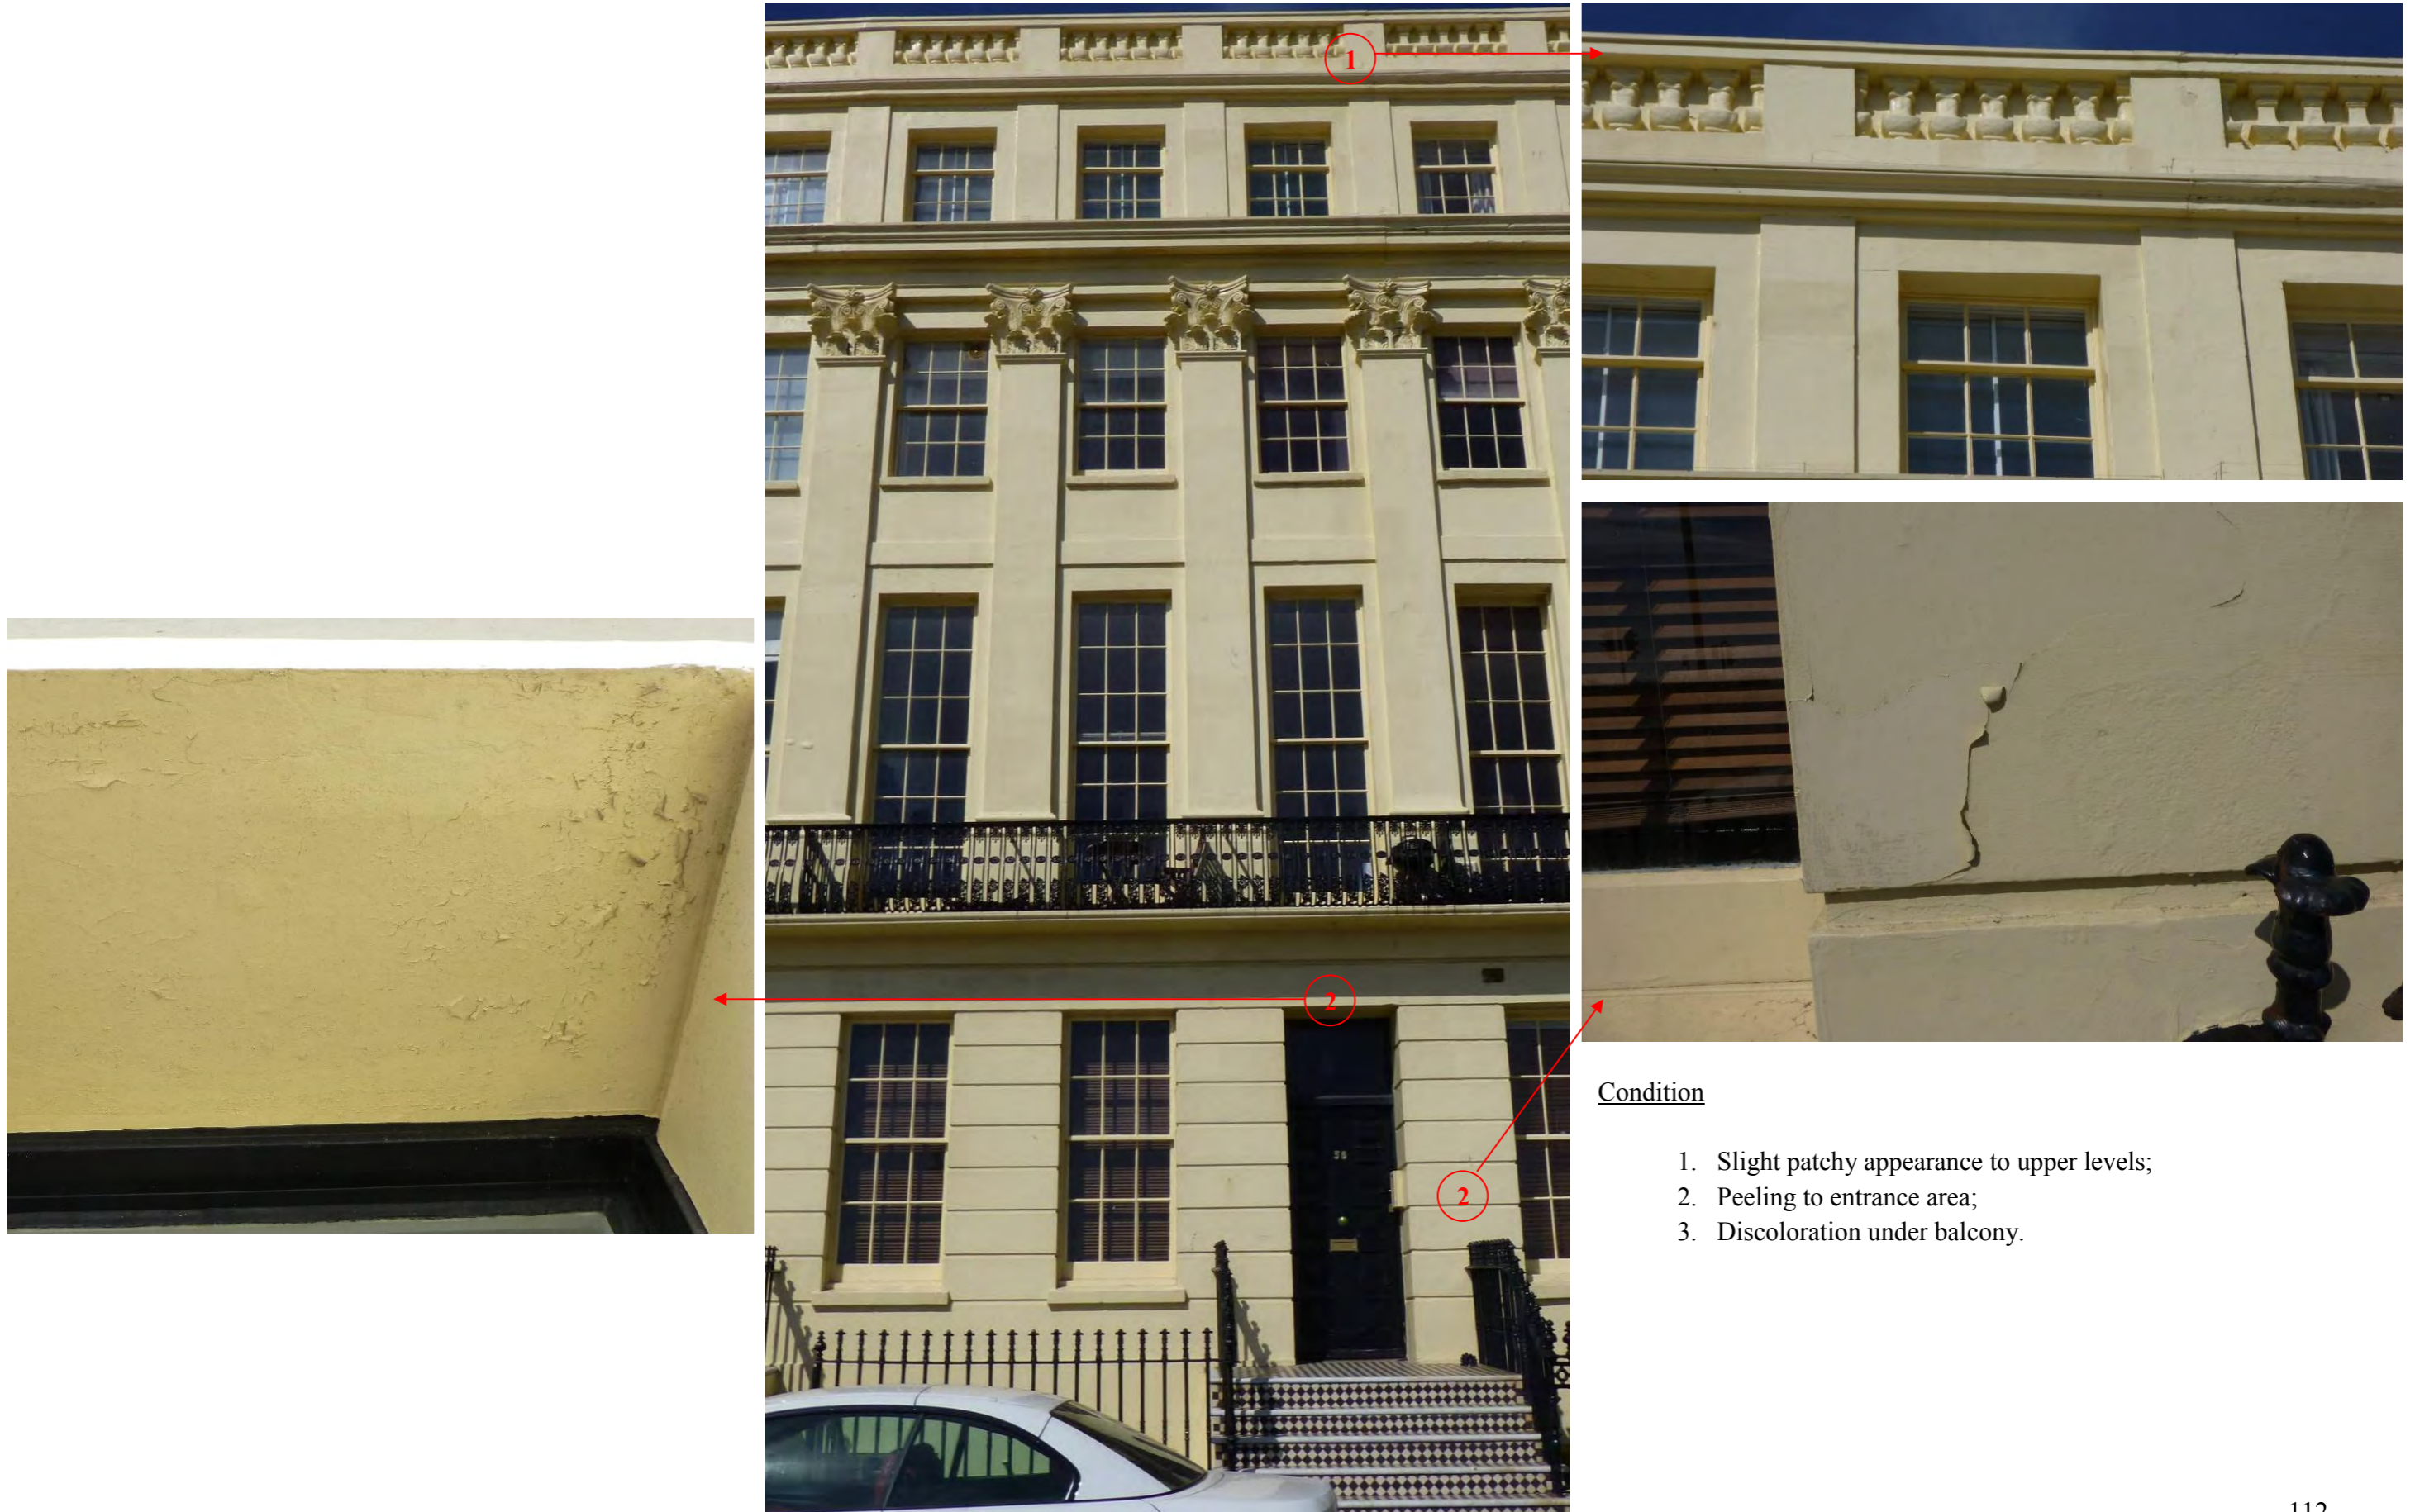
36 Brunswick Terrace

1. Slight patchy appearance to upper levels;
2. Peeling to entrance area;
3. Discoloration under balcony.

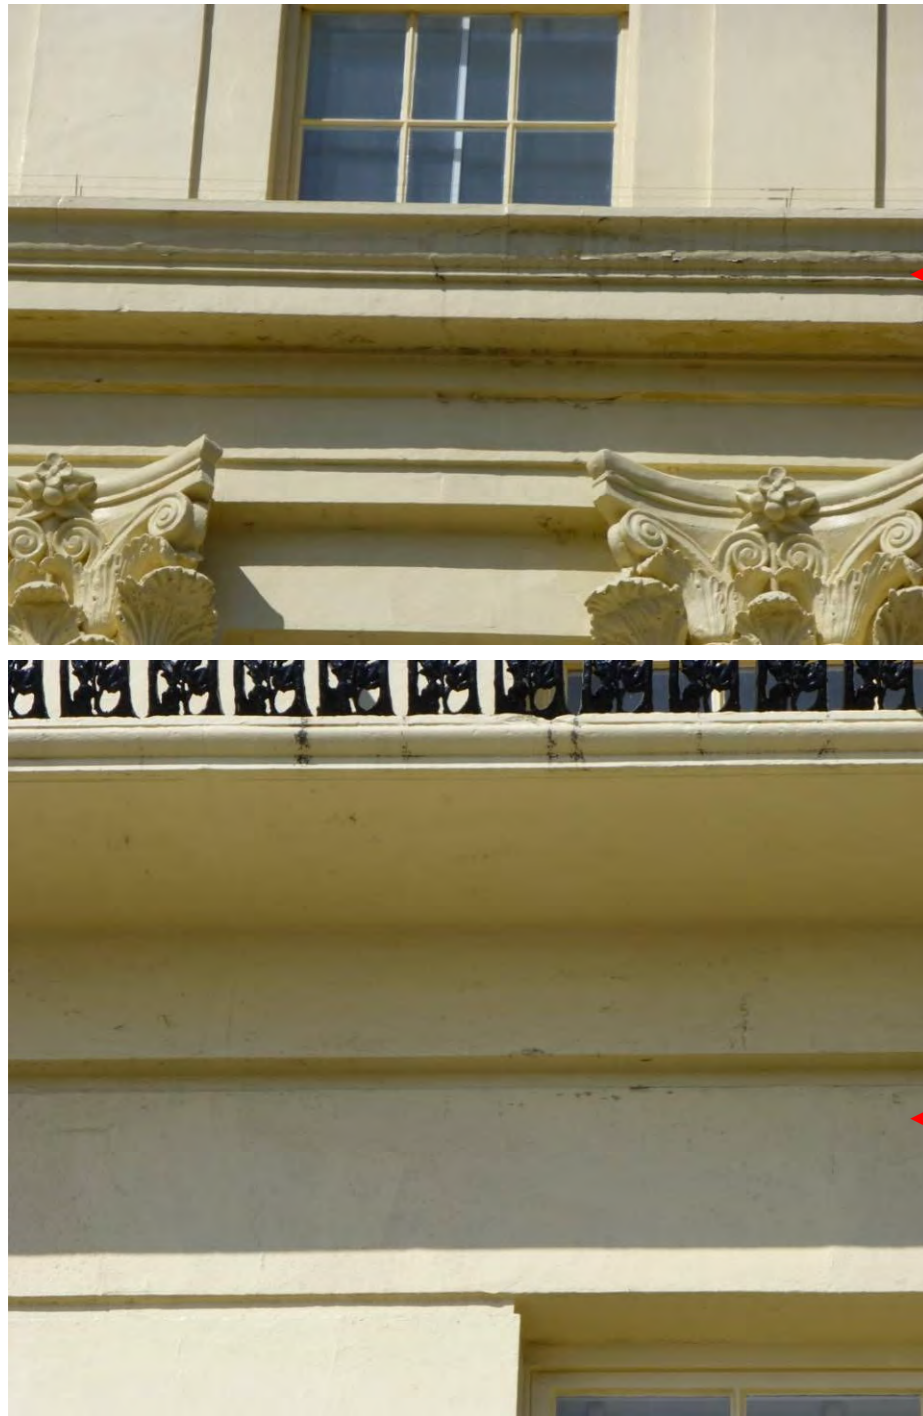
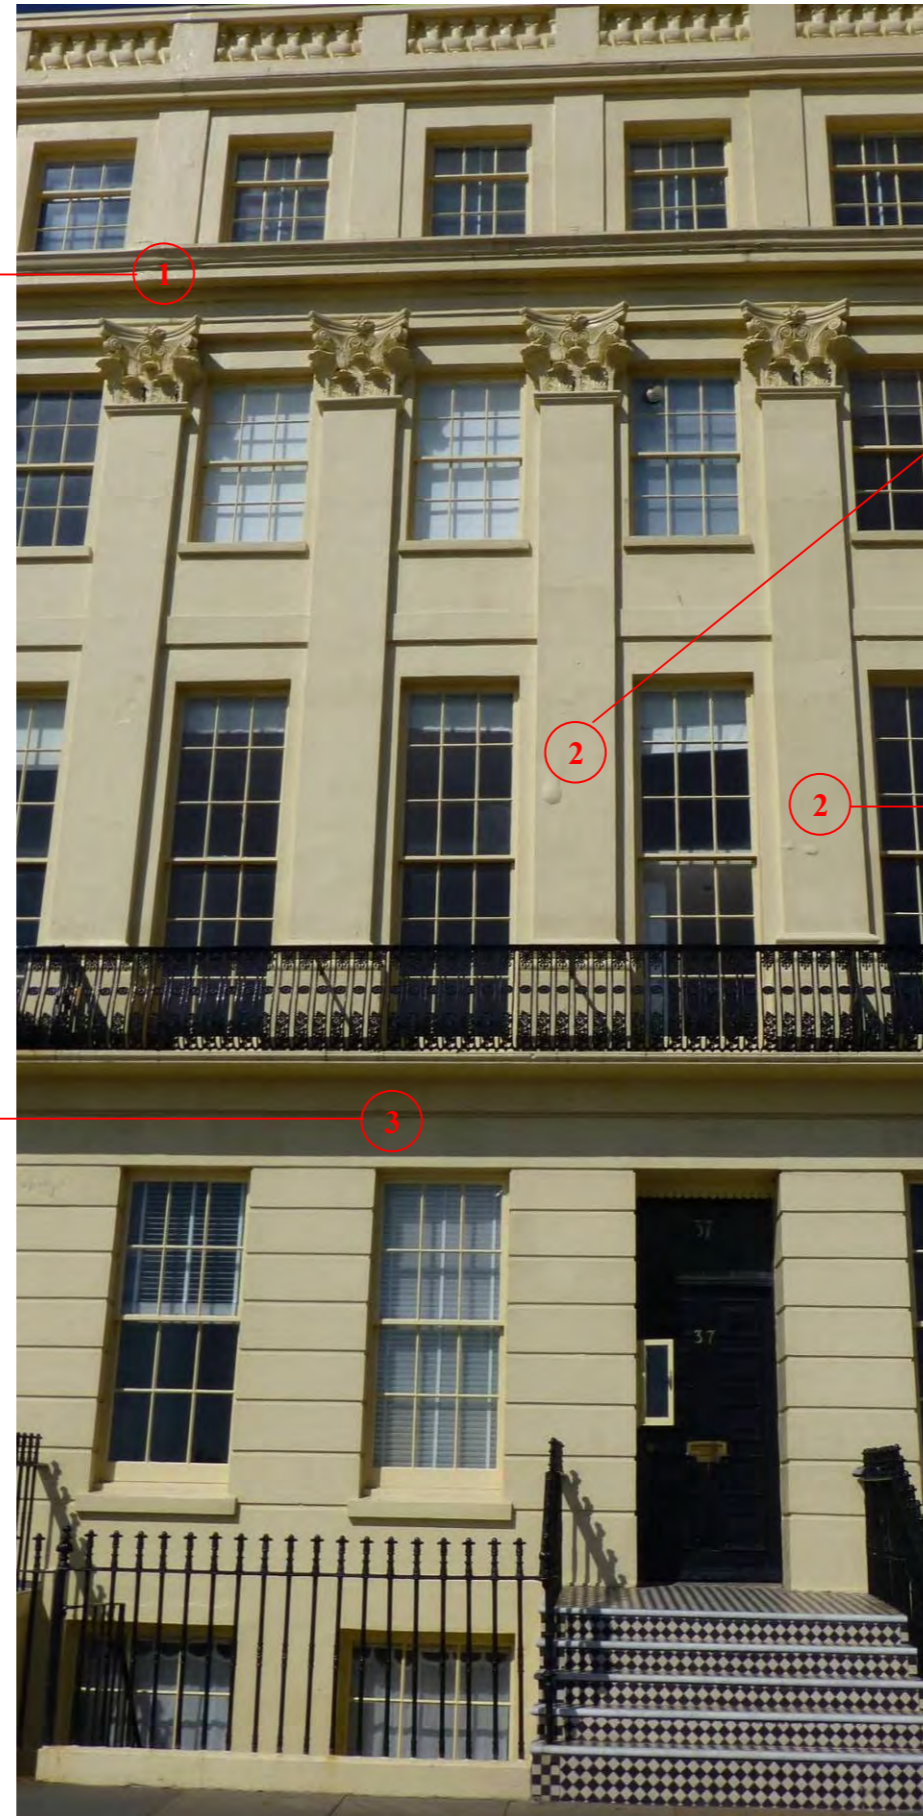
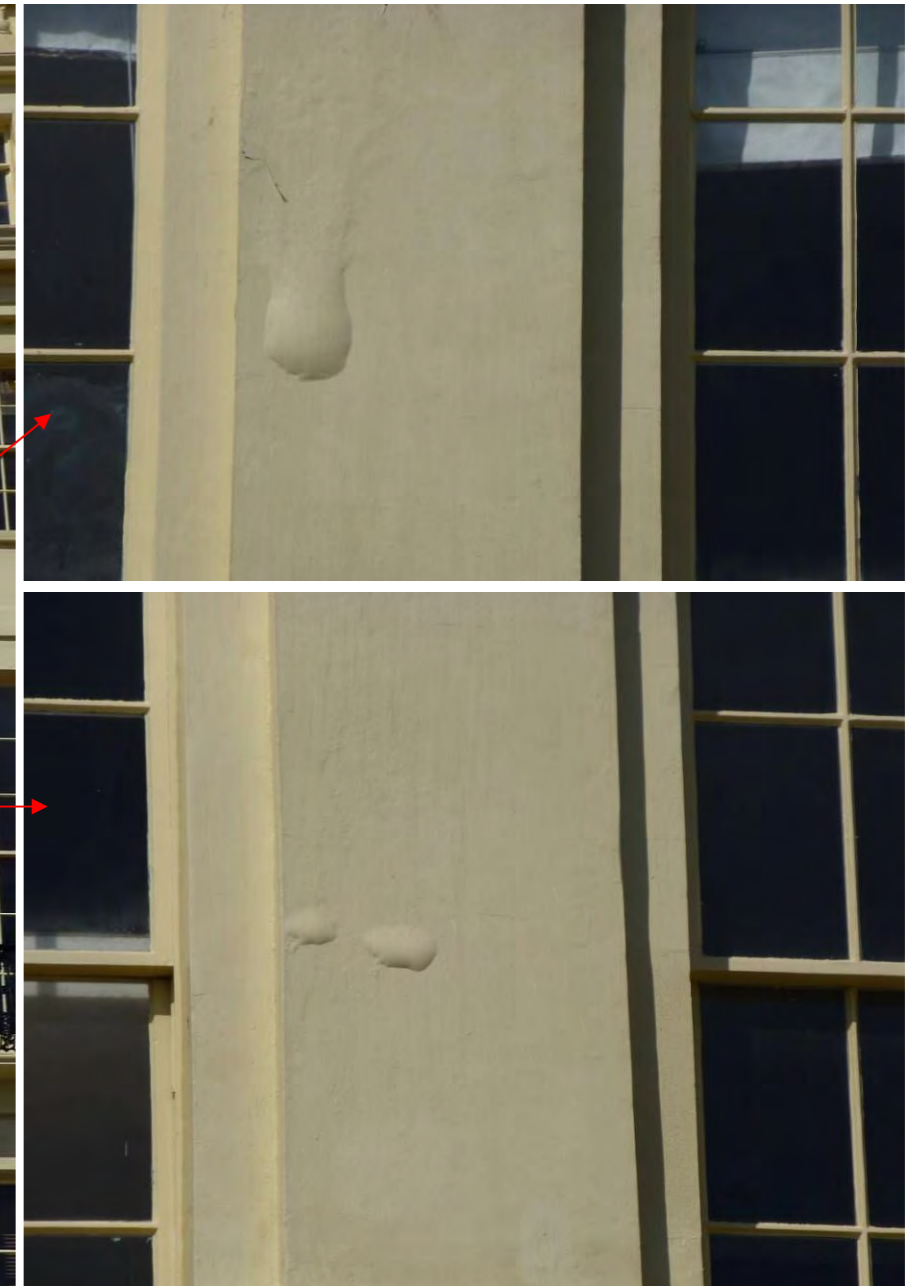
37 Brunswick Terrace

1. Localised failure to cornice over third and second-floor windows, relating to cracks within substrate;
2. Two large blisters to mid-wall on first floor – failure imminent;
3. Minor failing to underside of balcony.

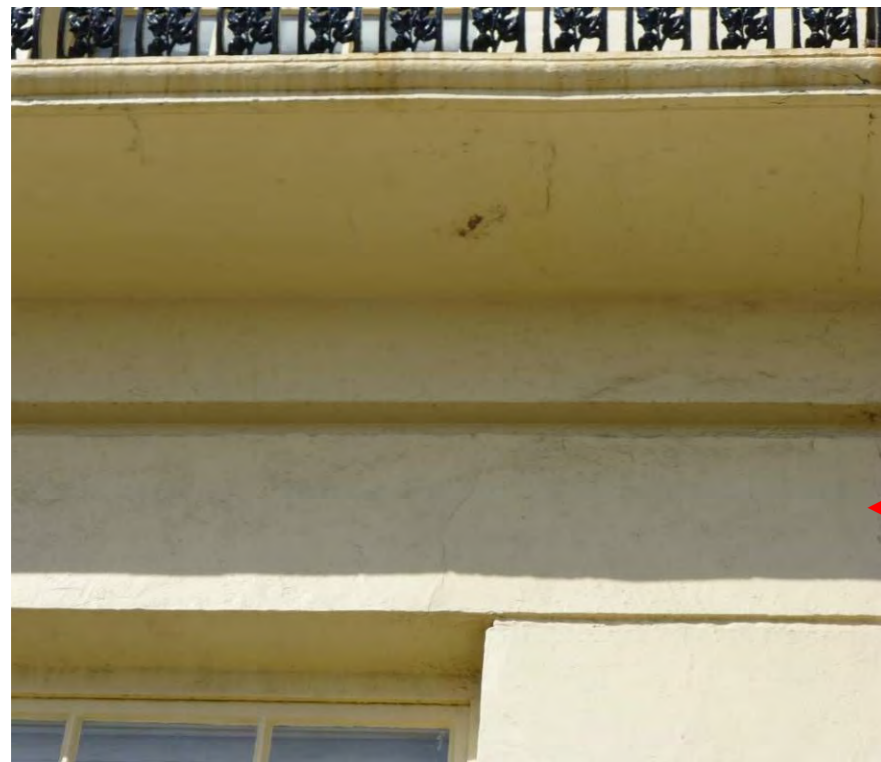
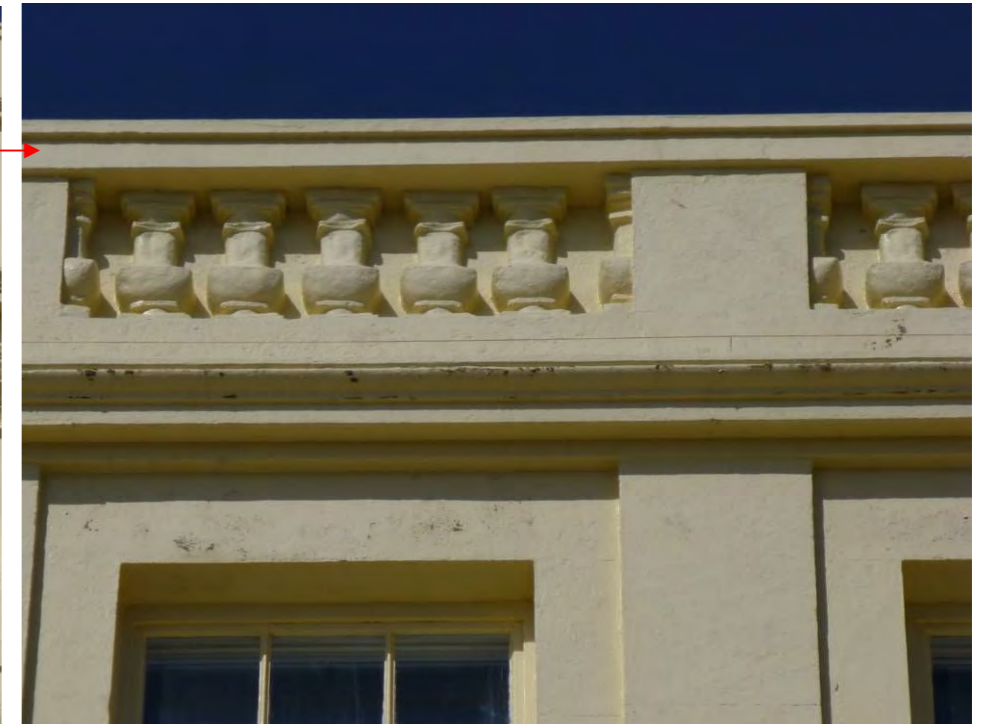
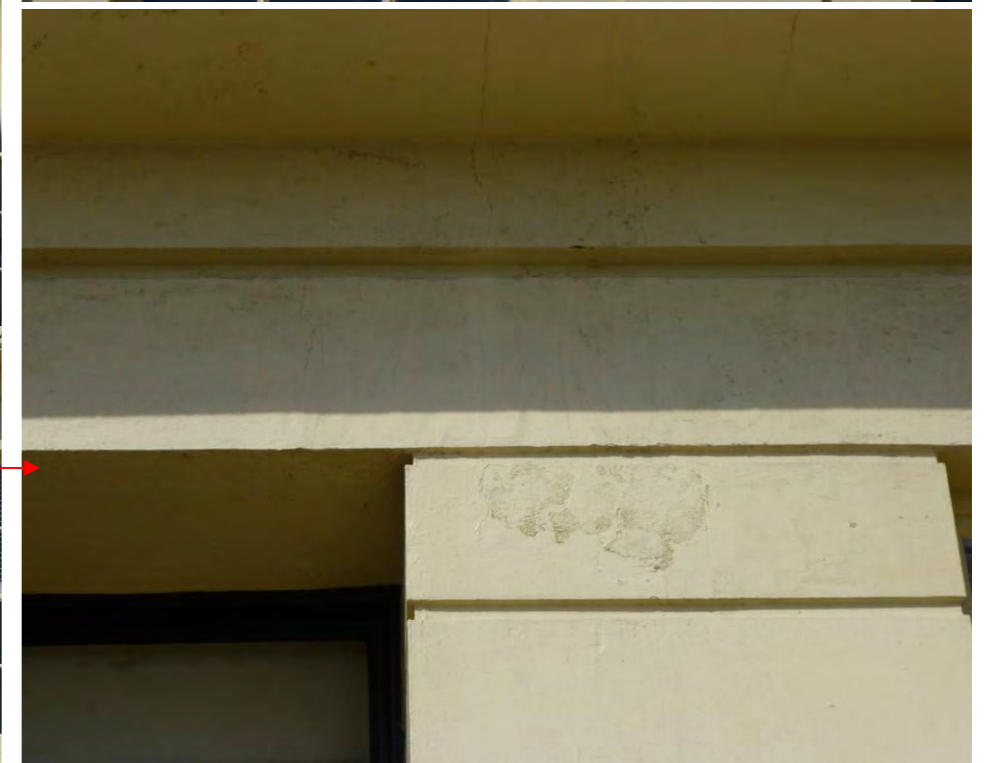
38 Brunswick Terrace

1. Failure at high-level cornice below balustrade and extending to wall below;
2. Very minor staining and substrate cracking to underside of balcony;
3. Isolated salt-eruption to top right-hand corner of entrance.
