**Investigation of Paint Failure at
Brunswick Estate
Hove
Brighton**

August 2013

**BRUNSWICK ESTATE
HOVE**

The following document investigates the failure of the external paint-system at Brunswick Estate, Hove based on research carried out by Elizabeth Hirst and Rachel Morley of Hirst Conservation between August and November 2013. The work was commissioned by Brighton & Hove City Council.

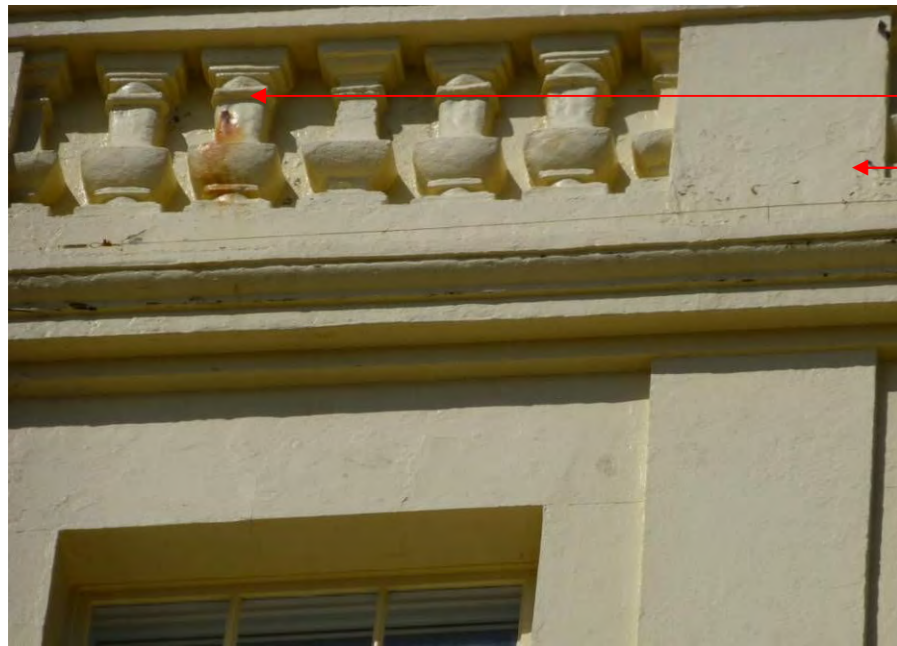
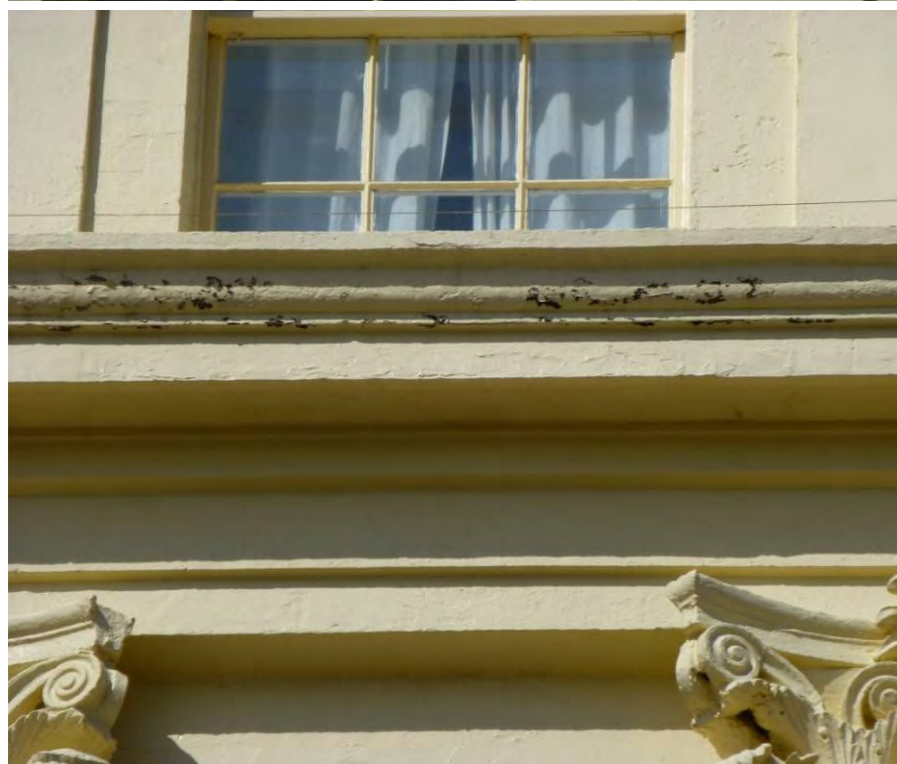
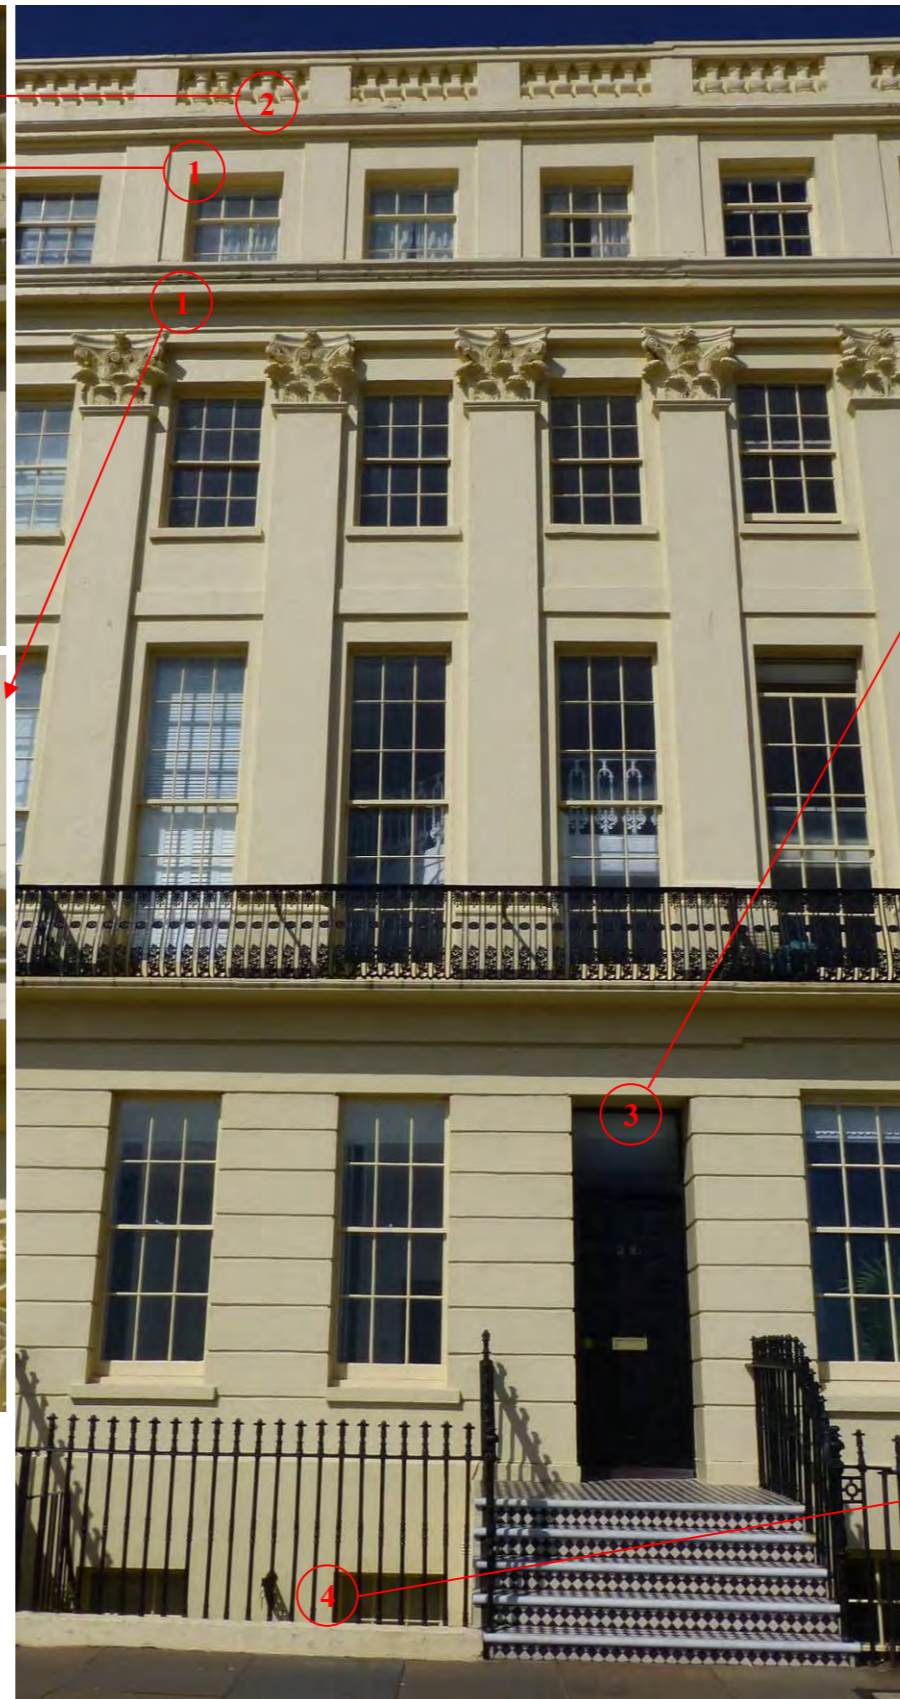
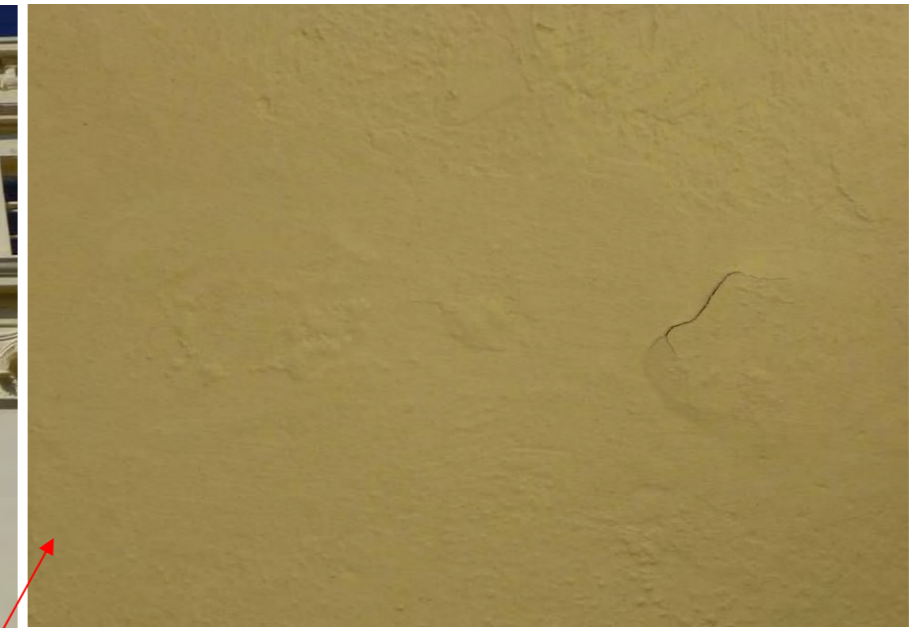
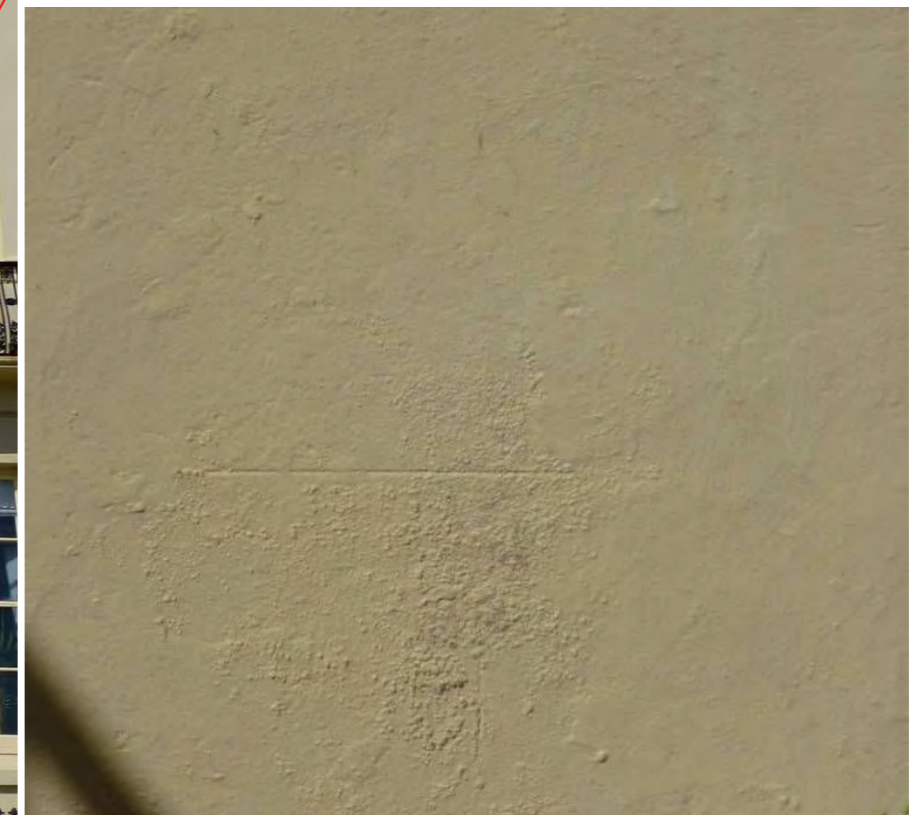
39 Brunswick Terrace

1. Localised failure at high-level within balustrade;
2. Large area of rust staining due to fixing within balustrade;
3. Noticeable fractures within cornice;
4. Salt blistering and flaking to underside of doorway;
5. Some salt eruptions to basement level.

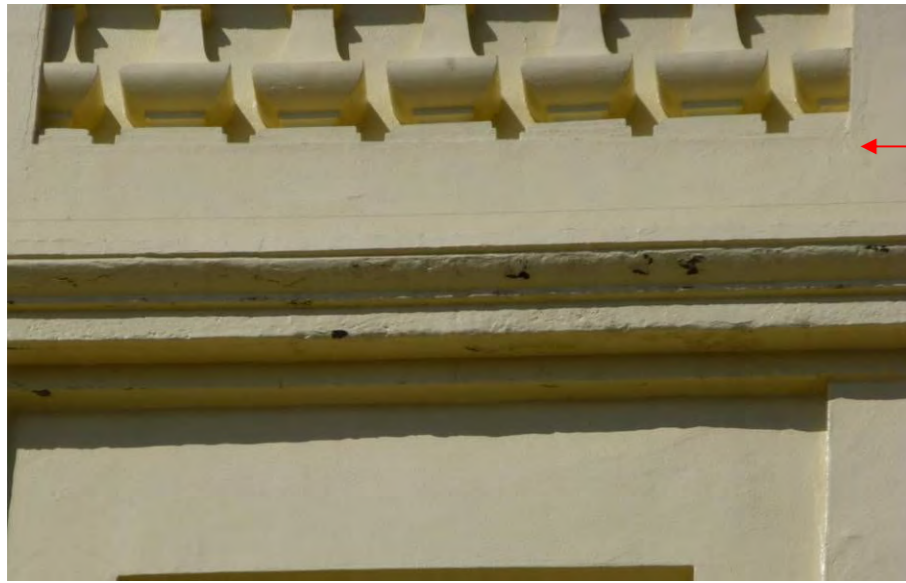
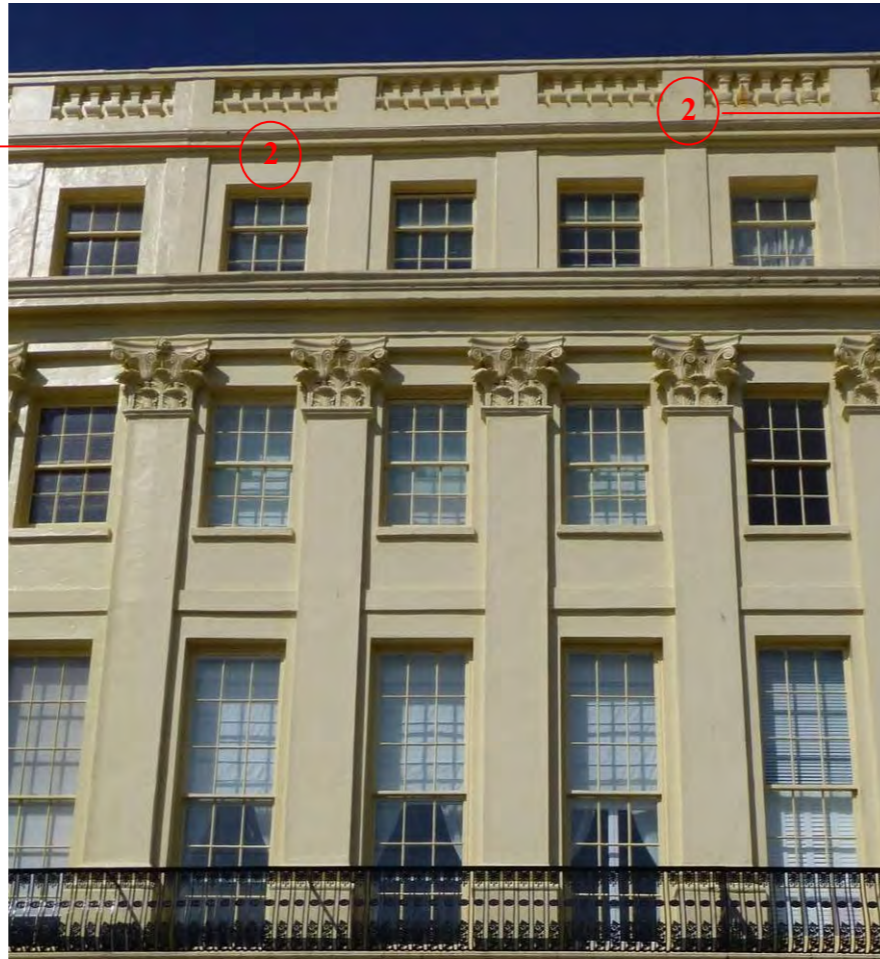
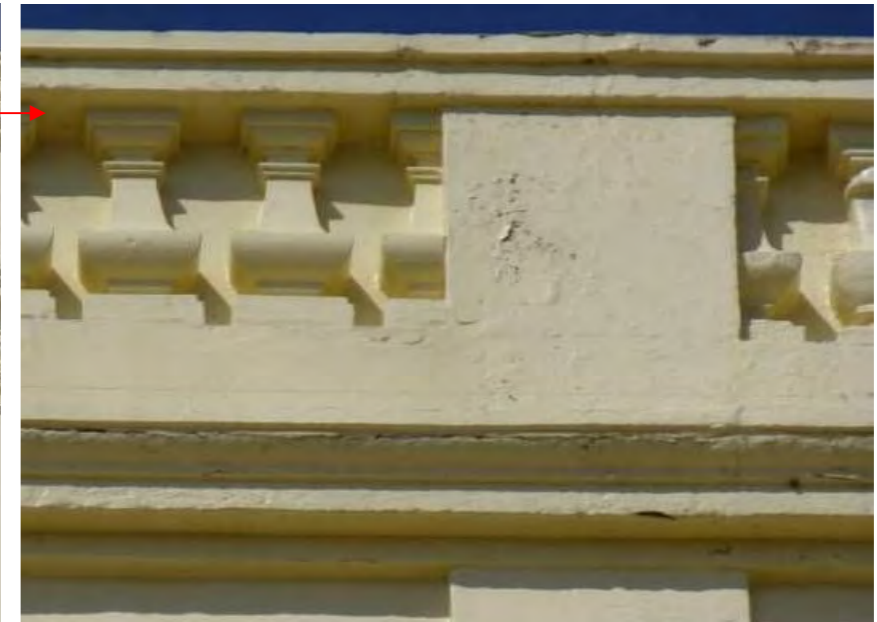
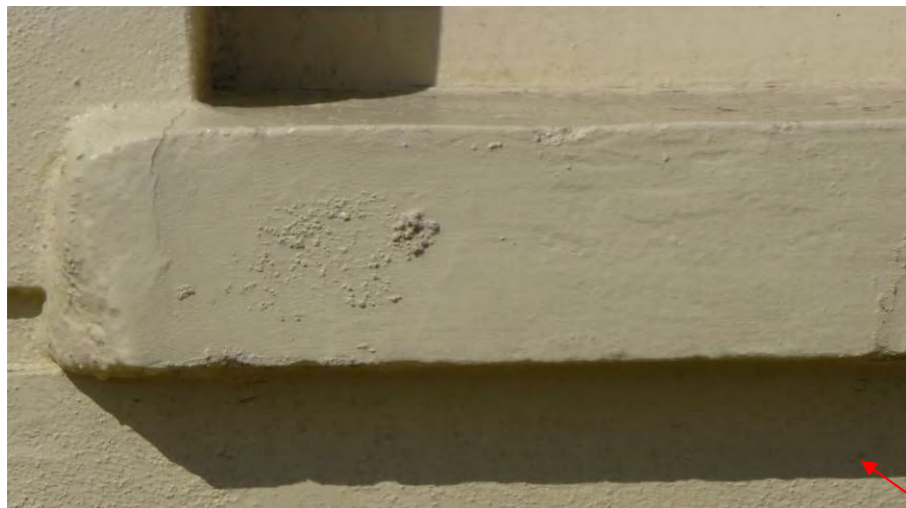
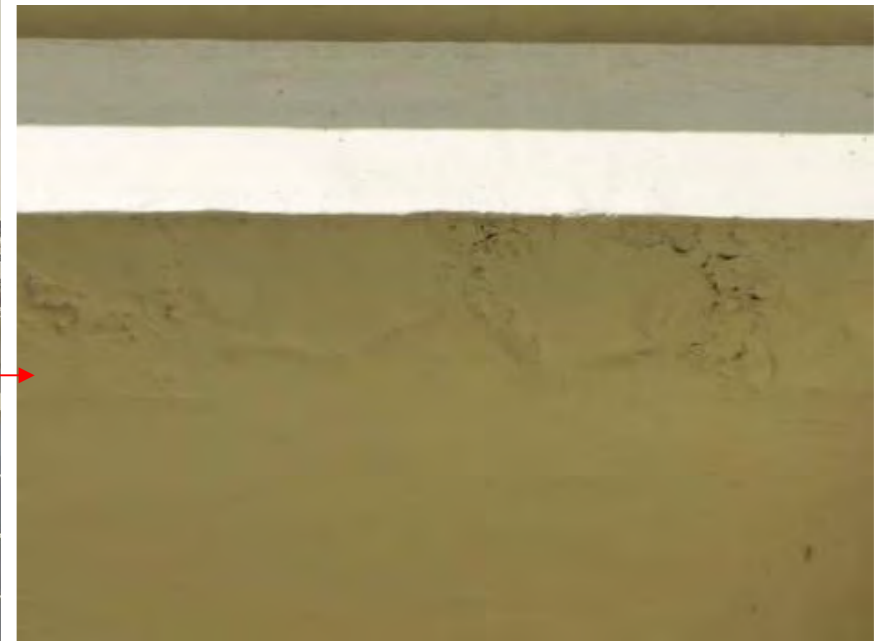
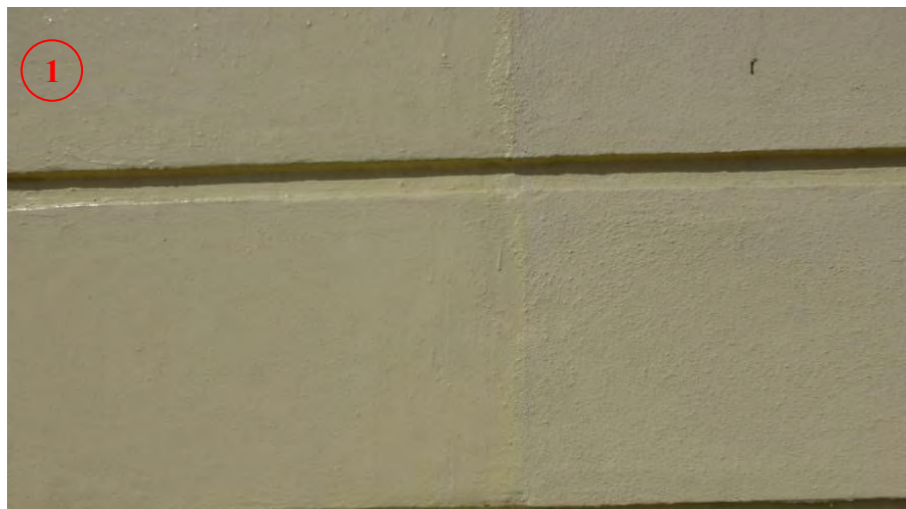
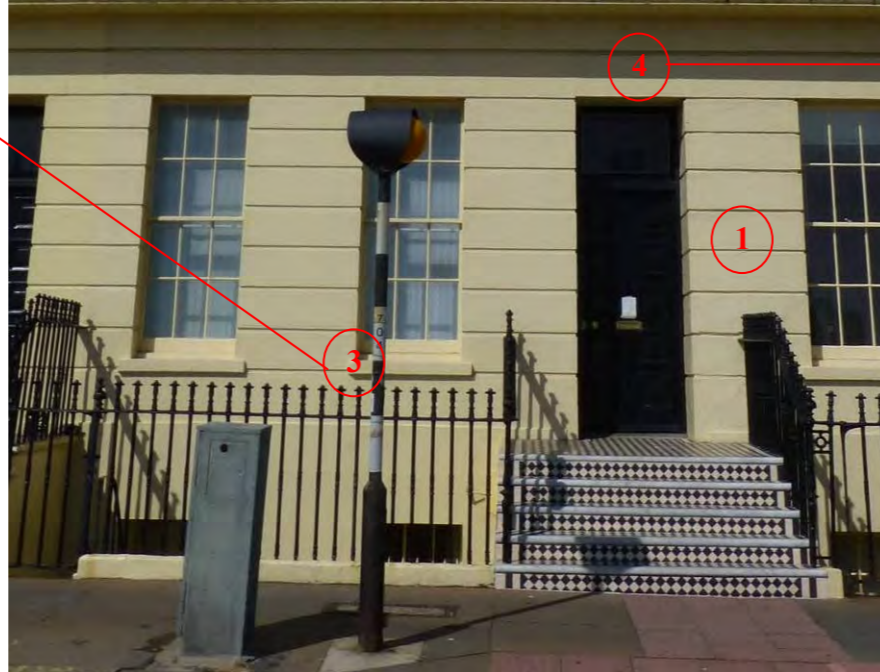
40 Brunswick Terrace

1. Different colour and finish to adjacent property 39;
2. Localised failure at high-level;
3. Salt-disrupted surface and flaking to ground-floor rustications;
4. Paint has delaminated to underside of doorway.

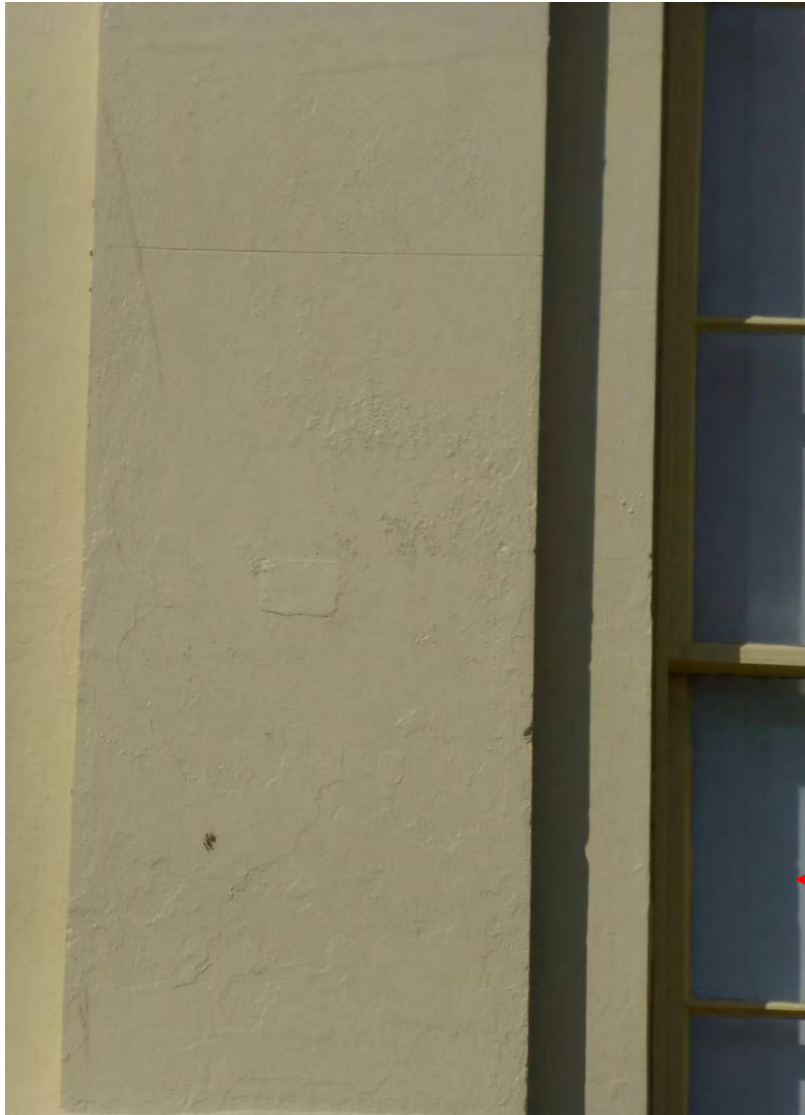
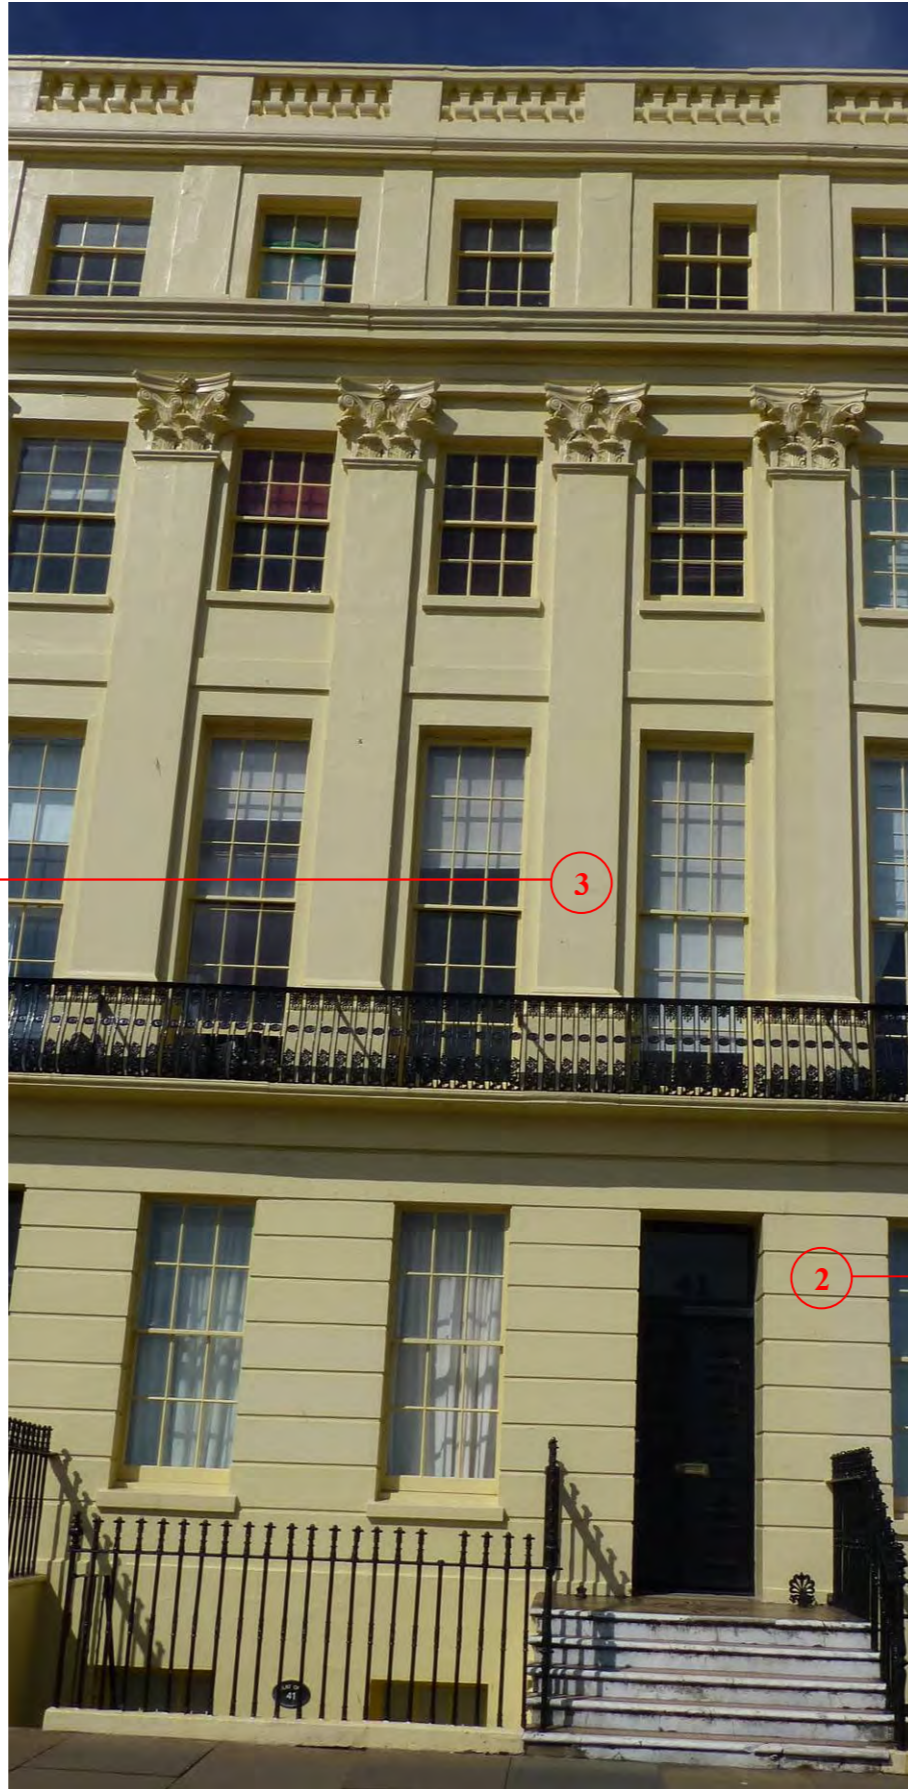
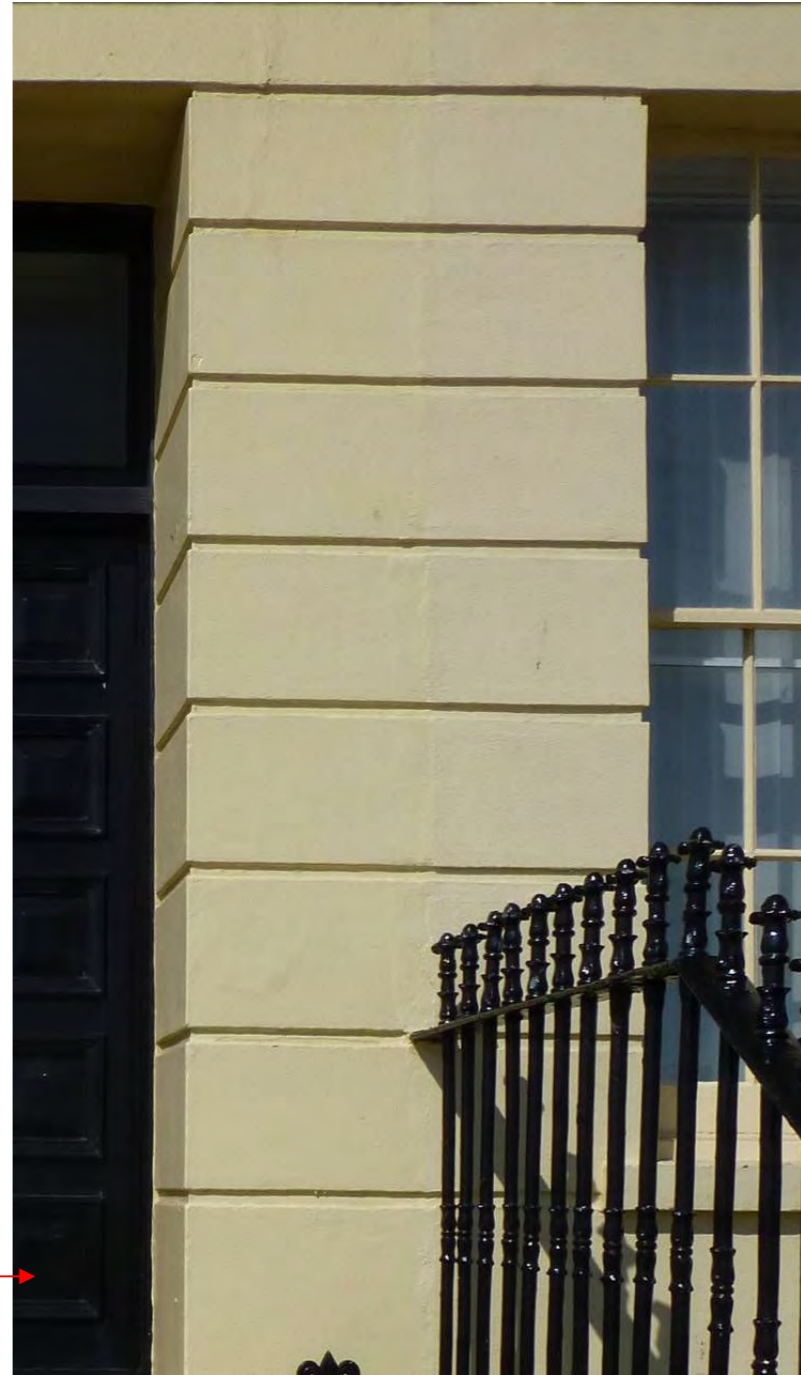
41 Brunswick Terrace

1. Possibly painted recently, excellent condition overall;
2. Different colour and finish to adjacent property 40;
3. Localised areas of uneven surface.

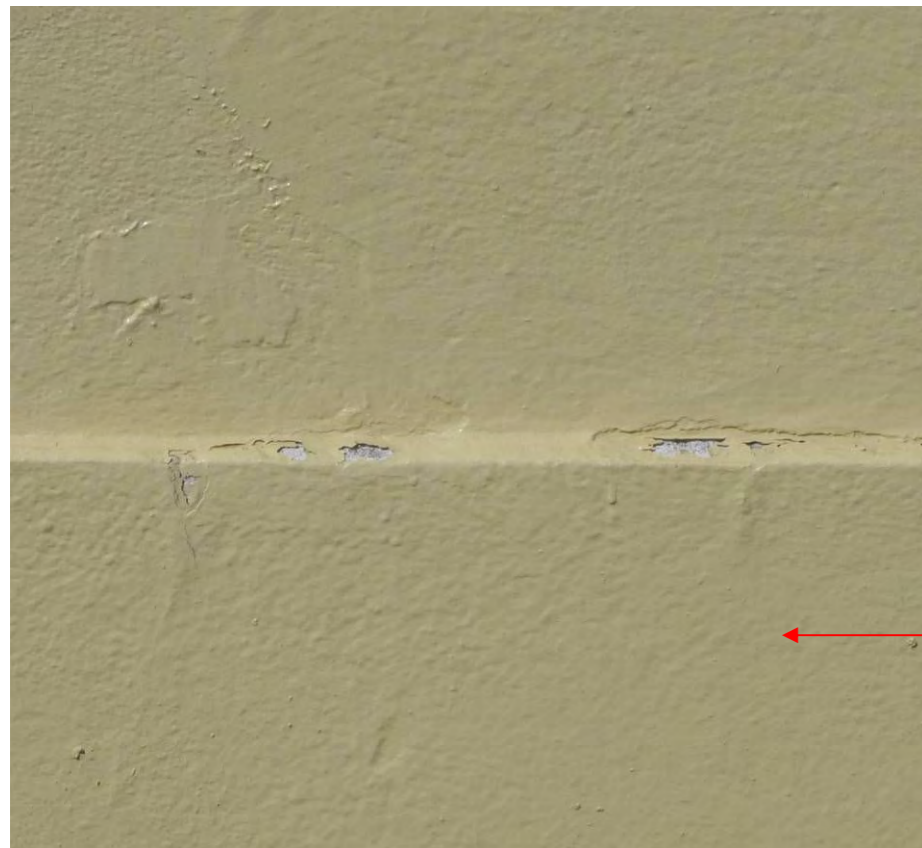
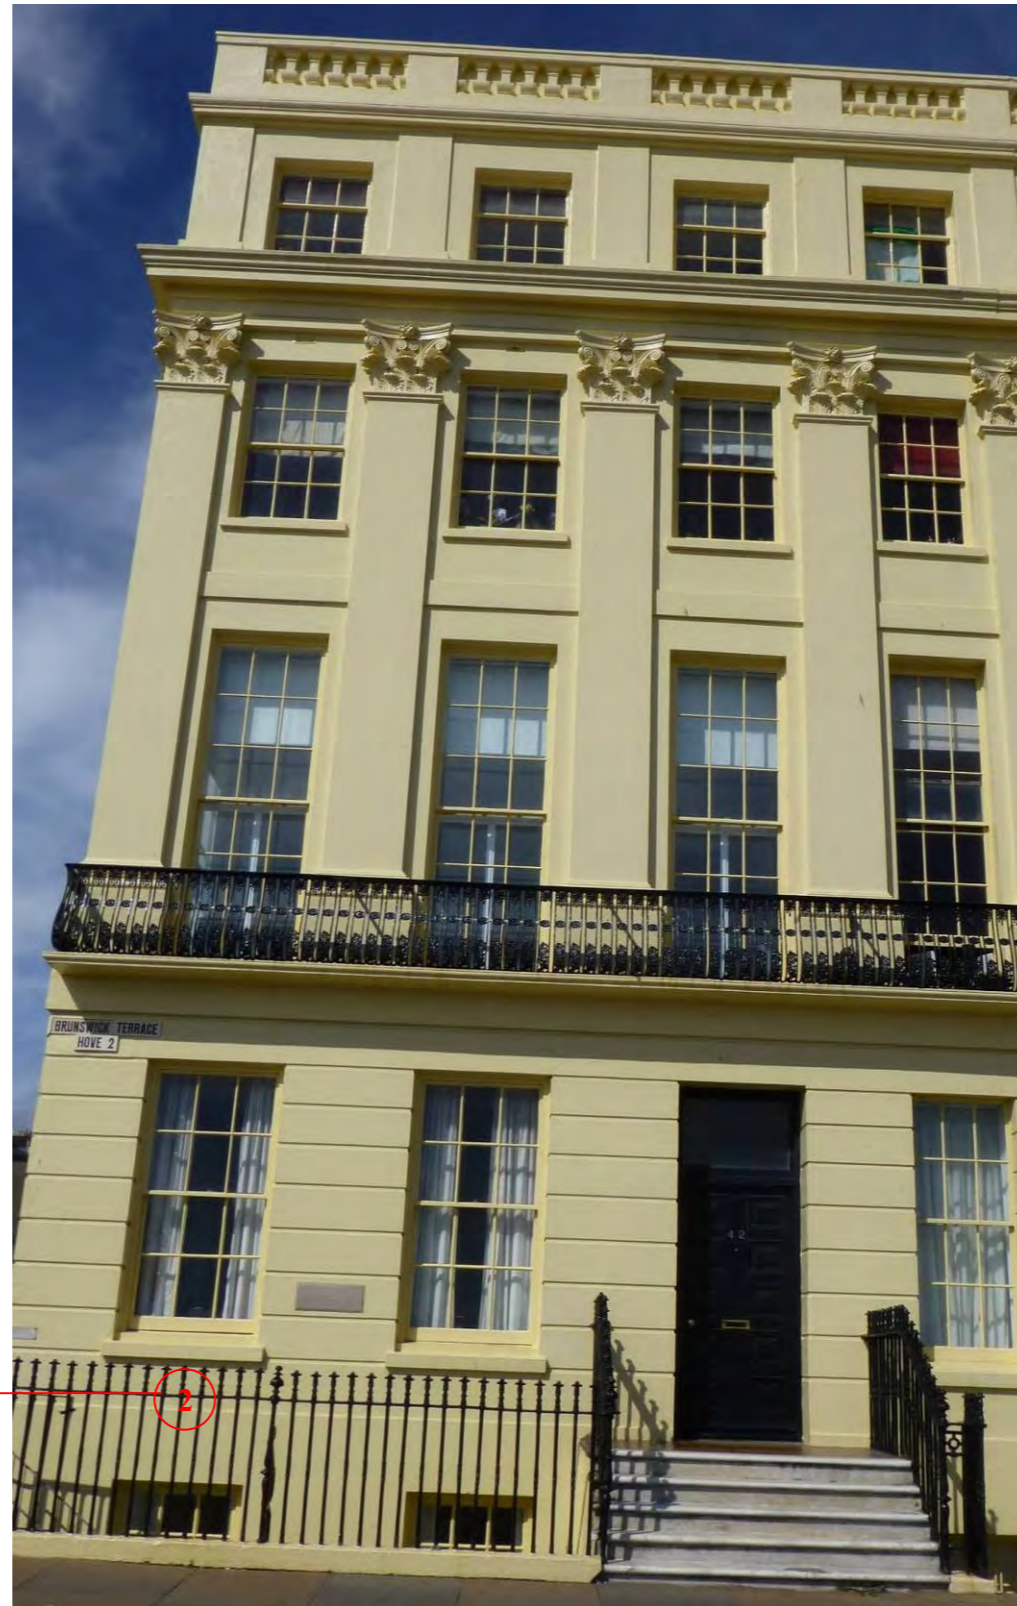
42 Brunswick Terrace (Brunswick Terrace Elevation)

1. Possibly recently decorated, excellent condition overall;
2. One isolated area of flaking to ground-floor rustication.

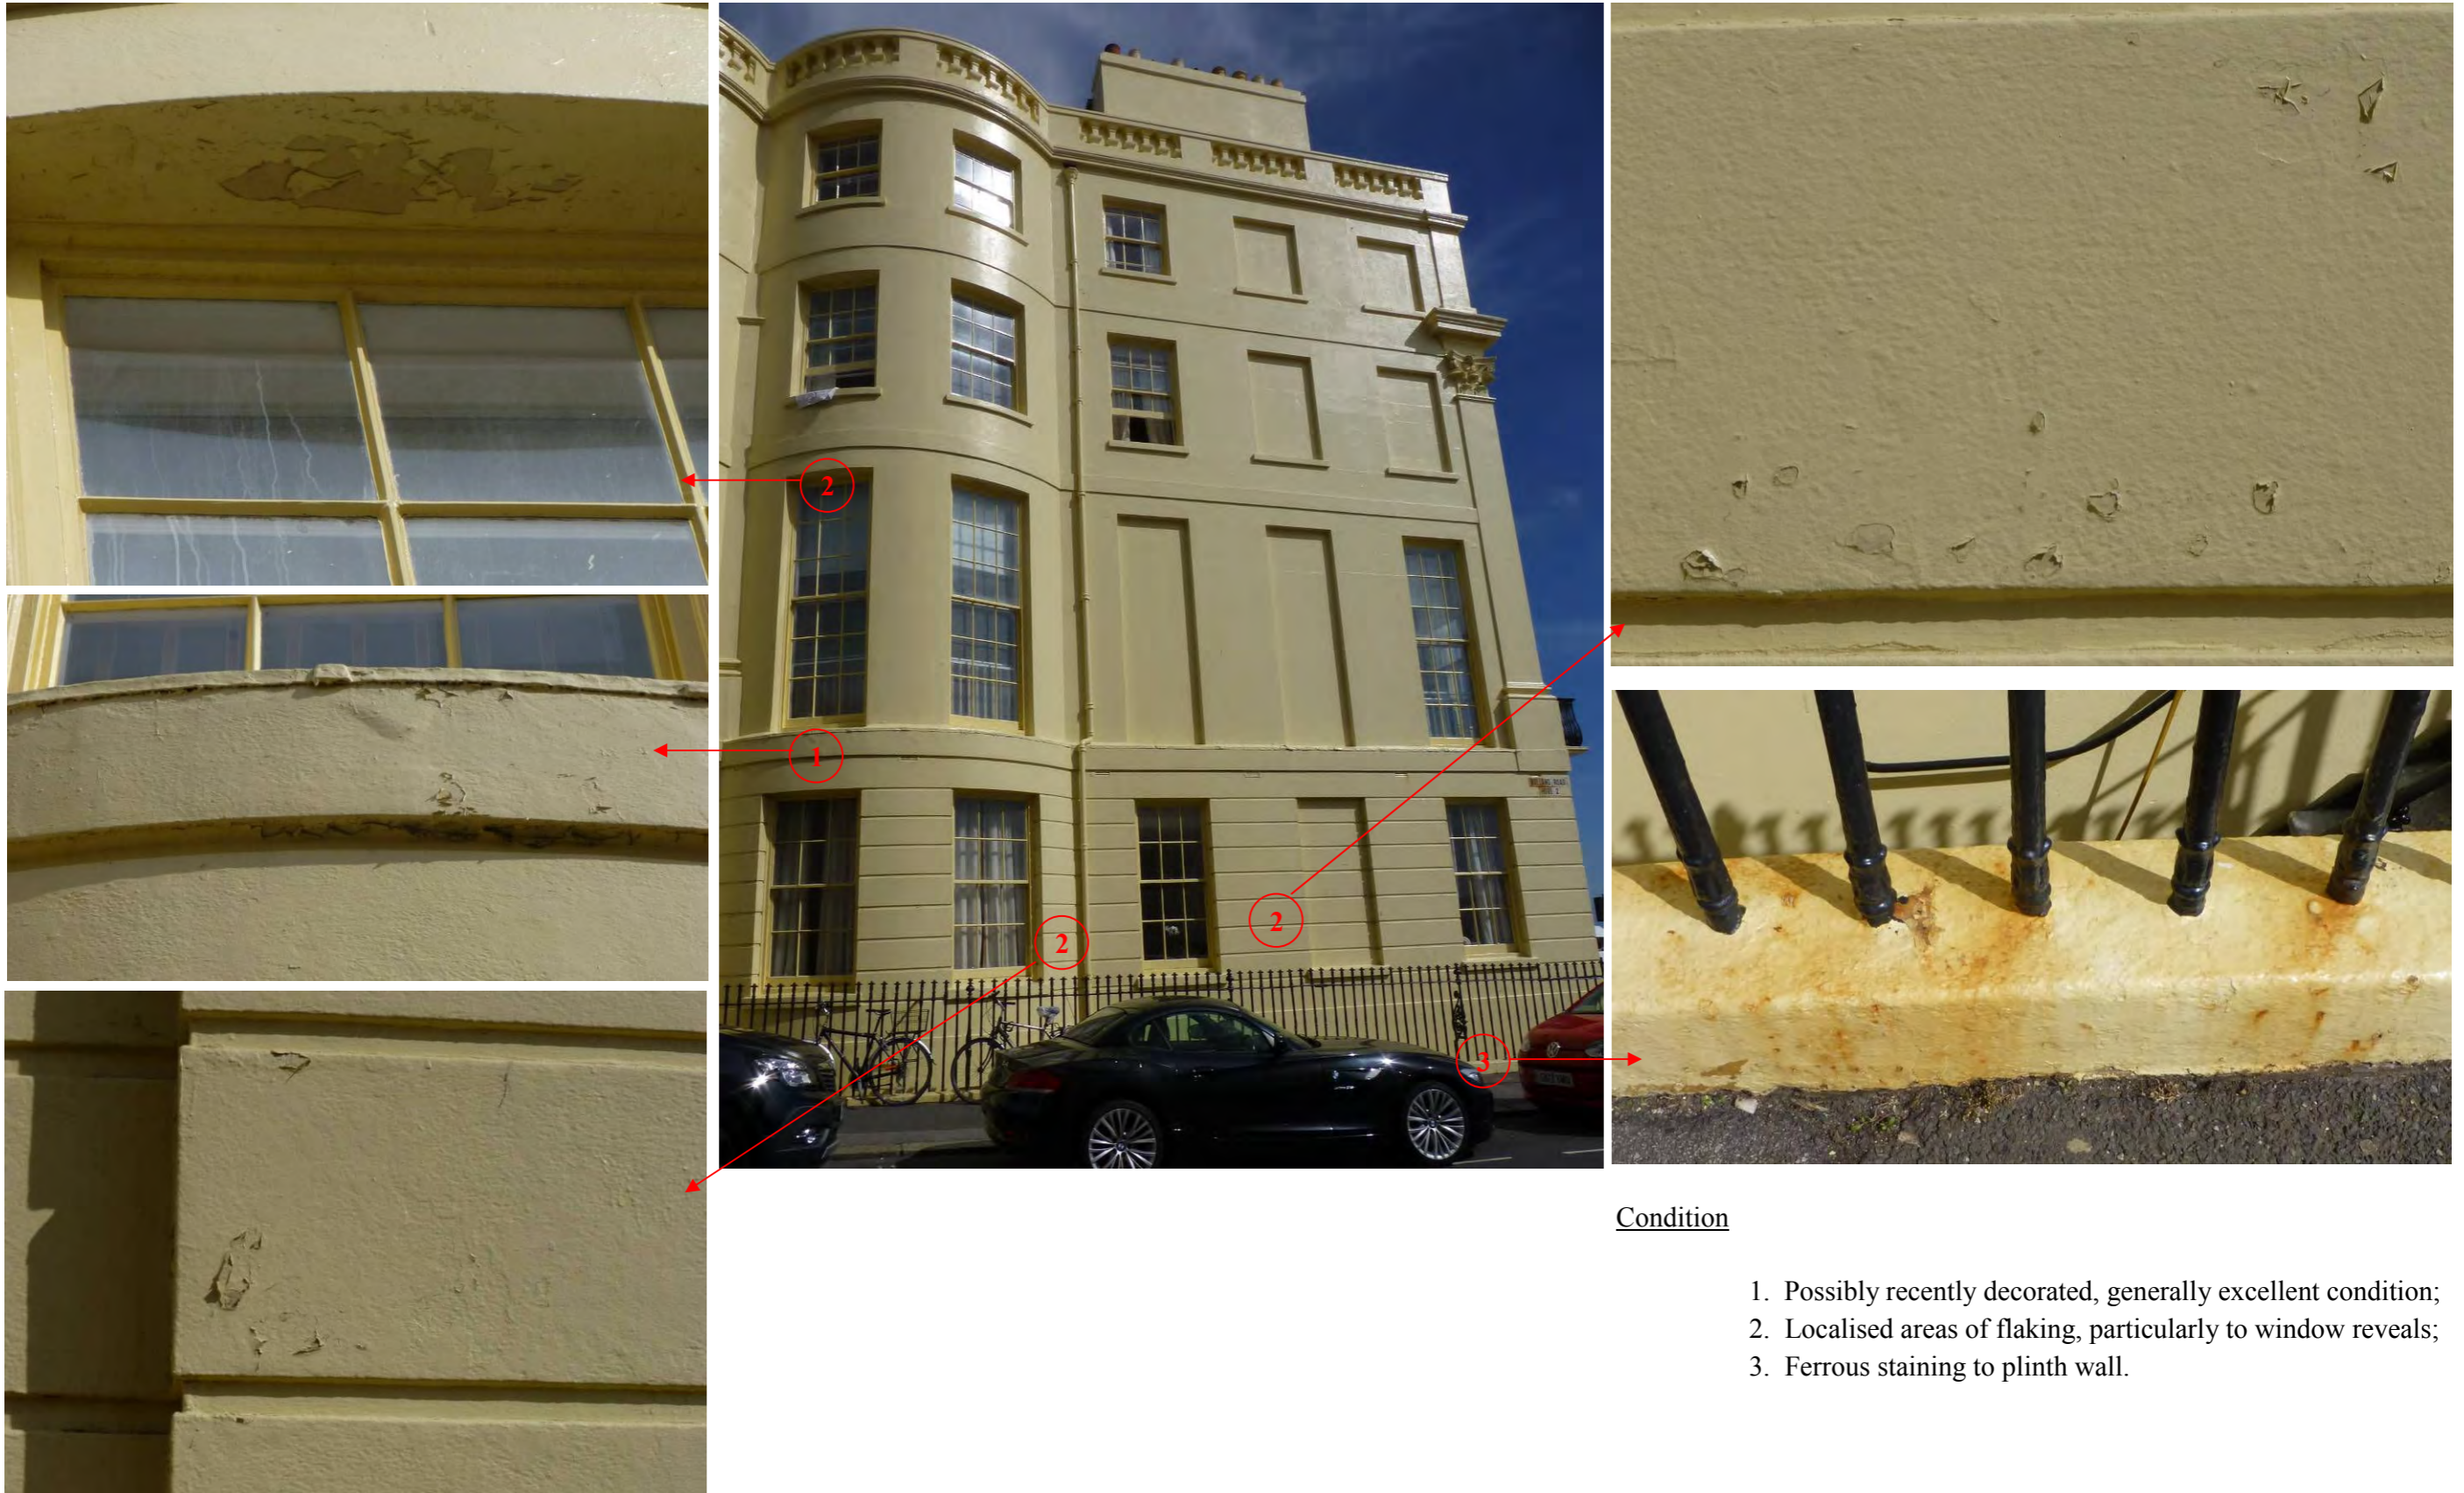
42 Brunswick Terrace (Holland Road Elevation)

1. Possibly recently decorated, generally excellent condition;
2. Localised areas of flaking, particularly to window reveals;
3. Ferrous staining to plinth wall.

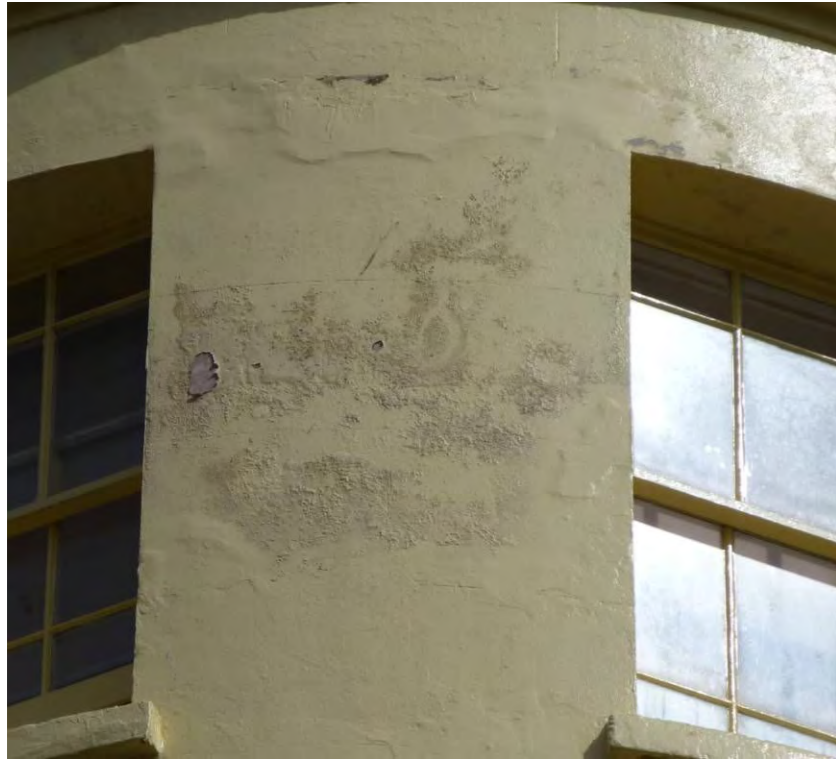
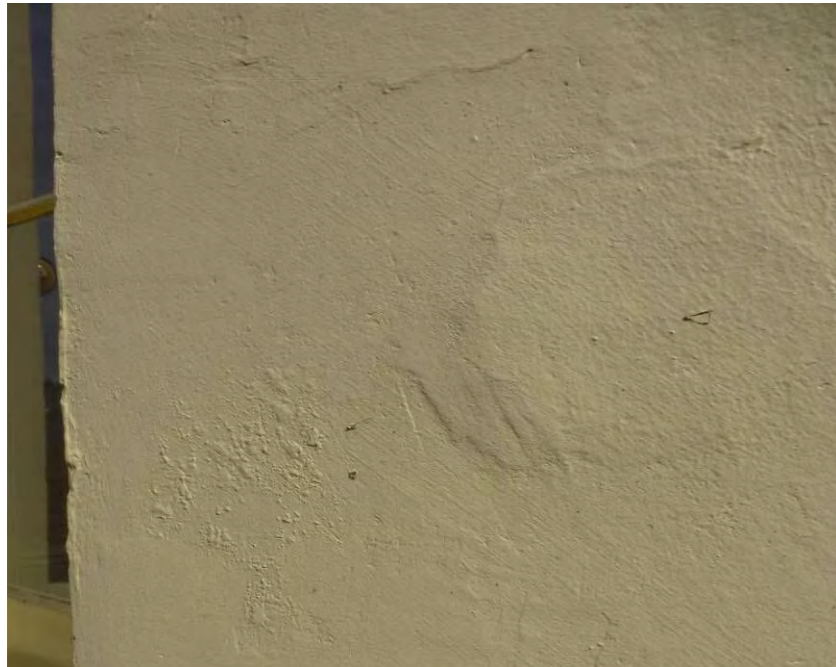
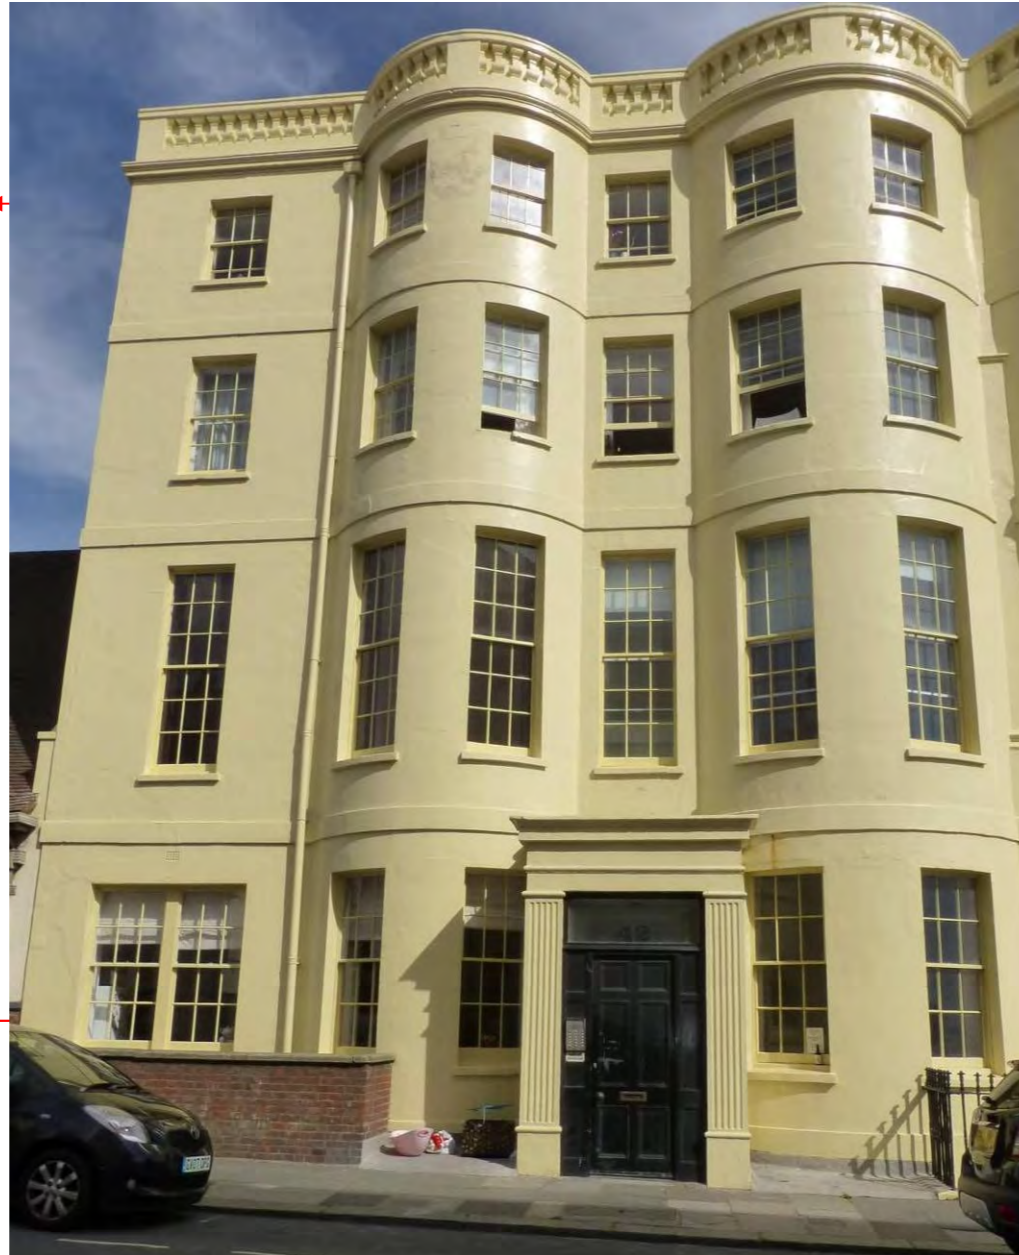
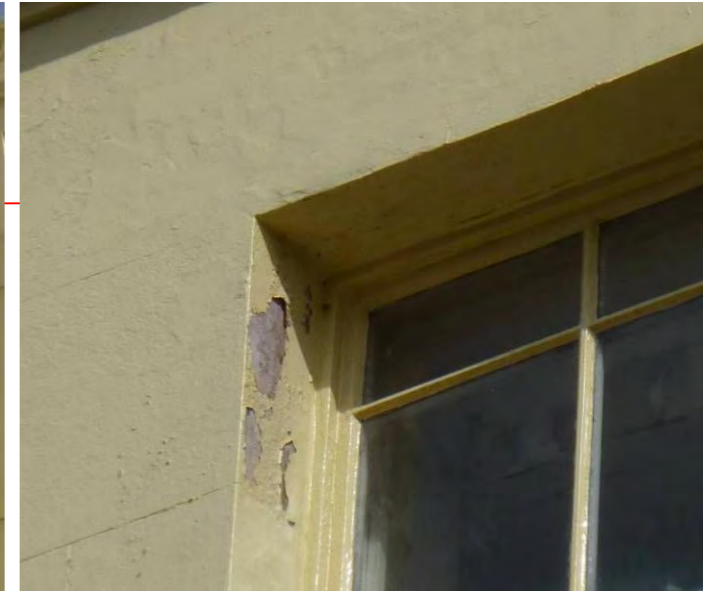
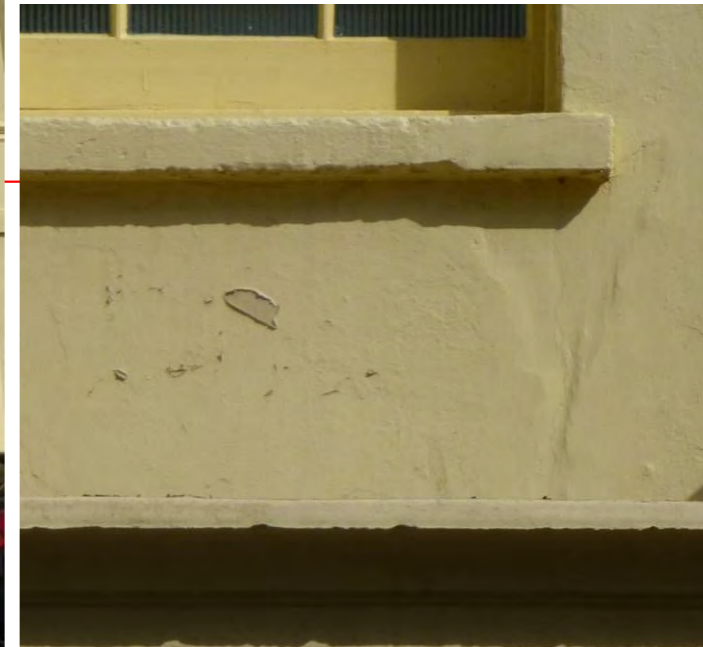
42 Brunswick Terrace (Holland Road Elevation contd.)

1. Salt eruption between third-floor windows to bow; further failure imminent;
2. Loss of sill to right-hand window of second-floor may cause on-going failure;
3. Small area of flaking to flat area above door;
4. Flaking to window reveals;
5. Inevitable failure to street side of basements.
