**Investigation of Paint Failure at
Brunswick Estate
Hove
Brighton**

August 2013

**BRUNSWICK ESTATE
HOVE**

The following document investigates the failure of the external paint-system at Brunswick Estate, Hove based on research carried out by Elizabeth Hirst and Rachel Morley of Hirst Conservation between August and November 2013. The work was commissioned by Brighton & Hove City Council.

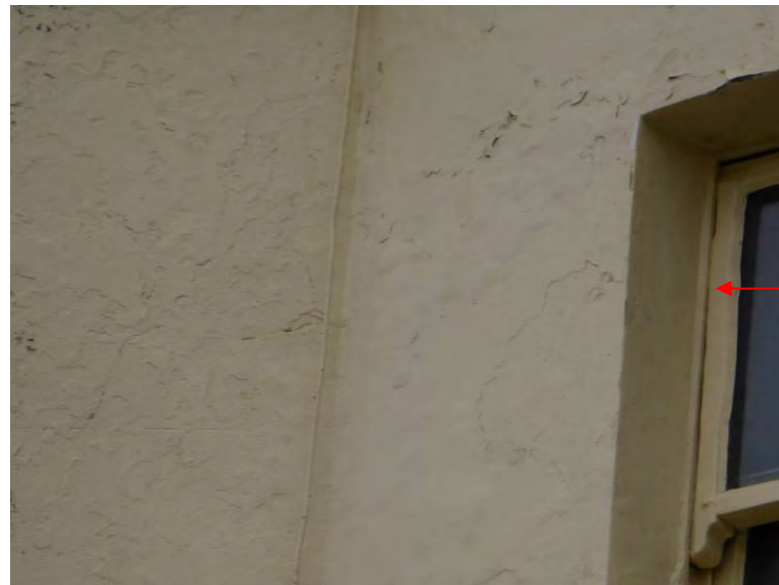
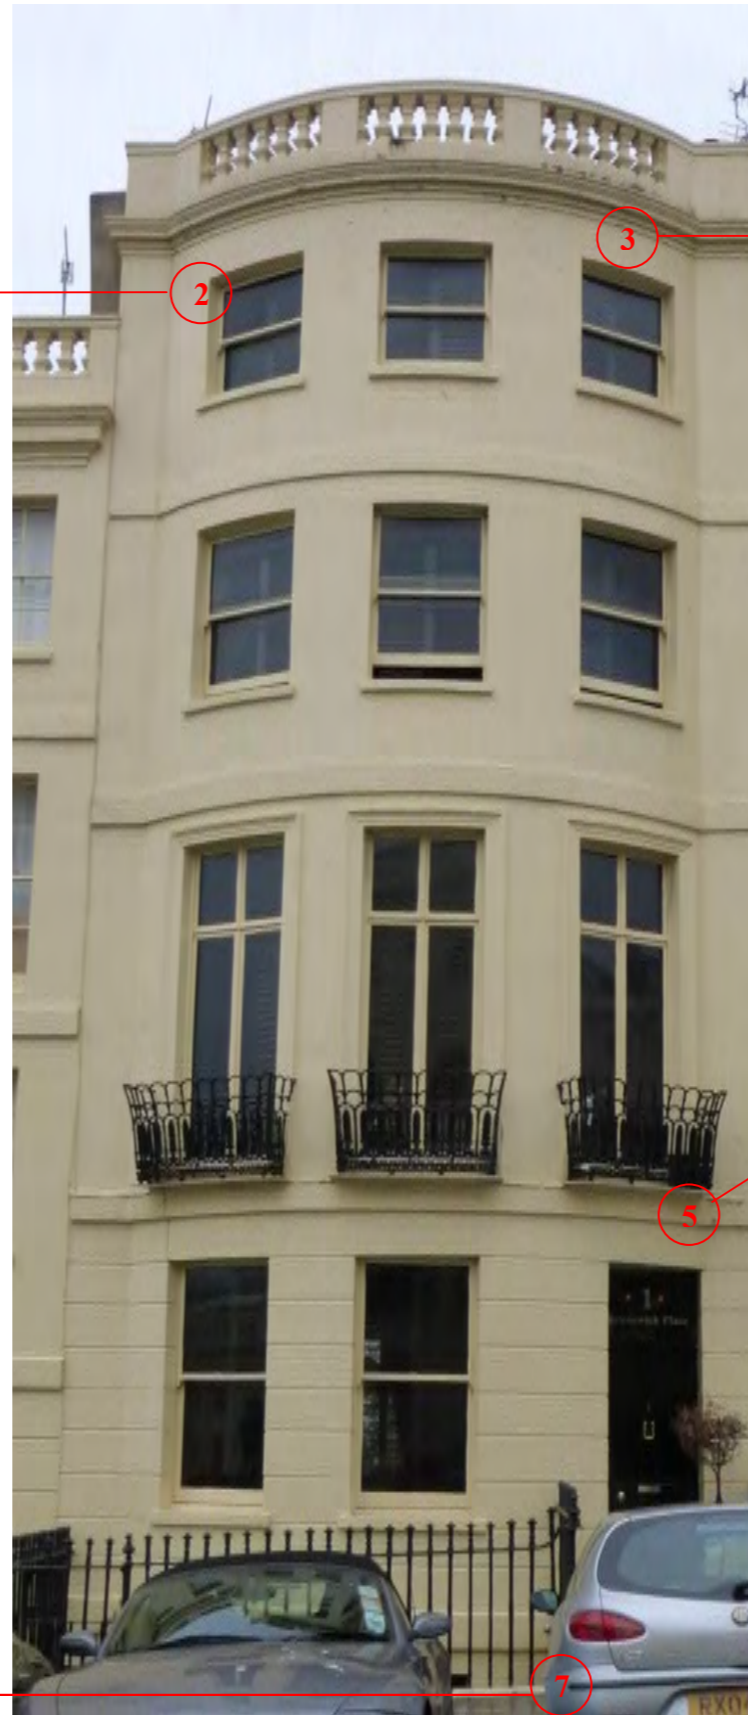
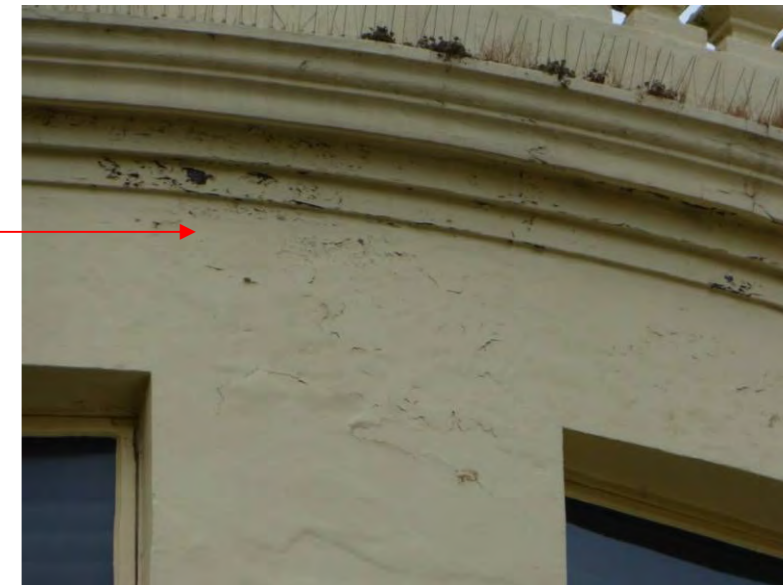
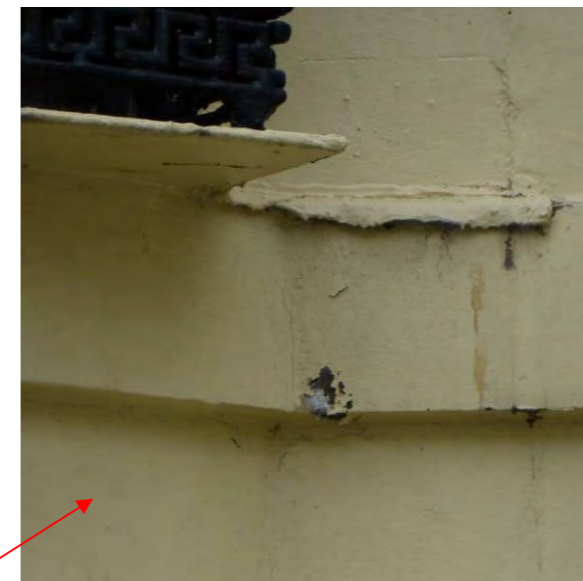
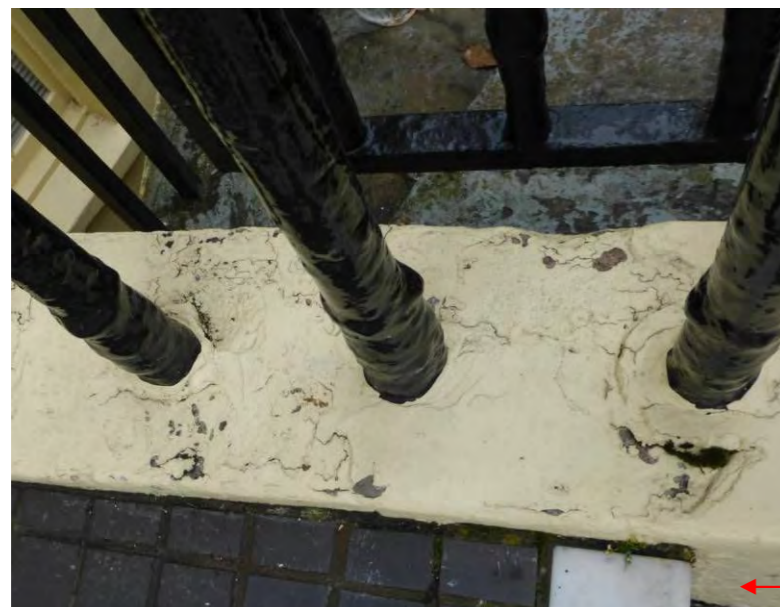
4.3 1 Brunswick Place

1. Balustrade to parapet generally good;
2. Flat areas above and around third floor windows failing;
3. Some failure to lower parapet edge – generally related to cracks;
4. Disruption in overall paint finish (though not severe at present);
5. Localised failure to lower right of balcony
6. Some modern finishes indicating earlier defects;
7. Flaking to plinth wall.

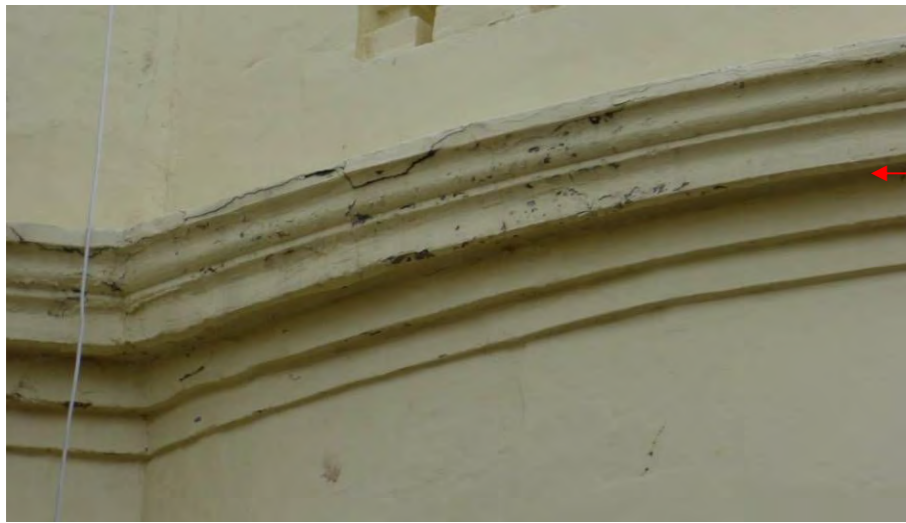
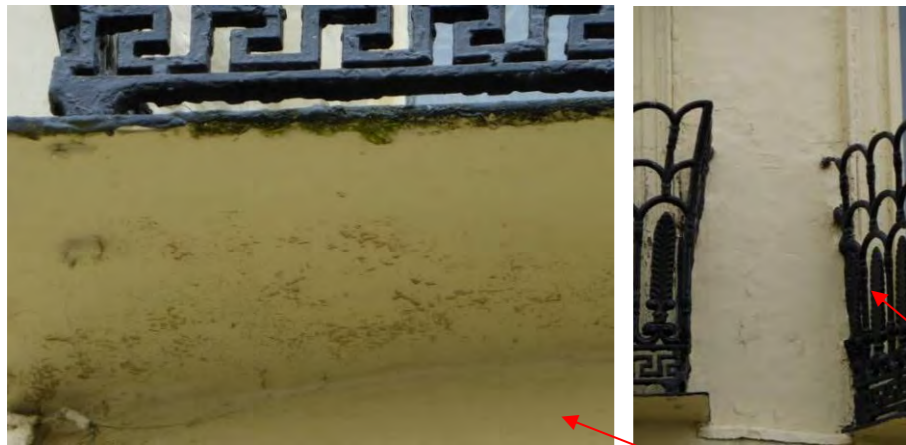
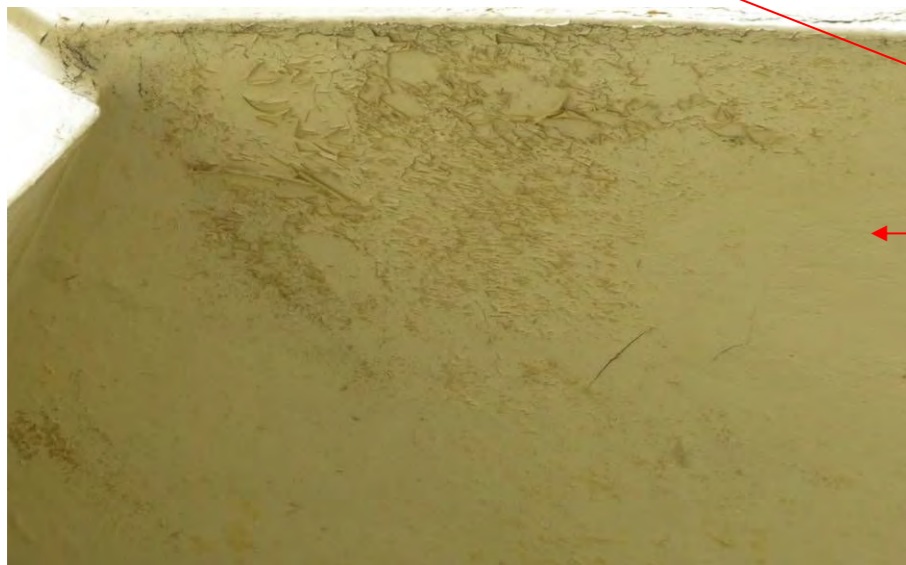
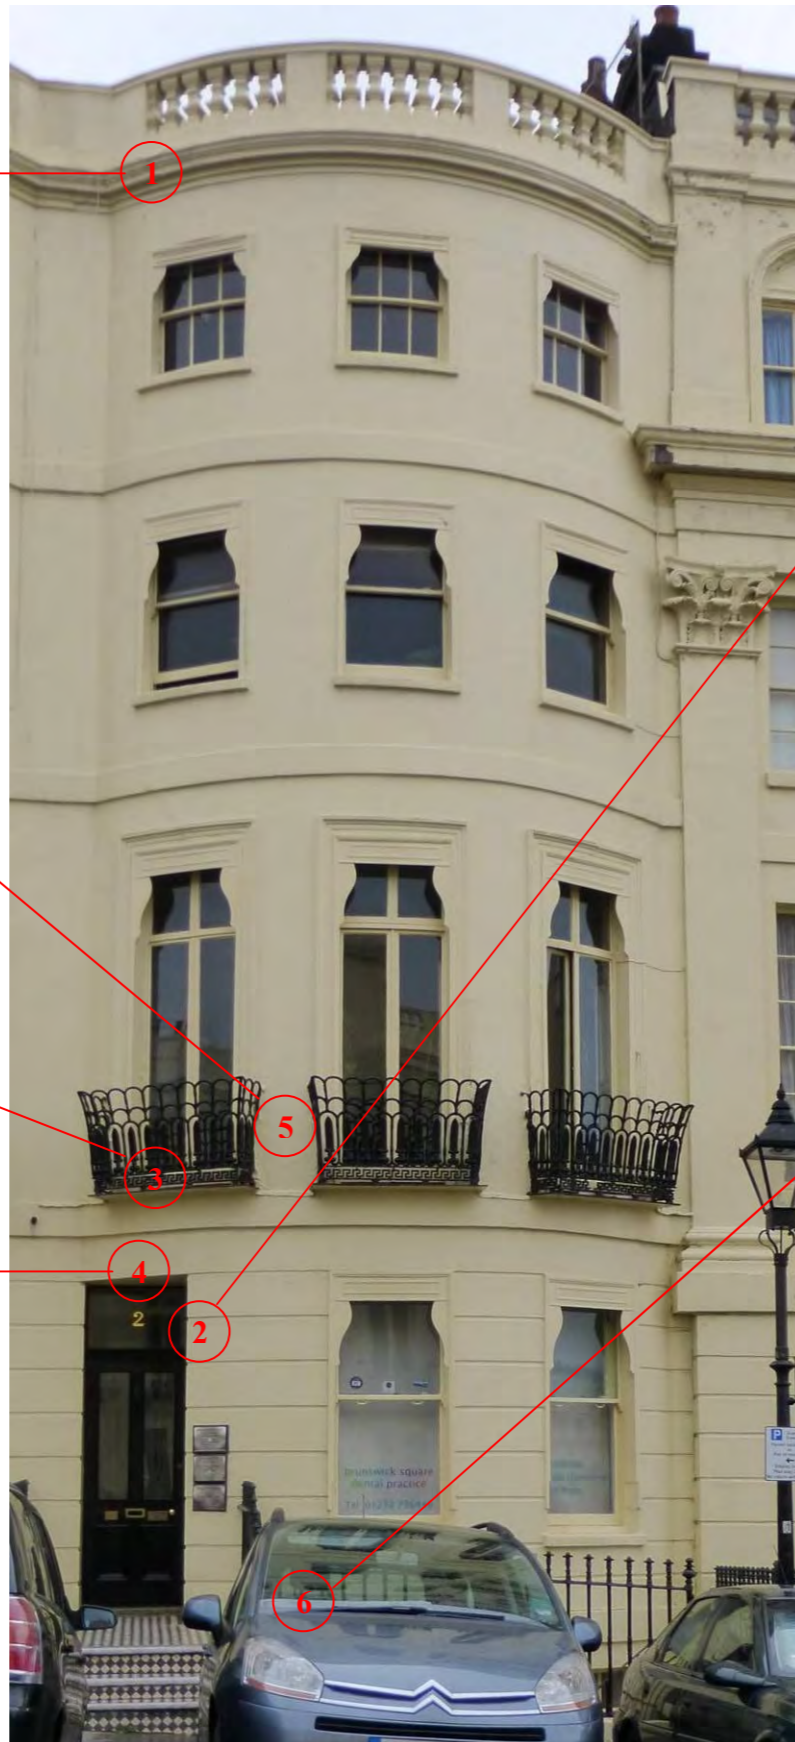
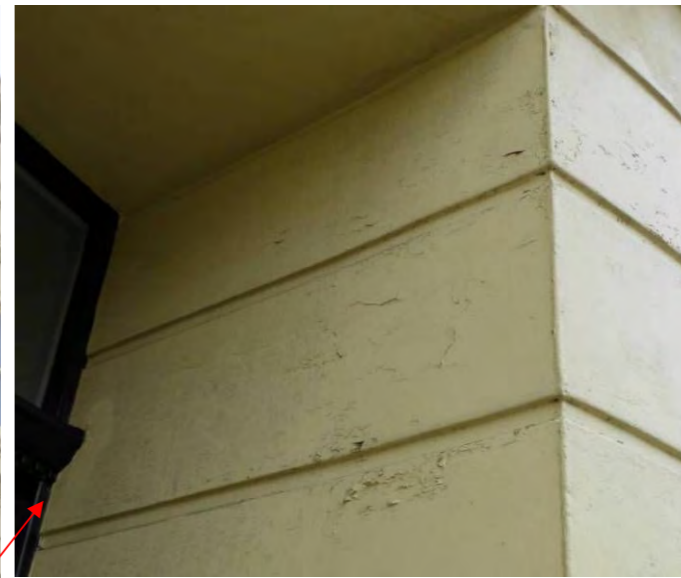
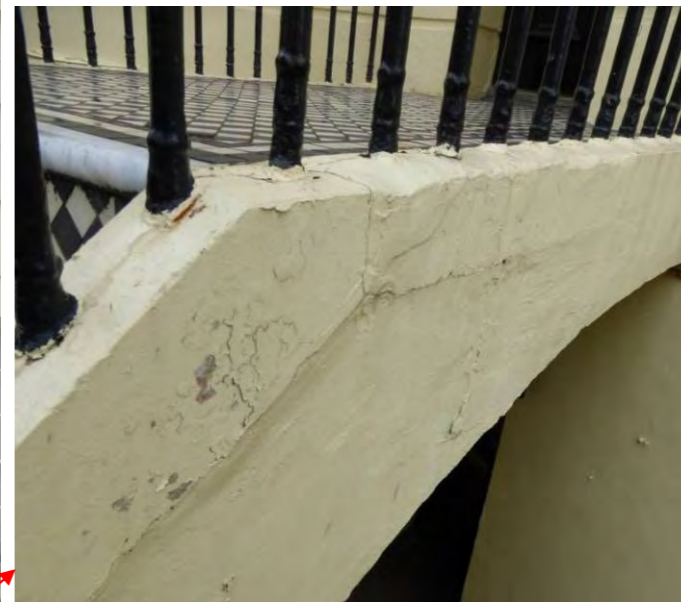
2 Brunswick Place

Generally good;

1. Some defects to high-level cornice below balustrade
- usually affected by fractures and substrate;
2. Impact from adjacent wires;
3. Flaking to underside of balcony;
3. Localised flaking to right of door;
4. Flaking to entrance area walls;
5. Remains of earlier paint system flaking;
6. Cracking and flaking to plinth wall.

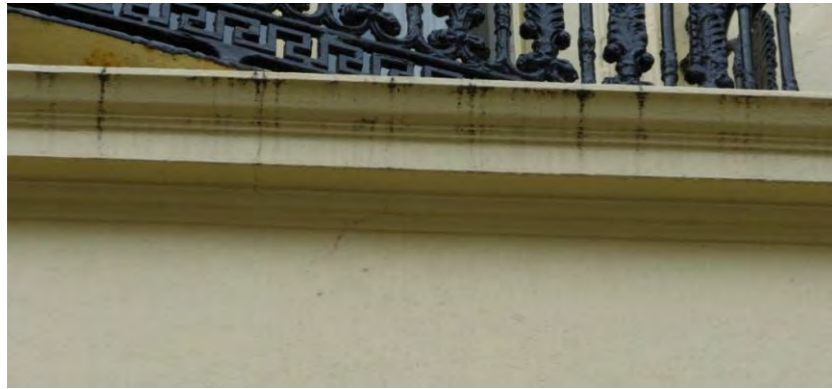
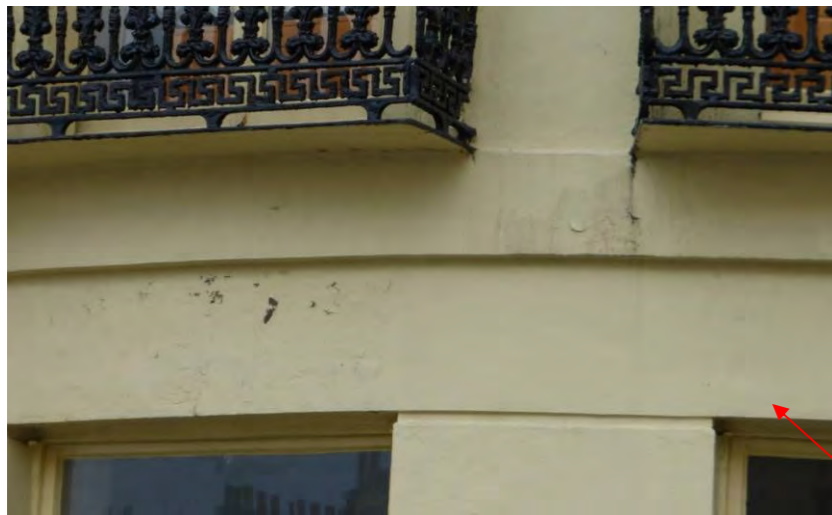
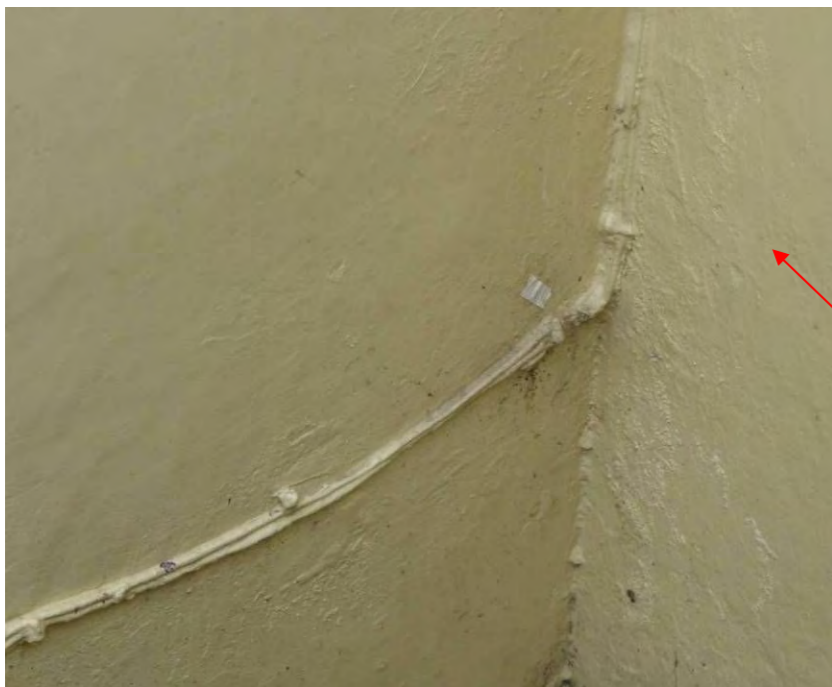
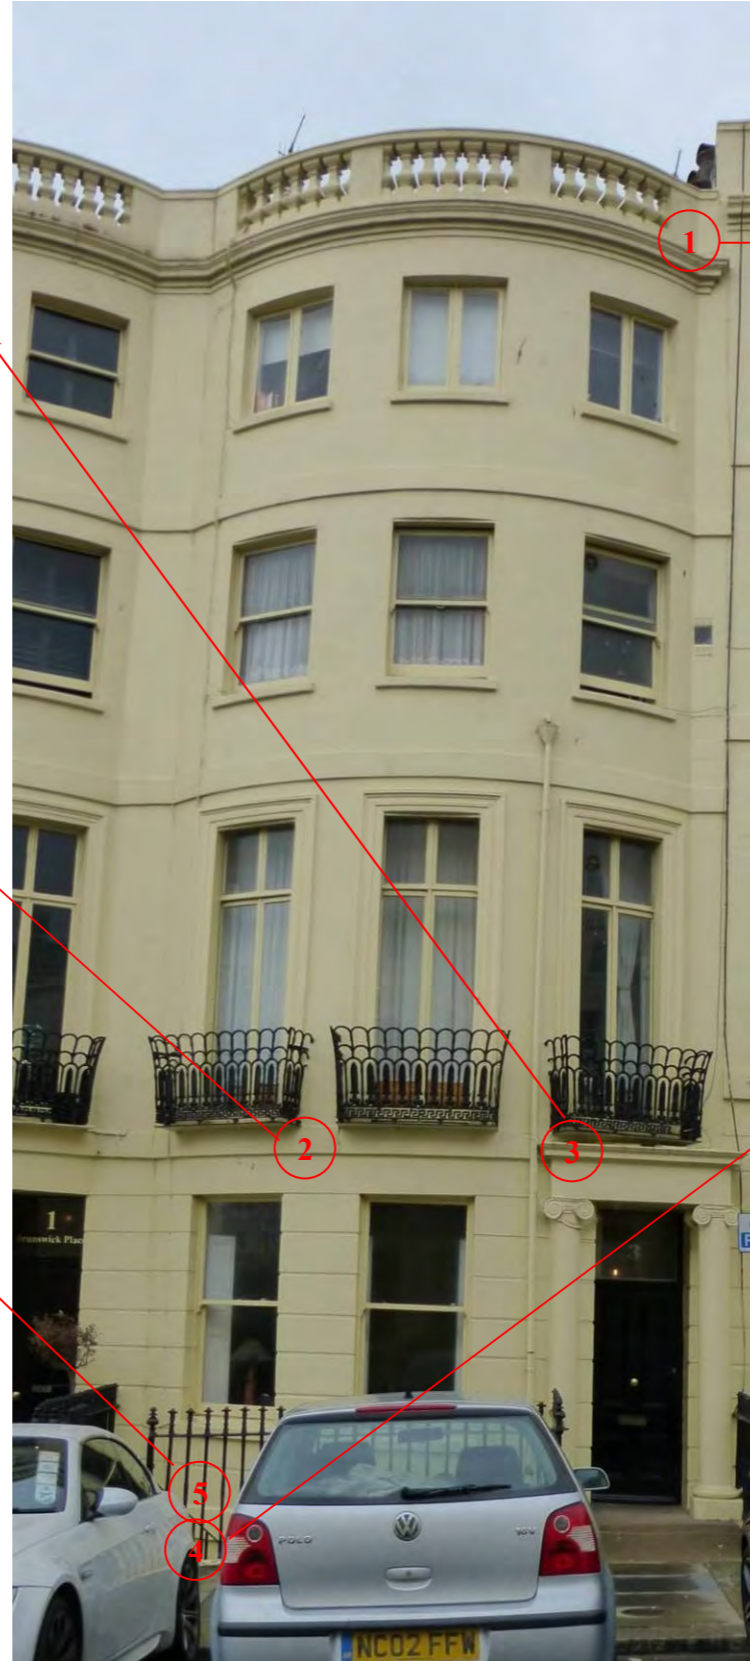
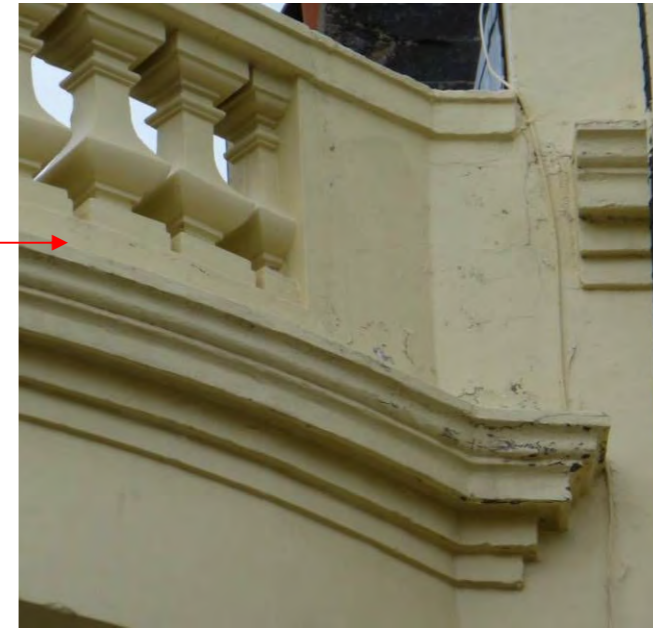
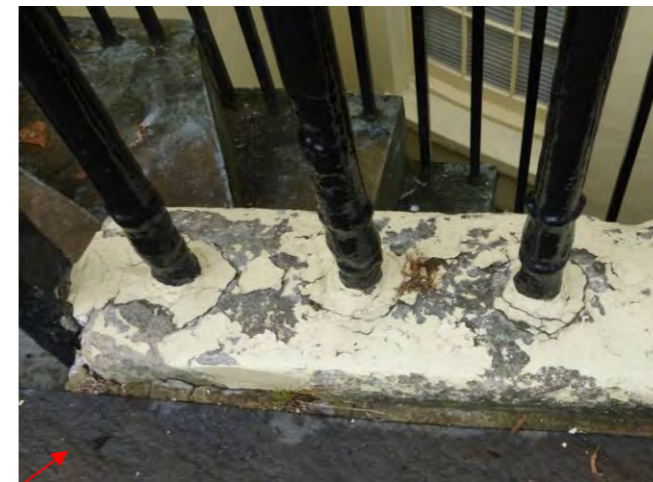
3 Brunswick Place

1. Localised failure to high-level cornice
– particularly near wires and right-hand corner;
2. Failure and losses to banding below terrace and balcony
- affecting high-level rustication;
3. Staining from far right balcony over doorway;
4. Excessive losses and flaking to plinth wall;
5. Some salt eruption at basement level, but generally good.

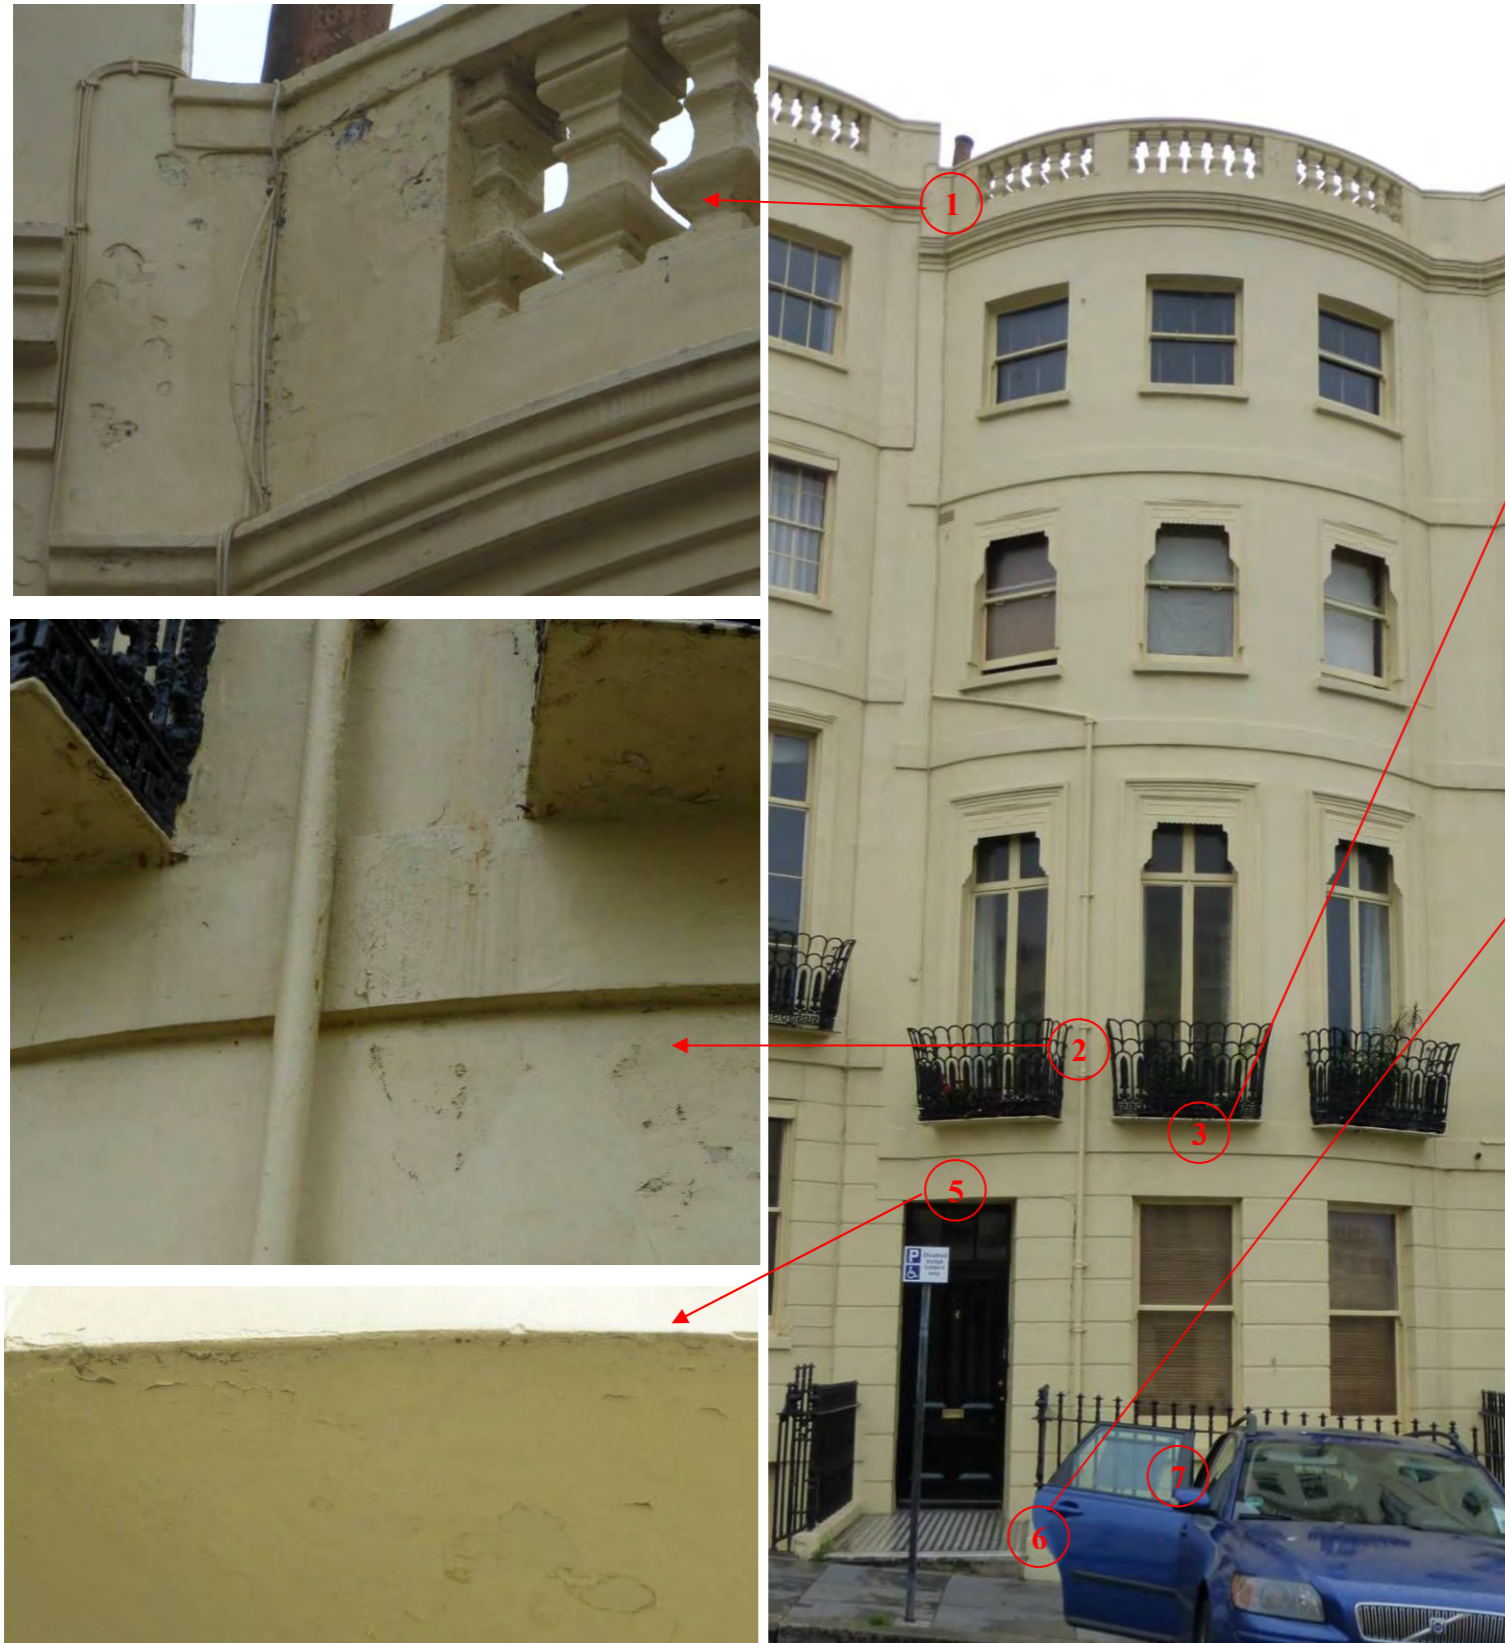
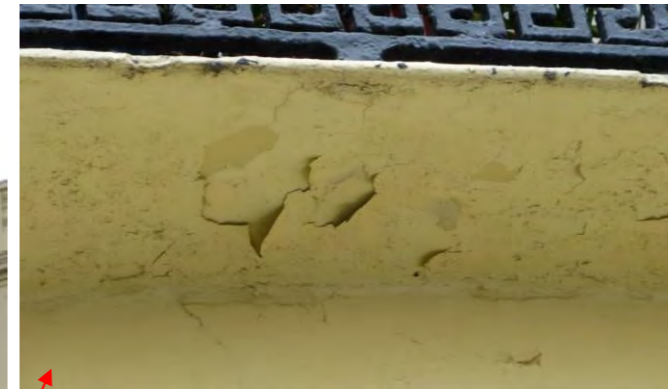
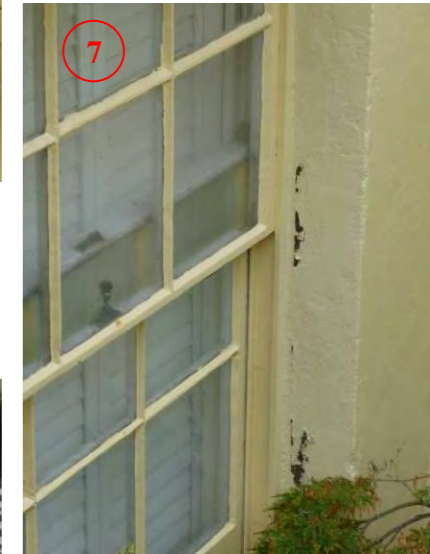
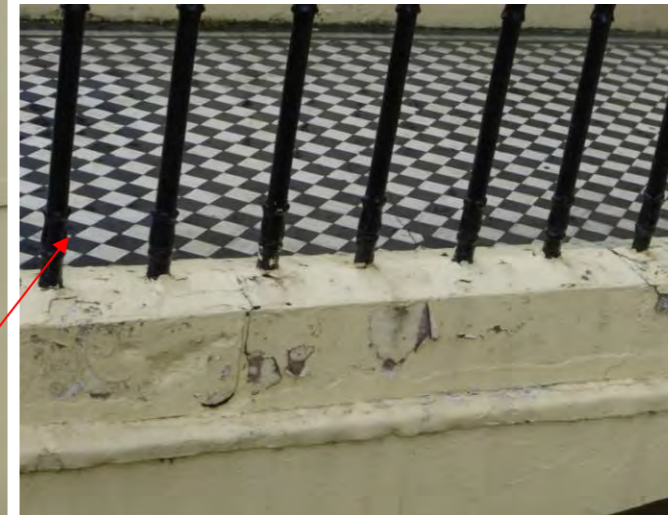
4 Brunswick Place

1. Failure at high level – some relate to cracks, but mostly general spalling;
2. Failure around downpipe at ground-floor level;
3. Flaking to underside balcony - expected;
4. Flaking to higher rustications possibly due to run-off from balconies;
5. Minor losses to doorway;
6. Excessive losses and flaking of plinth wall;
7. Basement level generally good – minor failing to window reveal.

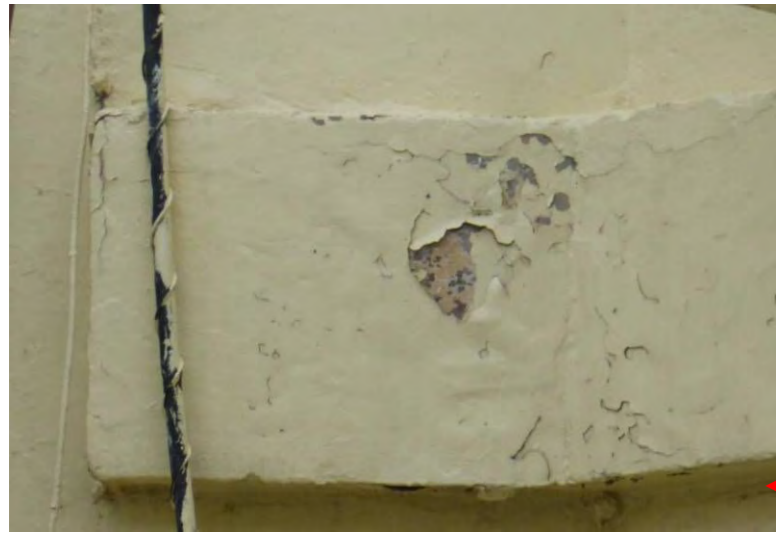
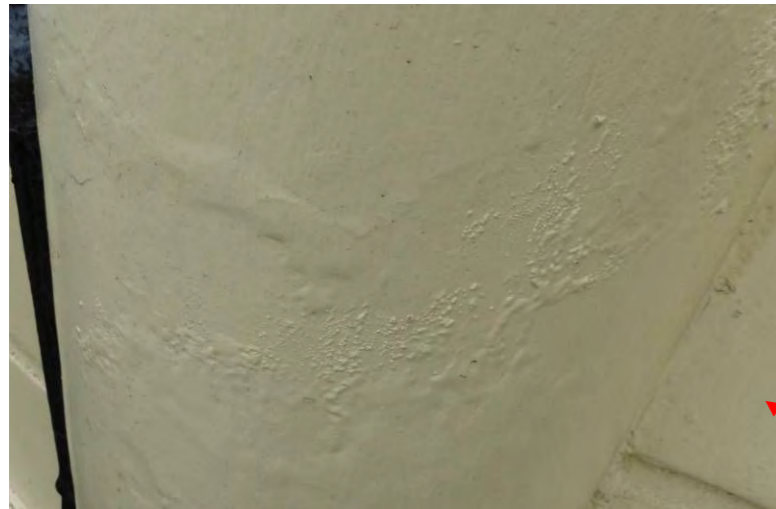
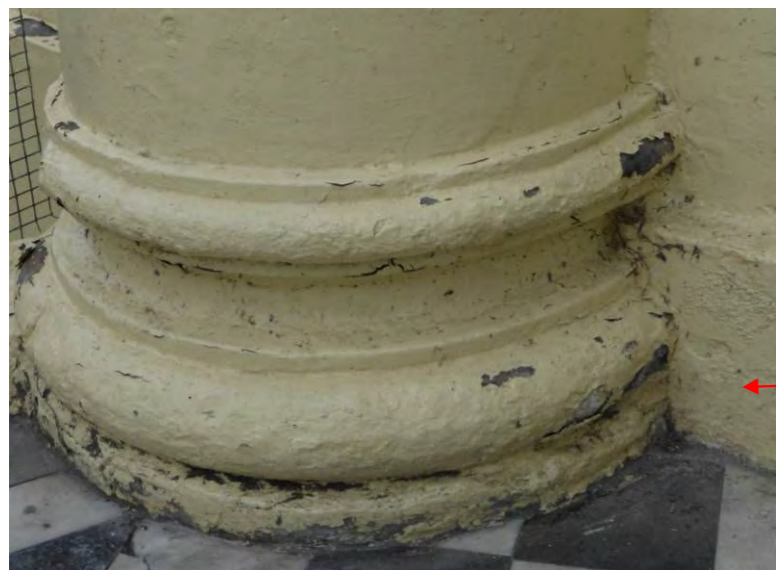
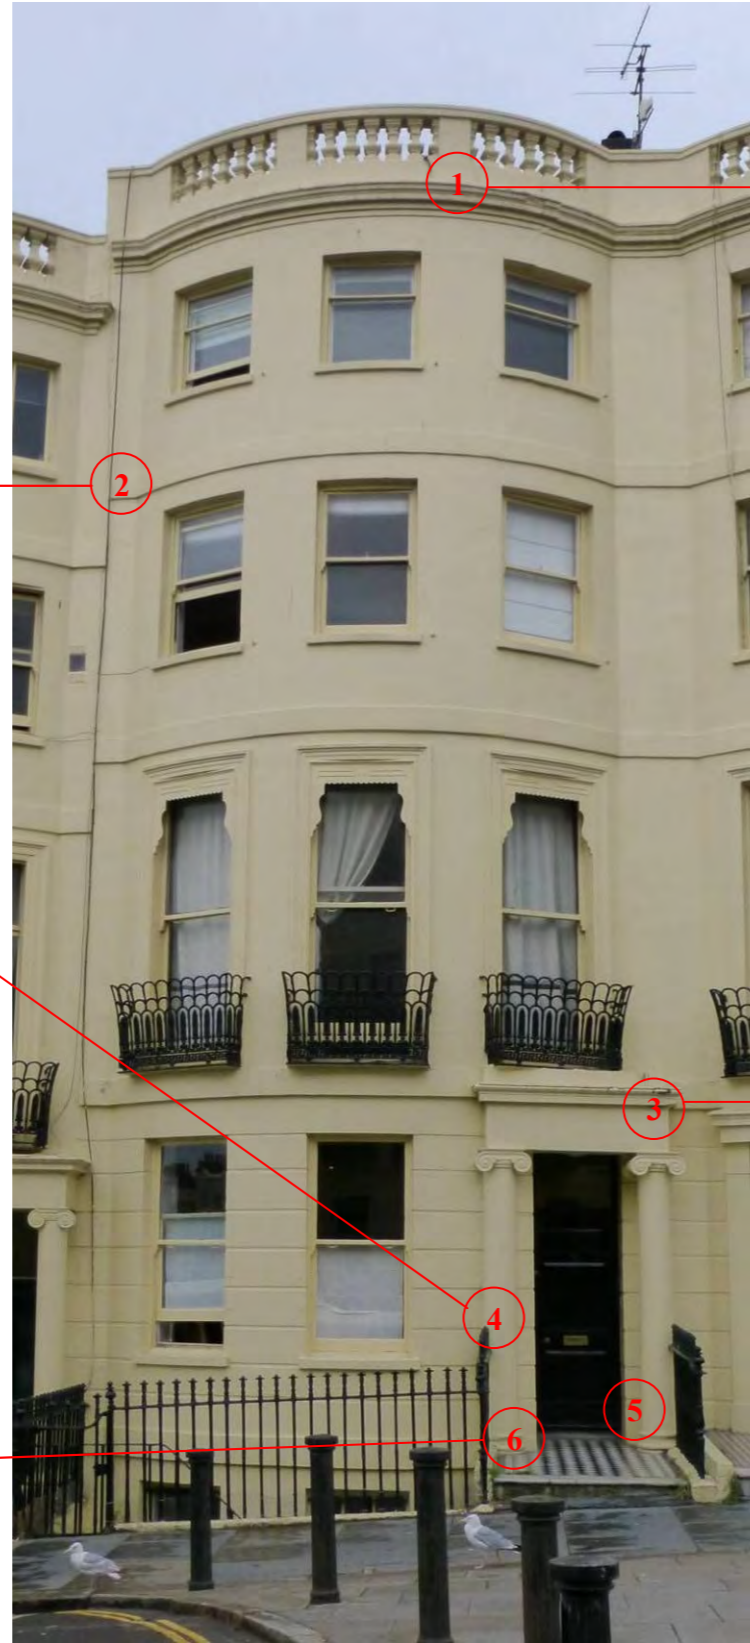
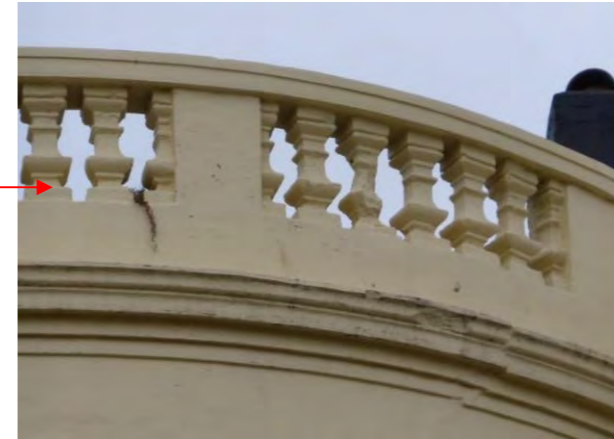
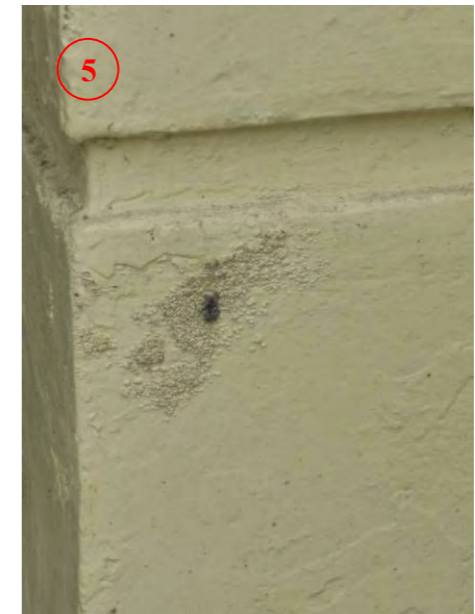
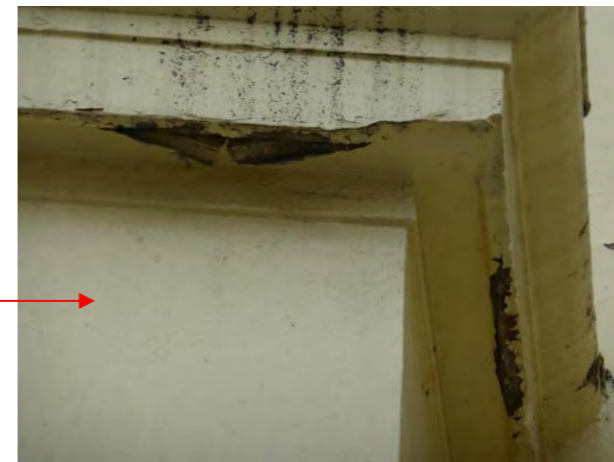
5 Brunswick Place

1. Parapet balustrade in good order;
2. Minor, localised damage to cornice and string-courses– possibly due to substrate damage/ineffective drip detailing;
3. Some flaking to ground-floor level revealing smooth substrate;
4. Column to left of doorway exhibiting blistering from salts, but not disrupting paint at present;
5. Salt eruptions around doorway;
6. Failure to column bases and plinth wall to railings;
7. Basement level generally good.

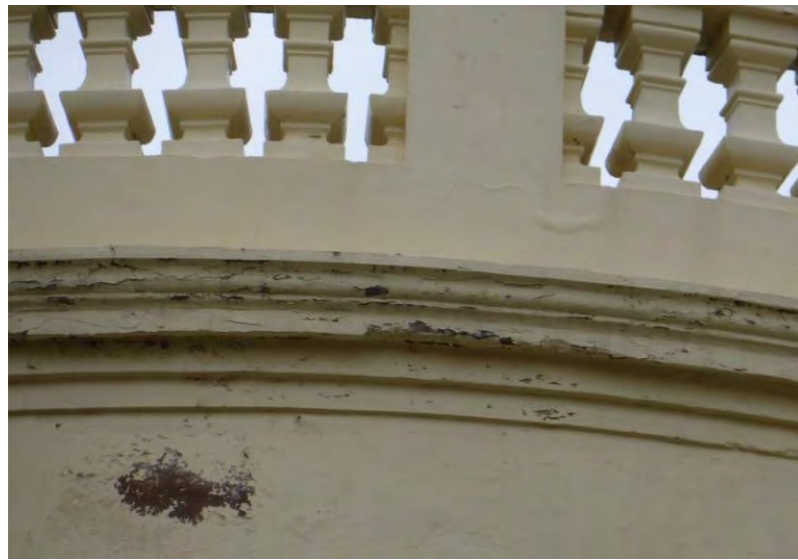
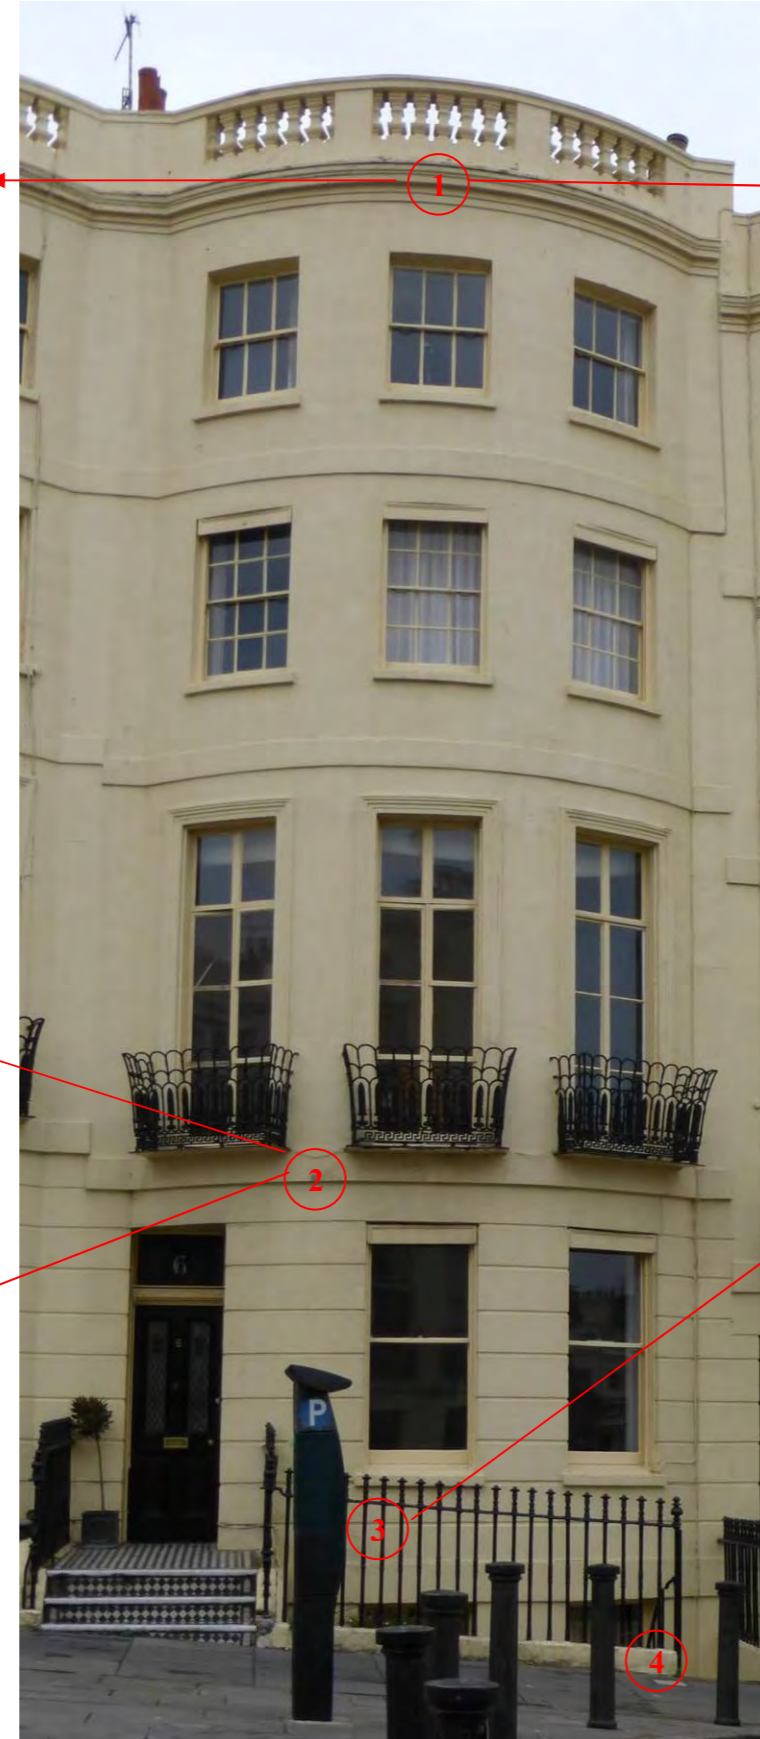
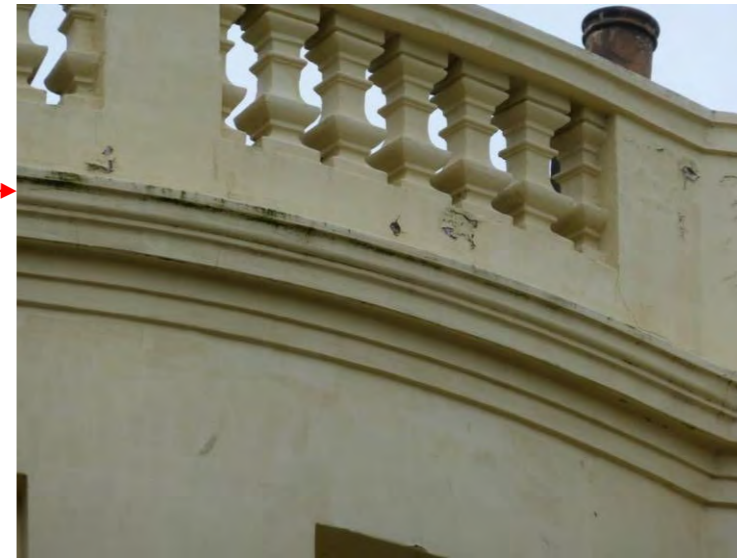
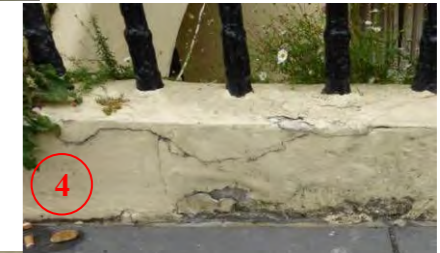
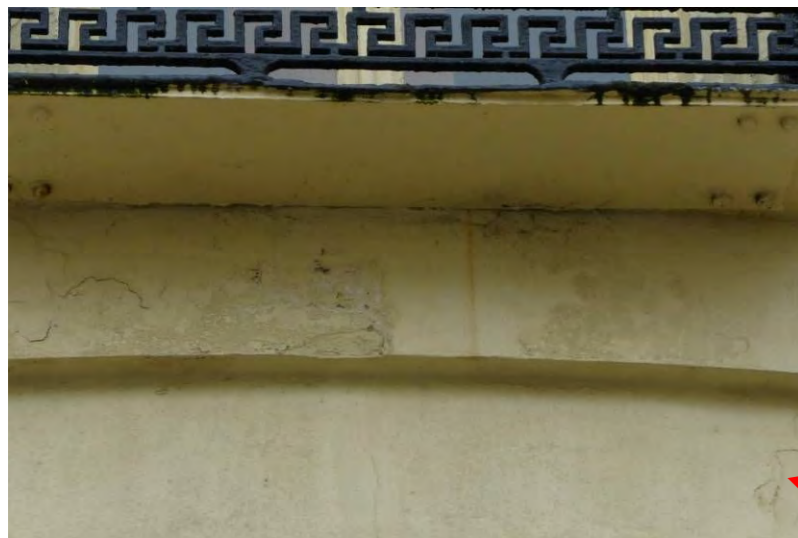
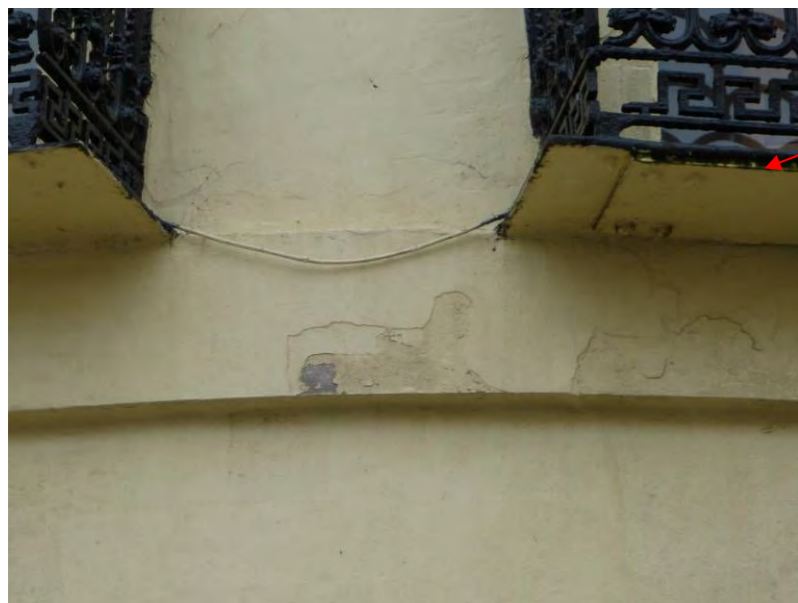
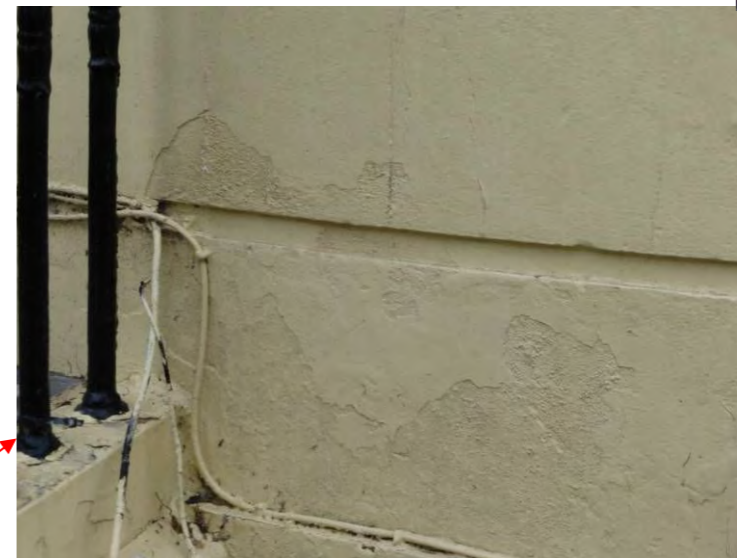
6 Brunswick Place

1. Losses and damage to parapet – fractures to cornice accelerating flaking;
2. Failure to upper section of ground-floor rustications;
3. Islands of delaminated render across this section;
4. Severe cracking, loss and vegetation growth to plinth wall.
