**Investigation of Paint Failure at
Brunswick Estate
Hove
Brighton**

August 2013

**BRUNSWICK ESTATE
HOVE**

The following document investigates the failure of the external paint-system at Brunswick Estate, Hove based on research carried out by Elizabeth Hirst and Rachel Morley of Hirst Conservation between August and November 2013. The work was commissioned by Brighton & Hove City Council.

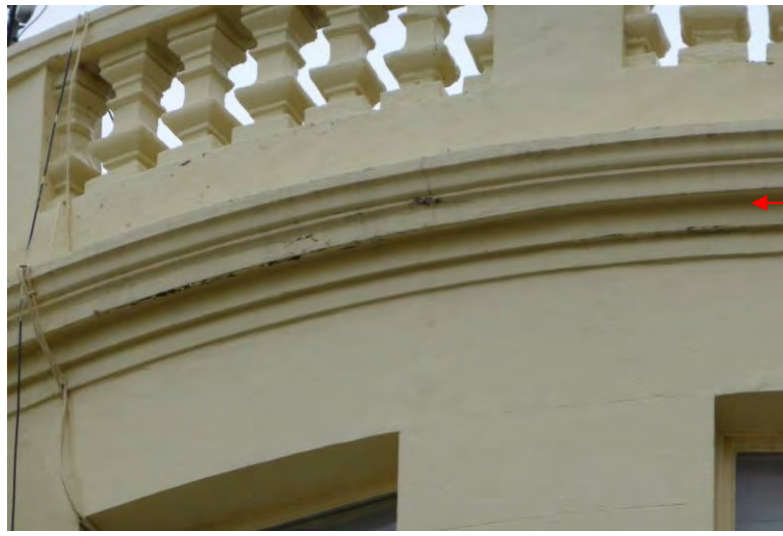
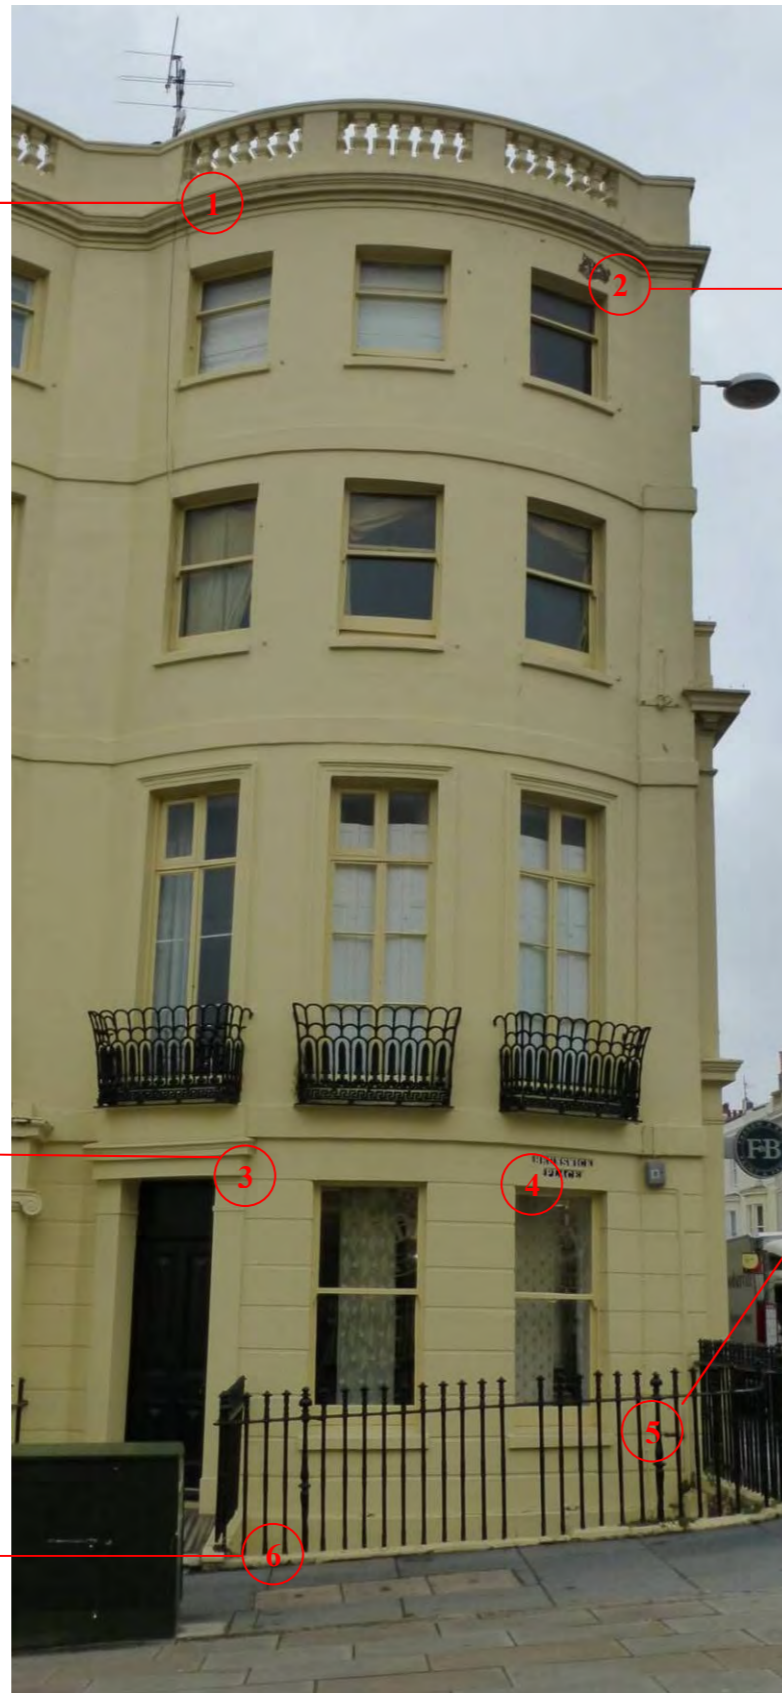
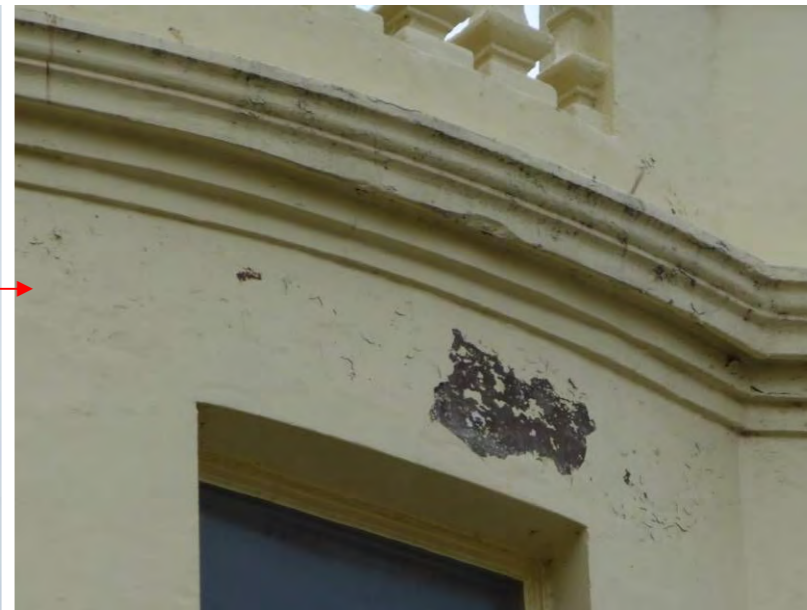
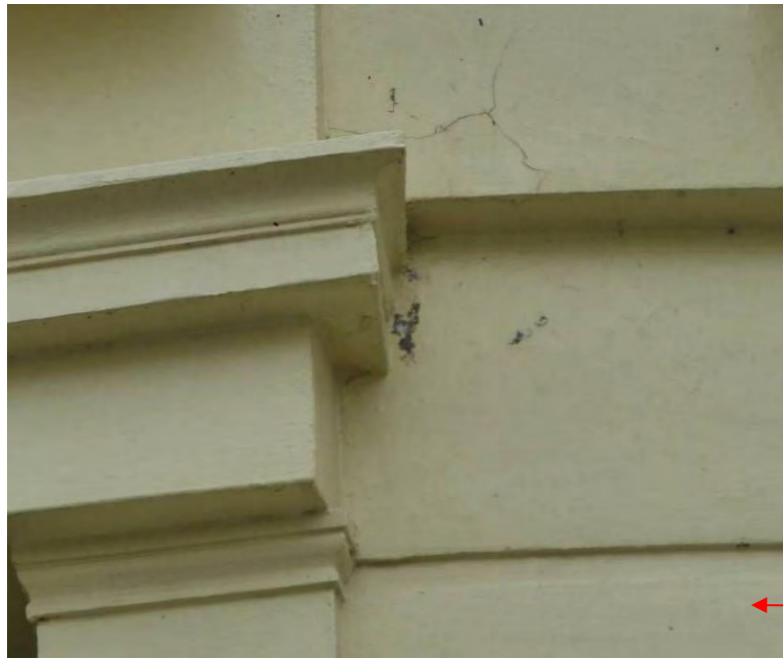
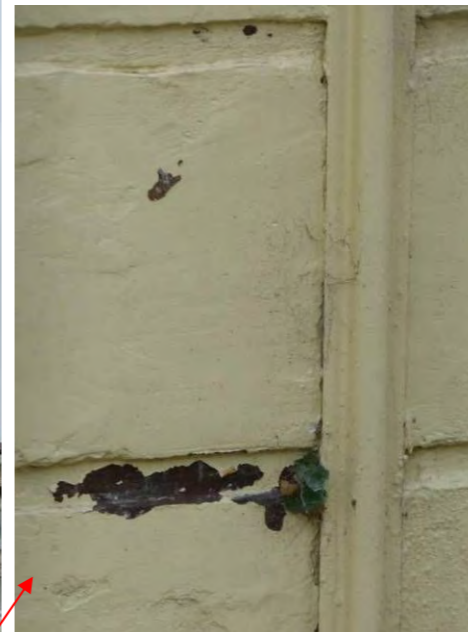
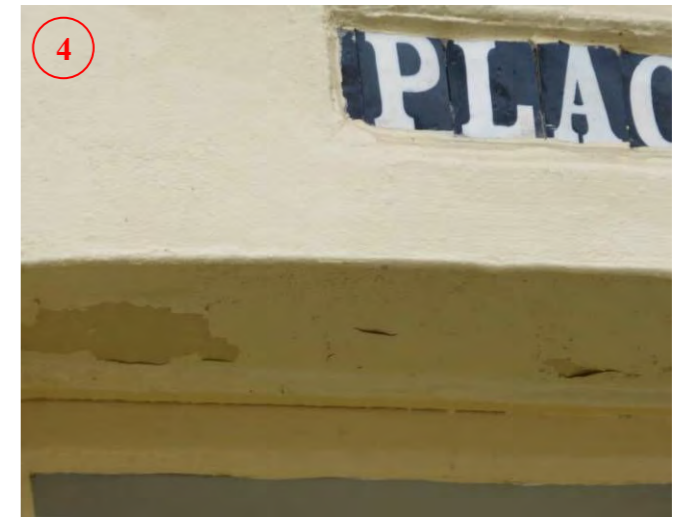
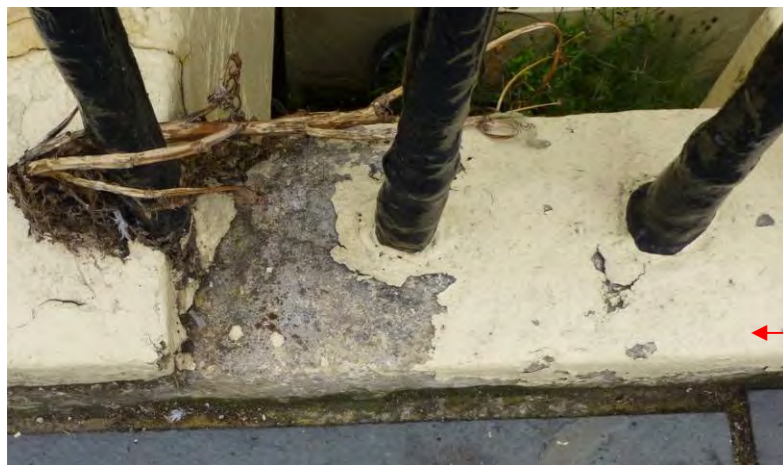
7 Brunswick Place (Brunswick Place Elevation)

1. Some flaking to high-level cornice;
2. Area of loss above right-hand window to third-floor revealing smooth earlier stucco;
3. Flaking to upper right of doorway;
4. Peeling to window reveal at ground-floor level;
5. Small losses in rustication indentations;
6. Flaking, loss of paint and substrate, and vegetation growth to plinth wall;

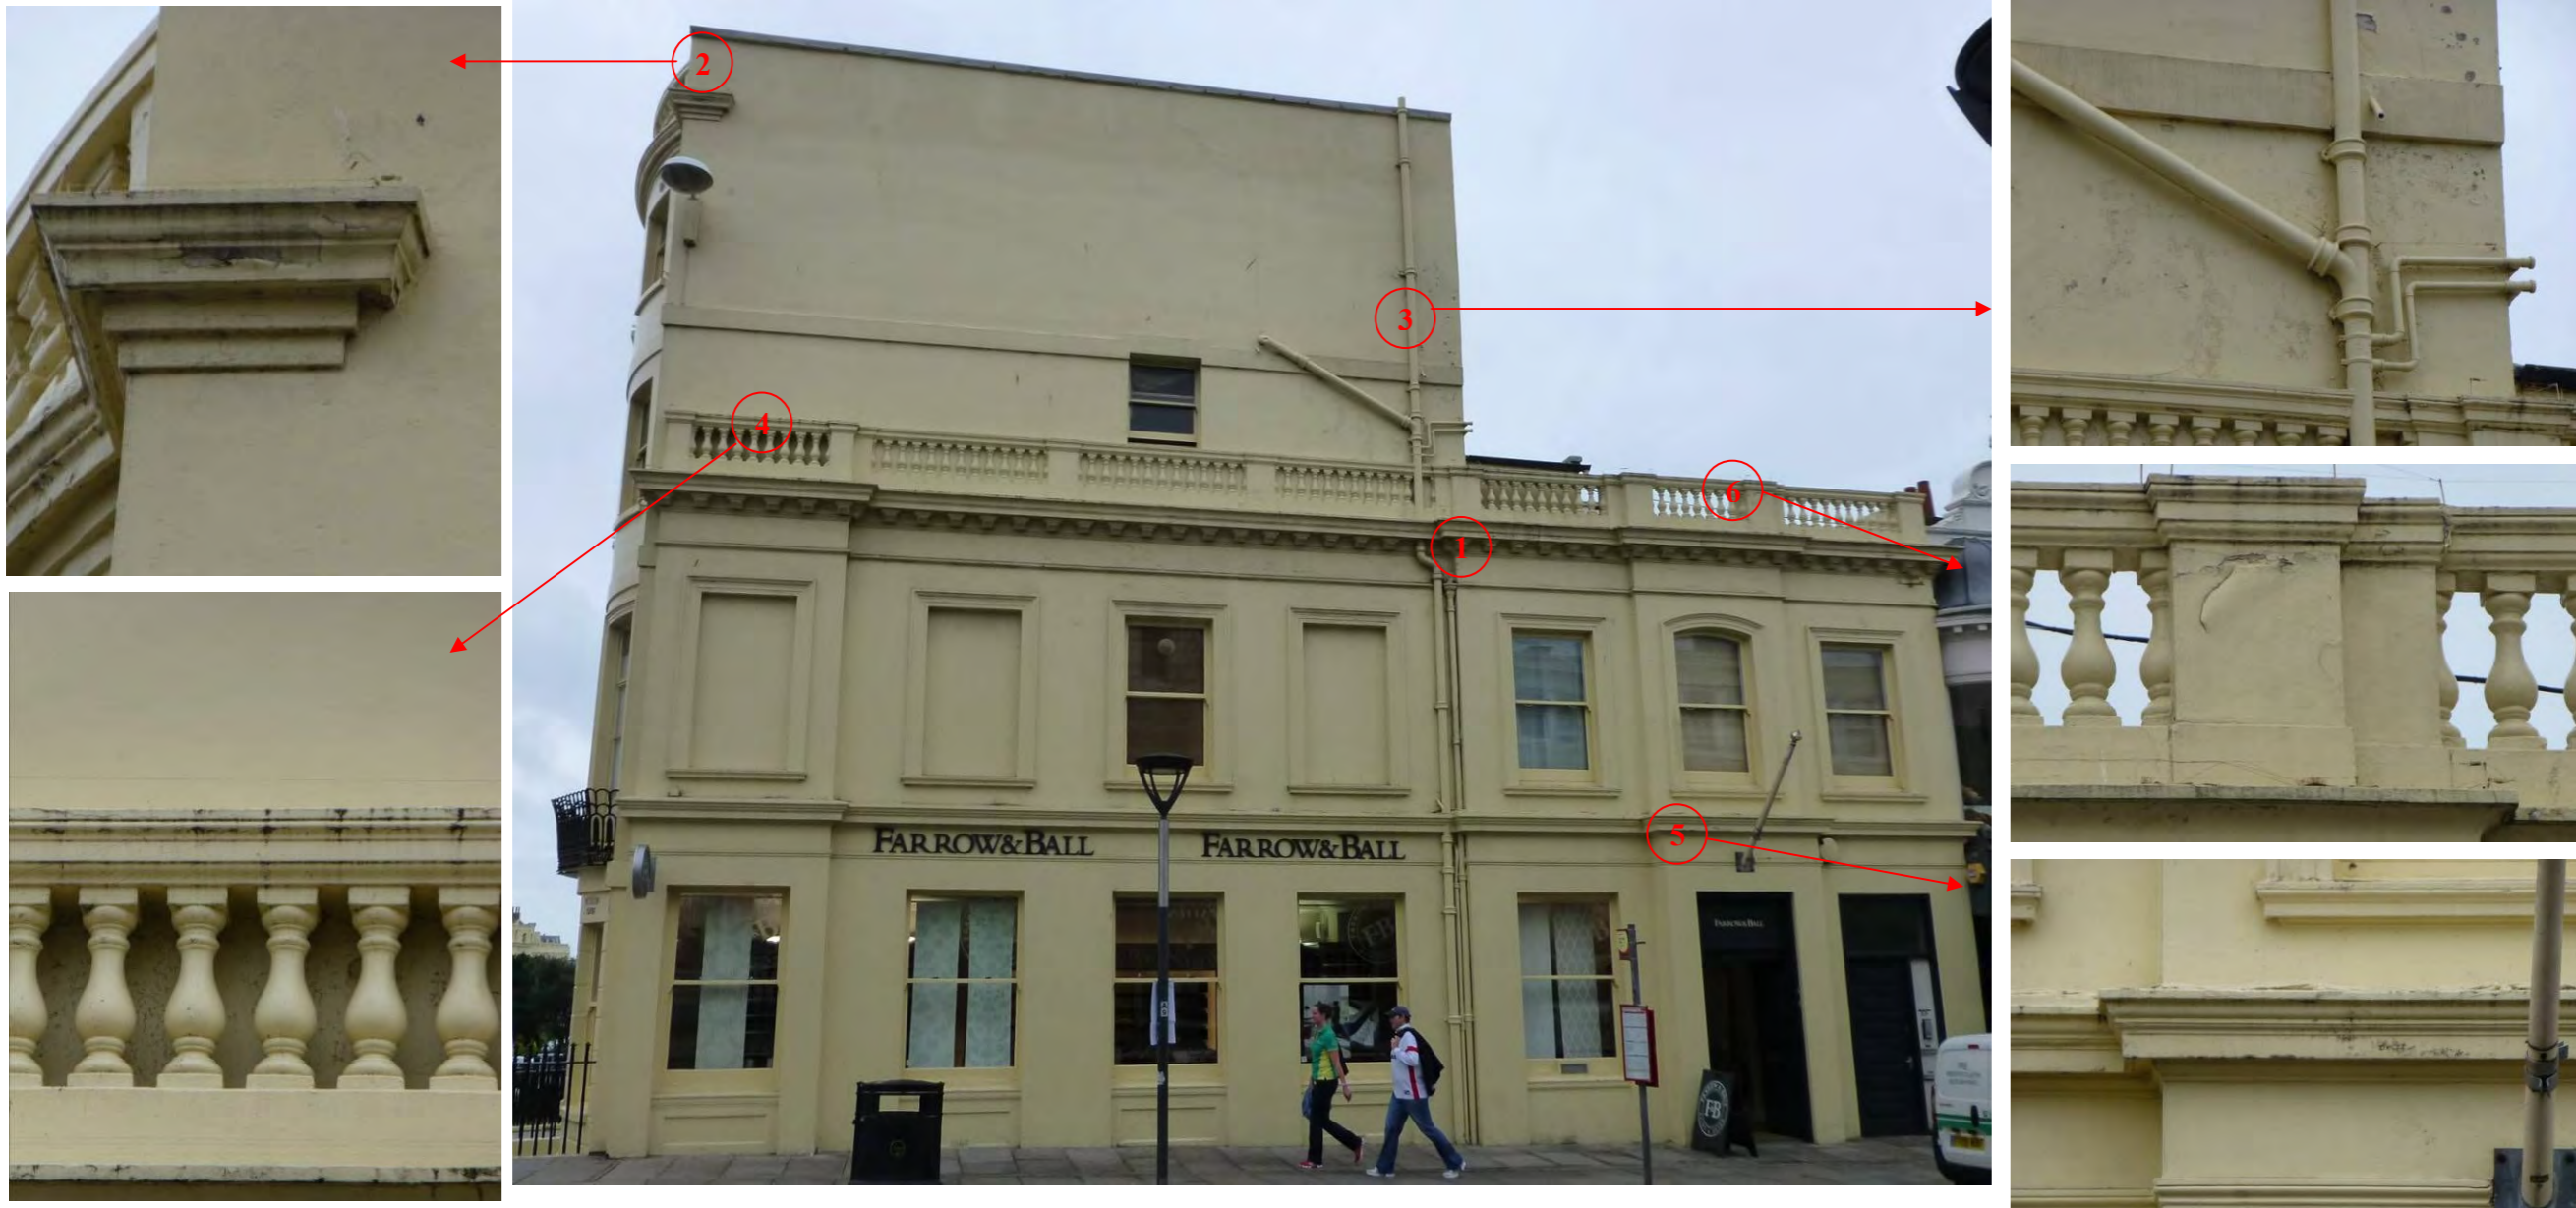
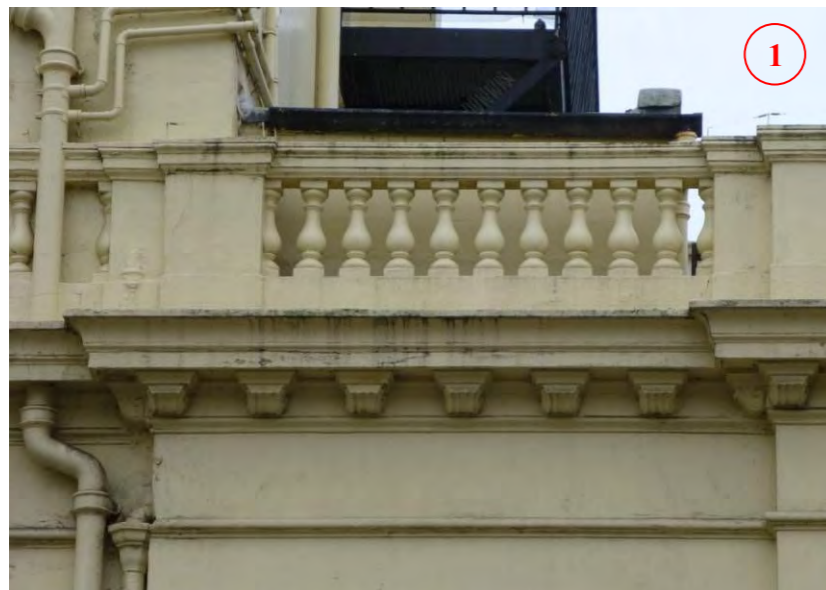
7 Brunswick Place (Western Road Elevation)

1. Overall discoloured, flaking elevation;
2. Flaking to cornice return from Brunswick Place elevation;
3. Failure and losses, particularly to right, and along downpipes;
4. Fissures and staining to across and under length of dentil cornice;
5. Similar to lower level moulded cornice over right-hand entrance;
6. Large sheet peeling to balustrade pillar of two-storey building;
7. Minor staining and losses at ground-level.

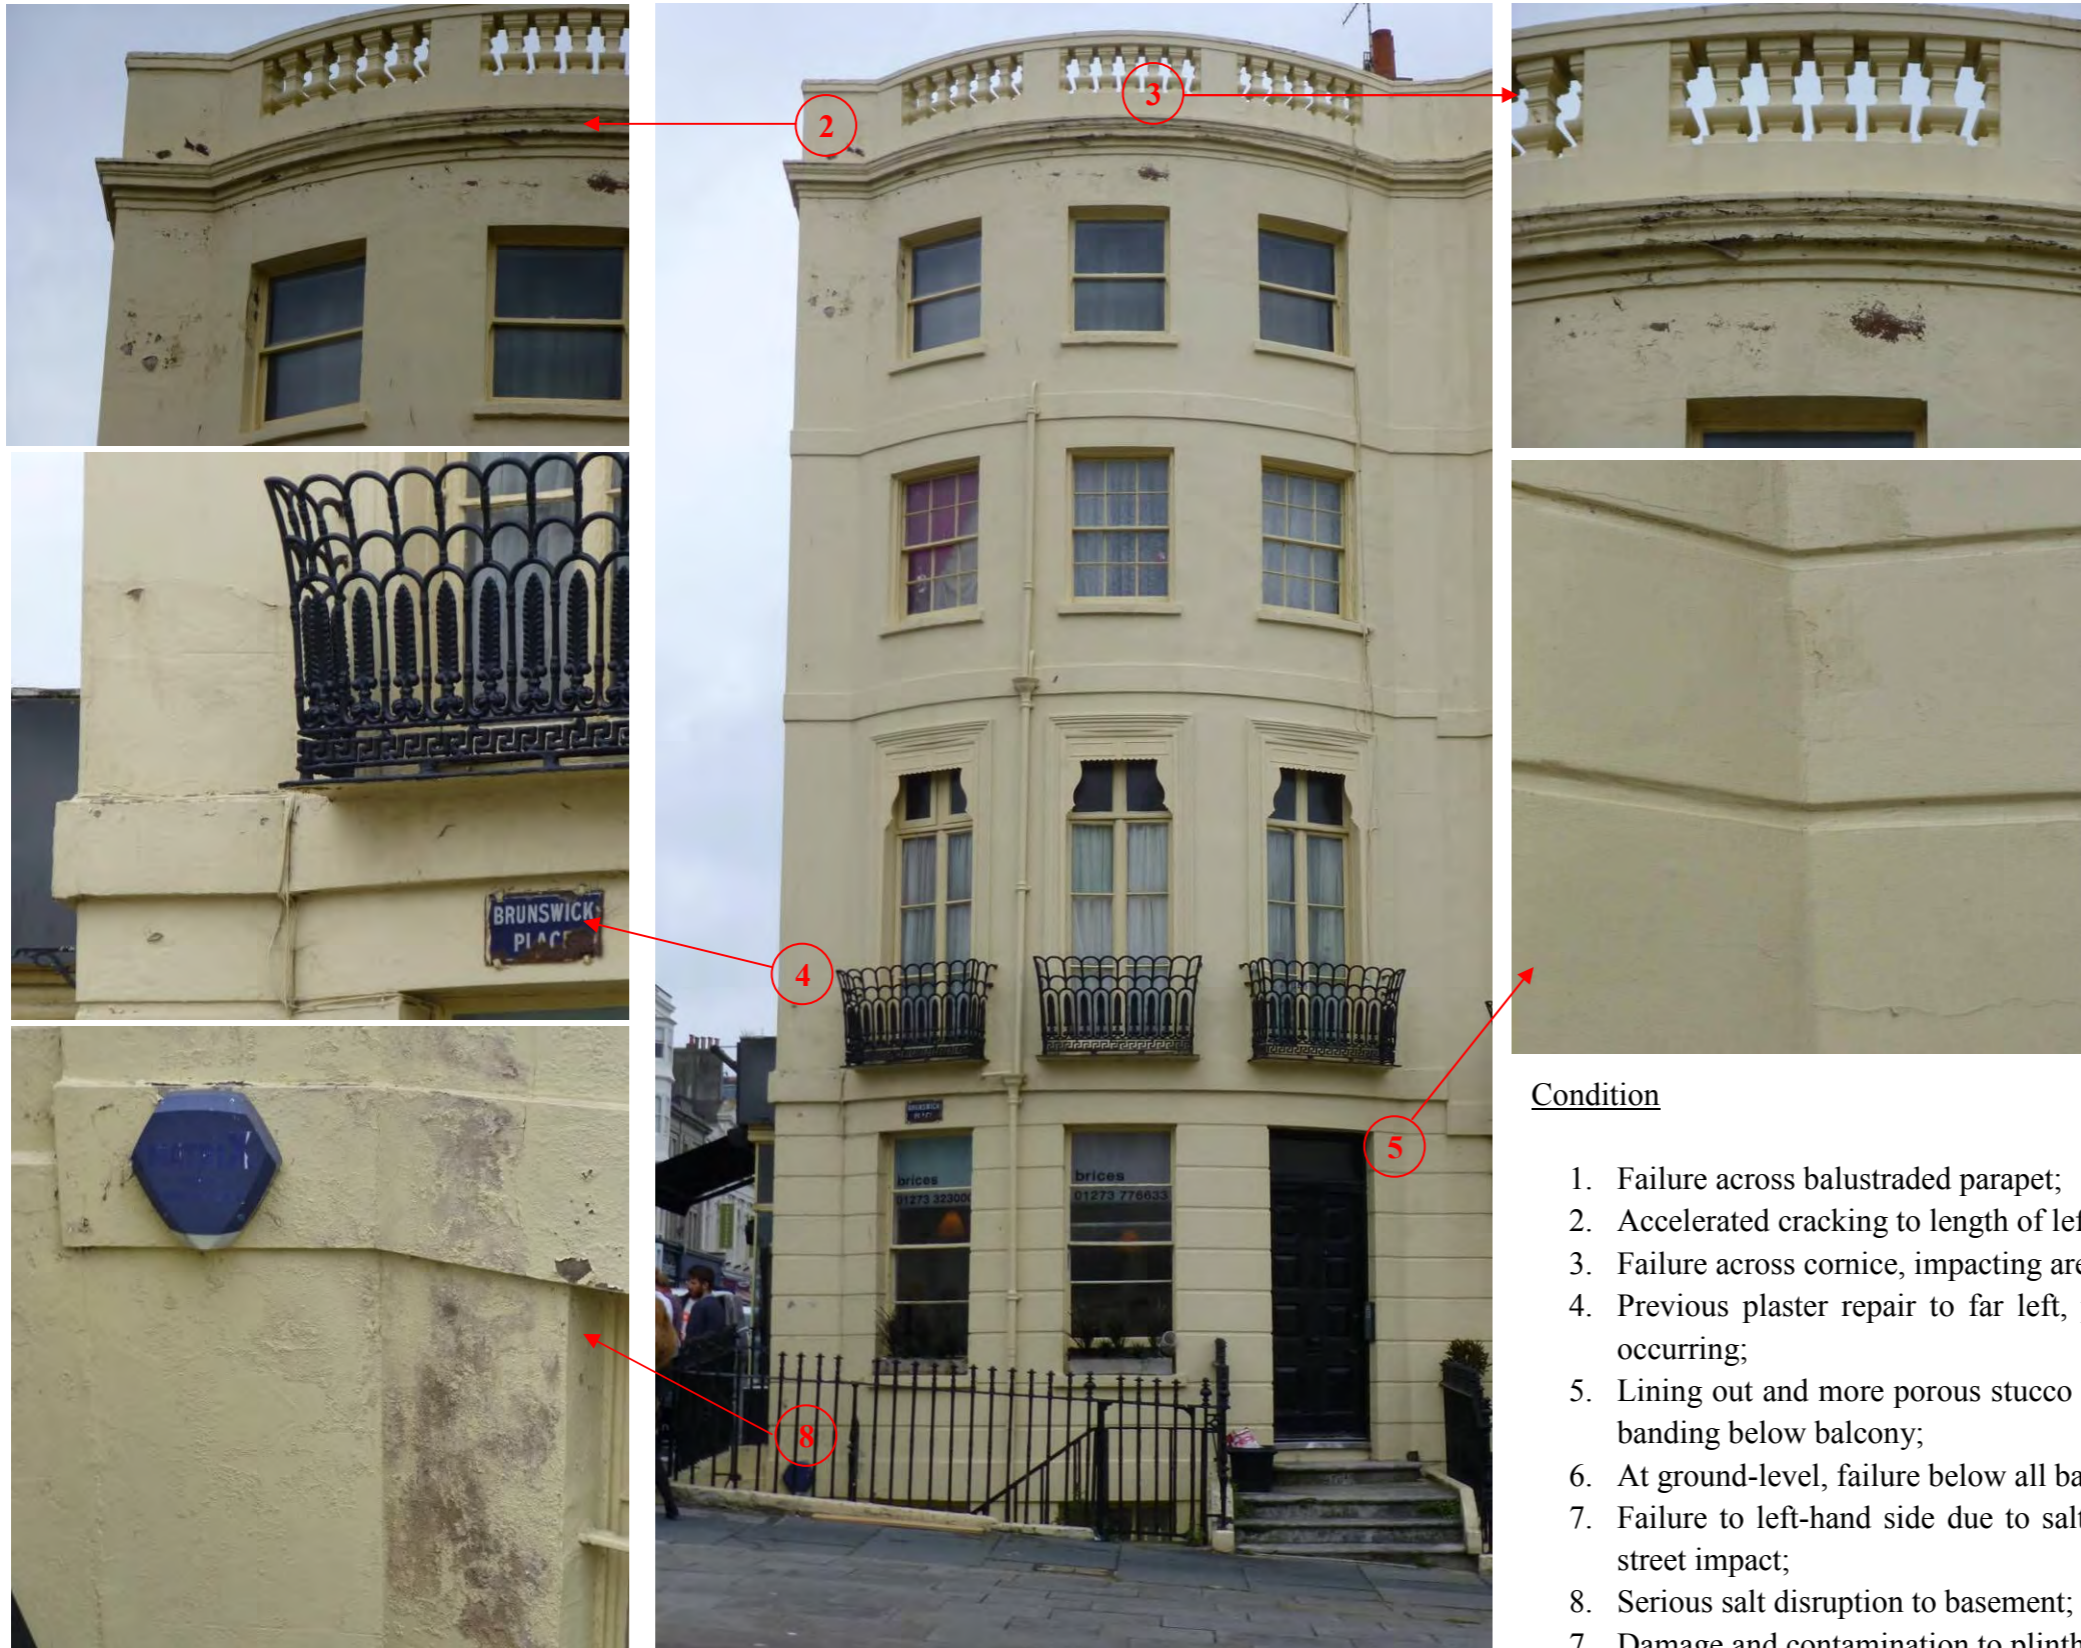
8 Brunswick Place (Brunswick Place Elevation)

1. Failure across balustraded parapet;
2. Accelerated cracking to length of left-hand corner due to cracking;
3. Failure across cornice, impacting area directly beneath;
4. Previous plaster repair to far left, poorer substrate where failure is occurring;
5. Lining out and more porous stucco below an area of failure, abutting banding below balcony;
6. At ground-level, failure below all balconies;
7. Failure to left-hand side due to salt issues, probably exacerbated by street impact;
8. Serious salt disruption to basement;
7. Damage and contamination to plinth wall detrimental to paint.

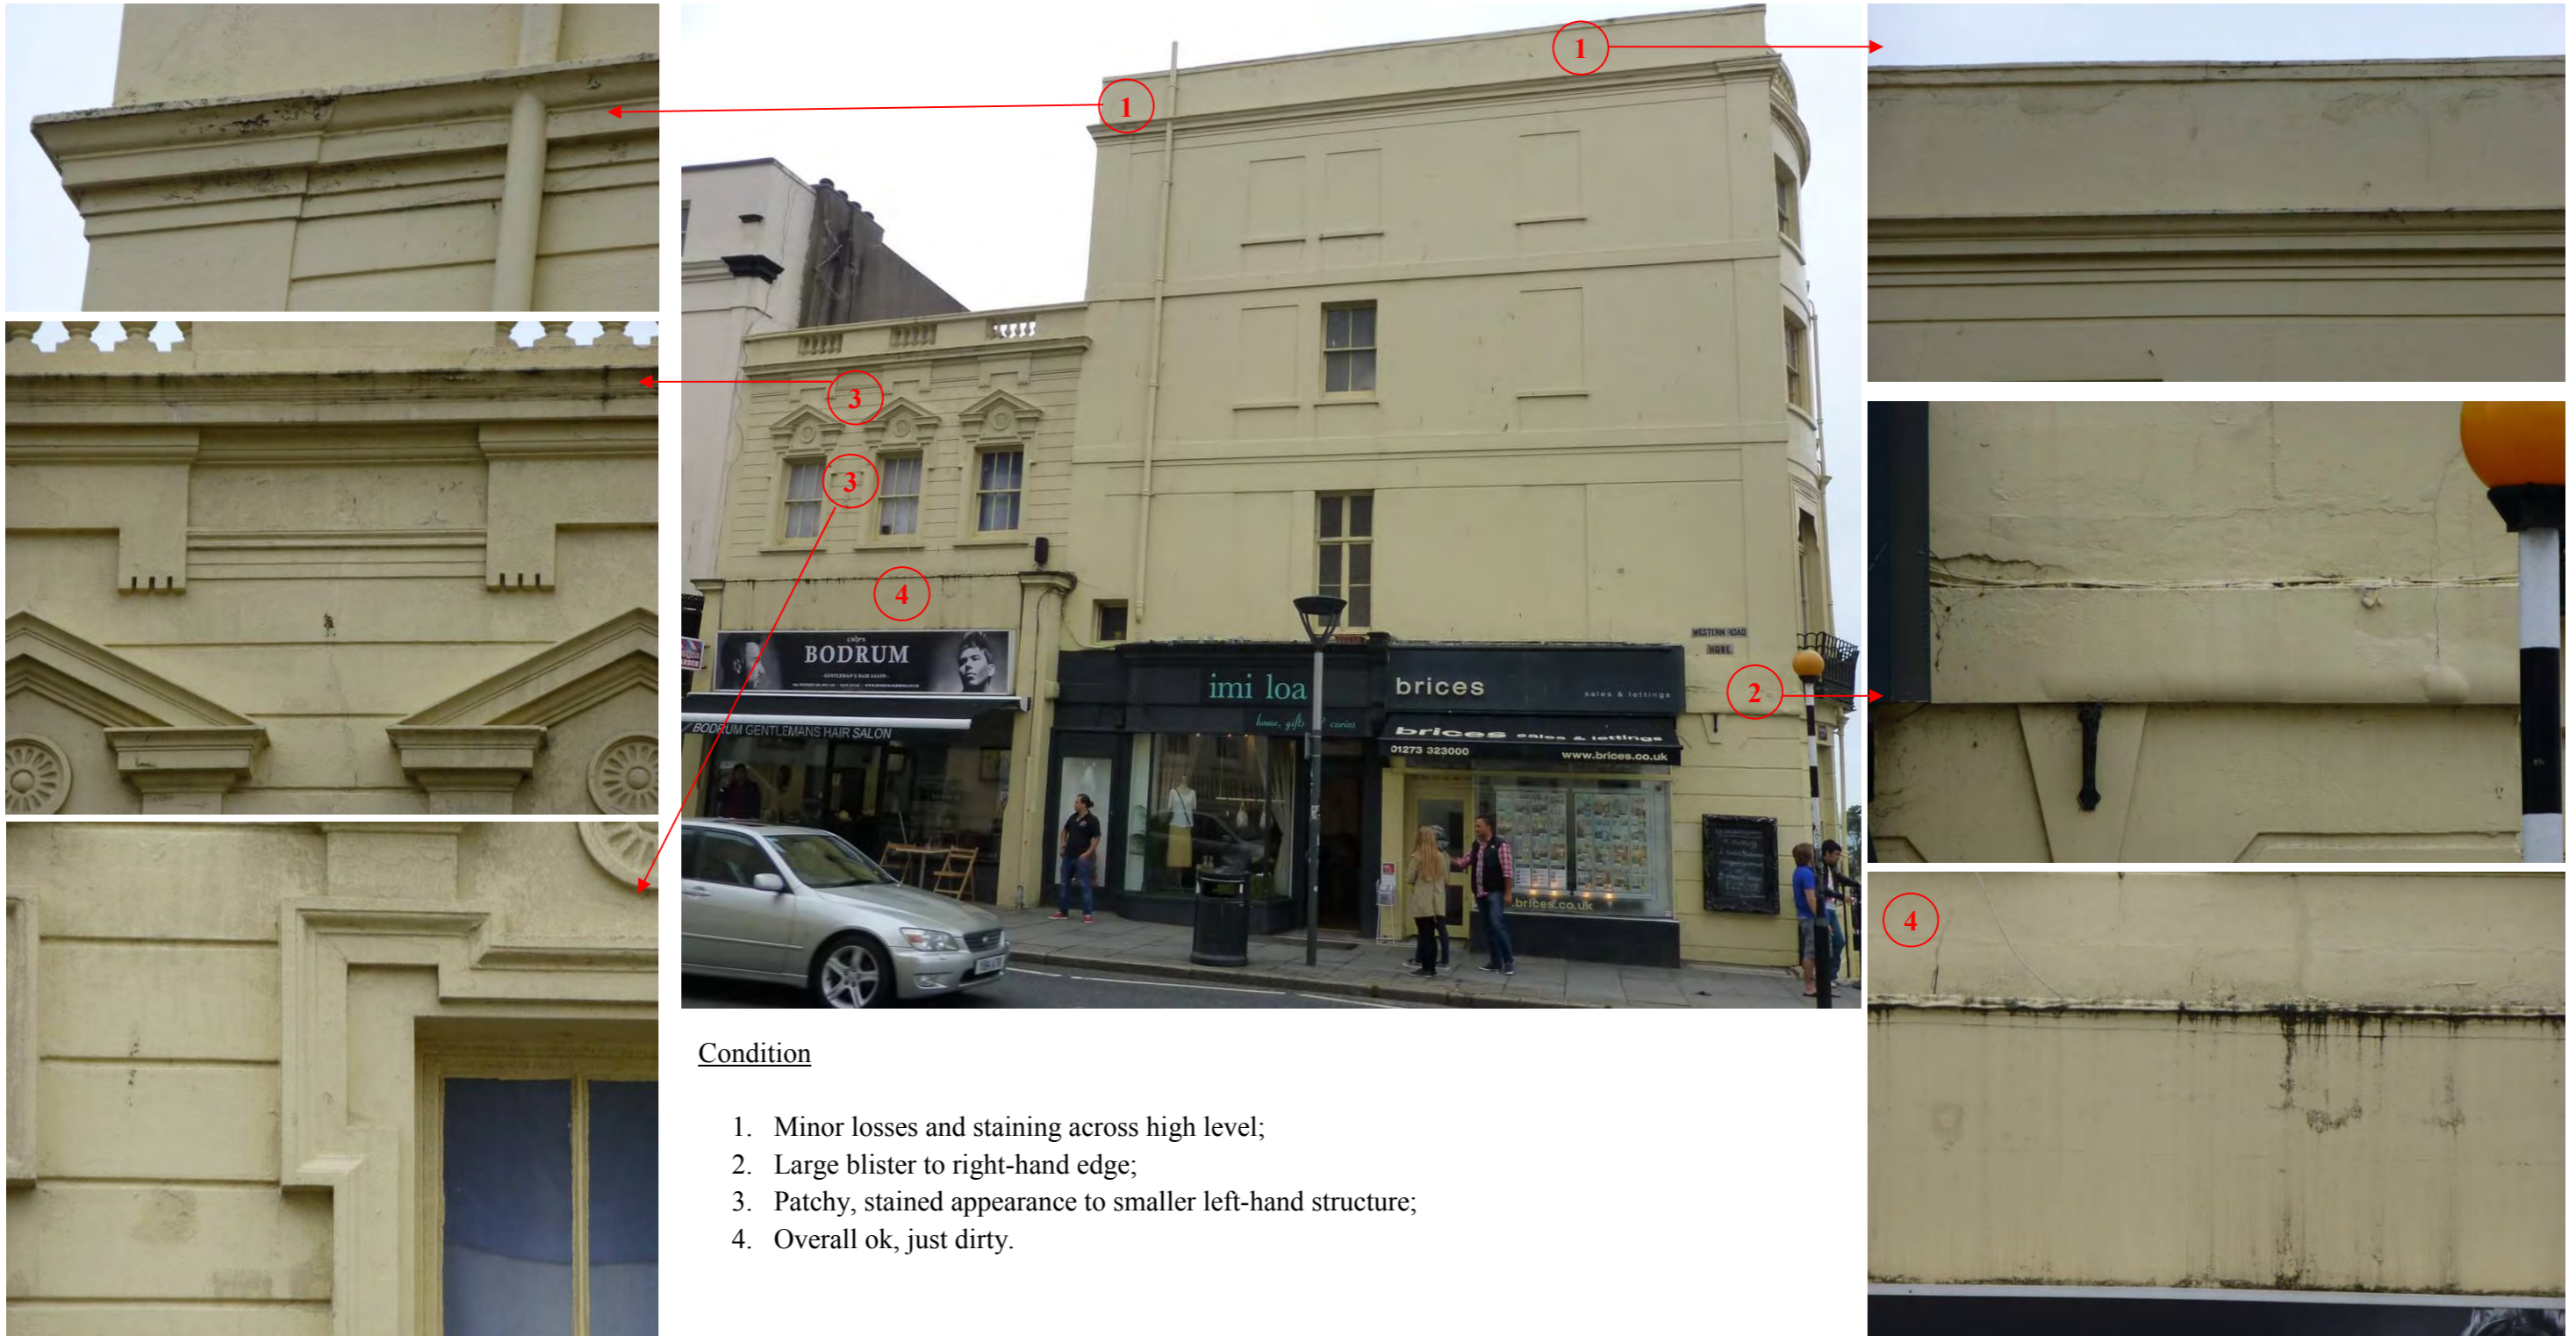
8 Brunswick Place (Western Road Elevation)

1. Minor losses and staining across high level;
2. Large blister to right-hand edge;
3. Patchy, stained appearance to smaller left-hand structure;
4. Overall ok, just dirty.

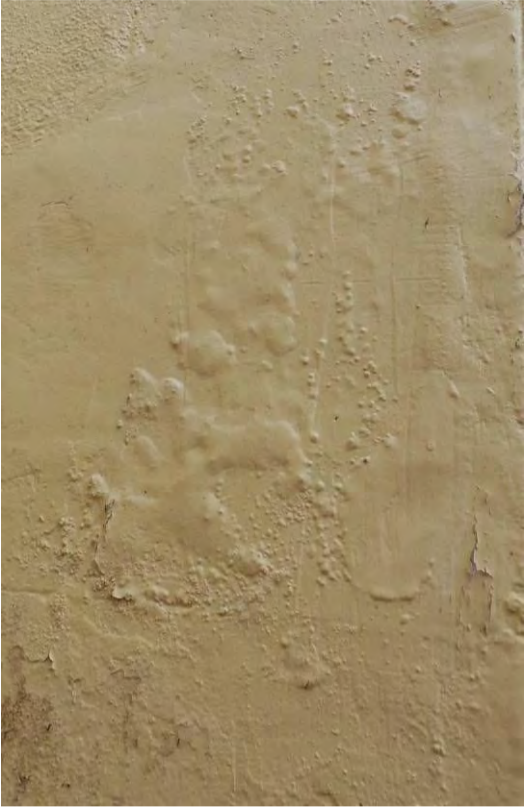
Defect	Possible Causes	Example
Blistering	Damp substrate; Trapped moisture

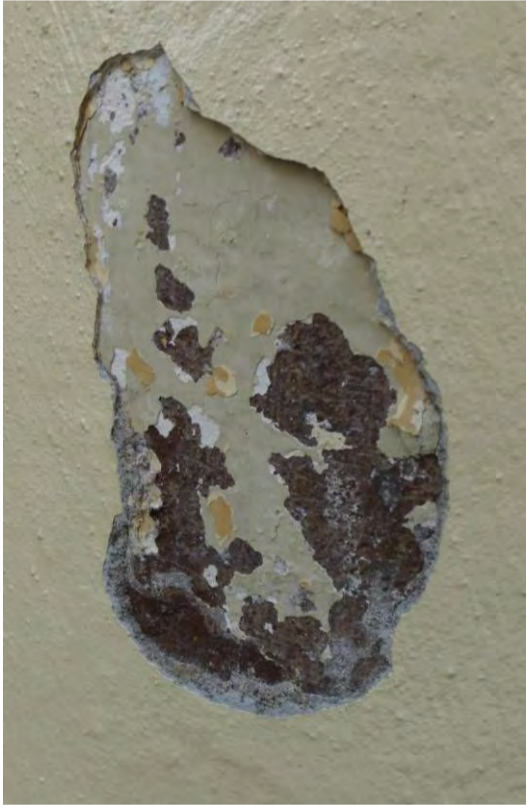
Flaking	Aging underlying layers become brittle and crack (blind-cleavage)

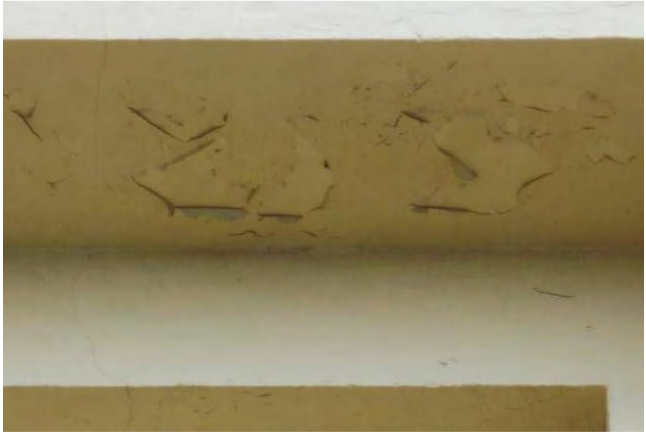
<p data-bbox="1094 2021 1770 2059">(Cracking to underlying layers (blind-cleavage) visible)</p>
Peeling	Poor adhesion as molecules failed to coalesce due to insufficient temperature

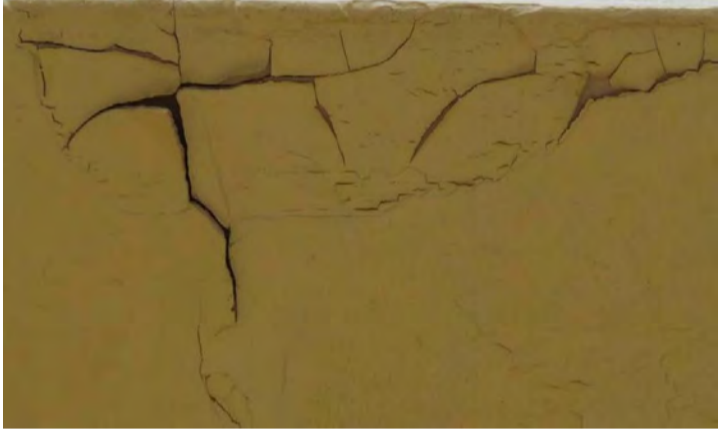
Defect	Possible Causes	Example
Cratering	Incorrect applicator; Applied too quickly (bubbling); Painting unprimed porous substrate	 
Staining	Environmental factors	 
Mud-cracking	Applied in too cool conditions; Paint has become viscous

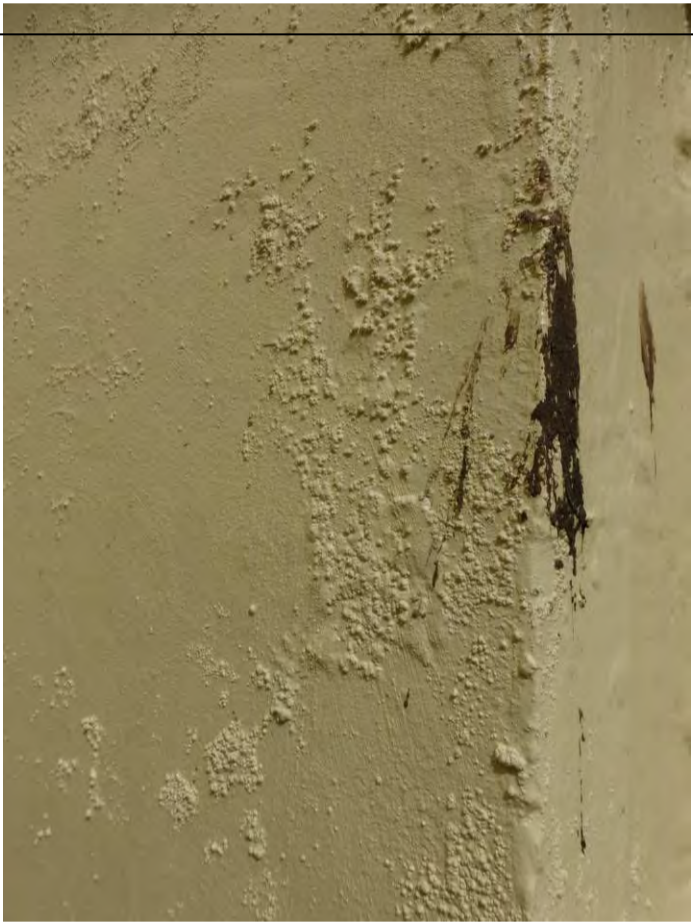
Defect	Possible Causes	Example
Failure along fractures	Moisture ingress through weak point; Paint incompatible with filler	 
Salt-efflorescence

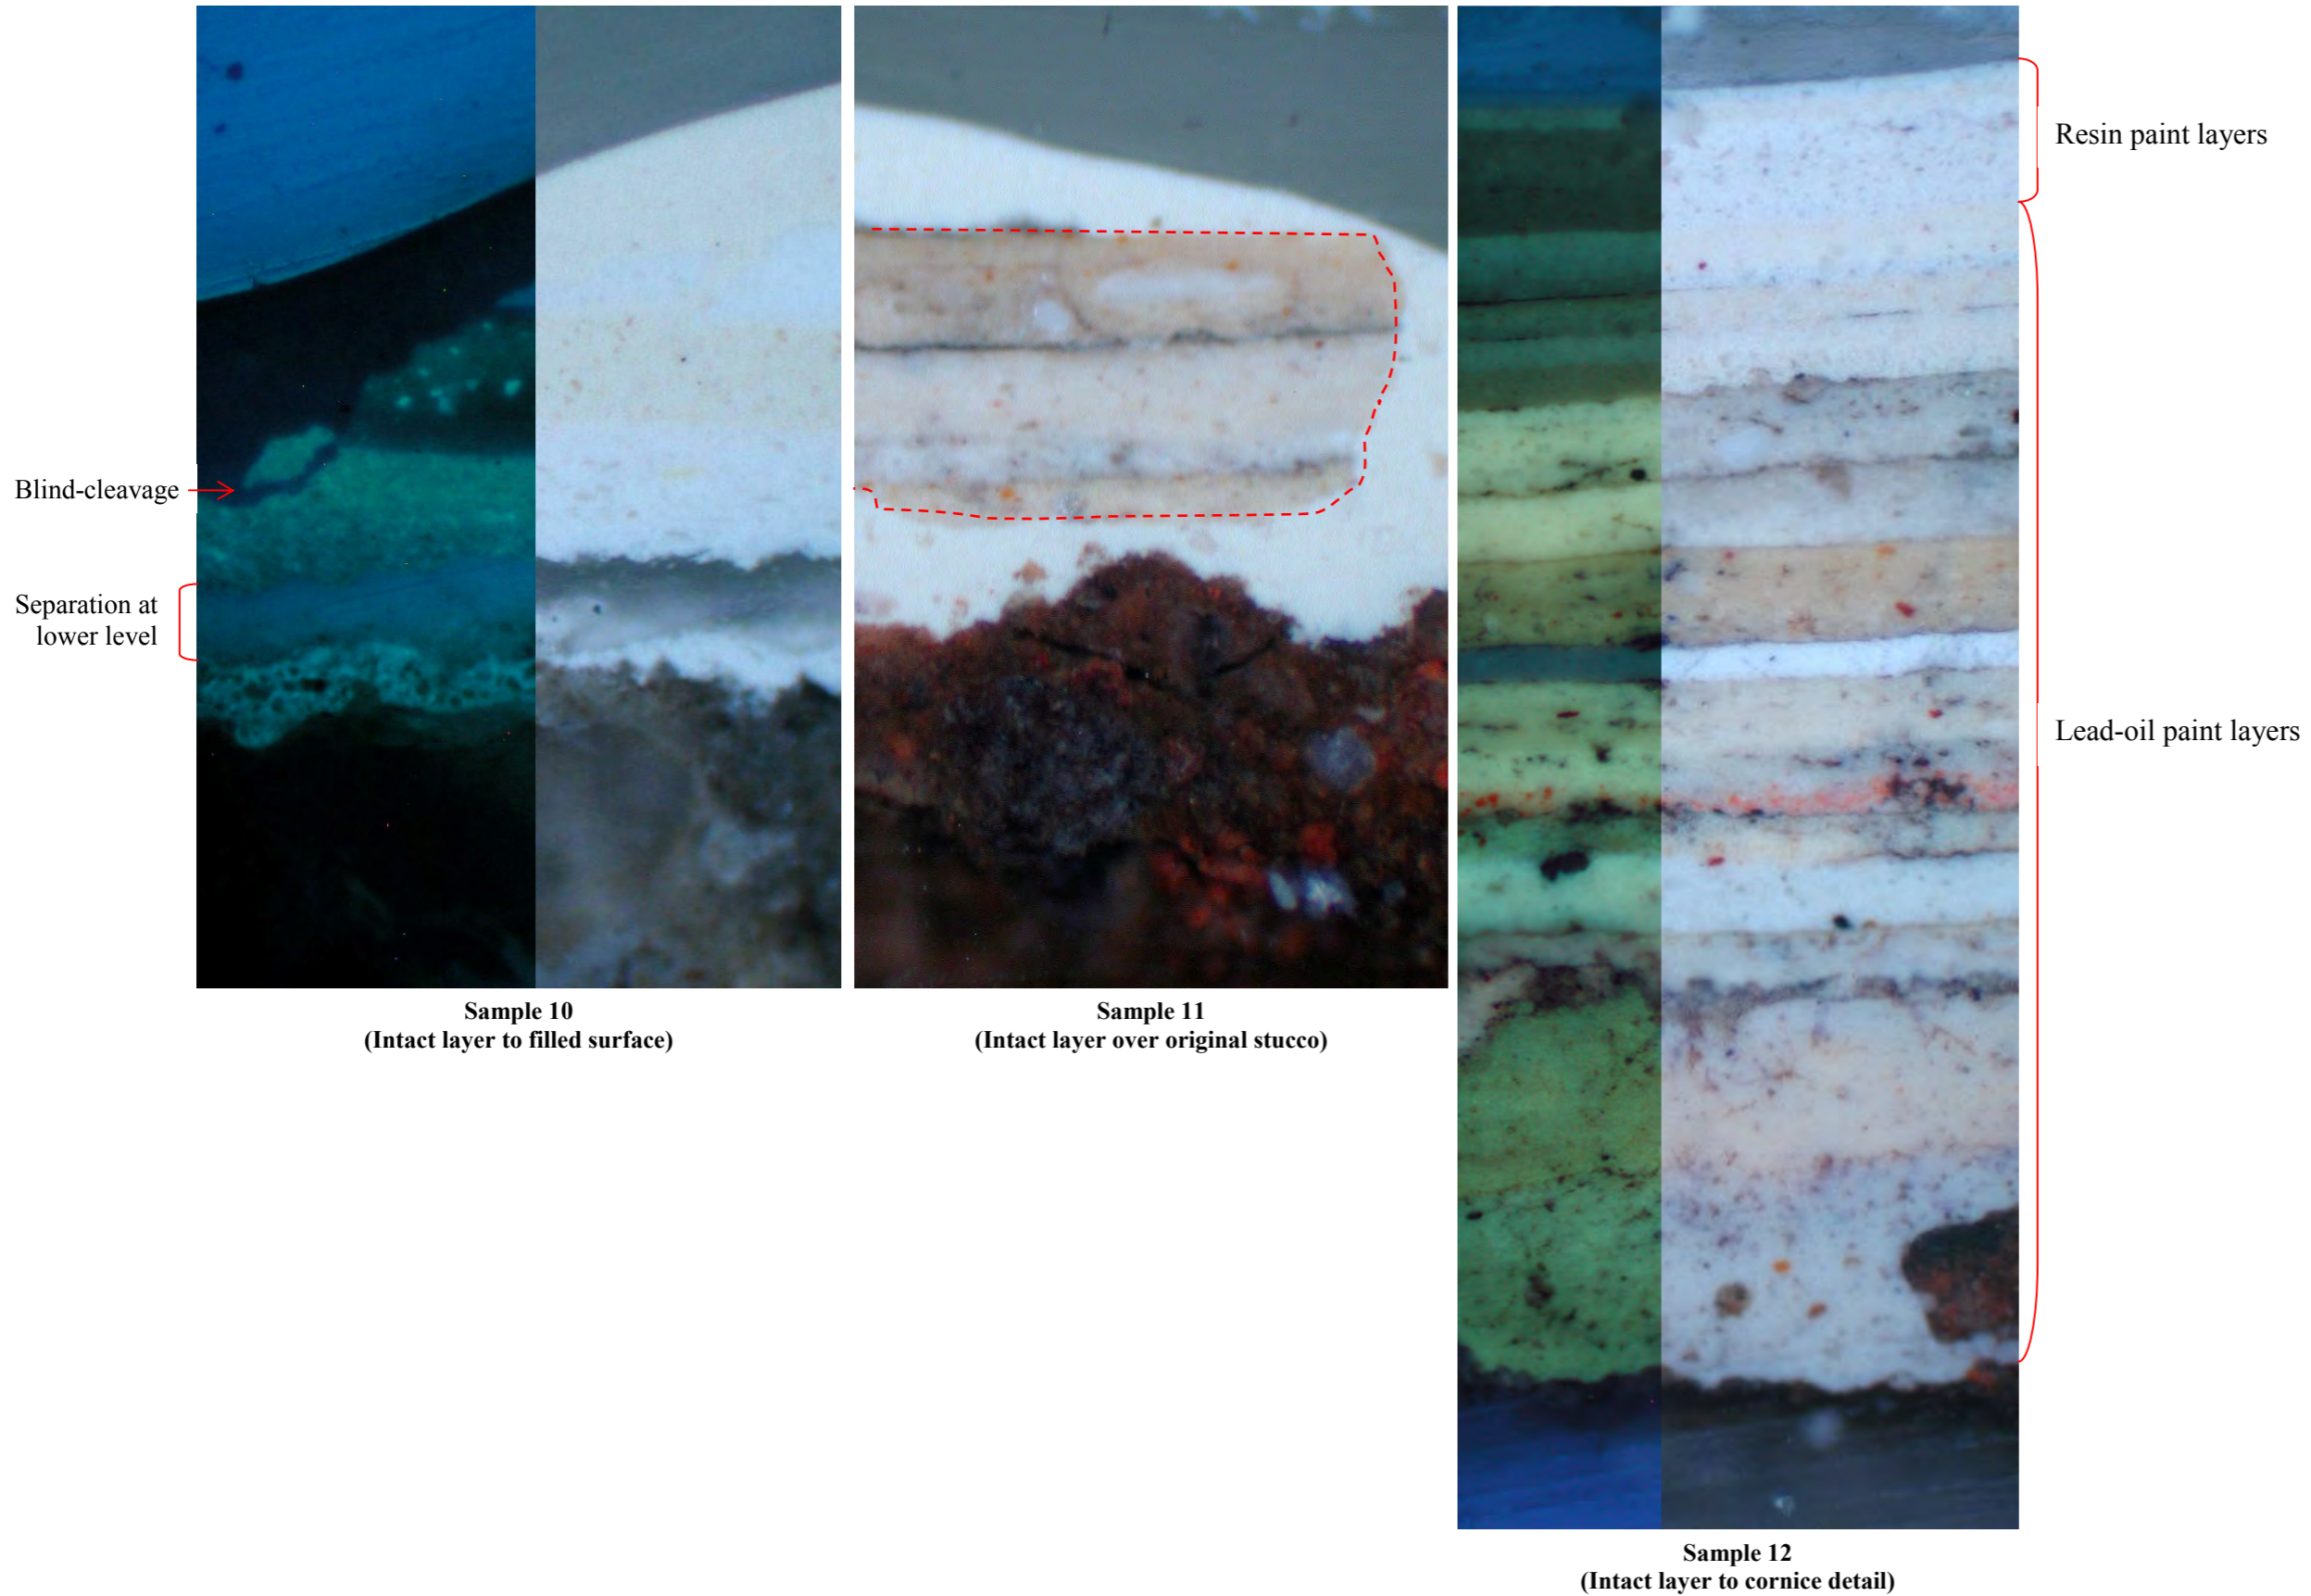
5.2.2 Stratigraphy

Samples 10, 11 and 12 are from the same area of intact, sound surface to a cornice.

Sample 10 shows delamination of earlier oil-paint layers at the substrate level, along with blind-cleavage through subsequent layers.
