**Investigation of Paint Failure at
Brunswick Estate
Hove
Brighton**

August 2013

**BRUNSWICK ESTATE
HOVE**

The following document investigates the failure of the external paint-system at Brunswick Estate, Hove based on research carried out by Elizabeth Hirst and Rachel Morley of Hirst Conservation between August and November 2013. The work was commissioned by Brighton & Hove City Council.

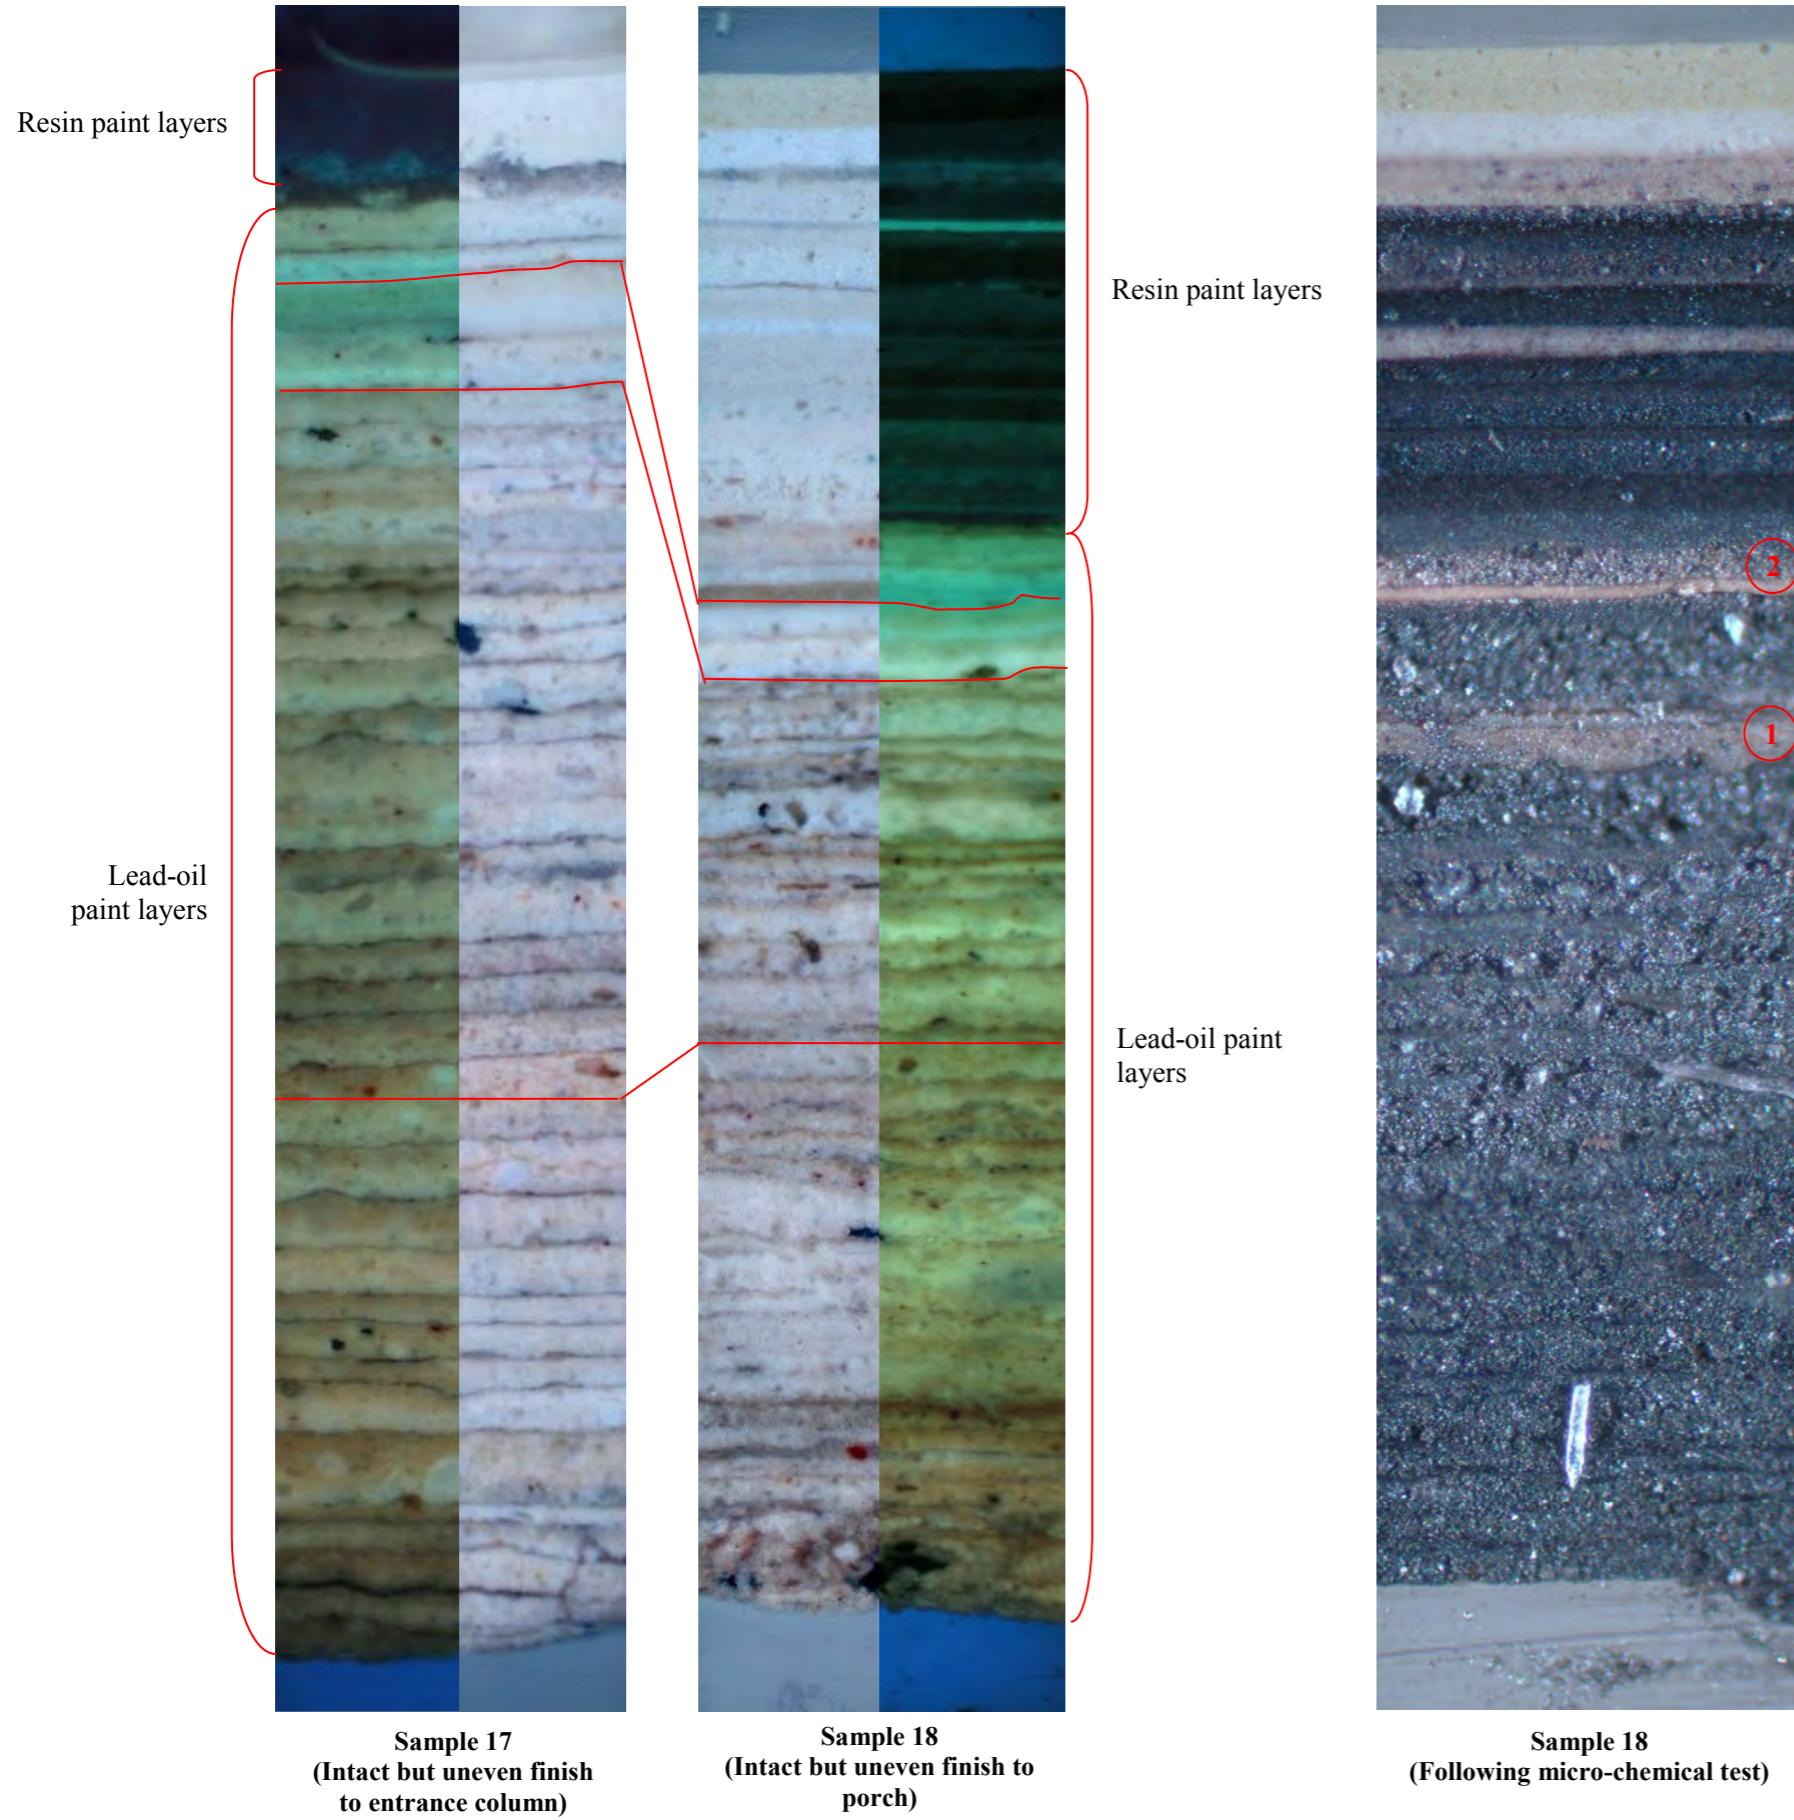
5.4.2 Stratigraphy

Samples 17 and 18 are taken from different architectural features of a porch and highlight the different treatment received by each.

Some layers between both marry together, as indicated by the solid red line, but one element has been stripped back or not painted as routinely as the other.

Finally, in sample 17 fracturing is visible in some of the earlier layers. While not an issue at present, should the critical loading of the paint-film be reached, this could result in failure.

Sample 18 stained with sodium sulphide tested positive for lead paints; sodium sulphide dyes lead black. The unstained layers number 1 and 2 are lead/zinc-oil and zinc-oil paints respectively. The earlier modern resin paints have stained moderately positive for lead, as they may contain lead driers – the use of lead driers added to alkyd and modern synthetic resin paints continued up until the 1970s. Further micro-chemical analysis is required to confirm this.

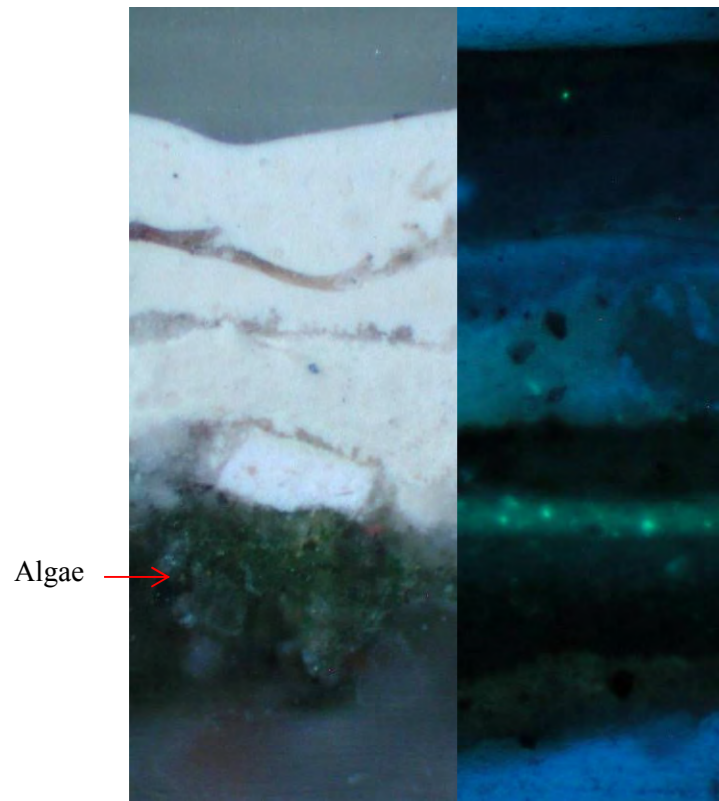
Sample 19
(Flaking finish to entrance column)

Sample 19 shows many distorted and unadhered layers with thick algal growth at substrate level. This indicates poor surface preparation and moisture-holding within the substrate which may account for the failure between layers – as in damp conditions molecules struggle to coalesce and form a sound, well-adhered film.

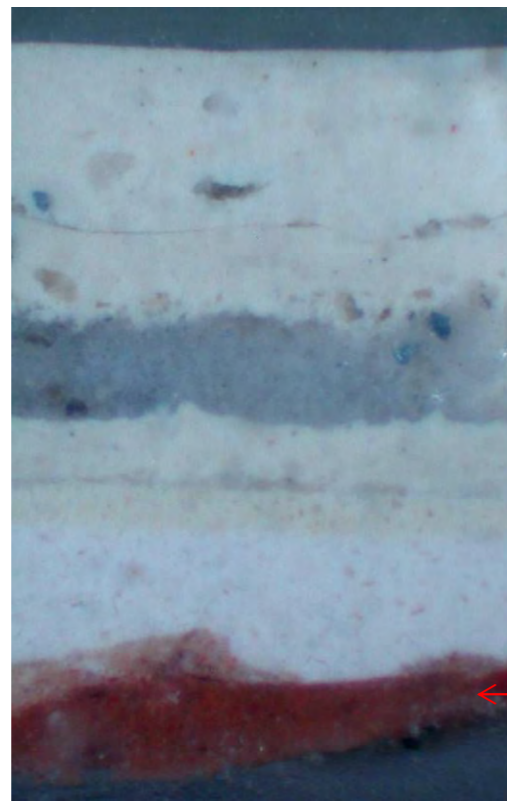
Sample 20
(Flaking finish to entrance column, higher than previous sample)

Red base layer

Sample 20 was taken from the same column yet reveals very different treatment. Micro-chemical stain tests reveal that the red layer, which is seen in a number of samples, is an iron-oxide primer. A layer of filler has been applied over existing paint-layers.

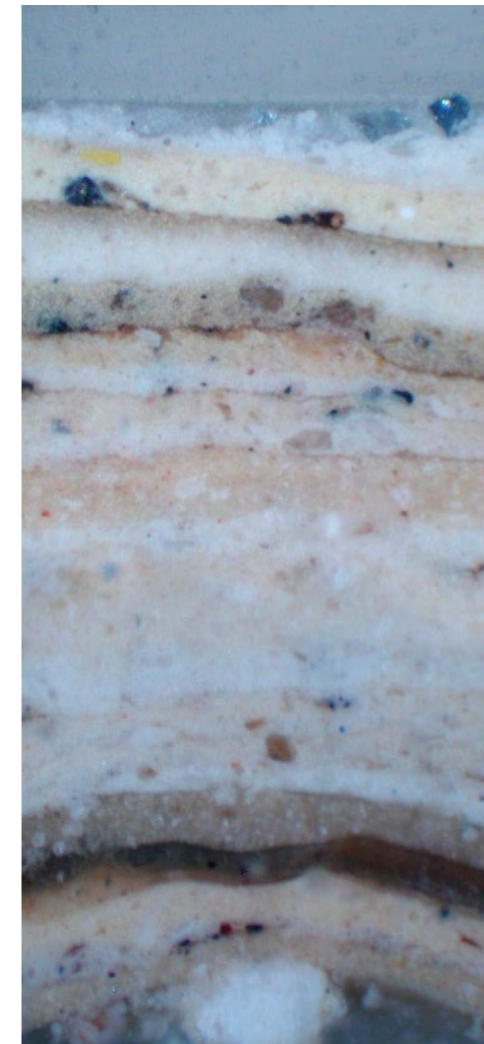
Sample 21
(Intact surface to recess behind column)

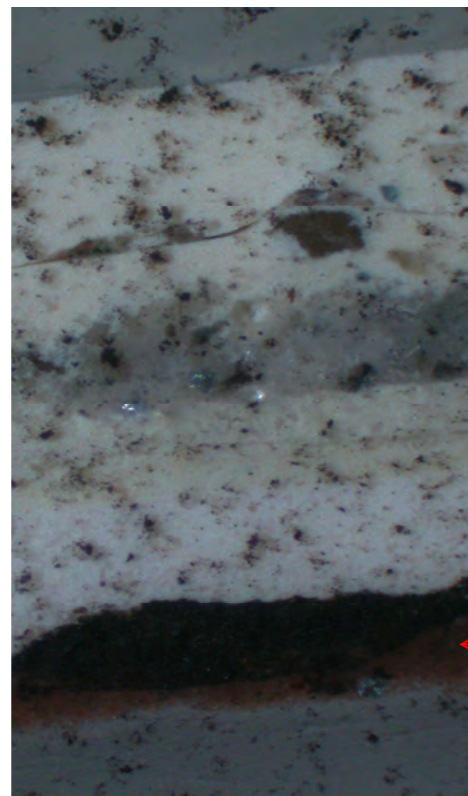
Sample 20
(Photographed in reflected light following stain test)

Base layer:
iron-oxide primer

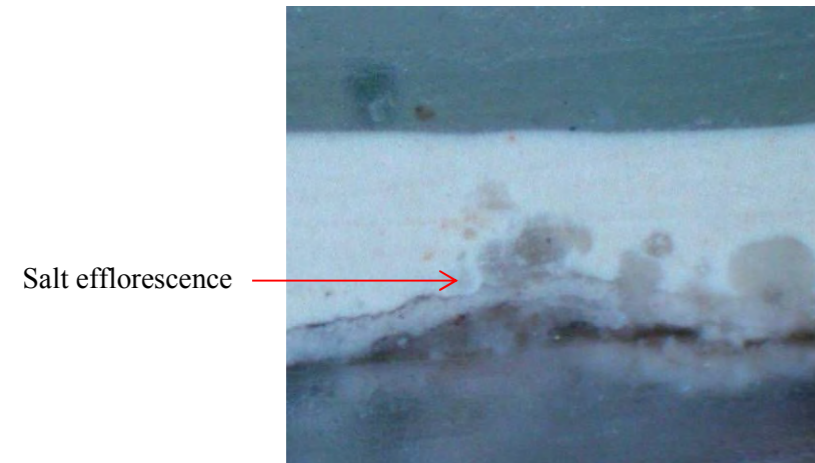
Sample 22
(Salt disrupted layer)

Sample 22 shows salt efflorescence through the paint layer. Sample 23 shows disruption, with modern paints under remnants of older films. Sample 24 contains modern layers only.

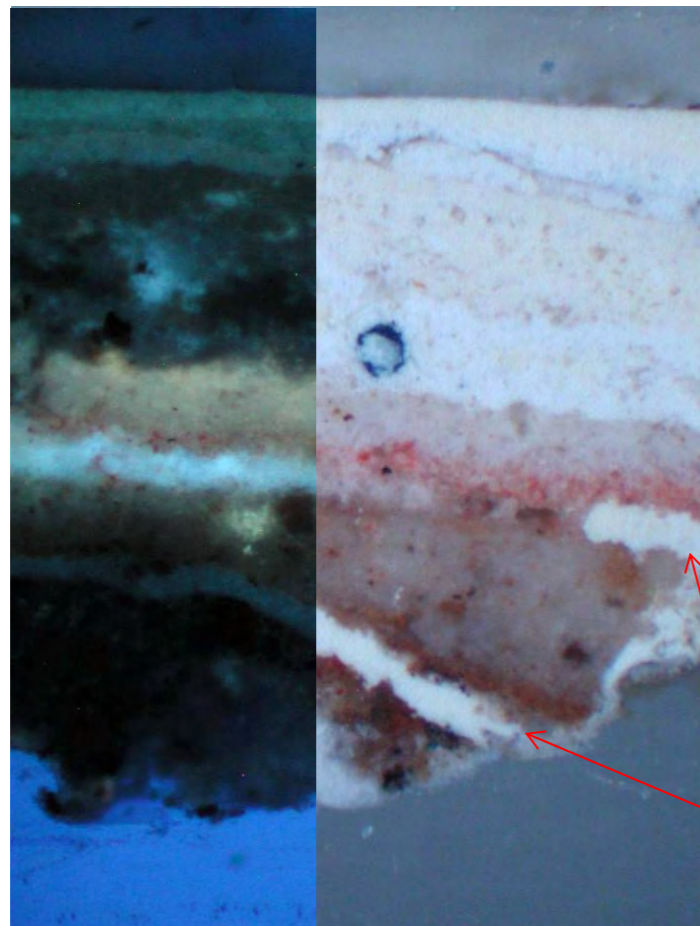
Sample 23
(Thinner finish to flaking area)

Modern paint under
older layer

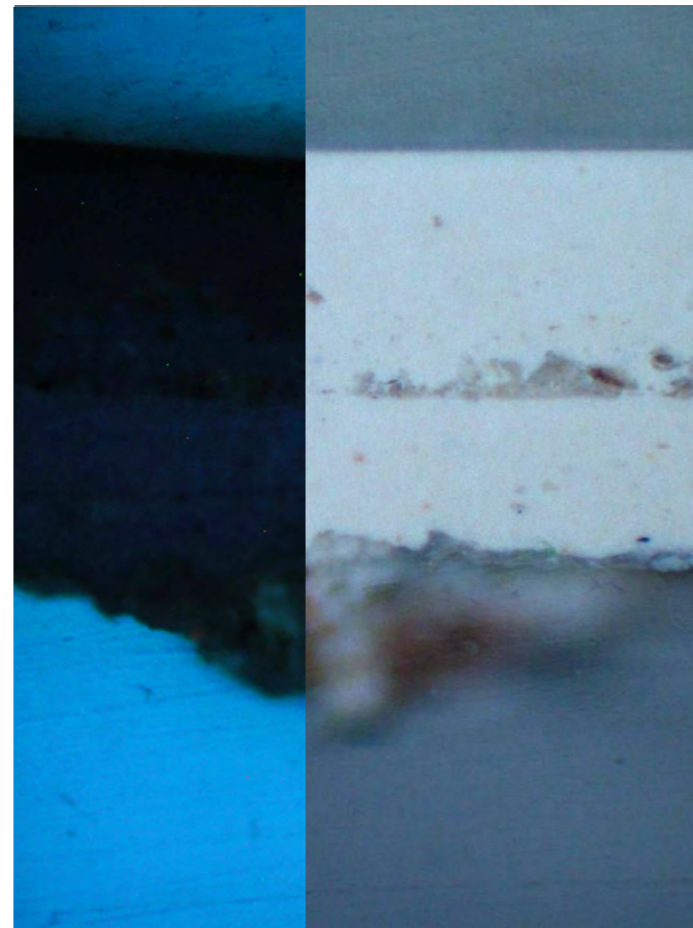
Sample 24
(Thicker finish to flaking area)

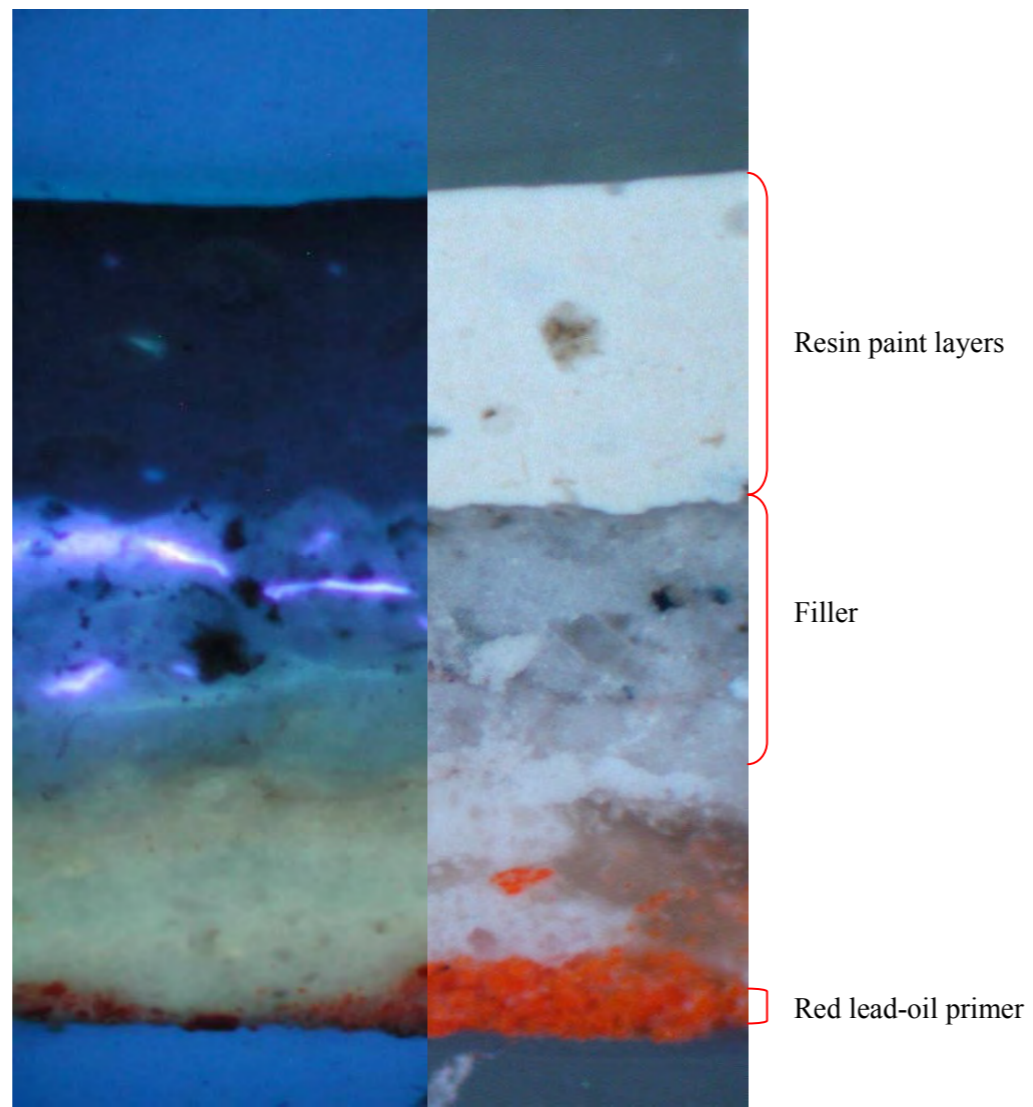
Sample 26
(Thicker finish to flaking area)

Sample 26 is taken from entrance jamb experiencing localised failure. The modern layers appear well intact and with good adhesion. There is evidence of filler spread over older old-based layers, indicating previous failure.

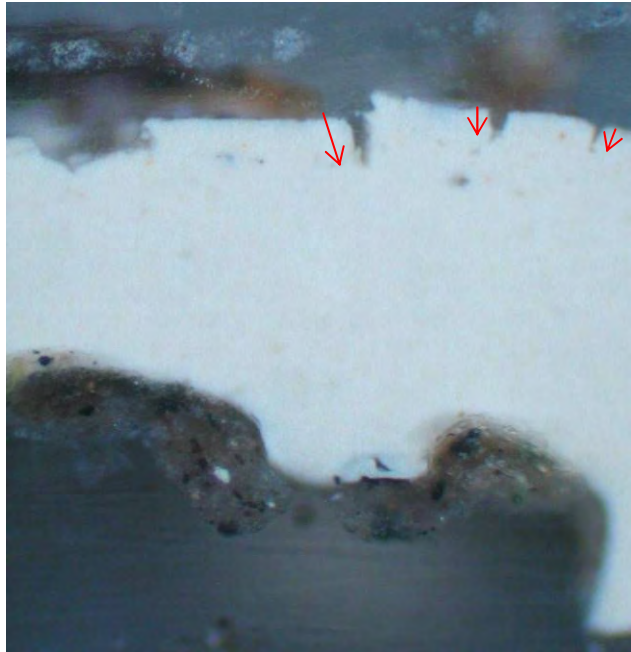
Sample 01

Vertical 'mud' cracking: indicating painted below minimum film forming temperature (MFFT);

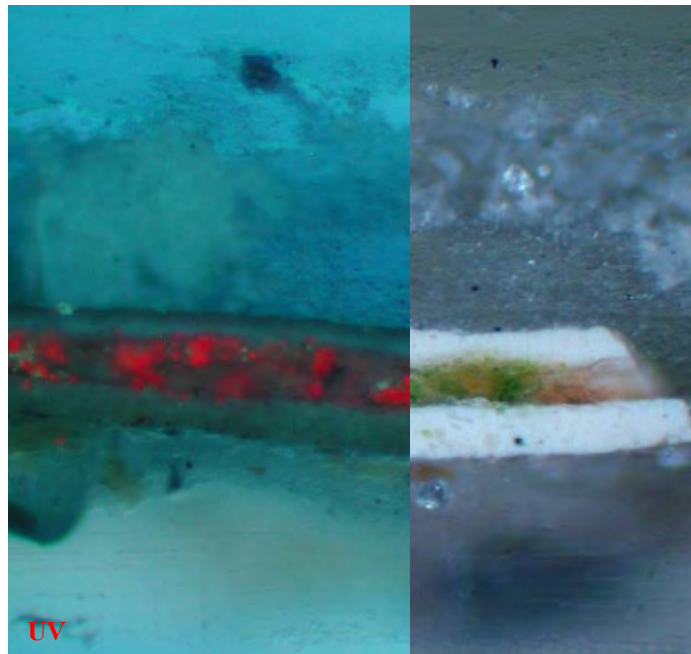
Sample 02

Algae: denoted by red in UV and green in reflected light, indicates moisture holding in substrate; in this instance, growth between layers suggests poor surface preparation;

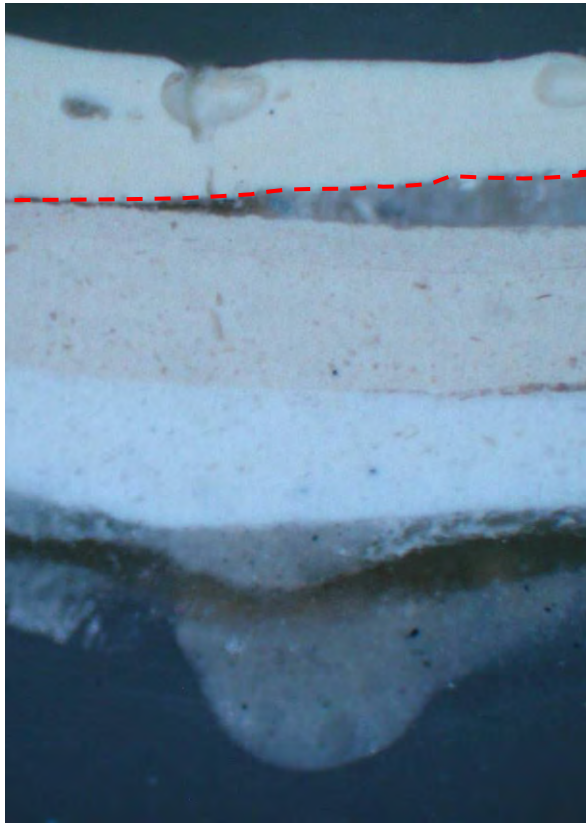
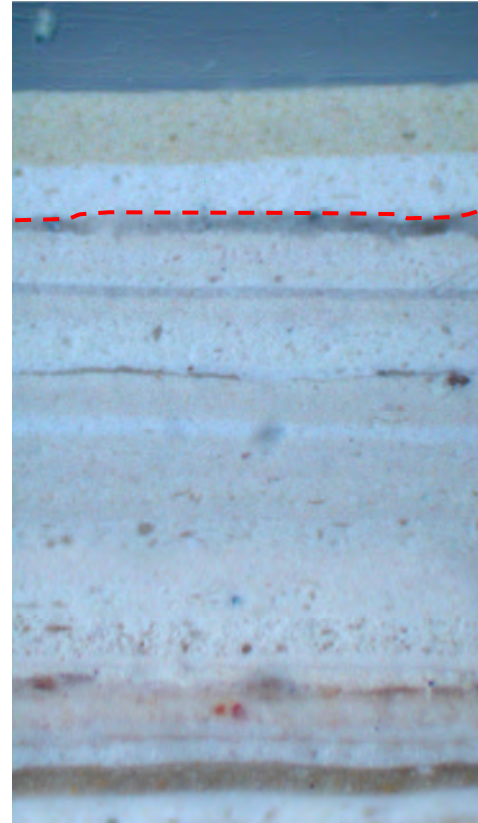
Failure at a specific interface: suggesting issues of critical loading, due to build up of layers, or impaired paint layer adhesion due to poor preparation;

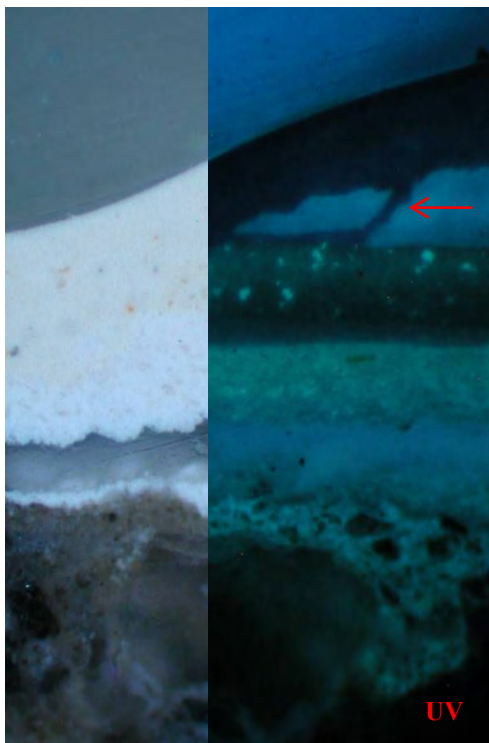
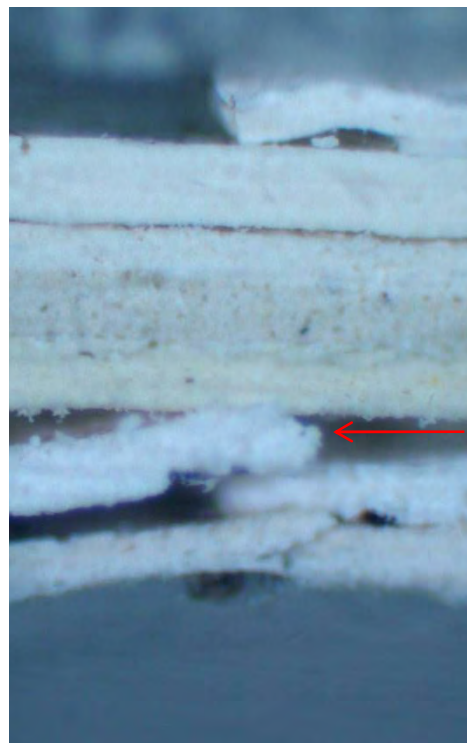
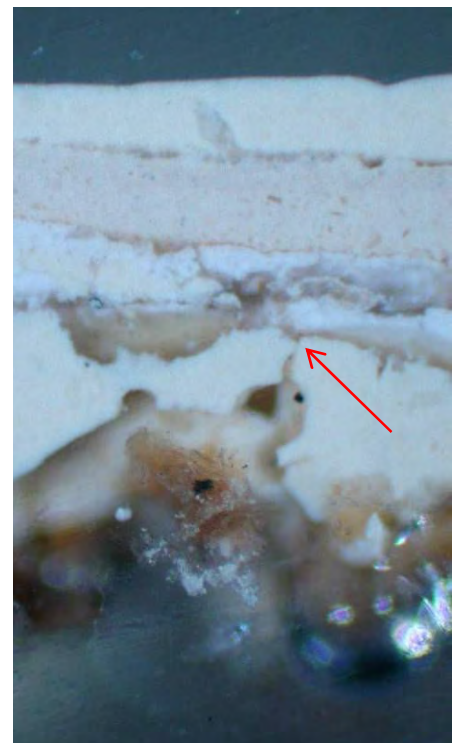
Blind cleavage: cracking of underlying, degraded layers providing unstable substrate for newer system;

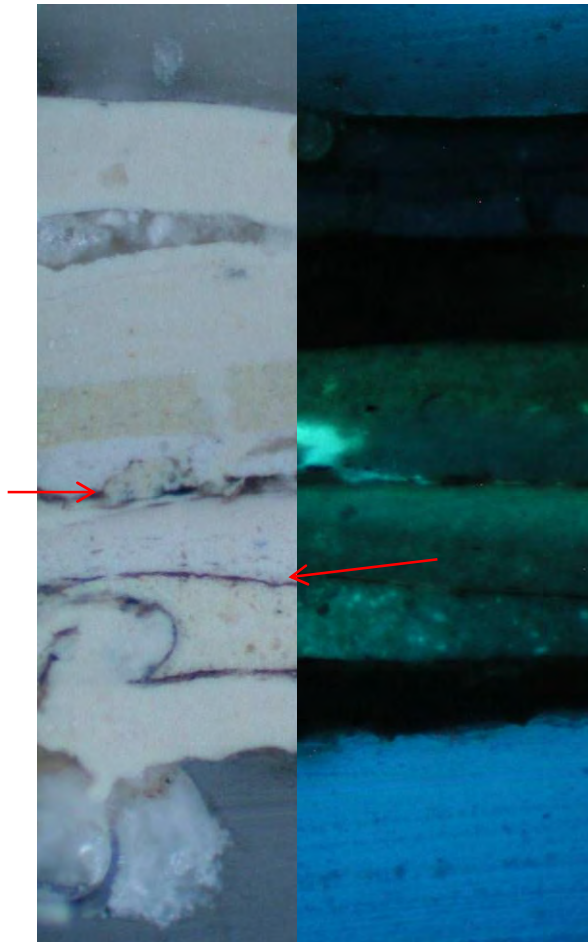
Sample 06

Aggregate grains/dirt between layers: indicating poor surface preparation;

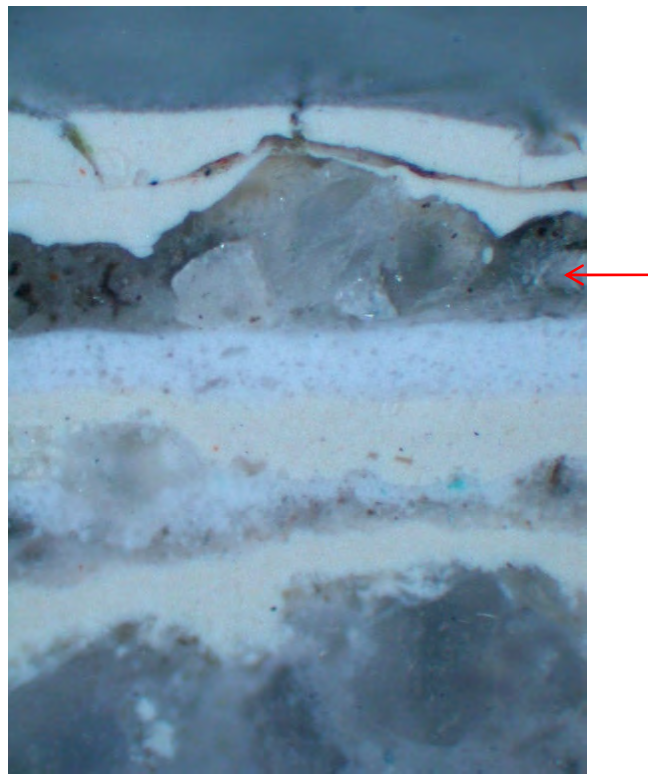
Sample 09

Fillers spread between paints: poor practice, issues with adhesion;

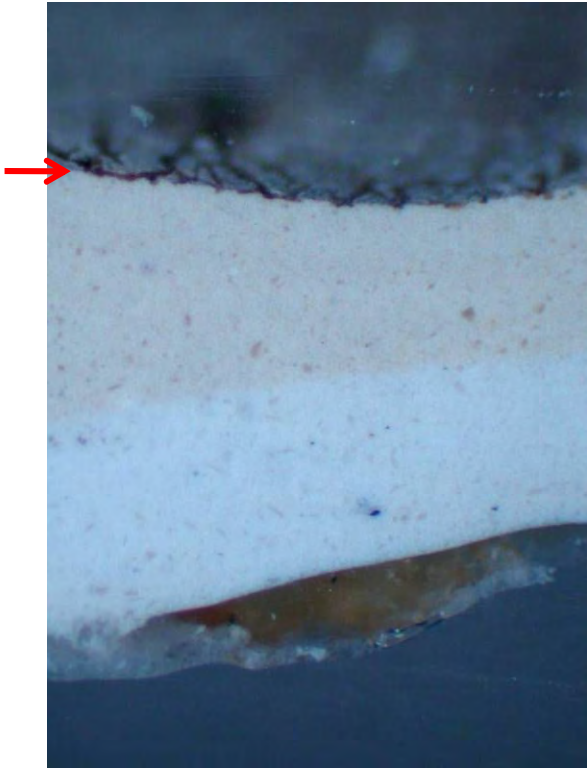
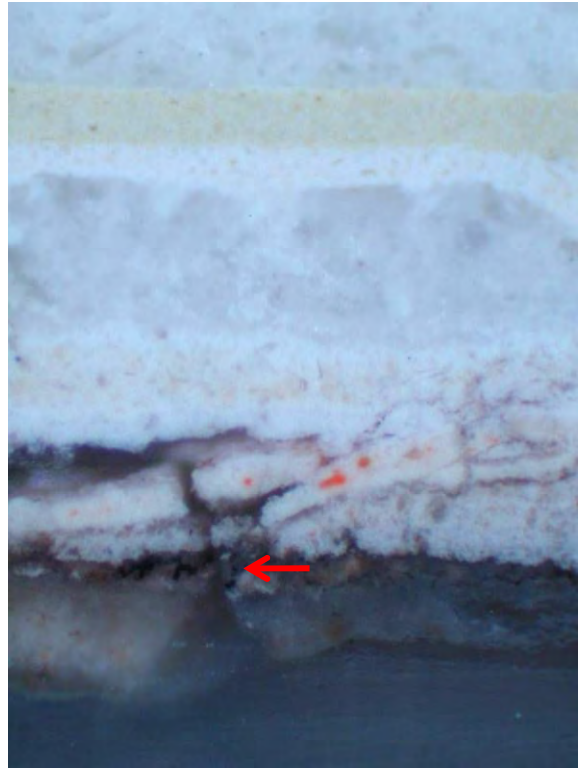
Organic cilia: indicating moisture from substrate or penetration through micro-cracked surface, or poor surface preparation;

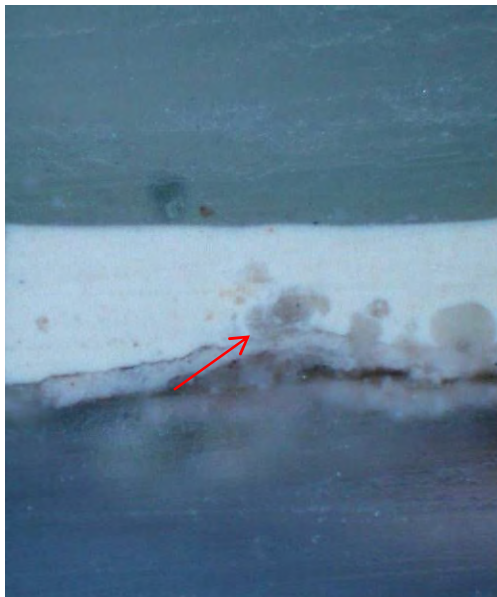
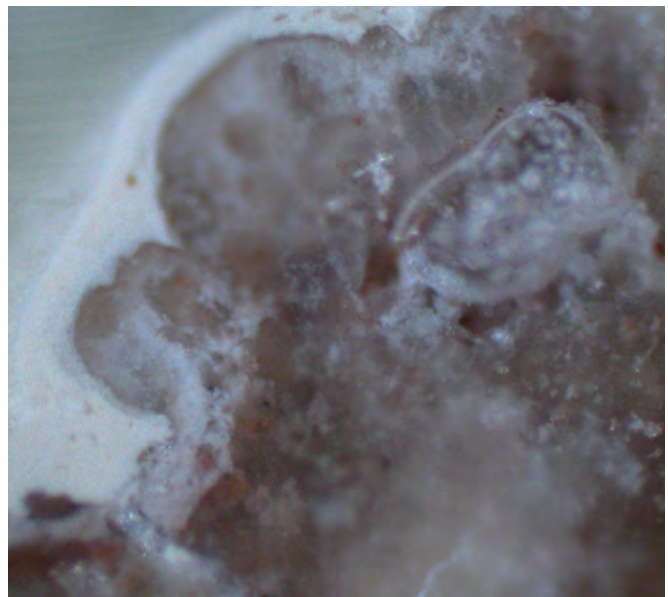
Sample 22

Salt efflorescence from substrate disrupting paint layer;

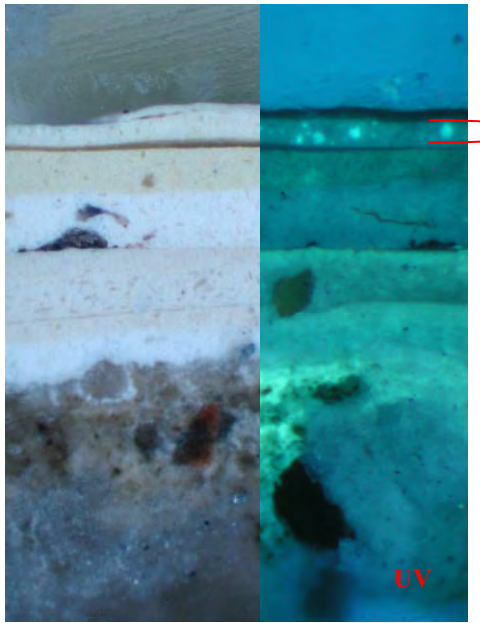
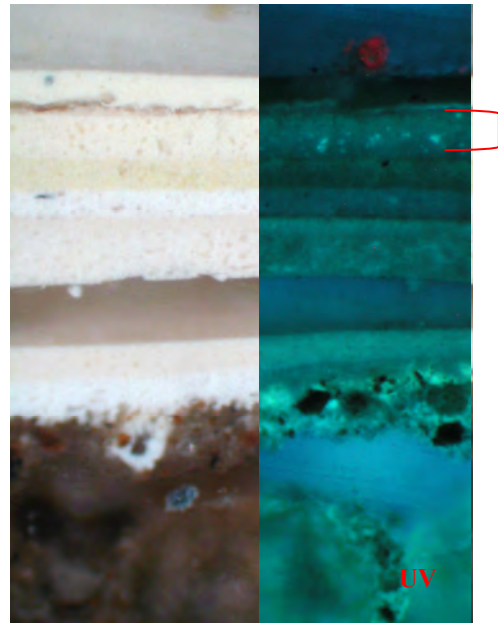
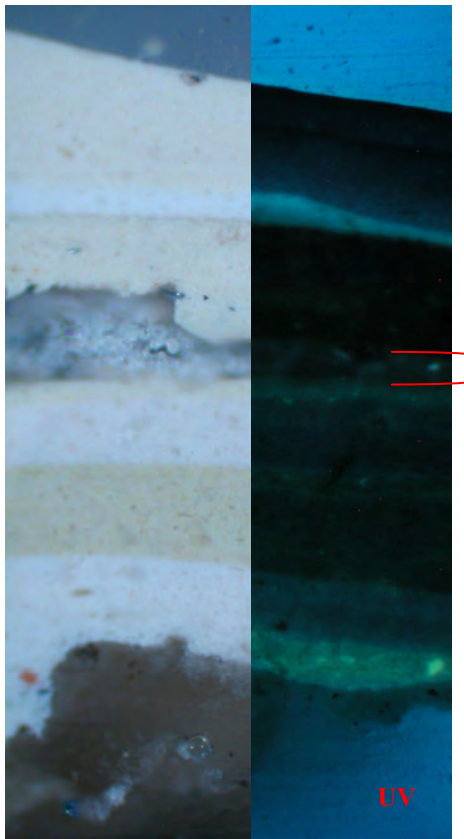
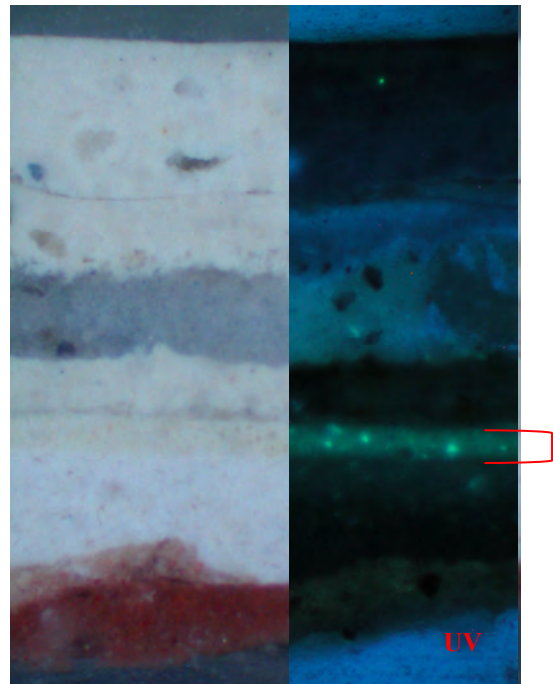
Aged zinc-oil paint: zinc paint has a higher oil demand and dries to a rather brittle film. In several samples, failure was noted at the junction of a zinc-oil paint-film. Above, zinc is denoted by the 'sparkling' layer in the UV photomicrograph and is highlighted by the red bracket.

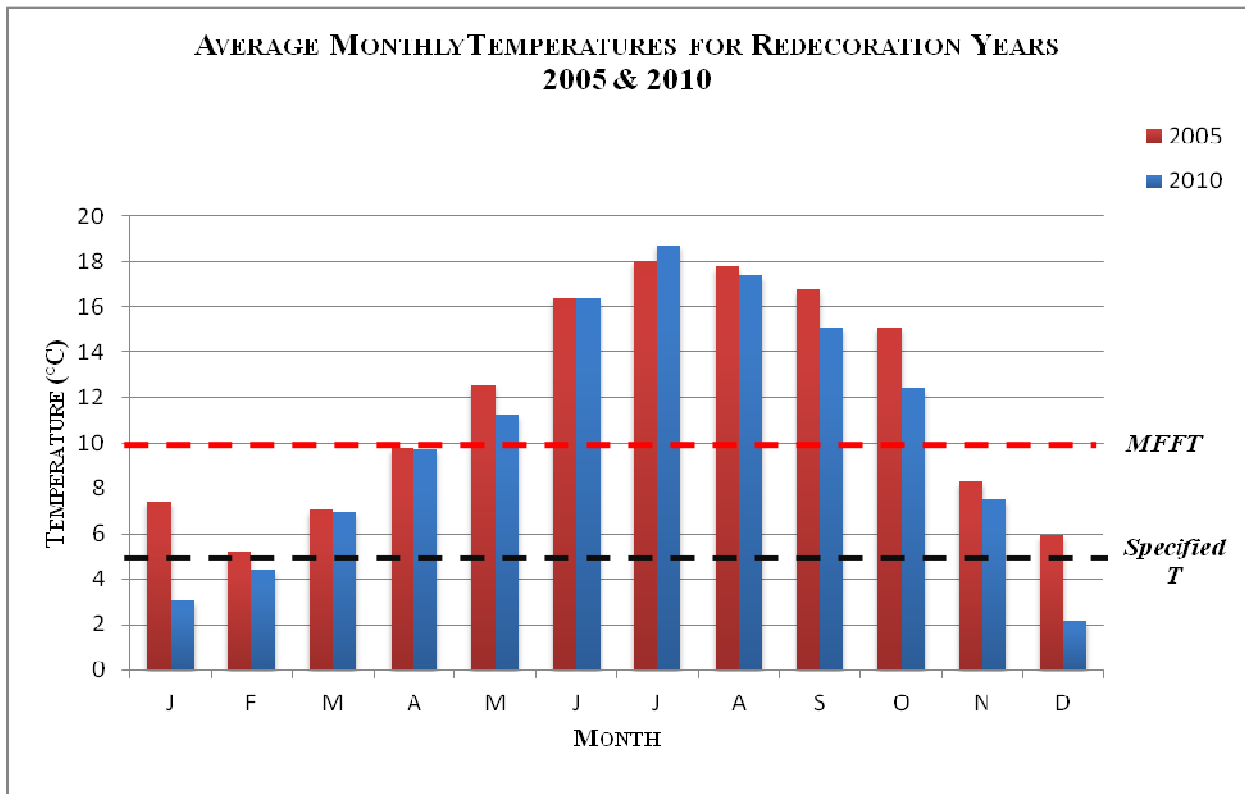
Graph 1: Average Monthly Temperatures for Redecoration Years 2005 & 2010

From Graph 1, it is clear that occasionally, the average temperature was above that directed by the specification, but below the minimum temperature specified in the product data sheet (8°C) and well below the minimum film forming temperature (MFFT), 10°C. These figures do not take relative humidity or sea-spray into account. Graphs 1 to 5 illustrate this data.

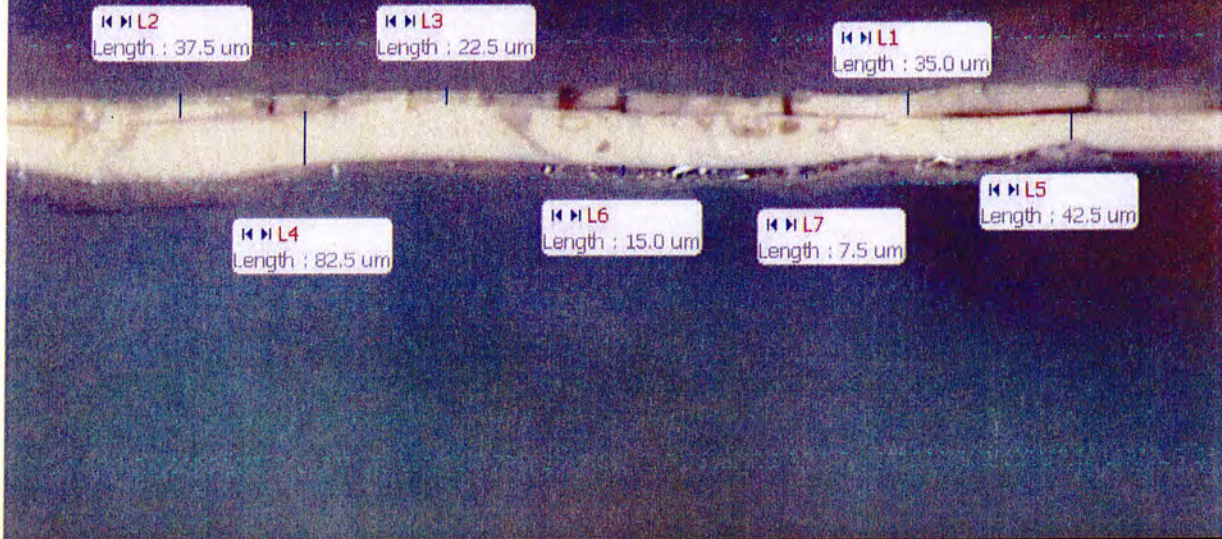
DEC/11/82168.

Cross section of the submitted flake sample shows the most recent application to be firmly adhering to the underlying coating. Cracking evident caused by low temperature during the drying process which does not allow the film to form properly and will allow moisture ingress.
